# RESERVE STUDY

**Plum Creek Condominium Association  
13913 Camelot Dr.  
Sterling Heights, MI**

**Date of Inspection: 8/15/2018**

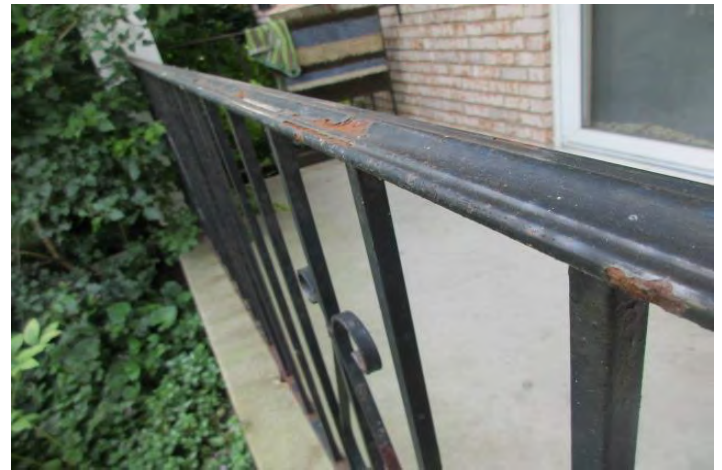
Example of chipped paint and metal oxidation at a top rail

Engineering Narrative
The paint finishes of the metal railings, located at the balconies of the apartment style buildings, are of an unknown age, and they are in an overall fair condition. Per the current condition, we recommend for paint finishes in 2020, in 2 years. With an average useful life of 6 to 8 years, and per request of the property manager, subsequent paint applications are planned every 6 years after. Paint applications are not included in 2032, when railing replacements are recommended.

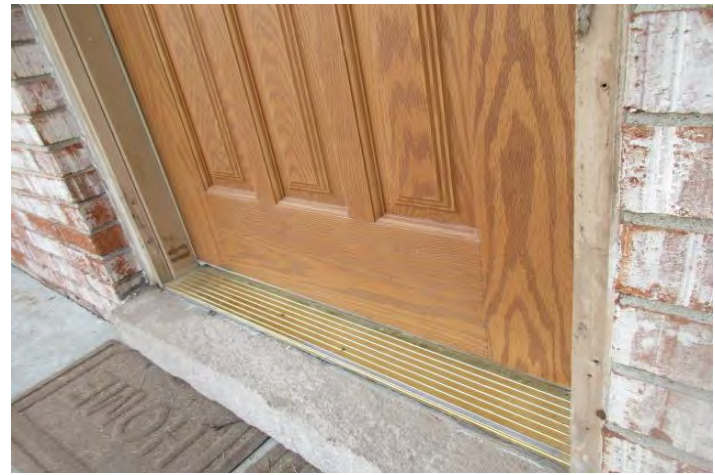
Isolated condition of a door that has been replaced with a finish that does not match other entry doors

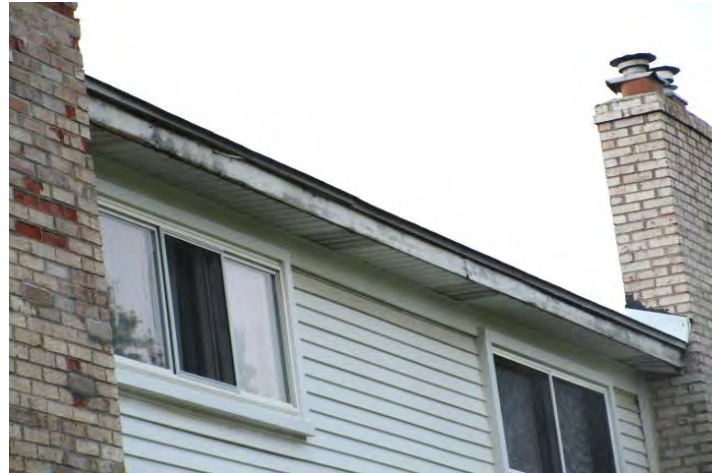
Isolated condition of missing gutter and fascia

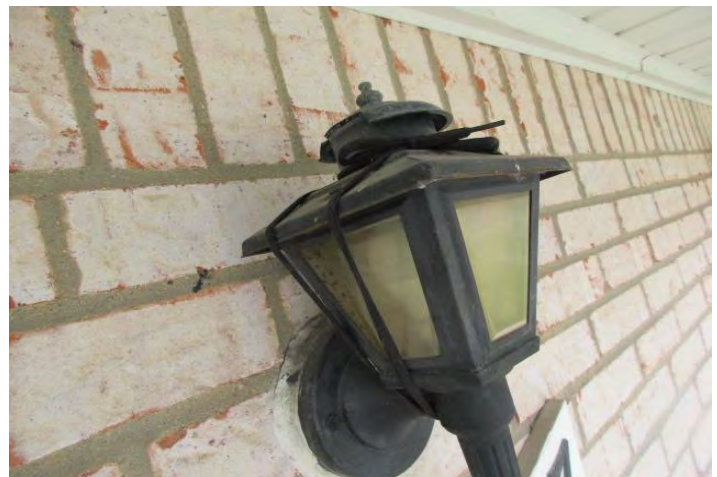
Isolated condition of a damaged fixture

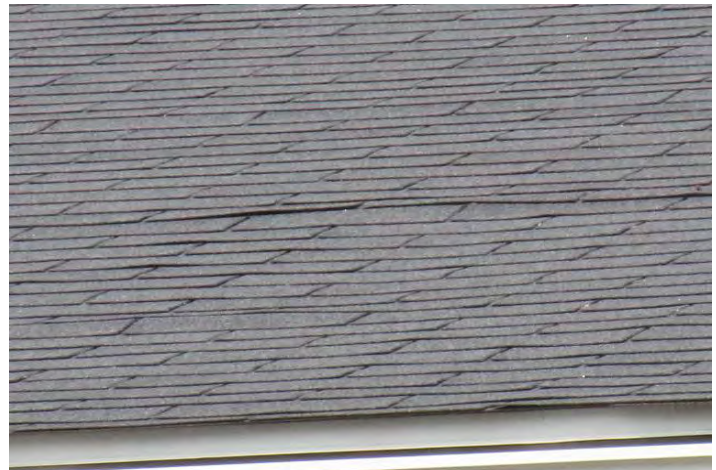
Isolated condition of shingles that have some "lift"

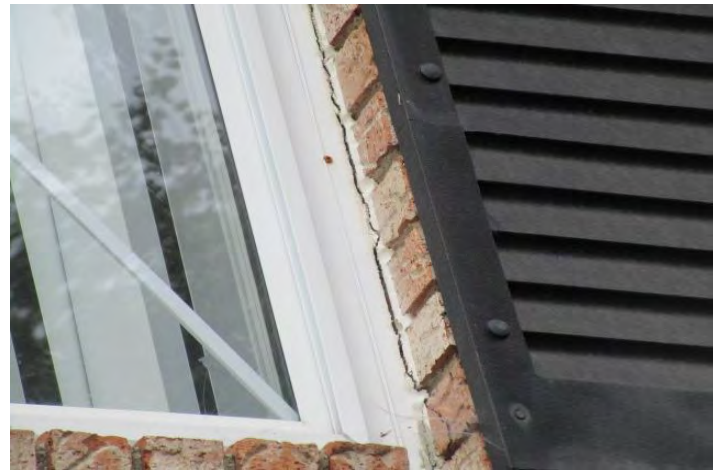
Isolated condition of a crack in the sealant of a window jamb

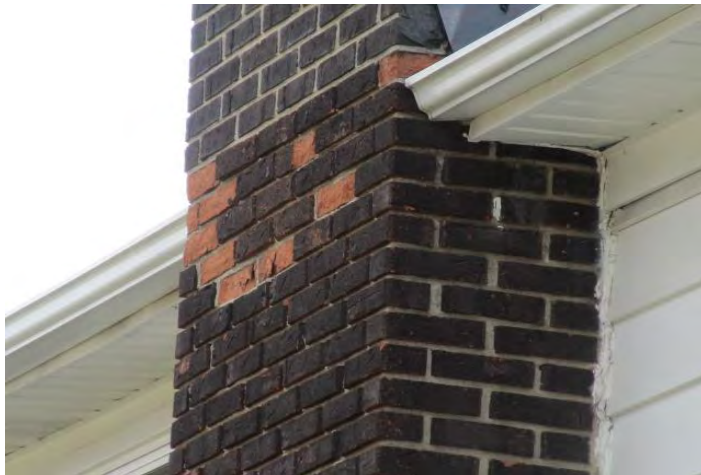
Overview of spalled faces at masonry bricks

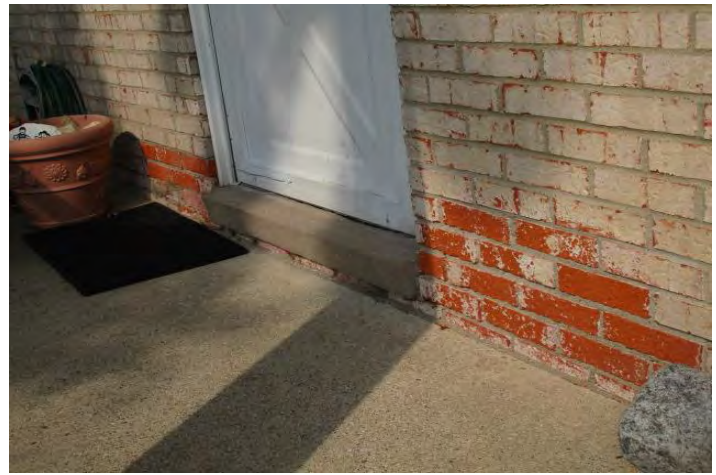
Overview of spalled faces at masonry bricks

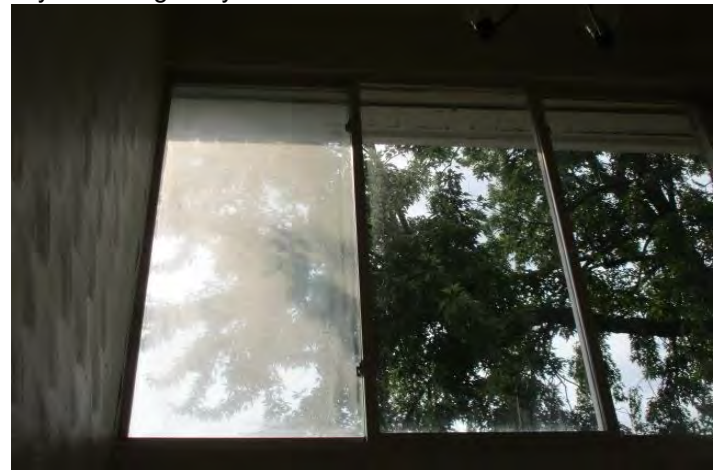
Isolated condition of a common area window that has a broken seal

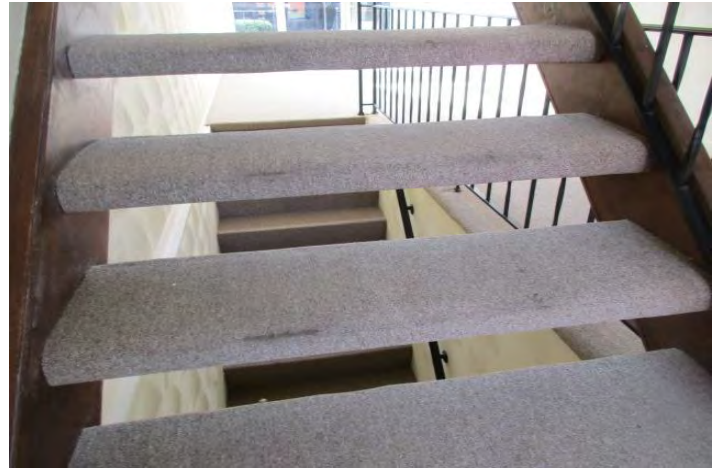
Example of worn carpet at stair treads

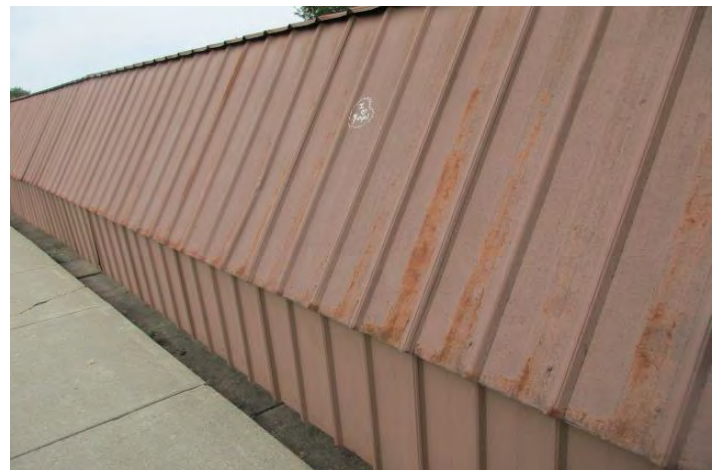
Isolated condition of oxidation at the roof of a carport

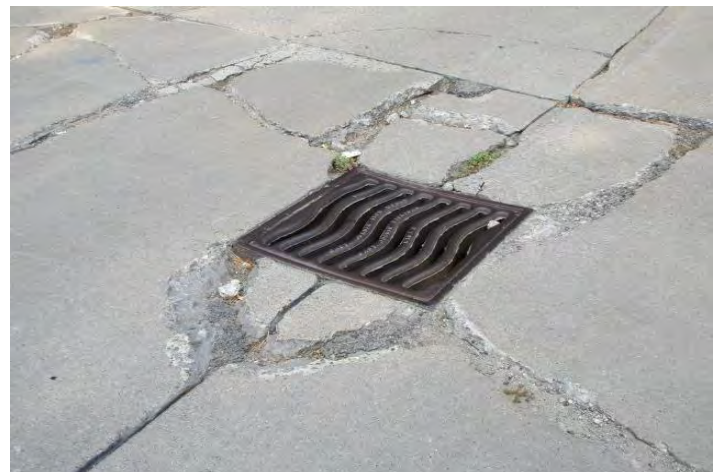
Isolated condition of damaged concrete around a catch basin

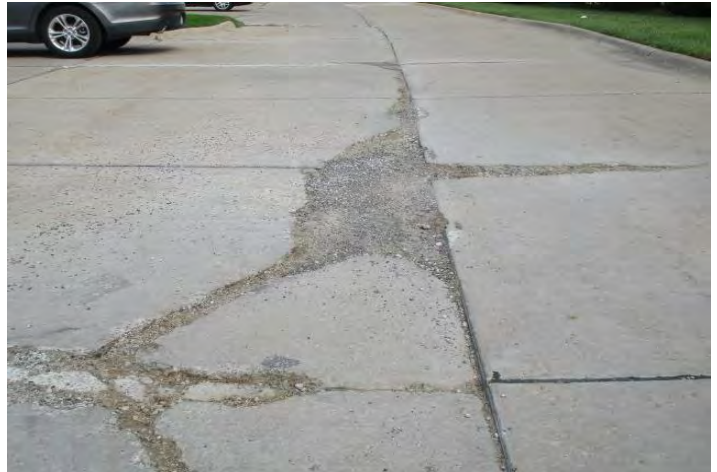
Example of typical damage found through out the property

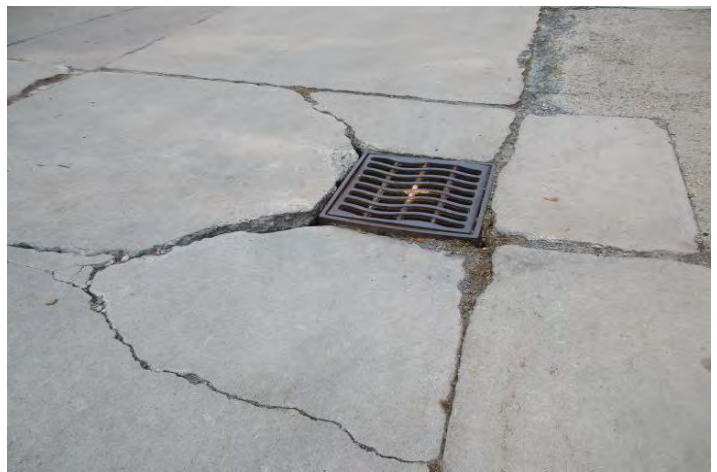
Isolated condition of damaged concrete around a catch basin

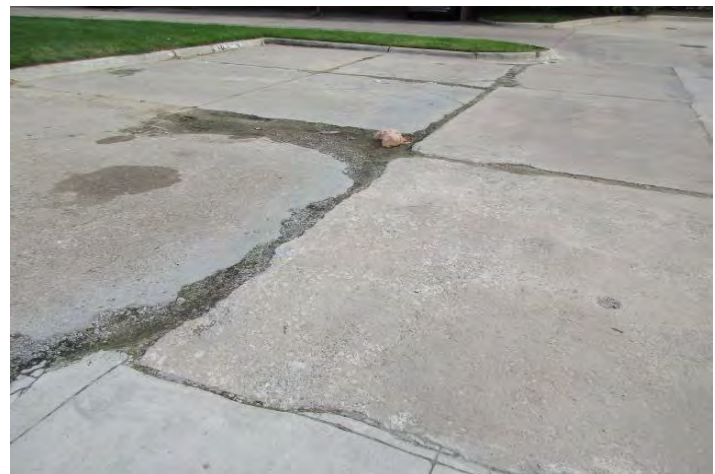
Example of typical damage found throughout the property

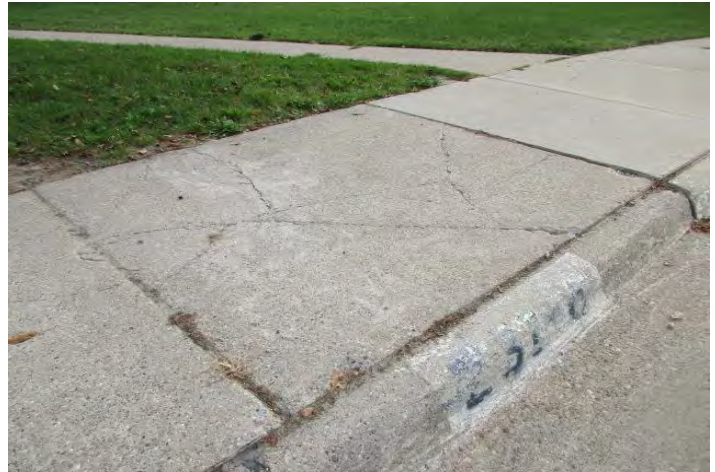
Isolated condition of cracks in a section of sidewalk

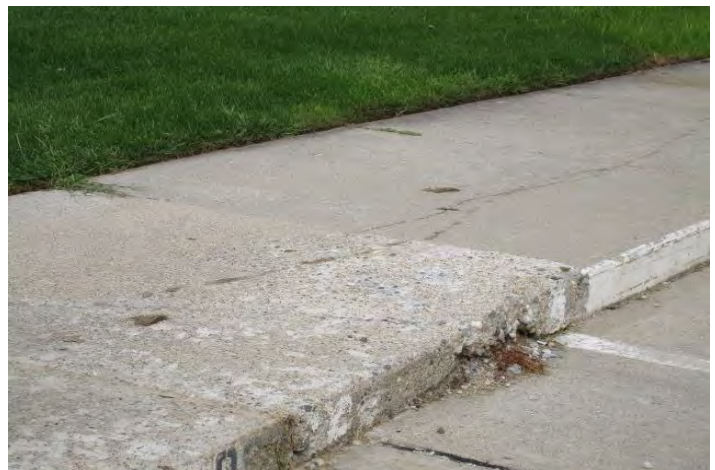
Isolated condition of surface spalling at a portion of sidewalk

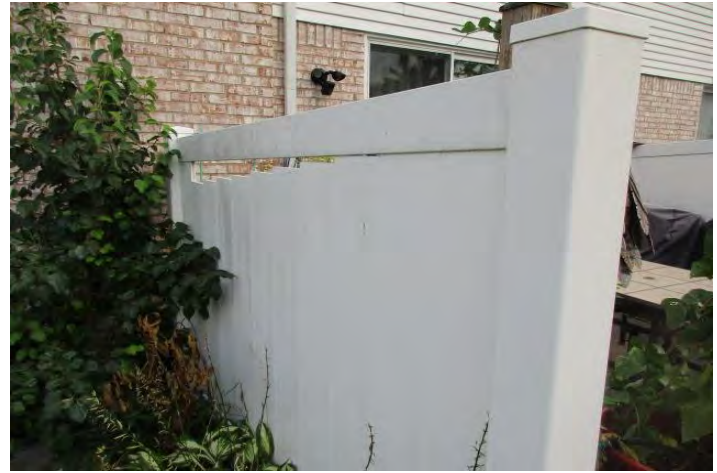
Isolated condition of a damaged privacy fence

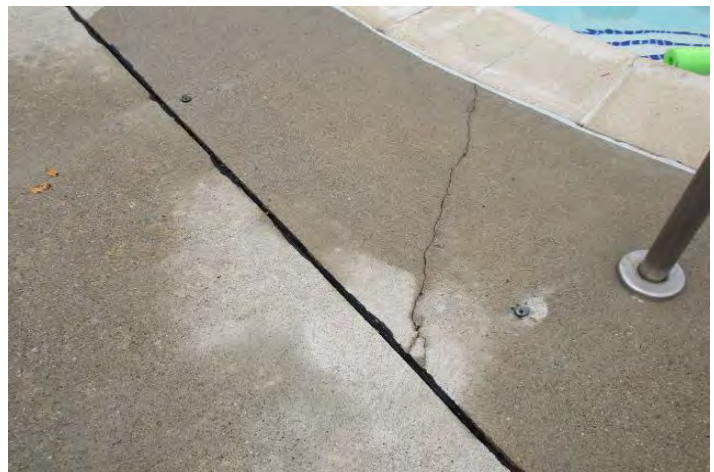
Isolated condition of a crack in the concrete deck

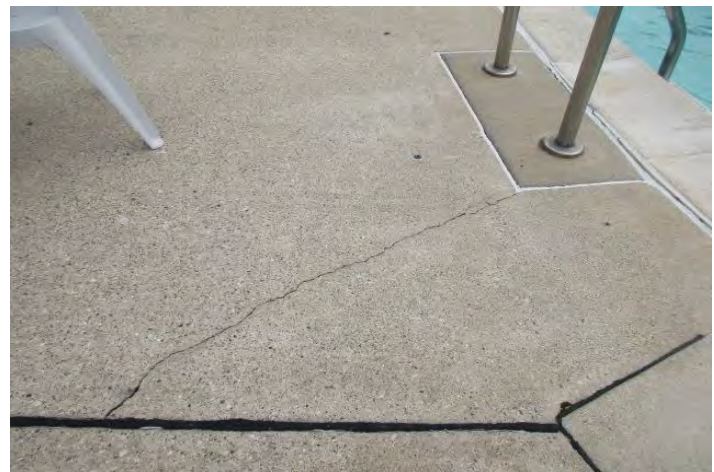
Isolated condition of a crack in the concrete deck

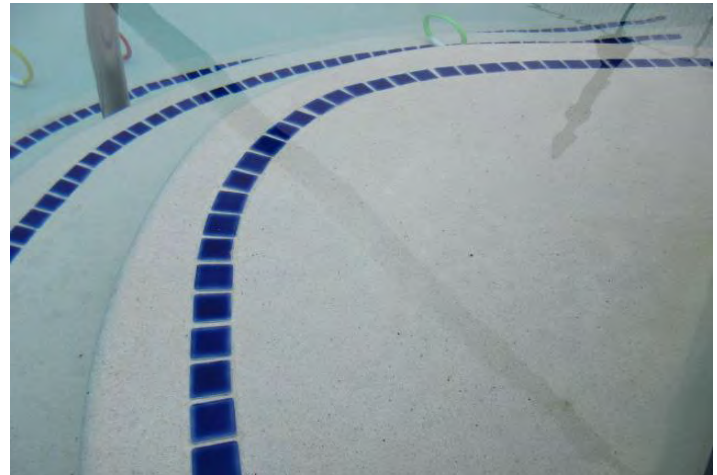
Paint finishes at the pool are in fair condition
