# I.Q. Home Inspections L.L.C.

## SUMMARY REPORT

**Inspection Address:** 4729 E Gatewood Rd, Phoenix , AZ 85050  
**Inspection Date:** 9/11/2014 Start: 12:00 pm End: 3:30 pm

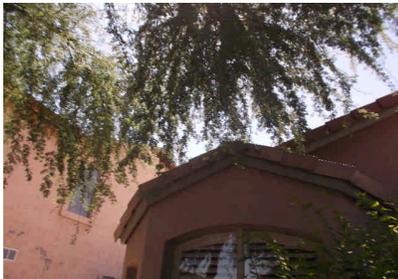
- 1.1 - A tree limb is threatening the roof and eaves, and should be trimmed or removed before it damages the roof or eaves.

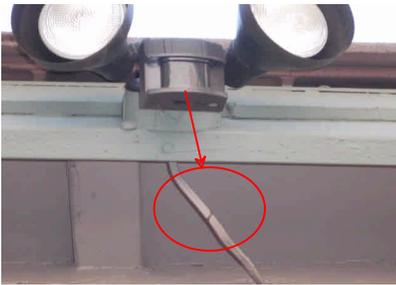
- 1.5 - Electrical Conditions:  
There are exposed electrical conductors. Current industry standards require that exterior conductors be placed in a protective conduit and you may wish to have further evaluated and serviced as necessary. Located at front spot lights above garage.

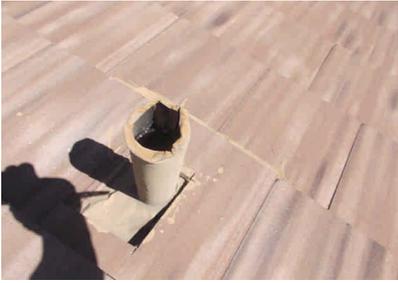
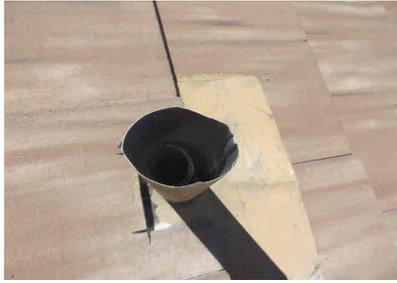
- 3.2 - The flashing around several plumbing vent pipes are not terminated correctly and should be serviced to forestall moisture intrusion. (top of flashing not bent over into vent pipe)

Plumbing vent - Not terminated correctly - *Continued*

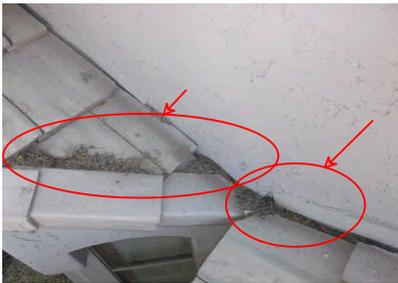
3.3 - The front valley flashing's need to be cleaned and kept clean to help forestall moisture intrusion and to promote proper drainage.

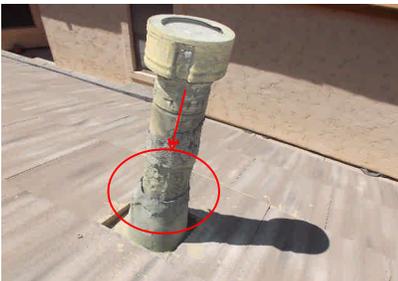
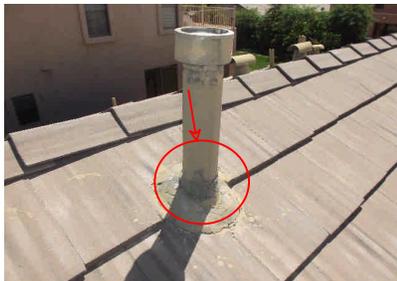
3.4 - The roof flashings/ flue pipes need to be sealed or serviced. They are comprised of metal that seals valleys and vents and other roof penetrations, and are the most common point of leaks. This is particularly true of the flashings on a layered roof, which are covered by the roofing material and which are even more susceptible to leaks.

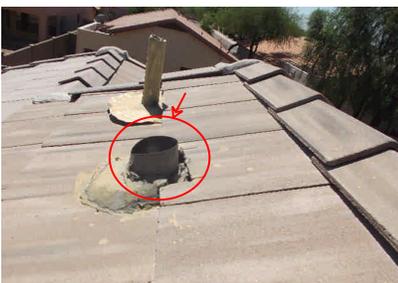
3.5 - The master bathroom exhaust vent pipe T-Top is absent and should be installed to prevent moisture intrusion.

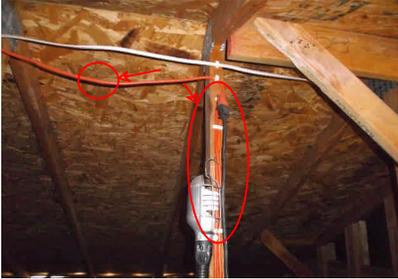
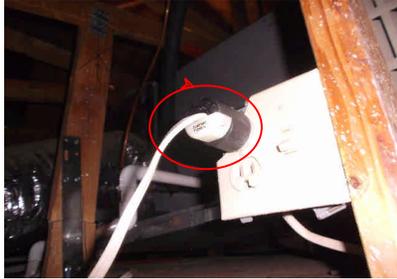
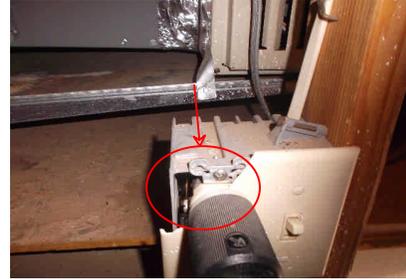
4.1 - The following was observed.

- Extension cord used to power portable light fixture at North end of garage attic. Cord not rated for this type of application.
- Atypical installation of Non metallic sheathed cable (Romex) spliced into plug.
- Damaged outlet cover plate noted by South garage attic access.

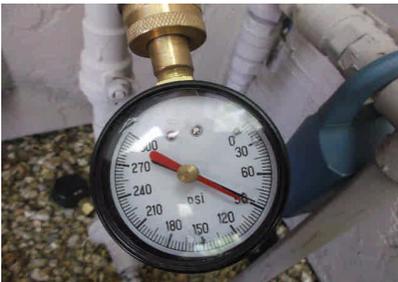
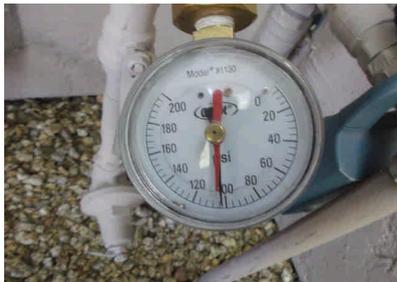
5.1 - The pressure at the distribution shut off is too high (90 - 100 psi) and will stress components of the system. A licensed plumber should reduce the pressure at the regulator to sixty pounds per square inch, which is optimum. However, the regulator may have failed and would need to be replaced.

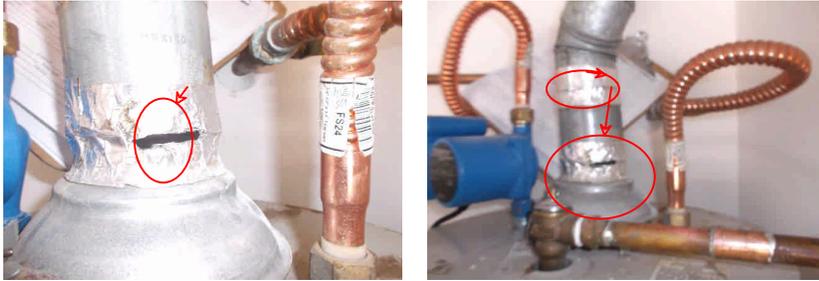
5.3 - The vent pipe is not well seated, and should be serviced. Manufacturers and current industry standards require that the draft diverter be secured to the top of the water heater and all flue pipe connections be secured with machine screws.

The bottom of the flue pipe is not attached/ screwed to the draft diverter and all connections should be screwed together.

Not well seated - *Continued*

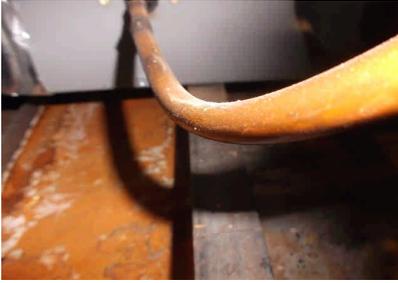
- 8.1 - There is evidence of rust in drip pan and may indicate a blockage in the primary condensate line or improper drainage at one time. We recommend the further review, by an HVAC technician or we recommend consulting with the homeowner.

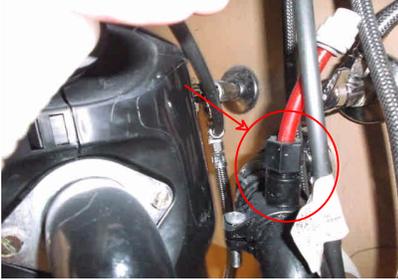
15.1 - The following was observed:

- The discharge/ waste line from the removed RO system is connected to the waste side of the drain line and should be installed before the drain trap.

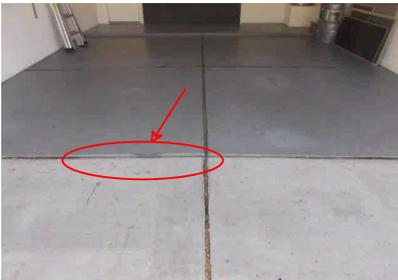
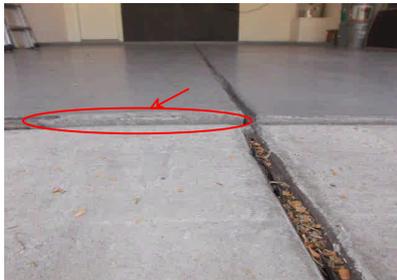
17.1 - the following was observed:

- The slab floor has lifted at the edge of the driveway which could be a trip hazard.

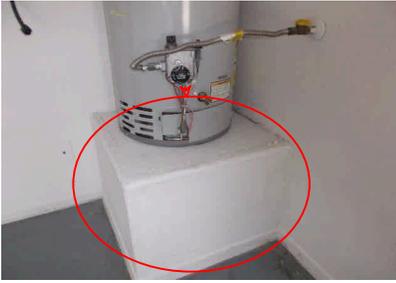
17.2 - There is moisture staining/damage that is likely from a previous water heater, no detectable moisture present at this time.  
We recommend consulting with the homeowner.

**Moisture stain - Near water heater - *Continued***

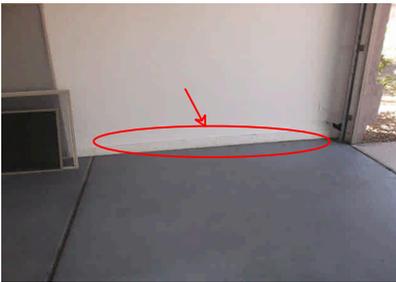
- 17.3 - There is a moisture stain, the cause of which should be explained by the sellers or explored further.
- Along base of West wall. Moisture detected with moisture meter.
  - Monitor West wall of garage particularly during prolonged rains.

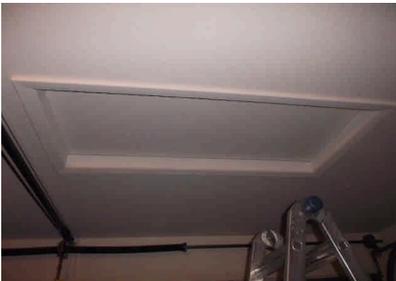
- 17.4 - The wooden hatch cover at North end of the garage to the attic area should be sheathed with metal or drywall in order to provide a firewall separation between the garage and the residence.

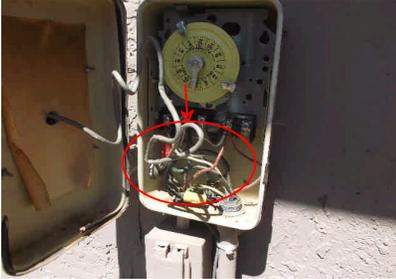
18.6 - The pool timer box is missing the interior safety cover.
