WOOD DESTROYING ORGANISM

FEB 04, 2021

3924 COLONY COVE TRAIL
JACKSONVILLE, FLORIDA 32277

WOOD-DESTROYING ORGANISMS INSPECTION REPORT

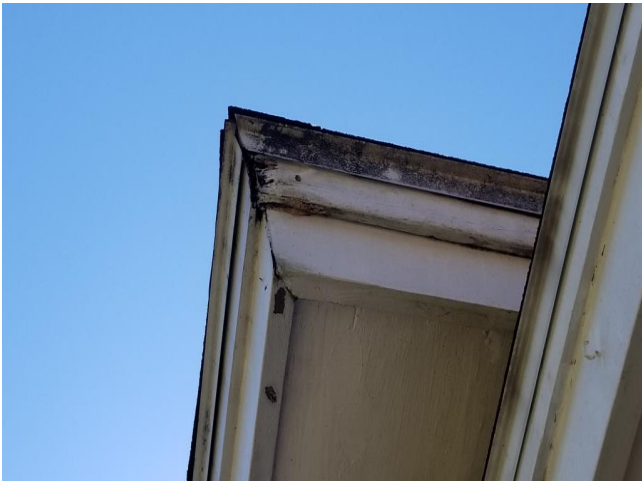
- Wood decay damage to window shutter on front of garage.
- Wood decay damage to fascia on front right corner of front porch. Upper level roof return also decayed above this area.

Fascia R side front porch

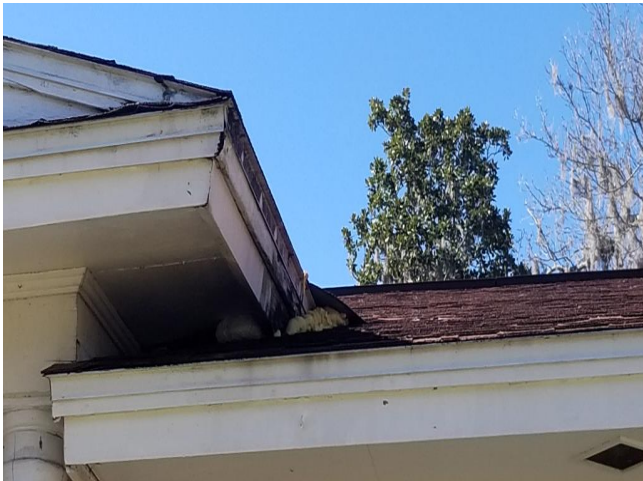
- Wood decay damage to all front porch columns.
- Wood decay damage to upper roof return area over left side of front porch.
- Wood decay damage to bottom level siding over front porch, below the gable vent.

Roof return over front porch

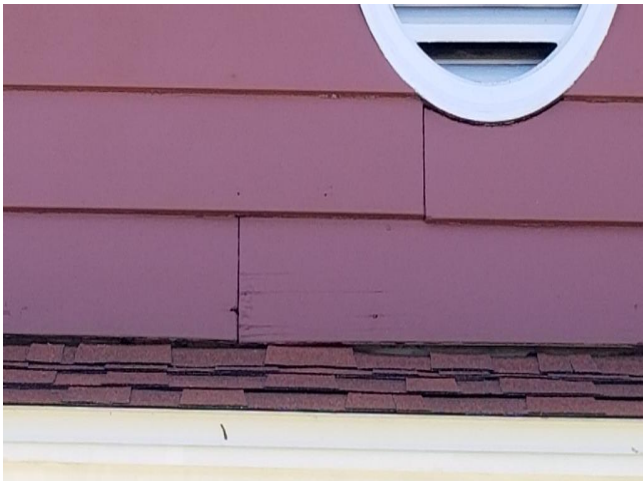
Siding over front porch

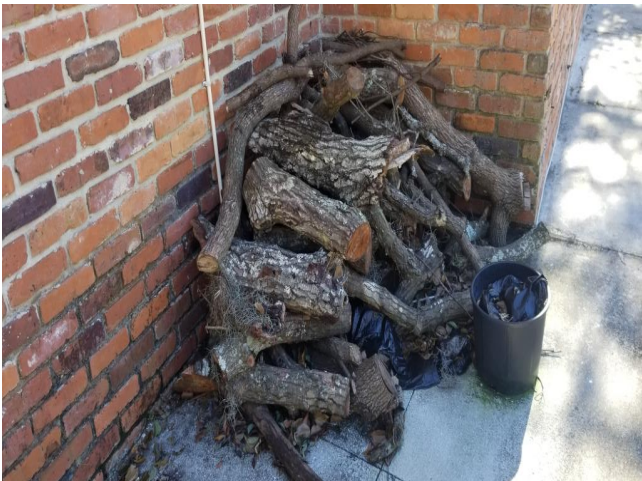
- Live squirrel observed in attic at time of inspection. Lead stack chewed up on the roof.
- Suspected rodent entry points at both roof returns on either side of front porch.
- Firewood pile stacked against back of home should be removed immediately.
- Dense palm vegetation on left side of home should be trimmed away from home or removed.

Remove pile

A wood/debris pile, on, or close to the ground, was observed near your house. This pile could not be fully inspected. We recommend that it be removed because it represents conditions which are conducive to Subterranean Termite Infestation in the adjacent structure. If, upon the removal of this firewood/debris pile, live Subterranean Termites are discovered, we would recommend that the structure adjacent to the wood pile be treated for Subterranean Termites. This treatment should be done by a company licensed to do so by the State of Florida, and should result in a warranty on the entire structure.

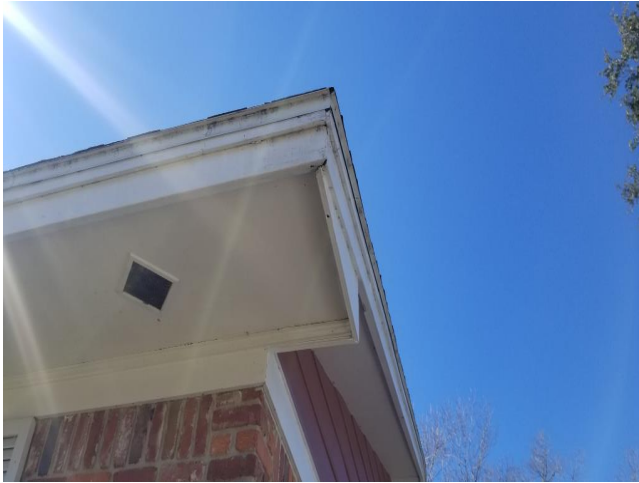
- Wood decay damage to bottom left side of garage door trim.
- Wood decay damage to front right corner fascia/drip edge.
- Wood decay damage to drip edge board on front of garage.

Front R corner fascia

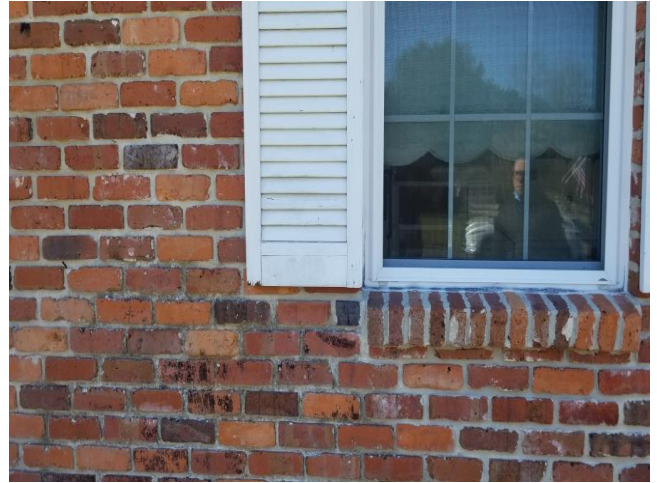
Garage shutter

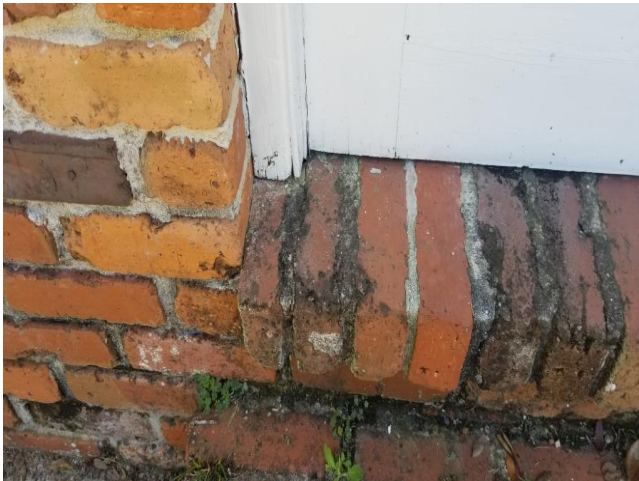
- Wood decay damage to bottom left side of back door trim.
- Wood decay damage to back right corner fascia/drip edge if facing home from street.

Back door

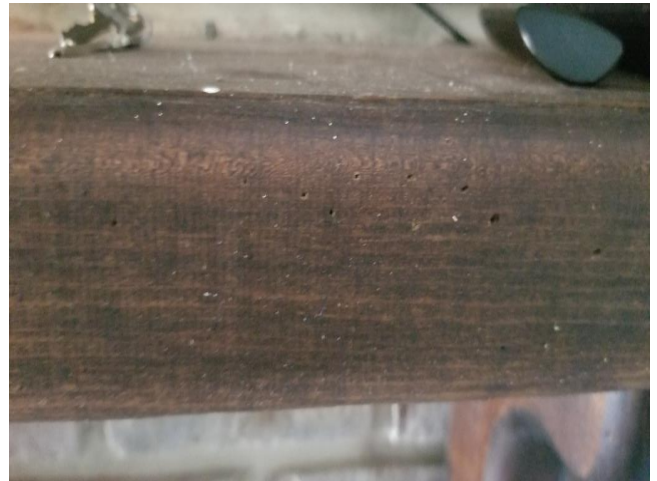
- Wood decay damage to garage interior baseboard at garage door. If facing garage from driveway this is on the left.
- Powder post beetle damage (exit holes) to fireplace mantle.

Powder post

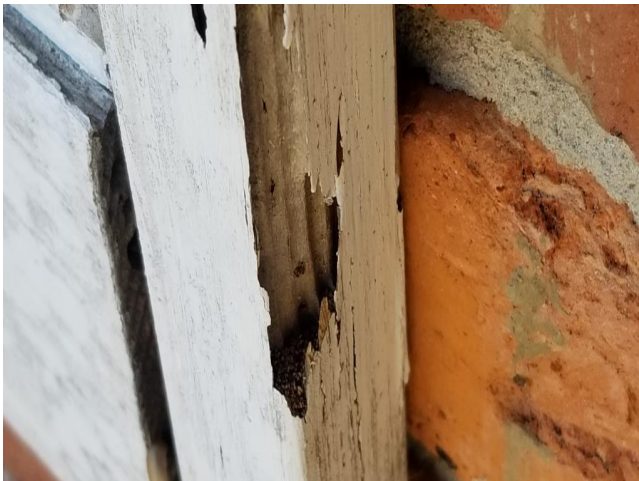
- Drywood termite frass found in front bedroom window shutter on front of home.
- Powder post beetle exit holes in the fireplace mantle.

- Drywood termite damage to window shutter on front of home, left of front porch.
- Wood decay damage to front left corner fascia/drip edge.
- Wood decay damage to back left corner fascia if facing home from street.

Drywood damage front shutter

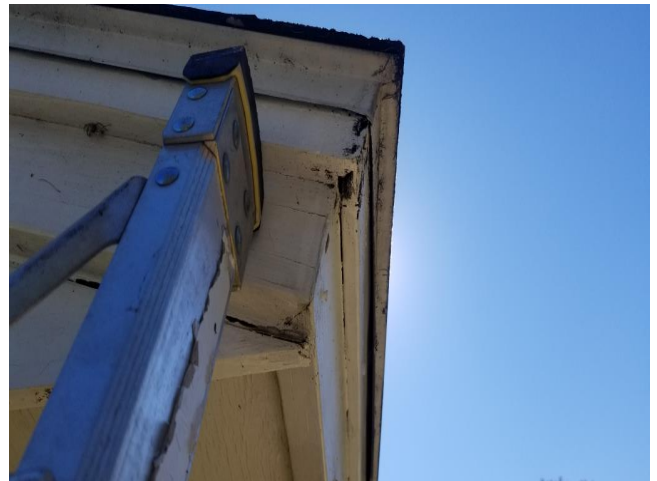
Back R corner

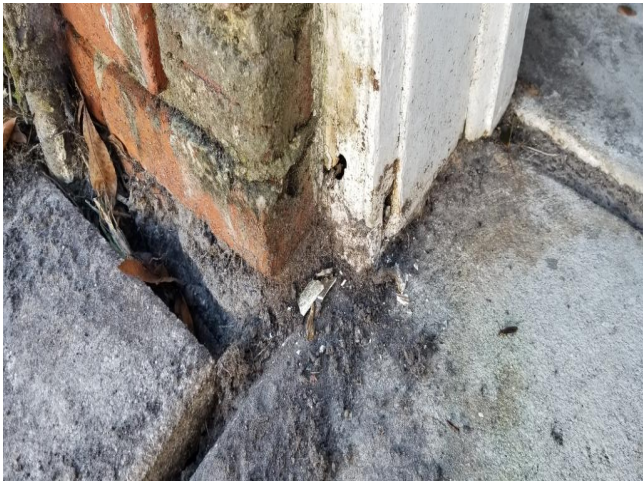
Garage door trim

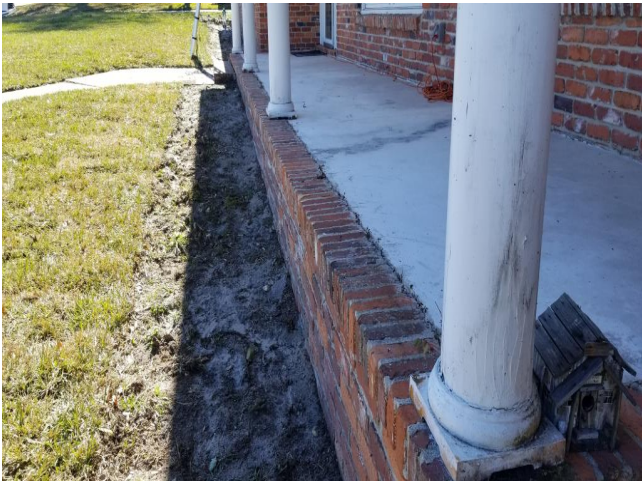
Columns

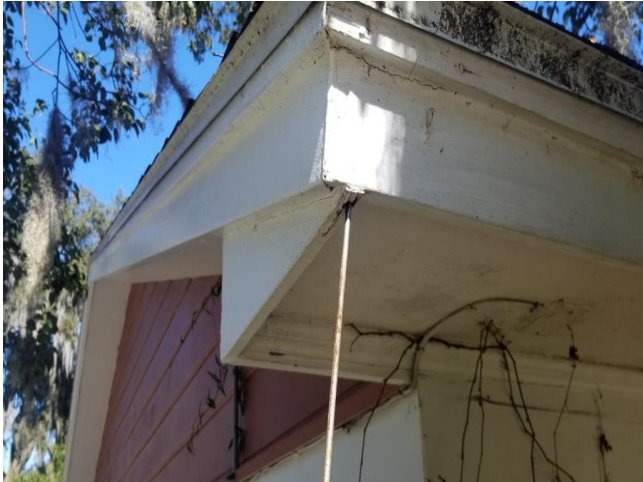
Back L corner

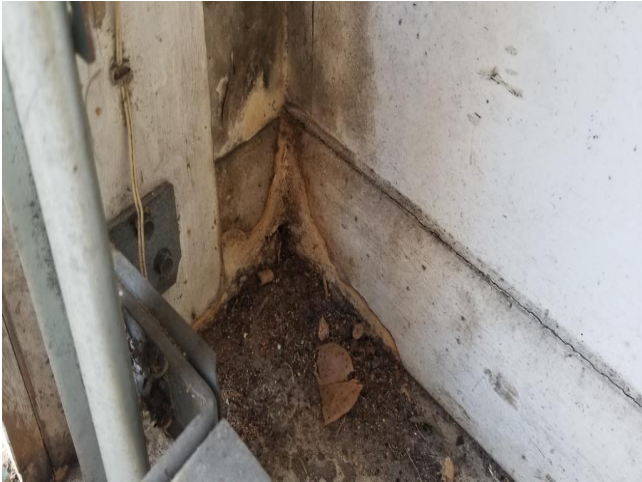
Garage interior

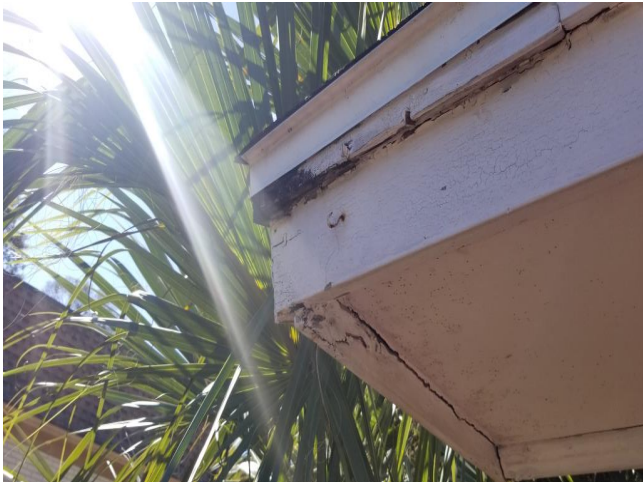
Front L corner

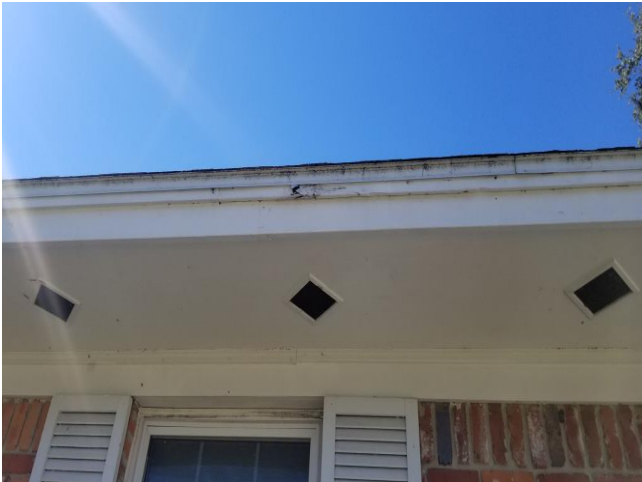
Front drip edge along garage
