Fire unchecked

Fire spreads in South America's tallest high-rise building in Caracas, Venezuela, because its sprinkler system had not been properly tested or maintained.

By **Jaime A. Moncada, P.E.**

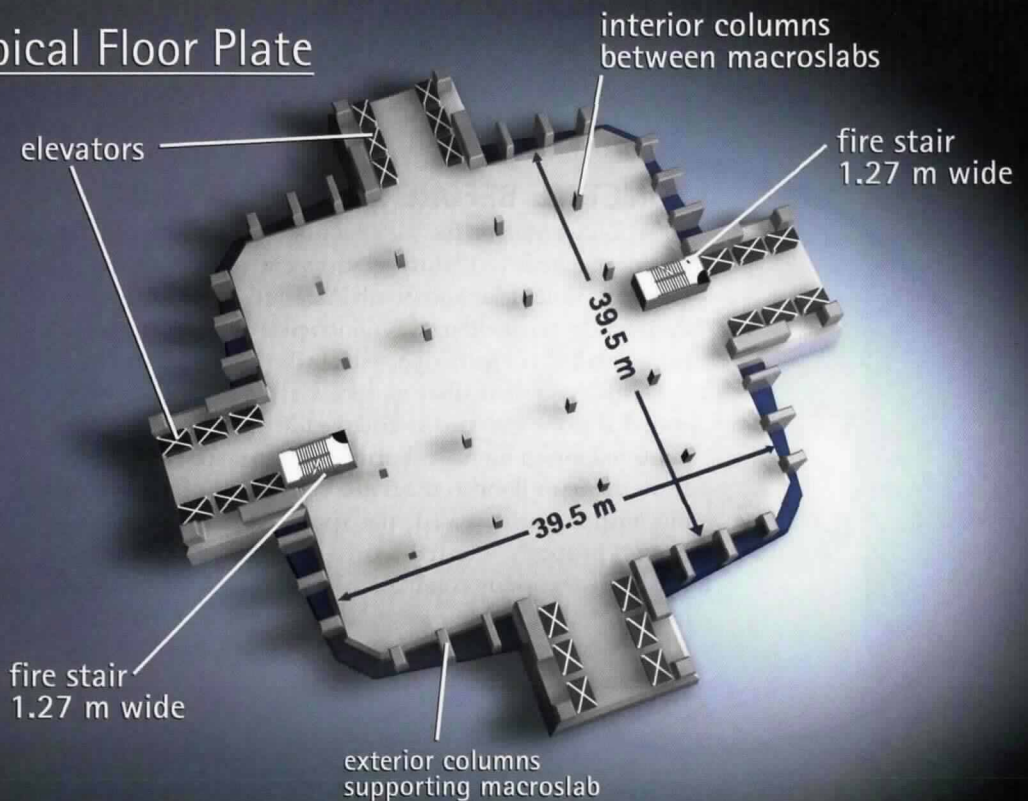
Typical Floor Plate

complex known as Parque Central, which was built between 1970 and 1982. The complex also contains more than 1,100 retail stores, seven 40-story residential towers, and a 35-story hotel. The East Tower has 56 floors above ground and 4 underground, with a total height of 725 feet (221 meters). Each floor plate covers an area of 20,450 square feet (1,900 square meters) that includes eight elevator banks and two enclosed, remote fire exit stairwells (see floor plan).

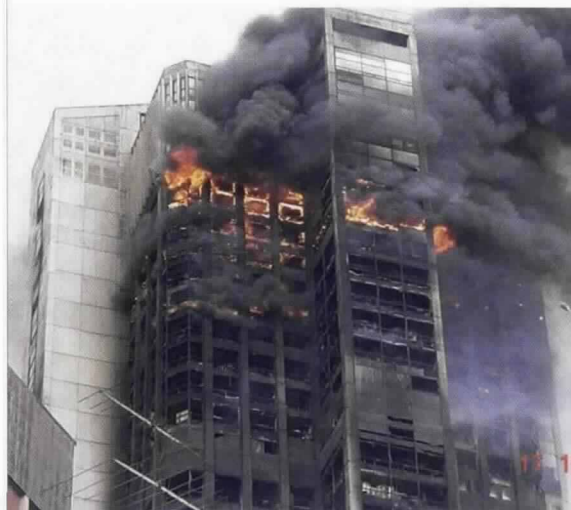
Top photograph shows the fire reaching the 47th floor of the Parque Central in Caracas, Venezuela. The middle photograph shows one of the last attempts by the government helicopters to cool down the fire using water-filled buckets. The bottom photograph shows an image taken by retreating fire personnel as they left the partially collapsed 35th floor.

3:08 pm—Fire reaches the 47th floor.

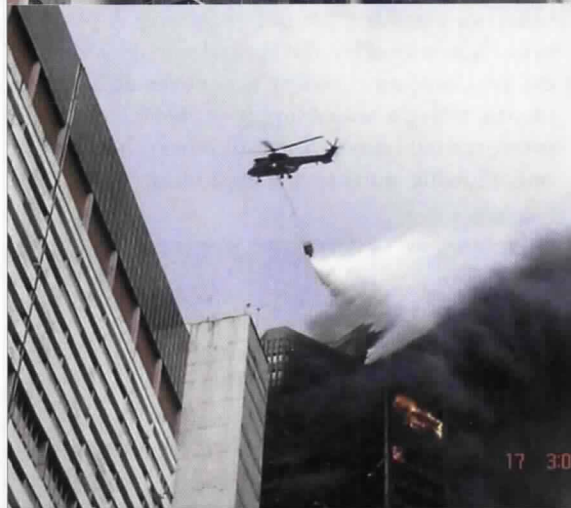
3:07pm—one of the last attempts by government helicopters to cool down fire using buckets.

The fire continued to move upwards through the afternoon, at a rate of about 2 1/2 floors per hour. Between 2 and 3 p.m., the Venezuelan government began using helicopters with water buckets, commonly used on forest fires, in an unsuccessful attempt to slow the fire down.

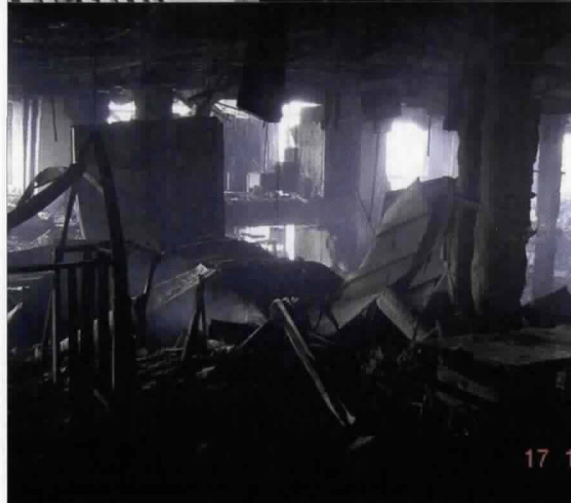
Five structural bays rest on four lines of columns in each direction supporting the steel deck. In effect, the concrete structure includes five stacked steel buildings, each supported by a macroslab. During the fire, two steel decks partially collapsed; other than that, there was no collapse inside the building. However, deflection in some steel beams was severe.
