By **Eduardo Alvarez, SFPE** and  
**Jaime A. Moncada, P.E., SFPE**

## Tragic fire at the Ycuá Bolaños Botánico Supermarket in Asunción, Paraguay

# NO EXIT

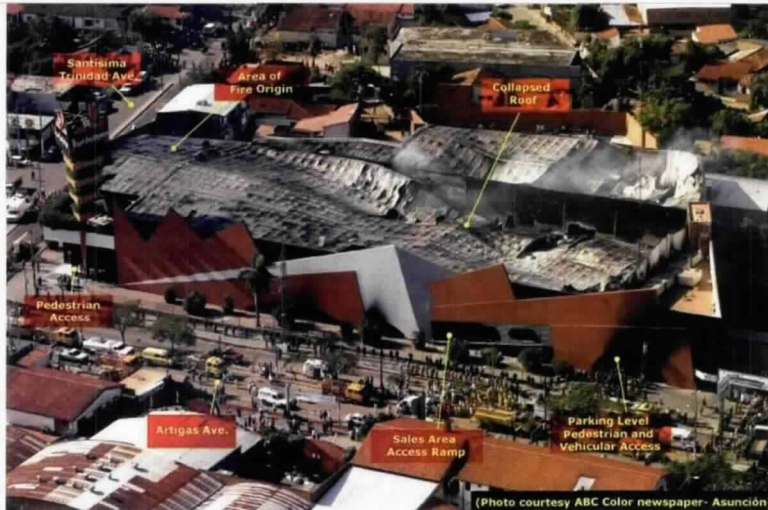
Aerial view of Ycuá Bolaños Botánico

**Most shoppers entered the building through the two vehicle accesses, next to one of which was an open stair and ramp for supermarket carts.**

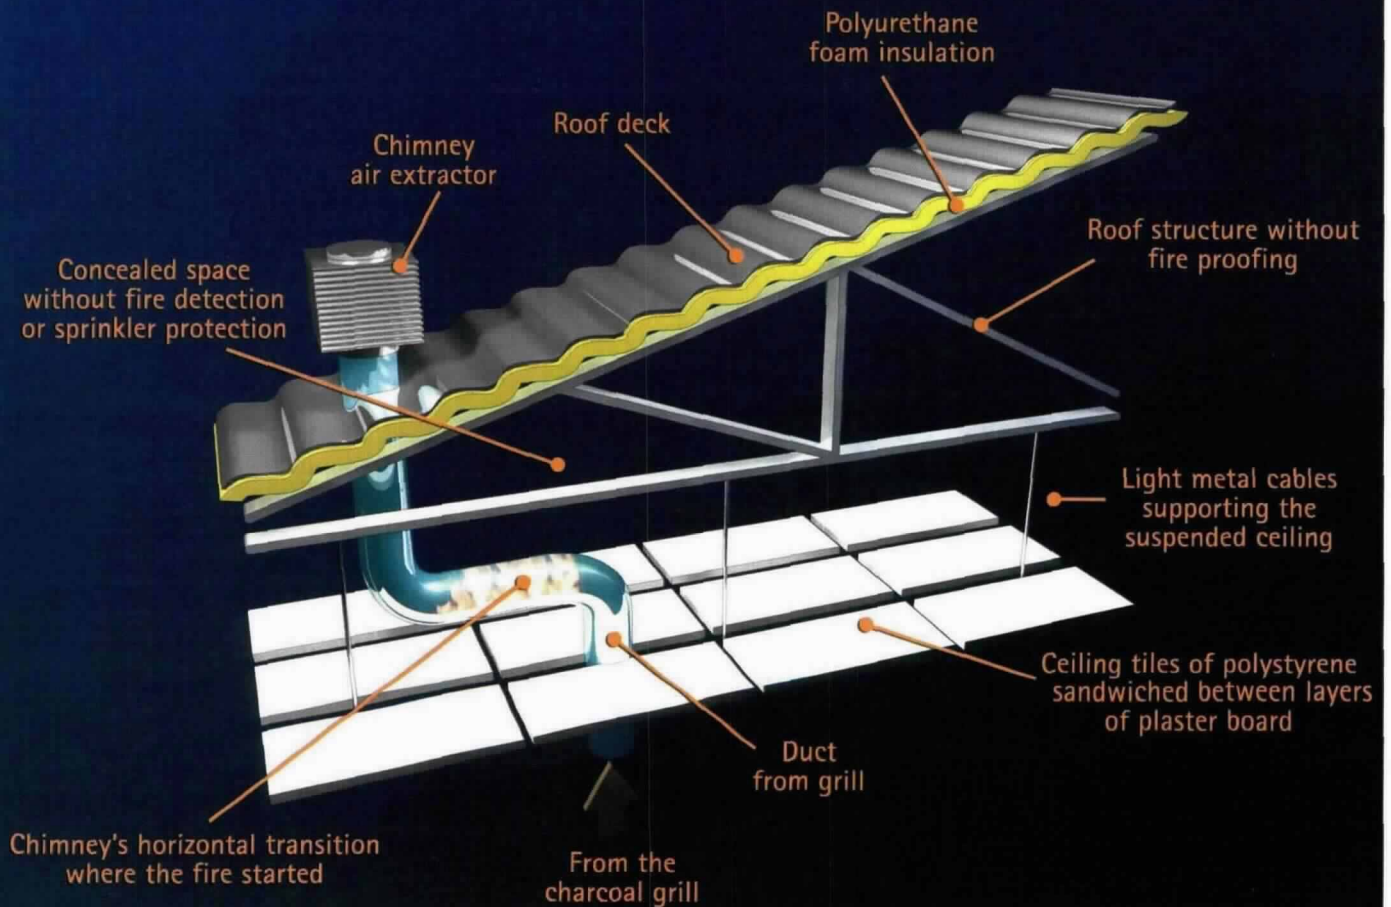
## Sketch of concealed space between roof deck and suspended ceiling

According to the ATF report, the fire was accidental. It started in the kitchen in the horizontal transition of the charcoal grill chimney, where a large accumulation of grease served as fuel load. The heat of the fire melted the chimney's metal bands, allowing the fire, until then confined to the duct, to break through the upper surface of the transition and rise up the pitch of the roof, where it ignited polyurethane insulation and ceiling tiles.

The fire continued to spread through the concealed space between the ceiling and the roof deck in a south-southwest direction, weakening the ceiling supports near the grill. It eventually broke through the ceiling around the grill's chimney on the mezzanine, causing the glass wall separating the food court from the sales area to break. This was the first time customers and employees saw the fire.
