HOW TO PREVENT YOUR BIKE FROM KILLING YOU!

Simon Pellaud, in a recent 9/2019 French pro race, snapped his fork just below the stem. How did this happen and how can you prevent this from happening to you?

During a recent bike fit, a client wanted to invert his stem, changing it from '-10' to '+10'. Simple enough, just unbolt the stem from the handlebars and fork and flip it over. Luckily, by doing this revealed a hidden danger that many bikes are probably suffering from. In this article, I will take you through what I found and the process of how to fix it.

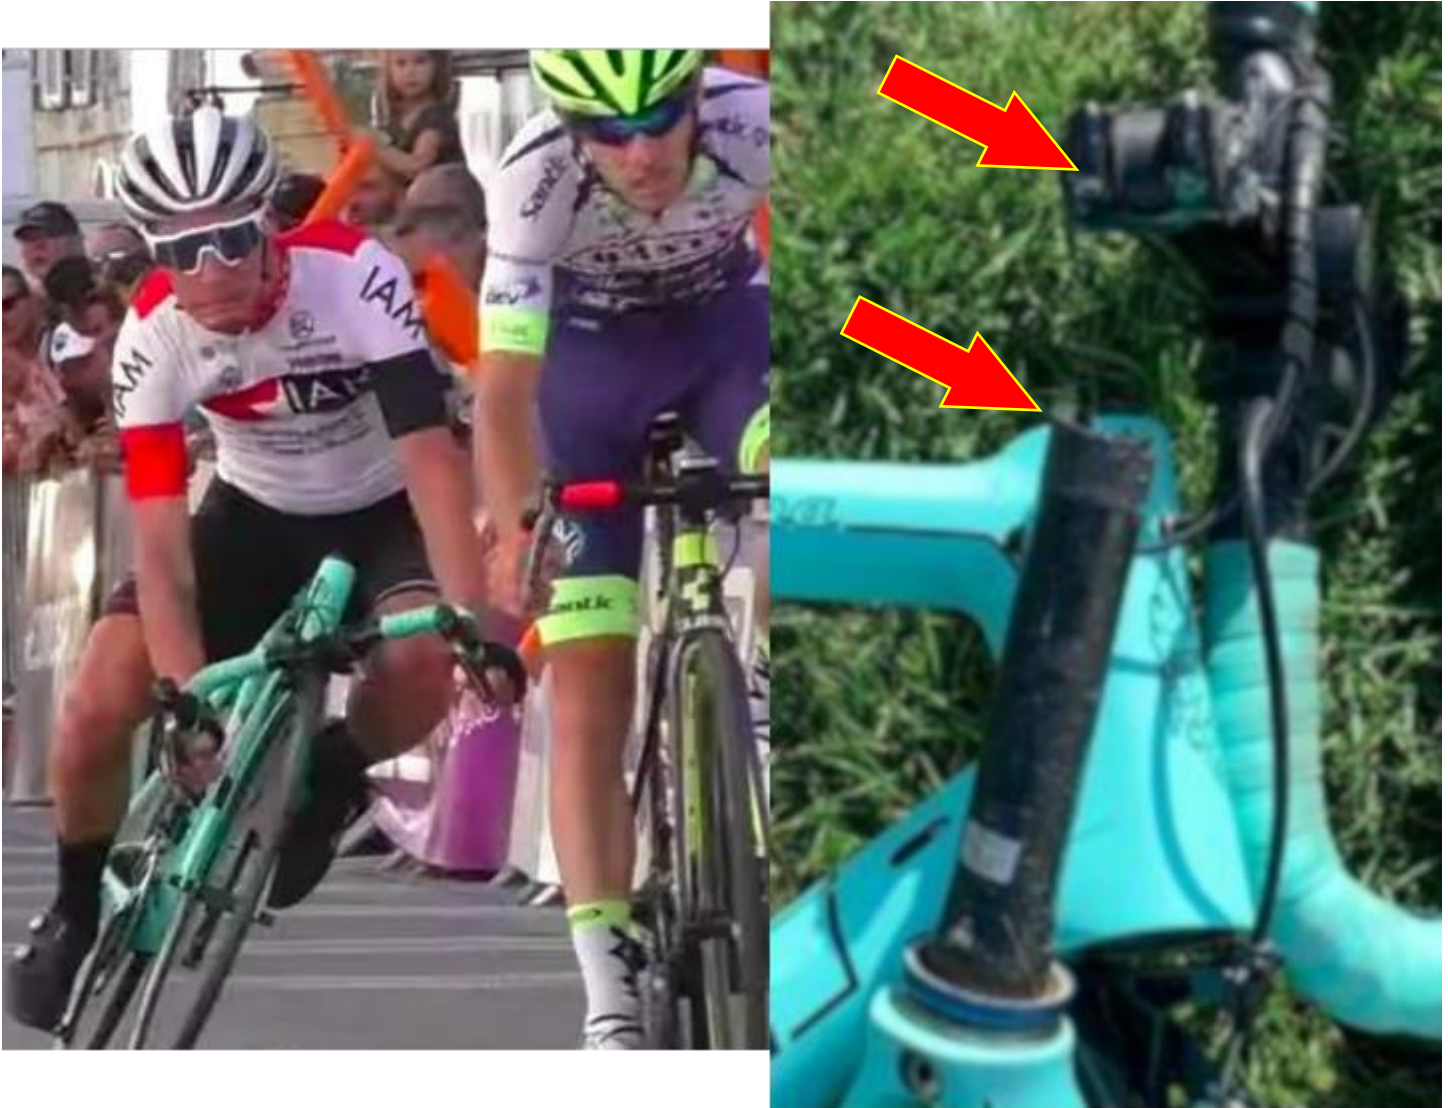
The photo below shows the instant the fork snapped and the condition of the bike after. You can clearly see that the fork snapped at the bottom of the stem. This is where to start the investigation.

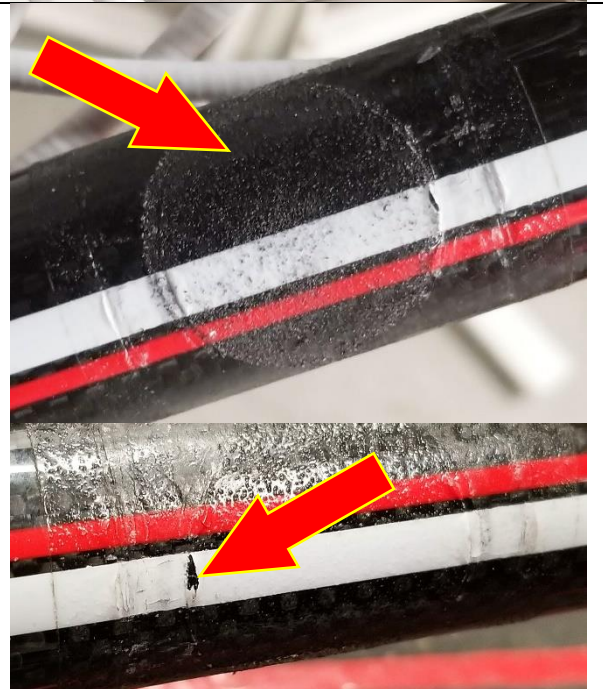
FRONT: Deep impressions in the carbon from the front of the stem.

REAR: Small crack developing.

Both of these caused by stress risers in the stem from the machining process. Eventually, either could lead to total handlebar failure.

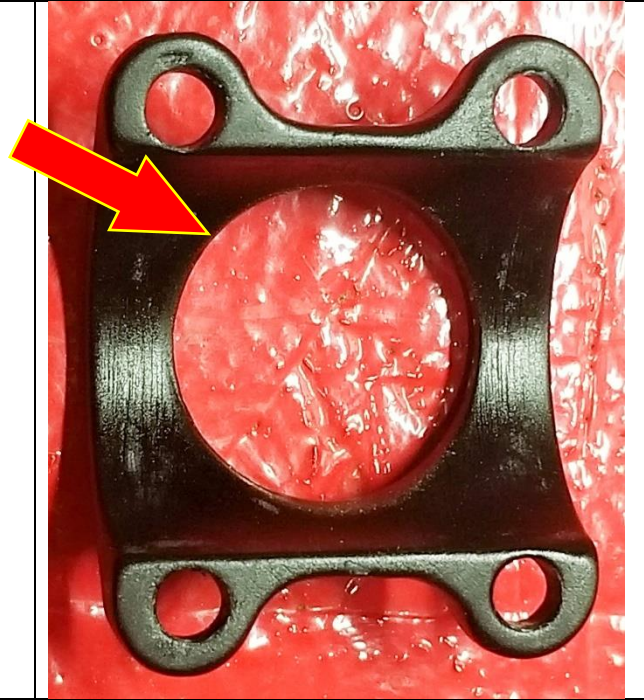
Here's the culprit. Sharp edges from machining.

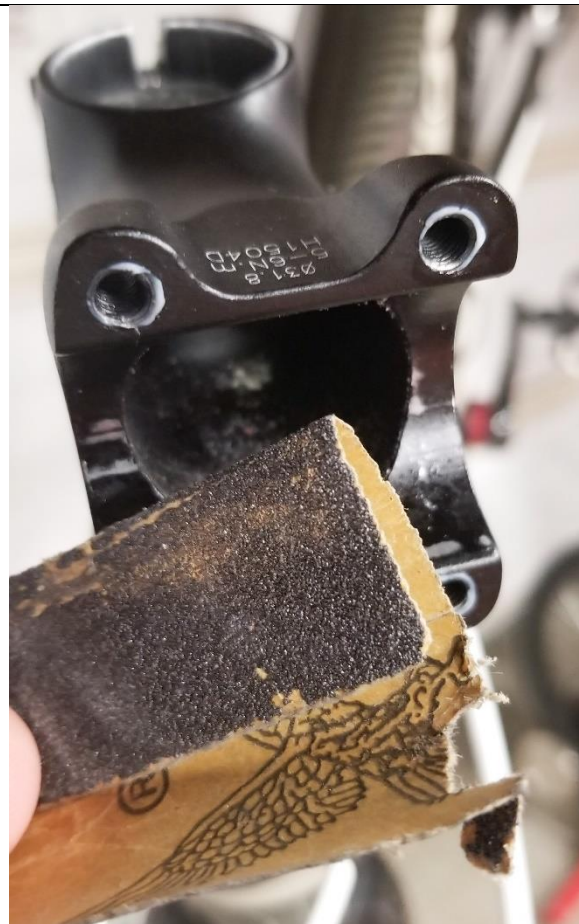
More sharp edges, time to sand.

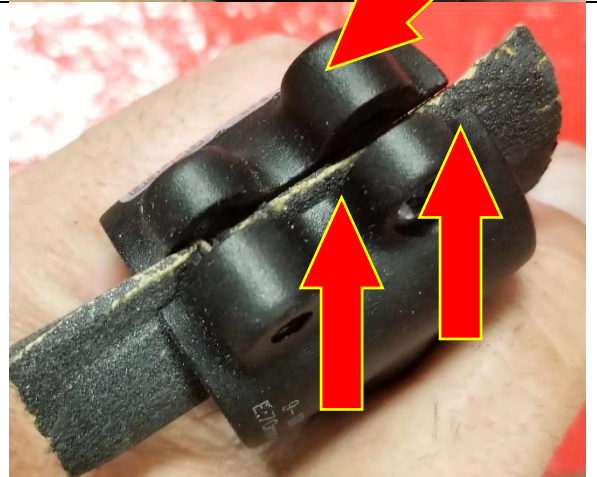
The real problem, hard to reach area along machined edge. Make sure you don't forget this area. Slip sandpaper inside slot so you can be sure to remove all burrs and sharp edges.

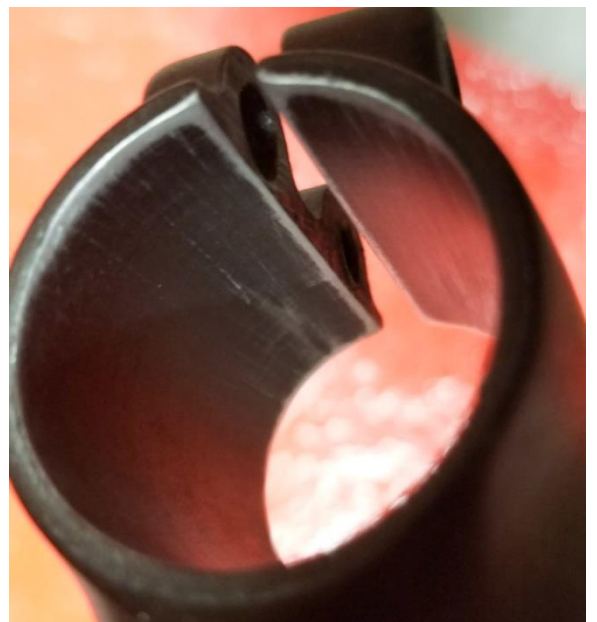
TOP: The inside edge from here to here was VERY SHARP and is what caused the crack to form.

BOTTOM: Post sanding smooth as a baby's rear end!

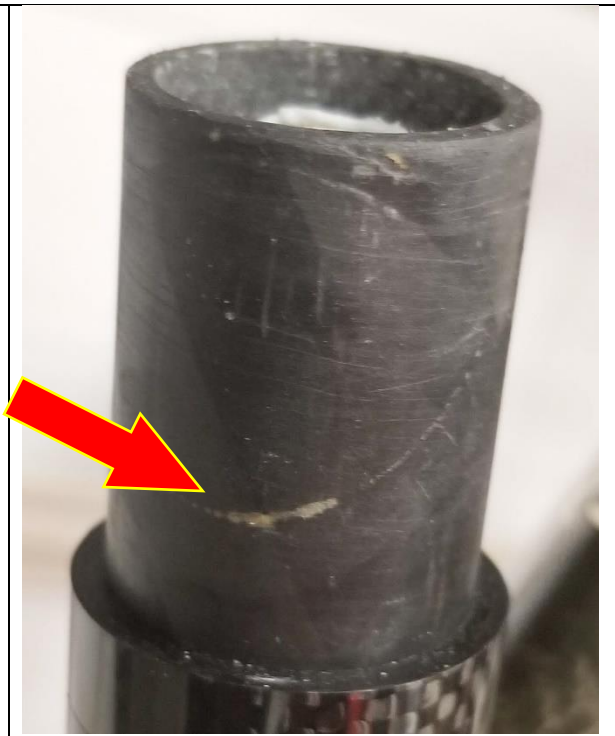
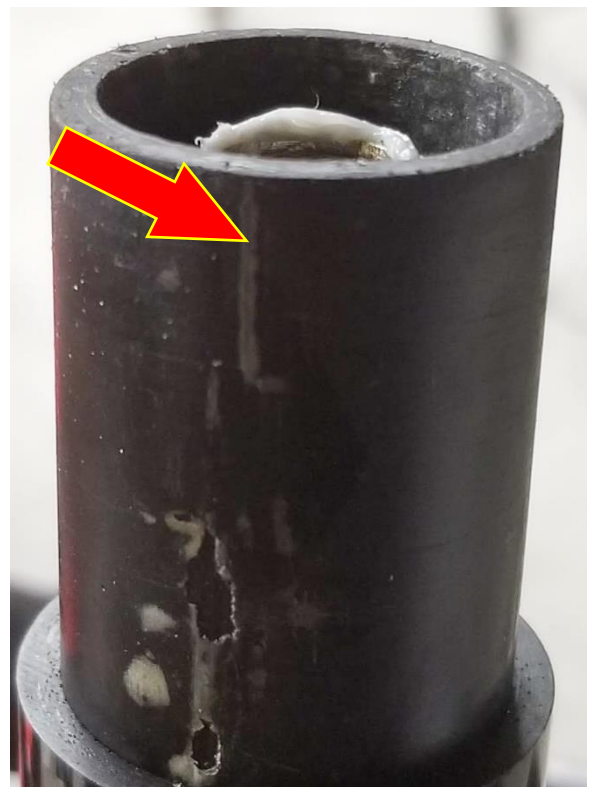
FRONT (top pic) – Deep impression where the sharp edges from the inside of the stem face plate 'etched' into the steerer tube.

REAR (bottom pic) – Crack starting caused by a VERY sharp edge at the rear of the stem along the right side of the pinch bolts.

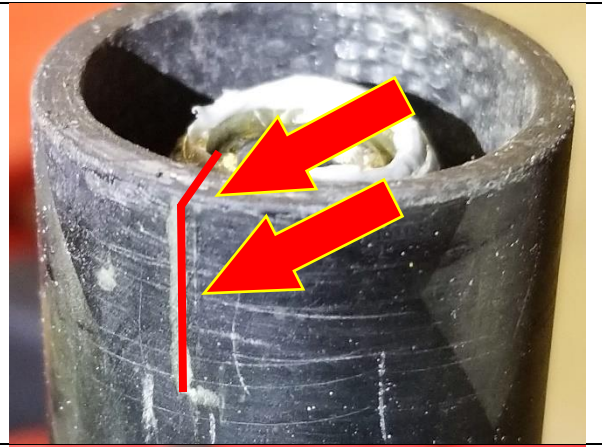
Close up of crack starting, located to the right of the red lines. When I loosened the pinch bolts, I had difficulty using the short handled 4mm wrench. They pinch bolts were at least 10nM

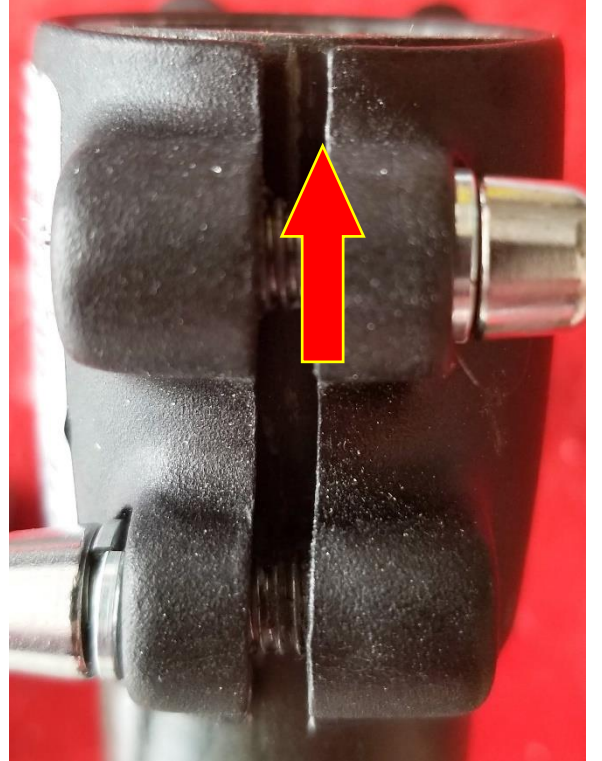
Sharp Edge (stress riser) top right side of stem concentrated stresses here.

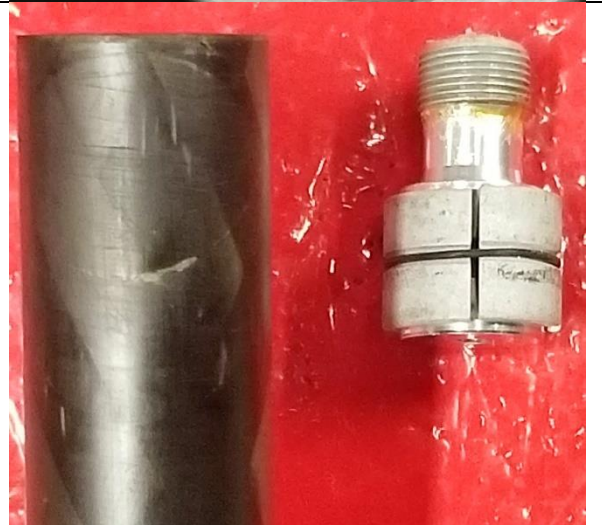
But first and as promised, let's discuss the **BIG PROBLEM**. This is the smallest compression plug I have seen. So small that there is absolutely **NO** support for the steerer tube from being crushed by the stem pinch bolts.

In fact, the compression plug was actually entirely below the bottom of the stem. Ideally, you want the compression plug to completely support the steerer tube along the full length of the stem.

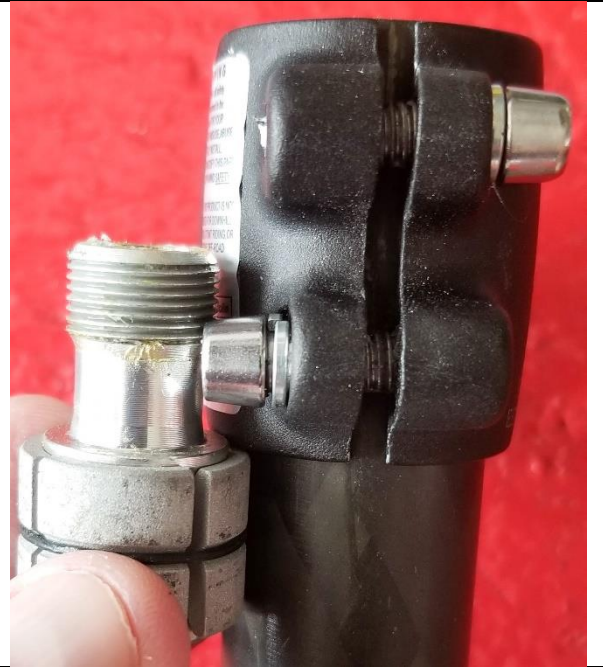
This is about where the compression plug was located inside the steerer tube.

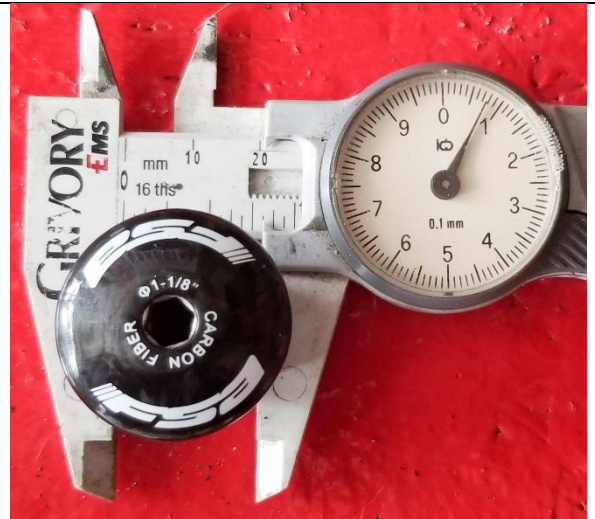
The outside diameter (OD) of the stem cap measures 20.75mm which is 3.25mm smaller than the ID of the steerer tube.

NOPE, no support here.
