# Stodola Engineering Limited

August 6, 2024

Re: Siegrist  
SEL File No. 24-104  
Date of Incident: 09/14/2023

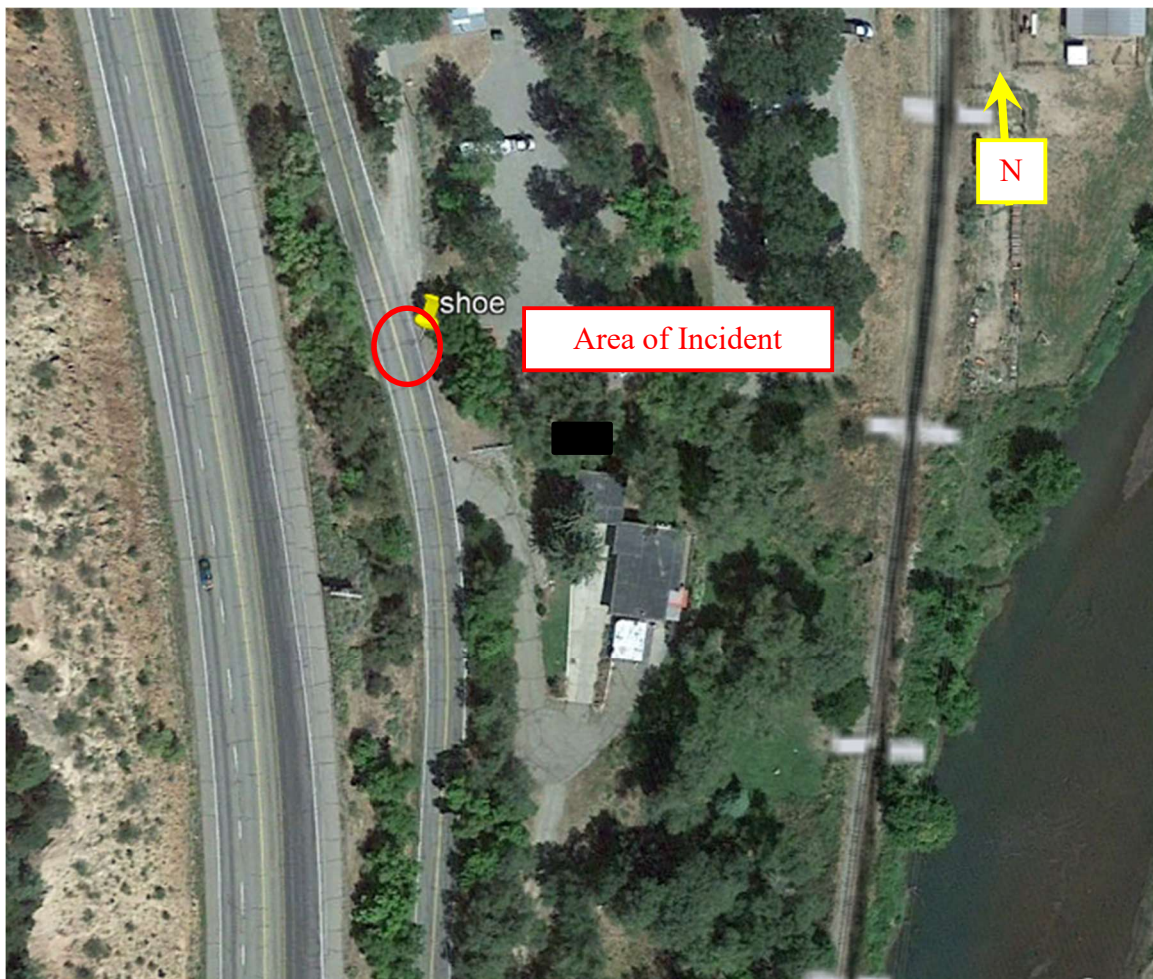
The scene was inspected and photographed on January 30, 2024. At the location of the incident, Animas View Drive is a two way, north/south roadway with one lane in each direction separated by painted double yellow lines. Fog lines are present with minimal paved shoulders outboard of the fog lines. There is a double fog line on the northbound lanes that is approximately 11 feet wide. The road curves to the left approaching the area of impact. There is a driveway to United Campgrounds of Durango north of the area of impact. Photograph A. The reported speed limit is 25 mph.

Photograph A. Google Earth Image from 9/11/2019

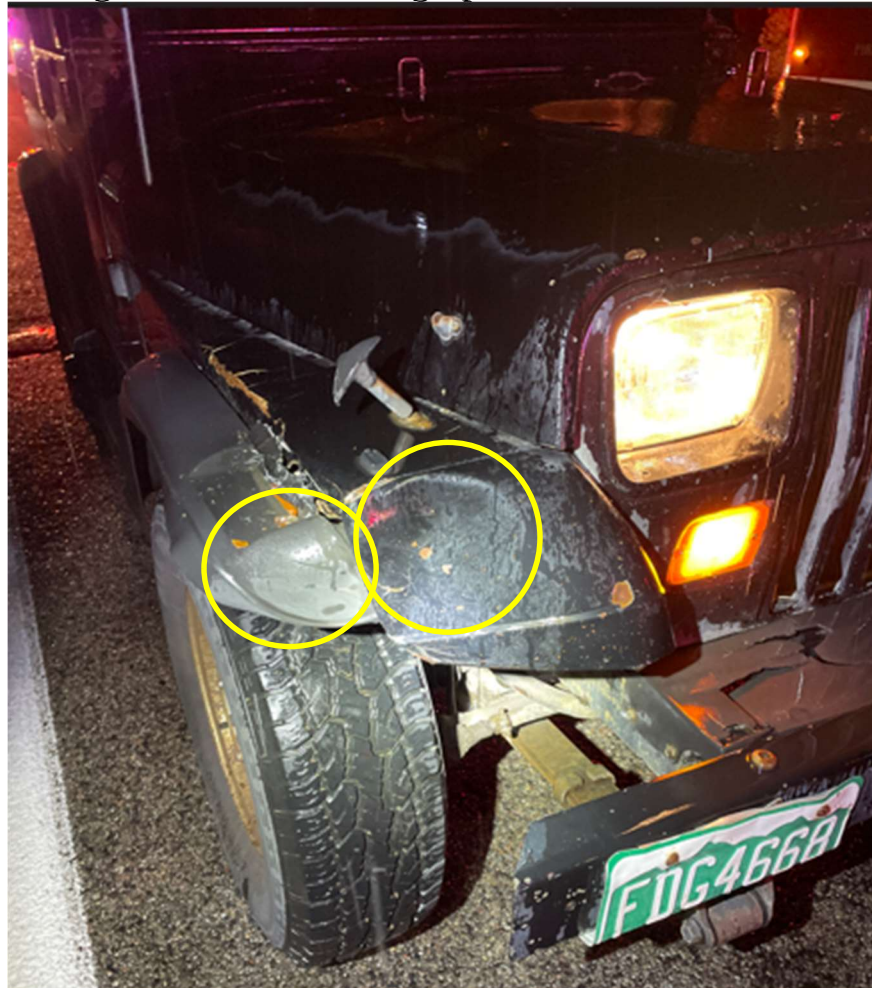
The Jeep exhibits damage and wear consistent with its age and milage (443,756 miles at the time of the SEL inspection). Relative to the incident, the right fender and wheel well cover are deformed, and the side light broken out in that location. The fender was previously damaged with rust showing through the Bondo. Photograph A.

Photograph A. Impact damage

Medical records from St. Mary's Hospital indicate that "stranding of the fat in the left paracolic gutter likely represented a focal contusion in this location" (pg. 28/744). This corresponds to an impact on the left side of Ms. Siegrist consistent with the damage to the right front fender. There is no physical evidence of her body going onto the hood of the vehicle or into the windshield. The trajectory of Ms. Siegrist and available physical evidence are indicative of a fender vault and Ms. Siegrist would not achieve a common velocity with the Jeep. Ms. Siegrist likely rotated in the air before coming to rest northeast of the area of impact as observed in the videos. The location of the right shoe on the right side of the right fog line and its pointing to the south indicates that she was walking on or to the right of the right fog line and out of the travel lane. The impact rotated her clockwise before she came out of her shoe.

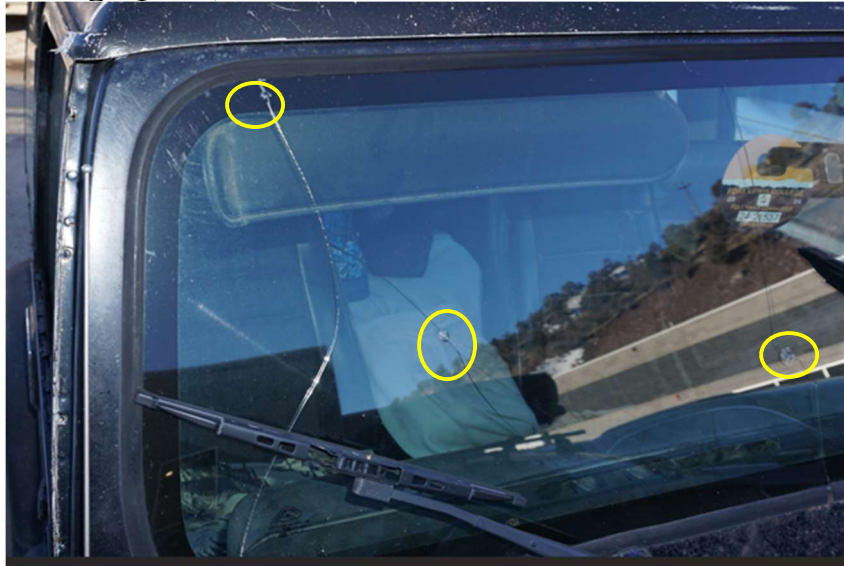
The windshield is fractured. There is no evidence of body contact with it. There are localized chips in the windshield in which the cracks run through. Photograph B, C.

Photograph B. Chips and cracks on Passenger side

As noted above, the Jeep had numerous chips and cracks. Cracks can obstruct a driver's vision, especially if they're on the driver's side. Chips and cracks can be especially hazardous in wet conditions when visibility is needed to avoid accidents. Colorado law states that "No vehicle shall be operated upon any highway unless the driver's vision through any required glass equipment is normal and unobstructed." (CO Code §42-4-201) Ms. Burkhart's Jeep was defective due to the cracks and chip present on the night of the incident.

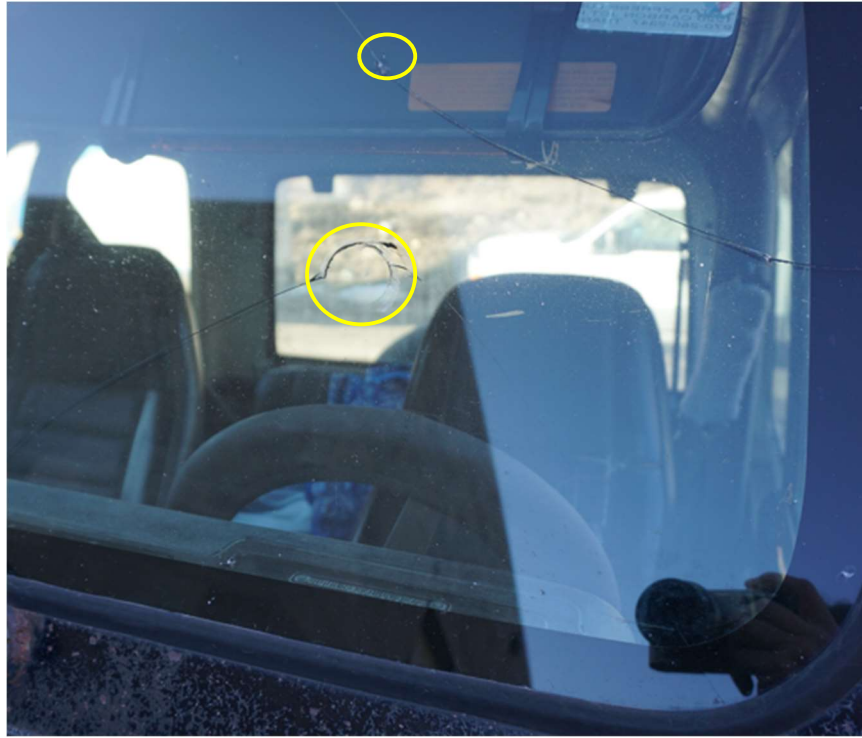
Photograph C. Chips and cracks on Driver side

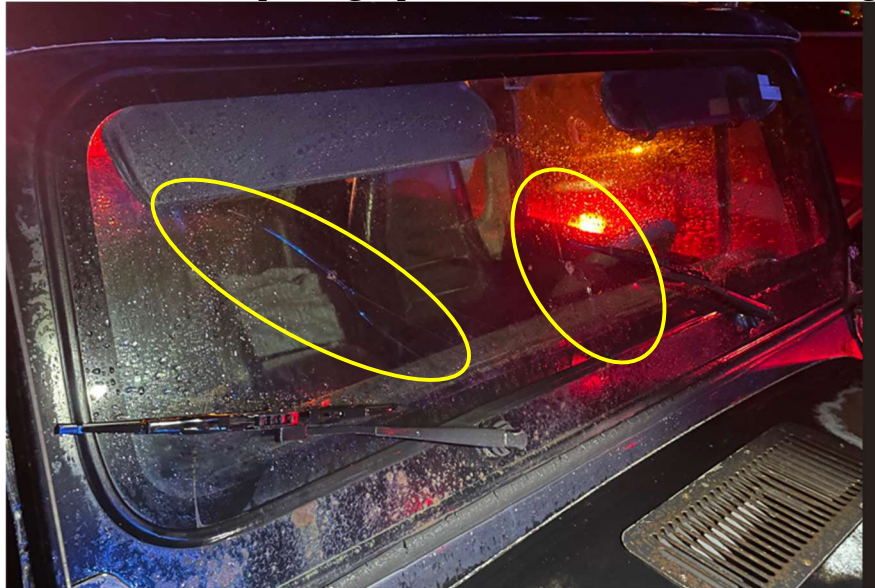
The cracks are visible in photographs taken at the scene. Photograph D.

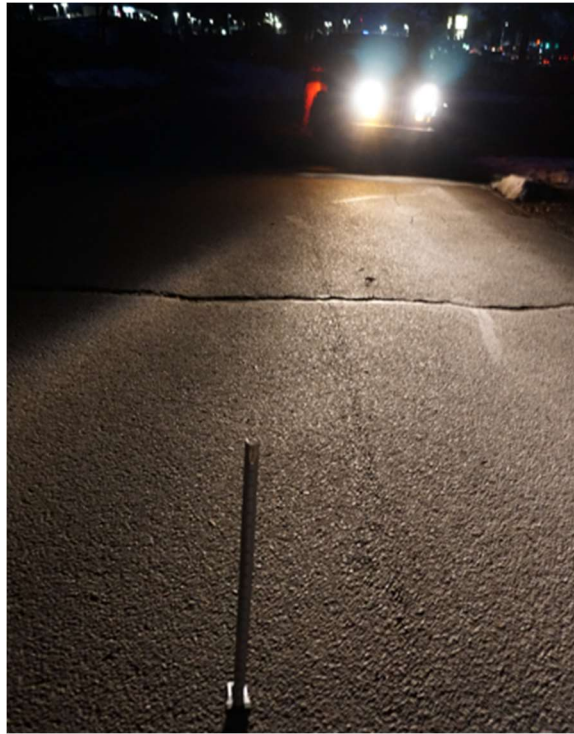
The vehicle's lights were observed at night. Light measurements taken 25 feet in front of the Jeep at a height of 26.5 inches were between 3.84 lux to the right of the Jeep and 37 lux in the center, between the rails.

Photograph E. This equates to 223 candelas on the right and 2148 candela between the rails.

Photograph E. Headlight pattern

The testing conducted on January 30, 2024, showed that values between the rails only resulted in 2,148 candela 25 feet in front of the vehicle, far below the requirements of the Federal Code. Ms. Burkhart was driving a defective vehicle that was not properly maintained.

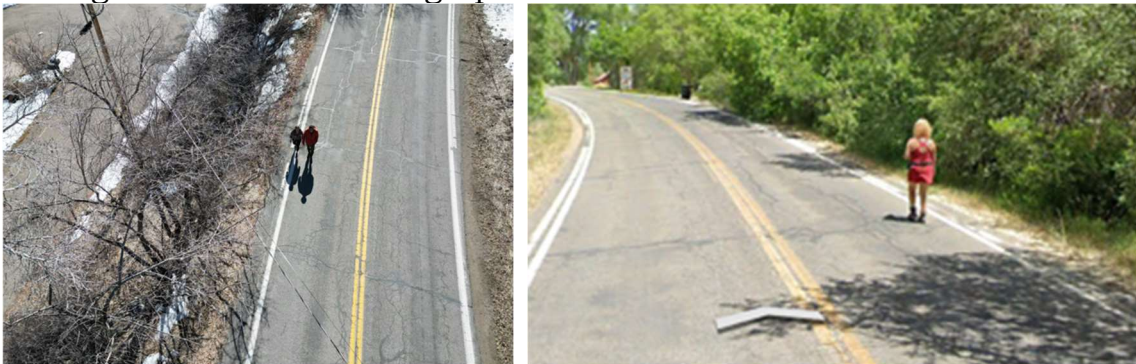
During the SEL scene inspection, pedestrians were observed following the same path as Ms. Siegrist. Photograph D. A pedestrian was also captured in Google Streetview. Photograph E.

Photographs D, E. Northbound pedestrians.
