# **2022 IR-THERMOGRAPHY INSPECTION XYZ ENERGY ANNUAL REPORT**

**ELECTRICAL SUB-STATION – TORONTO PLANT**

**PRESENTED BY: AHMAD ASSI  
RELIABILITY ENGINEER / LEVEL III IR-THERMOGRAPHER**

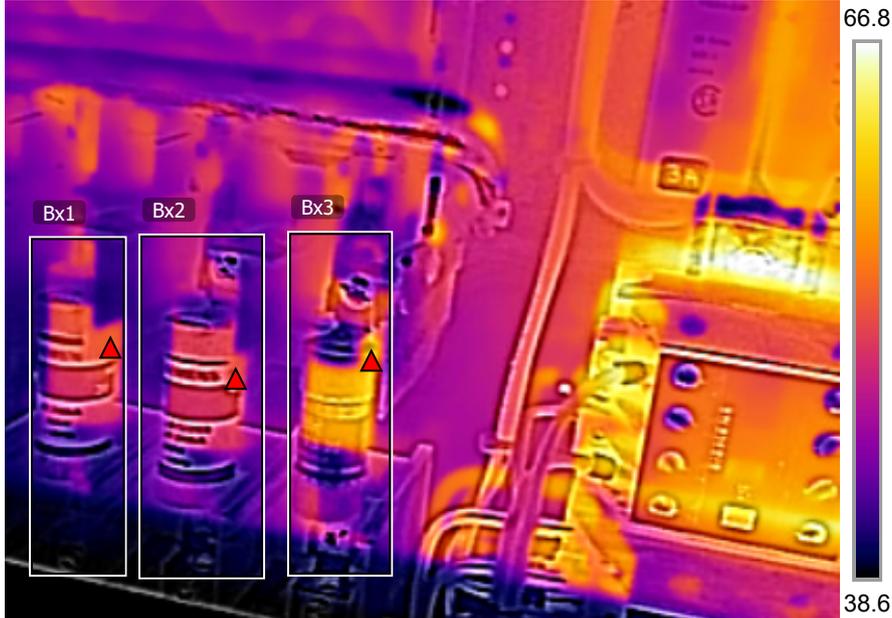
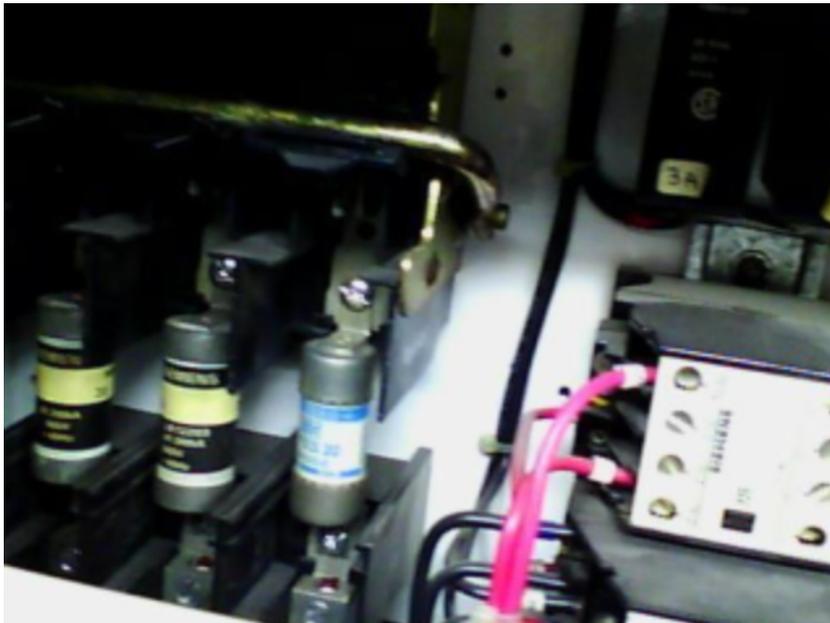
FLIR0053.jpg

Bx1	Max	48.6 °C
Bx2	Max	47.9 °C
Bx3	Max	56.0 °C

Fuse in box #3 is showing higher temperature compared to other fuses. We suspect this is due to wrong or different fuze mfg. We recommend replacing the fuse and ensure all fuses are of same mfg.

Main Room - MCC #5

Contactor #12

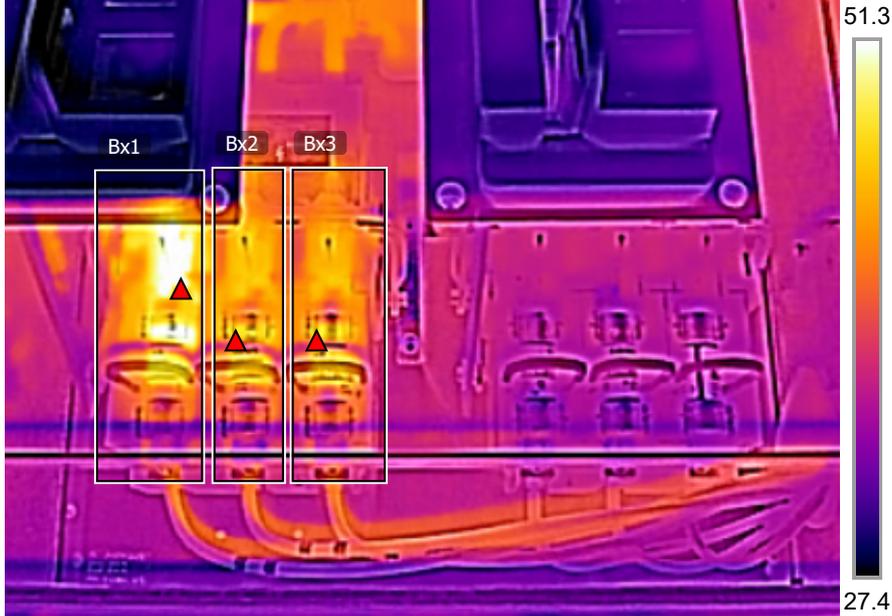
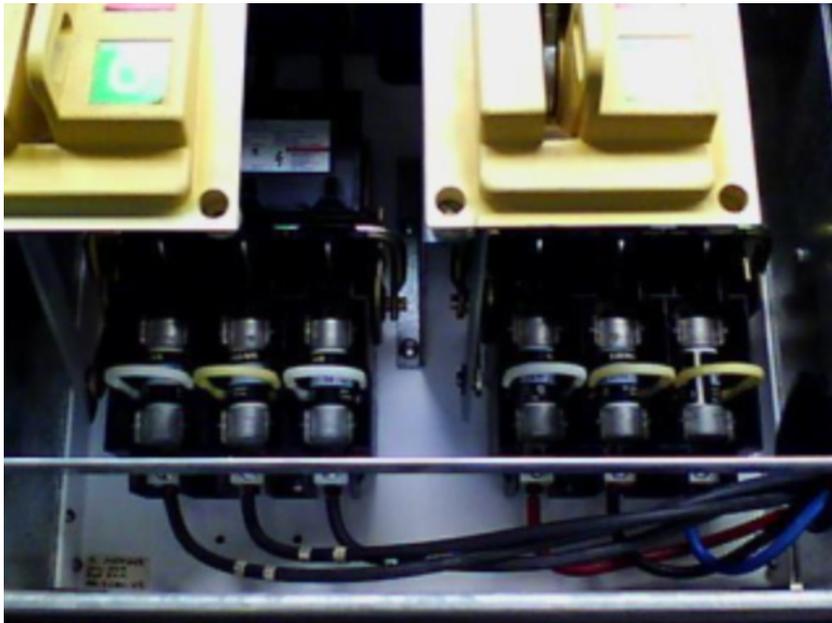
FLIR0068.jpg

Bx1	Max	59.6 °C
Bx2	Max	42.2 °C
Bx3	Max	41.8 °C

Left fuse in Bx #1 is showing higher temperature than other fuses. Fuse replacement is advised.

Main Room - MCC #5

Contactor #28

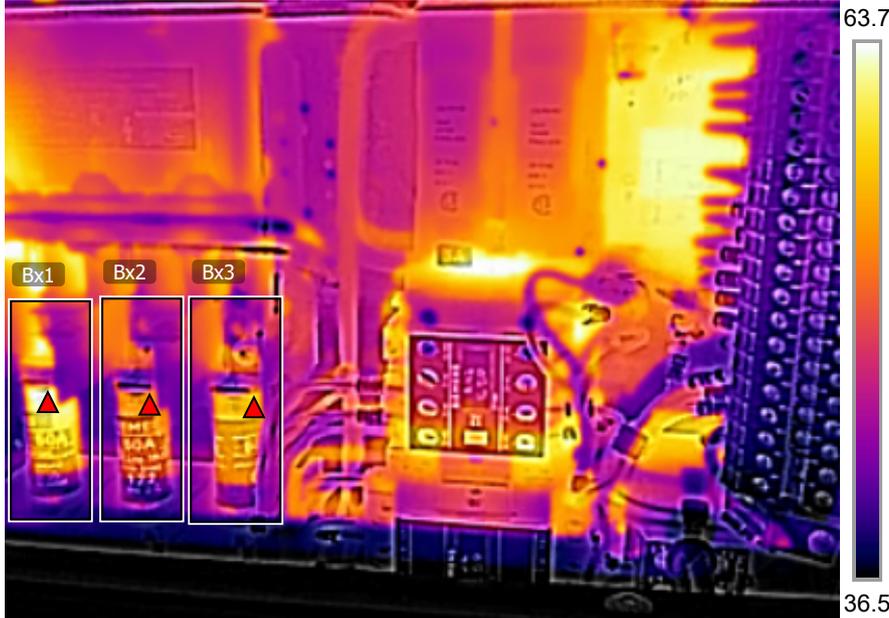
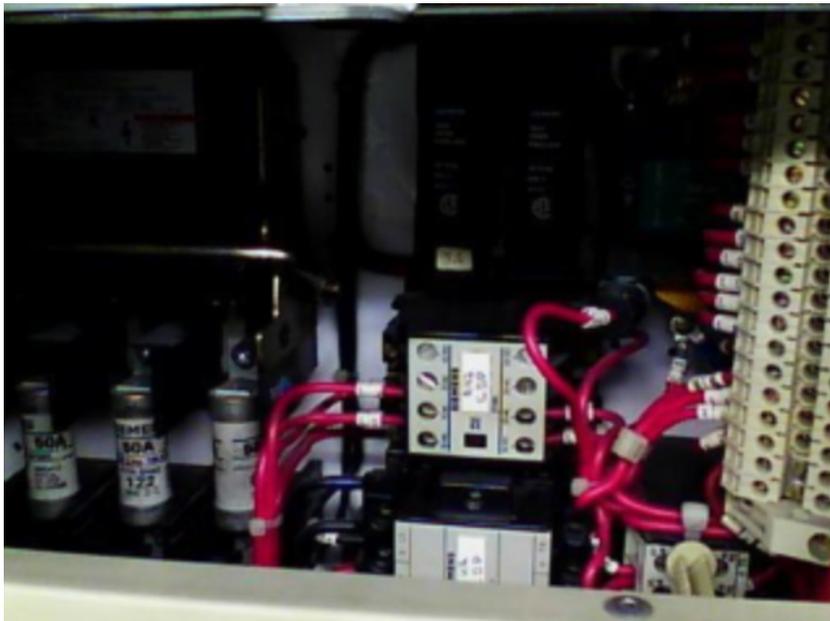
FLIR0088.jpg

Bx1	Max	64.8 °C
Bx2	Max	51.3 °C
Bx3	Max	55.0 °C

Fuse in box 1 is showing higher temperature compared to the other fuses. Fuse replacement is recommended.

Main Room - MCC #1

Contactor #24
