Section Inspection - 03/02/2020 - S/cell A-S/cell B

Section 1	Inspection 1	Date 03/02/20	Client's Job Ref Not Specified	Weather No Rain Or Snow	Pre Cleaned No	PLR S/CELL A-S/CELL B
Operator James McCall		Vehicle LK67 PXT	Camera Pearpoint	Preset Length Not Specified	Legal Status Not Specified	Alternative ID Not Specified

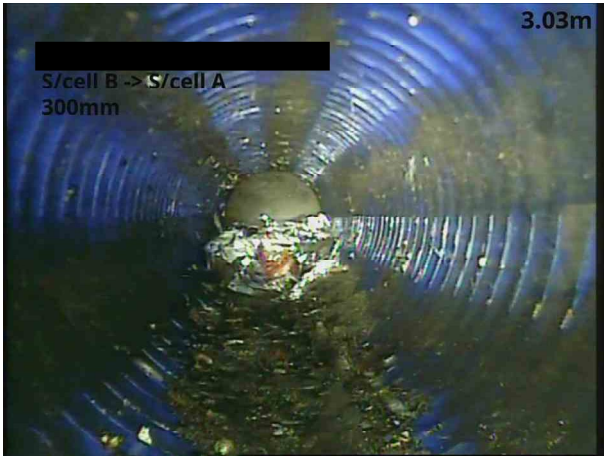
S_cell A-S_cell
 B_615e7f1b-1dde-4550-b645-6bc8b704c376_20200203_1656
 12_883.jpg, 00:00:48, 3.03 m
 General remark, perforated pipe

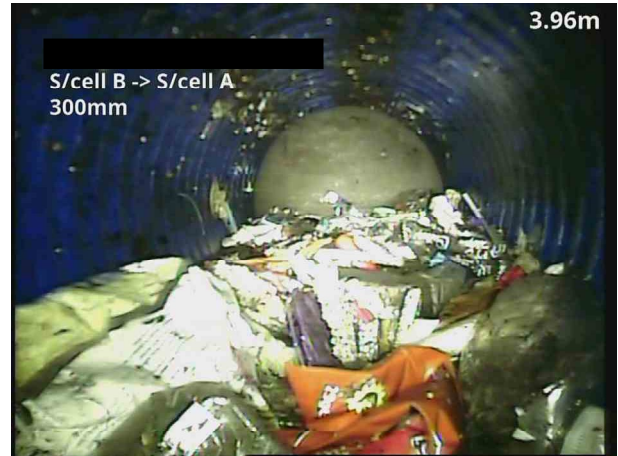
S_cell A-S_cell
 B_ef0019a9-a54f-4331-998c-f89f2b37d0f9_20200203_16564
 5_120.jpg, 00:01:00, 3.96 m
 Settled deposits, hard or compacted, 40% cross-sectional area
 loss, rubbish

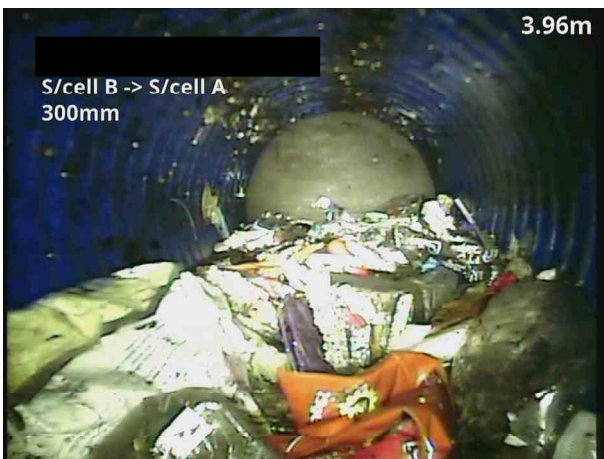
S_cell A-S_cell
 B_d7b508d3-8ada-4cb0-94d2-6b834e10eed0_20200203_165
 713_153.jpg, 00:01:05, 3.96 m
 General remark, Capped end ahead
