Fawn Lake Shelton, WA

Report #: 31686-6
Beginning: January 1, 2026
Expires: December 31, 2026

RESERVE STUDY Update "With-Site-Visit"

April 14, 2025

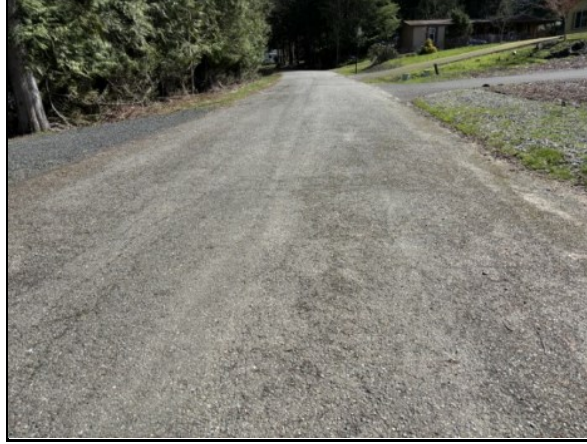
Comp #: 130 Asphalt Road - Partial Repair**Quantity:** Extensive square feet**Location:** Asphalt roadways within property perimeter**Funded?:** Yes. Meets National Reserve Study Standards criteria for Reserve Funding**History:** 2025: Association budgeting ~\$42K in work. 2024: ~\$17K spent on repairs. - 2022 ~\$5K pot hole repairs. 2019 expense of \$14,800 for asphalt patching**Comments:** History of targeted repairs / patching noted over the years. Work in 2025 anticipated. Assumption is community will continue to require periodic, local repair even with eventual asphalt resurface assumptions. Carefully track needs, adjust funding levels in future reserve study updates as conditions merit. Note: image is representative and does not necessarily indicate phasing.**Useful Life:**
3 years**Remaining
Life:**
2 years

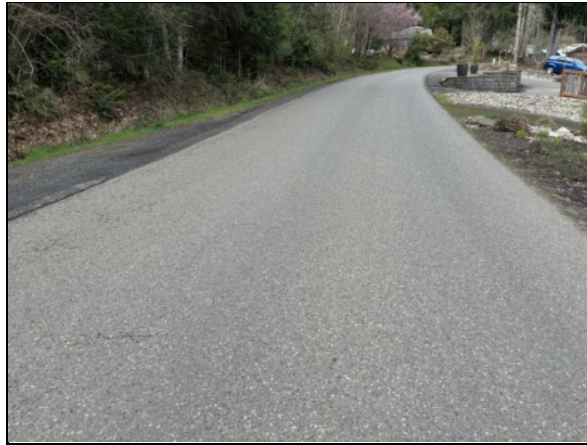
Comp #: 140 Asphalt Road - Stripe**Quantity:** Extensive linear feet**Location:** Asphalt roadways within property perimeter**Funded?:** No. Client reports no further striping will be completed**History:** Road striping in 2019 at expense of \$9,200**Comments:** Reported to us, will no longer be striping roadways.**Useful Life:****Remaining
Life:**

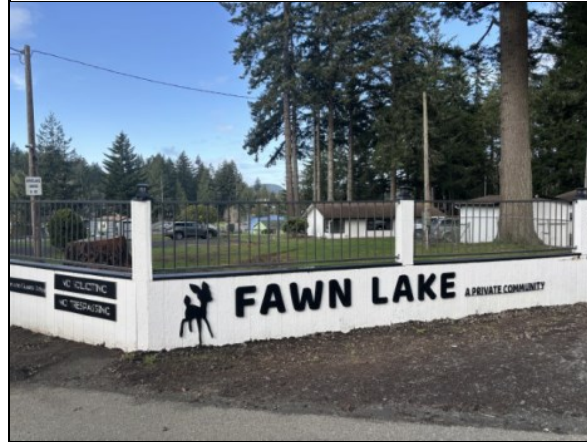
Comp #: 214 Community Signage - Replace**Quantity: Extensive quantity****Location:** Common areas**Funded?:** No. Annual cost best handled as operating expense**History:** None known

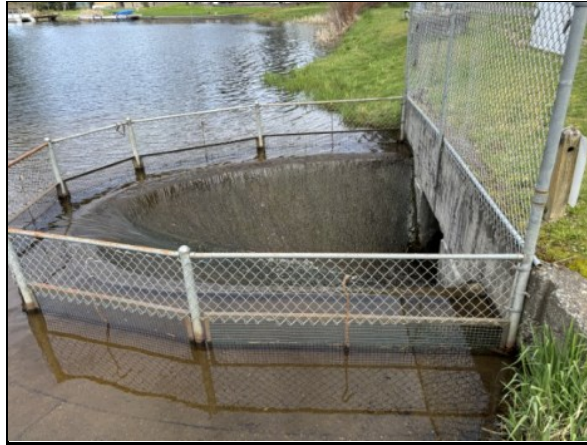
Comp #: 222 Chain Link Fence, Small Runs-Replace**Quantity: ~160 LF galvanized****Location:** Assorted runs at Dam outfall, spillway, causeway**Funded?:** No. Cost projected to be too small for select runs**History:****Comments:** Some local rust (especially at Southeast perimeter of causeway) but no widespread instability or major damage noted of small runs of chain link fencing of assorted ages. We assume can be repaired/replaced individually from operating as needed.**Useful Life:****Remaining
Life:**

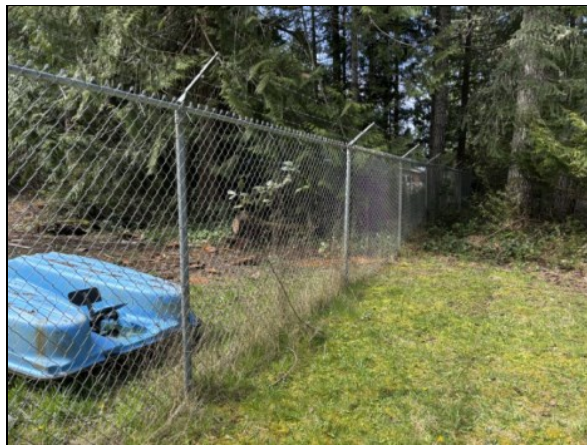
Comp #: 224 Chain Link Fence, 2004/2005-Replace**Quantity: ~900 LF galvanized****Location:** Office / Maintenance Buildings and Water Reservoir**Funded?:** Yes.**History:** 2004/2005 replacements at Office / Maintenance Buildings and Water Reservoir**Comments:** While some local deterioration of surfaces, no major instability or major damage noted of fencing.

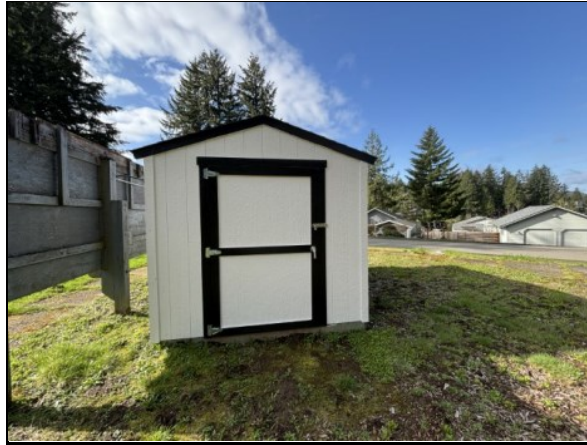
Comp #: 306 Tuff Shed - Maintain/Replace**Quantity: (1) wood shed****Location:** At main office building at entry to community**Funded?:** No. Sustain along with other similar component groupings**History:** Reportedly installed in 2018 at expense of \$2,400**Comments:** No obvious major damage noted of Tuff Shed brand wood structure shed; mostly used to store chemicals away from well protection areas. Ongoing maintenance, painting and roof replacements from either operating monies or along with other similar projects to sustain small structure with no separate reserve funding anticipated.**Useful Life:****Remaining
Life:**

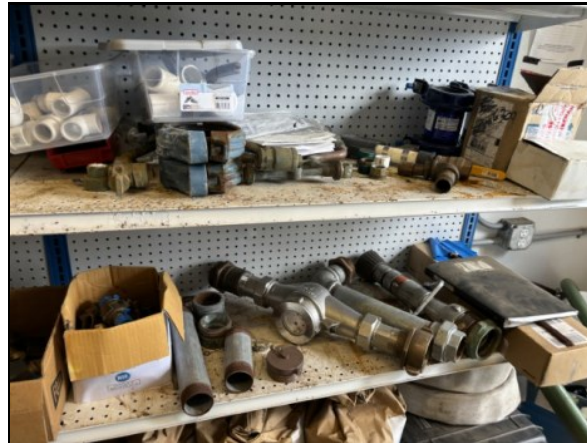
Comp #: 929 System Components, Small - Replace**Quantity: Assorted components****Location:** Water system, various**Funded?:** No. Annual cost best handled as operating expense**History:****Comments:** There are numerous small connections, meters, gauges, valve assemblies, etc. These ancillary water system components will need rebuilding or replacement from time to time but are expected to be below reserve funding threshold cost (\$3,000) and therefore should be expensed as general maintenance from within the operating budget per occurrence.**Useful Life:****Remaining****Life:**
