2 London Road Terrace London Road,  
Moreton-in-Marsh, Gloucestershire,  
England, GL56 0HN

**PROPERTY VISIT DATE**  
27/03/2025

**PREPARED ON BEHALF OF**  
Hayman Joyce

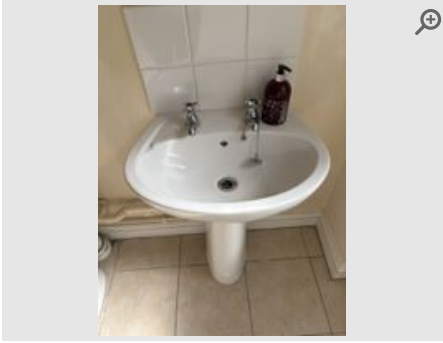
Sink/Basin

| Item | Description | Condition | Cleanliness | Photos |
|---|---|---|---|---|
| 2.9<br>Sink/Basin | Pedestal porcelain. Separate taps. Chrome taps. Plug & chain. Plug & chain<br>present. Free of cracks/chips. Discoloured sealant. Limescale to taps. White<br>Basin intact and free of cracks/chips. Minor limescale to taps. | ● Fair | ● Poor | <a href="#">1 photo</a> |

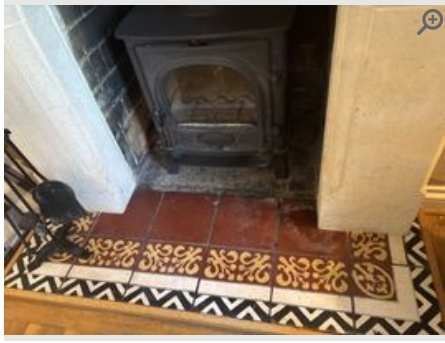
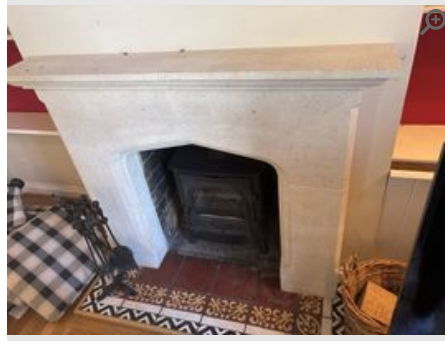
## Fireplace

| Item | Description | Condition | Cleanliness | Photos |
|---|---|---|---|---|
| 4.11<br>Fireplace | Log burner. Brick surround. Sandstone mantelpiece. Tiled hearth. Mantelpiece is chipped. Surround is scuffed/marked. Hearth is cracked. Hearth is chipped. Dirty. Dusty to mantelpiece. Dusty to surround. Dusty to fireplace. Dusty to hearth.<br>Companion set. Scuttle/Log basket<br>Mantelpiece has light surface marks. Some signs of wear evident. See photos for significant detail, including stains and scratches (if/where applicable). | ● Fair | ● Poor | <a href="#">2 photos</a> |

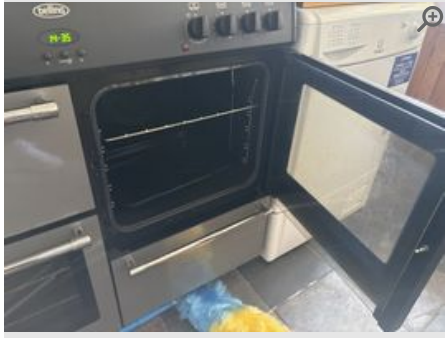
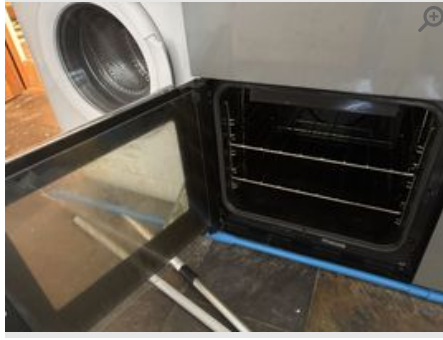
### Oven

| Item | Description | Condition | Cleanliness | Photos |
|---|---|---|---|---|
| 6.12<br>Oven | Range cooker. Chrome rack x 3. Greasy residue inside. Burnt carbon residue inside. Belling<br>Seal intact and door hinge functioning smoothly. See photos significant for detail, including dried food residue and grease | ● Fair | ● Poor | <a href="#">2 photos</a> |

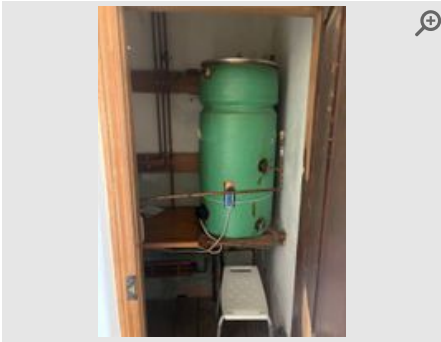
## Boiler/Storage Cupboard

| Item | Description | Condition | Cleanliness | Photos |
|---|---|---|---|---|
| 7.10<br><b>Boiler/Storage Cupboard</b> | Wood panelled. Varnished wood. Brass knob<br>Some light scuffs/scratches front side and reverse. Some light scuffs/scratches to inside walls. Refer to photos for defect details, including significant marks, stains and scratches (where applicable). | ● Fair | ● Fair | <a href="#">1 photo</a> |

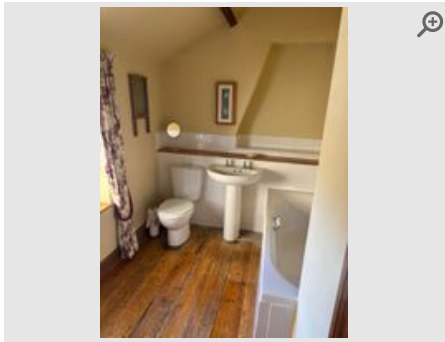
Sink/Basin

| Item | Description | Condition | Cleanliness | Photos |
|---|---|---|---|---|
| 8.12<br><b>Sink/Basin</b> | Pedestal porcelain. Separate taps. Chrome taps. Stainless steel plug. Plug & chain present. Free of cracks/chips. Free of limescale. White<br>Basin intact and free of cracks/chips. | ● Good | ● Good | <a href="#">1 photo</a> |

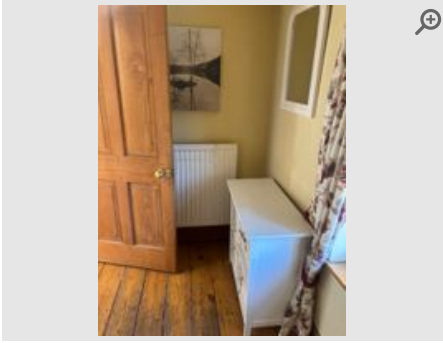
Cabinet

| Item | Description | Condition | Cleanliness | Photos |
|---|---|---|---|---|
| 8.14<br><b>Cabinet</b> | 4 drawers. 2 shelves. Laminate. White<br>4 wicker baskets on 2 shelves - good condition. | ● Good | ● Good | <a href="#">1 photo</a> |
