City of Port Aransas Shoreline Analysis and Improvements

FINAL Technical Report

August 24, 2016

**Submitted To:
City of Port Aransas**

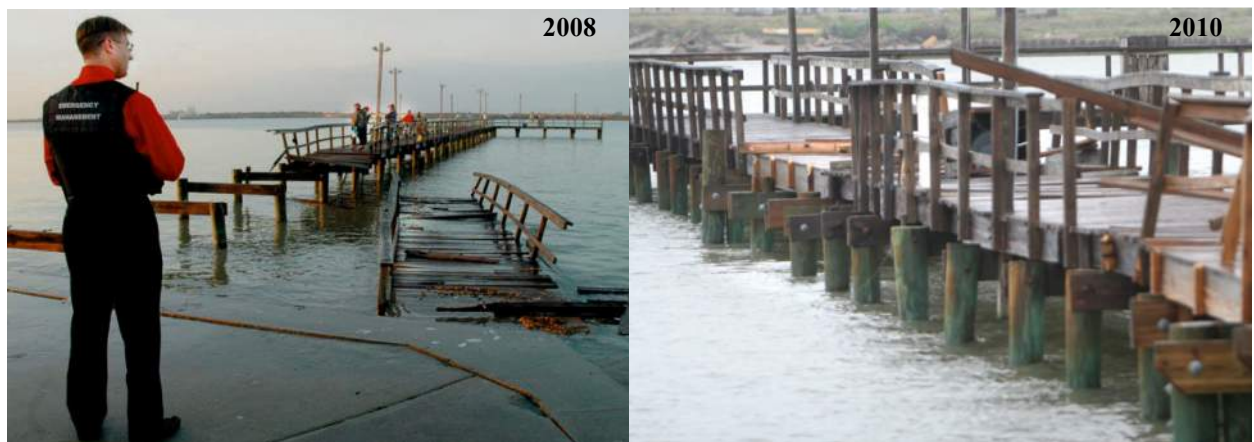
The shoreline along the Corpus Christi Shipping Channel (CCSC) in Port Aransas has been experiencing negative impacts from passing ship traffic, such as damage to the fishing pier and overtopping of the bulkhead and public access walkway. Figure 1 shows the location of the impacted shoreline near Port Aransas Nature Preserve (formerly known as Charlie's Pasture). The resulting ship wakes overtop the bulkhead which creates a safety hazard for visitors walking on the path along the top of the bulkhead. Tanker induced waves have also damaged the fishing pier. Approximately 25 feet of the pier was severely damaged in 2008 (Parker, 2008), as shown in Figure 2. When repairing the damaged pier, the deck elevation was raised in order to avoid future damage of the pier. Unfortunately, the new deck elevation was not sufficient to protect the pier as it was damaged again due to passing ship effects in 2010, also shown in Figure 2.

Figure 2. Examples of ship wave damage to fishing pier in 2008 (left) and 2010 (right).

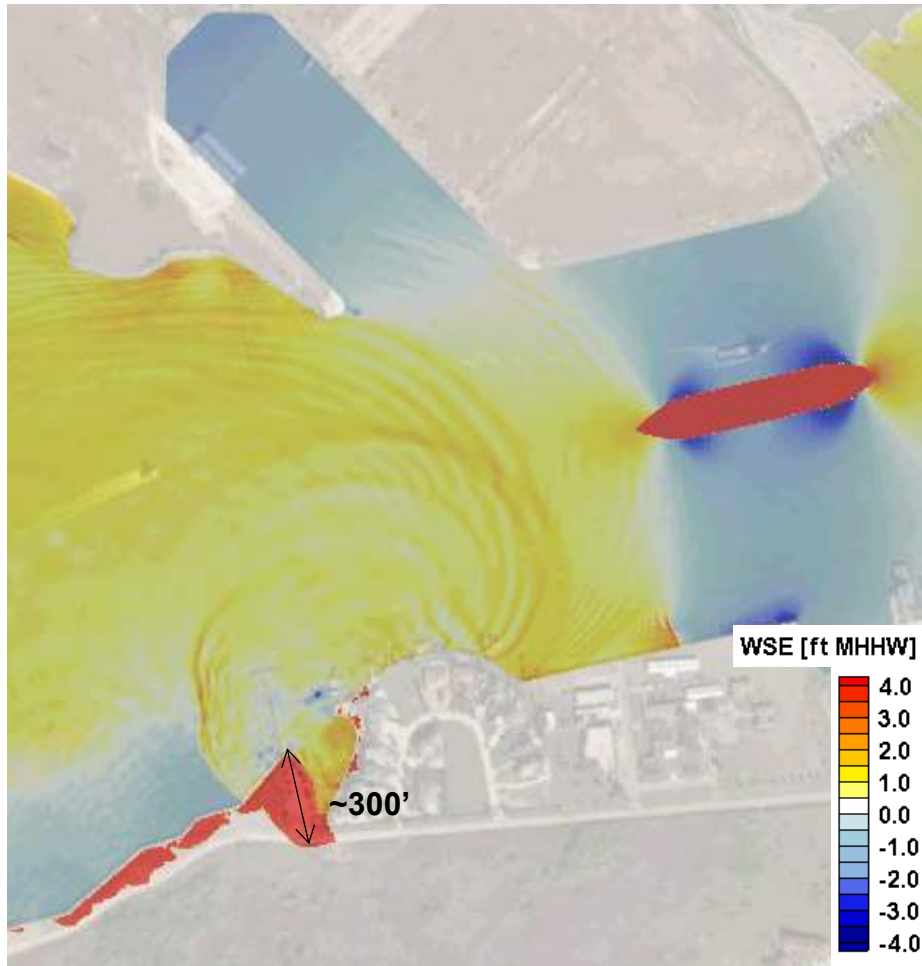
During the 2008 damage event, witnesses reported that the wave overtopped the bulkhead and traveled “more than 150 feet across the pier parking lot” (Parker, 2008). VH-LU water surface elevation results during this event (shown in Figure 6) show overtopping along the bulkhead and inundation of the entire parking lot. The furthest extent of over wash was up to 300 feet away from the bulkhead. The water surface elevations at the fishing pier were also compared to the known fishing pier deck elevation at the time of the accident. Figure 7 shows the VH-LU calculated maximum water surface elevation at the fishing pier which was approximately 1 foot above the deck elevation, indicating that damage would be likely to occur.

Figure 6. VH-LU water surface elevation results. Note: Red contours on land signifies when a dry node has turned wet due to resulting water surface elevations, i.e. when overtopping has occurred.

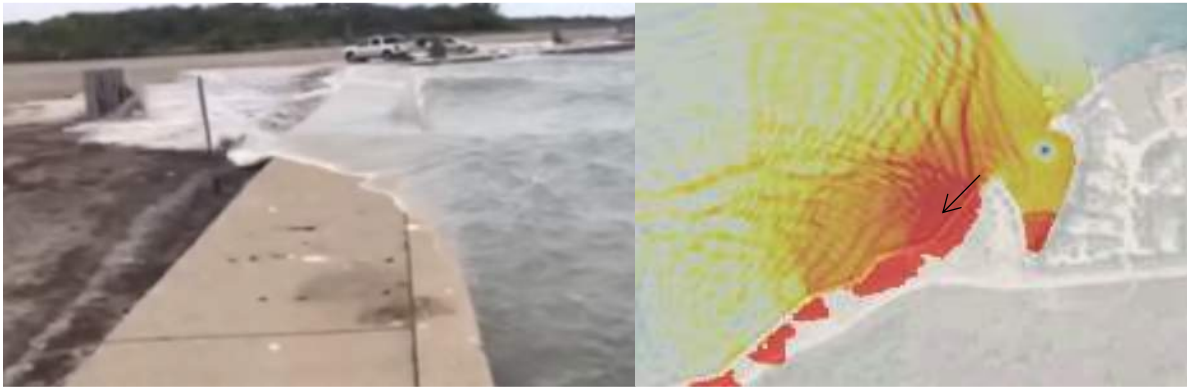
Site videos showing bulkhead overtopping during outbound events were also compared with model results. A video taken from the fishing pier looking southwest (Urban, 2014) showed extensive overtopping along the bulkhead, as shown in Figure 8. Similarly, the VH-LU model results indicate very similar overtopping along the bulkhead (in Figure 8).

Figure 8. Comparison of overtopping extents for outbound case between observed (left) and modeled (right). Note: Arrow shows the approximate location and view point of the observed conditions.

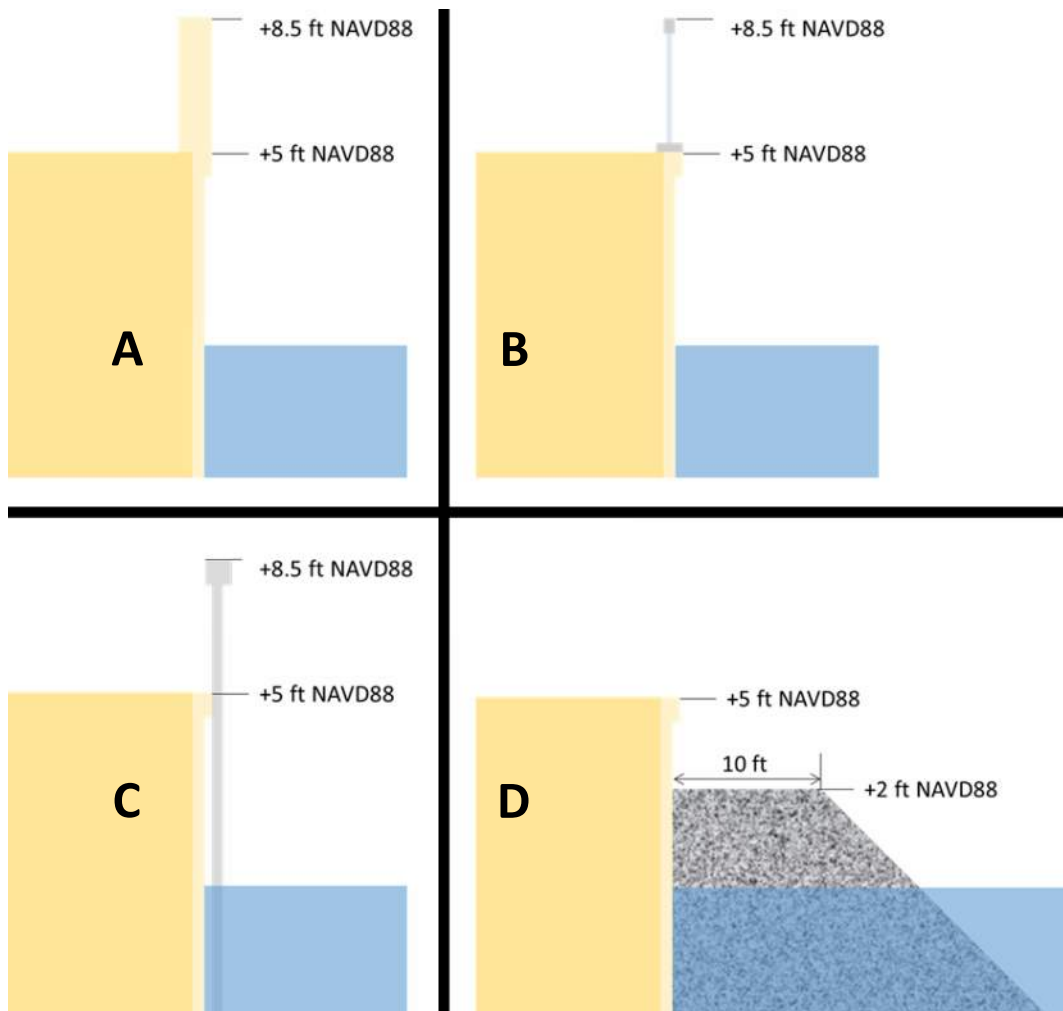
Figure 12. Conceptual bulkhead alternatives. Note: not shown to scale.

Several bulkhead modifications were considered to reduce or prevent overtopping. One modification considered was addition of a concrete barrier to the top of the existing bulkhead (Alternative A in Figure 12). While suitable for eliminating overtopping, more analysis is required to determine whether the existing bulkhead could support the additional load.

Another alternative analyzed was addition of a transparent barrier to the top of the bulkhead (Alternative B in Figure 12). Using a lighter material makes this a more feasible option than Alternative A as the load on the bulkhead would be significantly reduced. Also, using transparent materials would avoid obstructing channel views and provide a more aesthetically pleasing option than the concrete barrier (example structures are shown in Figure 13).

Alternative C in Figure 12 consists of installing a new, taller bulkhead in front of the existing bulkhead. The final conceptual alternative is a rock revetment in front of the existing bulkhead (Alternative D in Figure 12). This rock revetment would help reduce the overtopping, and also provide scour protection along the toe of the bulkhead.

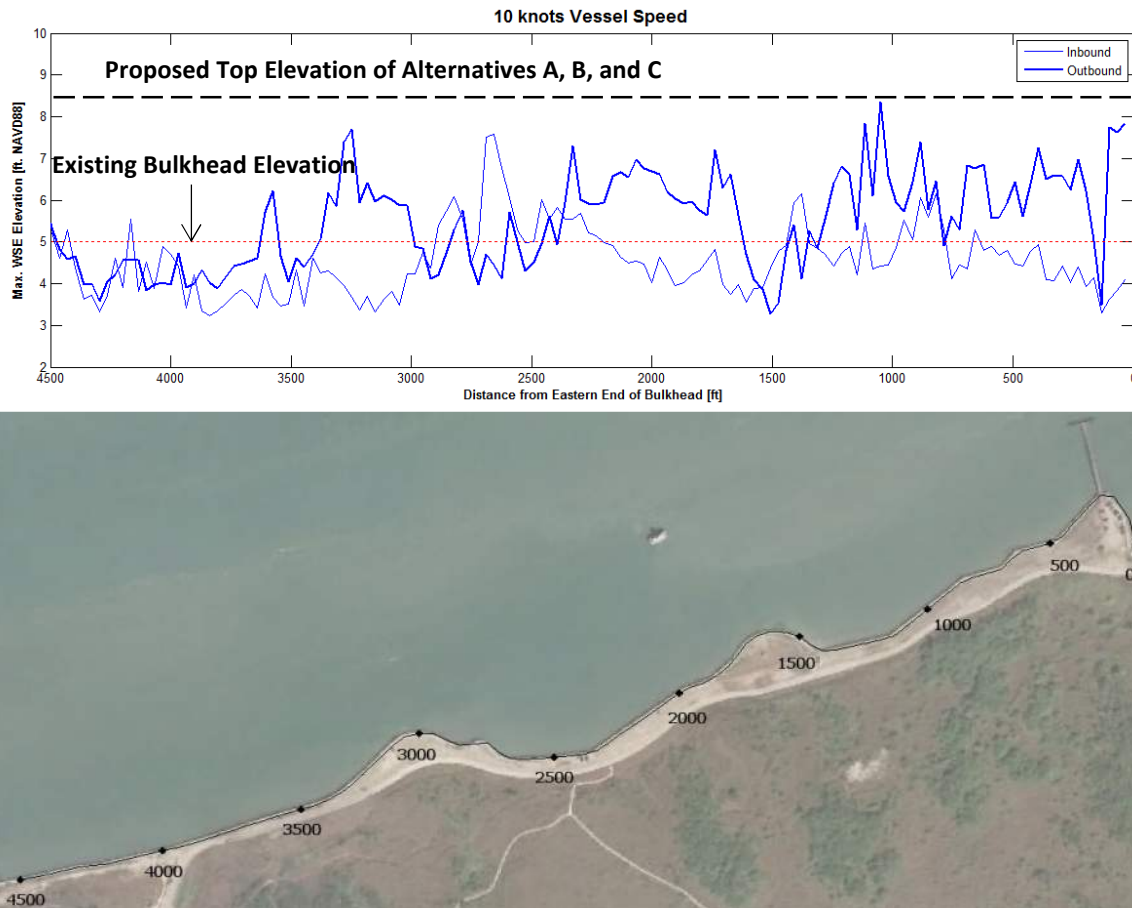
The top elevation of Alternatives A, B, and C were computed in order to prevent overtopping by the peak water levels during the design passing ship event. Figure 16 shows the maximum water surface elevation along the bulkhead, and the existing bulkhead elevation. From the data shown in Figure 14, it was determined a top elevation of +8.5 ft NAVD88 would likely preclude significant overtopping. The top elevation of Alternative D was developed only to ensure the rock structure was emergent during the design condition, or above MHHW (which is approximately 1.72' NAVD88). Therefore, Alternative D is not intended to eliminate overtopping by acting as a barrier. Alternative D could reduce overtopping due to its roughness and porosity, which would help break up the traveling bore wave and allow water passage through the structure.

Figure 14. Maximum water elevation along existing bulkhead (top) and associated distance along bulkhead (bottom)
