# Landmark Services

**September 7th 2019, 9:00 am**

**Inspection performed by:  
Rich Anthony**

**BUILDING ADDRESS:** Winona Mn. 55987  
**CITY:** Winona  
**STATE:** Mn  
**ZIP CODE:** 55987  
**INSPECTION DESCRIPTION:** Single family home, 2br 1ba.  
**SQUARE FOOTAGE:** 932 Sq Ft

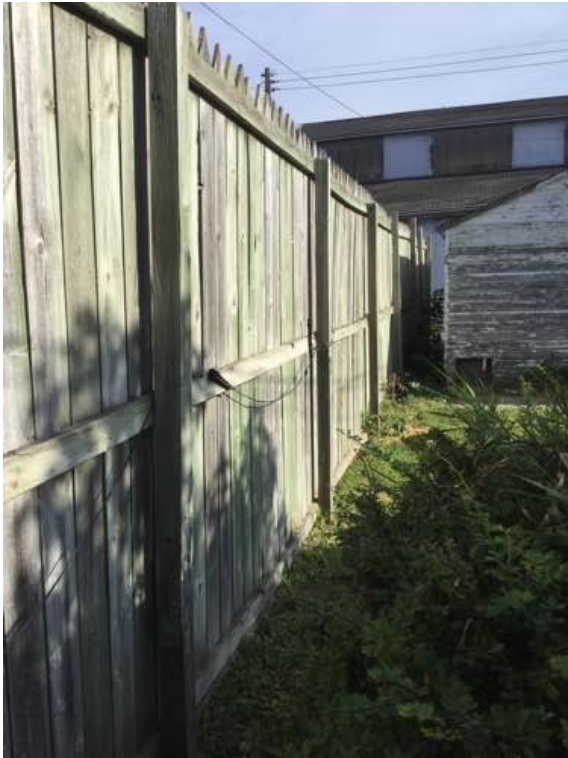
### FENCE

Fair

Could use paint to preserve the integrity and slow the deterioration.

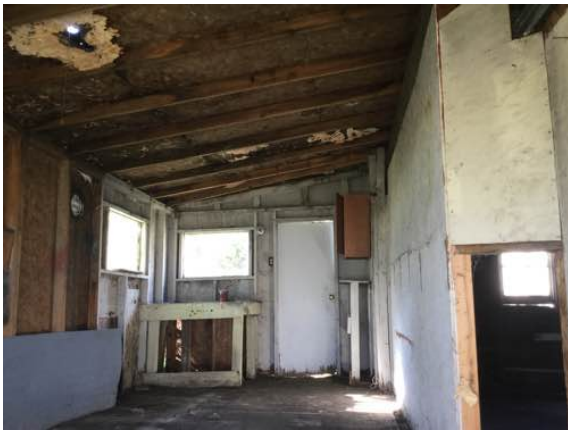
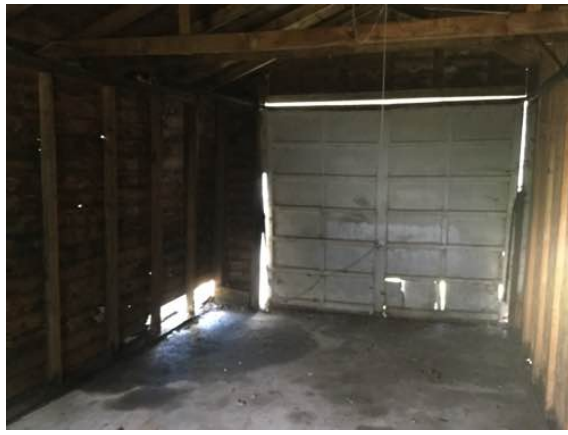
### SHED / OUTBUILDINGS

Poor

Garage is unsided in places, rotted wood in many places, poor roofing with holes.

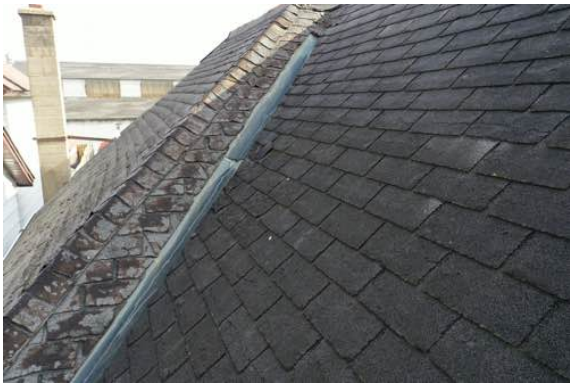
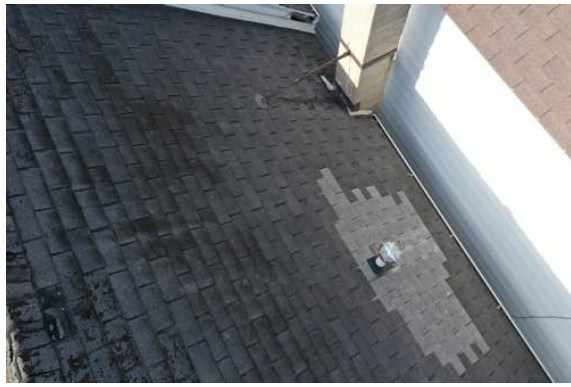
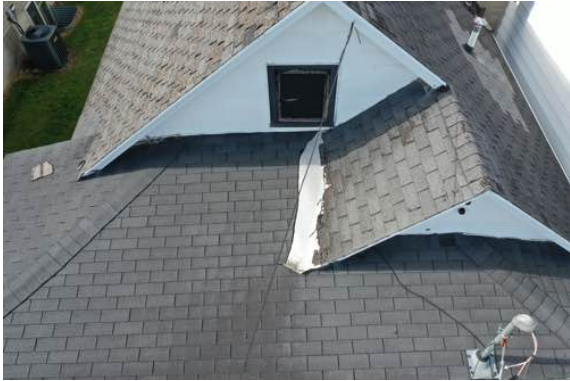
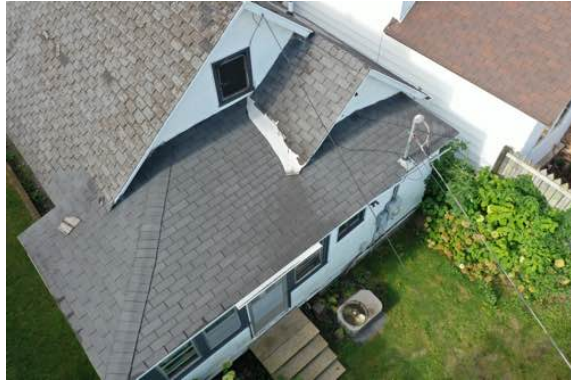
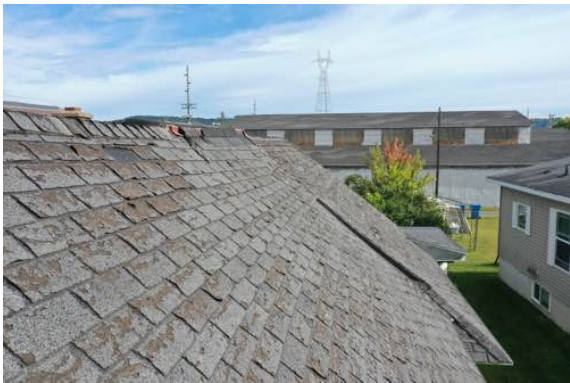
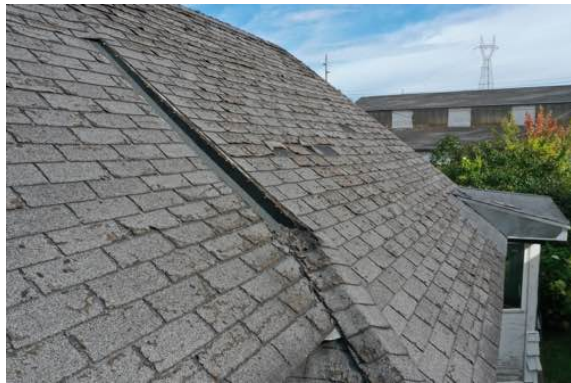
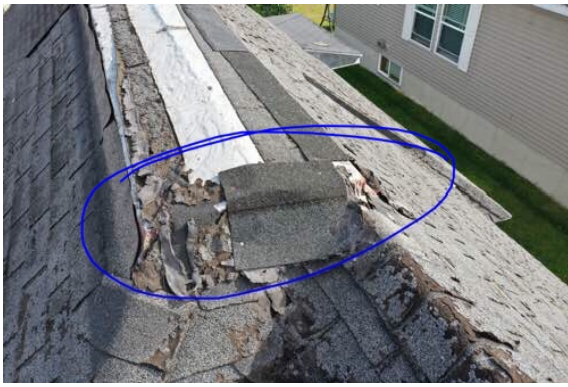
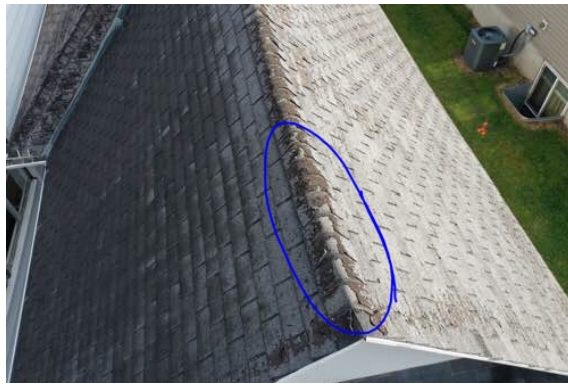
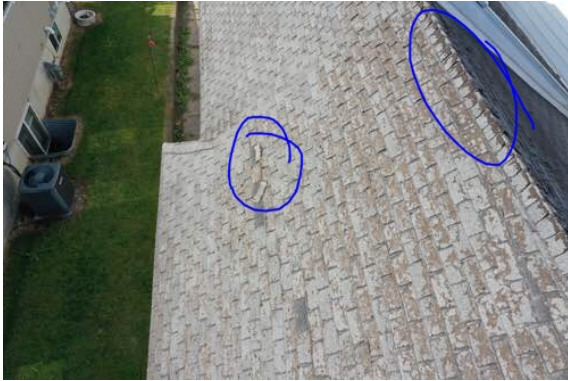
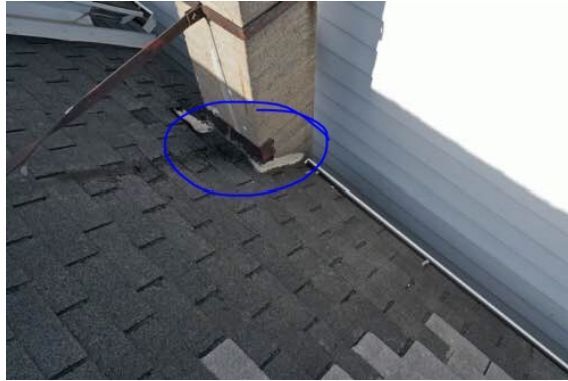
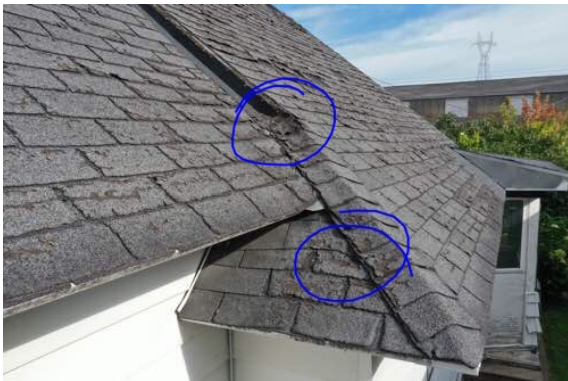
### SHINGLES MISSING / DAMAGED?

Poor

Many roofing faults, broken shingles, chimney appears to be improperly flashed, shingles are beyond useful life.

I recommend by a liscensed roofing contractor

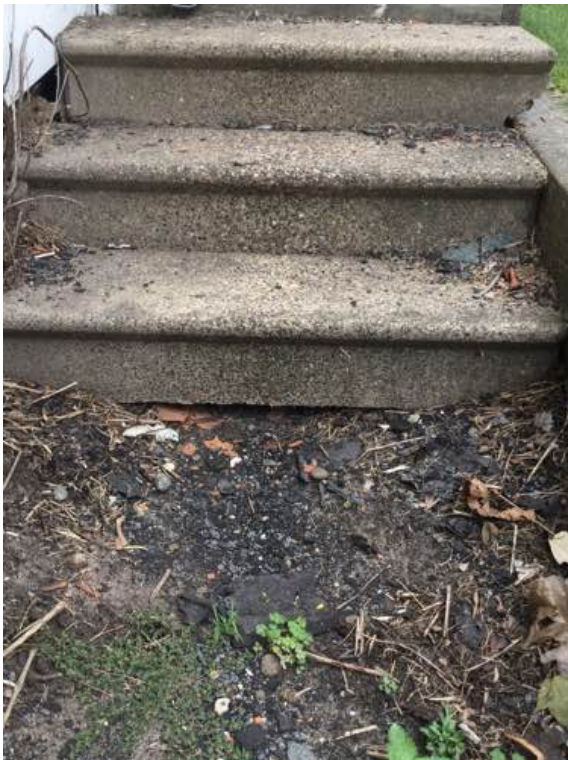
## **GUTTERS AND DRAINAGE**

Gutters and downspouts are recommended on east side of house, water appears to be draining under steps.

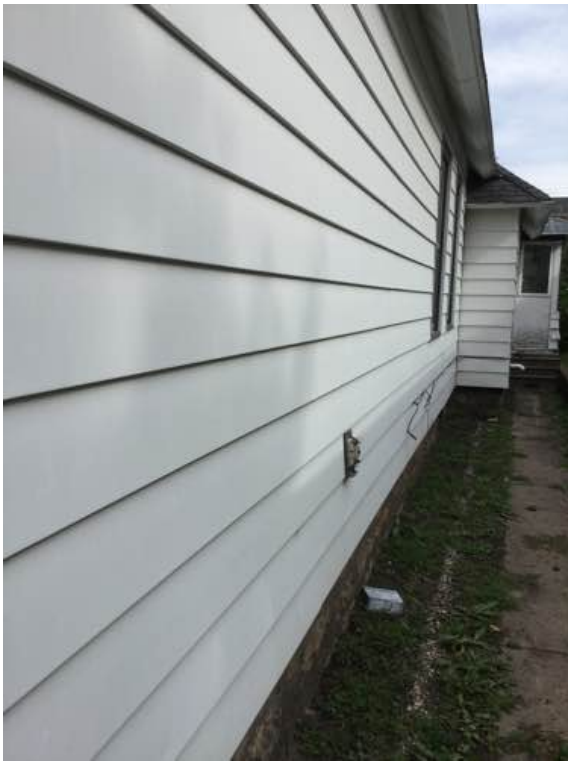
## **SIDING CONDITION**

Siding looks good overall, could use some attention with damages on corners and some detail areas need immediate attention. I recommend evaluation/repair estimate by qualified siding contractor.

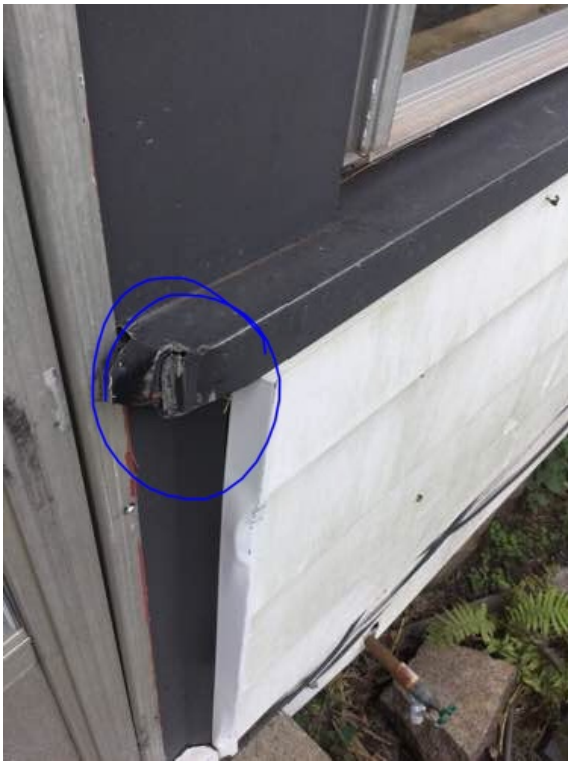
## **FLASHING**

Fair

Overall appears functional, needs minor attention in damaged areas. I recommend repair by qualified handyman or siding contractor.

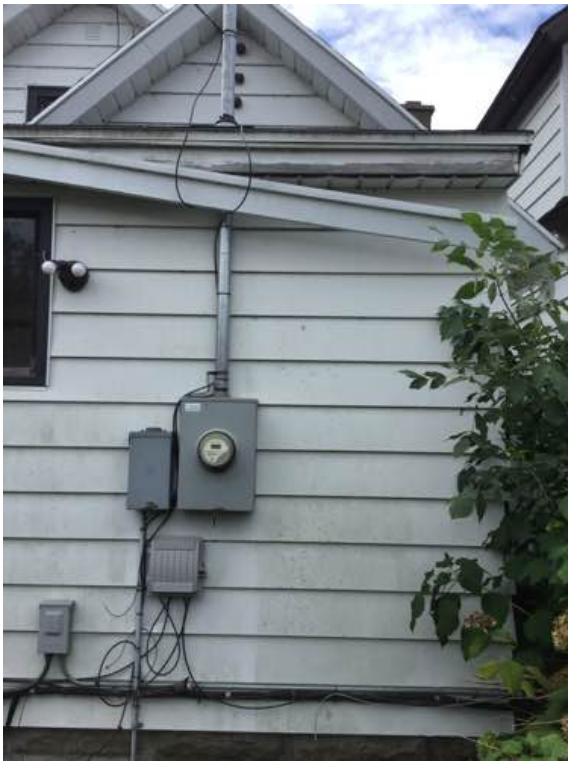
## **FASCIA**

Fair

Overall looks to be in good condition, but fascia covering has come loose on rear of home above electrical meter. I recommend repair by a qualified handyman or siding contractor.

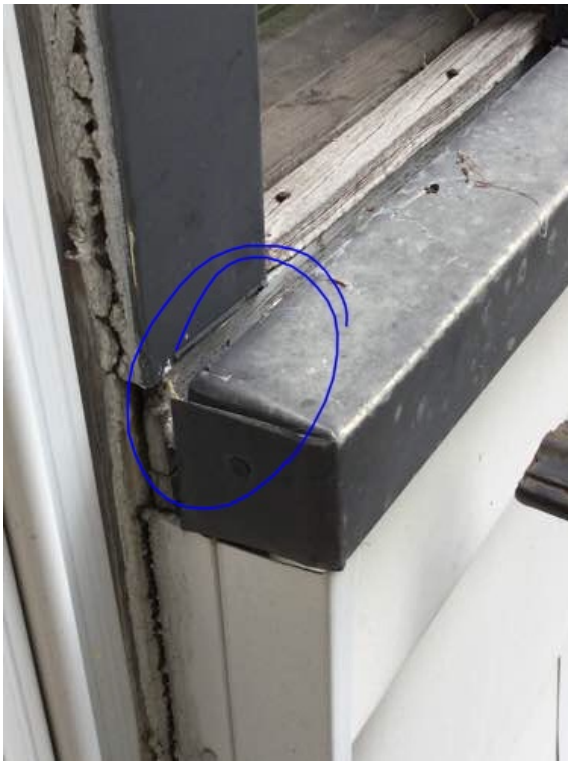
## **TRIM**

Generally in fair condition, painted wood surfaces require painting, metal seams could use caulking and/or repair.

I recommend consult with a qualified siding contractor or reputable handyman

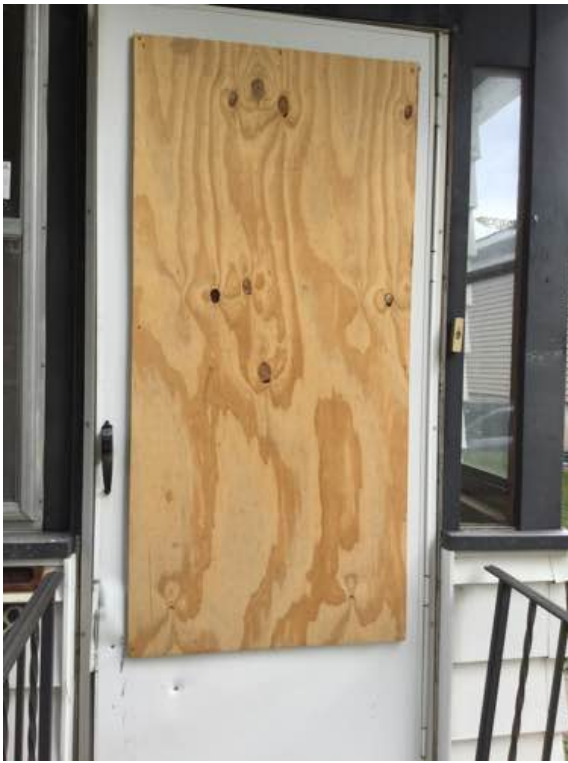
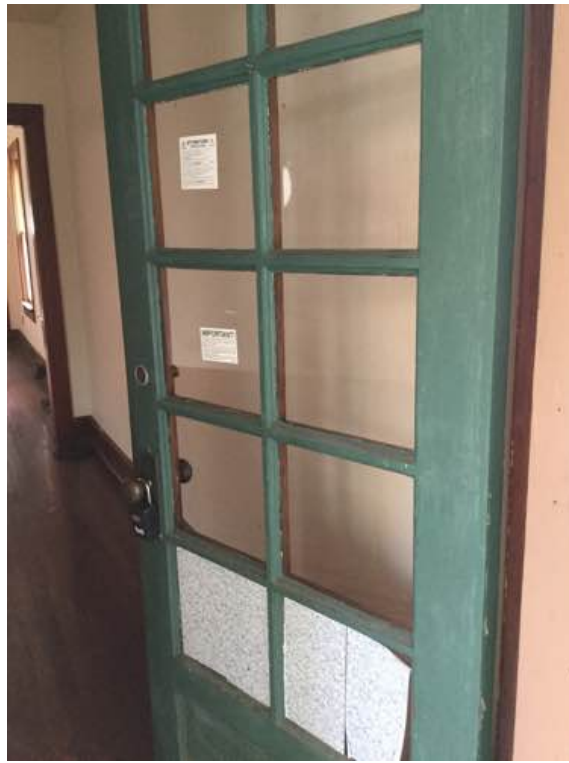
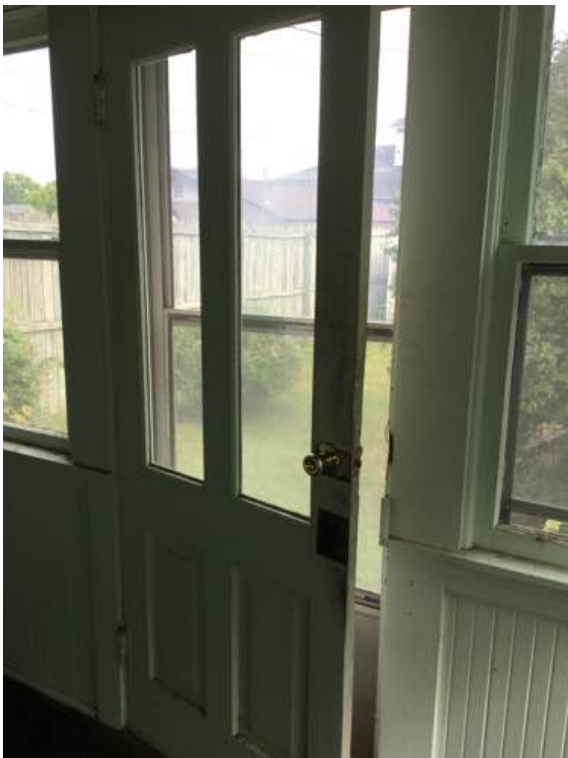
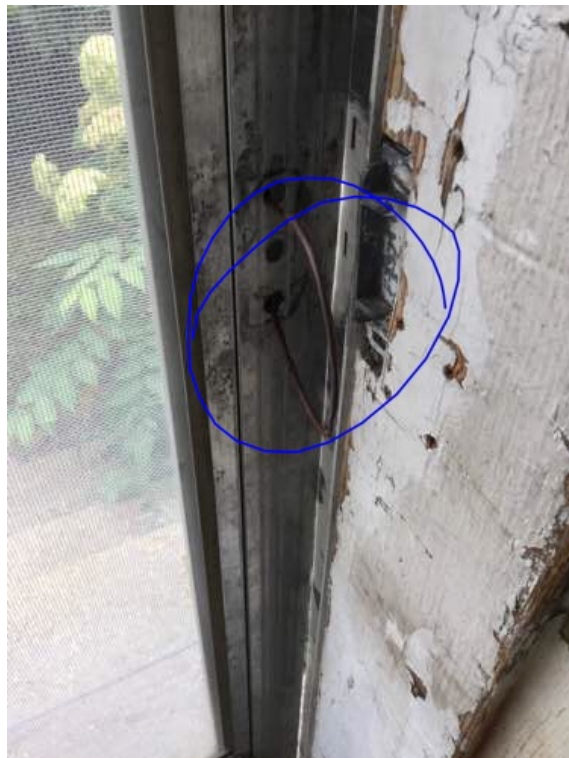
## EXTERIOR DOORS

Fair

Main doors function okay, vintage doors with character, have poor glazing and insulation values. Front screen door is broken, rear screen door is missing hardware. I recommend repair/replacement by a qualified contractor or reputable handyman.

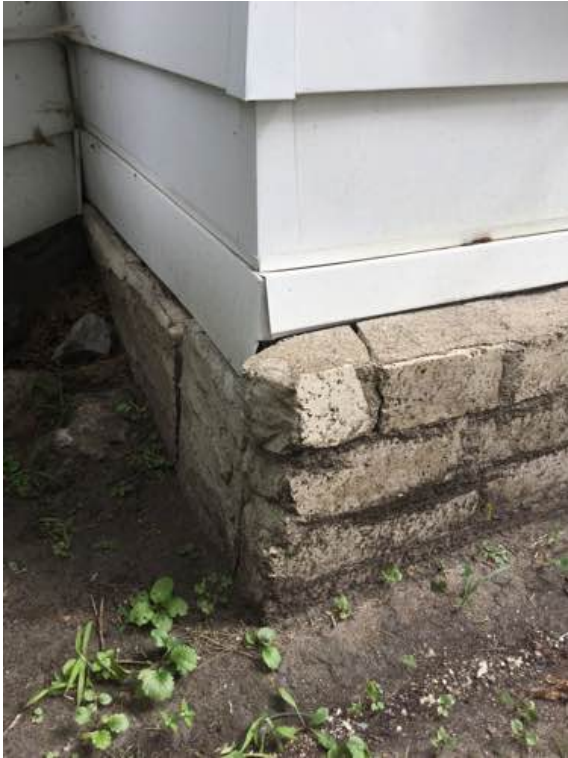
## STOOP / PORCH

Poor

Front porch appears to have poor/improper footings, signs of settling, I recommend review by a qualified masonry/foundation contractor.

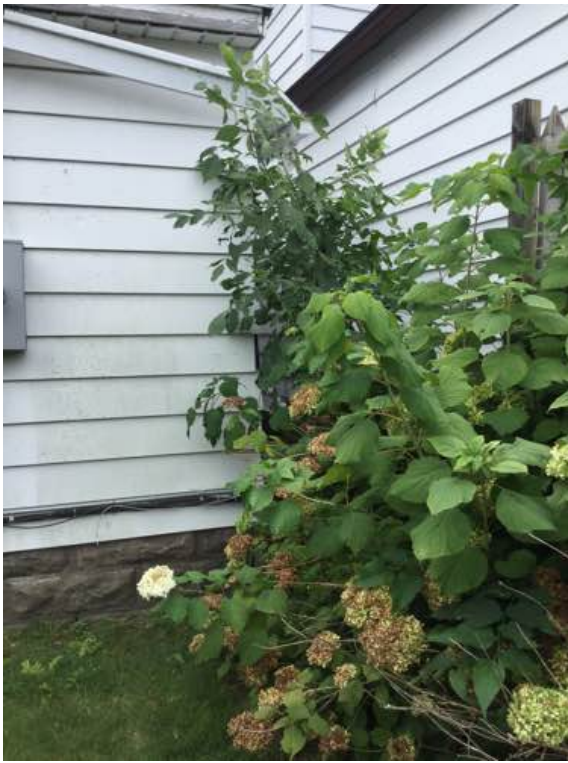
### **VEGETATION**

Poor

Plants and shrubbery are overgrown and too close to structures. I recommend evaluation by a qualified landscaper.

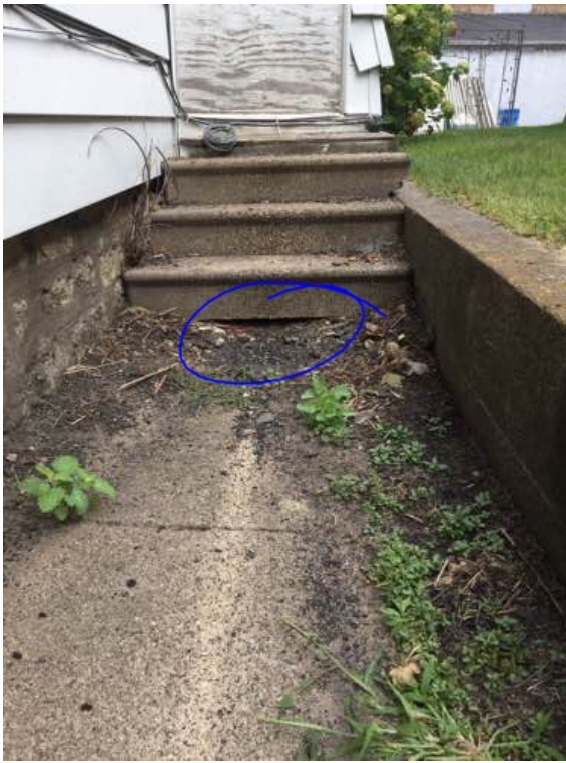
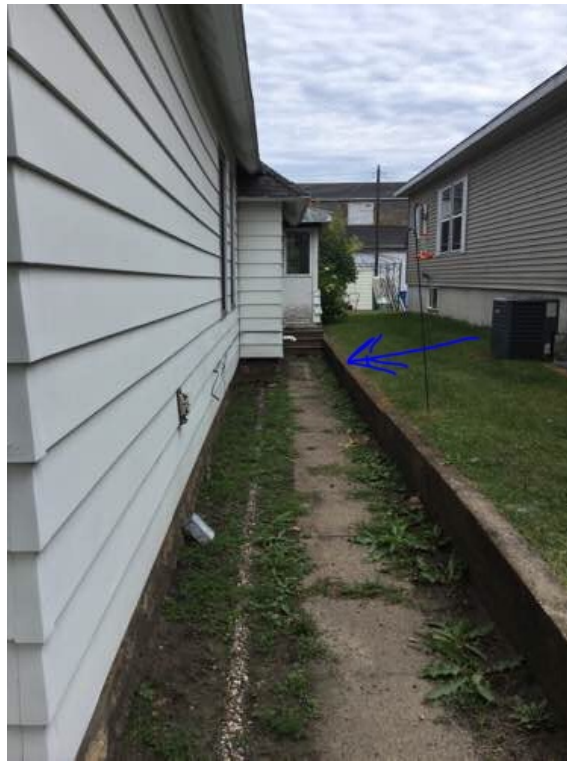
## **GRADING**

Poor

Neighbor property to East drainage slopes toward the home, creating a low area of potential drainage concern. The sidewalk as noted previously appears to channel water under the back porch. I recommend evaluation by a qualified landscape contractor.

East side of home has potential drainage concerns as addressed in the previous section on grading.

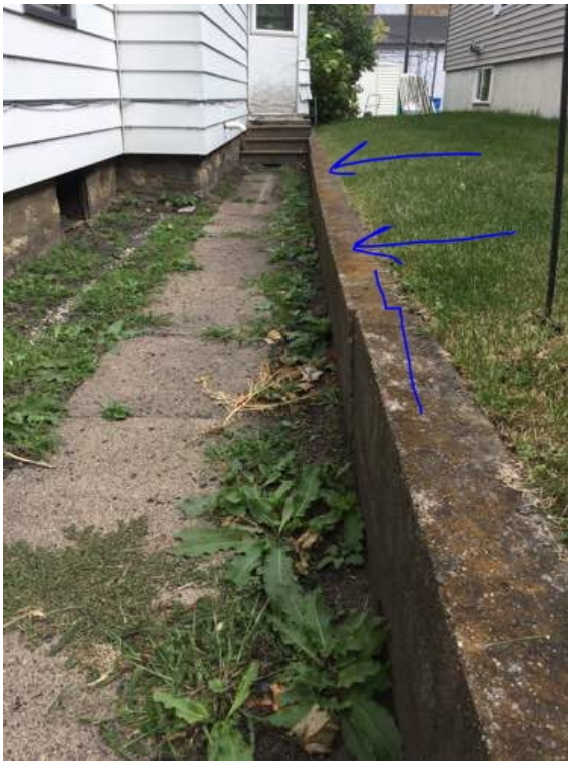
## **RETAINING WALL**

Fair

Retaining wall appears to belong to property to the east. It is in fair condition, but does lean toward the inspected property

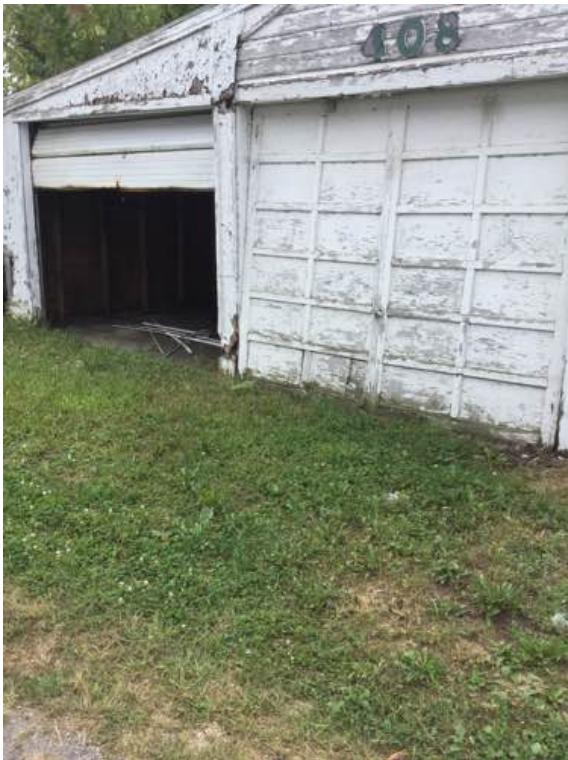
### **DRIVEWAY**

Poor

Grass driveway.

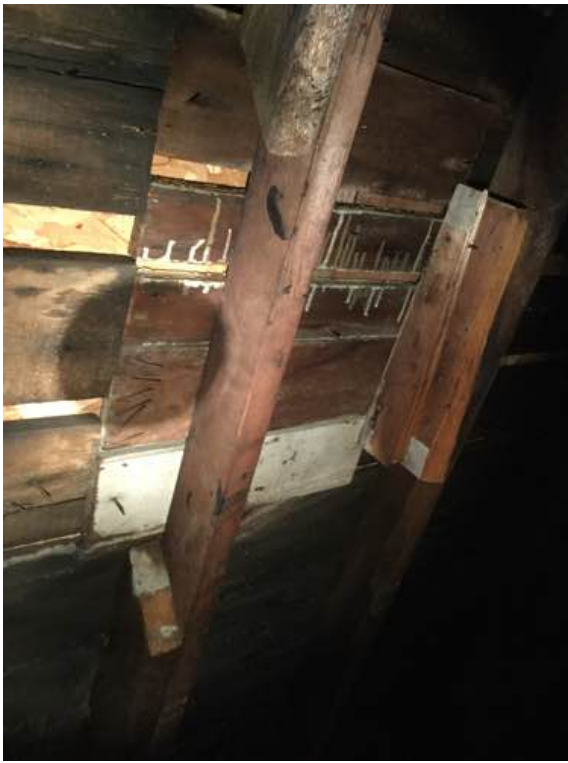
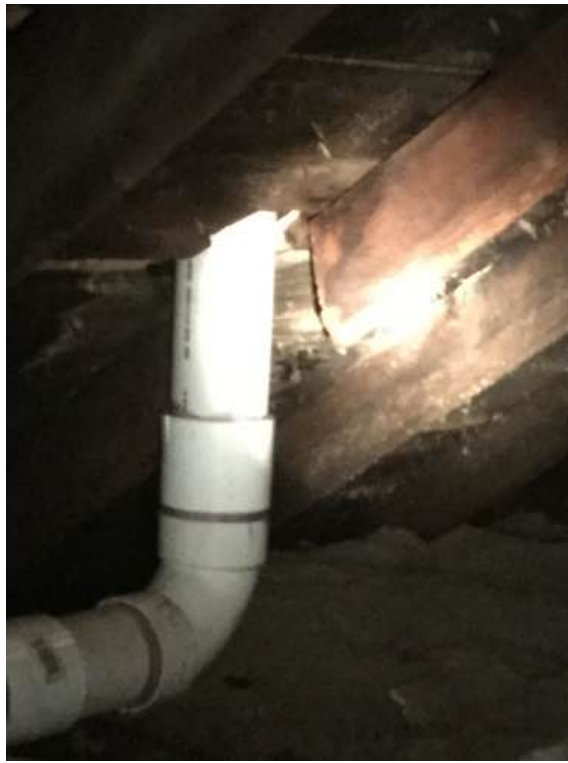
## FRAMEWORK

Poor

There are areas of concern where the roof truss members have been cut to allow roof penetrations. I recommend evaluation by a qualified contractor.

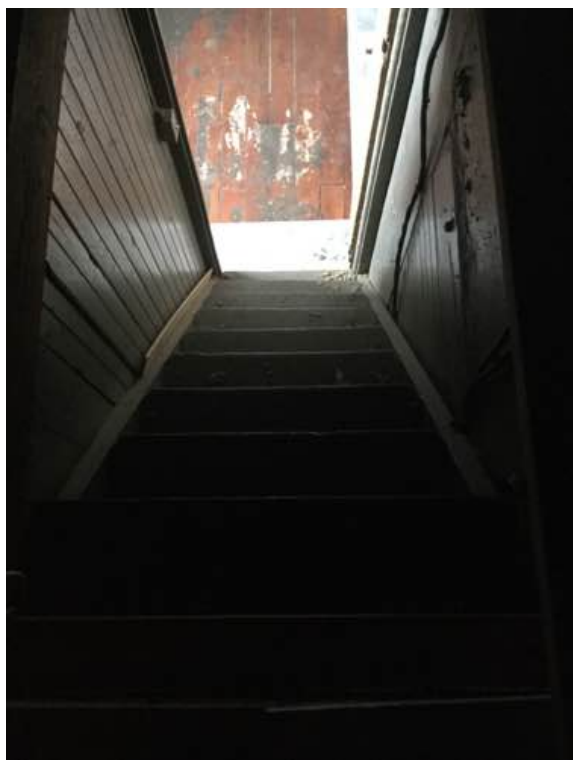
## **ACCESS**

Fair

Stairs are steep with no handrails. I recommend handrail installation by a qualified handyman

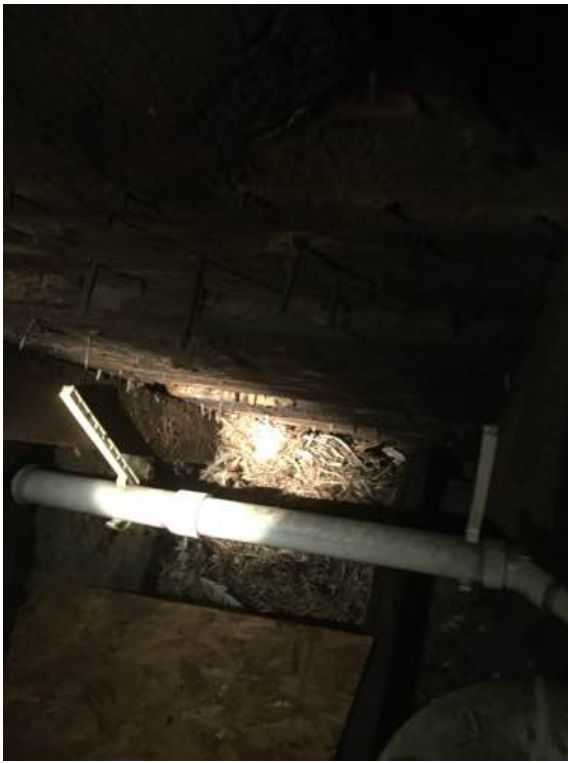
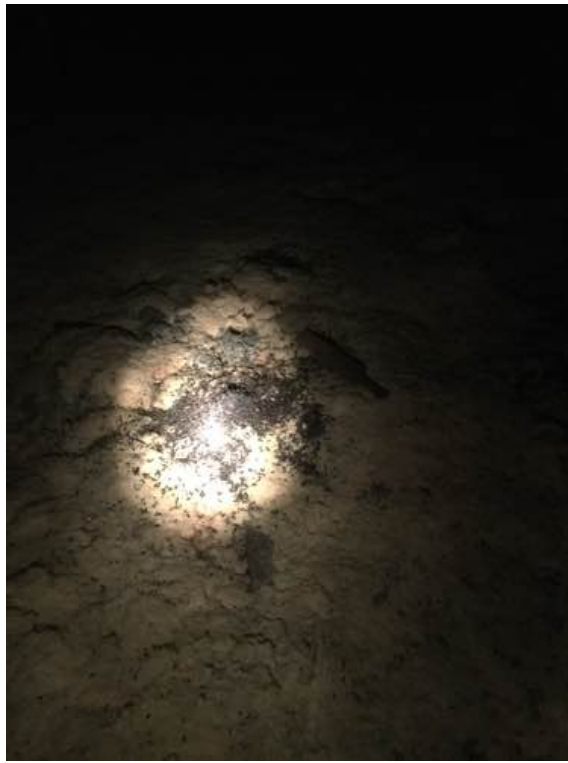
## **SIGNS OF PESTS IN ATTIC?**

Yes - see note

There are definite signs of mice and possibly squirrel or bird nesting/activity. Recommend evaluation/removal by a qualified pest removal contractor.

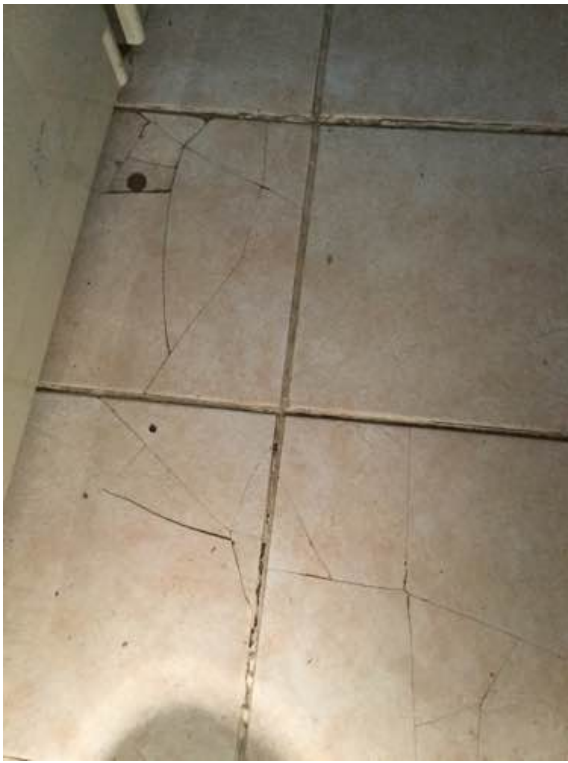
### FLOORING

Poor

Broken tiles by washer. I recommend evaluation/ repair by qualified flooring contractor.

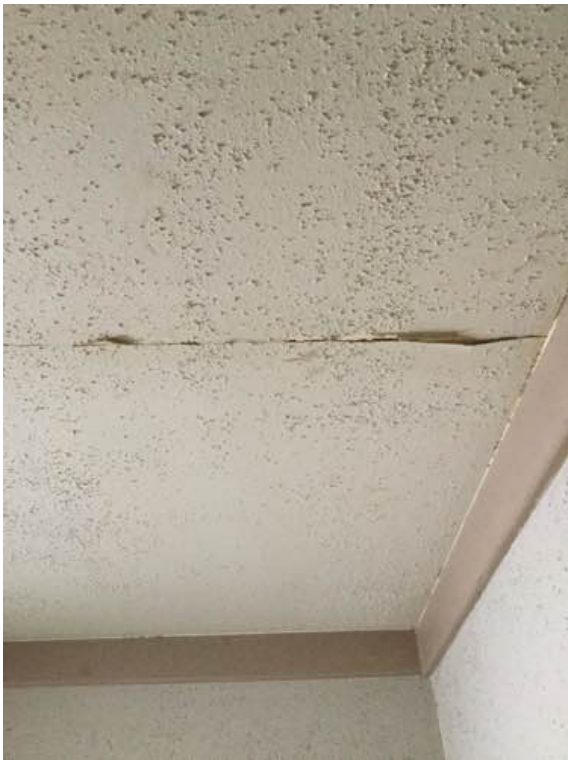
## **CEILING**

Poor

Split in ceiling at what appears to be a seam in drywall, likely from water damage. I recommend further evaluation by a qualified contractor.

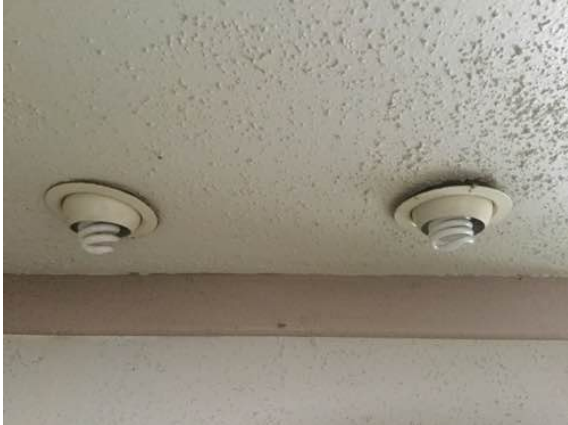
## **LIGHTING**

Poor

Fixtures appeared to be coming loose from their mounting, cannot be tested with the power disconnected.

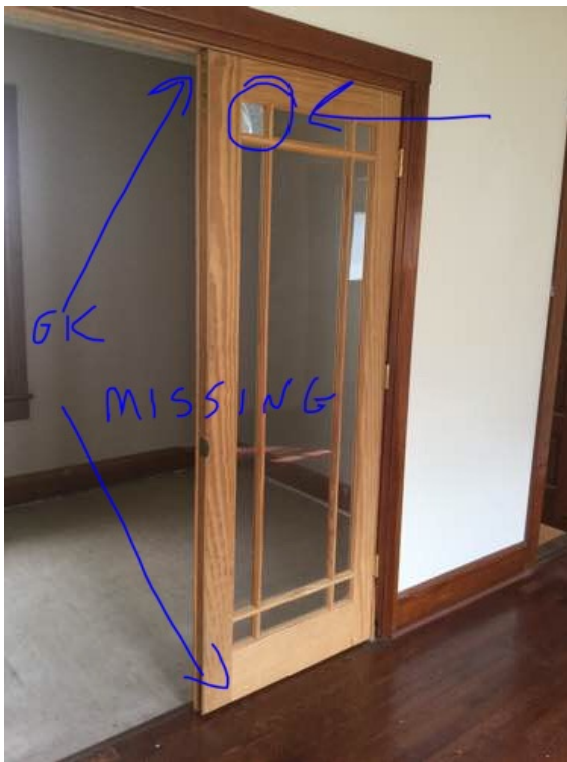
### **DOORS**

Fair

Need lower lock to make stationary door function properly. Broken glass.

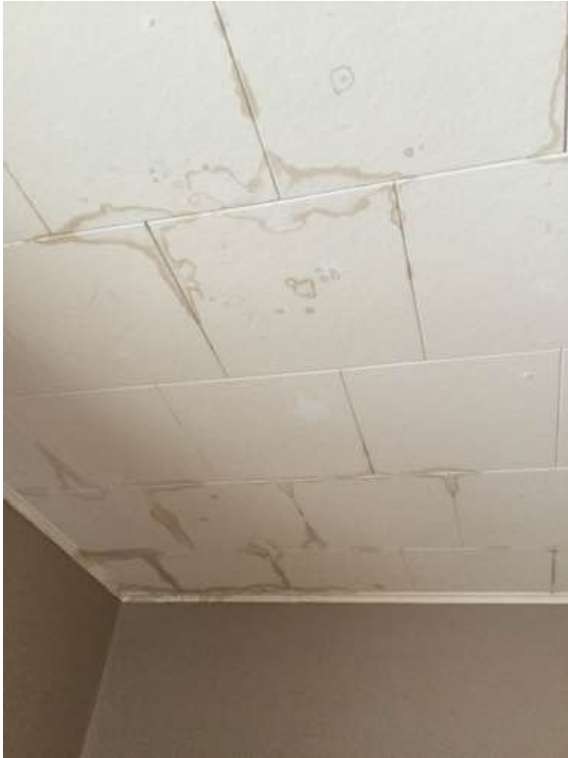
## **CEILINGS**

Poor

Water damage to ceiling. Recommend evaluation by a qualified carpenter.

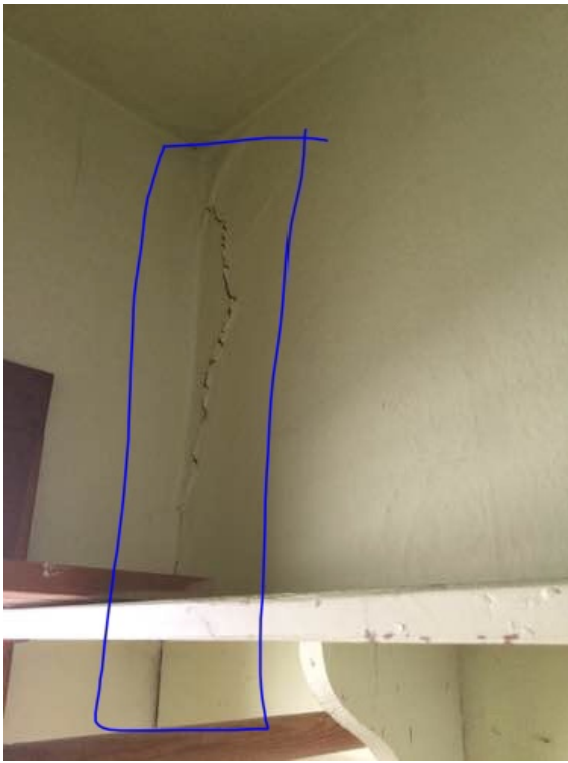
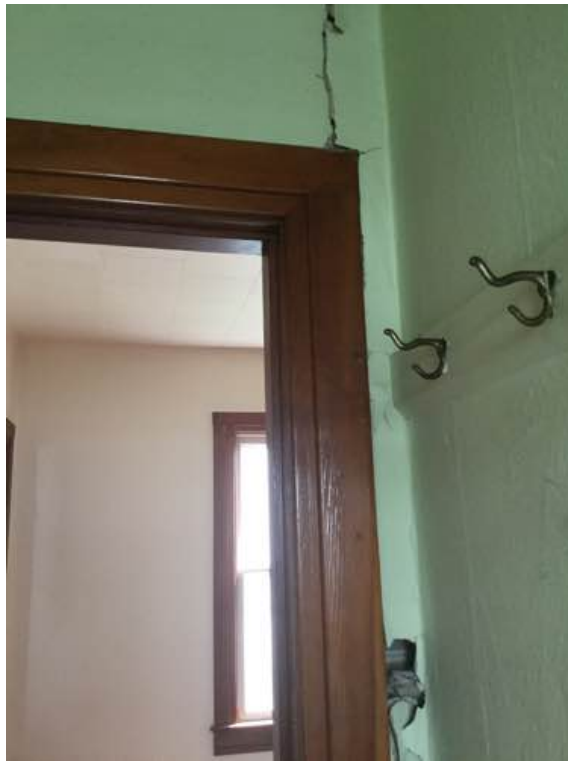
## **CLOSETS**

Poor

Water damage to walls in closet. Closet not accessible from bedroom. Closet door appears to be improperly framed. I recommend further evaluation by a qualified contractor.

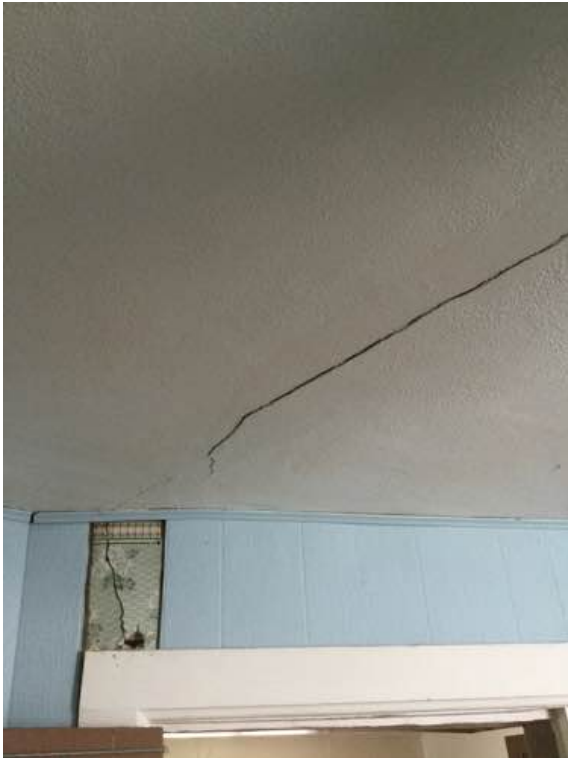
## **WALLS**

Poor

Paneling may hide some defects that were not visible at time of inspection. Large crack above the door that extends across the ceiling. I recommend review by qualified contractor.

Plaster is cracked beginning above door frame, travels across the ceiling to the west. I recommend further evaluation by a qualified contractor.

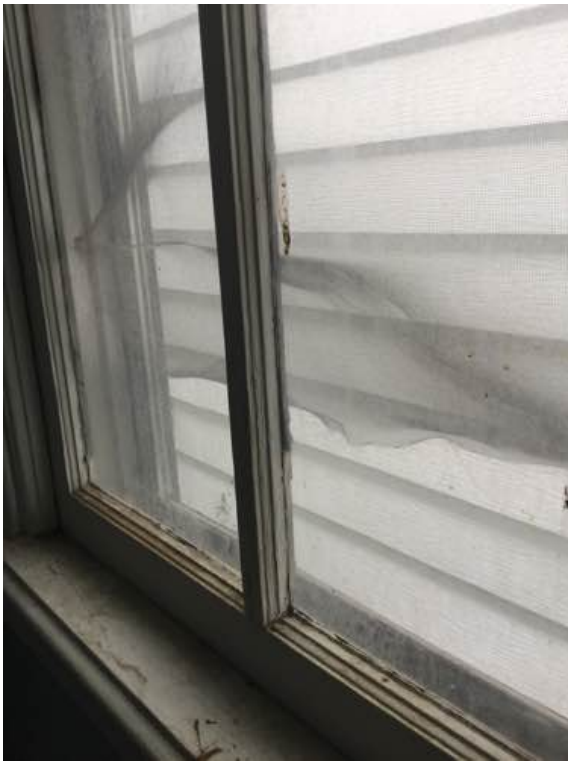
## **WINDOWS**

Poor

Functional vintage windows, screen needs replacement on window to the west.

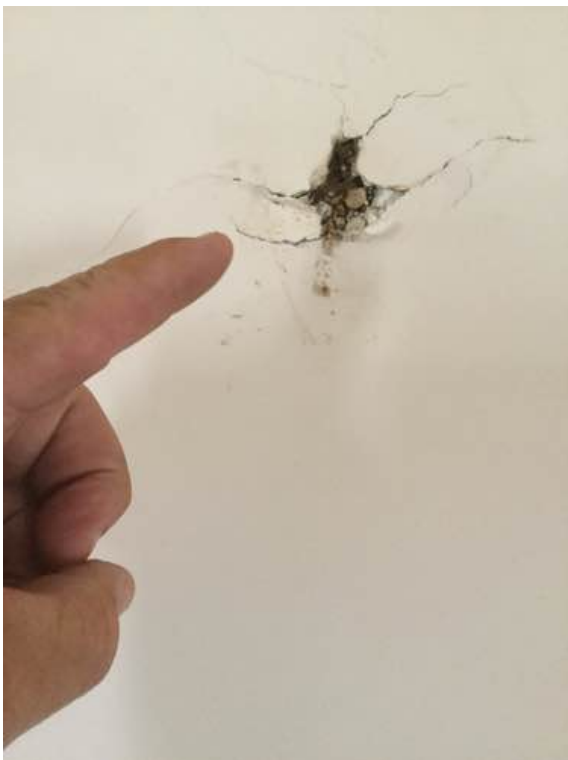
### **WALLS**

Poor

Apparent water damage to the exterior wall facing west, dampness observed in the plaster. I recommend further evaluation and or repair by a qualified contractor.

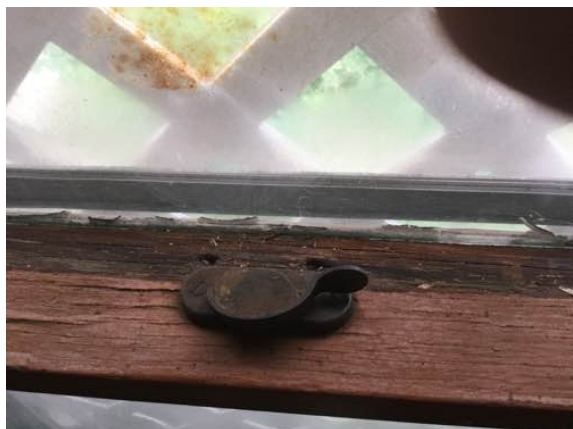
### **WINDOWS**

Poor

Old wooden windows, function okay, wood needs refinishing. Center window in bay window appears to have rotten wood. I recommend further evaluation by a qualified contractor.

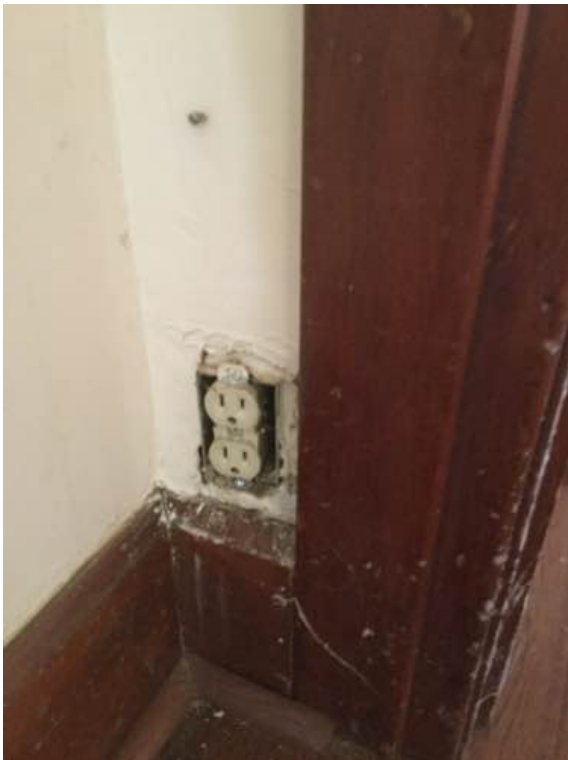
**OUTLETS**

Fair

Four non-grounded outlets and two grounded outlets exist in the living area. Electrical cover missing from one outlet. Cannot evaluate functionality due to the power to the property being shut off.

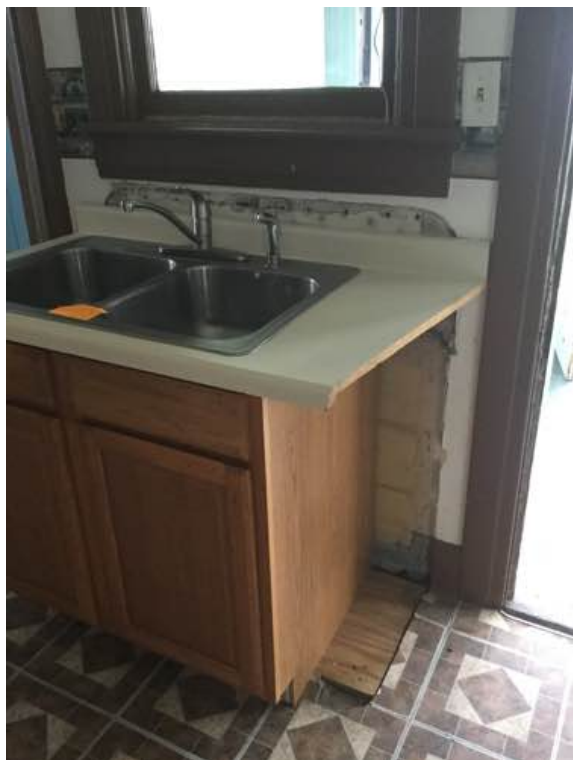
### **FLOORING**

Fair

The kitchen flooring appears to be functional, with the exception of the area surrounding the sink, it appears the sink and counter were replaced leaving gaps in the flooring and wall finishing.

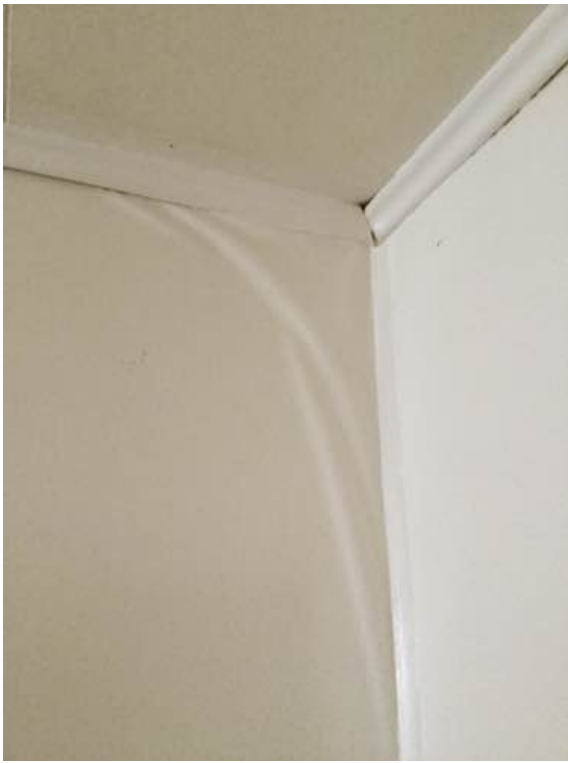
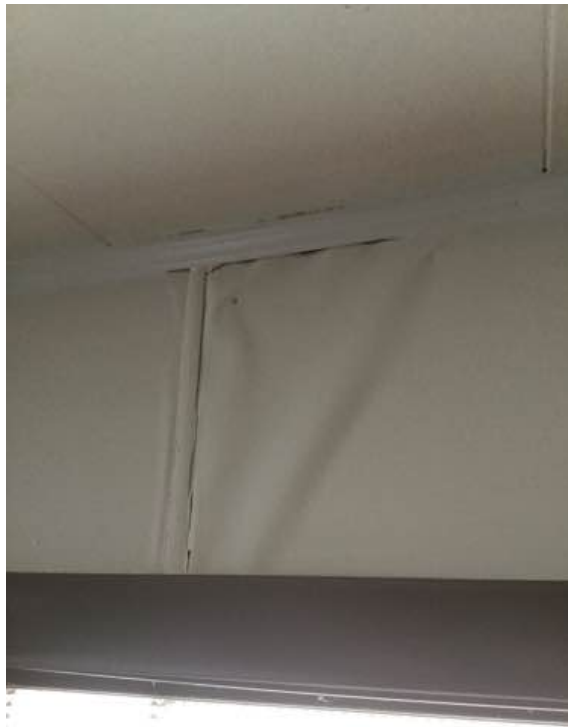
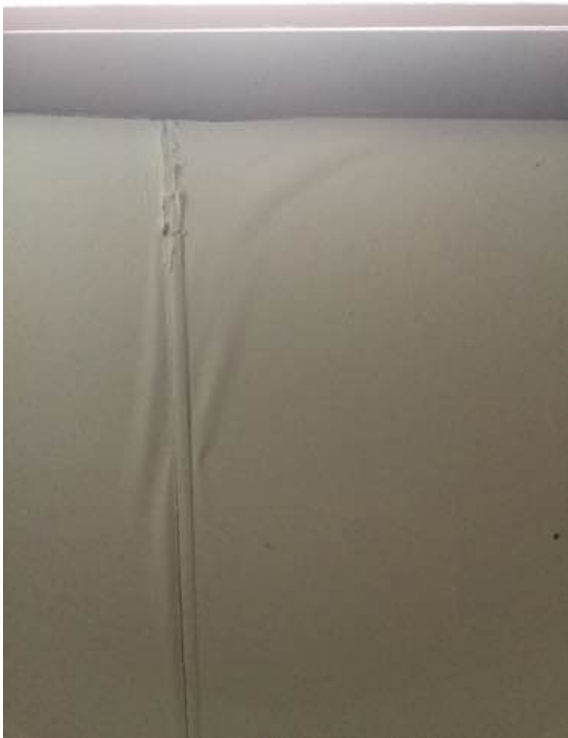
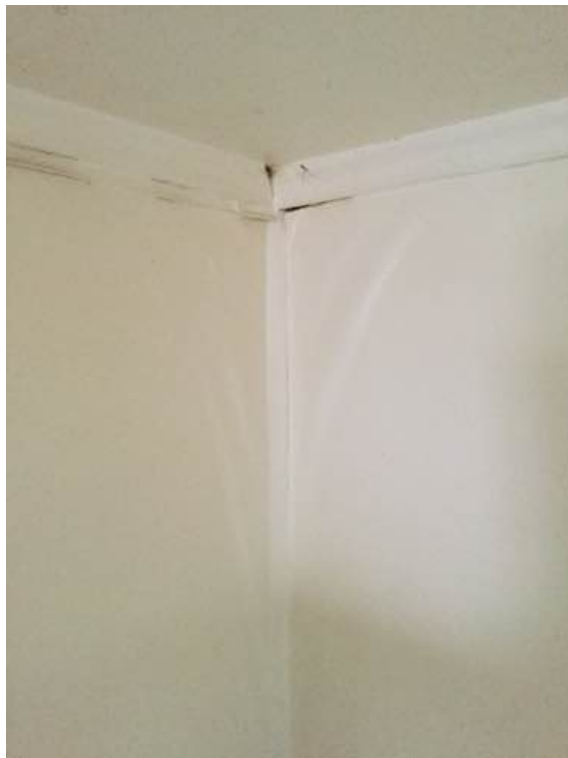
**WALLS**

Poor

The East kitchen wall shows signs of potential water damage, wallpaper is peeling in the Southeast corner, Northeast corner, and above and below the window. I recommend review by a qualified contractor.

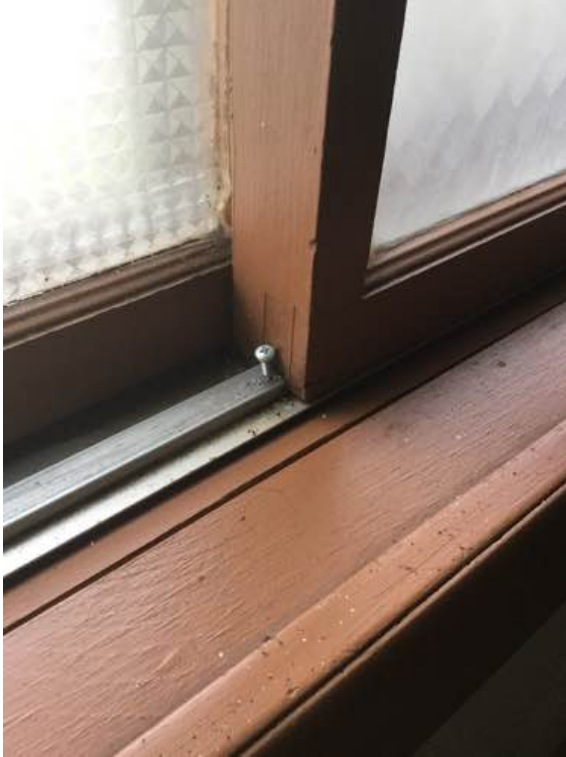
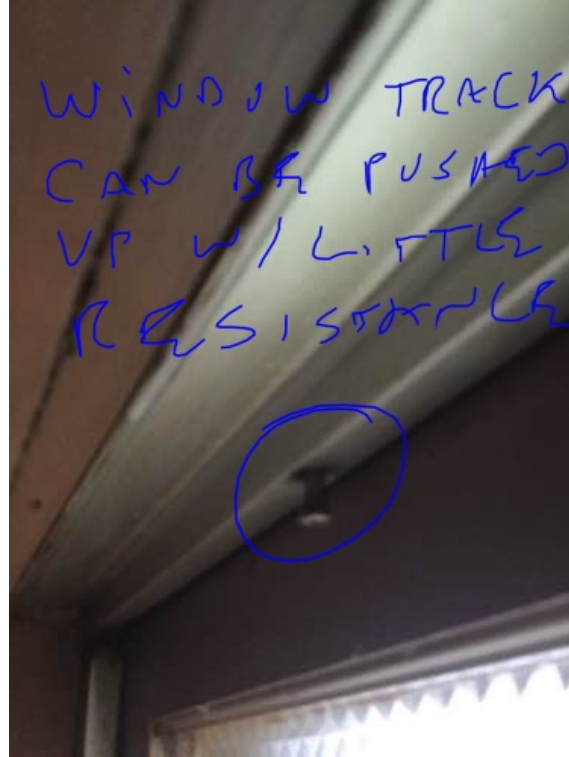
## WINDOWS

Poor

Kitchen window has been secured shut, the reasoning for that is unknown. The sliding track for the window appears to be problematic as well, possibly from water damage. Evaluation by a qualified contractor is recommended.

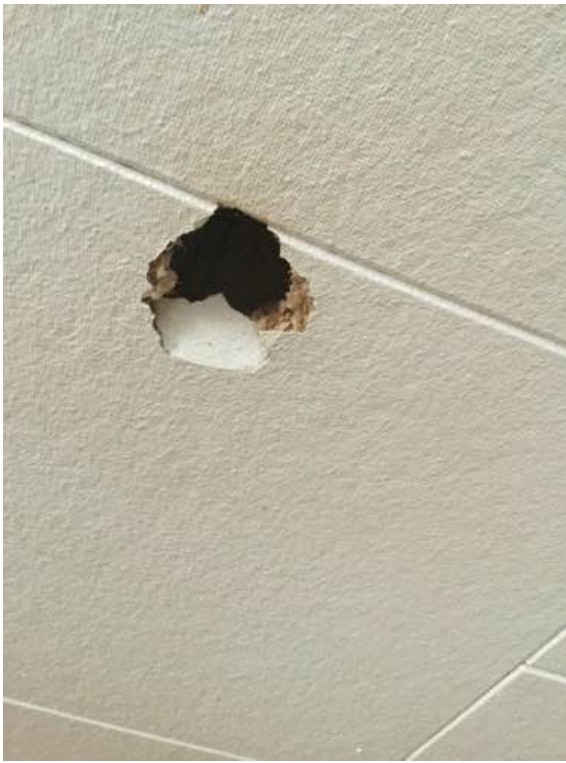
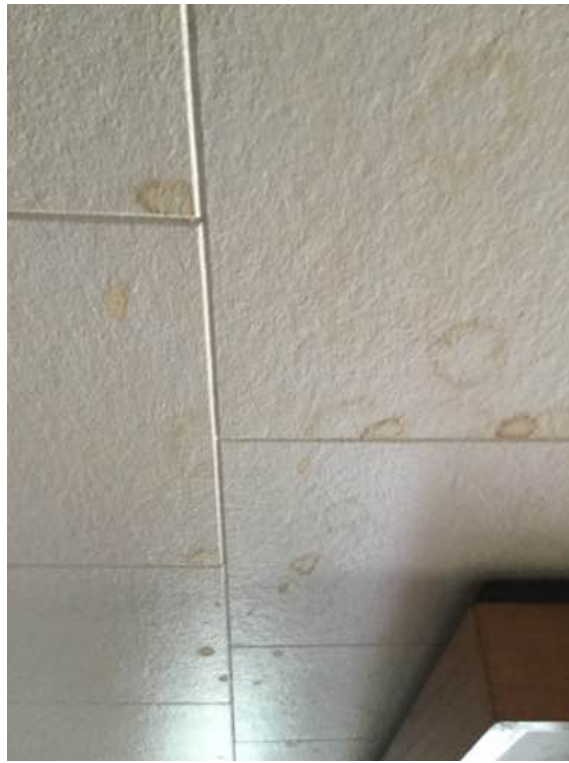
## CEILING

Poor

There is water damage to the kitchen ceiling. Water damage seems to be congruent with the gaps at the peak of the roof. I recommend evaluation by a qualified contractor.

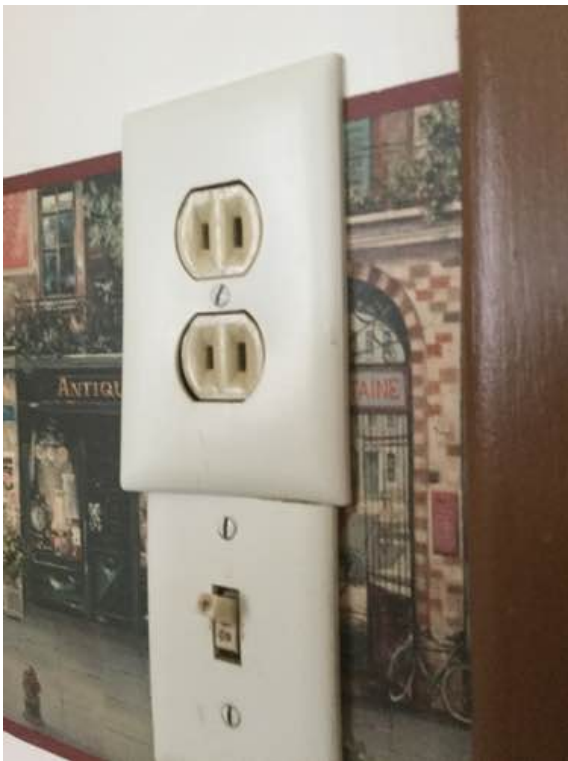
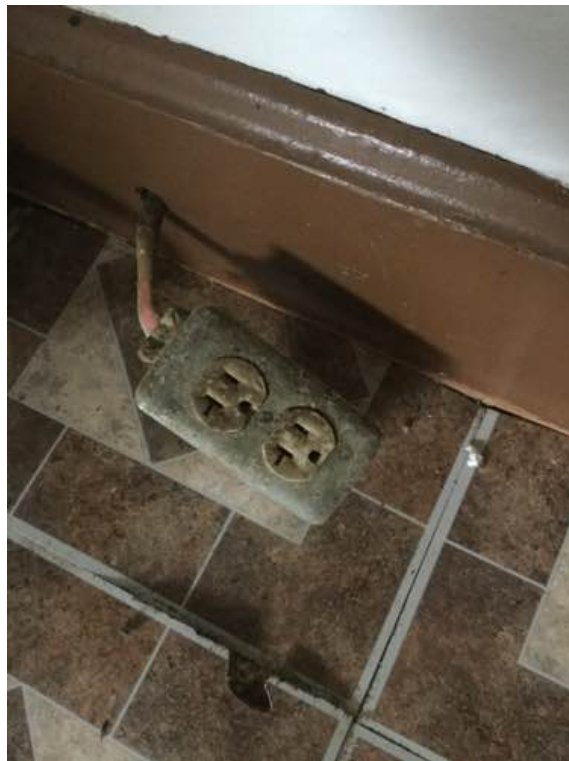
## OUTLETS

Poor

Two grounded outlets and two non-grounded outlets exist, but cannot be evaluated due to the electrical shut-off. One outlet has an improperly sized cover, the other is loosely placed in an un-mounted box. I recommend further evaluation by a qualified electrician.
