# Landmark Services

**September 7th 2019, 9:00 am**

**Inspection performed by:  
Rich Anthony**

**BUILDING ADDRESS:** Winona Mn. 55987  
**CITY:** Winona  
**STATE:** Mn  
**ZIP CODE:** 55987  
**INSPECTION DESCRIPTION:** Single family home, 2br 1ba.  
**SQUARE FOOTAGE:** 932 Sq Ft

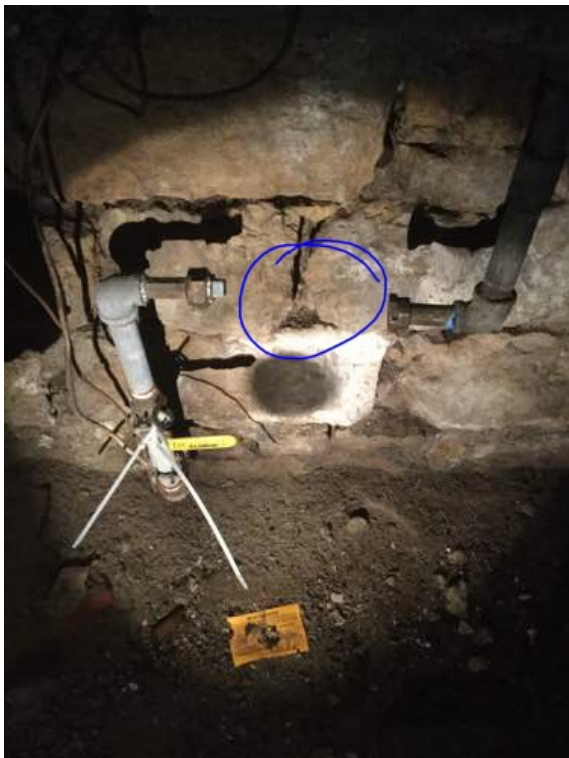
### WATER SUPPLY PIPING SIZE

Water meter is non-existent. Supply line sizing seems adequate.

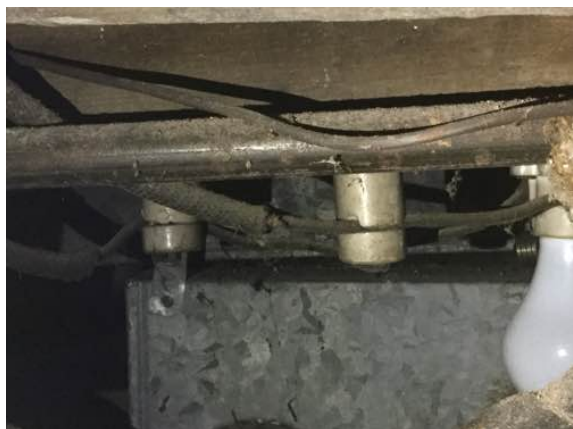
## **CONDUCTORS**

Fair

Some knob and tube along with exposed connections were observed.  
Could not test to see if they were carrying current, due to the power shut off.

Some knob and tube was observed, was not able to evaluate to determine whether it has been eliminated or is still part of the system. I recommend evaluation by a qualified electrician when the power is restored.

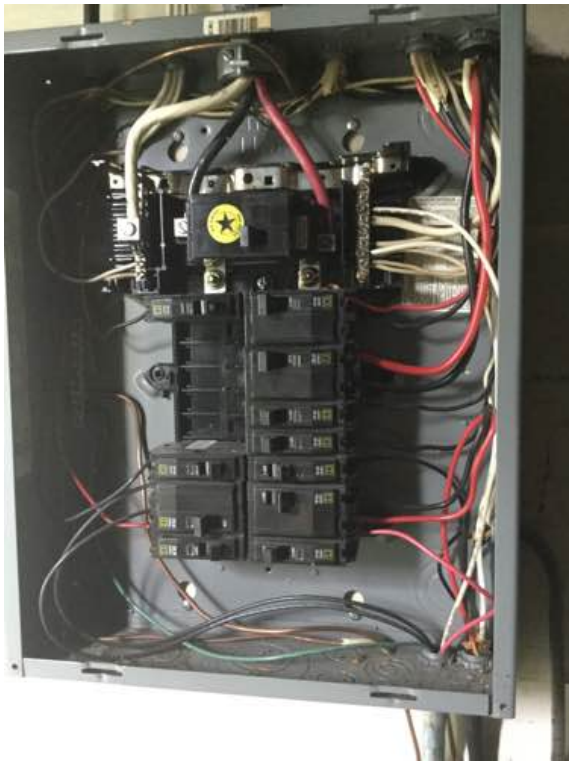
## **AMP RATING**

Electrical Service appears to be updated.

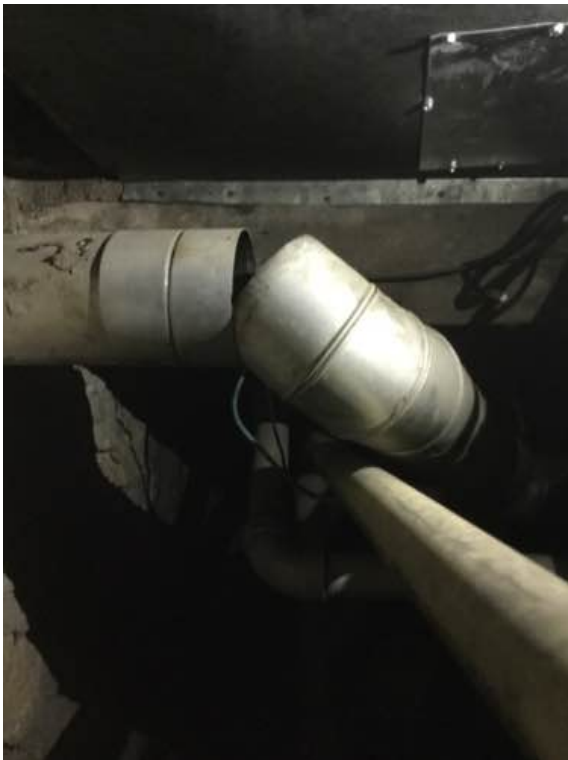
### **DUCTWORK / PIPING**

Poor

Ductwork is disconnected in at least one location. I recommend further evaluation by a qualified heating and cooling contractor

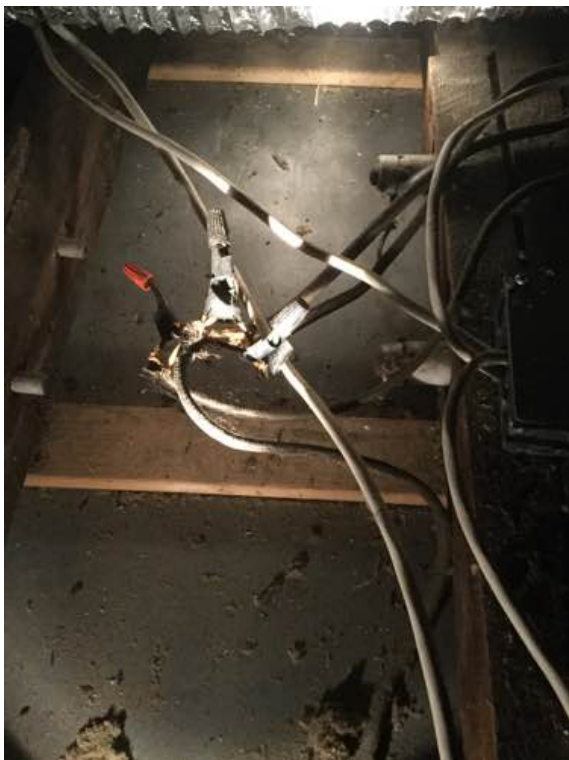
### **ELECTRICAL CONNECTIONS IN ATTIC.**

Poor

Unboxed electrical wiring connections exist in the attic. This creates a potentially hazardous situation.

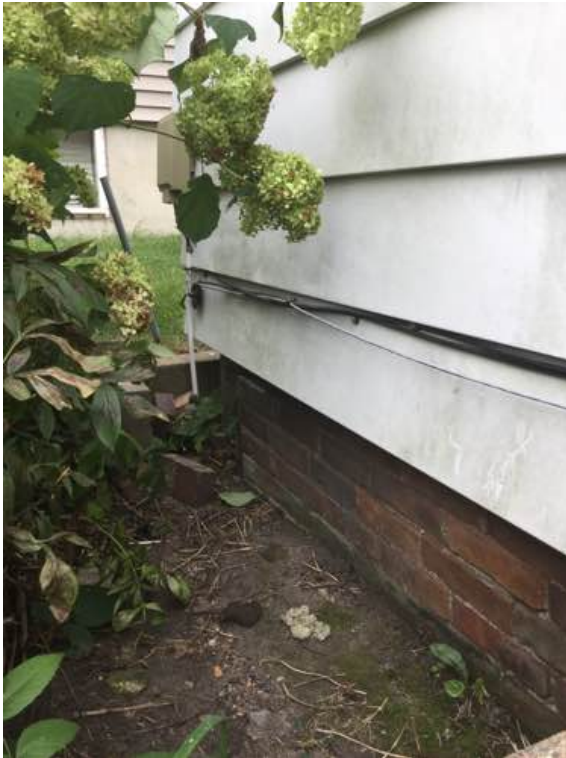
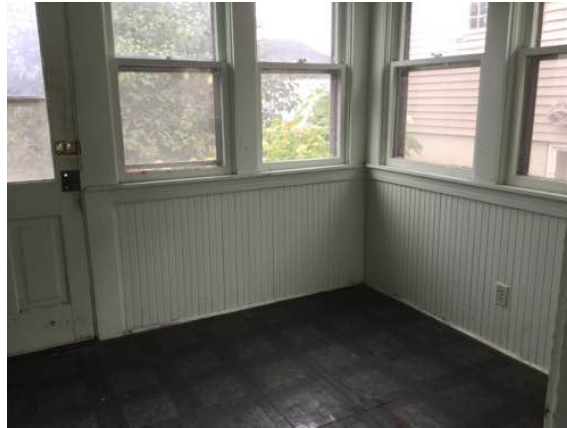
## **BACK PORCH**

Fair

Appears to be settling to the Northeast corner, potential footings for piers are inadequate for the climate. I recommend further evaluation by a qualified contractor.
