The Tour

SUBJECT: REPORT ON THE TENTH AND FINAL RE-MEASURE OF
WATERLINE W1A AND W2A BENCHMARK ELEVATIONS IN THE
WOODLANDS, TEXAS IN MARCH 2020.

RE: Review of Twelveth (12th) Re-measure of the Waterline W1A and W2A Benchmark Elevations in the Woodlands, Texas in March 2021

W2A Geological Monitoring Survey

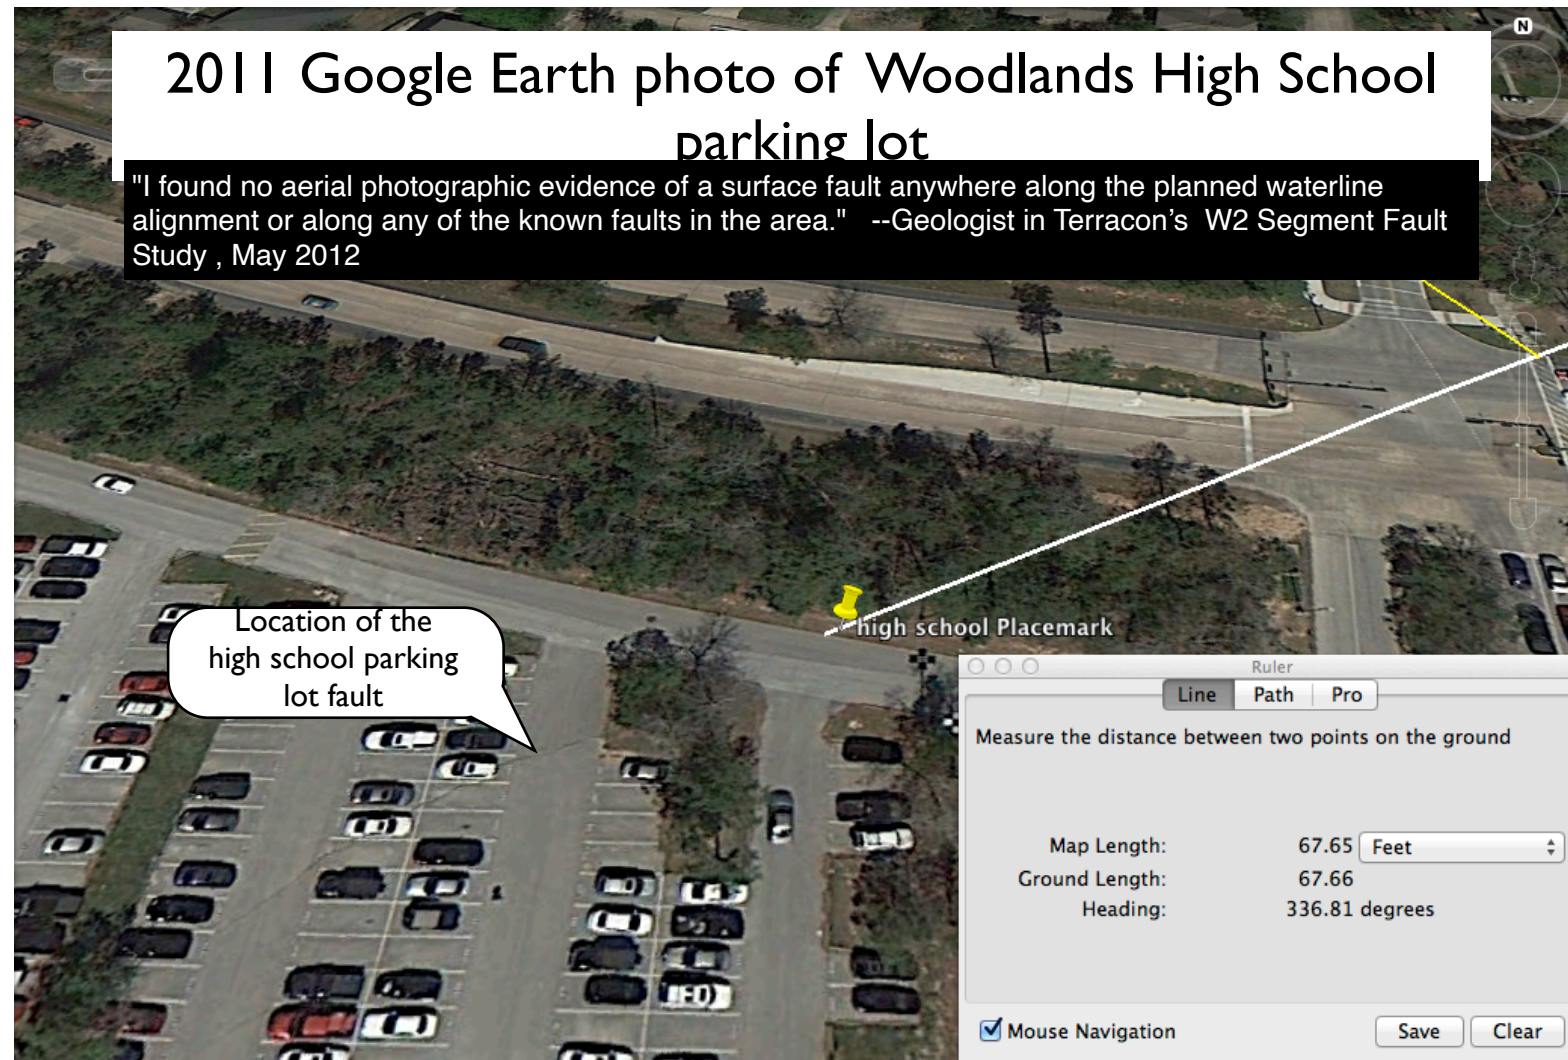
This March, 2011 photograph shows the parking lot fault clearly evident prior to Terracon's 2012 W2 Segment Fault study (and shows an alternate survey path suggested by a fault model of the PB Fault from elevation sections).

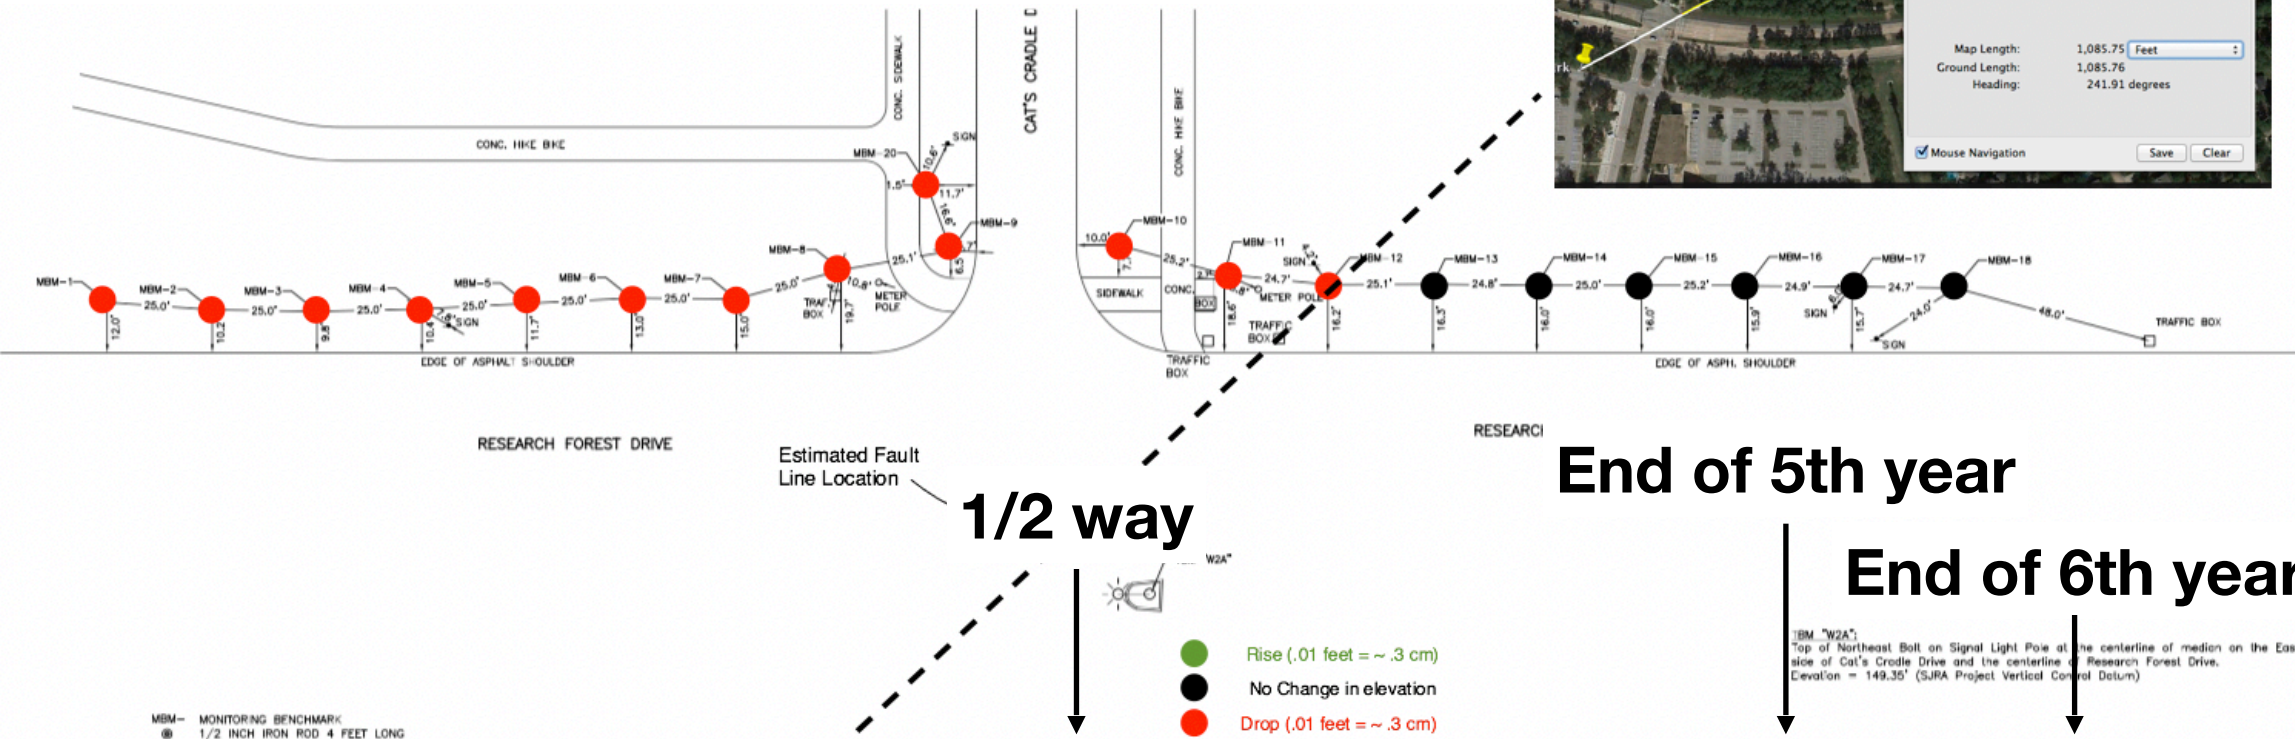
This slide shows changes in elevation of each of the 19 elevation monuments over six years along with the location of the fault that was predicted to SJRA management in August, 2013 before the GRP pipeline was placed in the ground across the Panther Branch Fault.

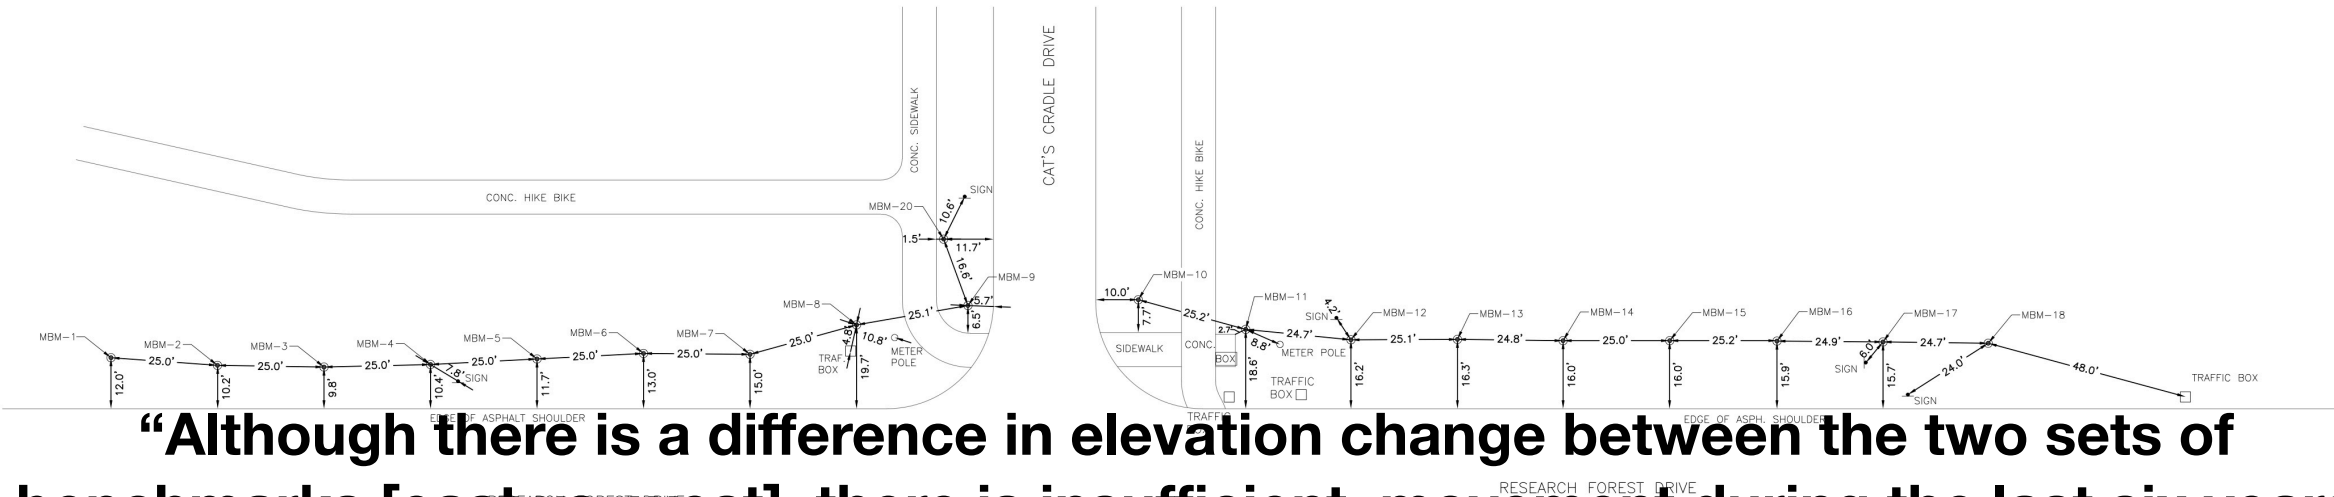
“Although there is a difference in elevation change between the two sets of benchmarks [east vs. west], there is insufficient movement during the last six years and during the last six months to attribute the difference in elevation change to an active fault”.

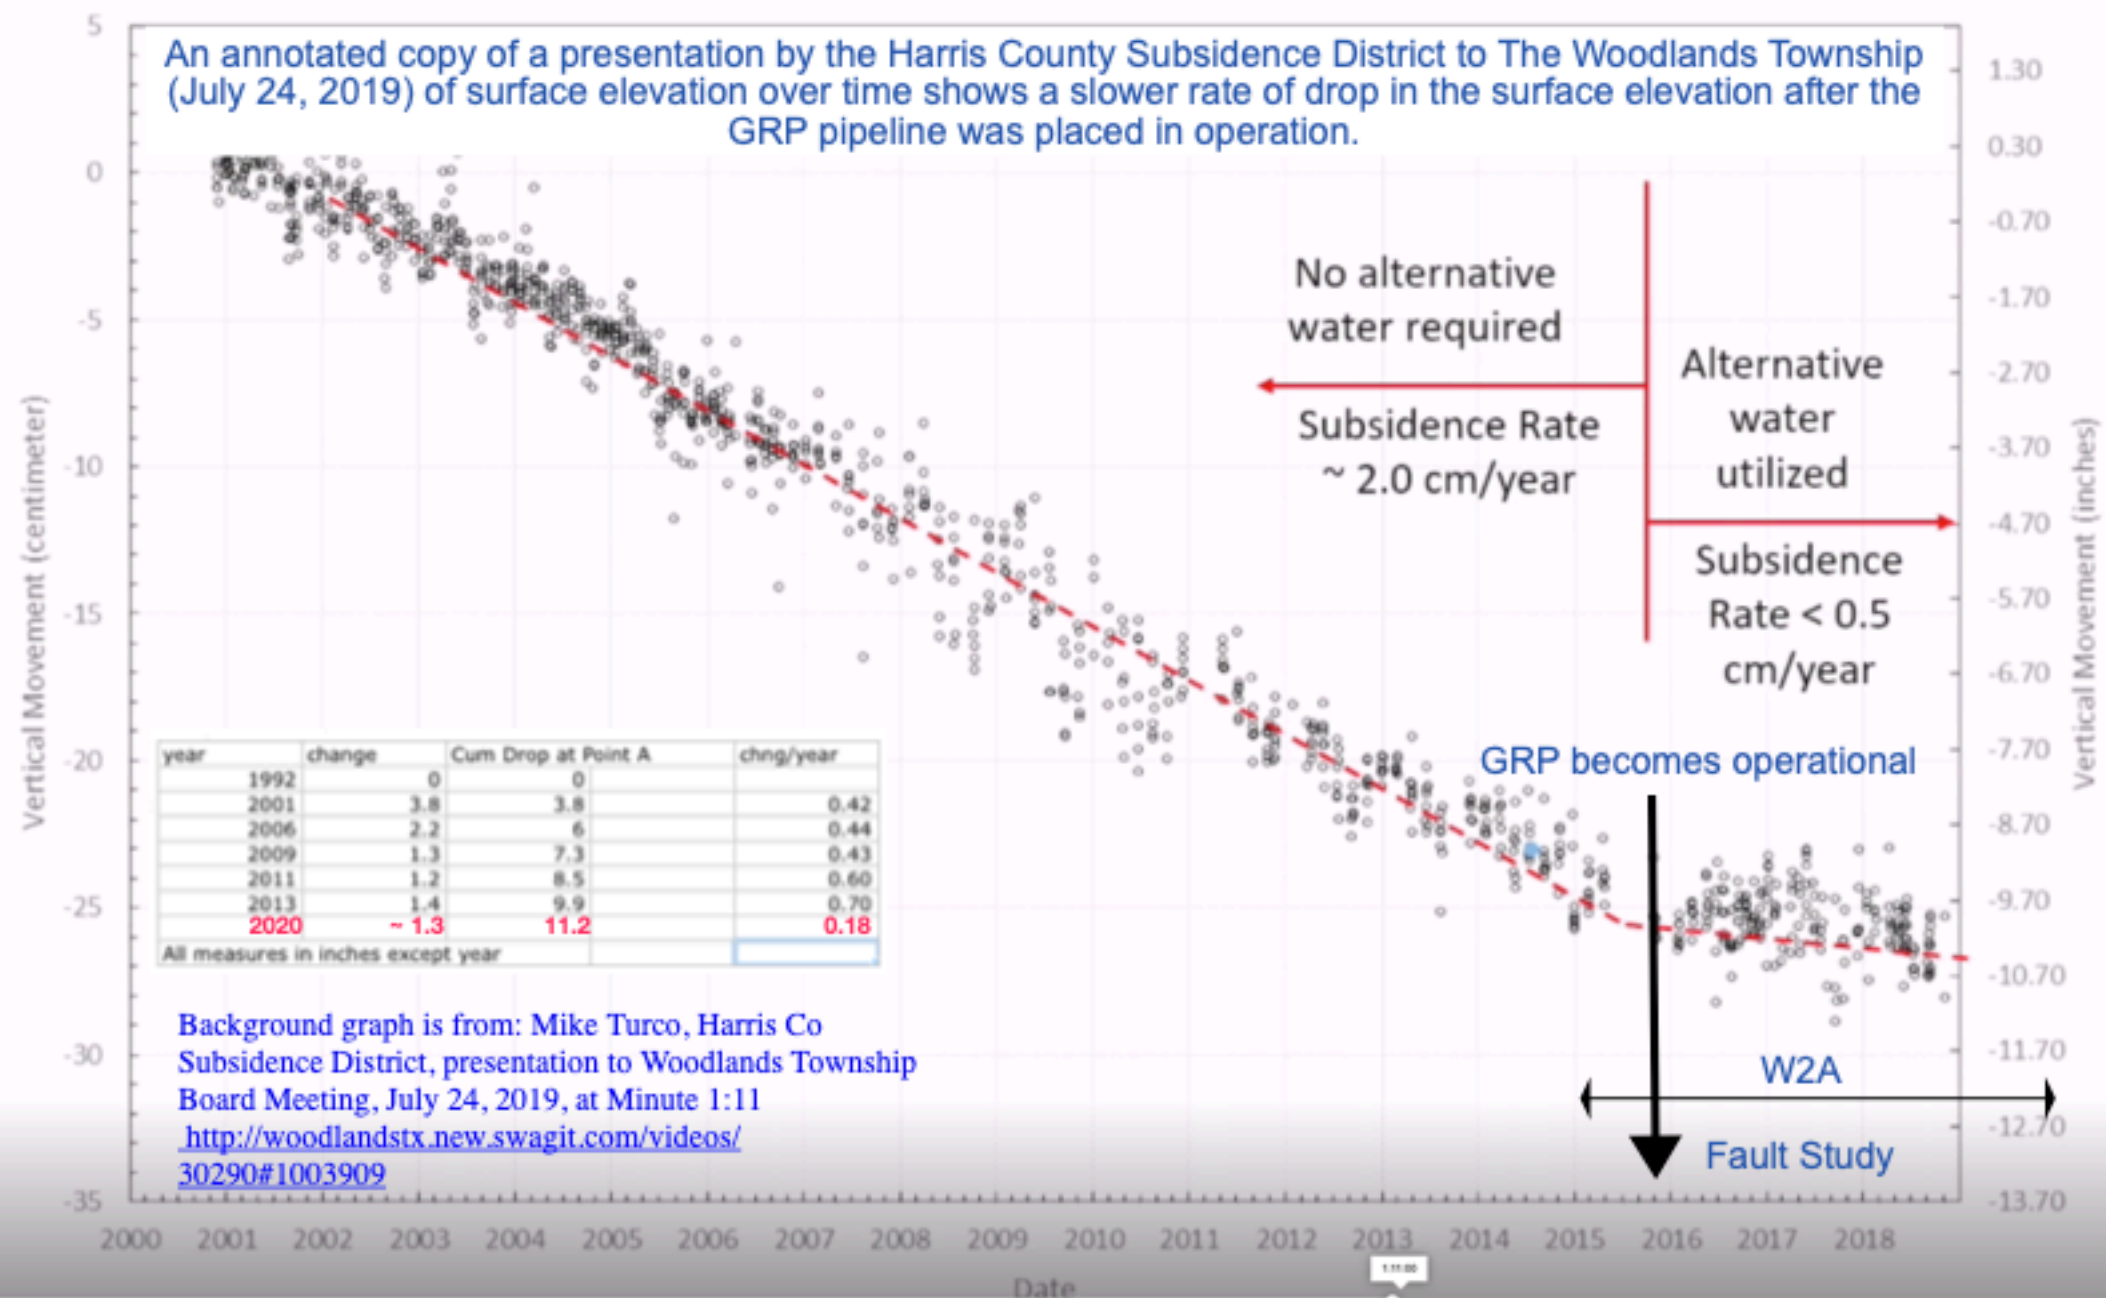
History of Subsidence at PAM-13 and at local residence before and after the GRP pipeline became operational

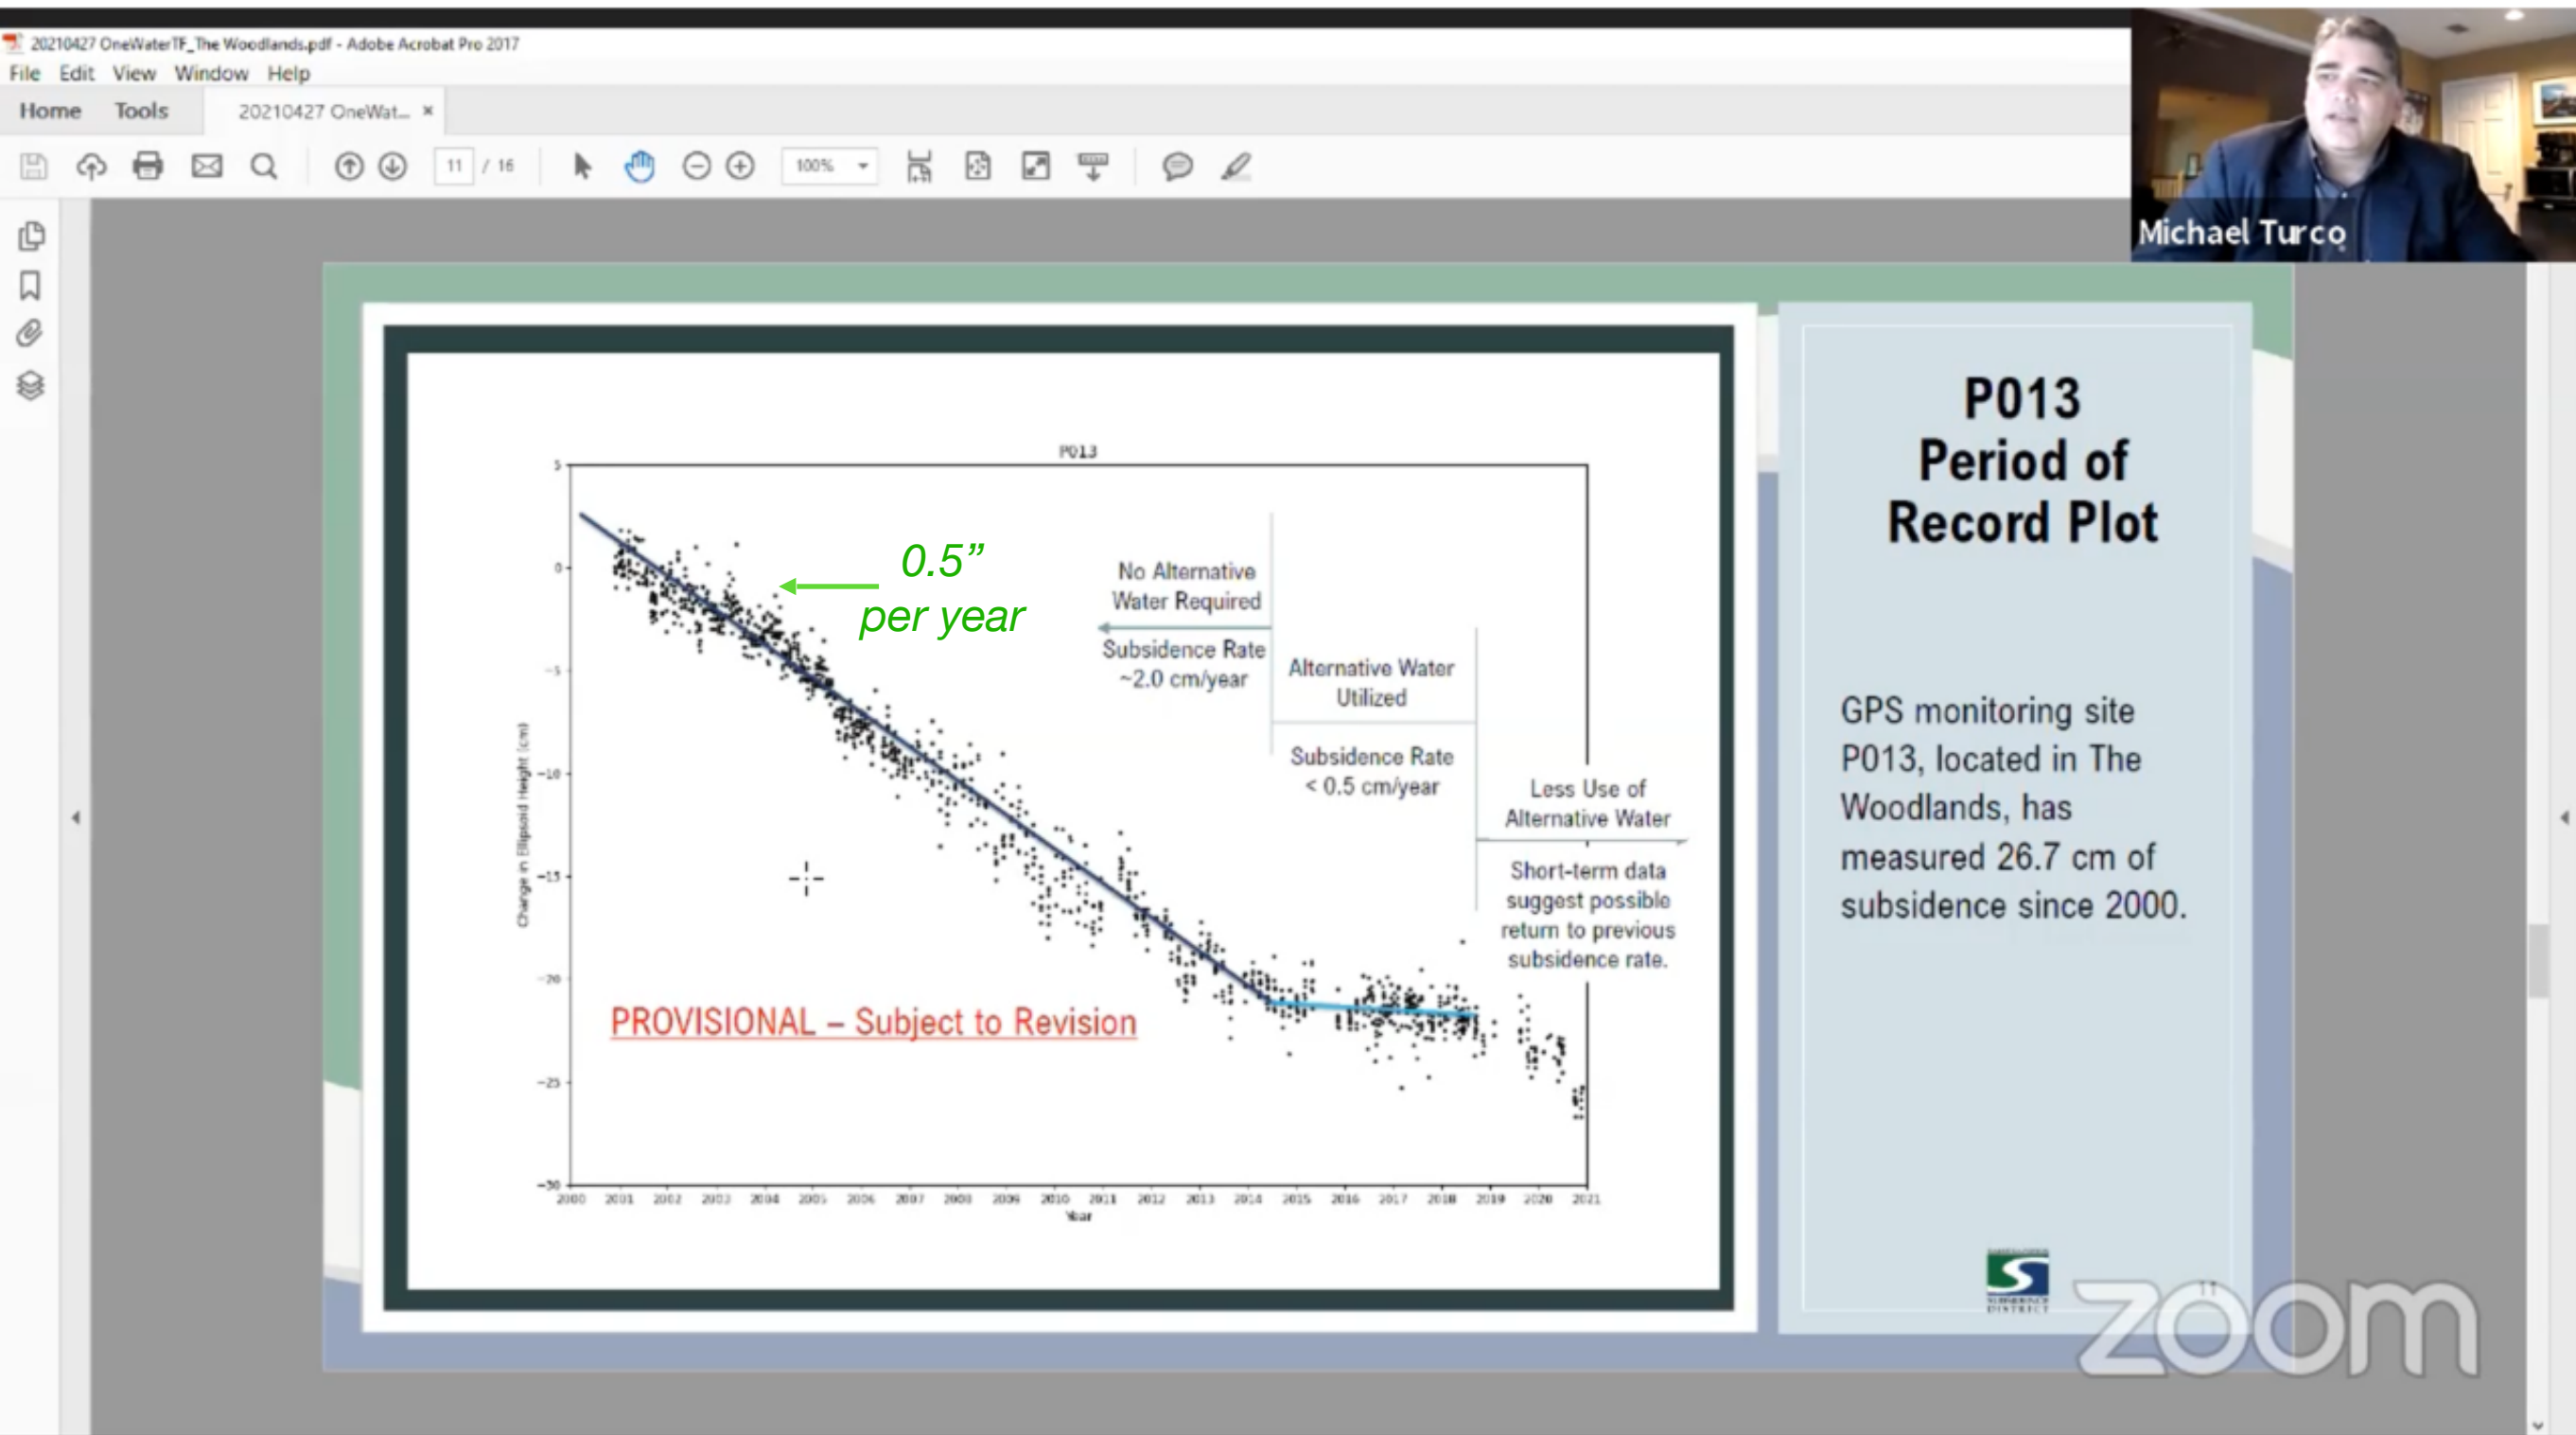
BEFORE
~-0.5"
per year

AFTER
~- 0.5"
per 5 years

Subsidence at fault line before and after the GRP pipeline became operational in 2015

Subsidence at Pam-13 before and after the GRP pipeline became operational in 2015

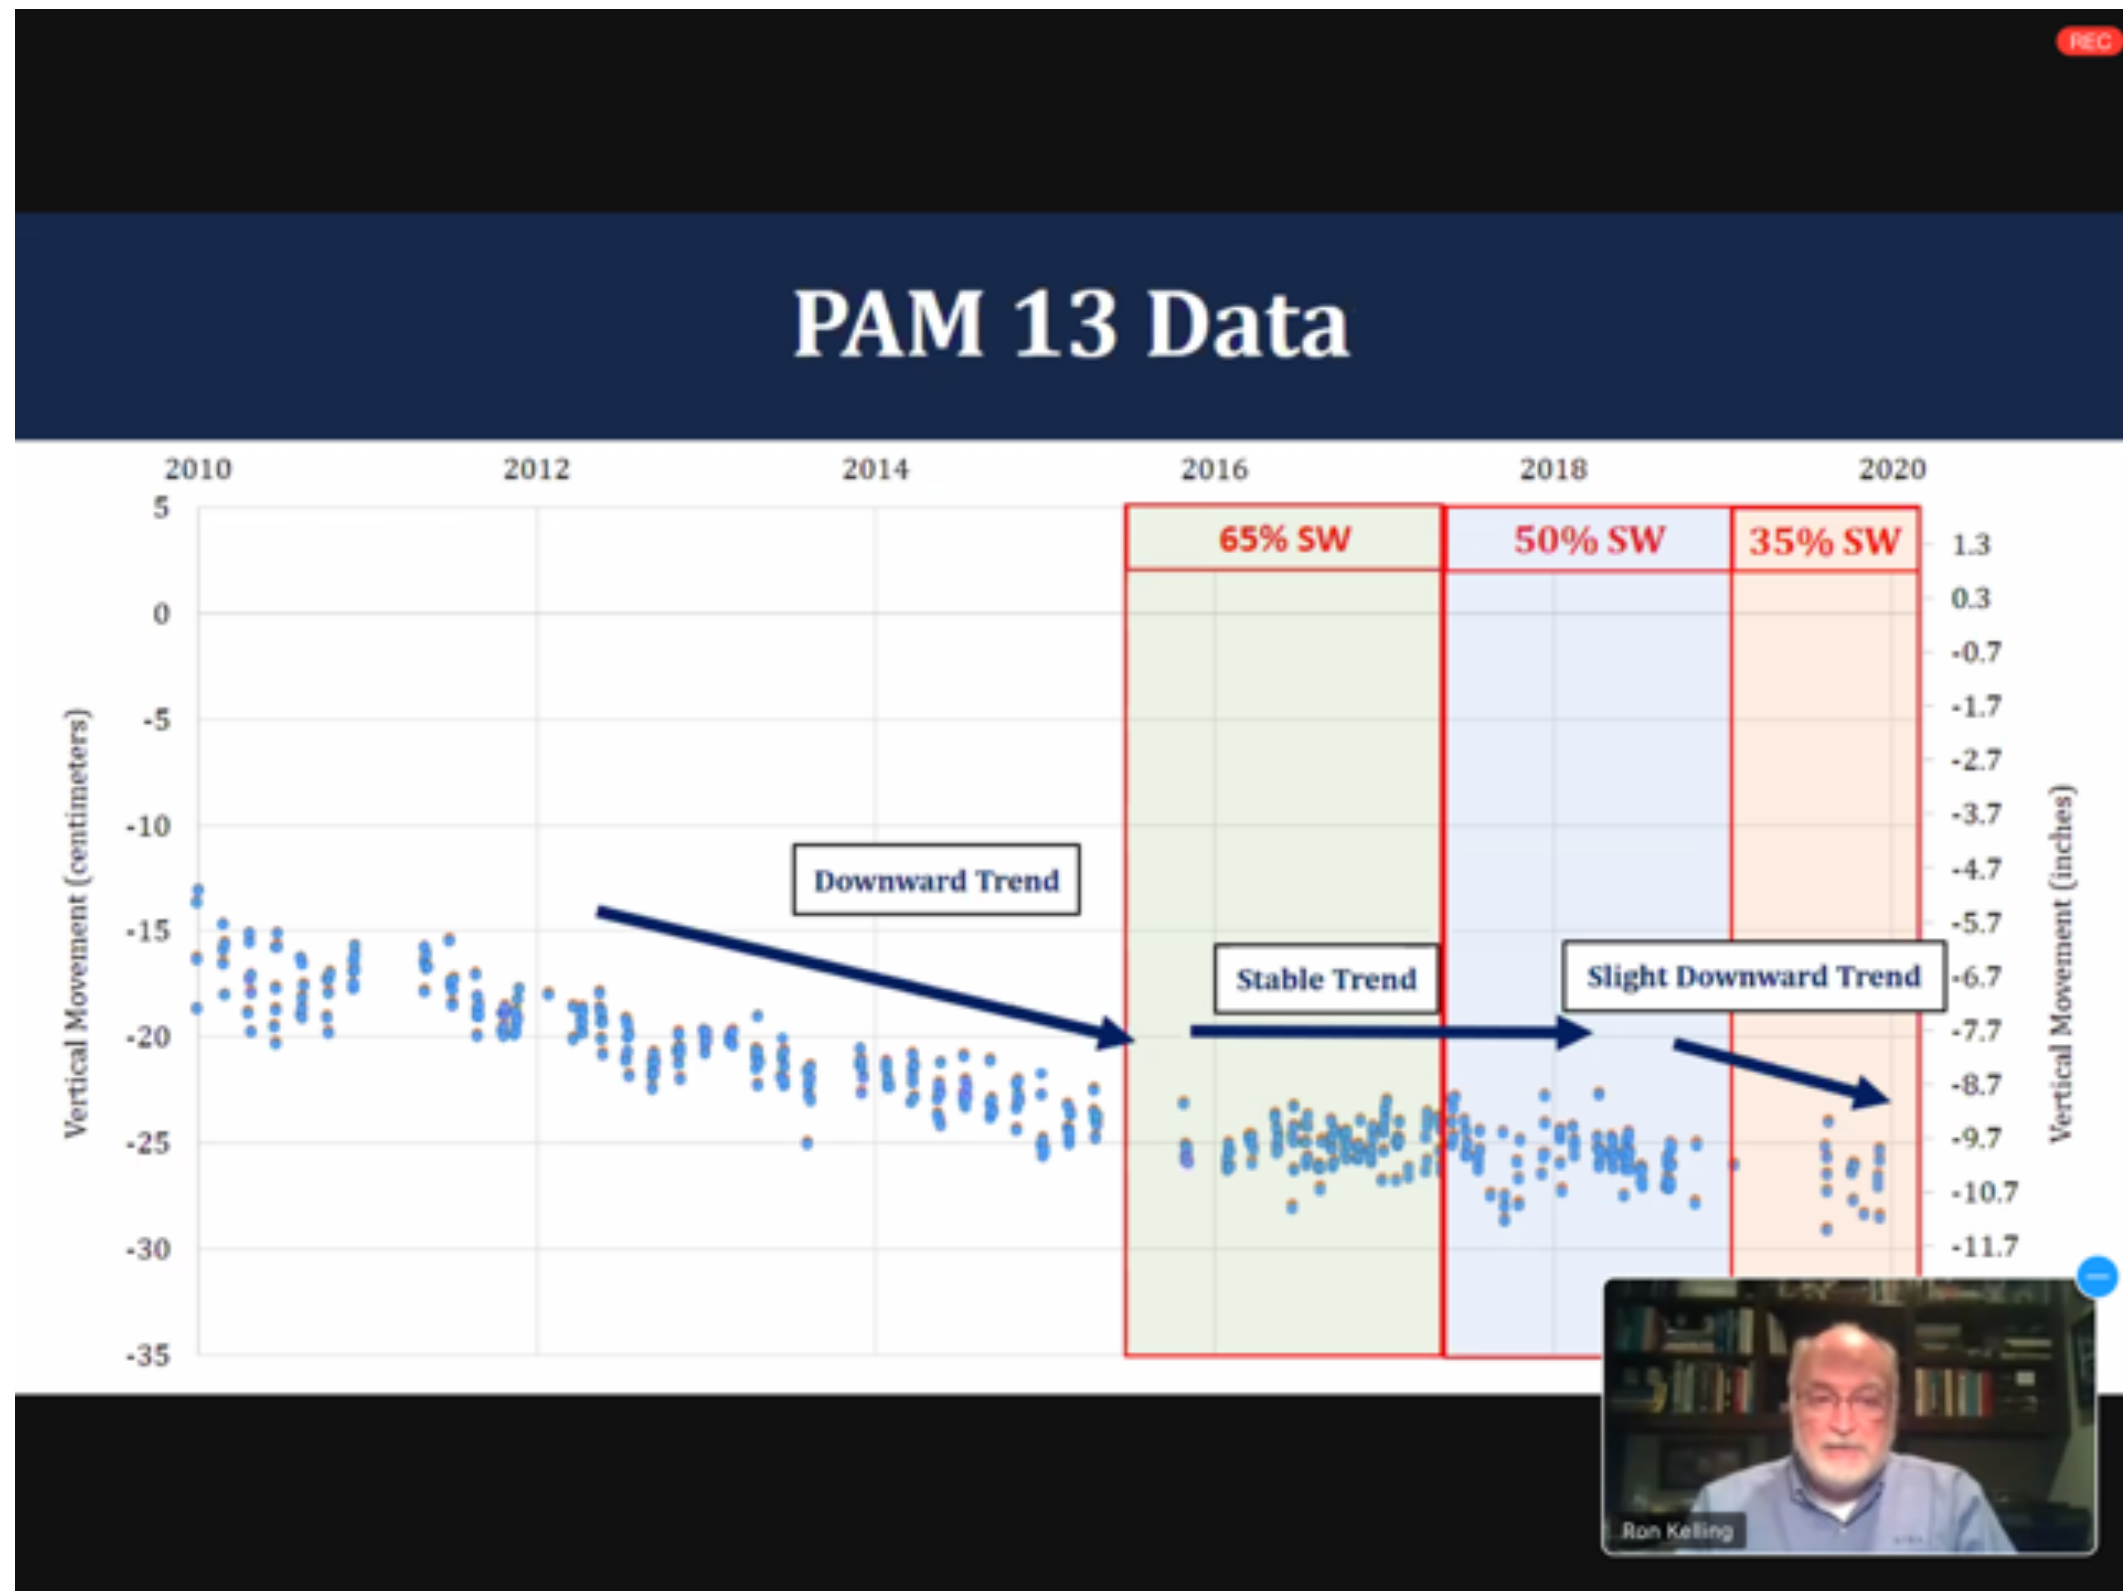
Subsidence at Pam-13

before and after the GRP pipeline became operational in 2015
and during changes in surface and ground water mix since

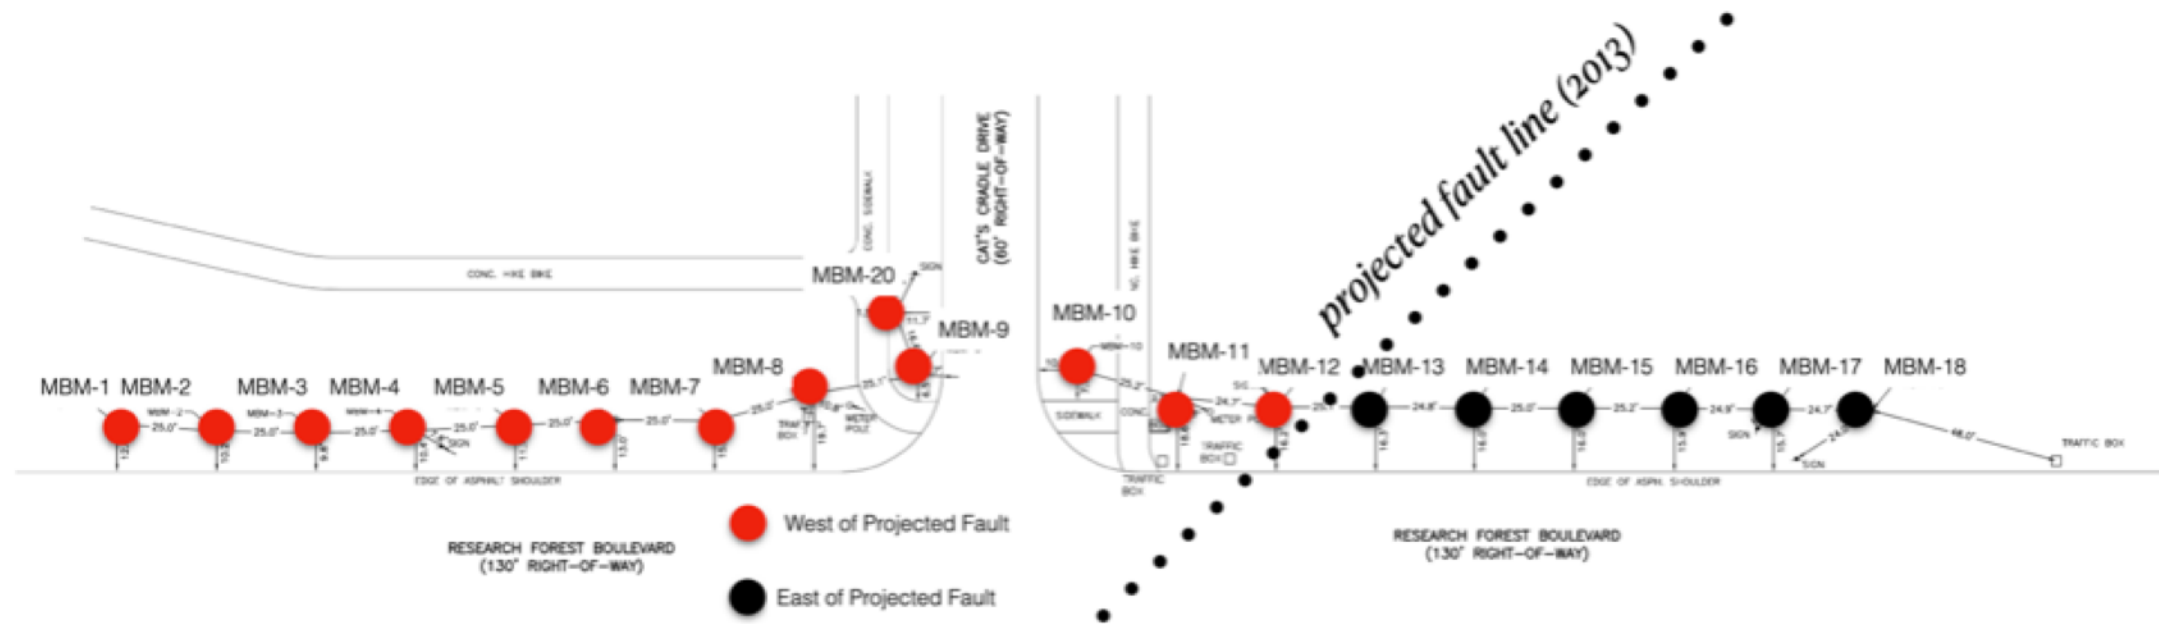
W2A Survey showing changes in feet on either side of projected fault

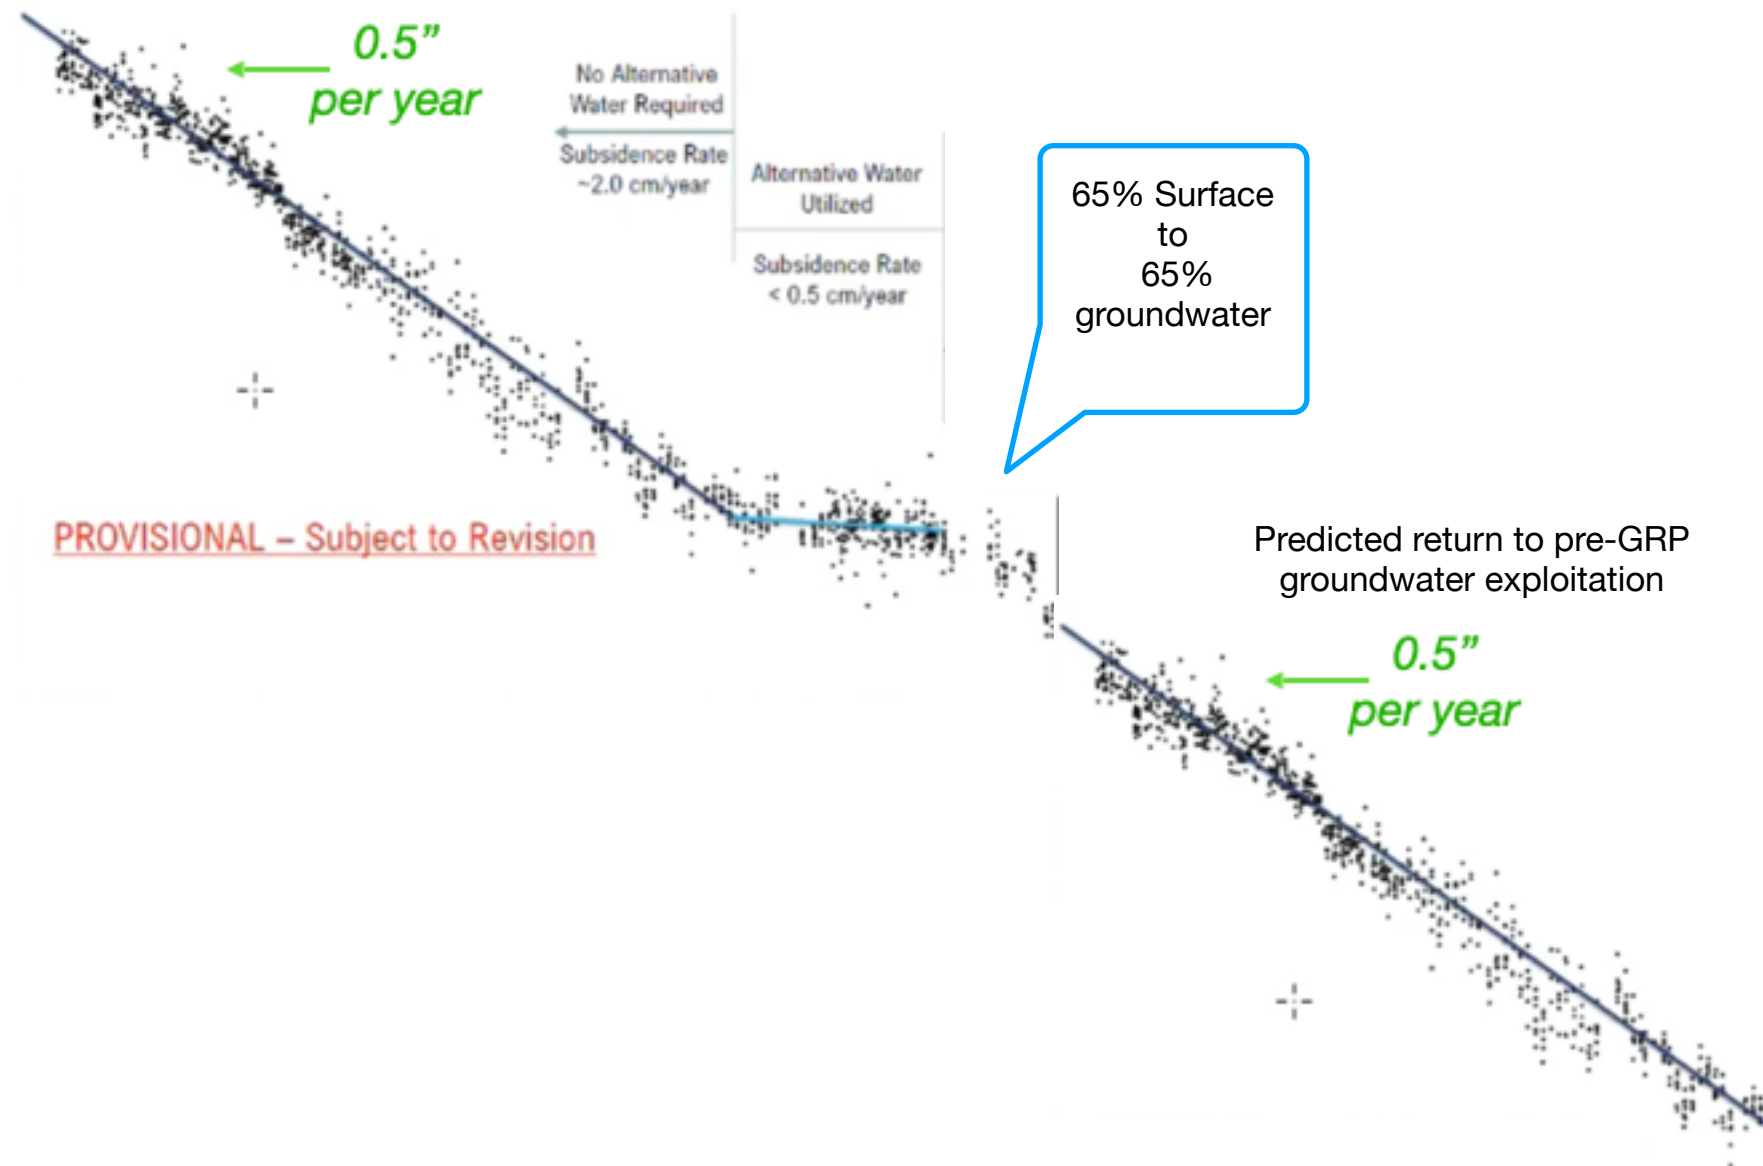
Future condition of fault if Subsidence returns to pre-GRP rates
