## Batavia Home Inspection Services, LLC

## Property Inspection Report

Property address: **123 Main Street  
Anywhere, USA**

Inspection date: **Saturday, January 23, 2021**

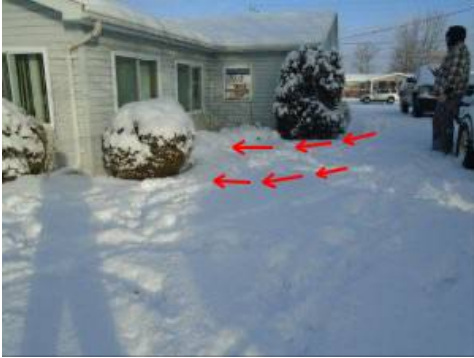
Photo 3-1

3) *Maintain* - The soil or grading sloped down towards building perimeters in one or more areas. This can result in water accumulating around building foundations or underneath buildings. It is a conducive condition for wood-destroying organisms. Recommend grading soil so it slopes down and away from buildings with a slope of at least 1 inch per horizontal foot for at least 6 feet out from buildings.

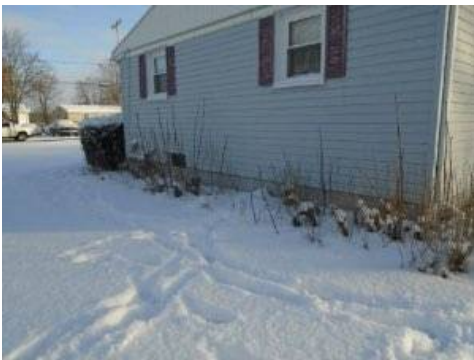
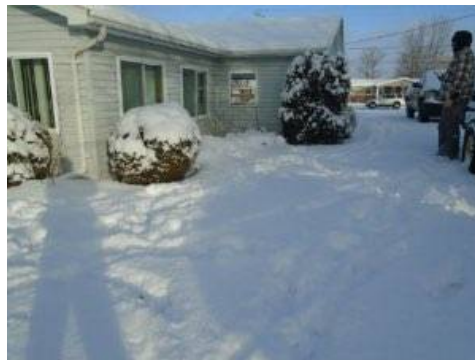
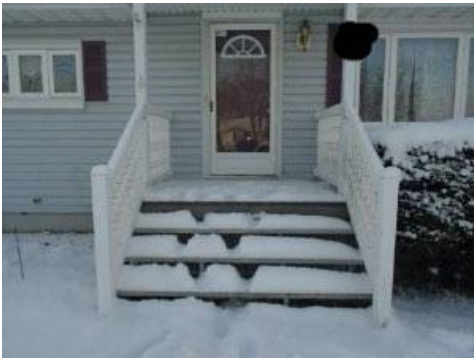
4) *Comment* - There was heavy snow cover at the time of inspection. Areas such as but not limited to driveways, walkways, decks, areas of foundation, wiring, perimeter slope and vegetation were not view able at this time.

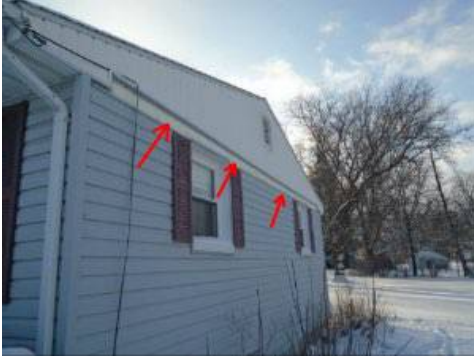
Photo 5-1

5) *Repair/Replace* - Some sections of siding and/or trim were missing. Recommend that a qualified person repair, replace or install siding or trim as necessary.

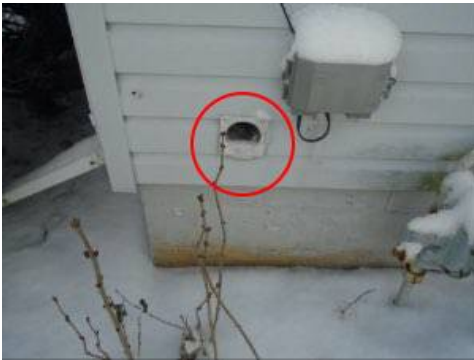
Photo 6-1

6) *Repair/Replace* - One or more exhaust duct end caps were missing. Their purpose is to prevent unconditioned air from entering the building, and keep out birds, rodents and bugs. Blocked ducts can cause fan motors and/or clothes dryers to overheat and can pose a fire hazard. Recommend that a qualified person repair or replace caps as necessary.

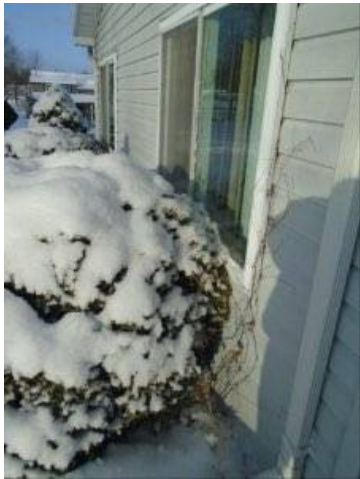
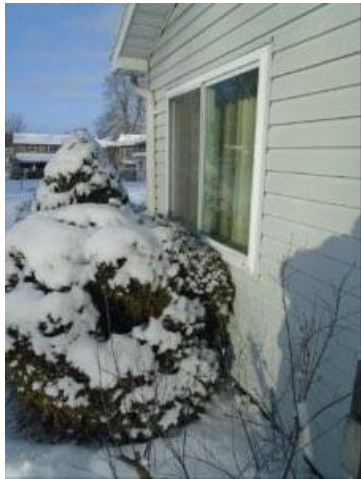
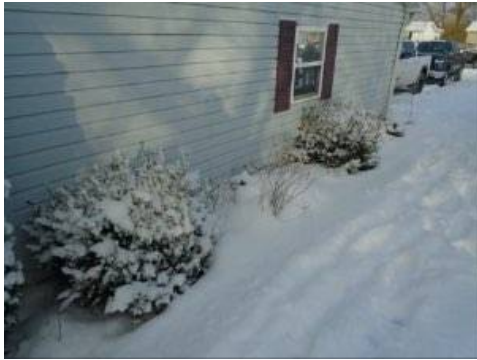
8) *Maintain* - Vegetation such as trees, shrubs and/or vines was in contact with or close to the building exterior. Vegetation can serve as a pathway for wood-destroying insects and can retain moisture against the exterior after it rains. This is a conducive condition for wood-destroying organisms. Recommend pruning, moving or removing vegetation as necessary to maintain at least 6 inches of space between it and the building exterior. A 1-foot clearance is better.

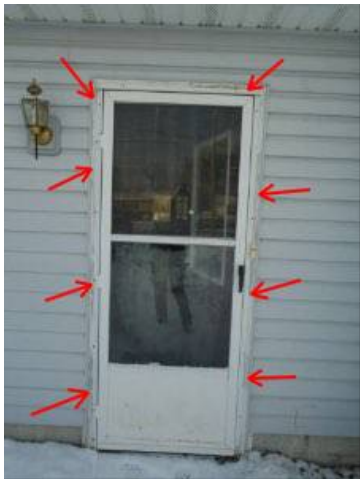
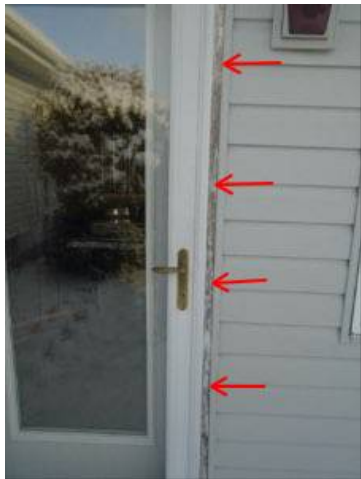
9) *Maintain* - The paint or stain finish in some areas was failing (e.g. peeling, faded, worn, thinning). Siding and trim with a failing finish can be damaged by moisture. Recommend that a qualified contractor prep (e.g. clean, scrape, sand, prime, caulk) and repaint or restain the building exterior where necessary and per standard building practices. Any repairs needed to the siding or trim should be made prior to this.

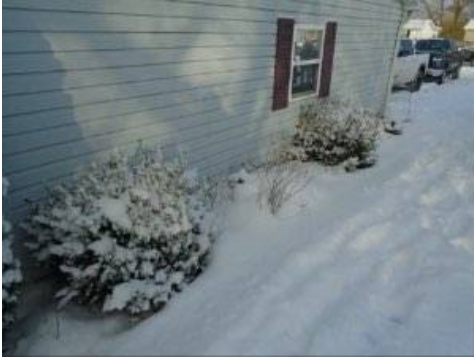
Photo 10-1

10) - Portions of the exterior foundation were covered with snow and or bushes and cover and were not able to be inspected.

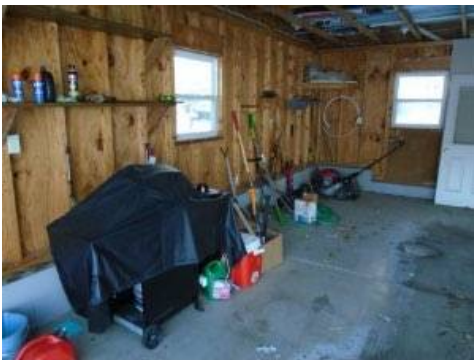
Photo 11-1

11) *Safety, Repair/Replace* - The garage was filled with many stored items at the time of inspection. Many walls and flooring were covered and commonly inspected items were blocked from view.

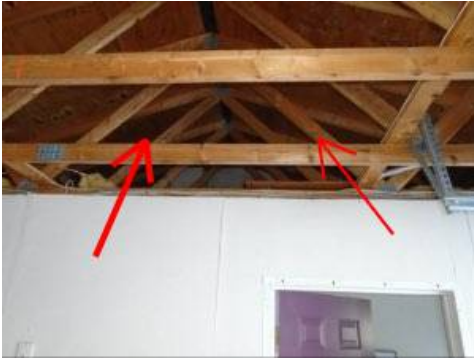
Photo 12-1

12) *Safety, Repair/Replace* - One or more areas with missing or substandard surface materials were found in the attached garage walls or ceilings. Current standard building practices call for wooden-framed ceilings and walls that divide the house and garage to provide limited fire-resistance rating to prevent the spread of fire from the garage to the house. Recommend that a qualified person repair per standard building practices. For example, by patching openings or holes, firestopping holes or gaps with fire-resistant caulking, and/or installing fire-resistant wall covering (e.g. Type X drywall). For more information, visit:

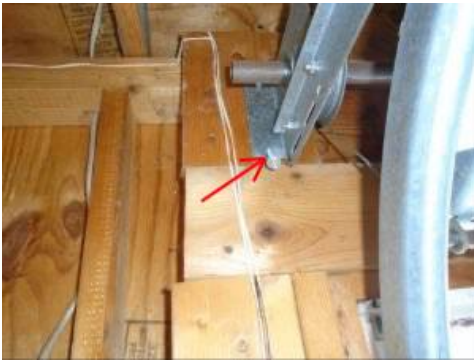
Photo 14-1

14) *Safety, Repair/Maintain, Evaluate* - Loose hardware was observed on the left interior torsion spring bracket. This should be evaluated and repaired by a qualified contractor as it can be a safety hazard.

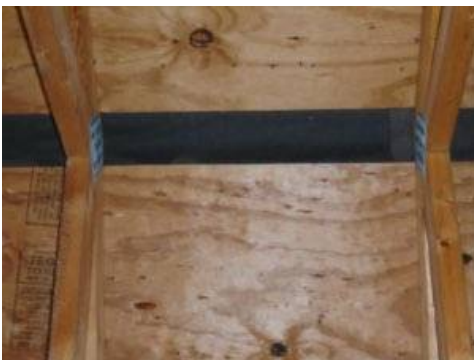
Photo 15-1

15) *Repair/Replace, Evaluate* - No ridge vent installed in garage. A ridge vent helps to balance out the transfer of hot and cold air to protect the roof substructure. Recommend to have it evaluated by a certified roofing contractor.

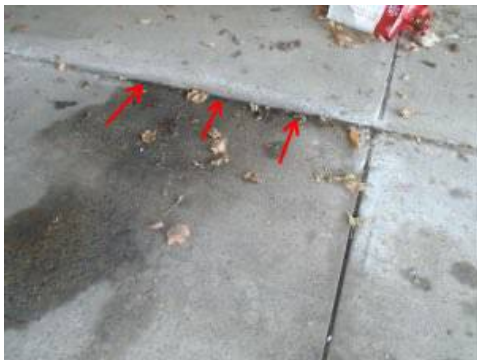
Photo 16-1

16) *Repair/Replace* - Heaving and/or settlement were found in one or more sections of concrete slab floors. Uneven surfaces can pose a trip hazard. Recommend that a qualified contractor repair or replace concrete slab floors where necessary.

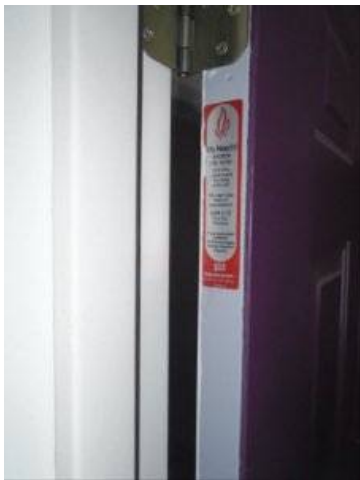
Photo 18-1

18) - Metal fire door, with visible fire-resistance rating. Door did not close on its own which is part of its fire rating. recommend it be repaired/replaced by a qualified contractor.

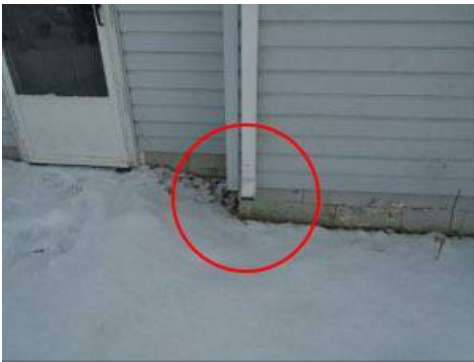
Photo 19-1

19) *Repair/Replace* - Extensions such as splash blocks or drain pipes for one or more downspouts were missing. Water can accumulate around the building foundation or inside crawl spaces or basements as a result. Recommend that a qualified person install, replace or repair extensions as necessary so rainwater drains away from the structure.

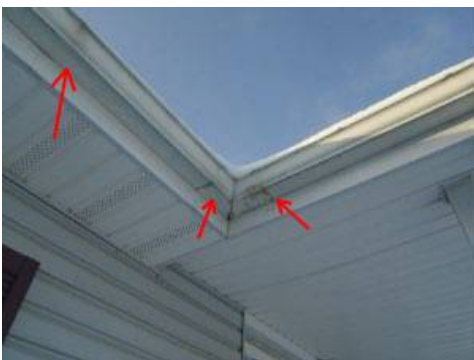
Photo 20-1

20) *Monitor* - Stains were found at the front of one or more gutters and indicate that the gutters have overflowed. If they have overflowed, it's usually due to debris clogging gutters or downspouts. The inspector was unable to verify that the gutters and downspouts drained adequately due to lack of recent, significant rainfall. Monitor the roof drainage system in the future while it's raining to determine if problems exist. Then if necessary, recommend that a qualified person clean, repair or replace gutters, downspouts and/or extensions.

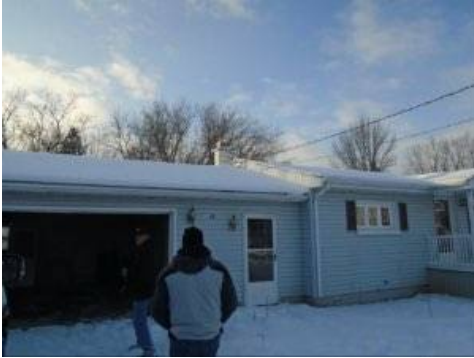
Photo 21-1

21) - The roof was covered by snow at the time of inspection. Although no leaks were found, the inspector was unable to determine the overall condition of the roof covering and could not determine the life span, or if the roof had any defects. When snow is cleared inspector can return upon request to complete the roof inspection.

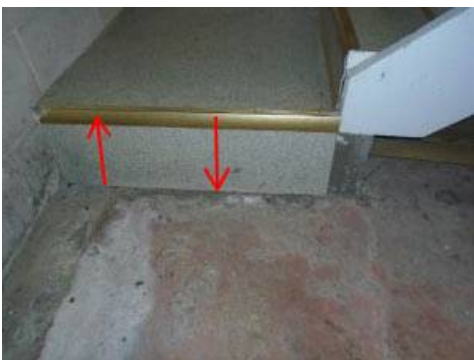
Photo 22-1

22) *Safety, Repair/Replace* - Risers for stairs at one or more locations were higher than 7 3/4 inches and posed a fall or trip hazard. Risers should be 7 3/4 inches or shorter. At a minimum, be aware of this hazard, especially when guests who are not familiar with the stairs are present. Recommend that a qualified contractor repair per standard building practices.

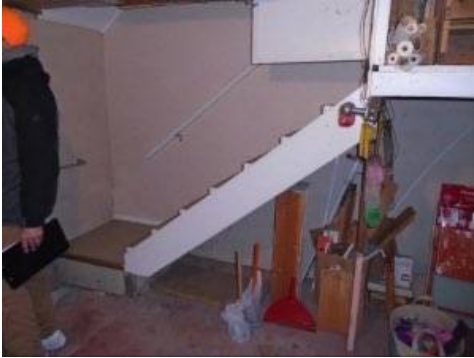
Photo 23-1

23) *Safety, Repair/Replace* - Guardrails at one or more locations with drop-offs higher than 30 inches were missing. This poses a fall hazard. Guardrails should be installed where walking surfaces are more than 30 inches above the surrounding grade or surfaces below. Recommend that a qualified contractor install guardrails where missing and per standard building practices.

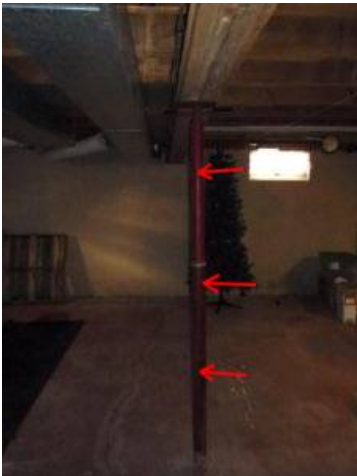
Photo 24-1

24) *Repair/Replace, Evaluate* - One or more adjustable steel columns were found. Some adjustable steel columns are rated for permanent use, but some are not. Based on the inspector's observations, columns in this building may not be rated for permanent use and may pose a safety risk for collapse. Recommend that a qualified contractor familiar with regulations surrounding use of such columns evaluate and repair if necessary, and per standard building practices.

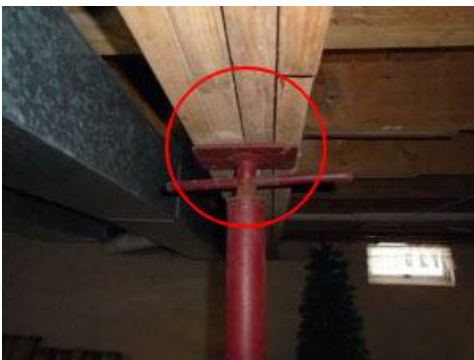
Photo 25-1

25) *Repair/Replace* - One or more support posts were not positively secured to the beam above. While this is common in older homes, current standards require positive connections between support posts and beams above for reinforcement. Recommend that a qualified contractor repair per standard building practices. For example, by installing metal plates, plywood gussets or dimensional lumber connecting posts and beams.

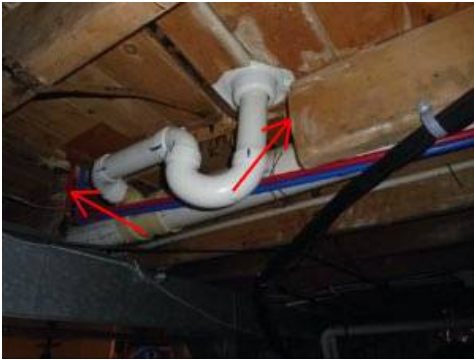
Photo 26-1

26) *Repair/Replace* - One or more joists were notched / cut/or had holes cut in them in such a way as to significantly weaken the joist(s). Joists that are cut and portions removed can weaken the structure above. General guidelines for modifying joists made of dimensional lumber include these restrictions:

[/list]Recommend that a qualified contractor evaluate and repair as necessary, and per standard building practices.

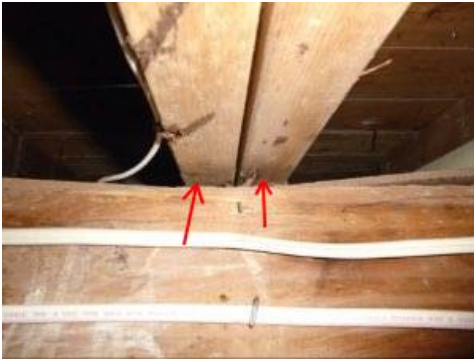
Photo 28-1

28) - Many of the floor joists do not rest on the main beam. The joists need to sit on the main beam to create a solid floor structure. Recommend a structural contractor evaluate and make needed repairs.

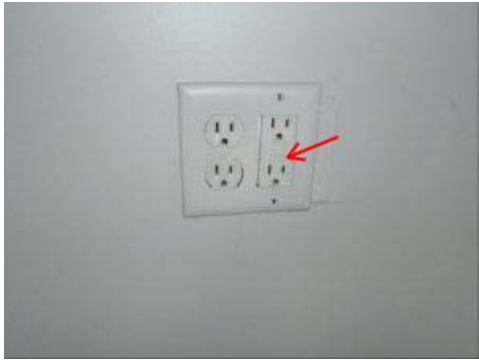
Photo 29-1

29) *Safety, Repair/Replace, Evaluate* - One or more ground fault circuit interrupter (GFCI) receptacles (outlets) wouldn't trip at the garage. This is a potential shock hazard. Recommend that a qualified electrician evaluate and repair as necessary.

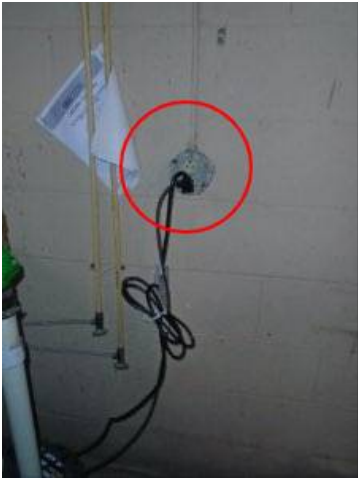
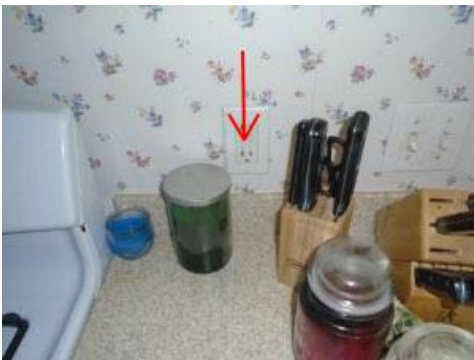
30) *Safety, Repair/Replace, Evaluate* - One or more electric receptacles (outlets) at the kitchen, utility sink, exterior and/or basement had no visible ground fault circuit interrupter (GFCI) protection, or the inspector was unable to determine if GFCI protection was present. If not GFCI-protected, receptacles in wet areas pose a shock hazard. Recommend that a qualified electrician evaluate and install GFCI protection if necessary and per standard building practices. General guidelines for GFCI-protected receptacles include the following locations:

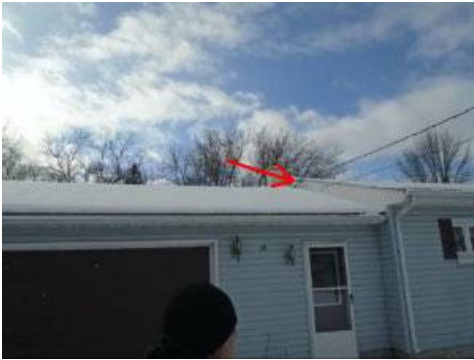
Photo 31-1

31) *Safety, Repair/Replace* - The service drop wires were easily accessible from the garage roof. This is a shock hazard. A qualified electrician or the utility company should repair per standard building practices.

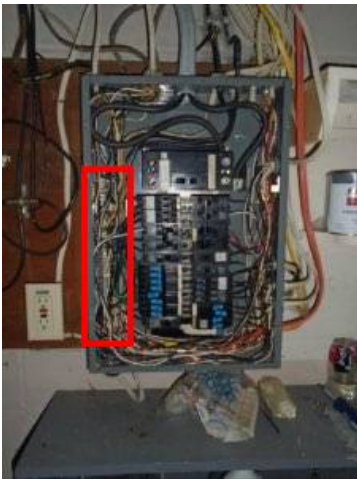
Photo 32-1

32) *Safety, Repair/Replace* - Neutral wires were doubled or bundled together under the same lug on the neutral bus bar in panel(s) #A. This is a potential safety hazard in the event that one of the circuits needs to be isolated during servicing. For one neutral to be disconnected, other neutrals from energized circuits sharing the same lug will be loosened. Power surges may result on the energized circuits and result in damage or fire. Also, multiple wires under the same lug may not be secure, resulting in loose wires, arcing, sparks and fire. Recommend that a qualified electrician repair per standard building practices. For more information, visit: <https://www.reporthost.com/?DTNB>

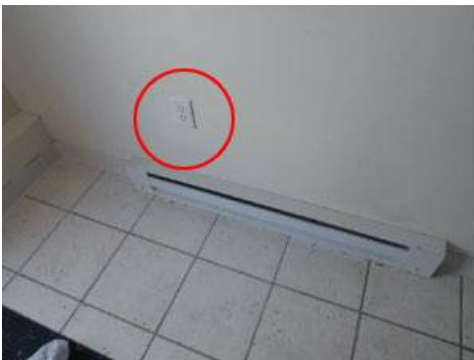
Photo 33-1

33) *Safety, Repair/Replace* - One or more receptacles (outlets) were installed directly above electric baseboard heaters. This was a common practice in the past, but insulation on appliance cords in contact with the heater(s) can be damaged by heaters. This is a shock and fire hazard. Recommend that a qualified electrician make repairs or modifications as necessary. For example, by converting receptacles to junction boxes, moving receptacles and/or moving baseboard heaters.

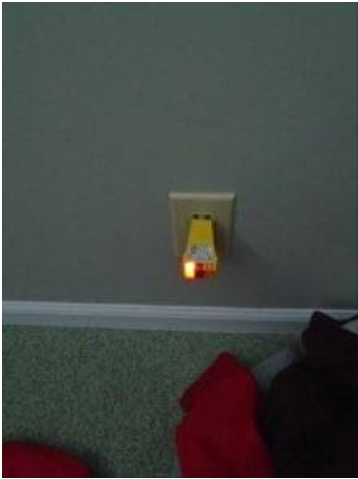
Photo 34-1

34) *Safety, Repair/Replace* - One or more modern, 3-slot electric receptacles (outlets) were found with an open ground. Three-slot receptacles should have a hot, a neutral and a ground wire connected. Homeowners often install new 3-slot receptacles on older, 2-wire circuits that only have hot and neutral wires. This is a shock hazard when appliances that require a ground are used with these receptacles. Examples of such appliances include computers and related hardware, refrigerators, freezers, portable air conditioners, clothes washers, aquarium pumps, and electrically operated gardening tools. Where the electric system was installed prior to when grounded circuits were required (1960s), it is permissible to replace 3-slot receptacles with 2-slot receptacles to prevent appliances that require a ground from being plugged in to an ungrounded circuit. However, the client should be aware of this limitation when planning use for various rooms, such as an office. For newer electric systems, circuits should be repaired so grounded, 3-wire cables provide power to 3-slot receptacles. Recommend that a qualified electrician repair per standard building practices.

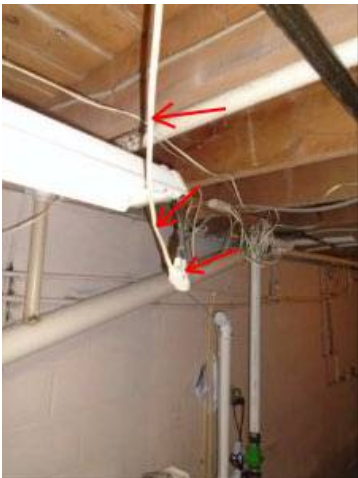
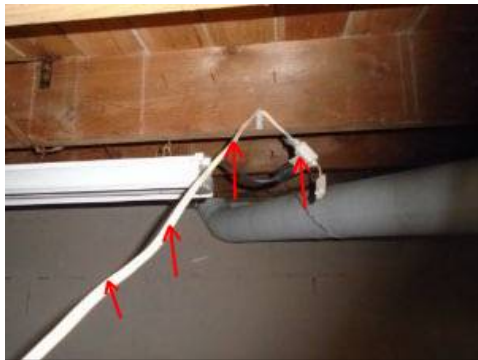
37) *Safety, Repair/Replace* - Extension cords were being used as permanent wiring at one or more locations. They should only be used for portable equipment on a temporary basis. Using extension cords as permanent wiring is a potential fire and shock hazard, and indicates that wiring is inadequate and needs updating. Extension cords may be undersized. Connections may not be secure resulting in power fluctuations, damage to equipment, overheating and sparks that could start a fire. Recommend that a qualified electrician repair per standard building practices and eliminate extension cords for permanently installed equipment.

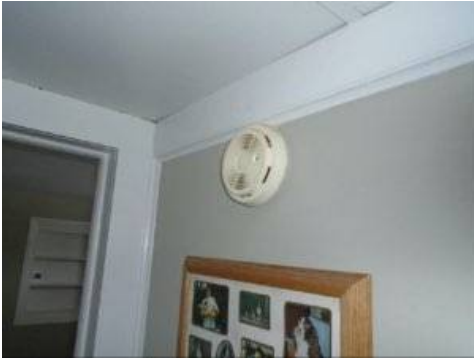
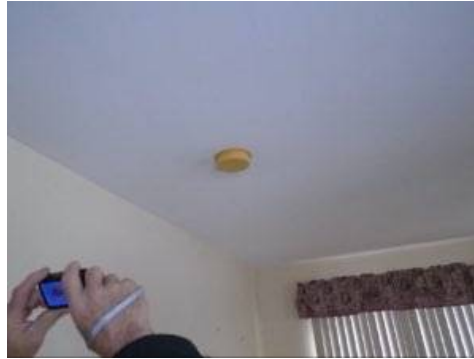
38) *Safety, Repair/Maintain* - Based on the age of this structure and the appearance of existing smoke alarms, the alarms may have been installed more than 10 years ago. According to [National Fire Protection Association](https://www.nfpa.org), aging smoke alarms don't operate as efficiently and often are the source for nuisance alarms. Older smoke alarms are estimated to have a 30% probability of failure within the first 10 years. Newer smoke alarms do better, but should be replaced after 10 years. Unless you know that the smoke alarms are new, replacing them when moving into a new residence is also recommended by NFPA. For more information, visit:

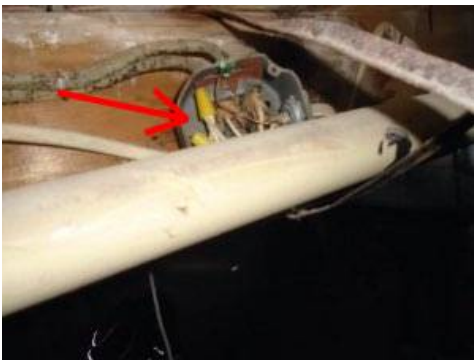
Photo 39-1

39) *Safety, Repair/Maintain* - One or more cover plates for switches, receptacles (outlets) or junction boxes were missing or broken. These plates are intended to contain fire and prevent electric shock from occurring due to exposed wires. Recommend that a qualified person install cover plates where necessary.

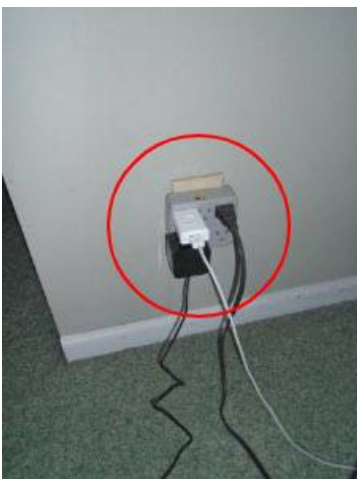
Photo 40-1

40) *Safety, Evaluate* - Few receptacles (outlets) were installed in one or more areas by modern standards. This can result in "octopus" wiring with extension cords, which is a fire hazard. Consult with a qualified electrician about upgrading circuits with additional receptacles per standard building practices.

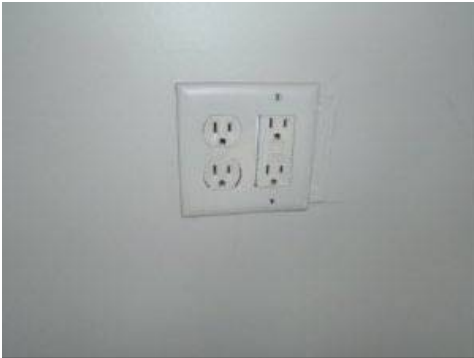
Photo 42-1

42) *Repair/Replace, Evaluate* - One or more electric receptacles (outlets) appeared to have no power in the garage. Recommend asking the property owner about this. Switches may need to be operated to make some receptacles energized. If necessary, recommend that a qualified electrician evaluate and repair.

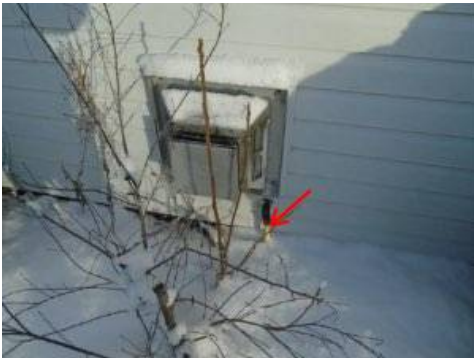
Photo 46-1

46) *Safety, Repair/Replace* - One or more sections of gas supply piping were underground and didn't appear to have an approved coating to prevent corrosion or rust. This piping is likely to rust as a result. Recommend that a qualified contractor repair per standard building practices.

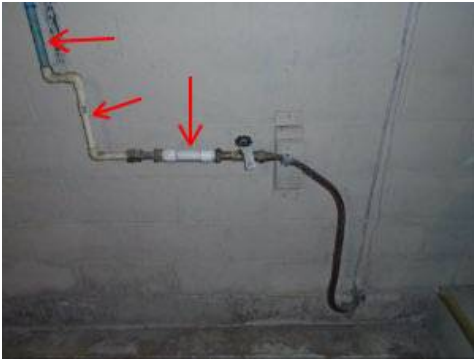
Photo 48-1

48) *Repair/Replace, Evaluate* - The water service pipe appeared to be lacking standard support or strapping. Leaks may occur as a result and pipes and fittings may be damaged. Recommend water main be evaluated and repaired per common building practices.

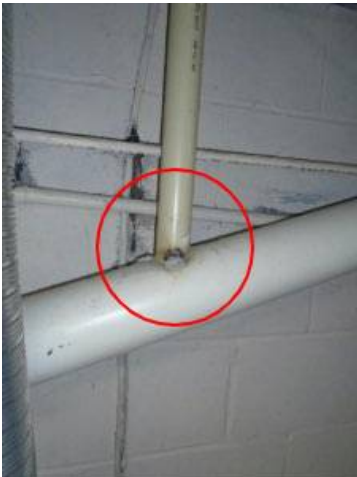
Photo 49-1

49) *Repair/Replace, Evaluate* - One or more drain pipes or fittings were substandard. Recommend that a qualified plumber evaluate and repair as necessary and per standard building practices.

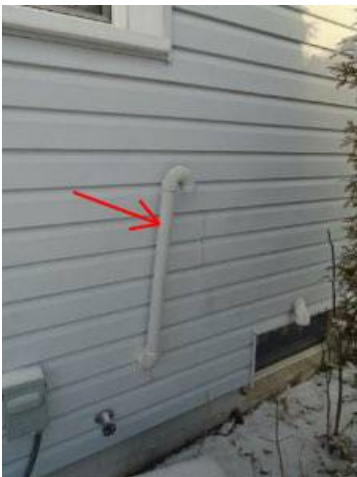
Photo 51-1

51) *Repair/Replace* - Only one vent pipe was visible for the plumbing system and it was too small. Main vent stack pipes should be at least 3 inches in diameter. If too small, then fixtures may not drain properly or sewer gases can enter living spaces. Recommend that a qualified plumber repair per standard building practices.

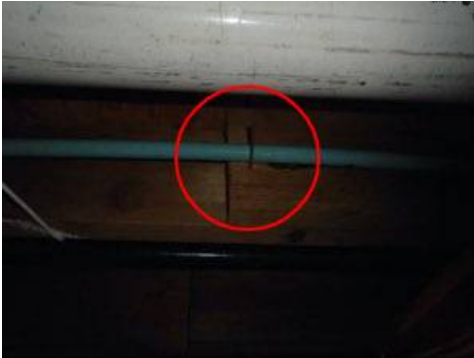
Photo 52-1

52) *Repair/Maintain* - One or more plastic PEX water supply pipes had substandard support or were loose. Leaks can occur as a result. PEX supply pipes should have approved hangers every 32-36 inches when run horizontally. Special hangers that allow movement from expansion and that won't damage the soft plastic piping should be used. Recommend that a qualified person install hangers or secure pipes per standard building practices.

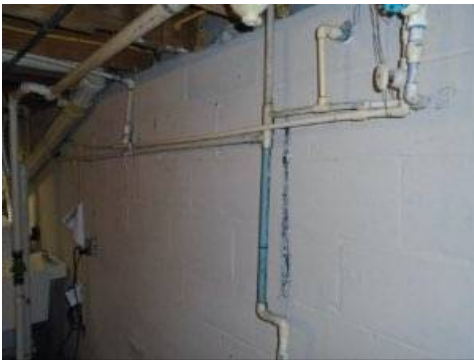
Photo 53-1

53) *Repair/Maintain* - One or more plastic PVC or CPVC water supply pipes had substandard support or were loose. Leaks may occur as a result. PVC and CPVC supply pipes should have supports every 4 feet. Special hangers that allow movement from expansion and that won't damage the soft plastic piping should be used. Recommend that a qualified person install supports or secure pipes per standard building practices.

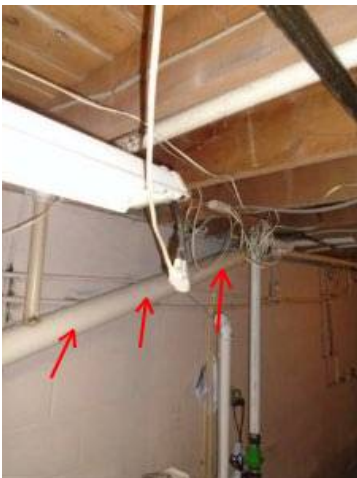
Photo 54-1

54) *Repair/Maintain* - One or more waste pipes had a substandard slope. Clogging or leaks can occur as a result. Drain and waste pipes should be sloped 1/4 inch per foot of length if less than 3 inches in diameter, or 1/8 inch per foot of length for larger diameters. Recommend that a qualified plumber repair per standard building practices.

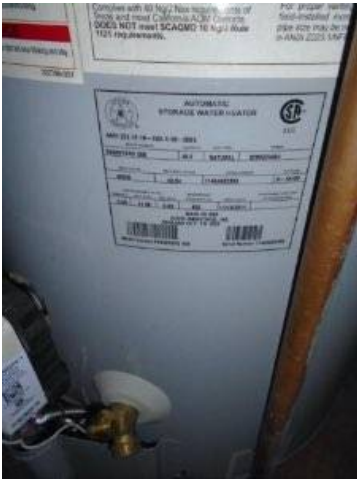
Photo 58-1

58) *Comment* - The estimated useful life for most water heaters is 8-12 years. This water heater appeared to be near this age and/or its useful lifespan and may need replacing at any time. Recommend budgeting for a replacement in the near future, or considering replacement now before any leaks occur. The client should be aware that significant flooding can occur if the water heater fails. If not replaced now, consider having a qualified person install a catch pan and drain or a water alarm to help prevent damage if water does leak.

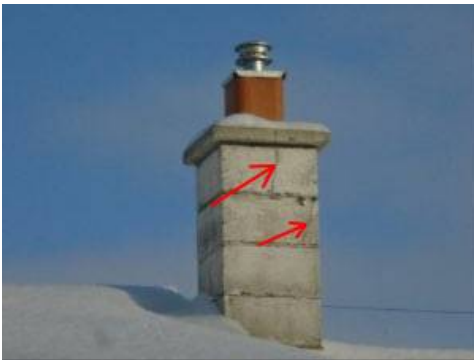
Photo 65-1

65) *Repair/Replace, Evaluate* - Masonry Block on chimney was cracked. This can allow water to enter the chimney and cause further damage. Recommend a certified contractor repair/replace damaged section(s).

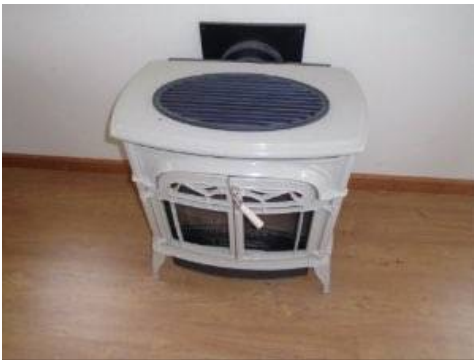
Photo 66-1

66) *Evaluate* - The inspector was unable to determine if the gas fireplace or stove was operable or serviceable, or perform a full evaluation. Normal controls such as an on/off switch, thermostat or remote control were not found, or operating such controls that were found had no effect on the stove or fireplace. Consult with the property owner and reviewing all available documentation for such appliances.

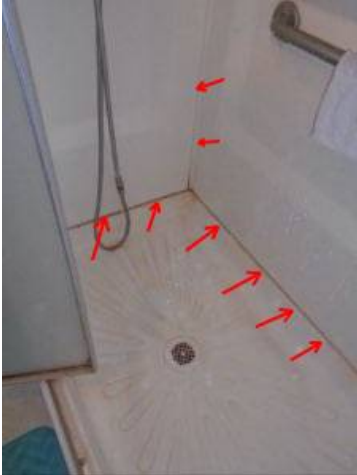
Photo 70-1

70) *Repair/Maintain* - Gaps, no caulk, or substandard caulking were found between the shower enclosure and the walls at location(s) #A. Water can penetrate these areas and cause damage. Recommend that a qualified person re-caulk or install caulking as necessary.

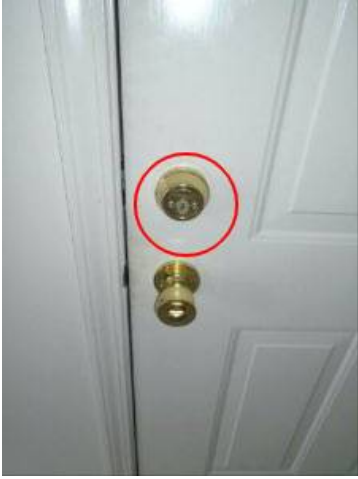
Photo 71-1

71) *Safety, Repair/Replace* - One or more exterior doors had double-cylinder deadbolts installed, where a key is required to open them from both sides. This can be a safety hazard in the event of an emergency because egress can be obstructed or delayed. Recommend replacing double-cylinder deadbolts with single-cylinder deadbolts where a handle is installed on the interior side.
