### **SUMMARY** 1234 Demo Ln NW, Dreamy, GA John Doe May 19, 2023

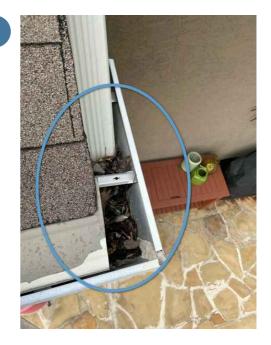
#### **DEBRIS IN GUTTERS**

I observed debris in the gutter. Cleaning and maintenance is recommended.

Recommendation
Contact a qualified gutter contractor

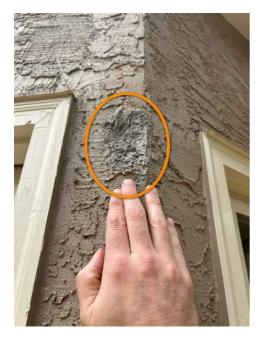
3.3.3 Siding, Flashing & Trim **PREVIOUS REPAIR NOTED**

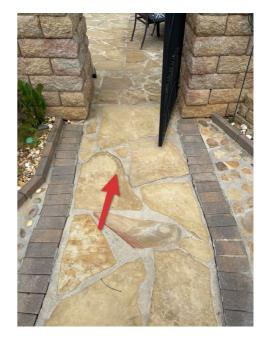
3.9.2 Walkways, Patios & Driveways **WALKWAY CRACKING - MINOR**

Hartwell Management Page 8 of 23 Minor cosmetic cracks observed. Recommend monitor and/or patch/seal.

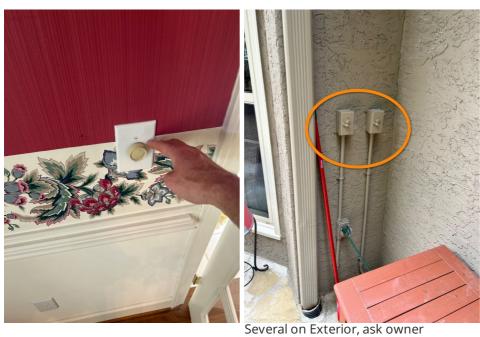
### 5.6.1 Lighting Fixtures, Switches & Receptacles **SWITCH UNABLE TO IDENTIFY**

Unable to identify what one or more switches operate. There were a few on the exterior. Owner said they worked.

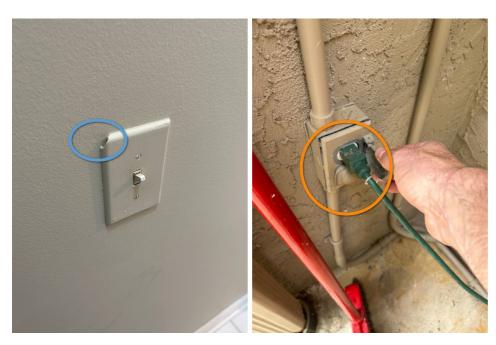
### **COVER PLATES DAMAGED**

One or more receptacles have a damaged cover plate. Recommend replacement.

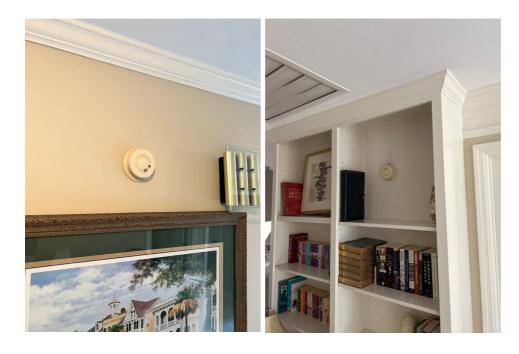
### IMPROPER LOCATION OF SMOKE DETECTOR PER CURRENT STANDARD

I observed indications of improper location of the smoke detector. Current standard is to have one in each bedroom. Only located two. 1. on main in hallway. 2. upstairs in hallway.

Smoke detectors should be installed on the ceiling, or installed on the wall no more than 12 inches from the ceiling.

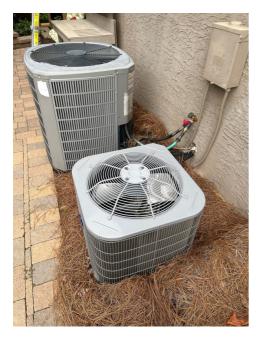
# NEEDS MORE CLEARANCE FROM GROUND COVER

Remove access pinestraw from around units.

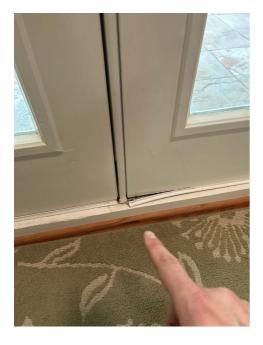
### POOR WEATHER-STRIPPING

At the time of the inspection, weather-stripping at an interior door was generally damaged or deteriorated. The Inspector recommends replacement/installation of effective weather-stripping components as necessary.
