HOME INSPECTION REPORT

Prepared by Kyle Kaufmann

KAUFMANN CONSULTANTS, LLC

INSPECTION LOCATION

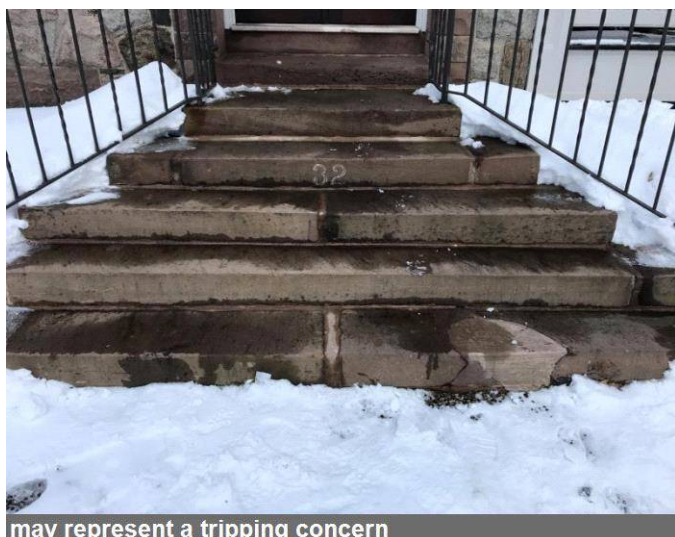
2.5 STEPS

may represent a tripping concern

The exterior steps are in some aspects, unsatisfactory condition. Deficiencies include, but are not limited to; The dimensions of the steps are uneven, which may represent a tripping concern. (see the adjacent photograph) **There is also some cracking masonry; which could adversely affect performance of the component, in addition to creating a potential tripping concern.** Have the cracks repaired as necessary.

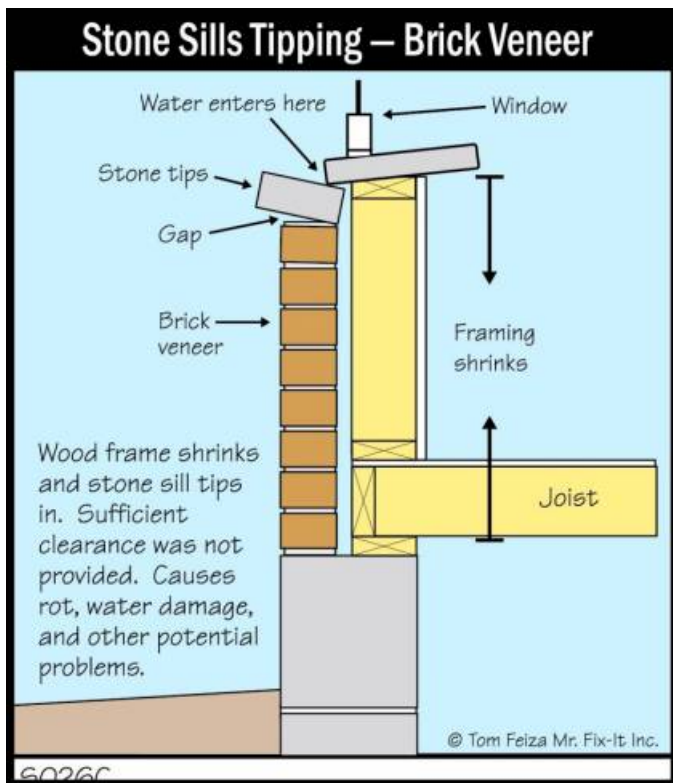
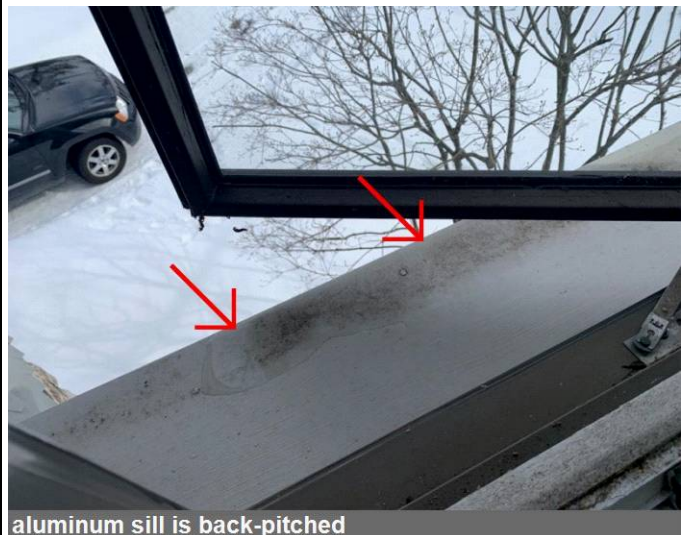
The aluminum sill is back-pitched. The significance of this condition is; Leaks through the wall system could cause rot/mold. (See the below photograph)

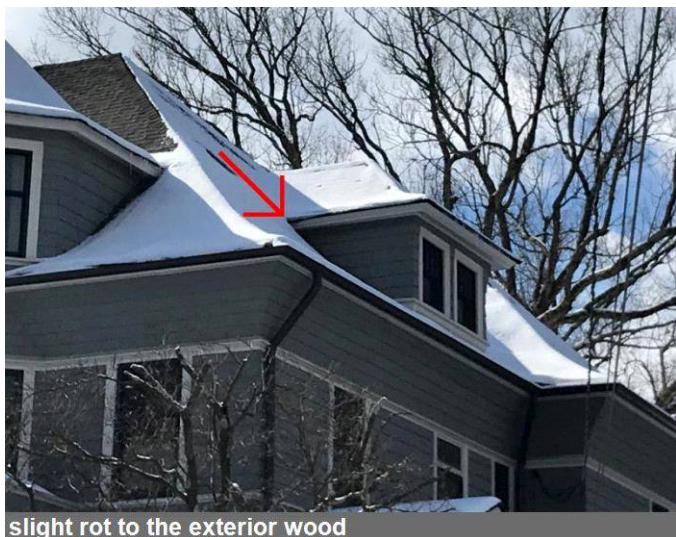
3.8 MOLDINGS & TRIM CONDITION:

slight rot to the exterior wood

The exterior trim/wood is in need of maintenance. Deficiencies include, but are not limited to the following; There is slight rot to the exterior wood/trim. Areas of rot include, but may not be limited to; Roof trim. (see the adjacent photograph) Proper care to the home's exterior includes replacement of rotted pieces and periodic re-painting and caulking to protect the wood from the elements. Budget for this contingency.

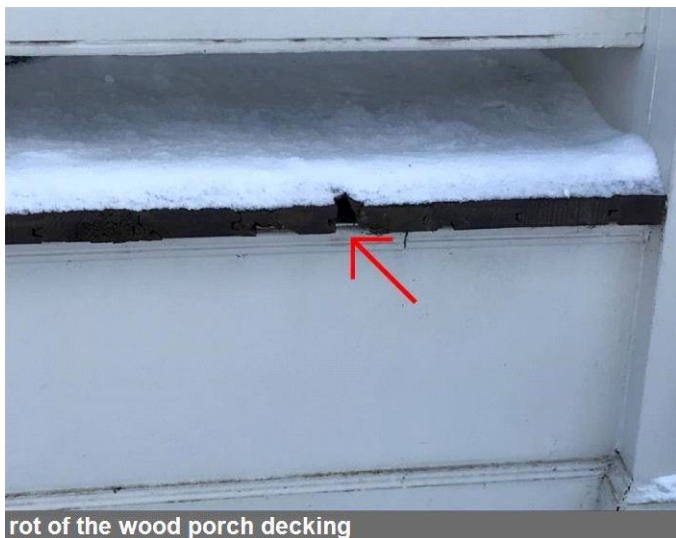
FRONT PORCH
3.9 CONDITION

rot of the wood porch decking

The right, front porch is unsatisfactory, which could result in loss of functional utility or cosmetic appeal. Deficiencies include, but may not be limited to the following; There is rot of the wood porch decking, which could result in loss of functional utility. (See the adjacent/below photograph) Replacement/repair of the damaged/rotted components is recommended.

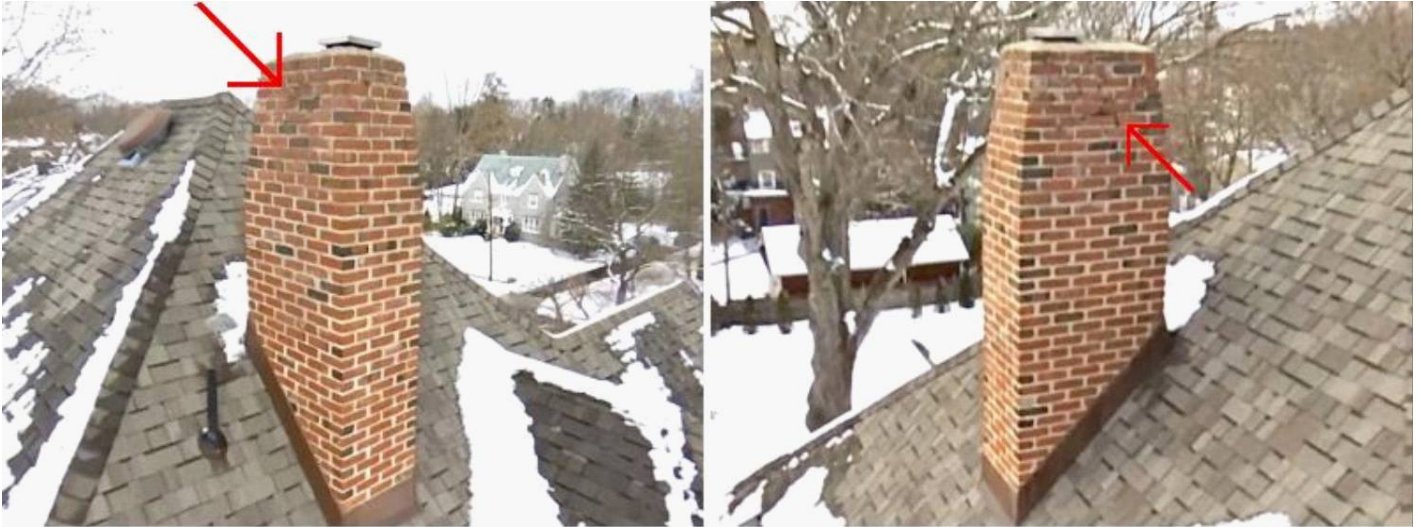
The masonry chimney is in some aspects, unsatisfactory condition (material defect). There is cracking of the masonry structure (see, upper, front).

The upper portions of the chimneys are tapered, which reduces their exposure to the elements. The configuration would not comply with modern building standards. The significance of this condition is; the chimney should get wider as it gets higher so that water can be effectively shed off of the structure.

cracking of the masonry structure

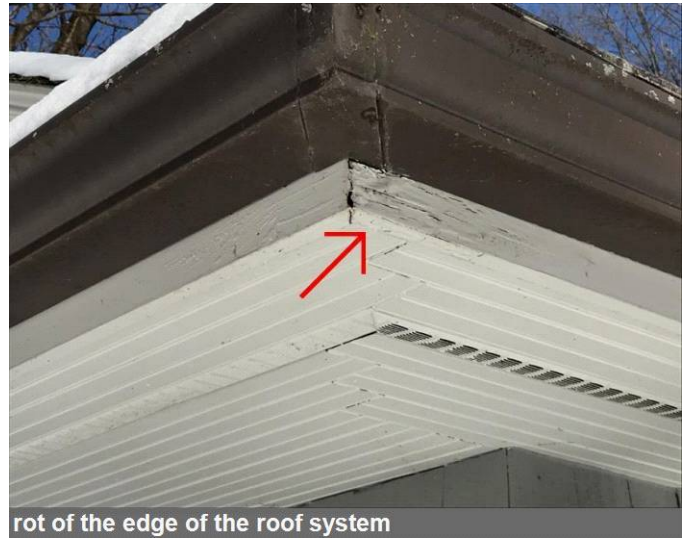
In general, the garage is in some aspects, unsatisfactory condition. There is rot of the edge of the roof system due to roof leakage or leakage from the gutter/drains.

rot of the edge of the roof system

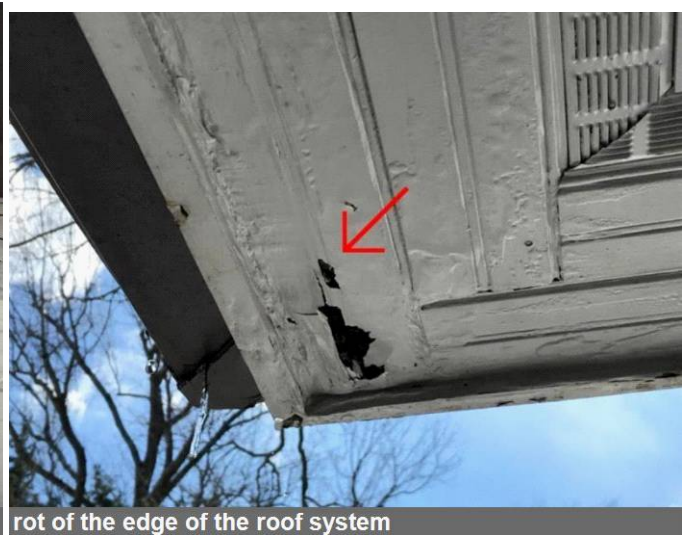
rot of the edge of the roof system

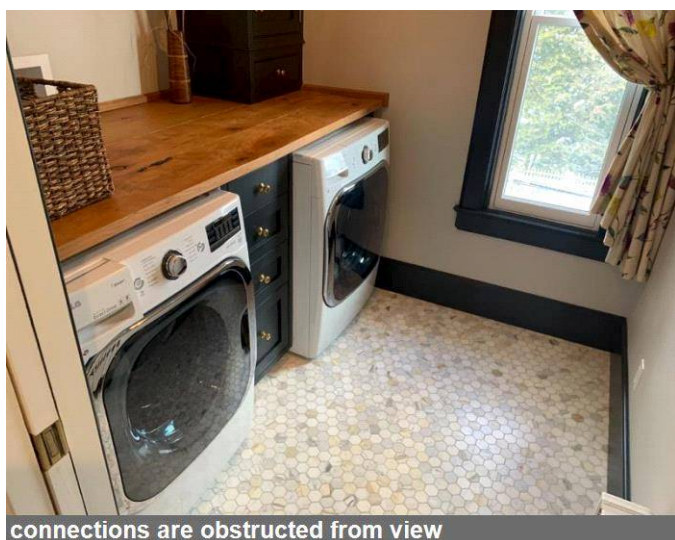
7.28 CONDITIONS:

The laundry connections are obstructed from view and could not be checked. A competent contractor should be consulted to more thoroughly evaluate the condition and to perform repairs as are necessary. A re-evaluation of this condition should be performed when conditions permit.

NOTE: There is, however, considered to be inadequate supply of air (oxygen) for safe operation of the gas dryer. The significance of this condition is; lack of oxygen could prevent complete combustion of the natural gas, which could generate carbon monoxide. Carbon monoxide is toxic. A competent contractor should be contacted to more thoroughly evaluate the condition and to perform repairs as necessary.

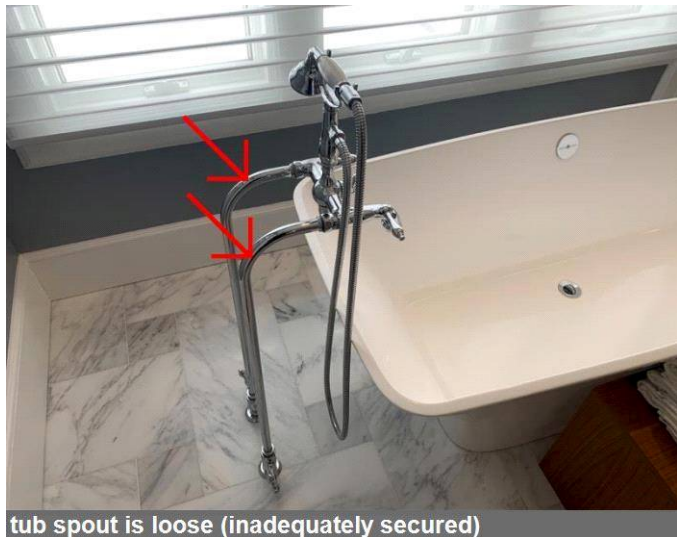
9.18 TUB AND SHOWER

The tub requires repair. Deficiencies include, but may not be limited to the following; The tub spout is loose (inadequately secured) which could result in leaks. The condition indicates the need for maintenance. The complexity and the cost of this work is un-determined.

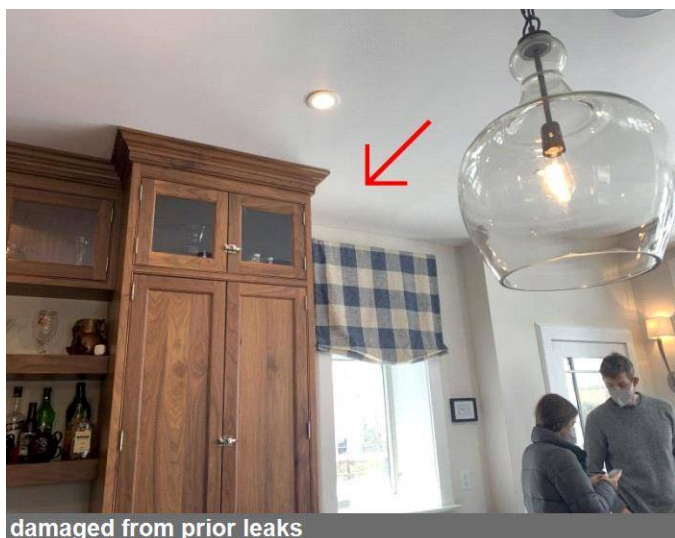
11.1 WALLS/CEILINGINGS:

There is staining consistent with leakage due to roof leaks, plumbing leaks or condensation. Have the sources of the leaks identified, repaired and the areas re-finished as necessary. These areas were checked with a moisture meter and found to be WET at the time of inspection. There are ceiling/wall surfaces that may have been damaged from prior leaks. These areas have not been completely or properly repaired/finished. Additional finishing will be necessary to restore these areas. The condition indicates the need for maintenance. The complexity and the cost of this work is un-determined.

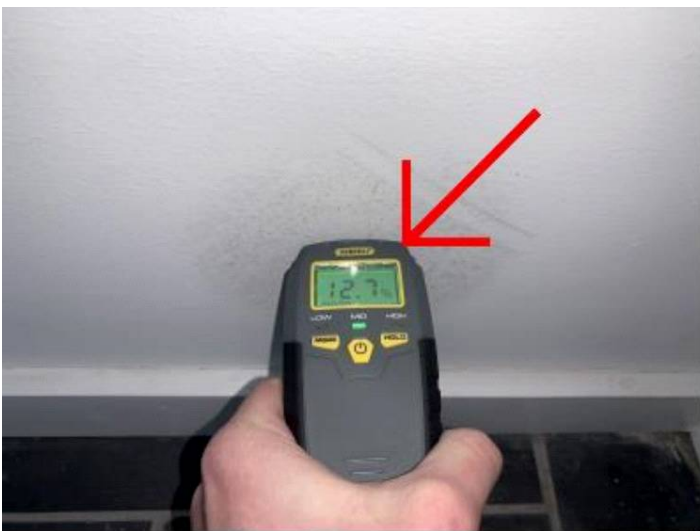
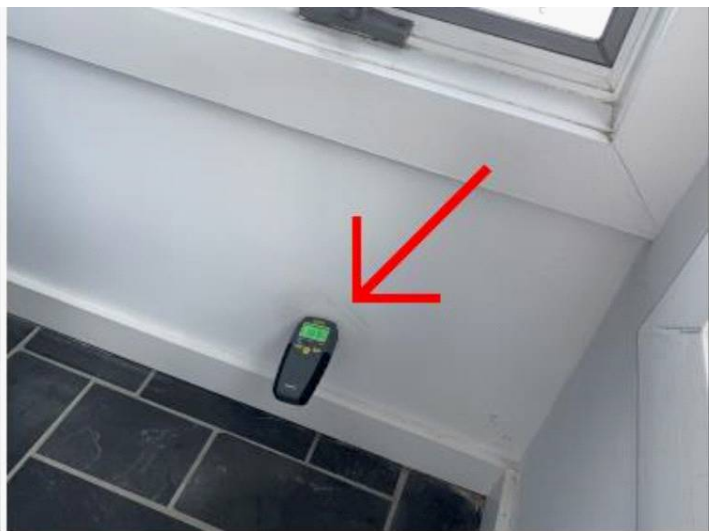
staining consistent with leakage

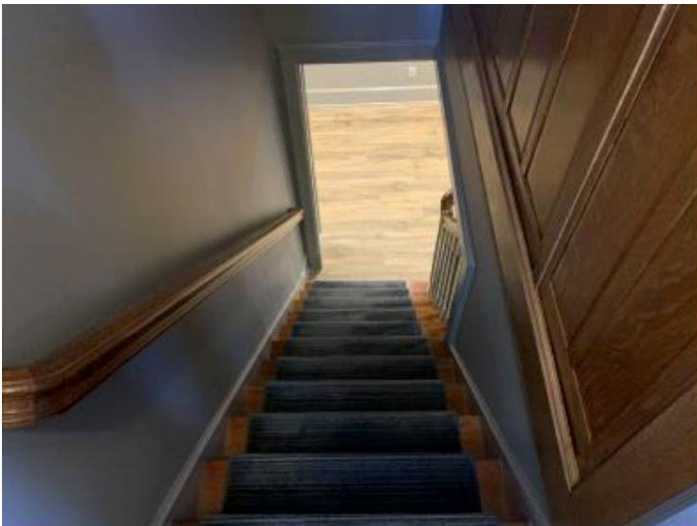
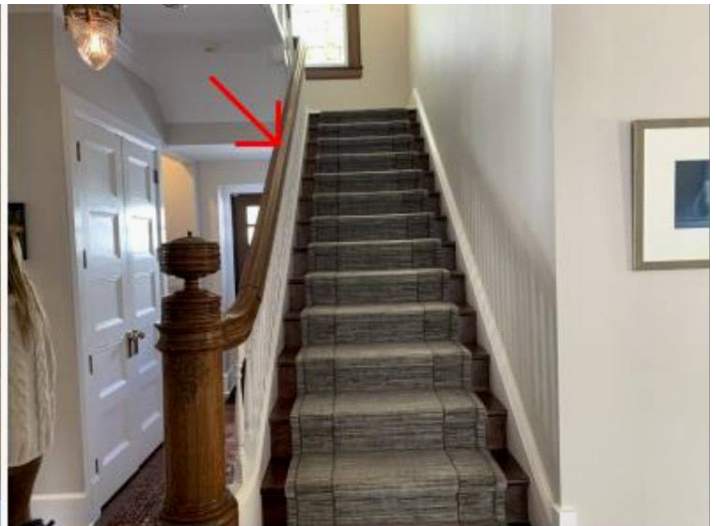
The basement, main floor, and 3rd floor stairs are in some aspects, unsatisfactory condition. Defects include, but are not necessarily limited to the following; The dimensions of the stairs and risers are uneven. This configuration would not comply with modern building standards. This creates a potential tripping condition. Repair/modification is difficult and possibly expensive. Components of the stairs are sagging with loose treads and risers indicating possible problem underneath.

Have the support structure repaired for improved safety. Components of the stairs are squeaky with loose treads and risers indicating possible problem underneath. The condition is quite common in older homes, but should be checked and repaired as necessary. Railings adjacent steps are primarily for safety. In general, railings should extend the full length of the steps, have no gaps greater than 4" and extend to a minimum height of 36". The railings are in some aspects, unsatisfactory condition. Defects include, but are not necessarily limited to the following; The railing is too short. Current standards are for the railing to be at least 36" high.

staircases view | railing is too short

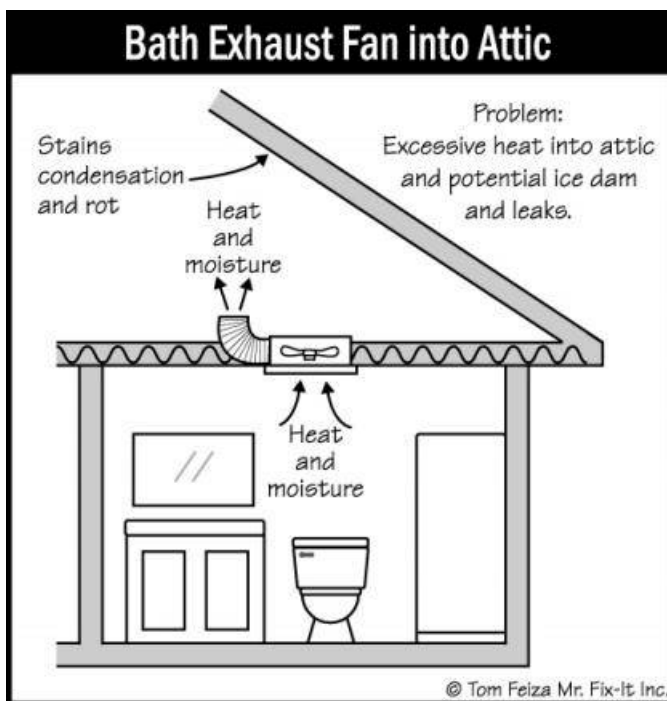
12.10 EXHAUST FAN DUCTING:

The bathroom vent fan ducts are in some aspects, unsatisfactory condition. Deficiencies include, but may not be limited to the following; The bathroom exhaust fans empty into the attic area. Modern standards recommend venting them through the roof and to the exterior. The condition could contribute to mold in the attic space.

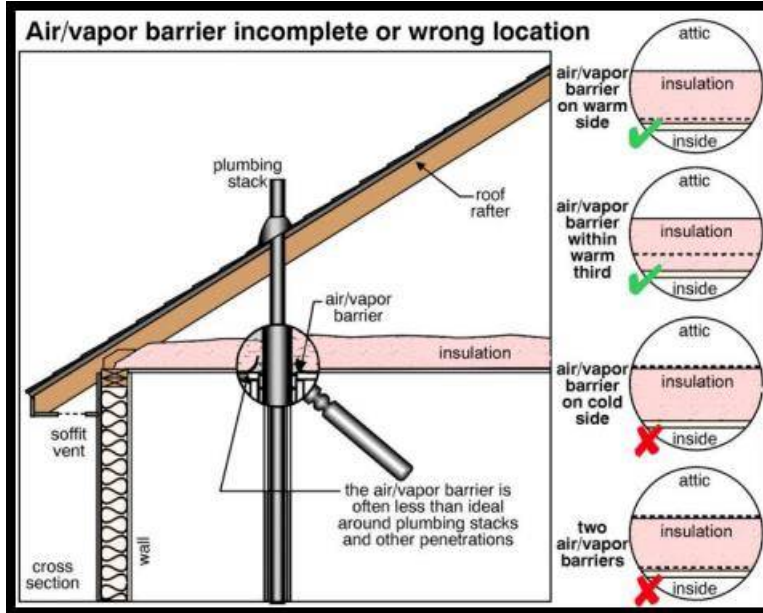
12.12 VAPOR RETARDERS:

The vapor barrier was installed up-side-down. This is a common installation defect made even by builders. The vapor barrier should be closest to the living space for optimum performance. In addition, **Portions of the vapor barrier are exposed. Portions of the vapor barrier are exposed. The material should not be left exposed because the material is combustible.** Either remove the vapor barrier, install it correctly or have the material correctly covered. Re-position vapor barrier as necessary. Insure that when installing additional insulation, a second vapor barrier is NOT installed as this "dual" barrier could allow moisture to condense between the two barriers. The attic does have the recommended vapor barrier, but there are multiple layers of vapor barriers due to

over-insulating attic. The attic should only be equipped with one vapor barrier and that barrier should be directly above the ceiling with the insulation above the vapor barrier. More than one vapor barrier creates potential for condensation to form in the space between the vapor barriers. A competent contractor should be consulted to more thoroughly evaluate the condition and to perform repairs as are necessary. The significance of this condition is; mold could result from condensation forming between the two vapor barriers.

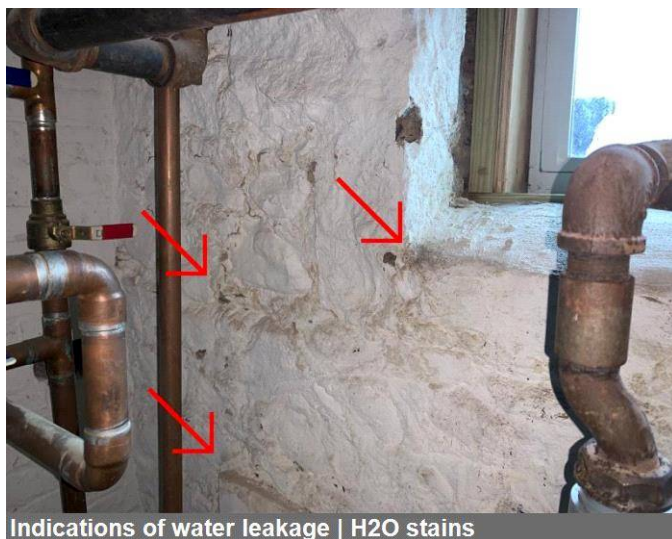
13.6 MOISTURE:

At this time, there are indications of water leakage through the foundation walls into the basement area, which is a "material defect". Indications are in the form of water stains/efflorescence on the floor/walls.

The inspection for water conditions is dependent upon seasonal weather conditions. It is possible that the interior of the home could appear dry during the home inspection, but later develop water conditions. At this time, there are indications of water leakage through the foundation walls into the basement area, which is a "material defect". Indications are in the form of water stains/efflorescence on the floor/walls.

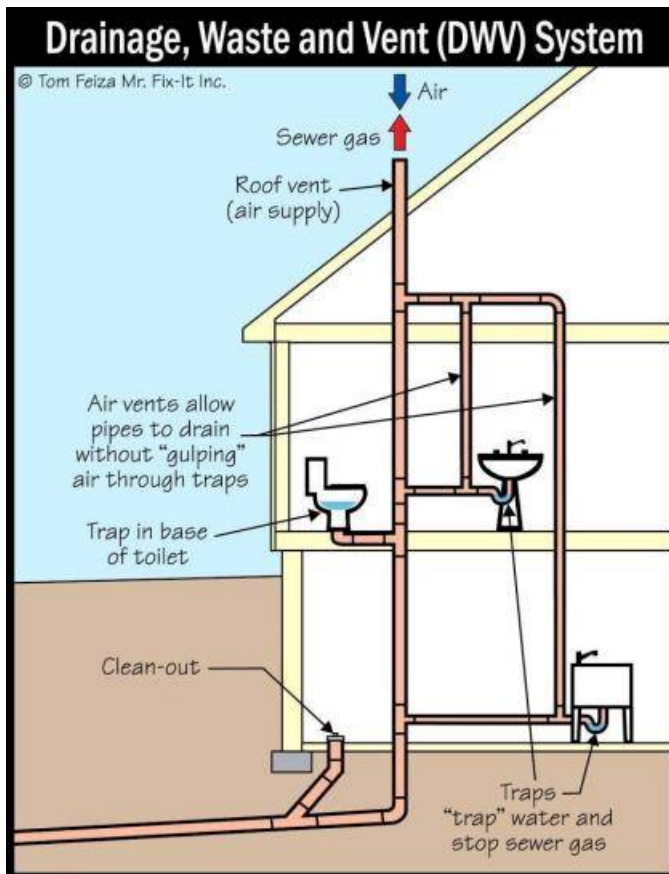
14.7 WASTE PIPE SYSTEM:

There are plumbing fixtures/pipes that are clogged. It is suggested that the interior of the waste piping be inspected by a licensed plumber, possibly utilizing a video camera from the house to the street connection. Clogs in this portion of the pipe can be very expensive to repair.

The plumbing system includes; PVC, ABS (plastic), lead, galvanized, and iron piping. The waste piping appears to be in some aspects, unsatisfactory condition. Deficiencies include, but may not be limited to the following: There are back-pitched vent pipes in the attic. This can block venting of sewer gases and result in leakage. There are pin hole (small) leaks that have developed in the waste piping. Vent pipes terminate too close to a bedroom window. (See the above photograph) The condition may allow sewer gases to enter the living spaces. This configuration would not comply with modern building standards. A licensed plumbing contractor should be contacted to more thoroughly evaluate these "material defects"/conditions and to perform repairs as necessary.

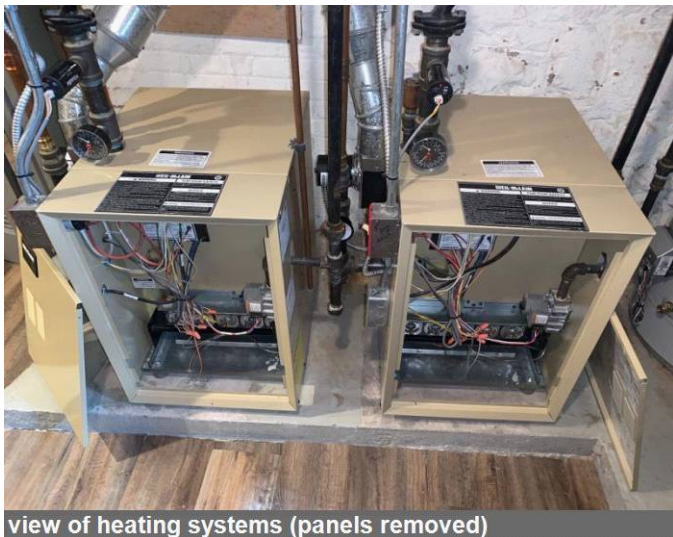
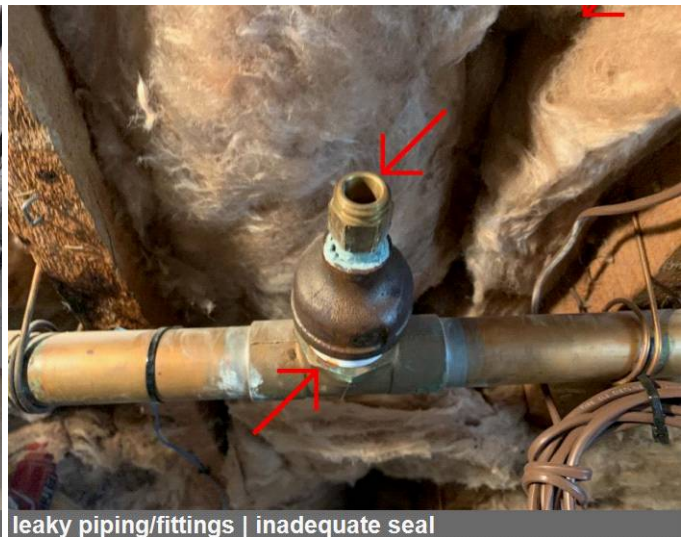
The boilers (heating systems) are in need of maintenance/repair. The radiant heating loops are malfunctioning, possibly due to leaks, air in the lines or other defects (see basement loops). There are 4 gas-burning appliances discharging into the same chimney flue. The significance of this condition is; there is potential for over-loading the chimney flue, which could result in spilling toxic gases (exhaust) into the living spaces. A licensed plumber should be contacted to determine safe chimney flue sizing for this configuration and make changes as needed.

NOTE: There are 4 gas-burning appliances discharging into the same chimney flue. The significance of this condition is; there is potential for over-loading the chimney flue, which could result in spilling toxic gases (exhaust) into the living spaces. A licensed plumber should be contacted to determine safe chimney flue sizing for this configuration and make changes as needed.

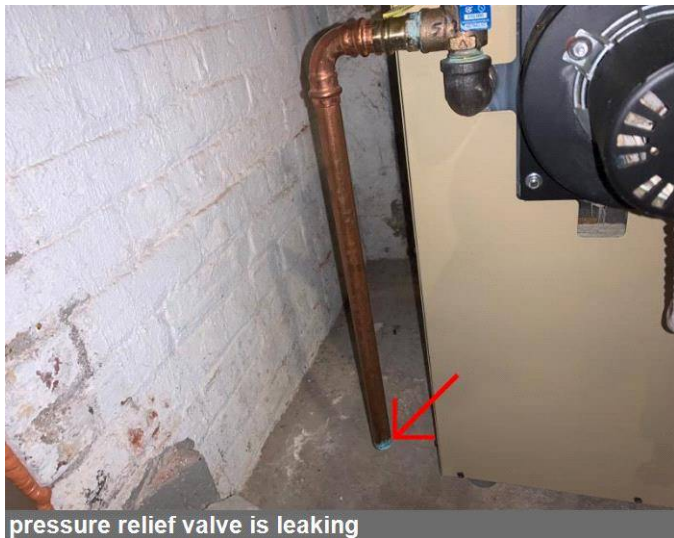
16.10 PRESSURE RELIEF VALVE:

pressure relief valve is leaking

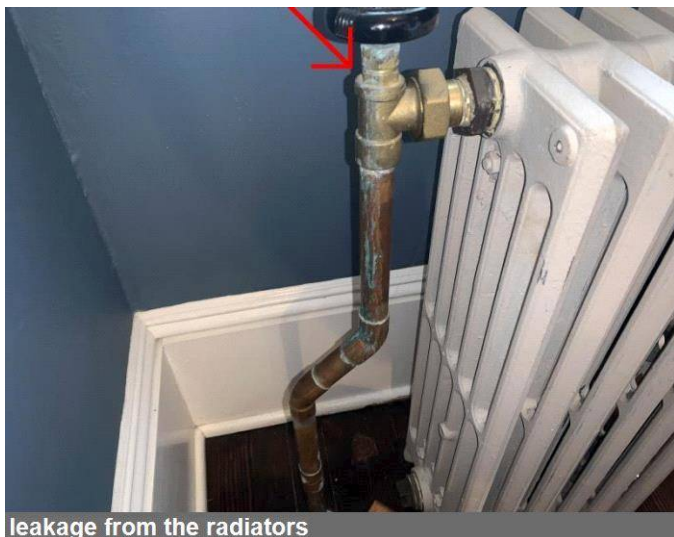
leakage from the radiators

There are un-heated spaces. Consider adding a heat source to the unheated spaces. There has been some leakage from the radiators and valves causing damage to the floor system. (See the adjacent and below photograph) Radiator handles are missing. Replacement is recommended.

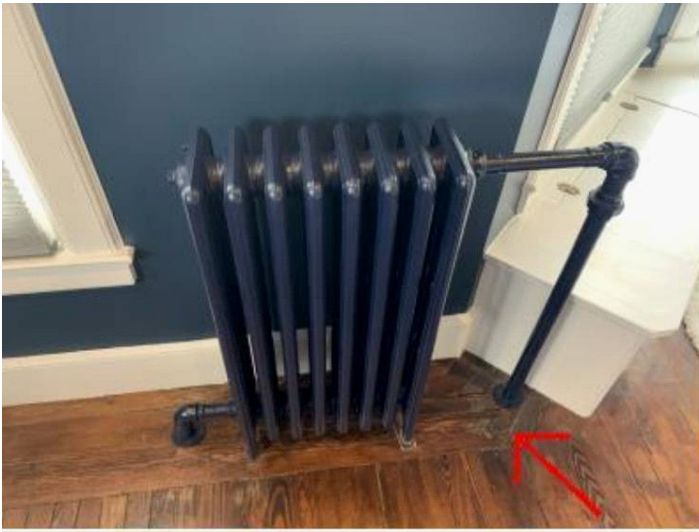
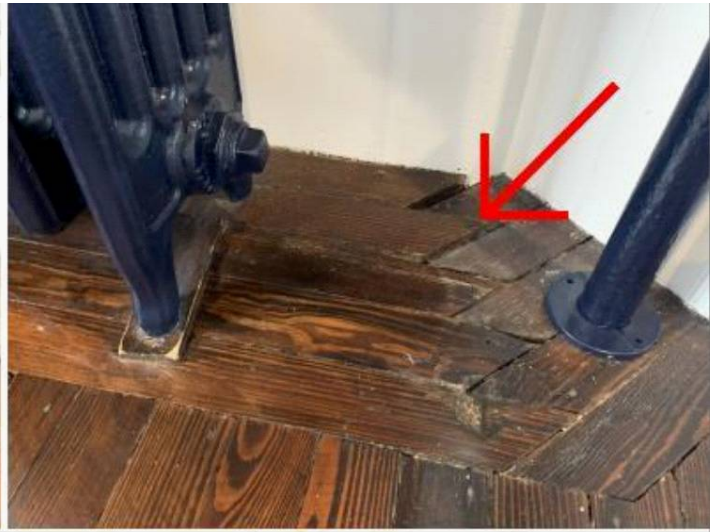
Damaged flooring (signs of leaks)

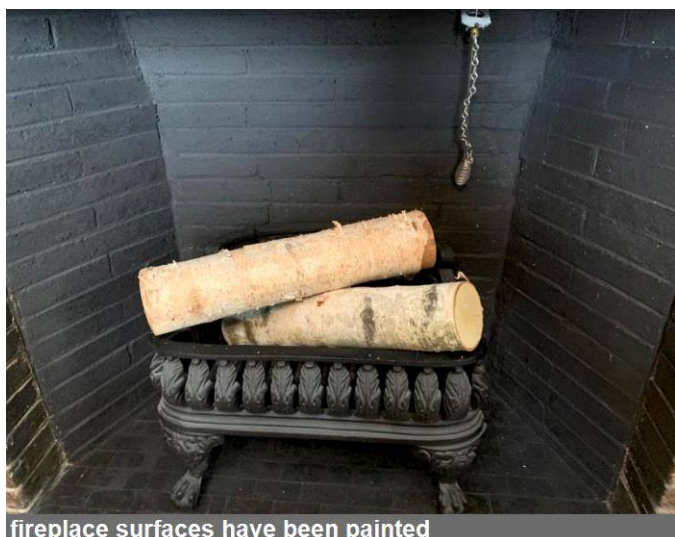
16.14 OVERALL CONDITION:

The fireplace is in some aspects, unsatisfactory condition. There is carbon staining of the exterior masonry surfaces, which typically indicates poor draft. This is not confirmed. The smoke chamber and flue are dirty and should be cleaned. There is cracking of the mortar from between the firebricks and cracking of the bricks in the firebox area. There is a crack/gap between the firebox and the wall. The significance of this condition is; heat from operating the fireplace could enter this space and cause fire problem.

The fireplace is in some aspects, unsatisfactory condition. Deficiencies include, but are not limited to the following; There is carbon staining of the exterior masonry surfaces, which typically indicates poor draft. This is not confirmed. The smoke chamber and flue are dirty and should be cleaned. The soot accumulation prevents the inspector from seeing the lower sections of the flue and chimney clearly. Have these areas cleaned and then have the flue re-evaluated. **The fireplace surfaces have been painted.** The significance of this condition is; If the paint is combustible, the condition could be a fire hazard. There is cracking of the mortar from between the firebricks and cracking of the bricks in the firebox area. This is a reflection of normal wear and tear, but should be addressed for safe operation of the fireplace.

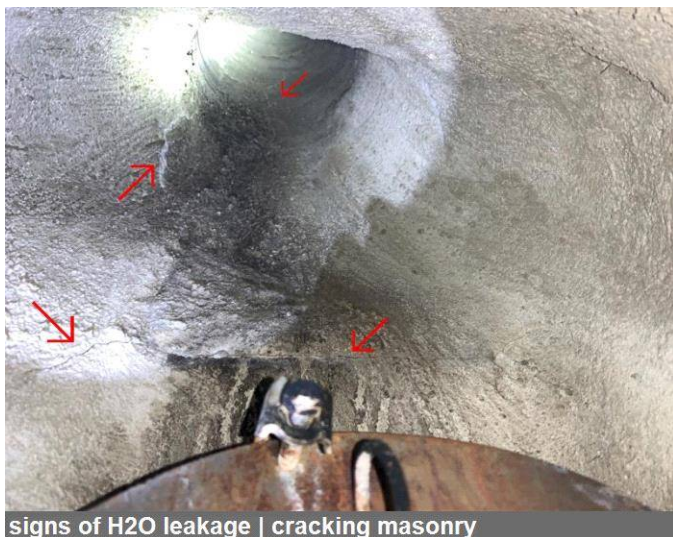
16.26 OVERALL CONDITION:

The fireplace is in some aspects, unsatisfactory condition. Deficiencies include, but are not limited to the following; There are signs of water leakage into the fireplace. The source is from the upper chimney area and is not located with certainty. Have the interior of the chimney checked for the source of the leakage. There is cracking of the cementitious material at the interior of the flue ("flue liner") of the hearth/firebox seam (see the adjacent photograph). This crack should be repaired to alleviate the potential for a fire condition. Contact a qualified contractor to evaluate the condition(s) and to perform necessary repairs.

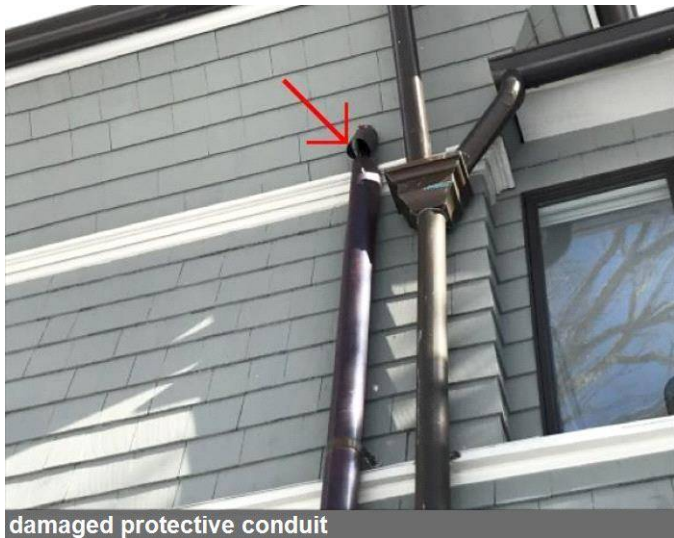
17.4 CONDENSER UNIT:

The refrigerant lines which serve the upper air conditioning coil are routed through a protective conduit which is damaged, (see the adjacent photograph). The significance of this condition is that the damage could cause damage to the refrigerant components and the air conditioning systems ability to cool.

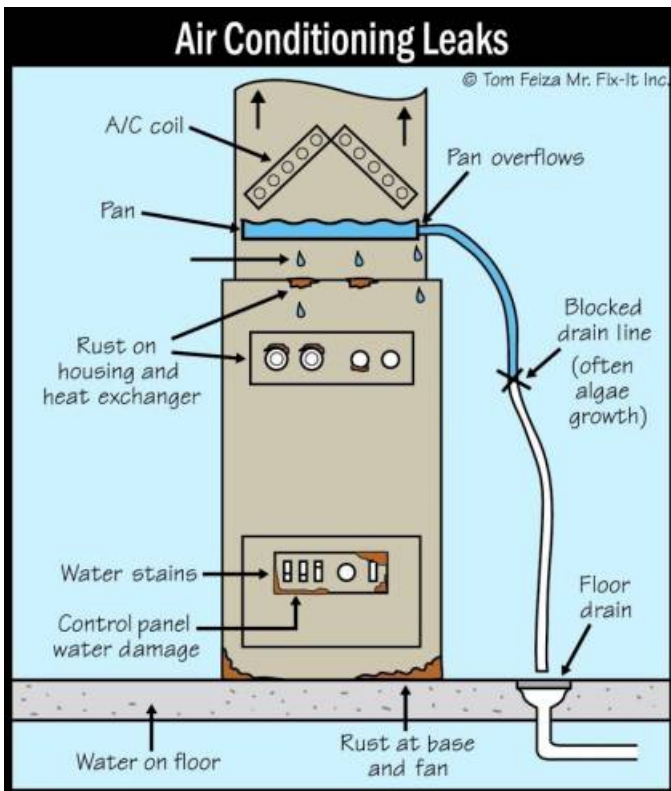
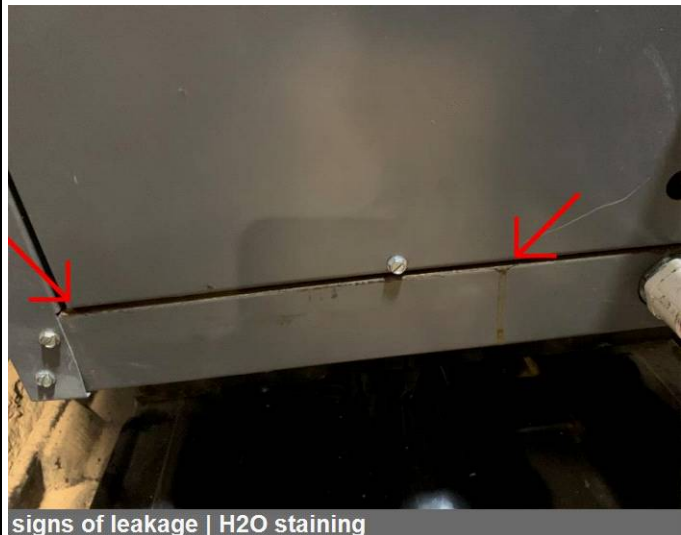
There are indications that the air conditioning system in the basement has been a source of leakage. This is indicated by water staining of the air handler housing components and the equipment below the unit. This is common and normally routine maintenance to clear the drains is sufficient, but not always. Under some circumstances the repair is difficult and expensive. Contact a competent heating and cooling contractor to more thoroughly evaluate the system and perform necessary repairs as necessary.

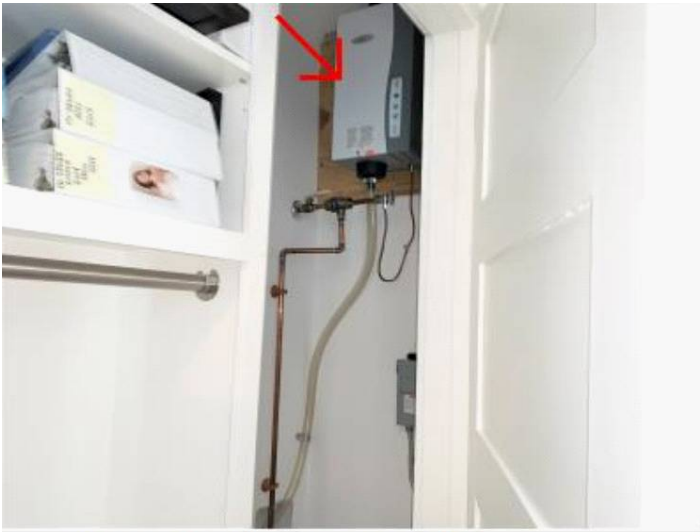
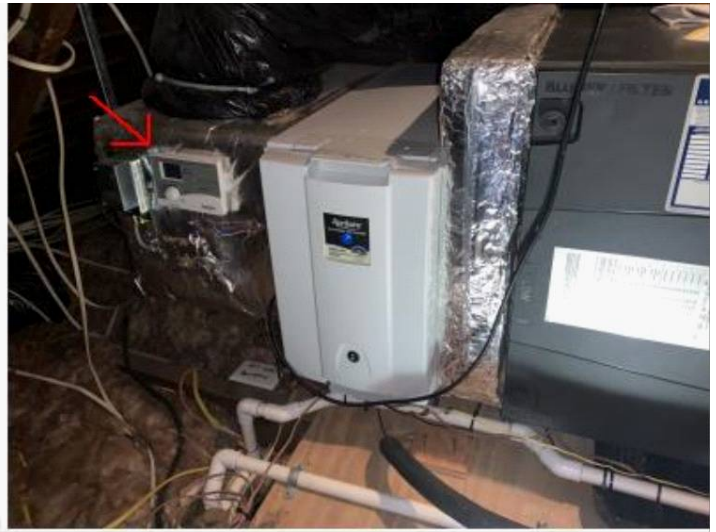
The humidifier equipment is not functioning properly. Maintenance is required at this time for this equipment to function acceptably.

NOTE: *Operation of a humidifier in an un-conditioned space (attic) could result in freezing pipes, leaks and water damage/mold.*

humidifier equipment/improperly installed
