## HOME INSPECTION REPORT

July 20, 2024

KAUFMANN CONSULTANTS, LLC

### REPORT SUMMARY

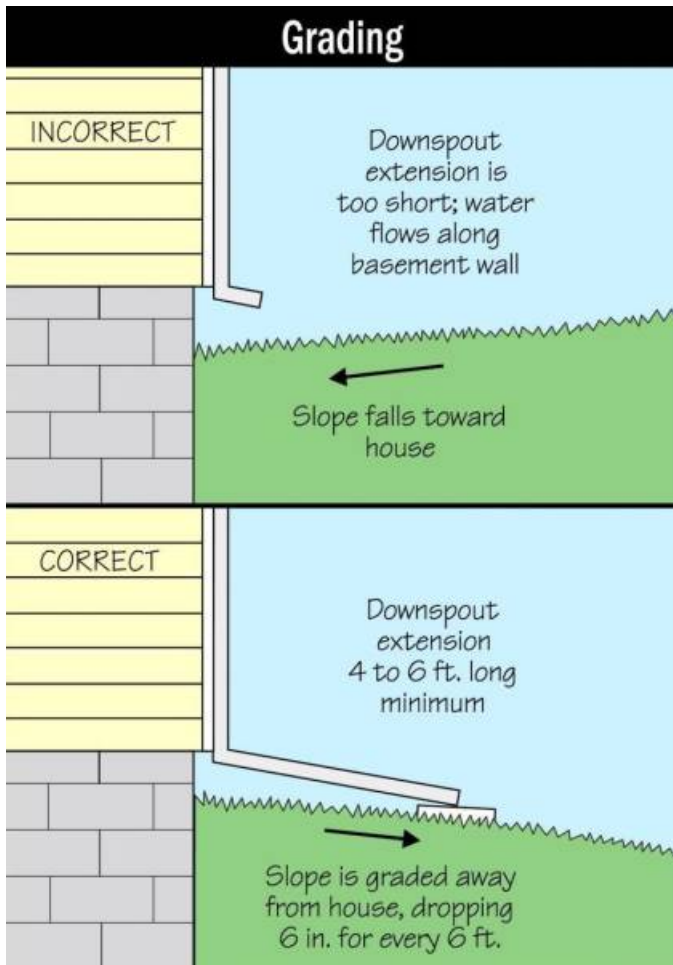
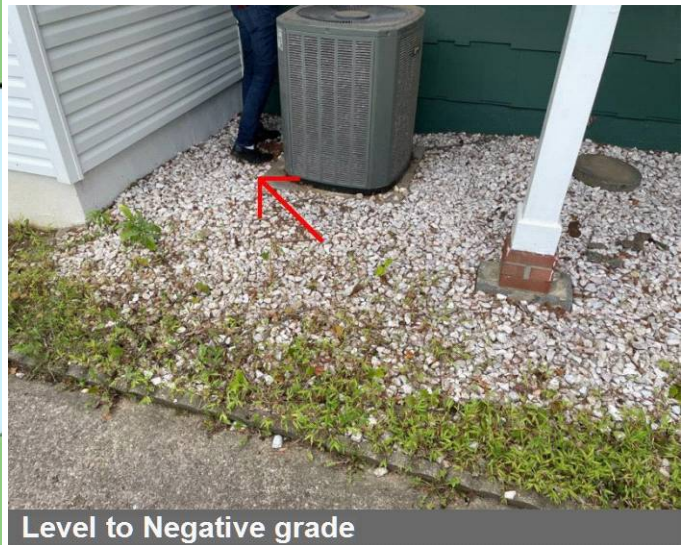
1. Level to Negative grade, which may contribute to a water condition in the basement is noted at the front and rear. (see adjacent photo) The general guideline is for the grading to drop 6" in the first 6' away from the foundation. This promotes water saturation away from the foundation and lessens the chance for water entry in and under the structure.

Level to Negative grade, which may contribute to a water condition in the basement is noted at the front and rear. (see adjacent photo) The general guideline is for the grading to drop 6" in the first 6' away from the foundation. This promotes water saturation away from the foundation and lessens the chance for water entry in and under the structure.

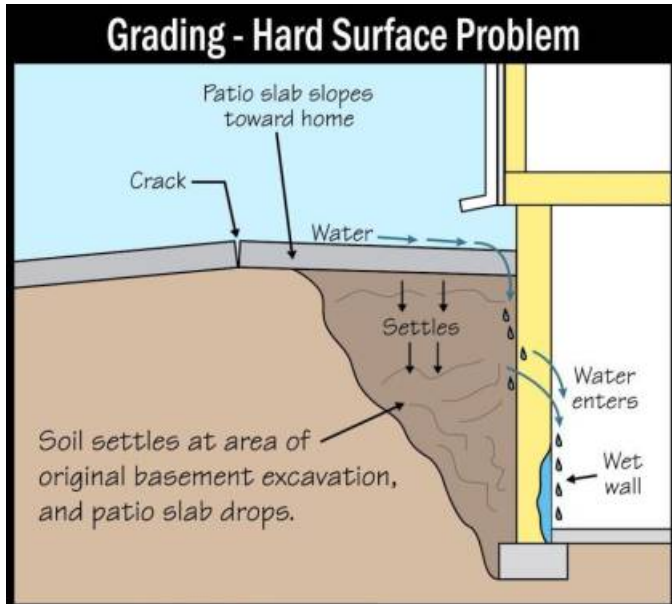
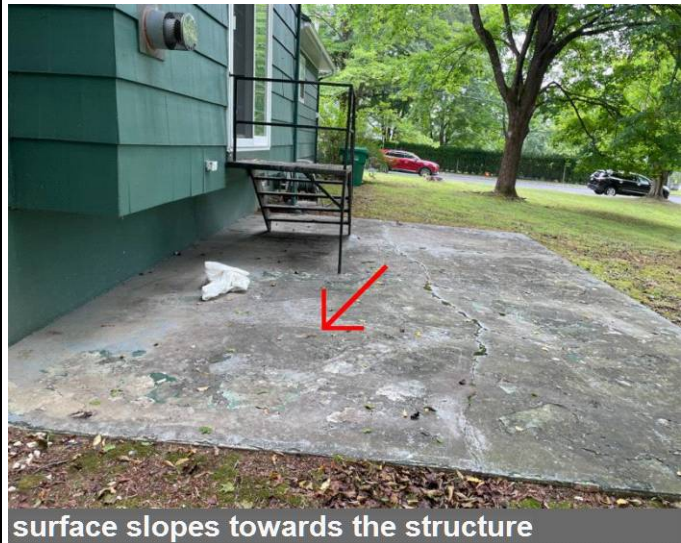
The masonry patio is in some aspects, unsatisfactory condition. Deficiencies include, but may not be limited to; The impervious surface slopes towards the structure adversely affecting drainage. Poor drainage near the foundation may cause or contribute to water conditions in the basement/crawlspace areas. (See adjacent diagram) Correct the drainage to draw water away from the home to alleviate potential for water problems. There are cracks that have developed in the patio. These cracks could result in raised edges and un-even surfaces, which may represent a tripping concern. Have the cracks repaired as necessary.

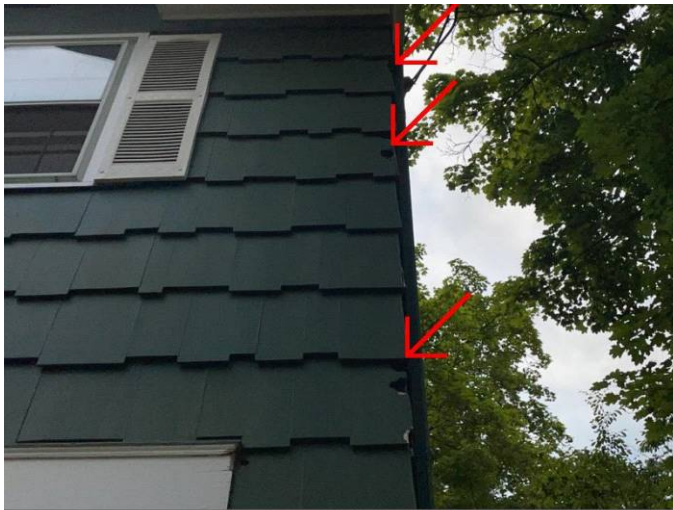
3. There is some bird damage to the home's exterior siding. This is typically related to birds pecking away at the exterior to get to insects (probably carpenter ants). The siding should be repaired and a qualified exterminator should be contacted for remedial measures. There is damaged exterior siding. There are areas of the exterior that are buckled possibly indicating structural problems beneath the siding. There is loose/inadequately fastened exterior siding. There is paint peeling. Have the exterior prepped and re-painted. There is rot/deterioration of the siding where the siding is in close proximity to the roofing.

The siding is in some aspects, unsatisfactory condition, which could result in loss of functional utility or cosmetic appeal. There is some bird damage to the home's exterior siding. This is typically related to birds pecking away at the exterior to get to insects (probably carpenter ants). The siding should be repaired and a qualified exterminator should be contacted for remedial measures. There is damaged exterior siding. There are areas of the exterior that are buckled possibly indicating structural problems beneath the siding. There is loose/inadequately fastened exterior siding. There is paint peeling. Have the exterior prepped and re-painted. There is rot/deterioration of the siding where the siding is in close proximity to the roofing. Contact a qualified contractor (siding specialist) to further evaluate the condition and perform repairs as necessary.

bird damage

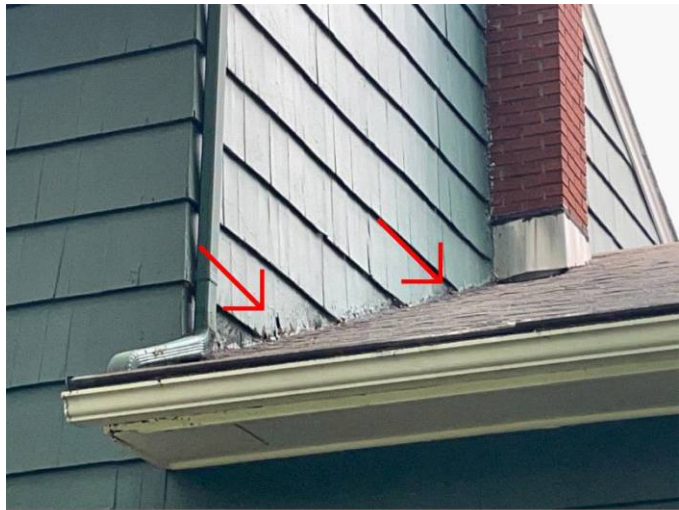
rotted exterior siding

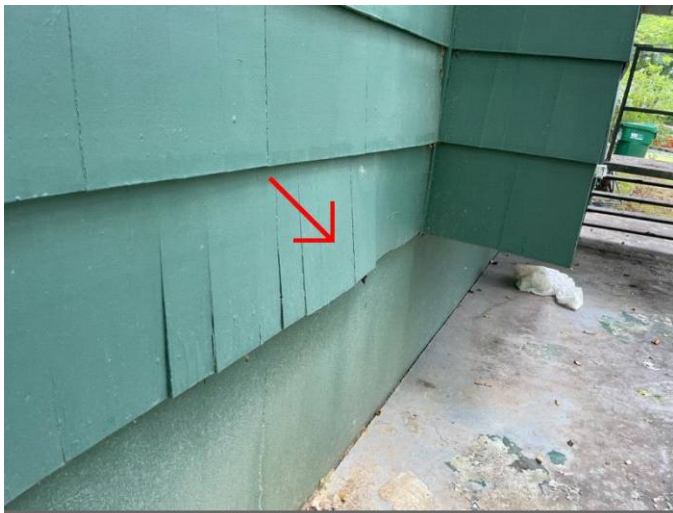
loose fastened exterior siding

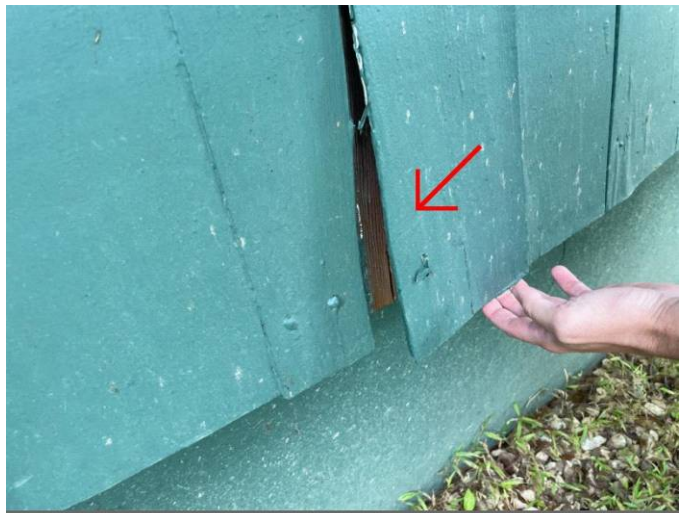
inadequately fastened exterior siding

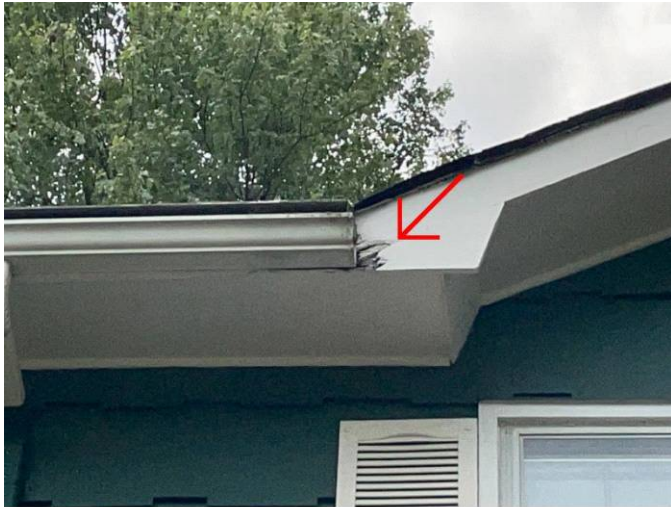
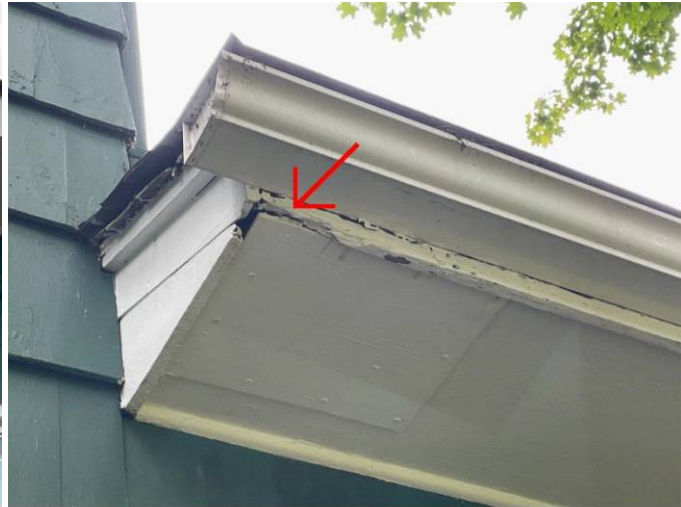
4. There is rot to the exterior wood/trim. Areas of rot include, but may not be limited to; Roof trim. There is carpenter bee damage to the roof trim.

The exterior trim/wood is in need of maintenance. Deficiencies include, but are not limited to the following; There is rot to the exterior wood/trim. Areas of rot include, but may not be limited to: Roof trim. Proper care to the home's exterior includes replacement of rotted pieces and periodic re-painting and caulking to protect the wood from the elements. Budget for this contingency. There are gaps between the trim components at roof edges. This is a concern because sometimes pests can enter the structure through these small gaps. Repair and/or replace any defective wood. There is carpenter bee damage to the roof trim.

rot to the exterior wood/trim

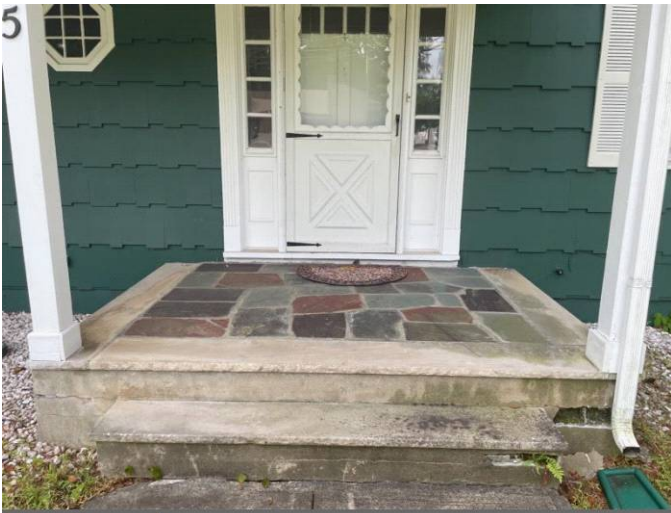
Front porch

The front porch is unsatisfactory, which could result in loss of functional utility or cosmetic appeal. Deficiencies include, but may not be limited to the following; Settling of the masonry landing results in a negative pitch. The significance of this condition is; water will be channeled to the home's exterior, wood-frame walls. This condition could result in water damage (rot and mold). There is cracking masonry, which could indicate structural problems or installation defects. The door bell is inoperable. The exterior front porch light is in functional condition. A qualified mason/contractor should be contacted to further evaluate/repair the condition as necessary.

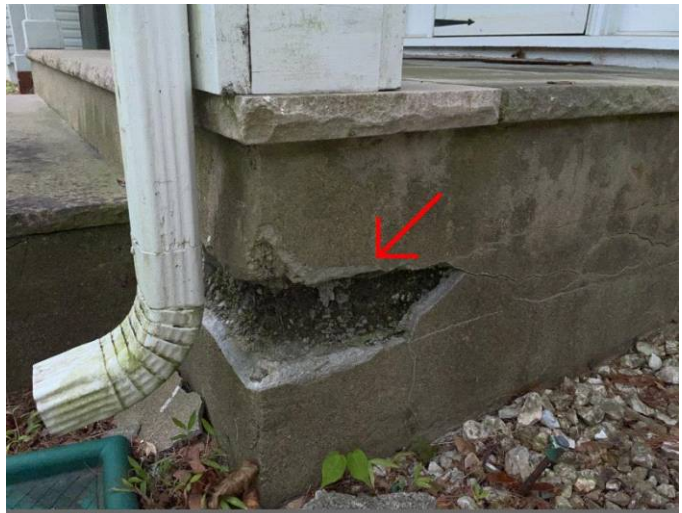
5. There is cracking masonry, which could indicate structural problems or installation defects.

cracking masonry

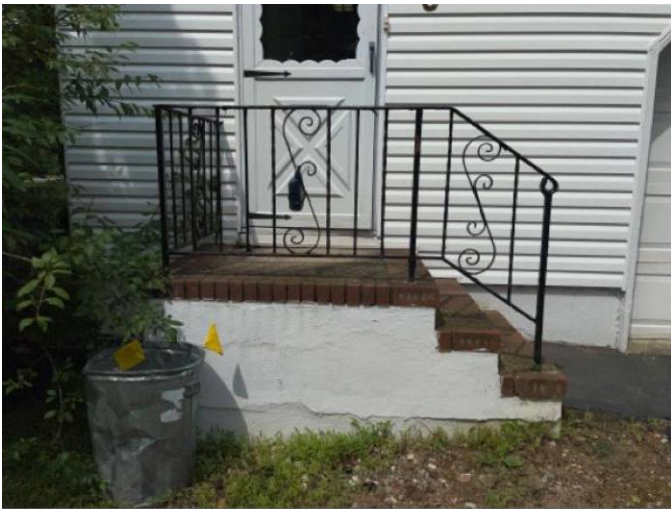
The side porch is unsatisfactory. Deficiencies include, but may not be limited to the following; There is some cracking of the masonry materials; which should be repaired by a qualified mason/contractor. The dimensions of the steps are uneven. This could represent a tripping condition. Contact a qualified contractor (mason) to perform repairs as necessary.

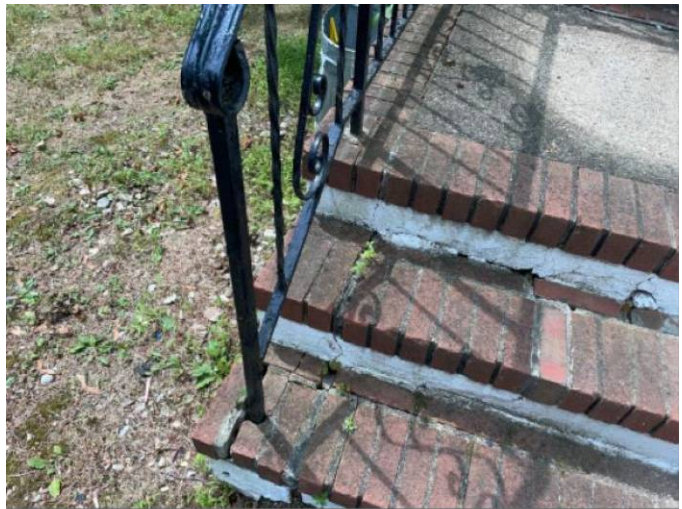
cracking of the masonry materials

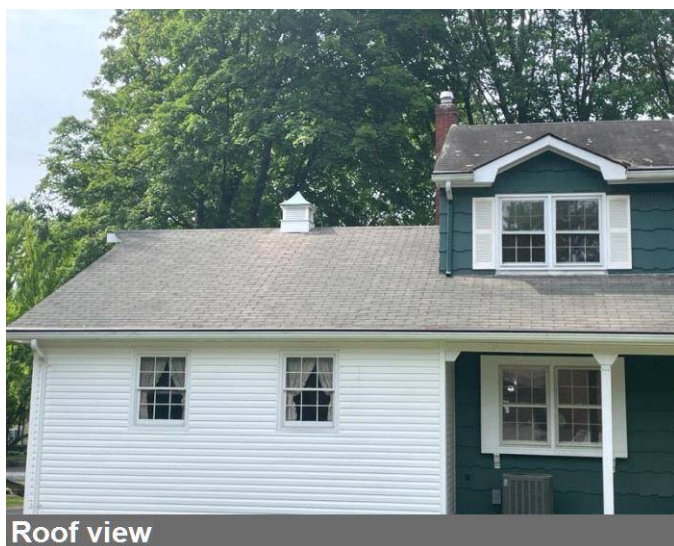
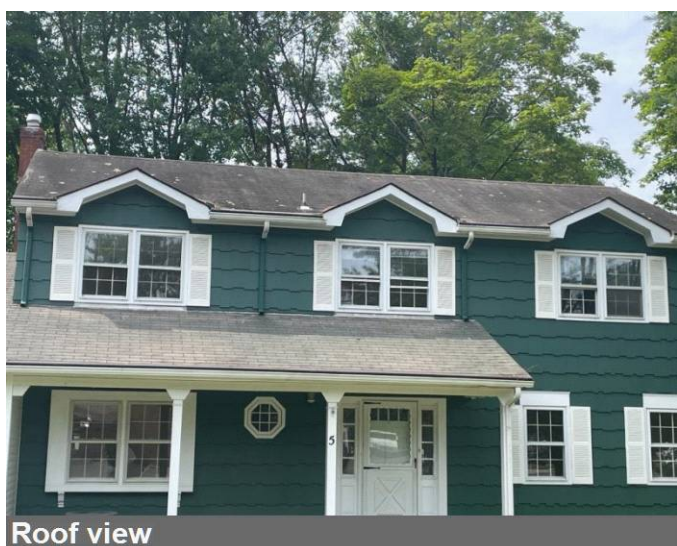
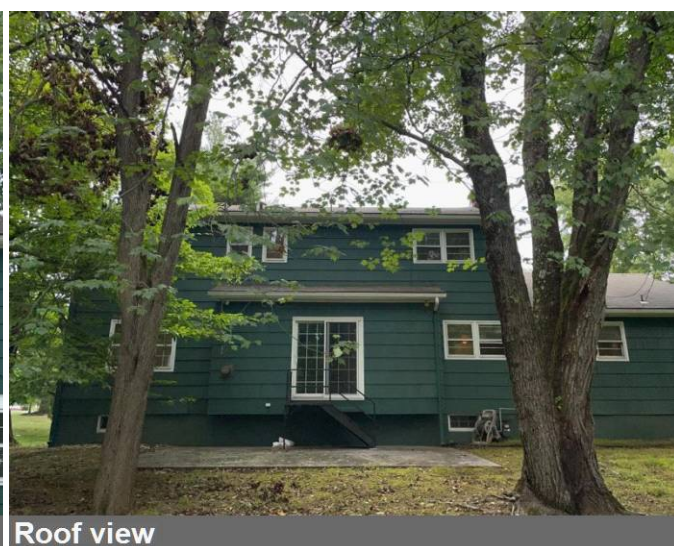
6. The roof is in some aspect, unsatisfactory condition, which represents a possible "material defect." Deficiencies include, but may not be limited to the following: There are damaged roof shingles that could cause leaks. Replacement of damaged shingles is recommended. There is significant pitting of the shingles. This is a reflection of the old age of the roof, as well as, the wear pattern from tradesmen walking over these areas. Nonetheless, the pitting could result in pre-mature failure (leaks). Missing shingles could result in leakage. Replacement of the missing

shingles as well as addressing the underlying cause of the material defect is recommended. Based on visual assessment only, the roof appears to be, over 20 years old. Documentation regarding the installation should be obtained prior to closing to confirm the age of the installation. Without documentation, the age is not confirmed. Contact a roofing specialist before the inspection contingency expires to more thoroughly evaluate the system and to obtain estimates for replacement.

The roof is in some aspect, unsatisfactory condition, which represents a possible "material defect." Deficiencies include, but may not be limited to the following: There are damaged roof shingles that could cause leaks. Replacement of damaged shingles is recommended. There is significant pitting of the shingles. This is a reflection of the old age of the roof, as well as, the wear pattern from tradesmen walking over these areas. Nonetheless, the pitting could result in pre-mature failure (leaks). Missing shingles could result in leakage. Replacement of the missing shingles as well as addressing the underlying cause of the material defect is recommended.

The roof covering also shows signs of excess wear due to exposure. These conditions include, but are not

NOTE: There are multiple layers of roofing on the structure at this time. Current standards restrict the installation to 2 layers of roofing or less due to load concerns and fire venting limitations. This is, however, a relatively recent limitation and it is not uncommon to find "grandfathered" deviations. Installing a second roof over a single layer of existing roofing is common, accepted and approved in some cases. Some heavier roof shingles (dimensional/architectural) cannot be covered with additional roofing under any circumstances. Keep in mind that re-roofing when there are multiple layers of roofing is more expensive due to the added expense of removing the old materials and in some cases replacement of the portions of the wood roof deck. Contact a roofing specialist before the inspection contingency expires to more thoroughly evaluate the system and to obtain estimates for replacement.

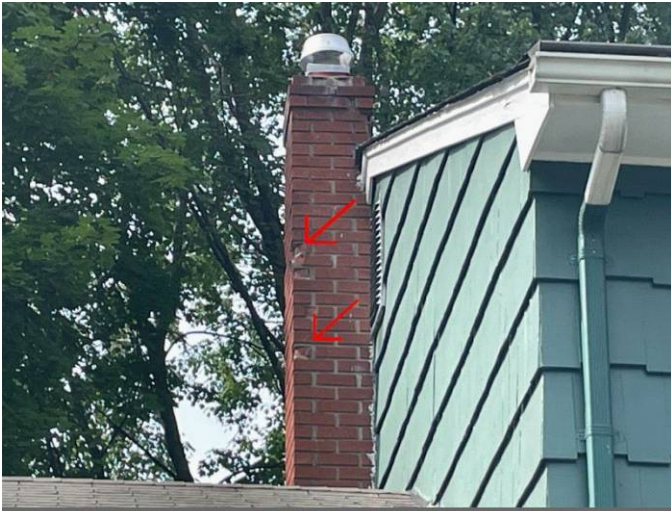
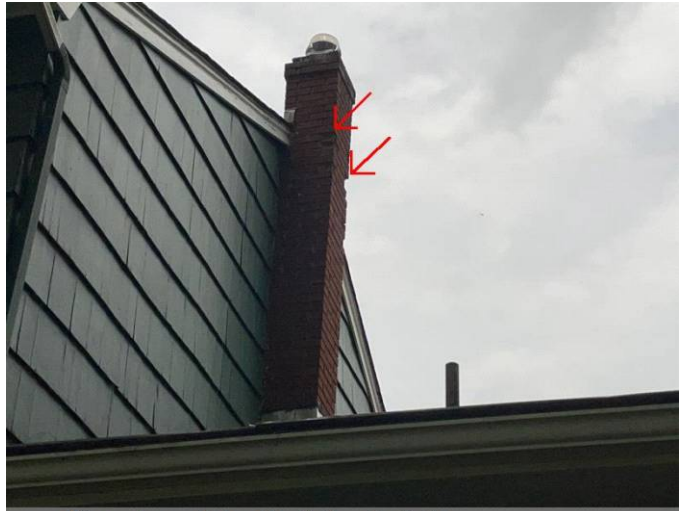
7. The masonry chimney is in some aspects, unsatisfactory condition (material defect). There is some spalling (cracking) of the bricks, particularly above the roof line. There is cracking of the masonry structure. Cracks could also be present inside the structure, which could represent a fire condition. The cracks could be a source of water leakage through the structure.

spalling (cracking) of the bricks

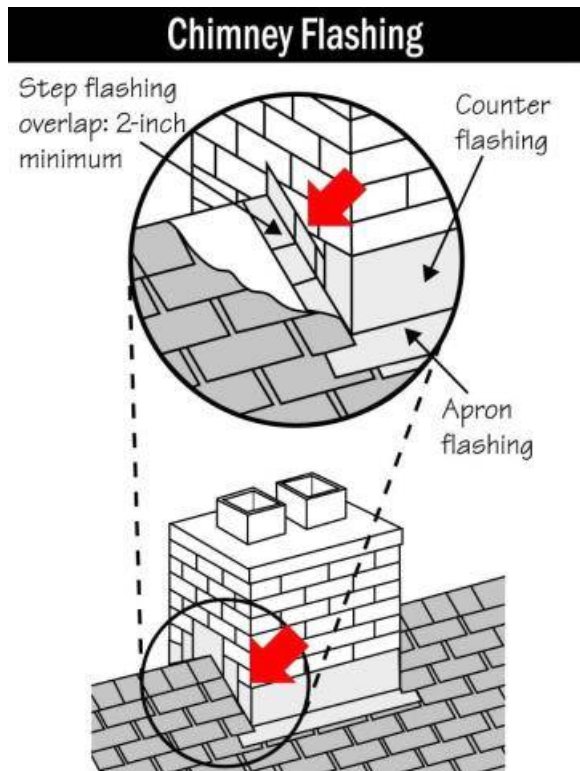
8. The application of mastic suggests past water intrusion. The nature and scope of repairs should be discussed with the present home-owner and the repairman, who performed the repair.

The application of mastic suggests past water intrusion. The nature and scope of repairs should be discussed with the present home-owner and the repairman, who performed the repair.

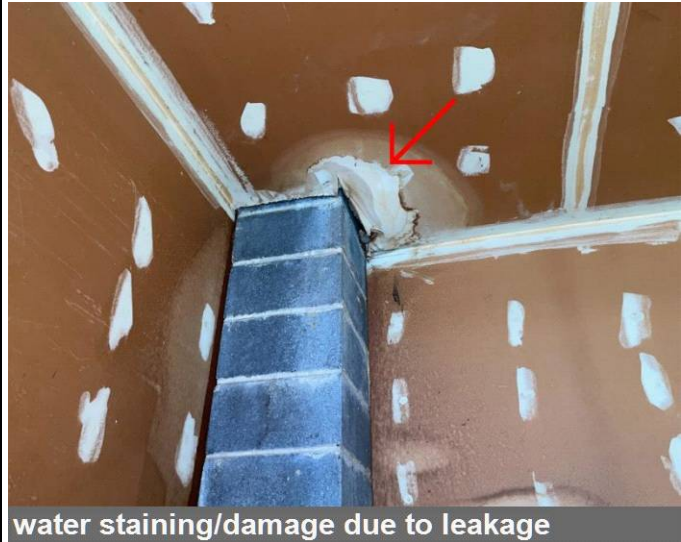
9. In general, the garage is in some aspects, unsatisfactory condition. Deficiencies include, but are not necessarily limited to the following: There is apparent water leakage into the garage from the exterior. This leakage has caused rot. Contact a competent contractor to evaluate the extent of the defect and the necessary repairs.

water staining/damage due to leakage

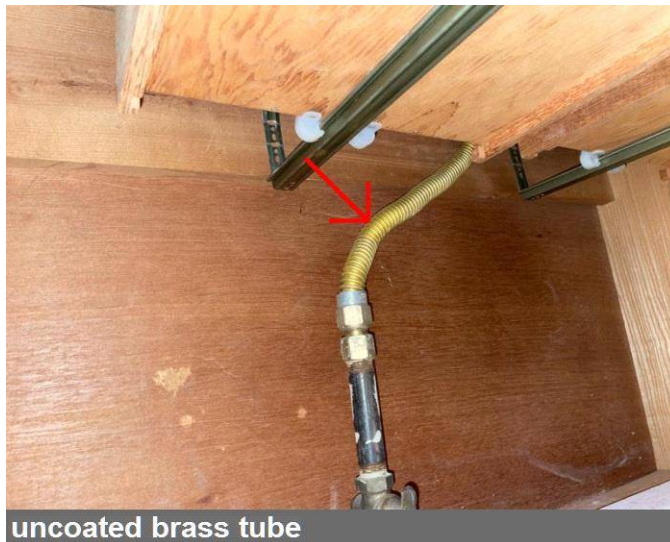
11. The unit is equipped with a flexible gas line. The type of flexible gas line used is an uncoated brass tube. The Consumer Product Safety Commission issued a news warning in September 1997 that all uncoated brass flexible gas line connectors should be upgraded with newer plastic coated or stainless steel models. The older brass models are prone to cracking or leaking and can cause a serious gas leak, explosion or fire. Consult an licensed HVAC or Plumber for the installation of a new flexible line.

The unit is equipped with a flexible gas line. The type of flexible gas line used is an uncoated brass tube. The Consumer Product Safety Commission issued a news warning in September 1997 that all uncoated brass flexible gas line connectors should be upgraded with newer plastic coated or stainless steel models. The older brass models are prone to cracking or leaking and can cause a serious gas leak, explosion or fire. Consult an licensed HVAC or Plumber for the installation of a new flexible line.

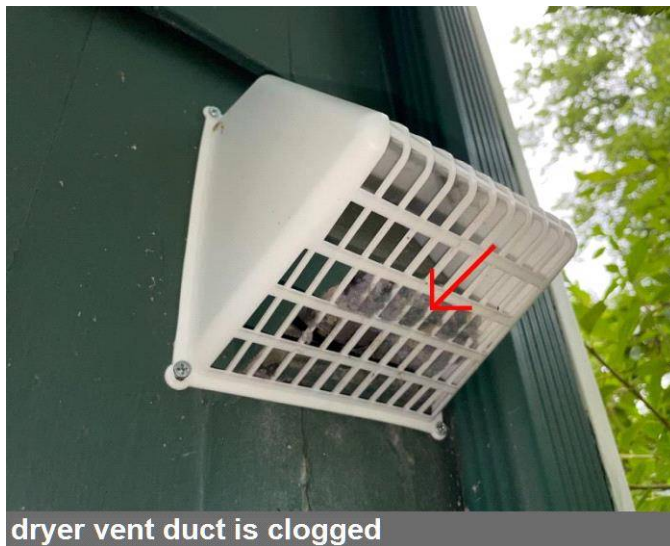
The dryer exhaust is vented to the outside. The dryer vent duct is clogged, which adversely affects function and creates a potential fire concern. Clean the ducting as necessary. **FOR YOUR INFORMATION.** There are more fires caused from lint accumulation in the dryer vent pipe than from fireplaces. It is recommend that you check the ducting when moving in and have it checked regularly. A licensed chimney sweep performs this service.

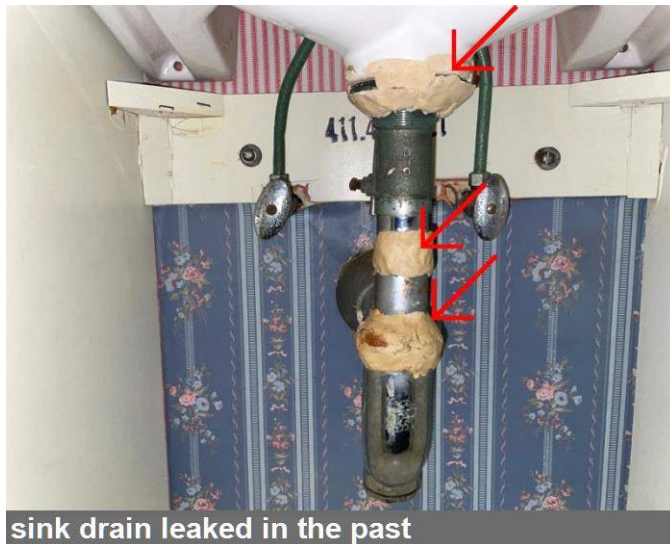
12. The faucet, sink and drain lines are in need of maintenance. Deficiencies include, but may not be limited to; The sink drain leaked in the past. This is indicated by staining/corrosion of the drain piping. Replacement should be anticipated. The faucet is leaking. Replacement/repair is recommended. The sink stopper is inoperable, which limits use of the fixture.

Repair/replacement is recommended. The sink drain is clogged, which limits the use of the fixture. The condition indicates the need for maintenance/repair.

sink drain leaked in the past

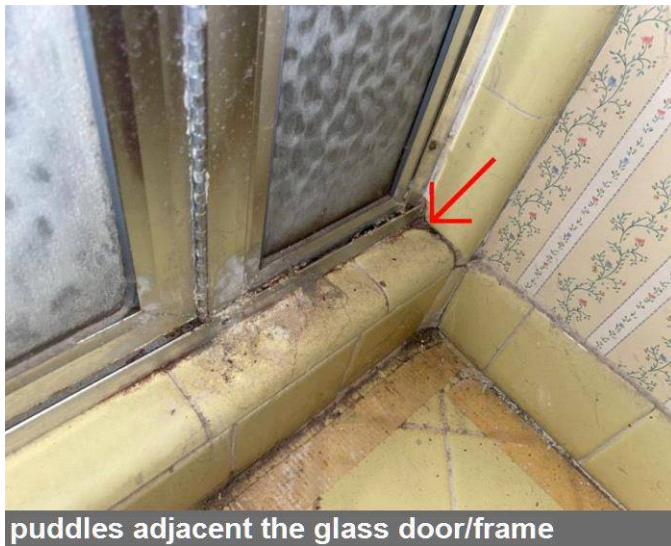
puddles adjacent the glass door/frame

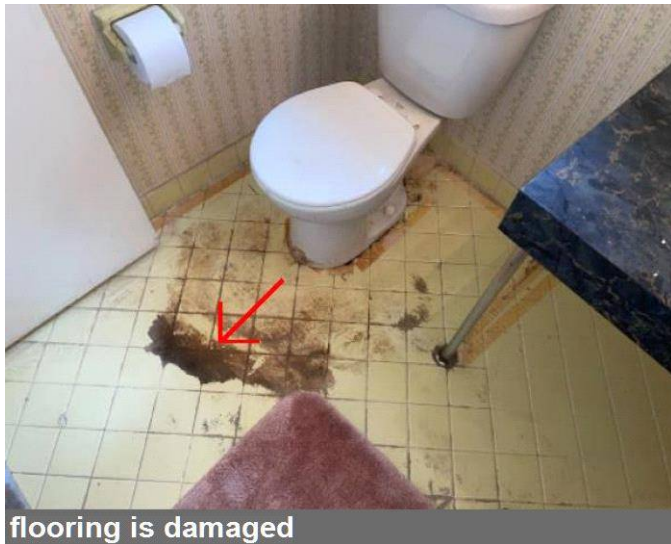
flooring is damaged

Floor, wall and ceiling surfaces are in need of maintenance. **The flooring is damaged in some locations.** The condition indicates the need for maintenance/repair.

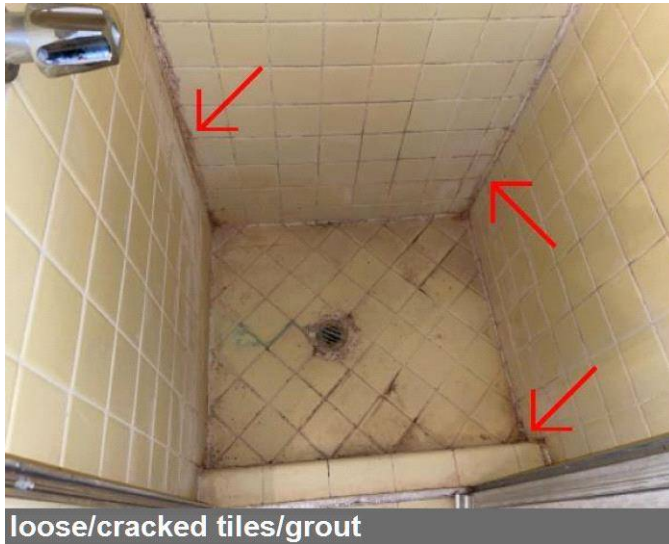
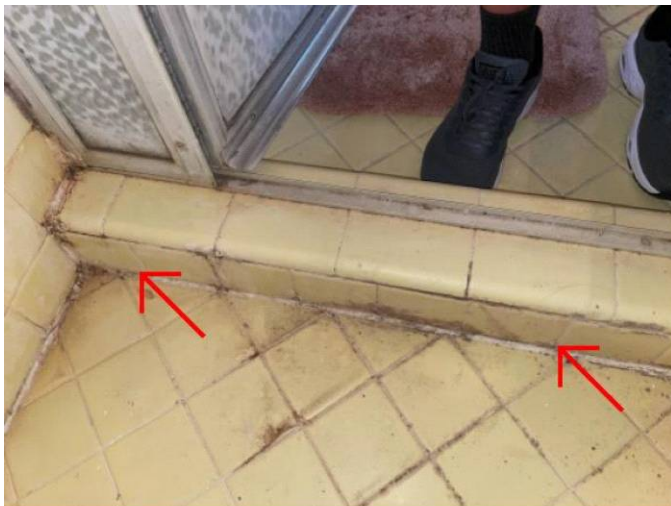
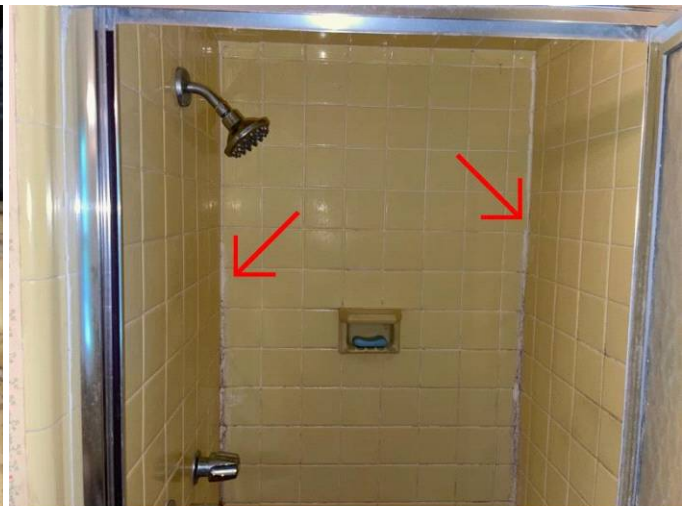
13. The shower is in need of repair. The shower floor, wall, and ceiling surfaces are in need of maintenance. There are loose/cracked tiles/grout. Water leaks through to the lower areas could result. The shower floor is cracked. The significance of this condition is; leaks may result. There is no anti-scald device installed on the shower plumbing. The configuration would not comply with modern building standards. Modern building standards require the use of "anti-scalding devices to alleviate potential for scald injury. It is suggested that up-grade to modern fixtures with anti-scald devices be considered.

The shower is in need of repair. The shower floor, wall, and ceiling surfaces are in need of maintenance. There are loose/cracked tiles/grout. Water leaks through to the lower areas could result. The shower floor is cracked. The significance of this condition is; leaks may result. There is no anti-scald device installed on the shower plumbing. The configuration would not comply with modern building standards. Modern building standards require the use of "anti-scalding devices to alleviate potential for scald injury. It is suggested that up-grade to modern fixtures with anti-scald devices be considered.

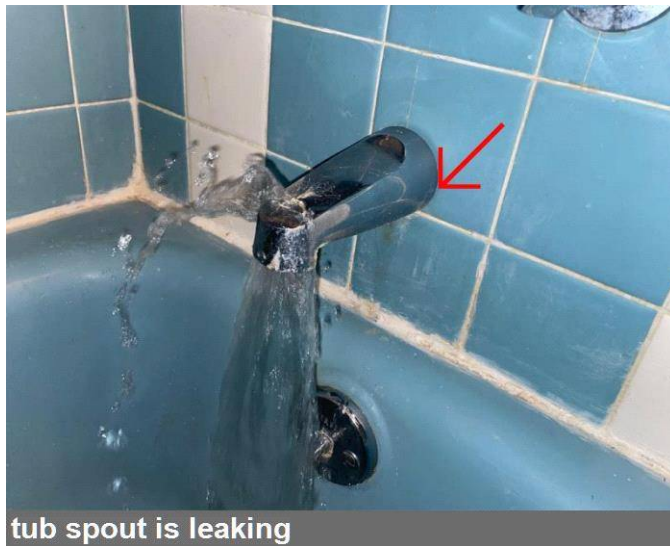
14. The tub requires repair. Deficiencies include, but may not be limited to the following; There

is some flexing of the acrylic/plastic tub, which could indicate inadequate support under the plastic tub/floor. These type of components are normally installed in a bed of cement, which makes the component rigid and alleviates potential for cracks. The significance of this condition is; Cracking of the tub could result in leaks. The tub spout is broken/damaged. The tub spout is leaking, which could allow for rot and/or mold formulation. Repair is recommended. Contact a qualified contractor to further evaluate the condition, identify the source of the leak, and perform repairs as necessary. NOTE: There is no anti-scald device installed on the tub plumbing. It is recommended that the perimeter of the tub be caulked to alleviate potential for leaks.

The tub requires repair. Deficiencies include, but may not be limited to the following: There is some flexing of the acrylic/plastic tub, which could indicate inadequate support under the plastic tub/floor. These type of components are normally installed in a bed of cement, which makes the component rigid and alleviates potential for cracks. The significance of this condition is; Cracking of the tub could result in leaks. The tub spout is broken/damaged. The tub spout is leaking, which could allow for rot and/or mold formulation. Repair is recommended. Contact a qualified contractor to further evaluate the condition, identify the source of the leak, and perform repairs as necessary. NOTE: There is no anti-scald device installed on the tub plumbing. It is recommended that the perimeter of the tub be caulked to alleviate potential for leaks.

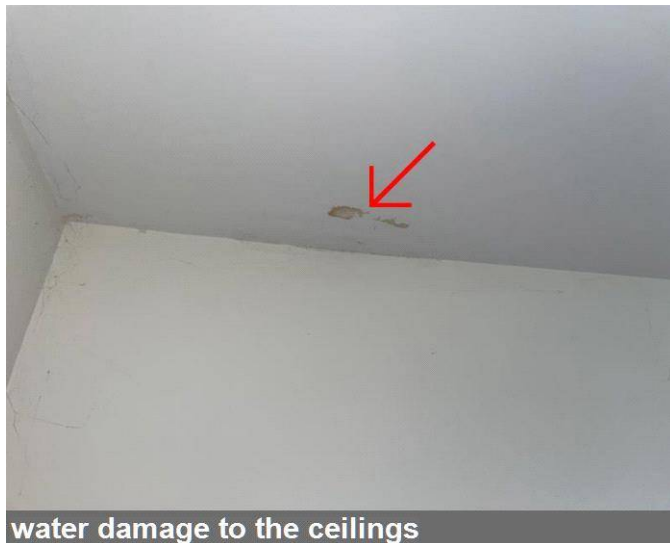
The bedrooms are in need of maintenance. Deficiencies include, but may not be limited to the following; There is apparent water damage to the ceilings. The source of the leaks is not confirmed. Have the source of the leaks identified and repaired.

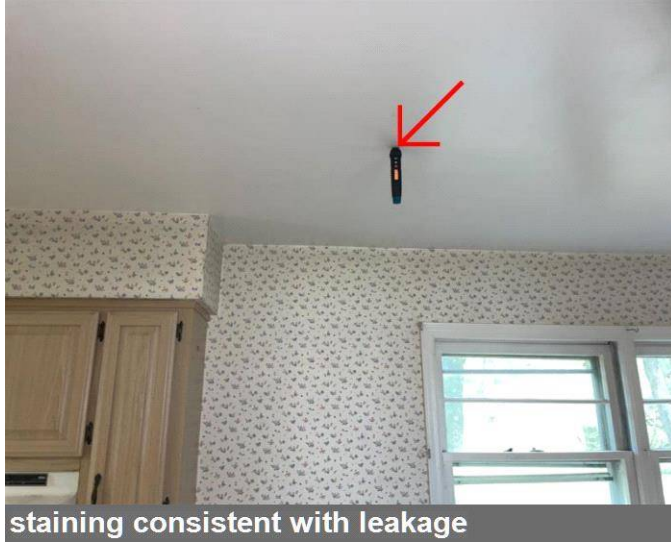
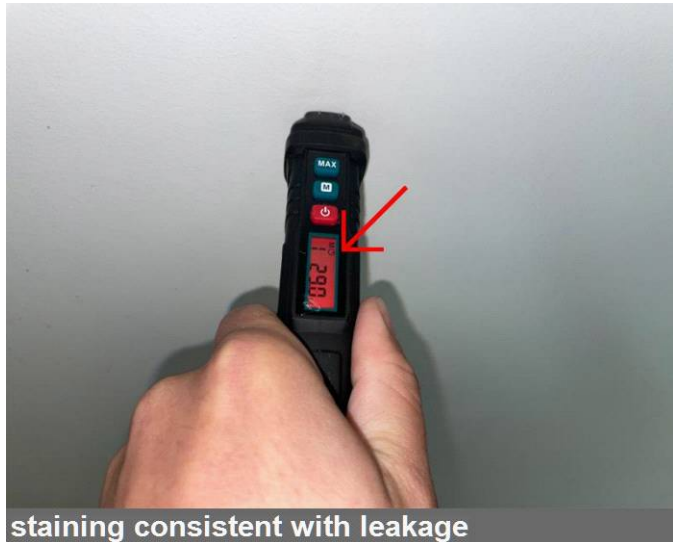
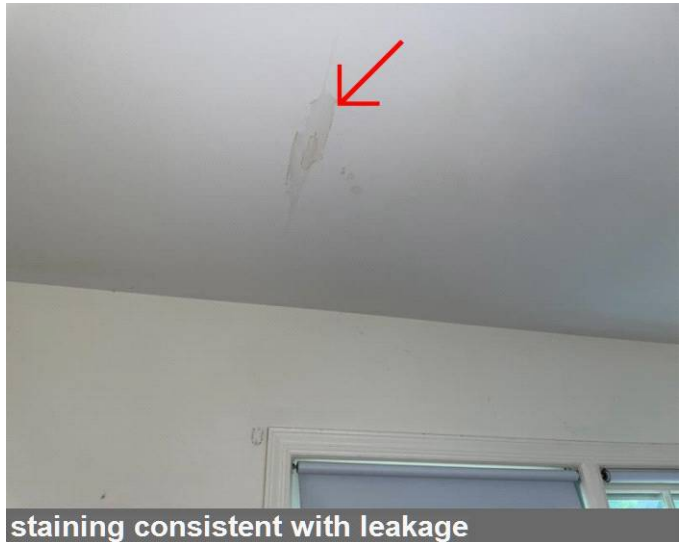
15. There is staining consistent with leakage due to roof leaks, plumbing leaks or condensation. Have the sources of the leaks identified, repaired and the areas re-finished as necessary. These areas were checked with a moisture meter and found to be WET at the time of inspection.

There is staining consistent with leakage due to roof leaks, plumbing leaks or condensation. Have the sources of the leaks identified, repaired and the areas re-finished as necessary. These areas were checked with a moisture meter and found to be WET at the time of inspection.

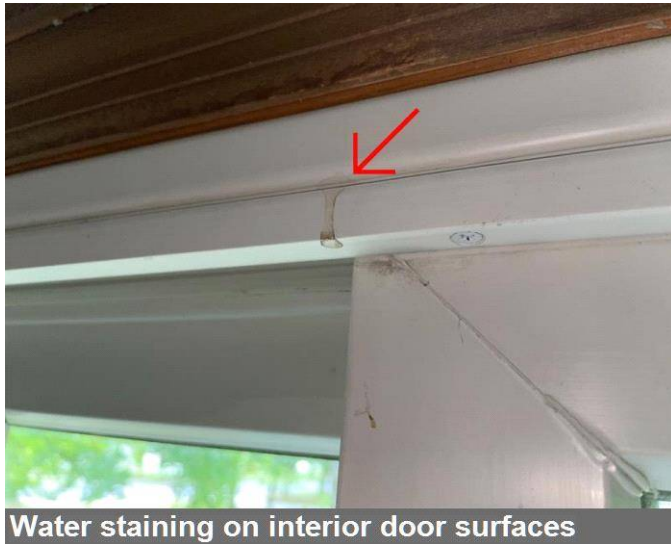
The exterior doors are in some aspects, unsatisfactory condition. Deficiencies include, but are not necessarily limited to the following; Water staining on the interior door surfaces indicates leakage that should be repaired. Weather stripping materials are damaged/torn. The significance of this condition is; Leaks can cause rot/mold. Maintenance/repair is recommended.

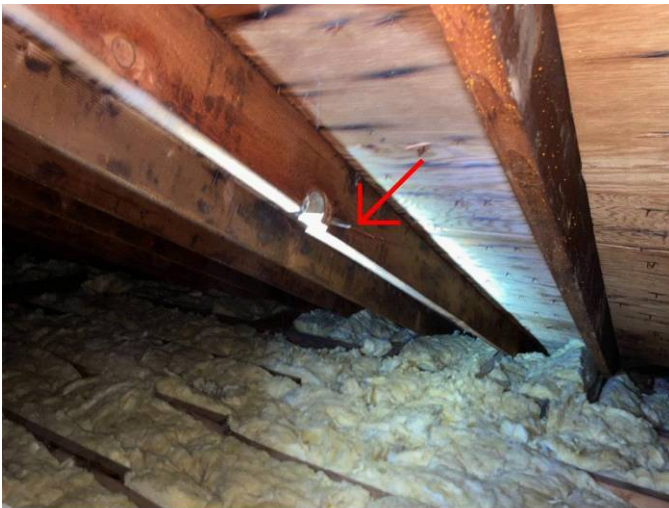
The attic appears to be in some aspects, unsatisfactory condition. There is a cracked rafter, which should be repaired. The roof system framing includes 2X6@16OC (on center) This configuration is common in older homes and generally proves to be adequate, but would not comply with modern building standards.

cracked rafter

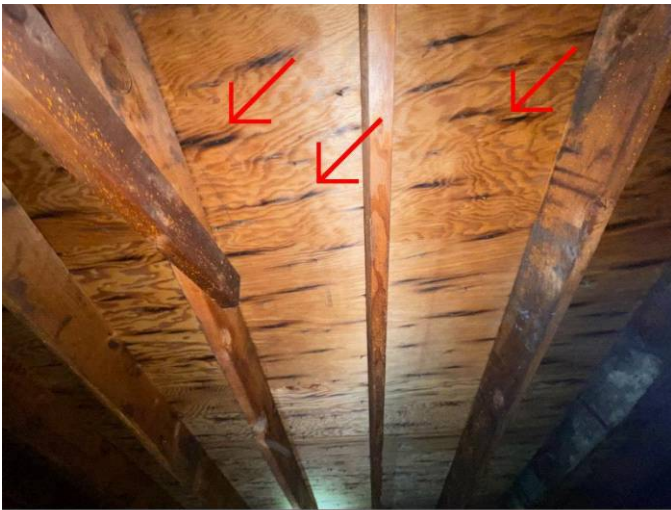
18. There is suspected mold forming on the underside of the roof at the nails. Lack of cool-air venting allows for condensation to form on the nails. This stains the roof decking. There is suspected mold forming in the attic space.

suspected mold forming

***NOTE:** Inadequate venting could cause mold to form in the structure. Kaufmann Consultants, LLC does not perform mold testing. Mold testing is beyond the scope of a home inspection. You should contact a qualified mold testing contractor to test the structure for the presence of mold.*

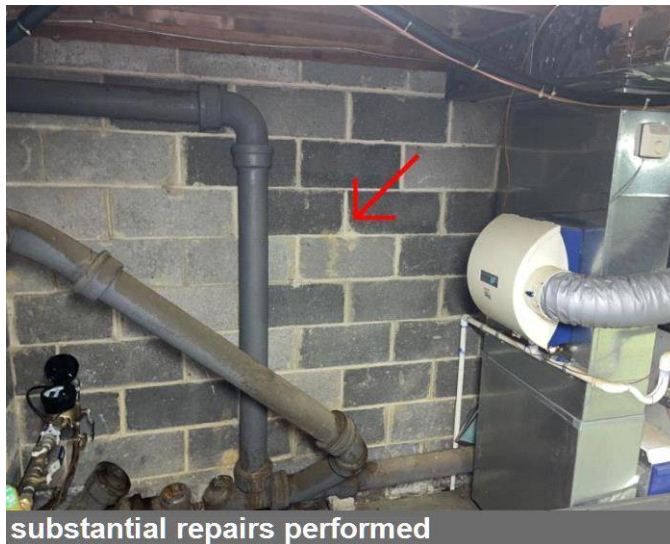
The home's foundation walls appear in some aspects, unsatisfactory condition. There have been substantial repairs performed to the home's foundations. Typically, foundations do not require such significant repairs. It is possible something is being concealed. The nature and scope of the repair work should be discussed with the present home-owner and the contractor who performed the work. Documentation regarding this repair work should also be acquired and scrutinized prior to closing to help understand the condition.

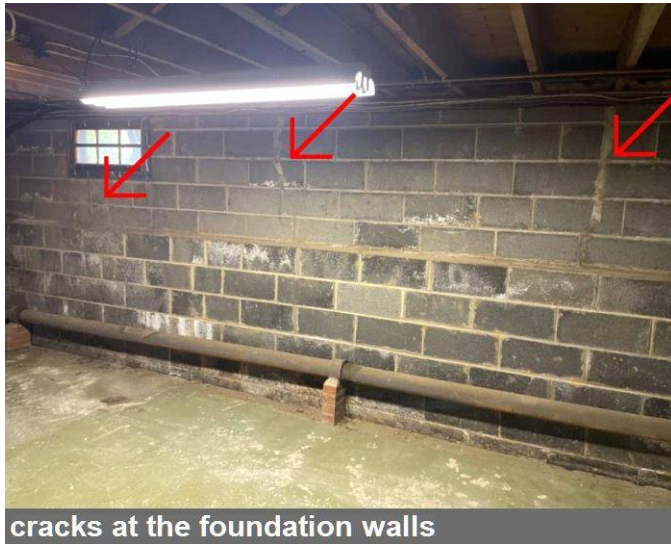
20. Cracks were observed in the visible sections of the foundation walls. In general, all foundations settle and this results in cracking of the masonry components. The cracking observed in these foundations does not appear to be significant. It is, however, recommended that you contact a structural engineer evaluate the cracks for material impact. In addition, have the cracks repaired. This should be considered part of long-term maintenance. Monitor the foundations for additional movement (cracking) in the future. If additional cracks appear, have them repaired as necessary.

cracks at the foundation walls

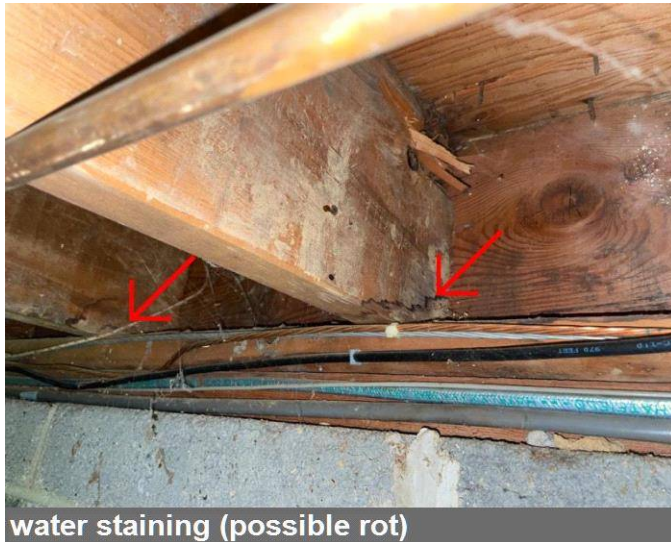
**water staining (possible rot)**

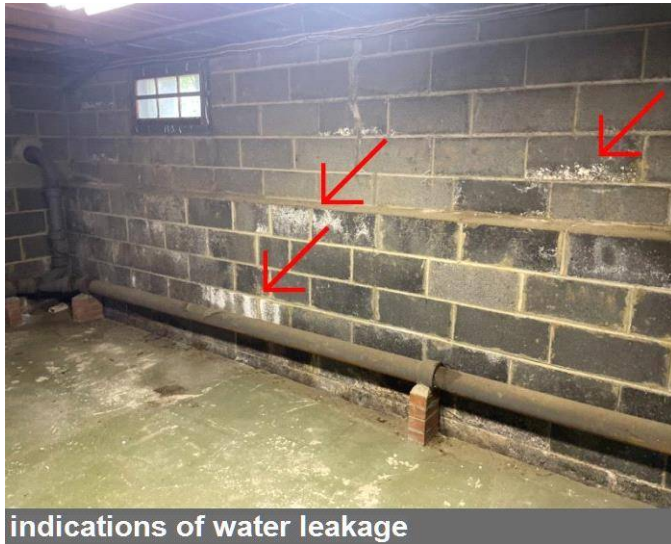
21. At this time, there are indications of water leakage through the foundation walls into the basement area, which is a "material defect". Indications are in the form of water stains/efflorescence on the floor/walls.

The inspection for water conditions is dependent upon seasonal weather conditions. It is possible that the interior of the home could appear dry during the home inspection, but later develop water conditions. At this time, there are indications of water leakage through the foundation walls into the basement area, which is a "material defect". Indications are in the form of water stains/efflorescence on the floor/walls.

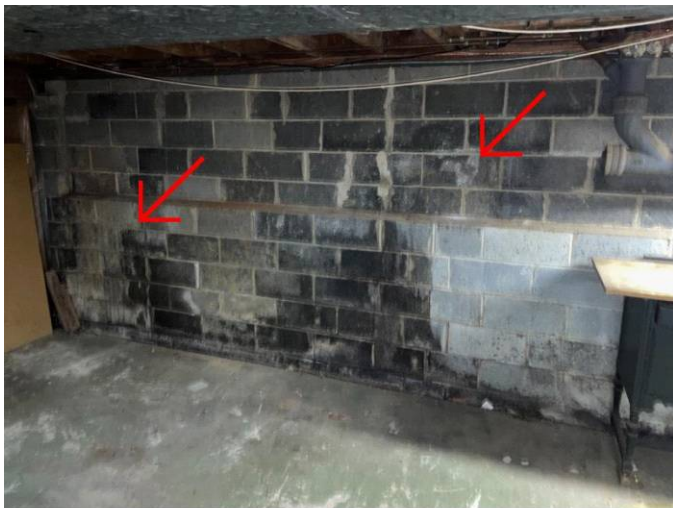
indications of water leakage

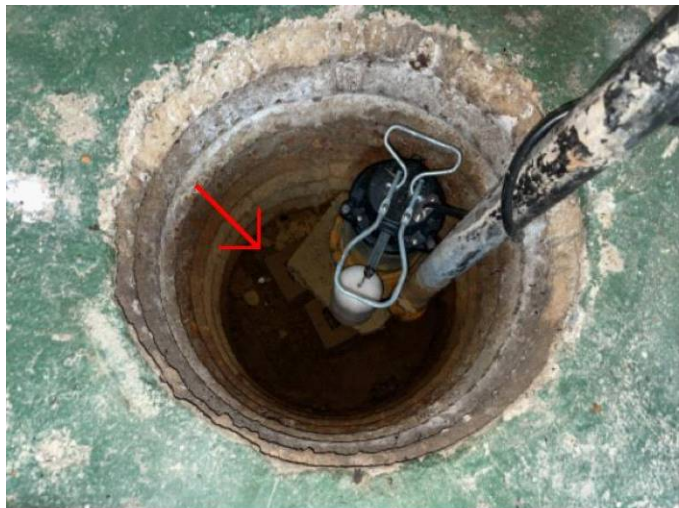
indications of water leakage | sump pit

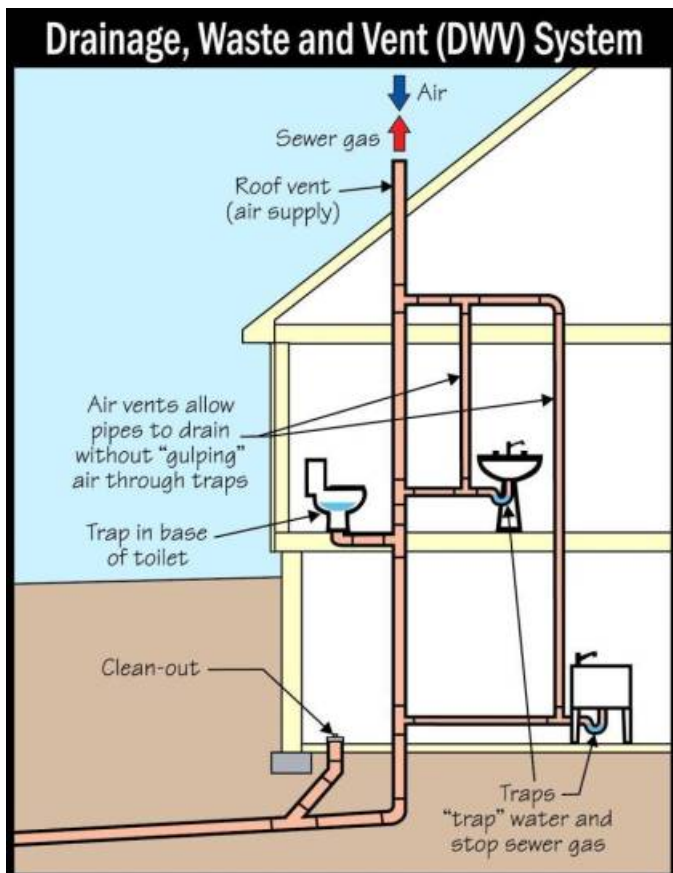
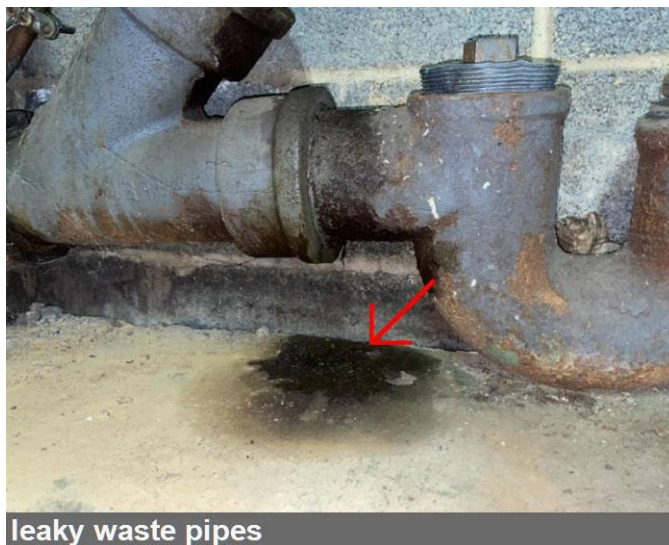
22. There are leaky waste pipes, which could allow for sewer leakage into the home. Replacement is recommended. There are pin hole (small) leaks that have developed in the waste piping.

There are cracked/damaged waste pipes, which could allow for sewer leakage into the home.

The plumbing system includes; PVC, ABS (plastic), lead, galvanized, and iron piping. The waste piping appears to be in some aspects, unsatisfactory condition. Deficiencies include, but may not be limited to the following: There are leaky waste pipes, which could allow for sewer leakage into the home. Replacement is recommended. There are pin hole (small) leaks that have developed in the waste piping. There are cracked/damaged waste pipes, which could allow for sewer leakage into the home. Replacement is recommended. Contact a qualified contractor (licensed plumber) to further evaluate these conditions and perform repairs as necessary.

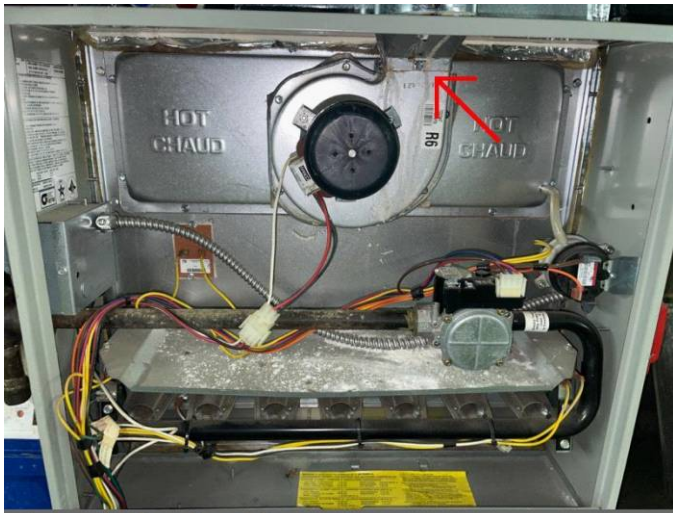
25. There are signs that exhaust condenses inside the chimney and the condensate seeps back down the flue to the furnace. This indicates defect in exhaust system. This is an older unit that is in operational condition. It is working beyond it's projected service life and any additional use is a bonus. Replacement should be anticipated. Contact an HVAC contractor before the inspection contingency expires to more thoroughly evaluate the system and to obtain estimates for replacement.

The furnace is in some aspects, unsatisfactory condition. There are signs that exhaust condenses inside the chimney and the condensate seeps back down the flue to the furnace. This indicates defect in exhaust system. The significance of this condition is; damage to the system components could result or unsafe conditions could occur. A competent HVAC contractor should be consulted to more thoroughly evaluate the condition and to perform repairs as are necessary. The fan compartment "kill" switch is damaged/disabled or missing, which could be dangerous. Replacement/repair of the "kill" switch is recommended. This is an older unit that is in operational condition. It is working beyond it's projected service life and any additional use is a bonus. Replacement should be anticipated. Contact an HVAC contractor before the inspection contingency expires to more thoroughly evaluate the system and to obtain estimates for replacement.

signs that exhaust condenses
