## HOME INSPECTION REPORT

July 20, 2024

KAUFMANN CONSULTANTS, LLC

### REPORT SUMMARY

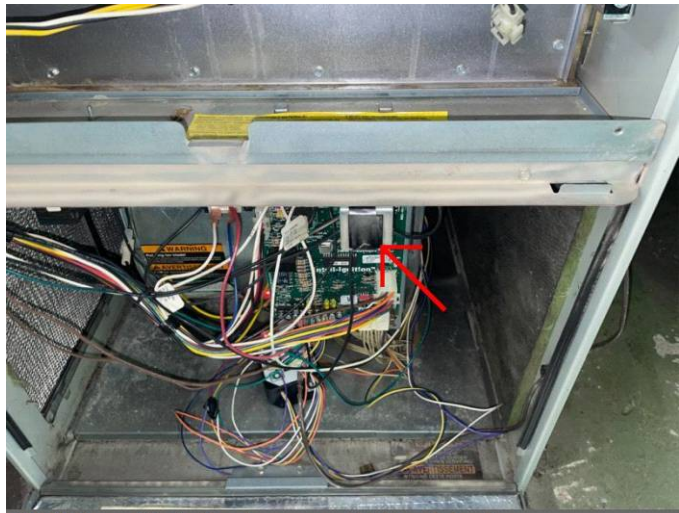
"kill" switch is damaged/disabled

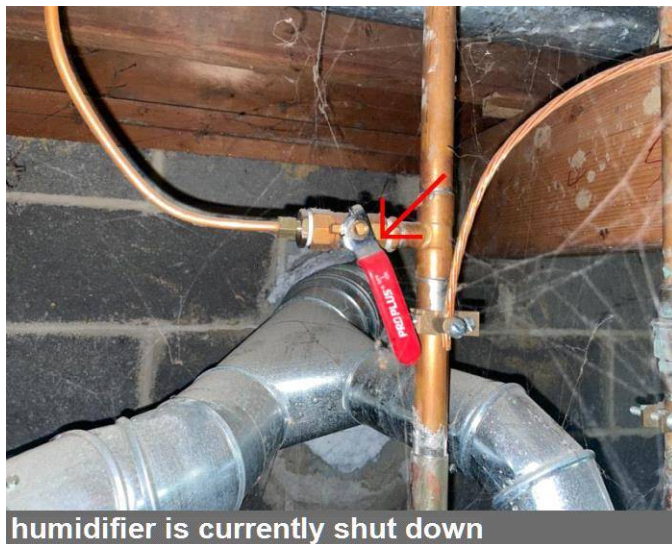
humidifier is currently shut down

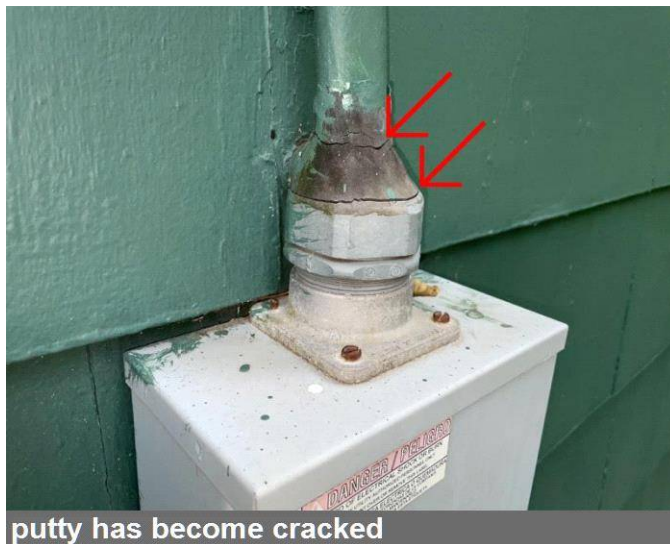
putty has become cracked

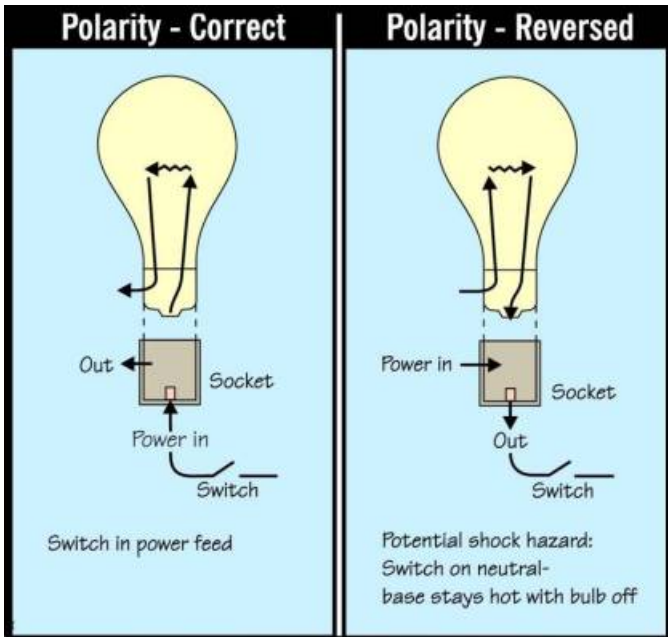
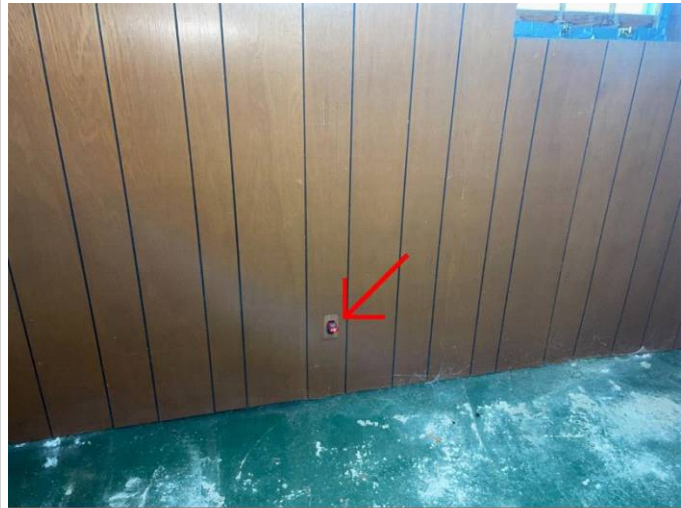
Reverse polarity is detected in outlet/s. Reversed polarity in an outlet is most often due to the improper connection of wires to the outlet itself, and is normally easy to correct. Some electronic appliances sustain damage when connected to reversed polarity outlets. Some locations where reverse polarity outlets are present include, but are not necessarily limited to the following: Living room, kitchen, and basement.

Reverse polarity is detected

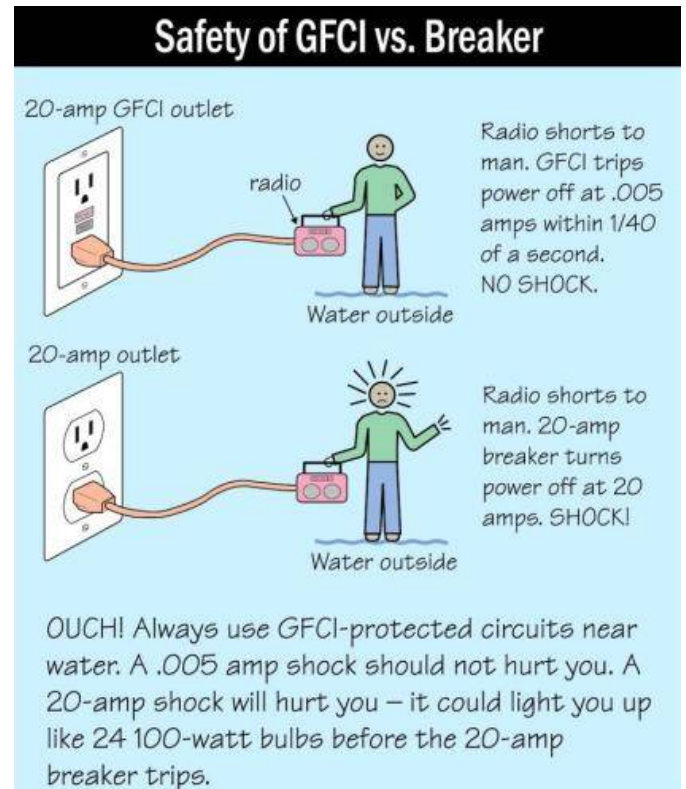
One or more electric receptacles (outlets) had no functioning ground fault circuit interrupter (GFCI) protection where that protection should exist. If not GFCI- protected, receptacles in wet areas pose a shock hazard. It is recommended that a qualified electrician evaluate and install GFCI protection if necessary and per standard building practices. General guidelines for GFCI- protected receptacles include the following locations: Outdoors (since 1973) Bathrooms (since 1975) Garages (since 1978) Kitchens (since 1987) Crawl spaces and unfinished basements (since 1990) Wet bar sinks (since 1993) Laundry and utility sinks (since 2005).
