Executive Summary

October 17, 2016

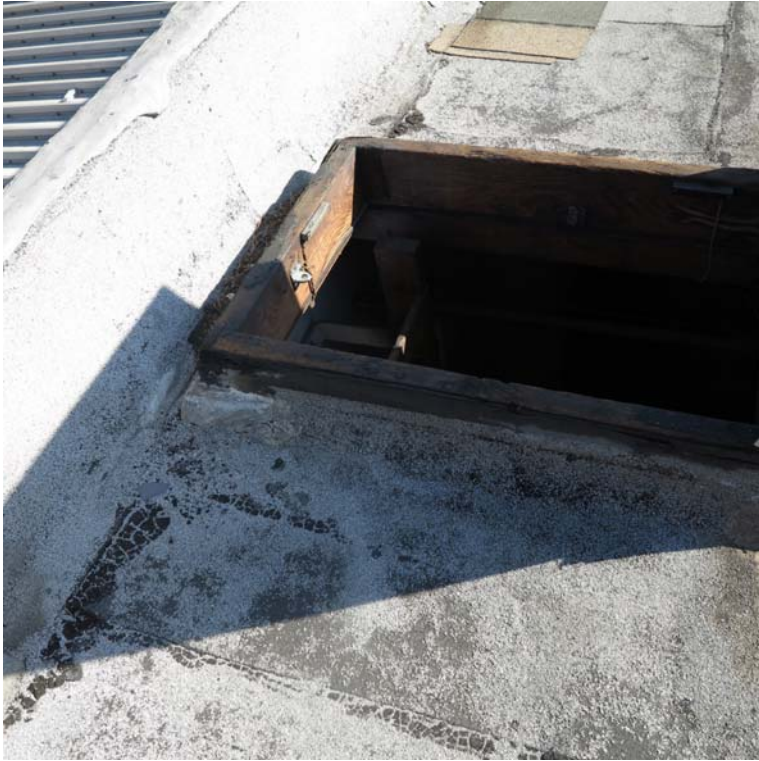
Substandard and dangerous roof hatch

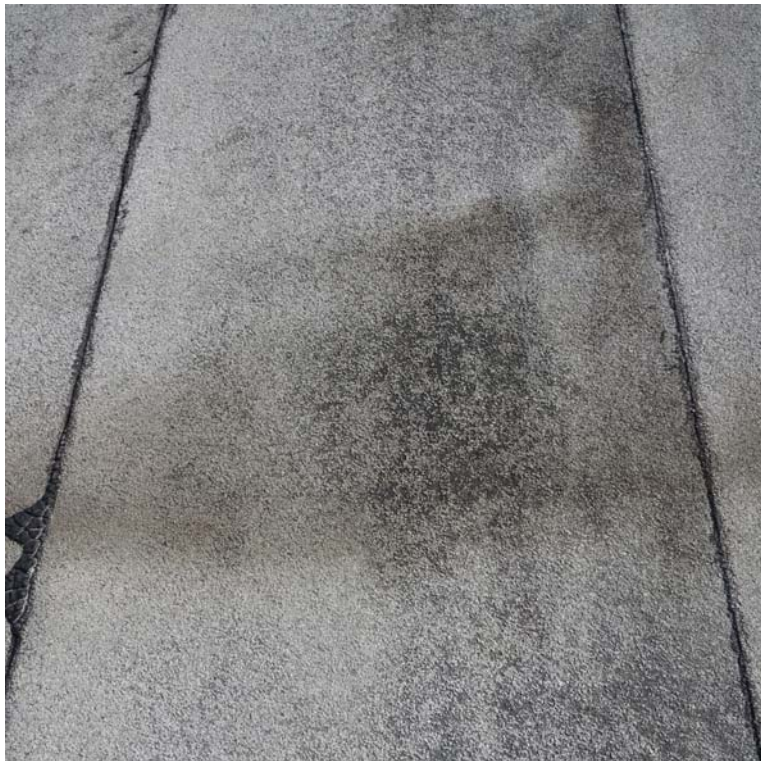
Roofing capsheet is wearing and losing protective granules

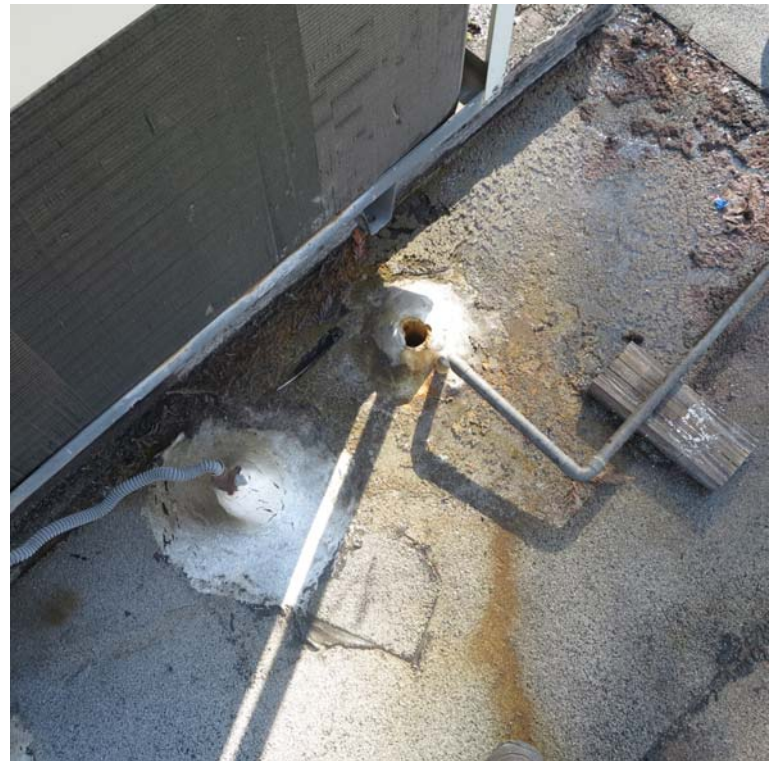
Disconnected condensate line

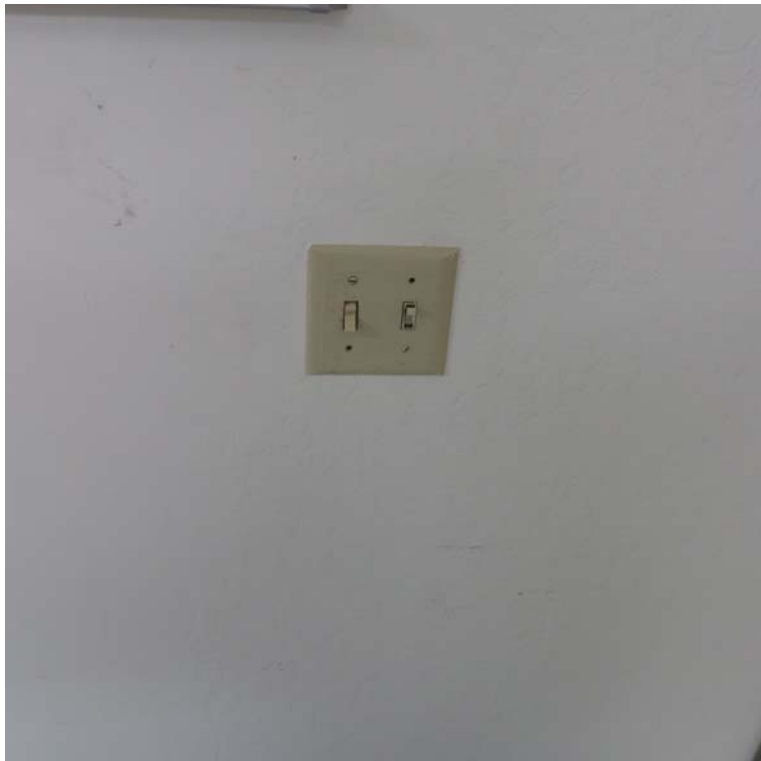
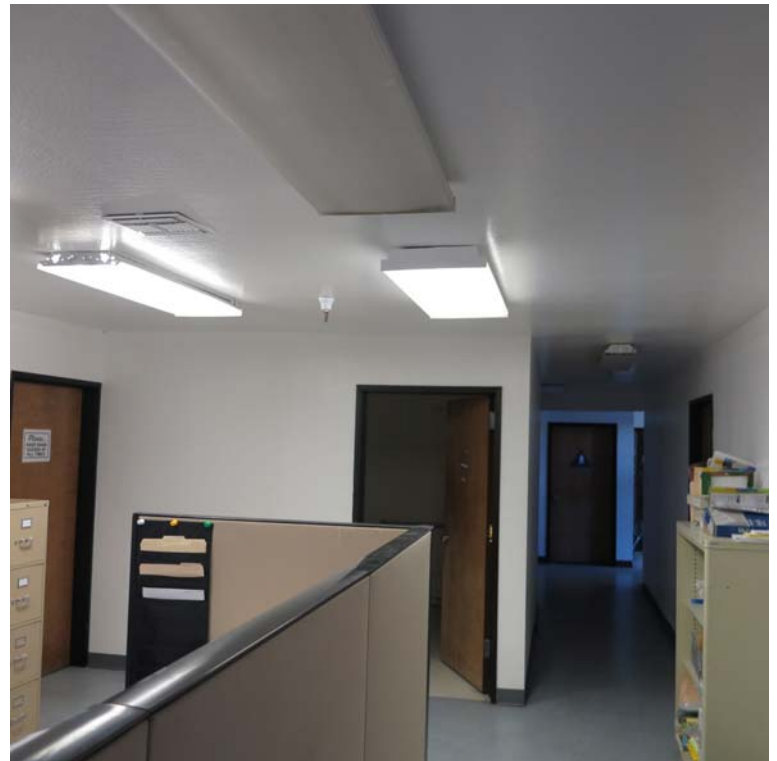
Dual level lighting controls, typical except in mezzanine at 3314

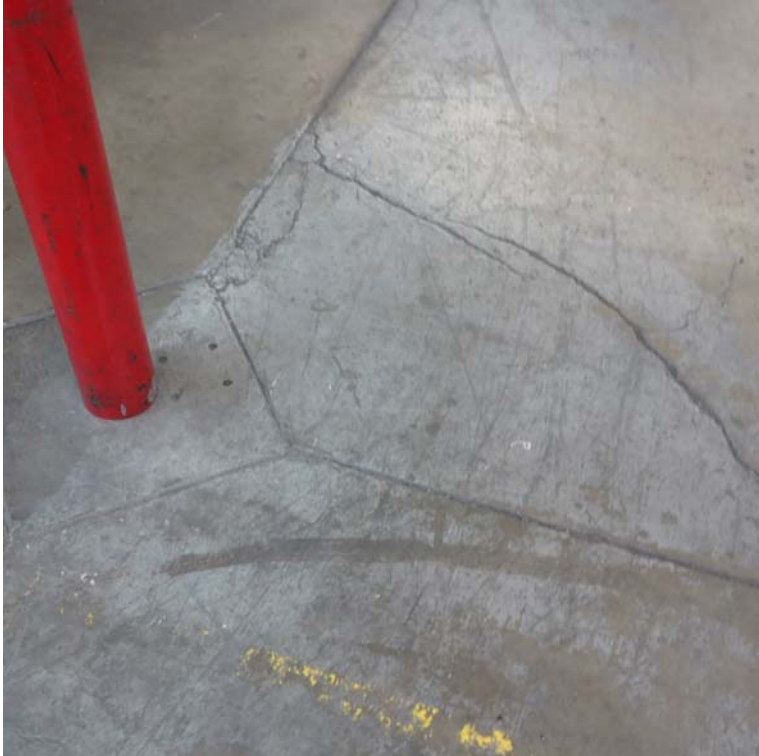
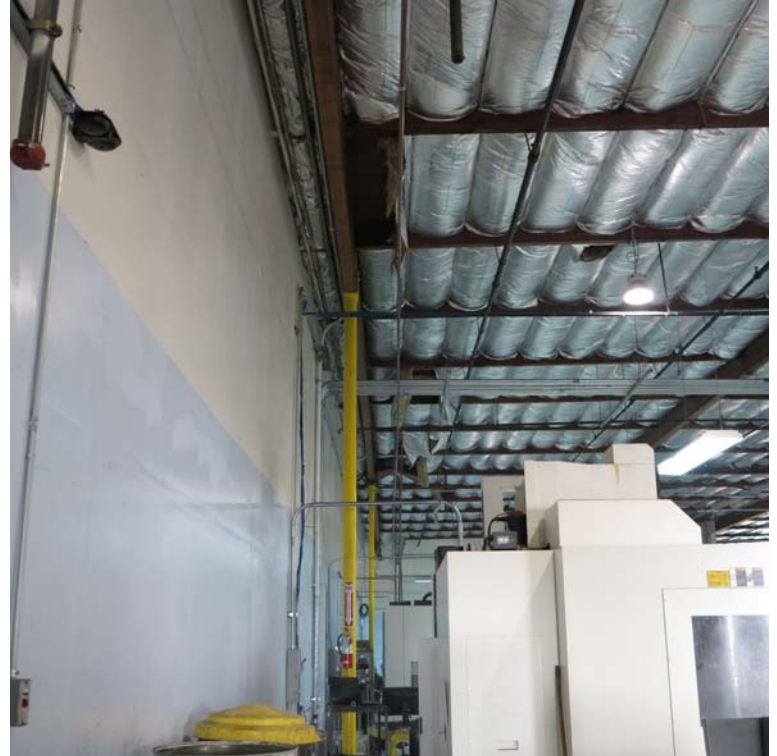
Typical floor fractures in the slab. Not unusual for type of bldg. and age.

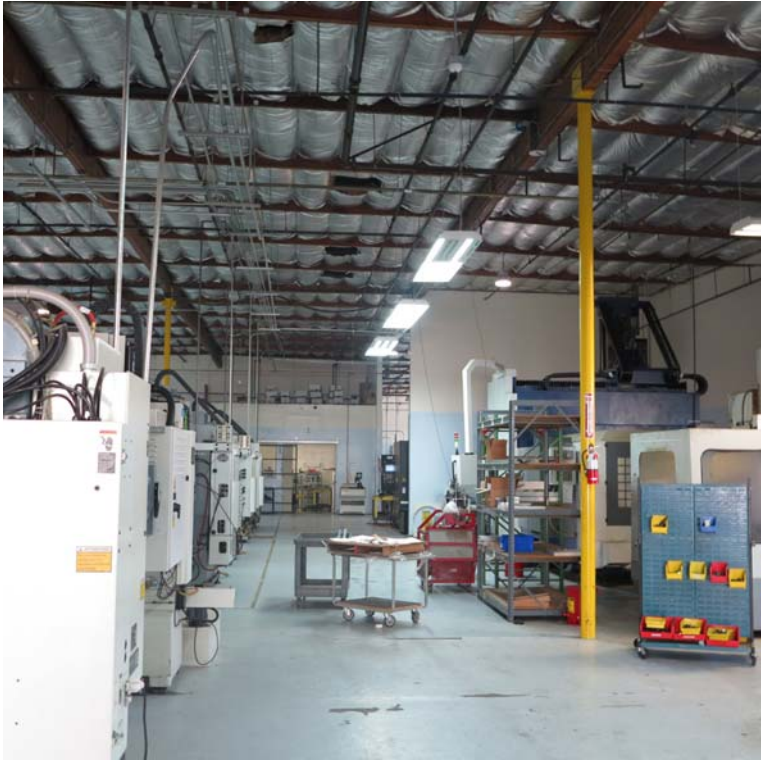
View showing lines of structural columns bearing the roof

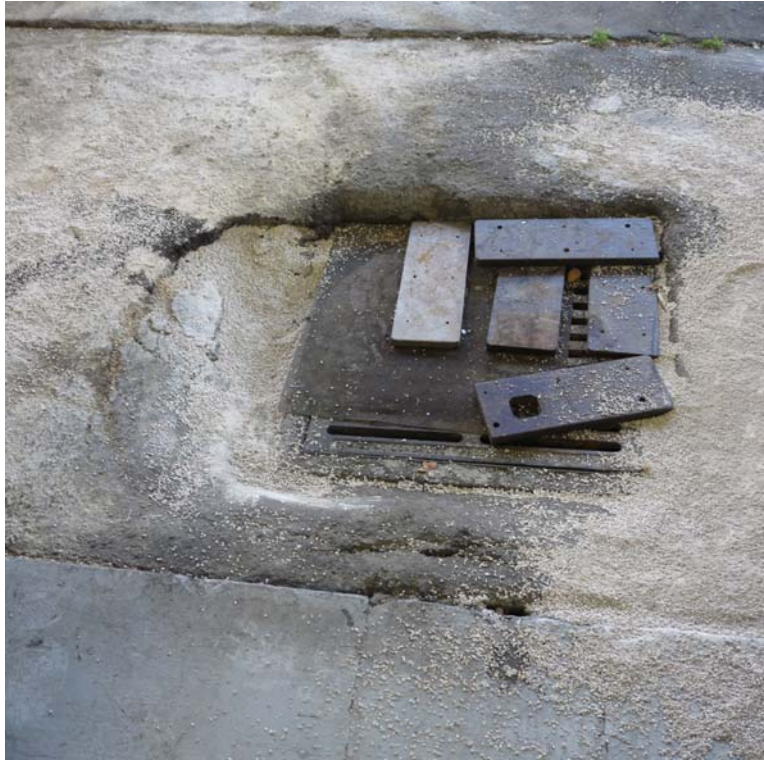
Failure at storm drain- appears to have been this way for some time

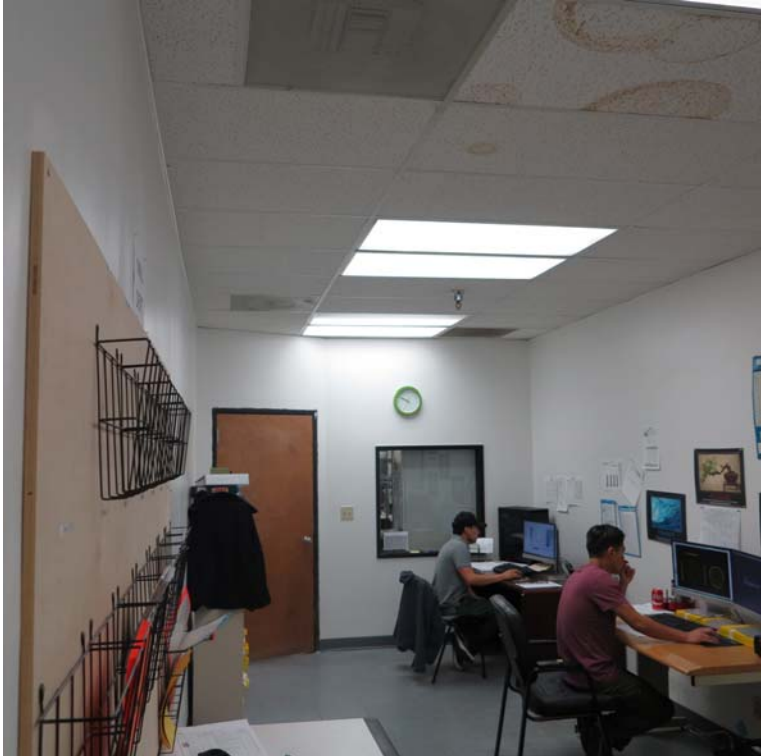
Evidence of roof leaks on acoustic ceiling, 3314

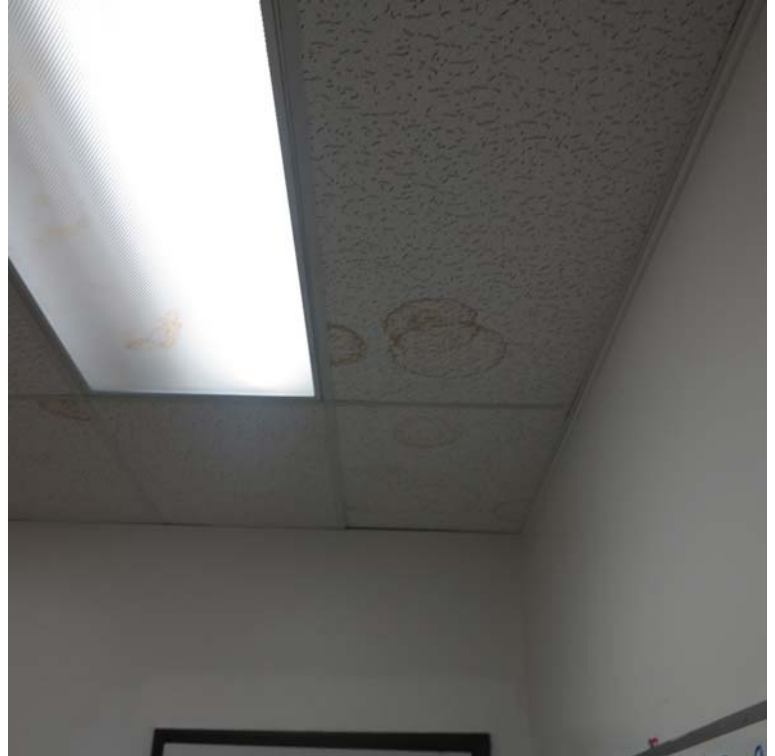
Stained ceiling tile -roof leak likely cause

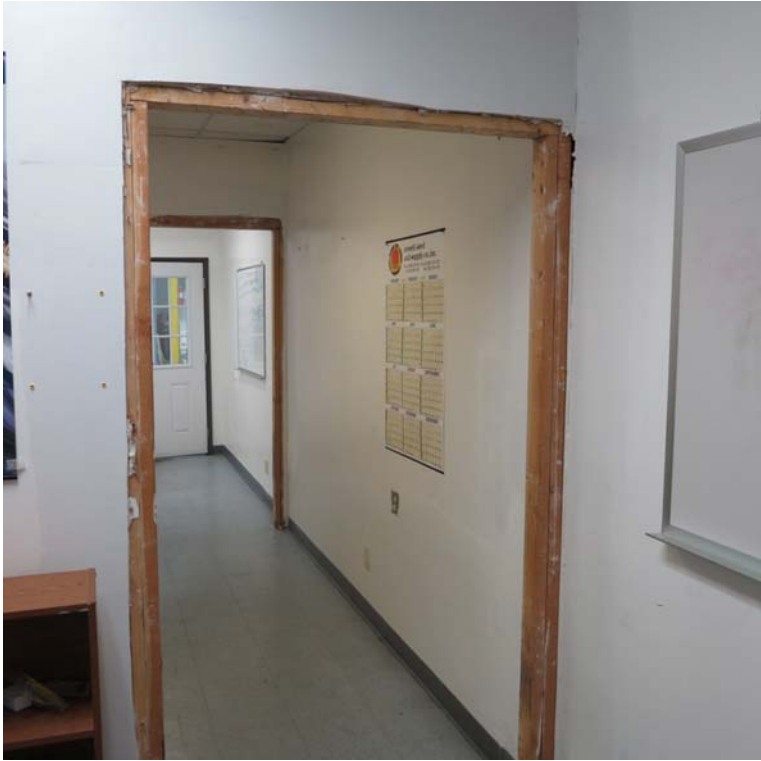
This work was allegedly done with permit, cosmetic work unfinished

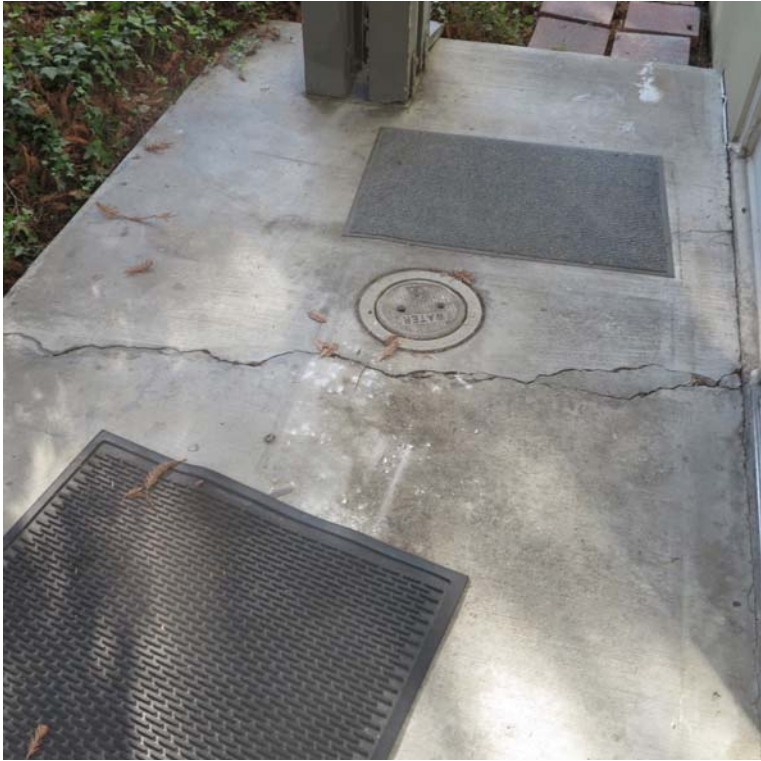
Fracture at 3310 entry where south part of the walkway appears to be subsiding

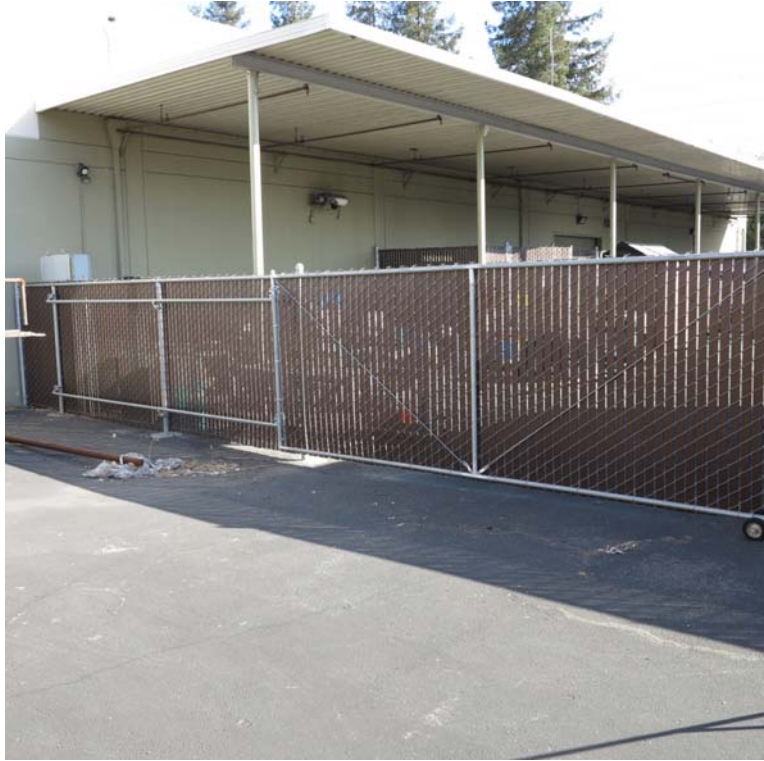
Rolling gate at 3310.

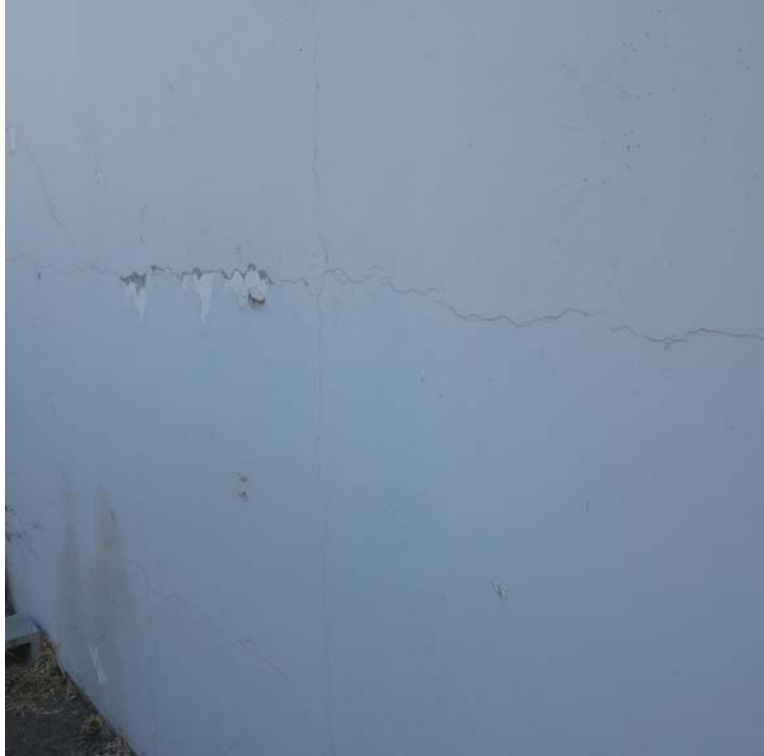
Tiny fractures in the west wall of 3310, not serious.

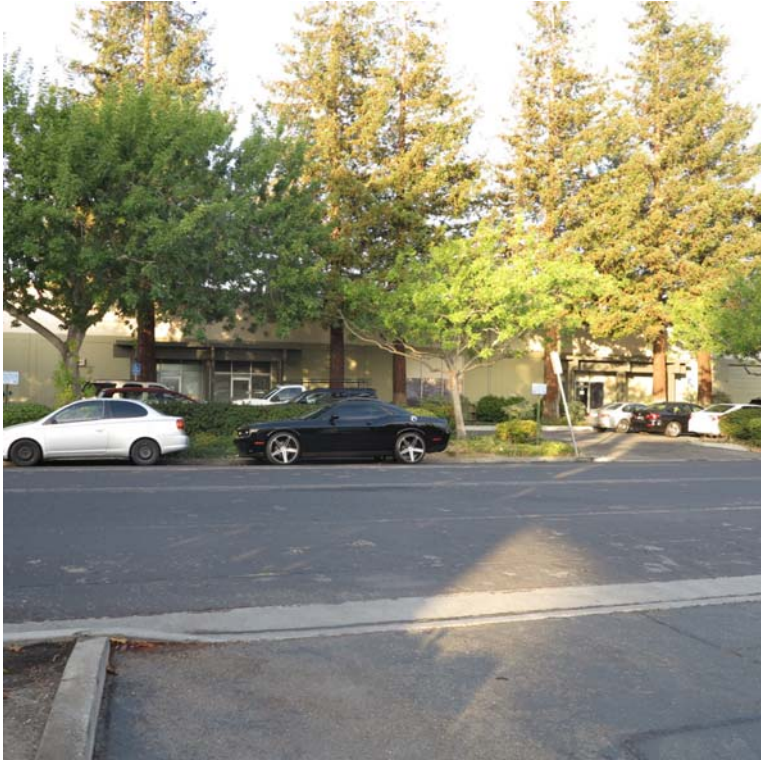
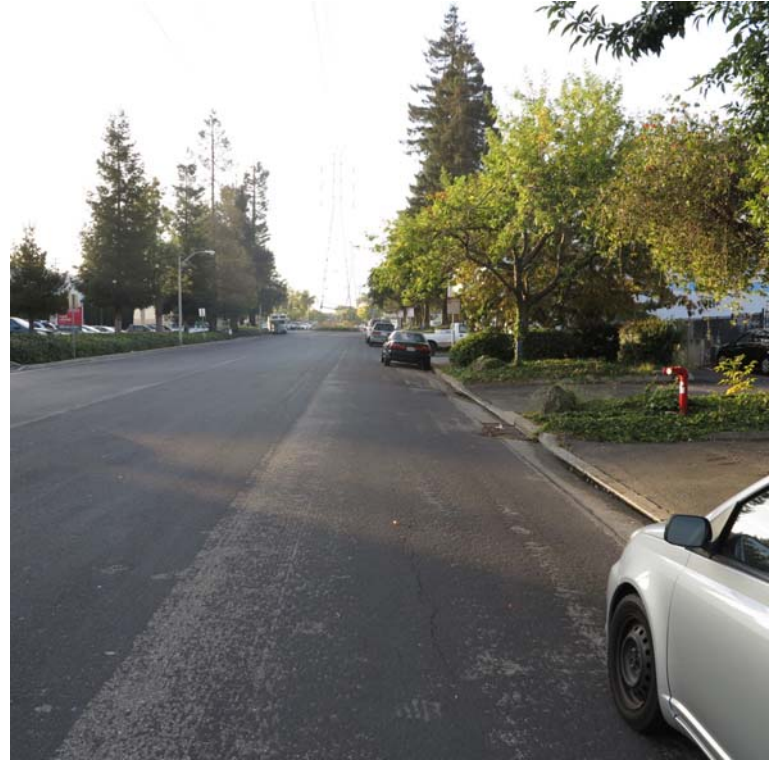
View of east (front) of property

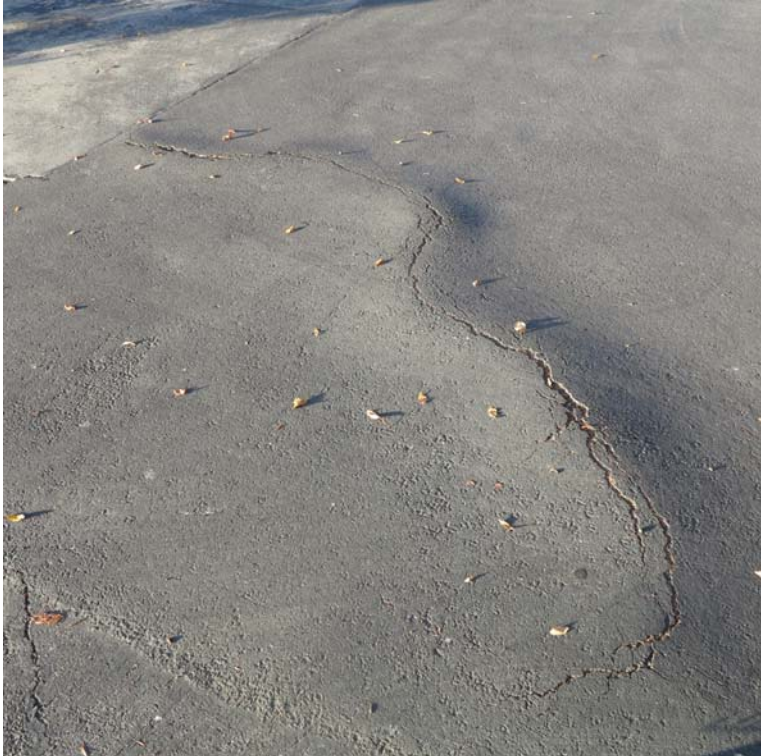
Front asphalt parking areas heavily "alligatored"

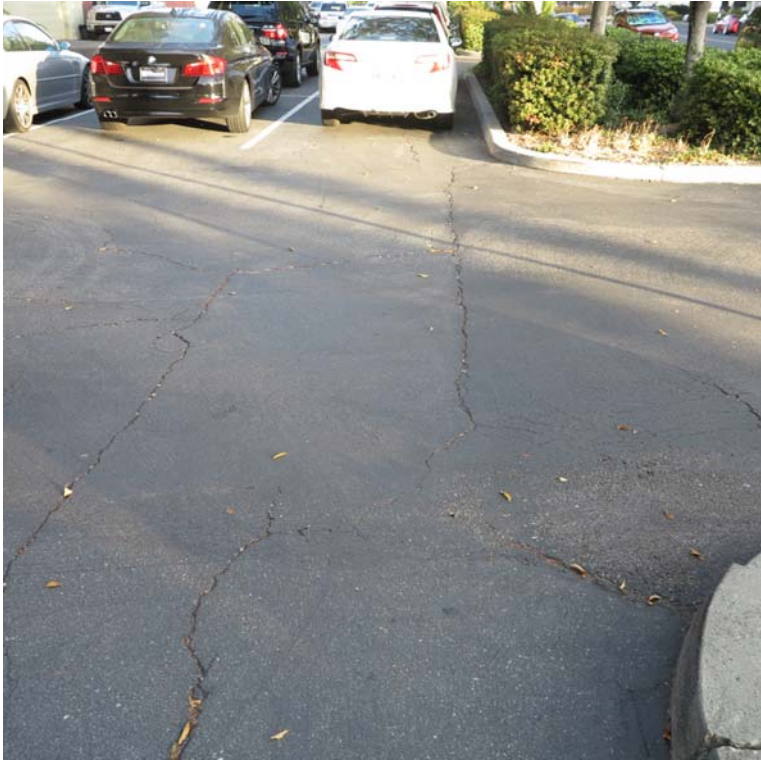
More asphalt damage in front parking

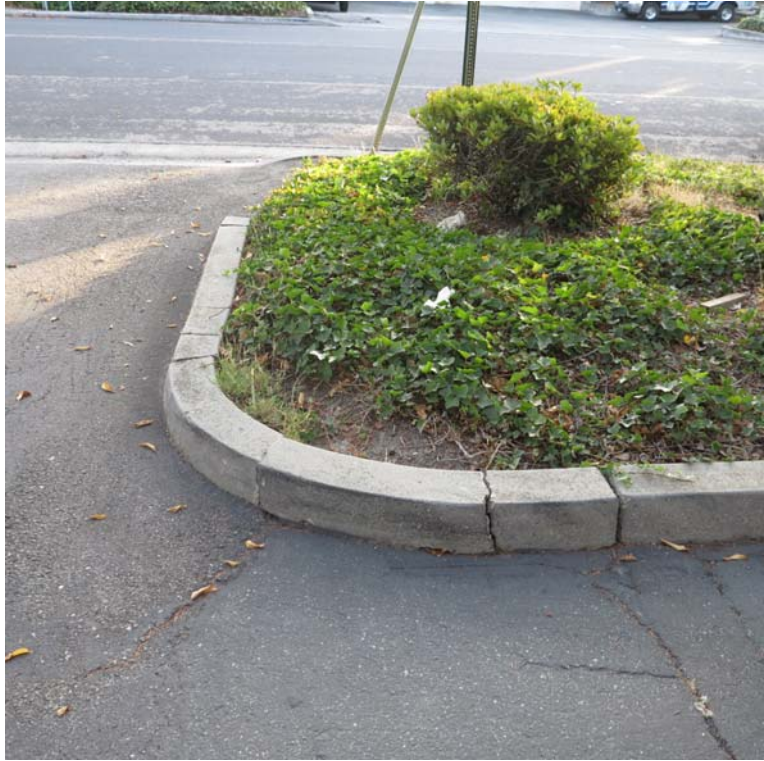
Landscape curb damaged

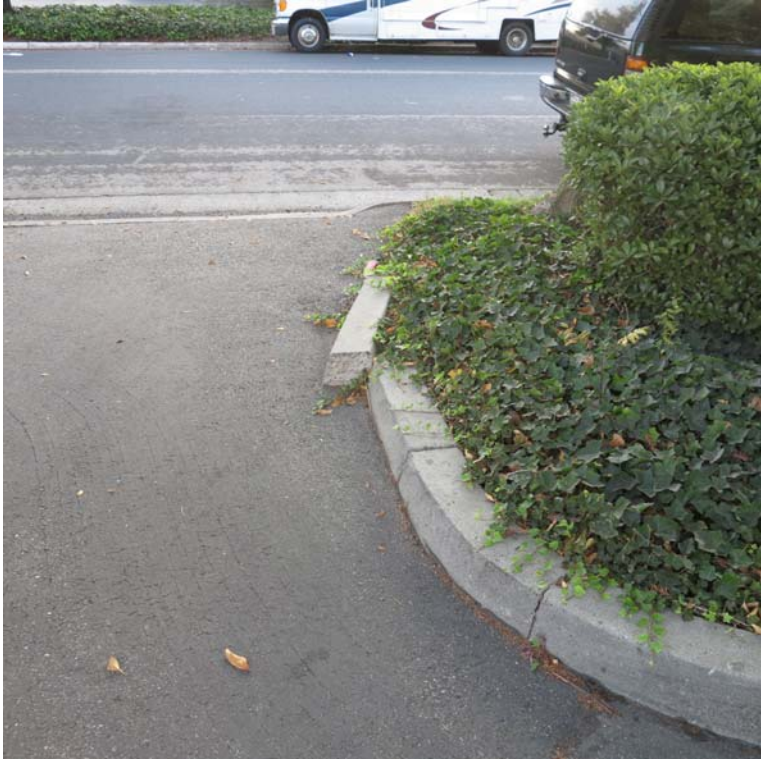
Landscape curb damaged

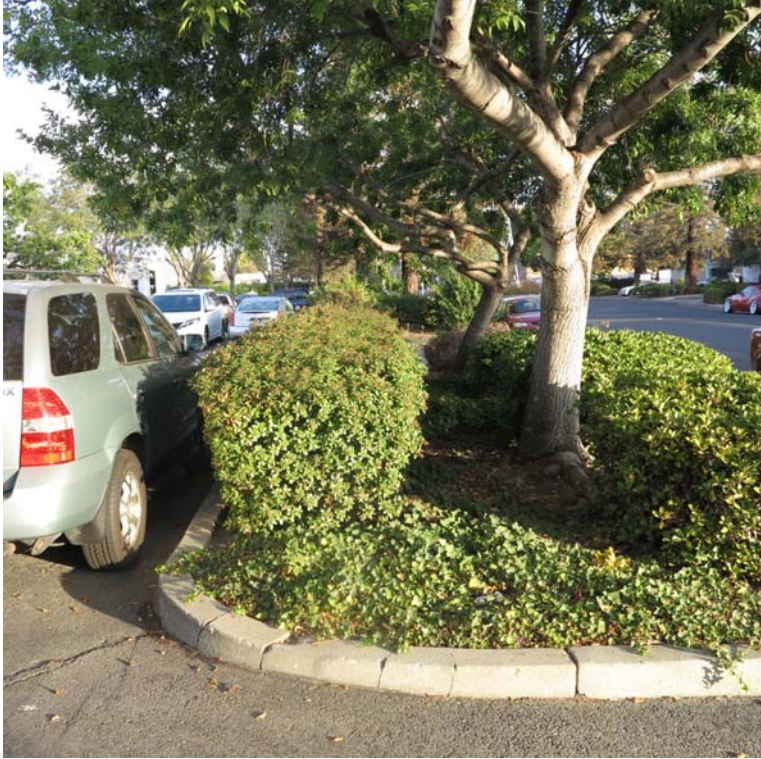
Tree root damage at curb and asphalt

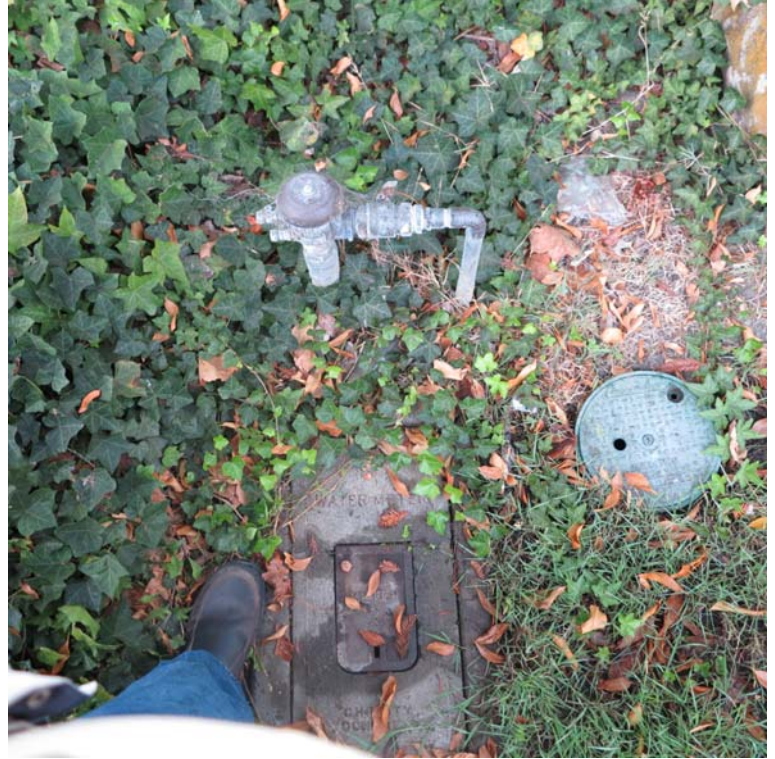
Water meter, supply and backflow preventer

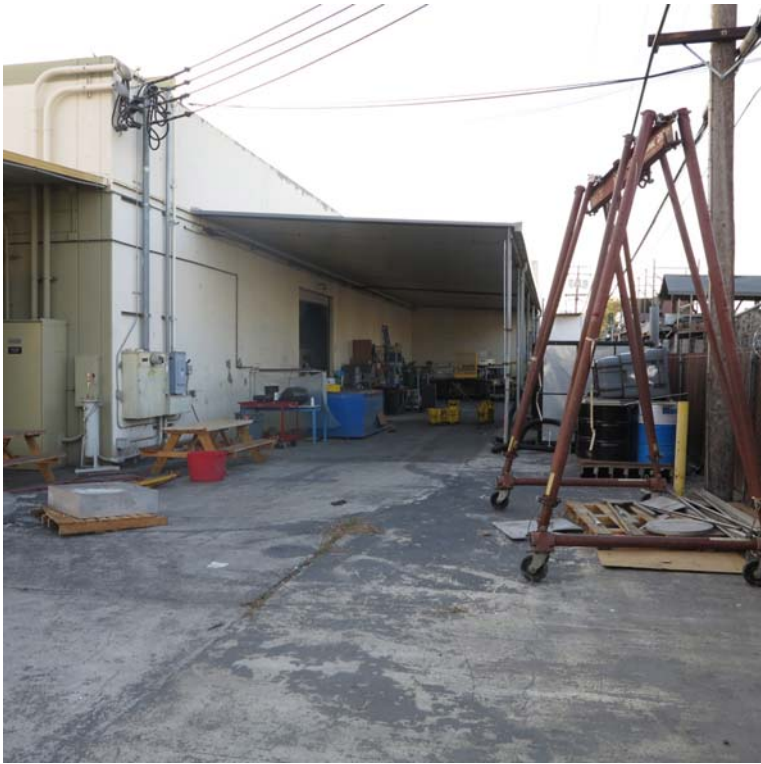
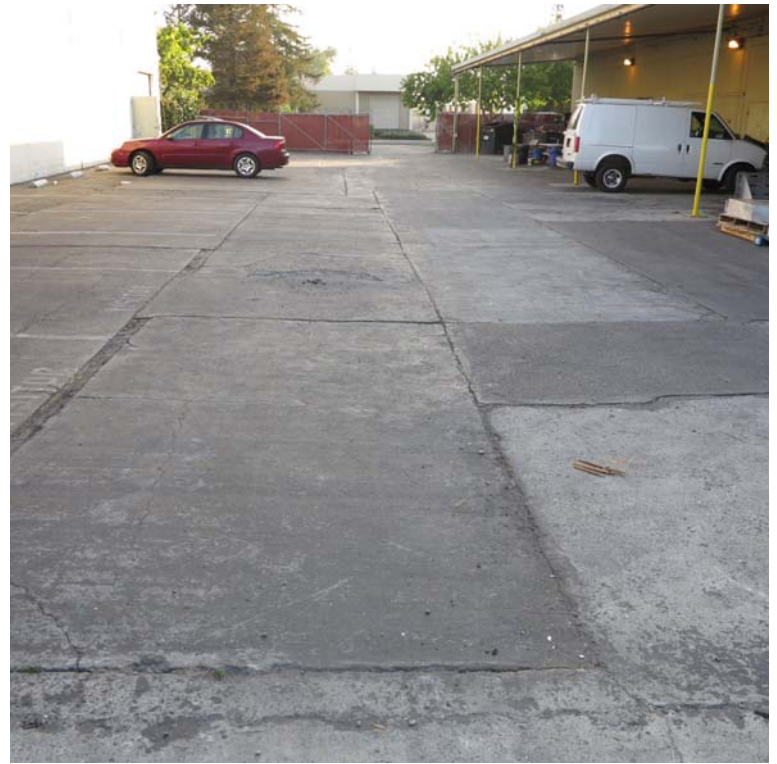
Meter locations and 3320 overhang

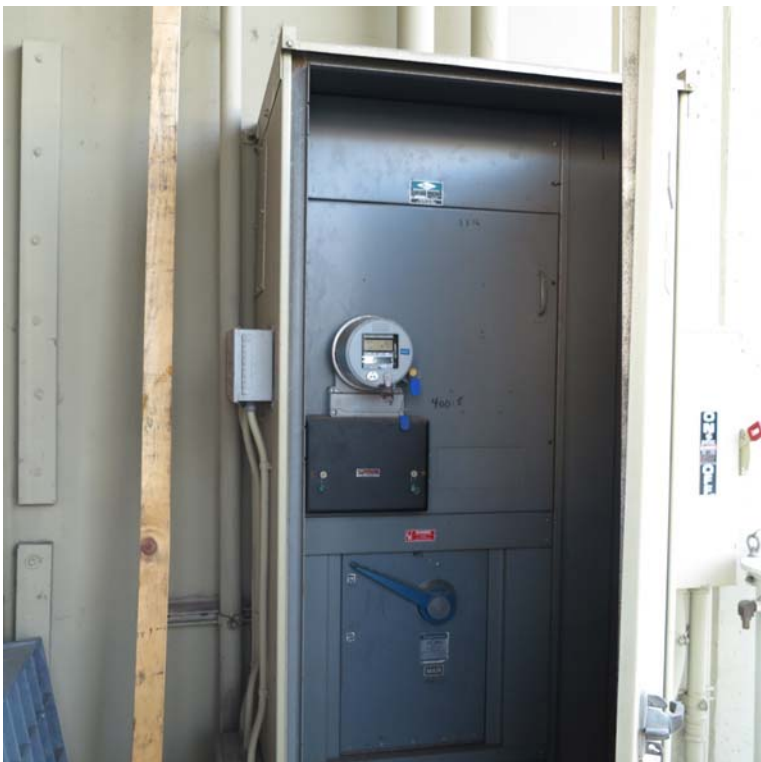
Main disconnect for 3314 is 600 amps @240v

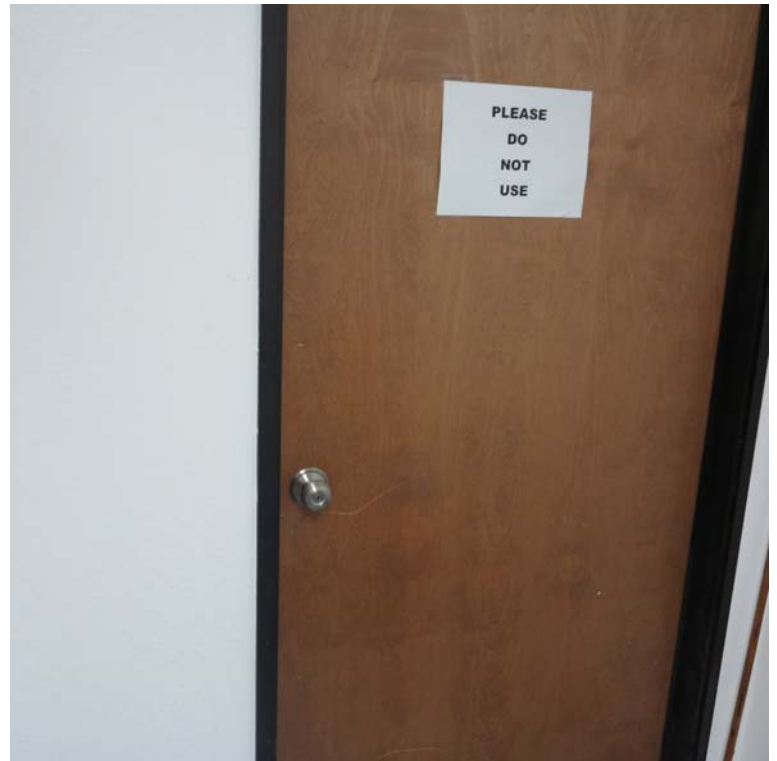
Unused restroom has improper (round) hardware

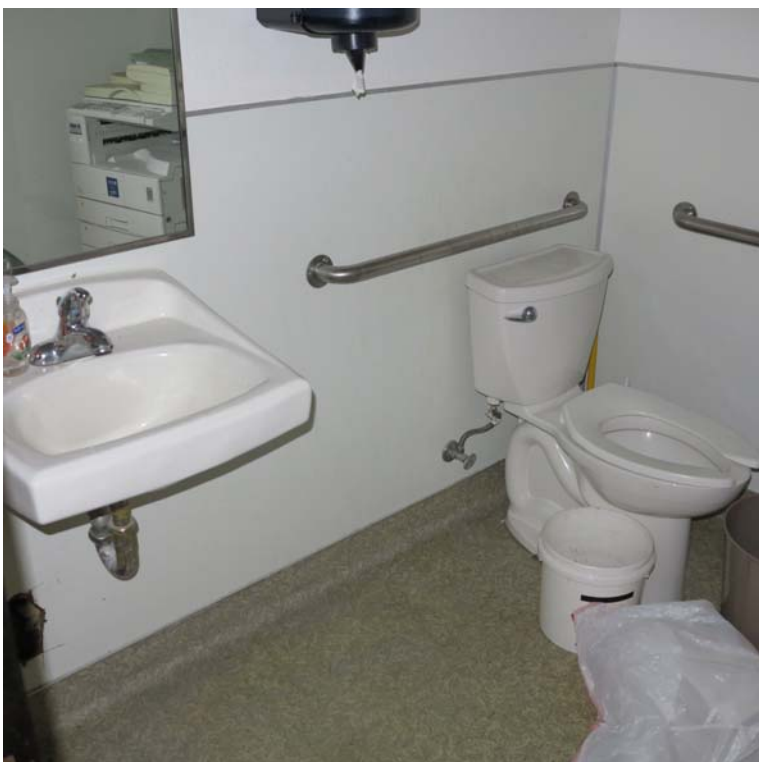
Towel dispenser is mounted too high

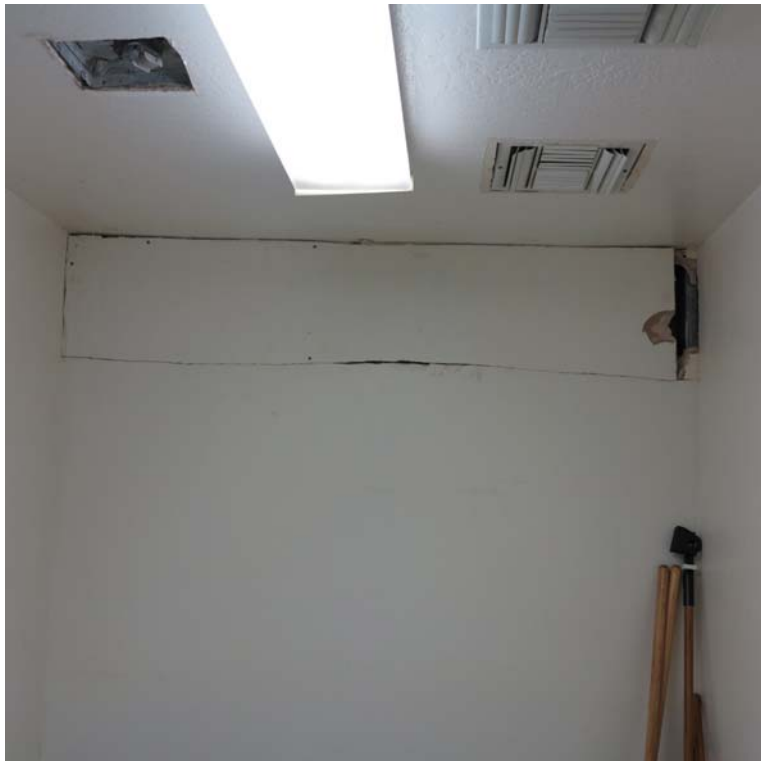
Drywall damage in one of the restrooms

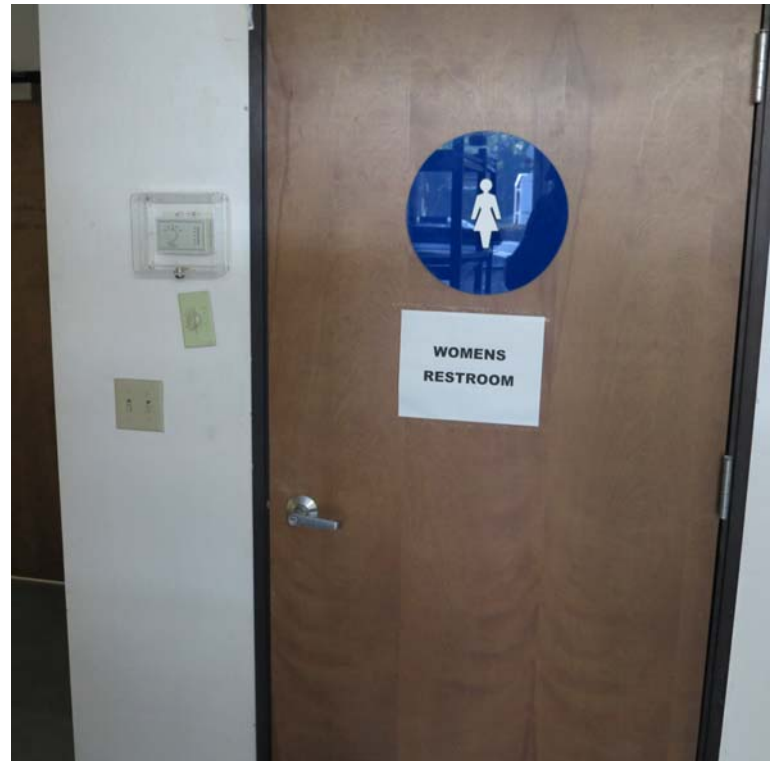
Missing braille signage at strike side of the door

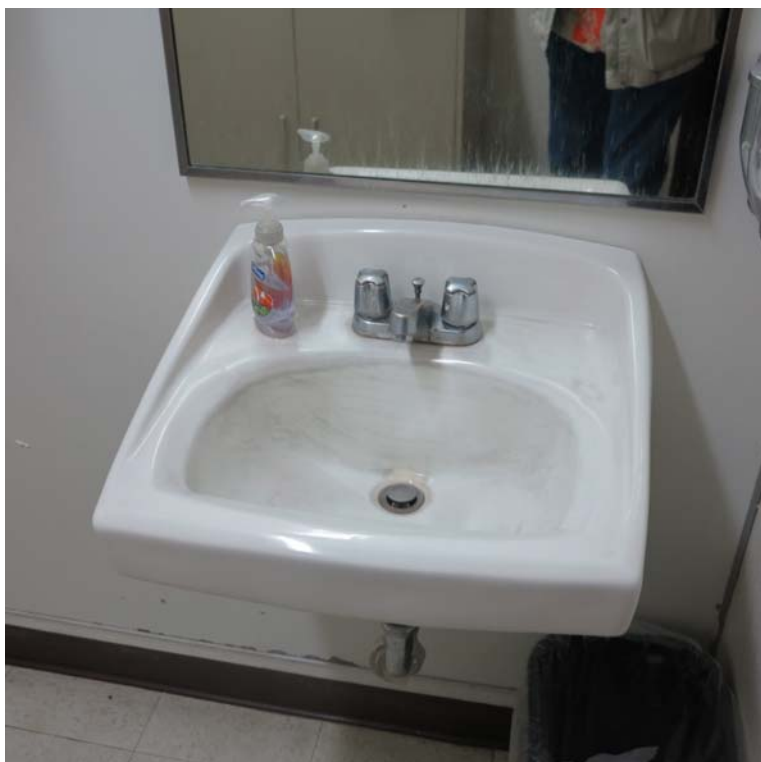
Incorrect faucet style (requires grasping)

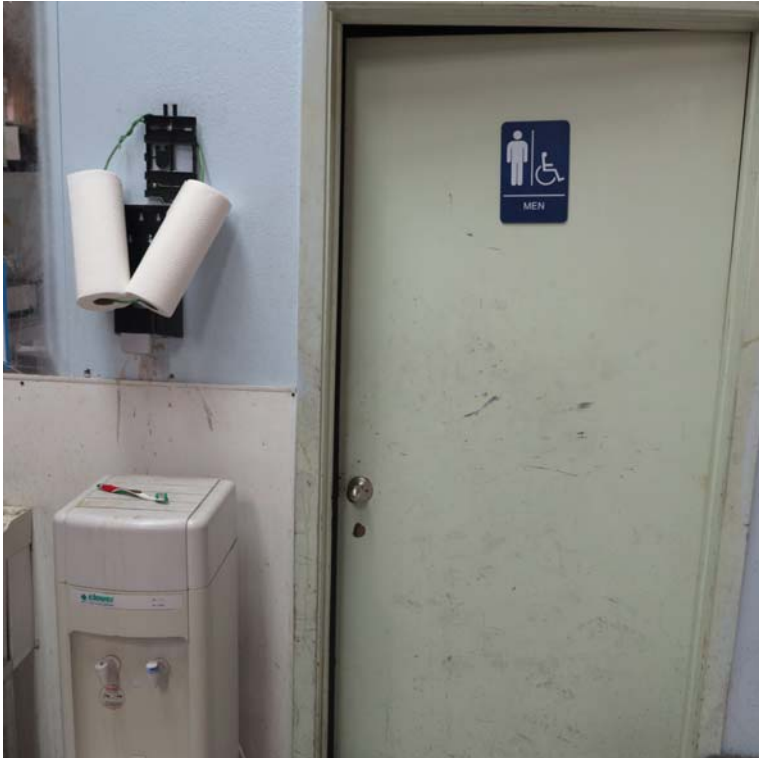
Incorrect signage and improper door hardware

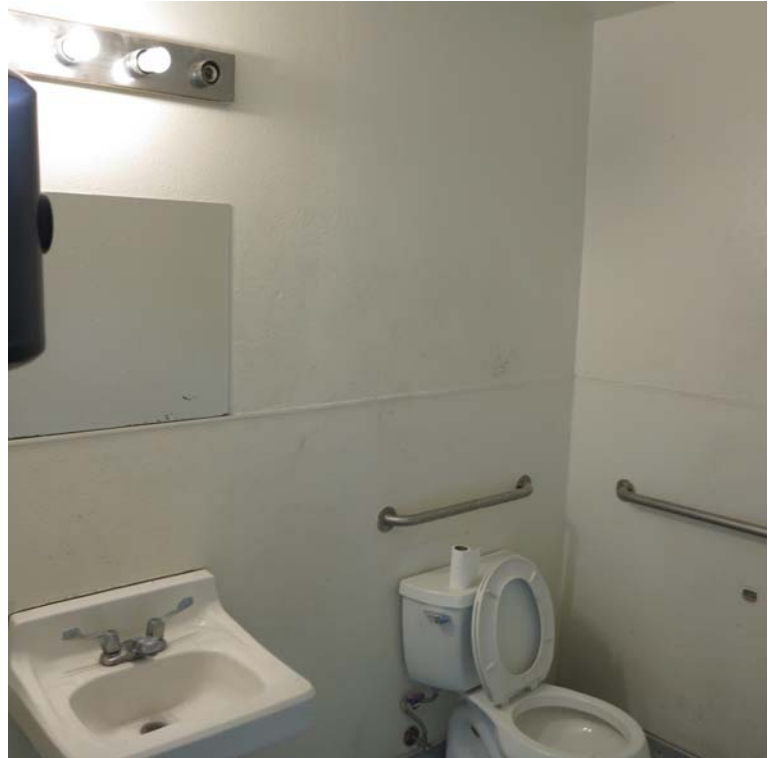
Mirror mounted too high
