4-Point Inspection Form

Address Inspected: 101 Anywhere St, Tampa Fl

Actual Year Built: 1954 Date Inspected: 6/11/2019

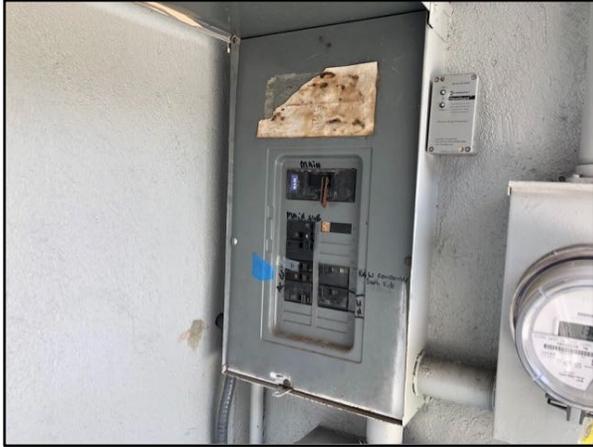
Main electrical service panel with interior door label

Located on front of home, Primary Data on label unreadable. Based on the visible information this panel is rated for 200 amps.

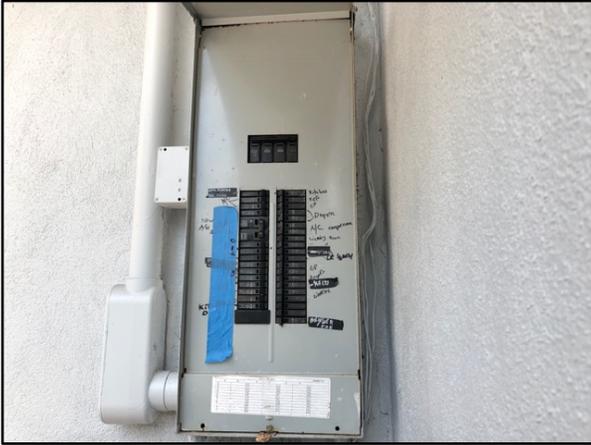
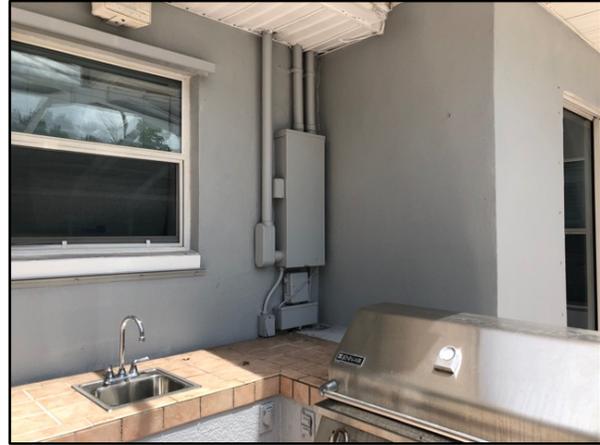
Subpanel(s)

Located on rear of home - 200amp panel

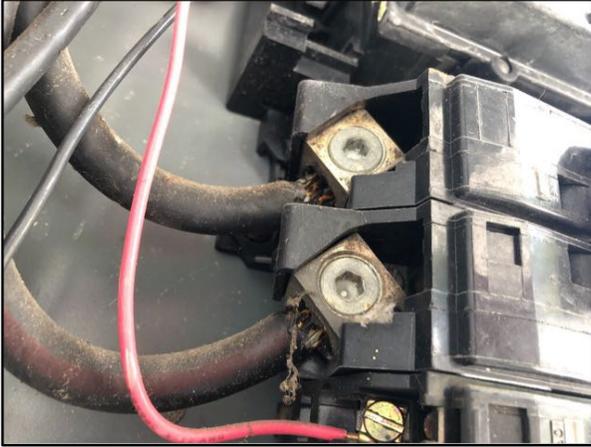
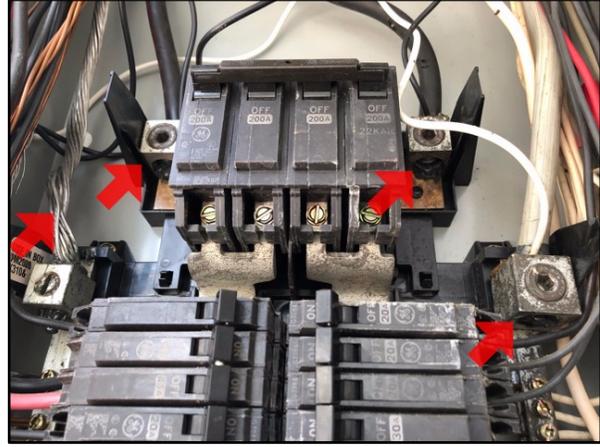
Electrical Upgrade Photos

BCAW feeds main sub panel on rear of home. All BCAW is NM sheathed with no signs of corrosion. All aluminum wiring in both panels is recently protected with an anti-oxidation coating. See receipt from owner.

3) Install GFCI outlets on all two wire outlets 4) Install aluminum oxidation inhibitor on aluminum wiring in sub panel above outdoor kitchen 5) Installed knock-out seals to all knocked out openings in main panel. 6) Install breaker blanks in main panel and sub panel as needed.		
	*Electrical work due to home inspection report: 1) Install aluminum oxidation inhibitor on aluminum Service Entrance Conductors. 2) Sub panel under main electrical panel to have branch ground wires installed and neutrals and grounds to be separated OTHER CHARGES FOR CODE. Breaker blanks to be installed.		
		TOTAL LABOR	AMOUNT
		Labor: <u>Wesley Anron</u> Paid w/ check # <u>3350</u>	
		TOTAL LABOR	TOTAL MATERIALS
		TOTAL OTHER	TOTAL TAX
		TOTAL	TOTAL
			\$125.00
DATE: 6/15/17 SIGNATURE: XXXXXXXXXXXXXXXXXXXX J.P.		Thank You
