INSPECTION REPORT

1102 14TH ST EAST

Inspection Date: Monday, September 28, 2020

RE: Report No. 1098 1102 14th St East Palmetto, FL 34221

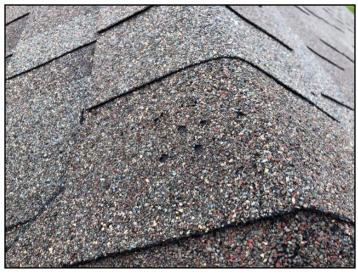
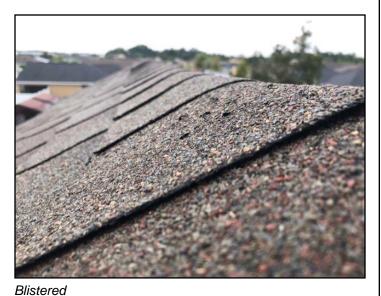
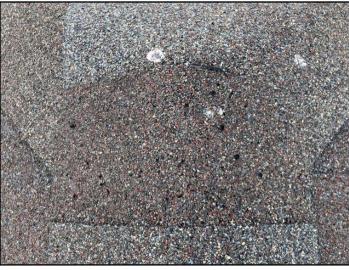
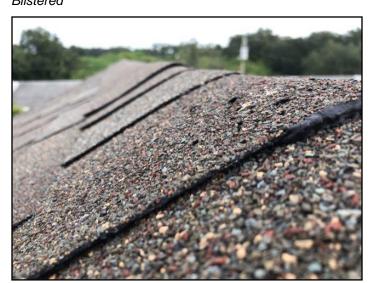
1. Condition: • Blistered

Implication(s): Shortened life expectancy of material

Blistered

Task: Repair or Protect, Time: As soon as possible,

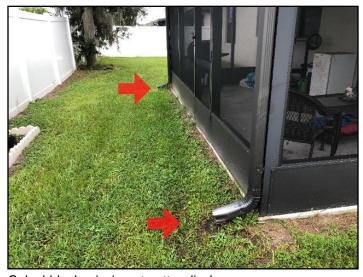
3. Condition: • Splashblock missing at gutter discharge point. Splashblocks prevent soil erosion by moving water away from the foundation. Install splashblocks correctly to protect structure.

Splashblock missing at gutter discharge...

Task: Correct, Improve, Time: As soon as possible,

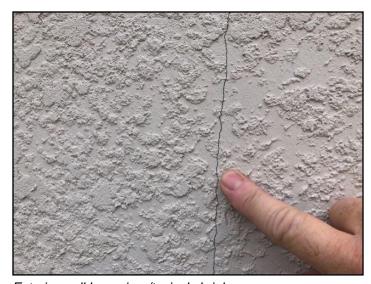
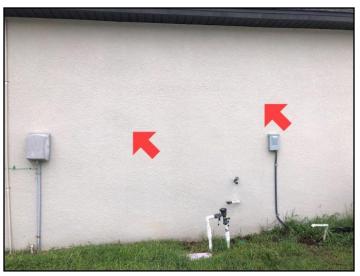
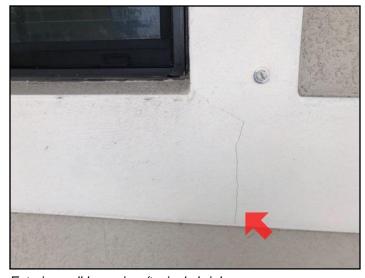
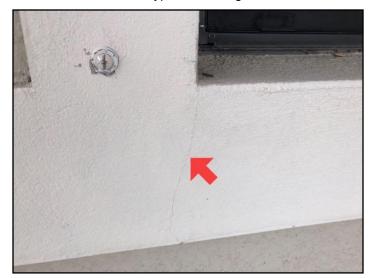
4. Condition: • Exterior wall has minor/typical shrinkage cracking which are susceptible to shrinkage over time. Recommend sealing cracks to prevent water intrusion and further cracking/damage. Observe regularly and monitor for any growth and contact a licensed professional structural engineer for further evaluation if cracking worsens.

Exterior wall has minor/typical shrinkage...

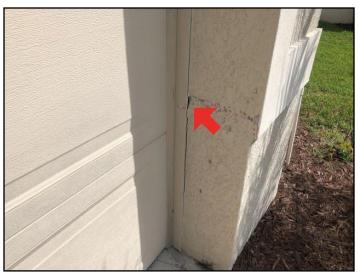
5. Condition: • Damaged

Wall damaged from vehicle on side of garage entrance. Structure of wall is not compromised, only aesthetic / surface damage. Seal corner bead with caulk to prevent water intrusion and paint over scuff mark.

Implication(s): Chance of water damage to contents, finishes and/or structure | Material deterioration

Damaged

Task: Repair, Time: Immediate, 1102 14th St East, Palmetto, FL September 28, 2020 Report No. 1098

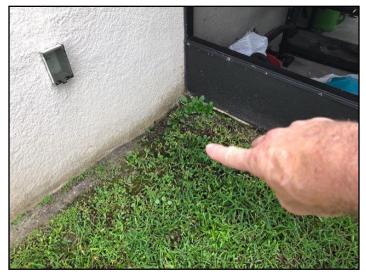
6. Condition: • Soil erosion from roof runoff is causing ponding of water near the foundation. Recommend gutters to properly move water at least 4-6ft from the foundation to prevent settlement damage.

Ponding at foundation

Task: Upgrade,

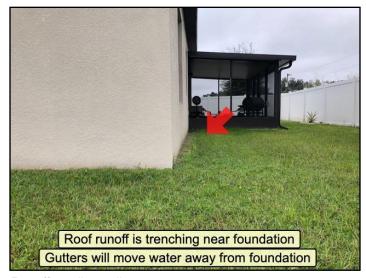
Runoff eroding soil

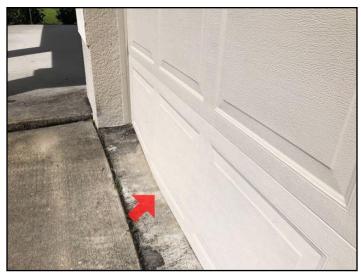
7. Condition: • Damage

Garage door is damaged / bent at the bottom. Door operates and closes correctly therefore damage is only superficial and does not affect the operation of the door.

Damage

Task: Repair or replace,

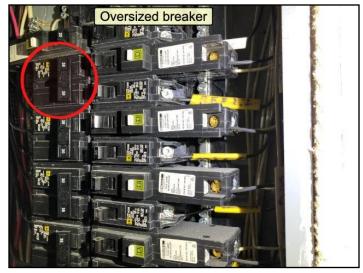
Condition: • Branch circuit breakers are sized for the equipment, system or circuit they supply. Oversizing breakers can cause damage to the equipment, electric shock or fire due to not tripping (stopping power to the circuit). Recommend further evaluation by a licensed professional electrician for correction.

Breaker should be no larger than 25amp as per manufacturer specifications.

8. Condition: • Branch circuit breakers are sized for the equipment, system or circuit they supply. Oversizing breakers can cause damage to the equipment, electric shock or fire due to not tripping (stopping power to the circuit).

Implication(s): Equipment overheating | Fire hazard

Oversized breaker for AC unit

Recommend further evaluation by a licensed professional electrician for correction.

Task: Replace, Time: Immediate,

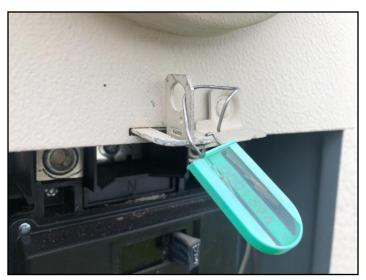
Condition: • Tamper indicator seal broken on service entrance panel. This tag is installed by the electric company as a visual indicator for meter tampering. Recommend contacting the electric company for a new tag to ensure meter is not tampered with.

9. Condition: • Tamper indicator seal broken on service entrance panel. This tag is installed by the electric company as a visual indicator for meter tampering. Recommend contacting the electric company for a new tag to ensure meter is not tampered with.

Elect panel seal broken

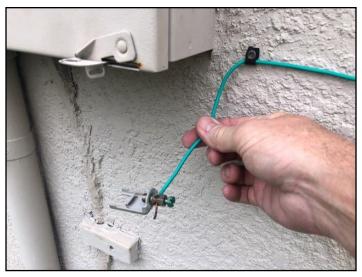
10. Condition: • Not well secured

Ground wire for cable TV system/coax Cable box has a ground wire that is not connected to the panel correctly. Recommend contacting cable TV service and have them properly connect the ground wire to the panel.

Implication(s): Electric shock | Fire hazard

Not well secured

Task: Repair, Time: Immediate,

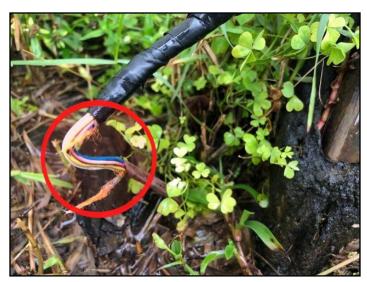
11. Condition: • Buried cable

Thermostat wiring is run underground with line set and is damaged from lawn maintenance. A protective sleeve should be placed around wire after repair to prevent damage to equipment.

Implication(s): Electric shock Task: Repair & Protect

Buried cable

Time: Immediate,

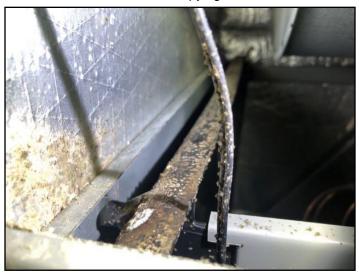
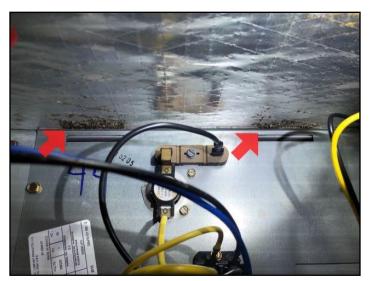
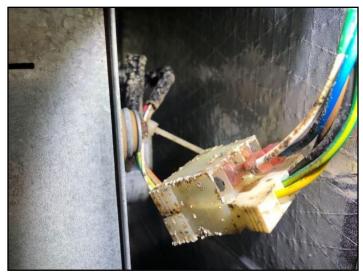
13. Condition: • A biological/organic growth was discovered during the inspection in or around HVAC system. We do not test for biological substances. Recommend a thorough cleaning of all air handler components before occupying residence.

Organic substance inside air handler

Task: Clean,

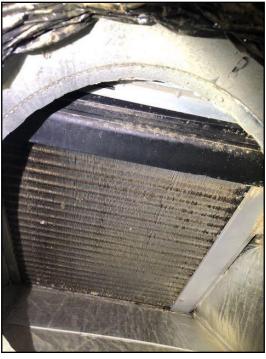
14. Condition: • Dirty

Dirty

Task: Service component,

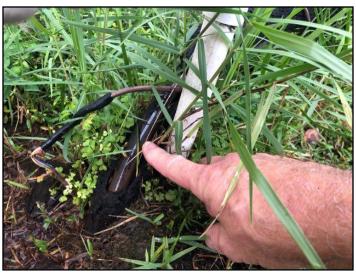
15. Condition: • HVAC refrigerant piping is not fully insulated or insulation is deteriorated. Refrigerant 'line set' should be fully insulated (the larger of the two pipes) to prevent temperature drop.

HVAC refrigerant piping is not fully...

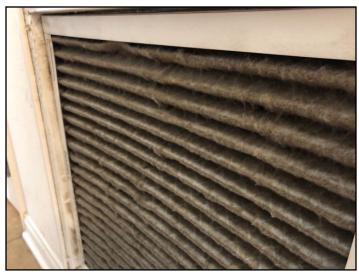
16. Condition: • Return filter dirty

Return filter dirty

Task: Replace,

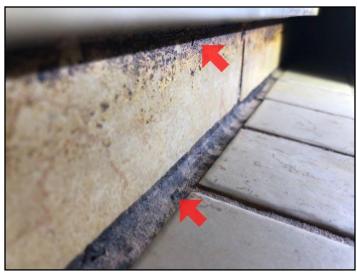
17. Condition: • Grout is stained with mold or mildew and should be replaced.

Grout stained with mold

Task: Replace,

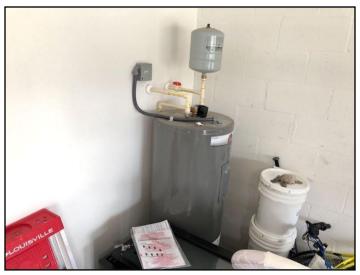
18. Condition: • Protective bollard (post) is recommended.

Water heaters located in the garage should have a protective bollard in front of them to prevent damage from vehicles.

Implication(s): Damage to water heater, piping and structure if ruptured.

Protective bollard (post) is recommended....

Recommend one be installed to prevent damage to water heater. These can be easily installed by homeowners.

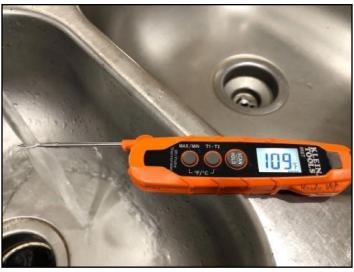
Recommended water heater temp is 120.

Recommend adjusting temp closer to 120 without exceeding as higher temps can scald. This can simply be done by following the manufacturer's instructions for adjusting the temperature and checking actual water temp at the closest valve in approximately 30 mins.

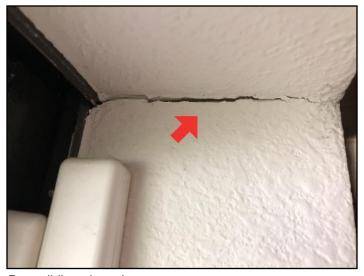
Rear sliding glass door

19. Condition: • Minor typical settlement cracking observed within the home. These are typical cracks seen in most homes and are cosmetic only. Seal and paint.

Task: Repair,

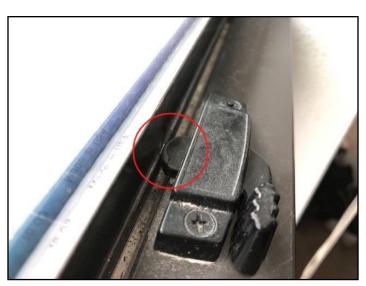
Window locks will not engage to secure window.

20. Condition: • Inoperative

Inoperative

Task: Repair, Time: Immediate,

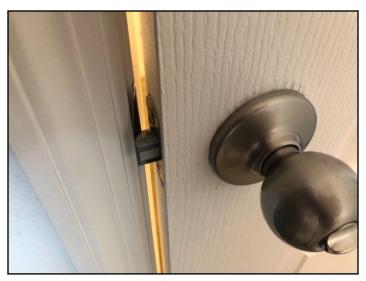
21. Condition: • Does not latch properly

Does not latch properly

Location: Office Task: Repair,

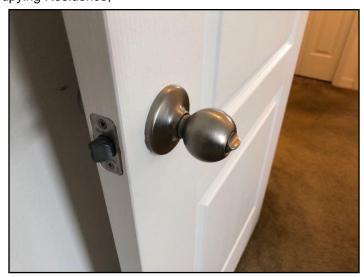
22. Condition: • Interior Door knob installed with lock on outside of door.

Does not latch properly

Task: Correct,

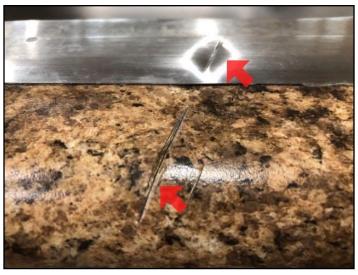
23. Condition: • Damage, stained Implication(s): Hygiene issue

Damage, stained
