# INSPECTION REPORT

For the Property at:  
**123 Anywhere AVE**  
TAMPA, FL 33611

Prepared for: BRUCE WAYNE  
Inspection Date: Thursday, January 16, 2020  
Prepared by: Derle Parmer HI11344

RE: Report No. 1046  
123 Anywhere Ave  
Tampa, FL  
33611

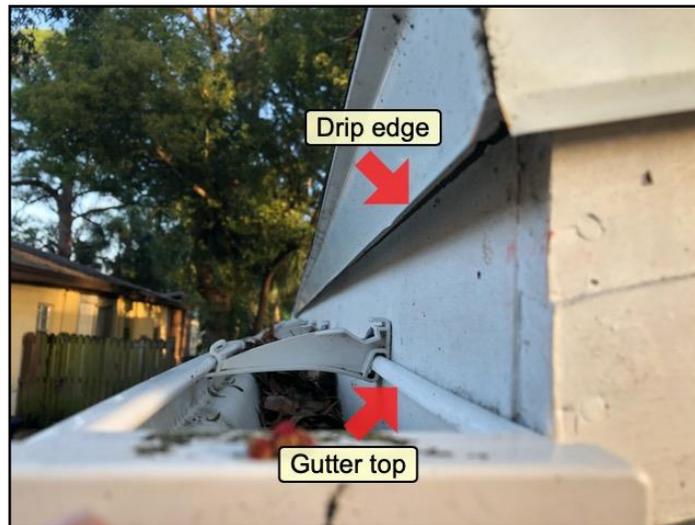
1. Condition: • Gutters installed incorrectly. They should be installed behind the drip edge to allow water to run directly into the gutter. This installation allows water behind gutter and will cause future water damage.

Implication(s): Water damage to fascia, soffit and structure

Gutters installed incorrectly

Task: Correct

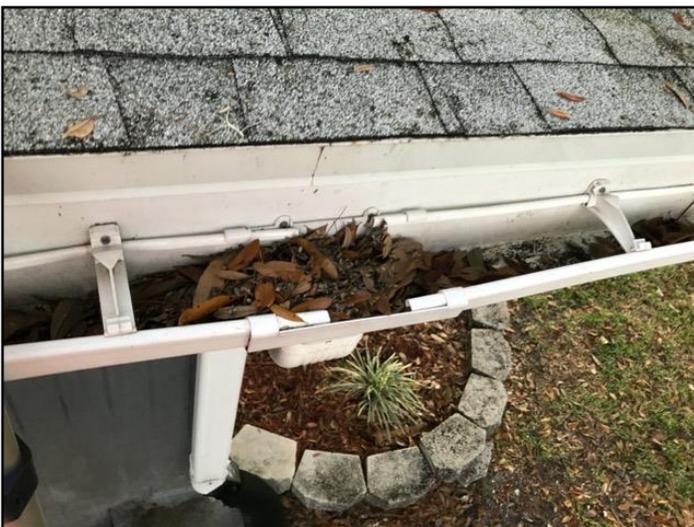
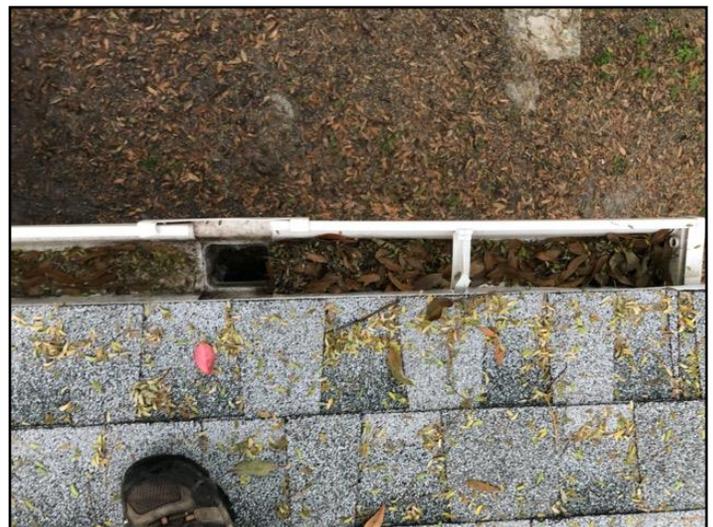
2. Condition: • Clogged

Implication(s): Chance of water damage to contents, finishes and/or structure

Clogged

Task: Clean

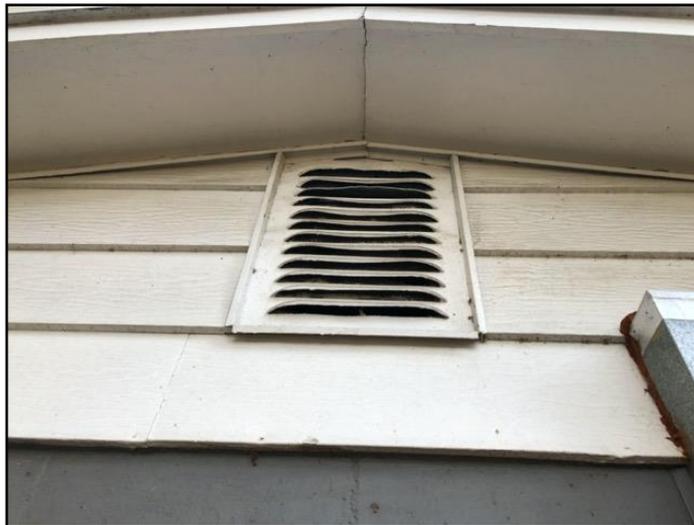
**3. Condition:** • Replace mesh on gable vents to stop pest.

*Gable vent mesh ineffective*

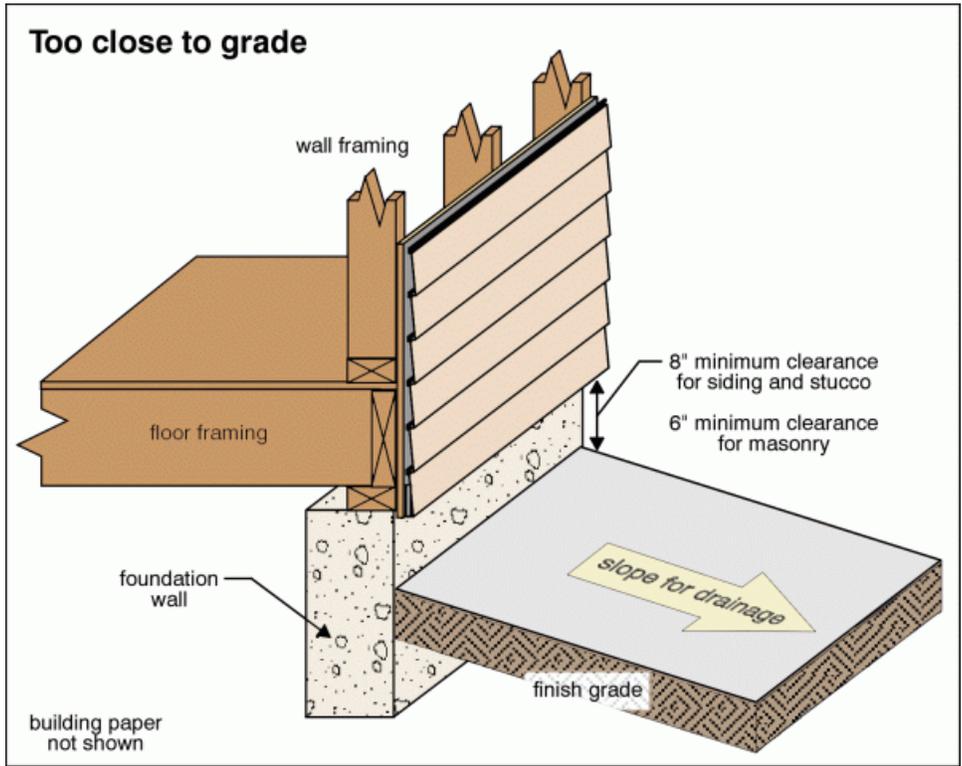
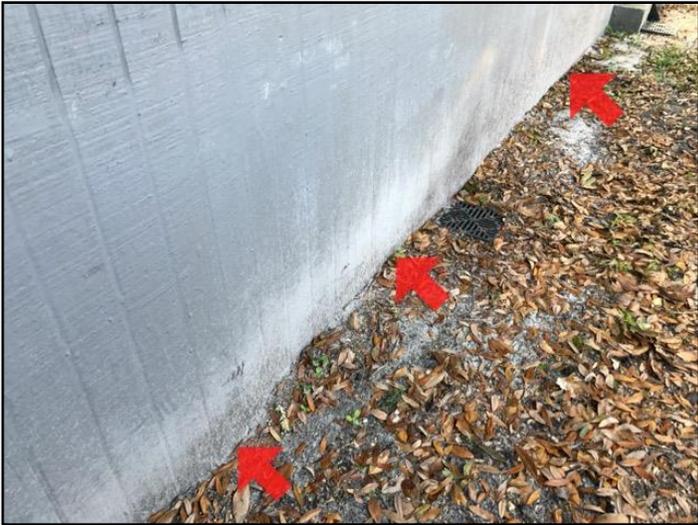
**4. Condition:** • [Too close to grade](#)

Wood in contact with soil will allow insects to enter the home and water damage to wall and structure. Recommend protecting from soil contact.

**Implication(s):** Chance of water damage to contents, finishes and/or structure | Material deterioration | Rot | Insect damage

*Too close to grade*

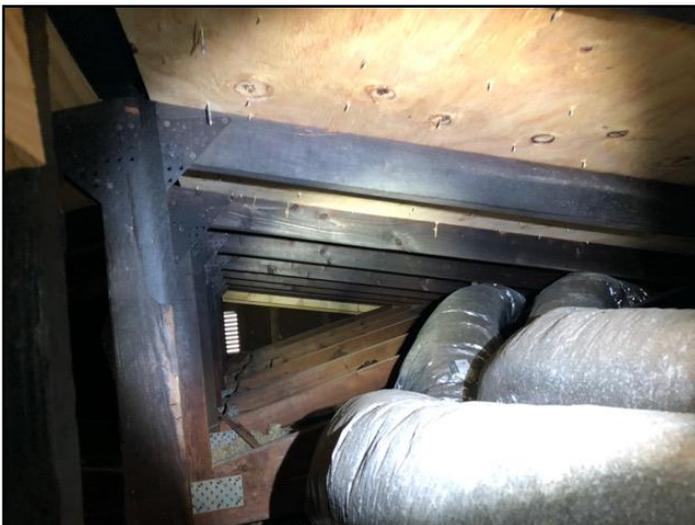
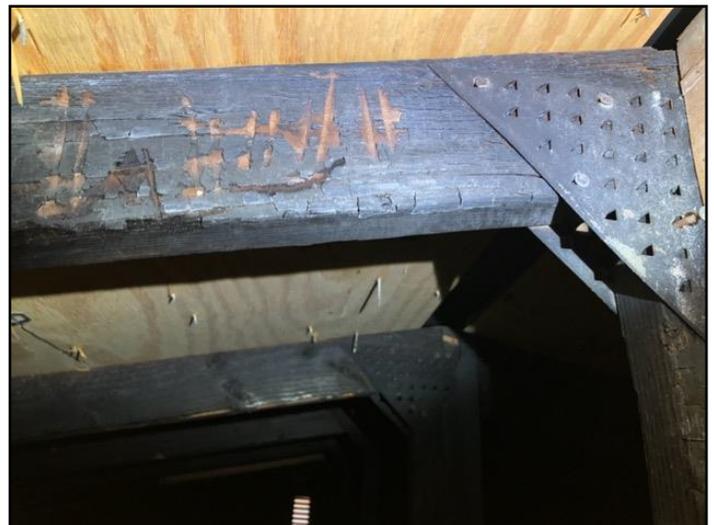
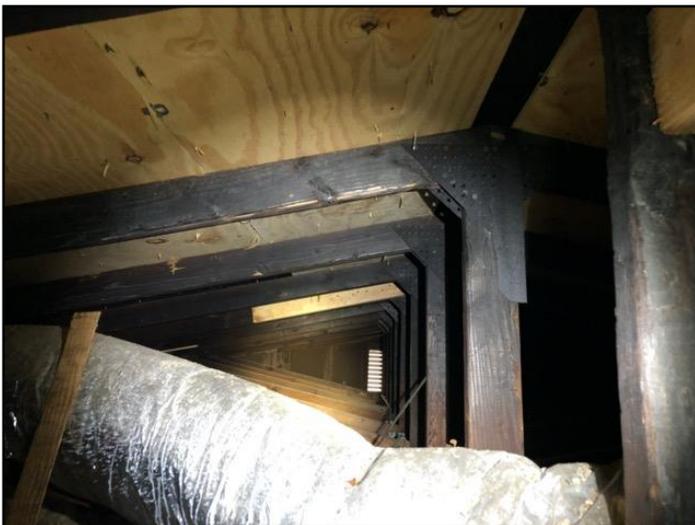
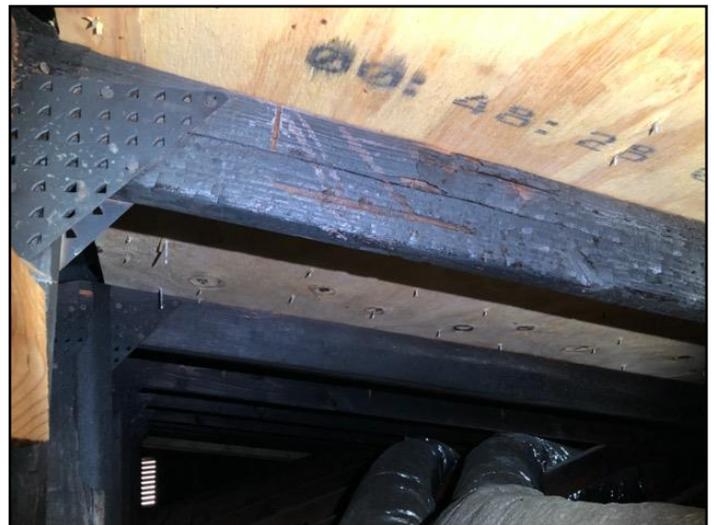
**5. Condition:** • Trusses in attic are fire damaged. Recommend obtaining disclosure about fire if available and further evaluation by a licensed professional structural engineer to ensure trusses are not compromised and options for repair if needed.

Fire damage

**Task:** Further evaluation, disclosure

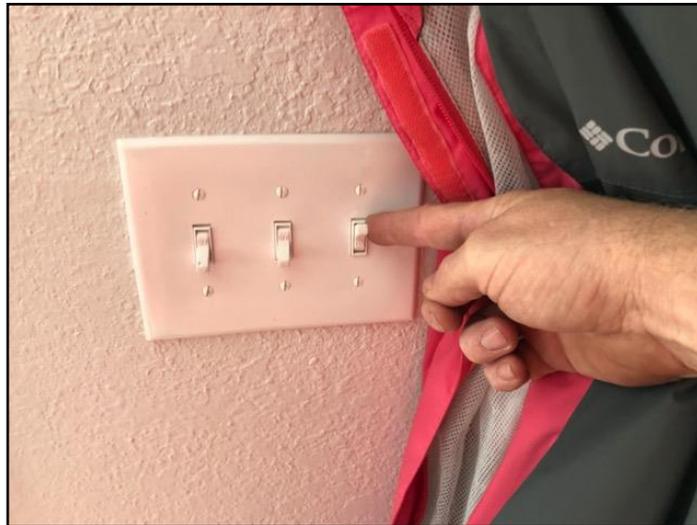
**6. Condition:** • [Inoperative](#)

*Switch at front door inoperative*

**Task:** Repair or replace

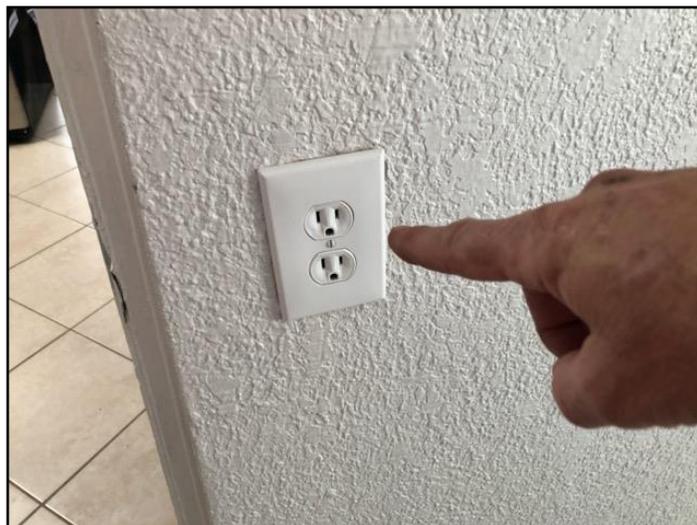
**7. Condition:** • [Inoperative](#)

*Inoperative*

**Task:** Repair or replace

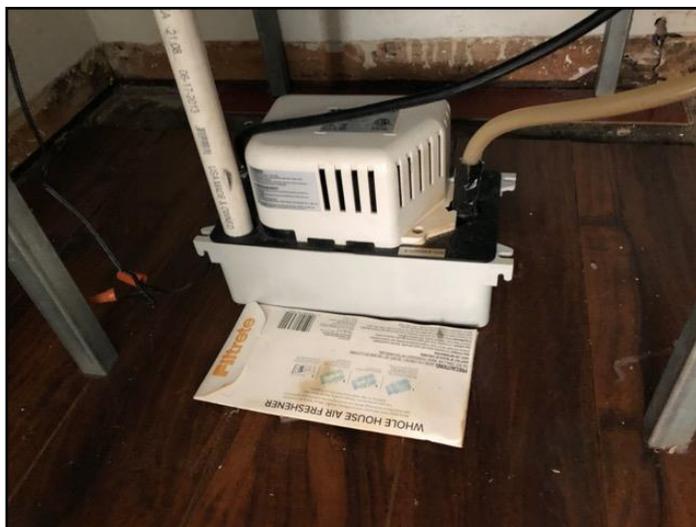
10. **Condition:** • Place condensate drain pump in dedicated drain pan to prevent water damage to flooring/structure if pump fails.

**Implication(s):** Water damage to flooring/structure

*Pump not in drain pan*

**Task:** Protect

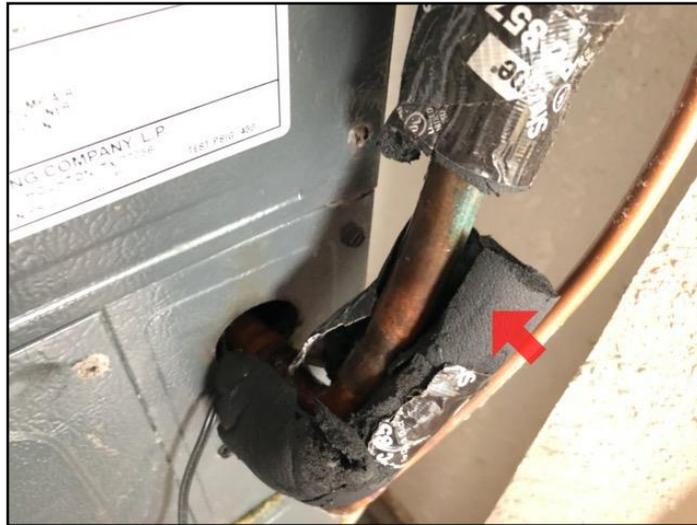
11. **Condition:** • [Insulation - missing](#)

Insulation - missing

**Task:** Repair or replace

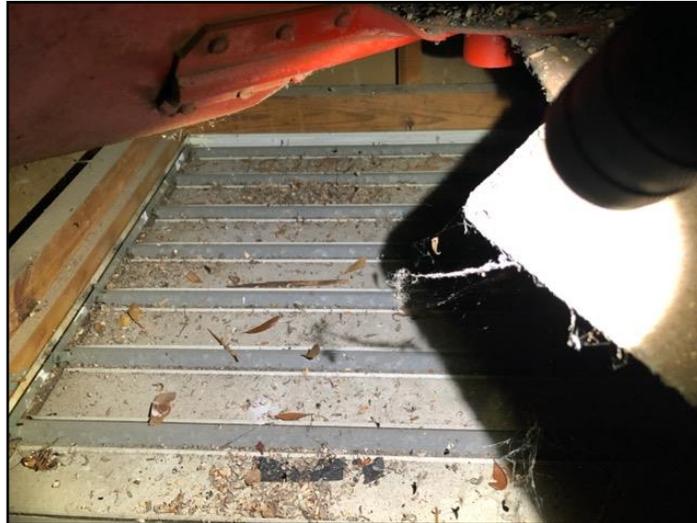
**12.** • Abandoned whole house fan vent grill is not insulated and allows large loss of conditioned air. Install insulation to optimize HVAC system and save on energy bill.

*No insulation*

**Task:** Improve

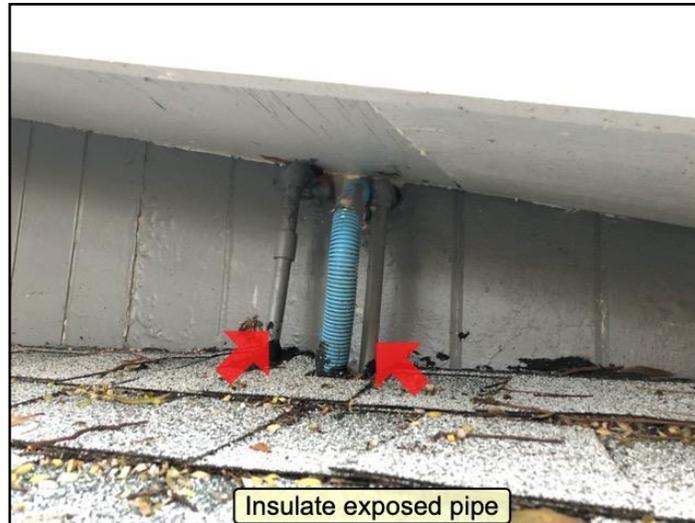
**Implication(s):** Water damage to structure and foundation erosion

**Task:** Protect

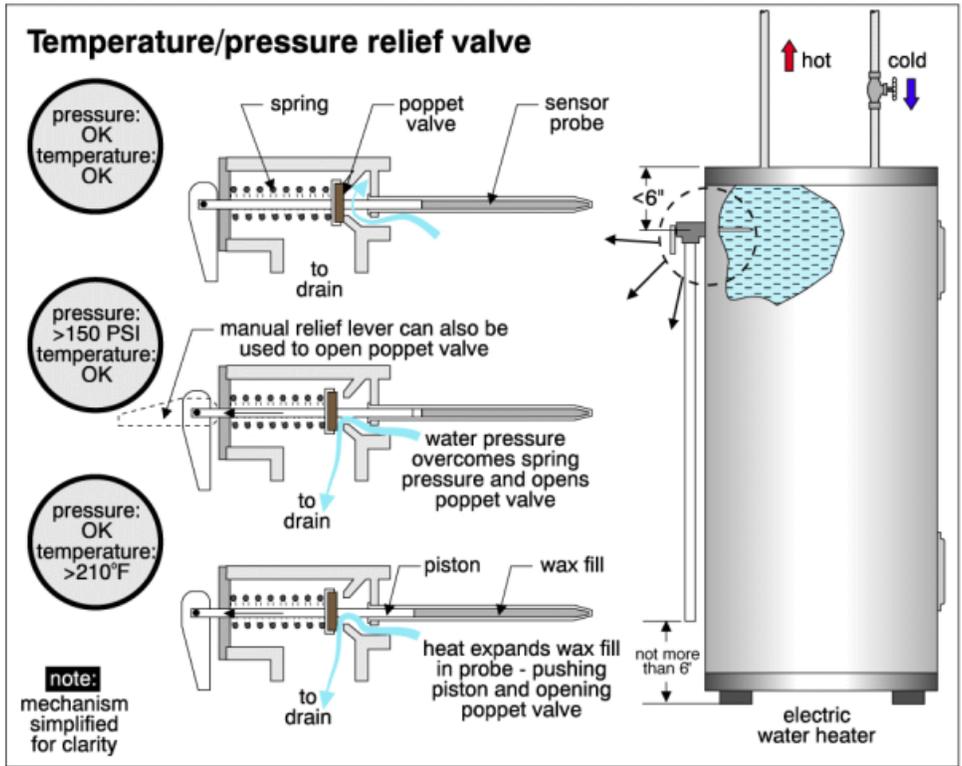
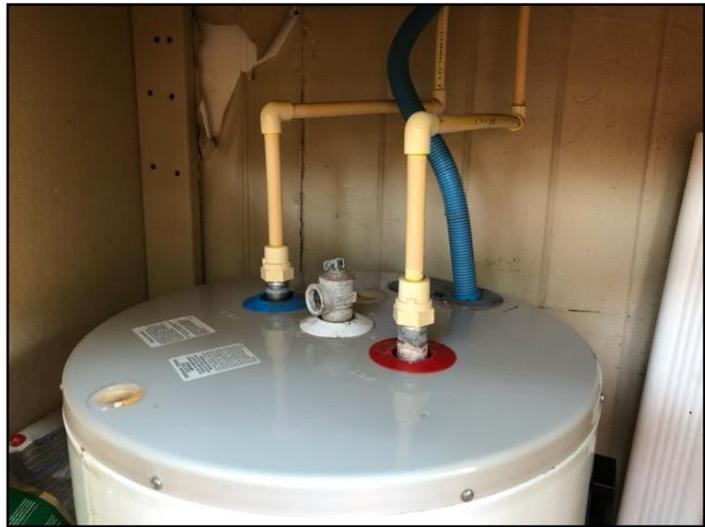
**14. Condition:** • [Discharge tube missing](#)

Discharge tube missing

**Task:** Correct

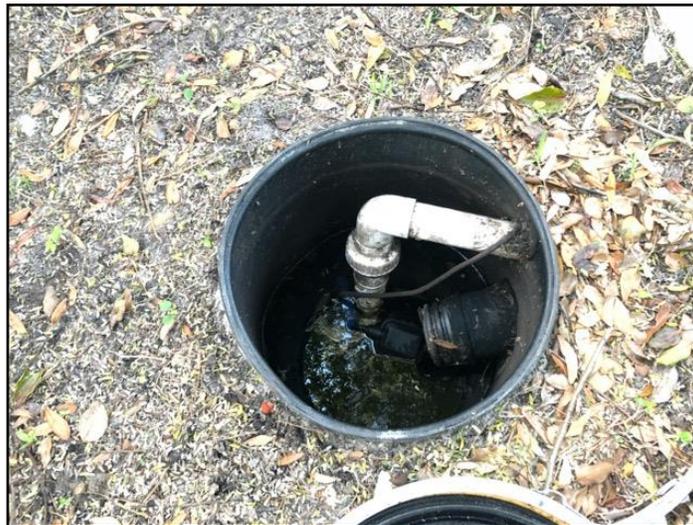
**15. Condition:** • The pump operates but float valve did not turn off the pump when it emptied the tank. Replace the float to ensure the pump operates correctly.

Additionally, Sump pump is missing or has faulty check valve to stop water from backfilling after pump stops. Install check valve to prevent pump from running excessively.

**Implication(s):** Premature failure of pump

*Missing check valve*

**Task:** Repair

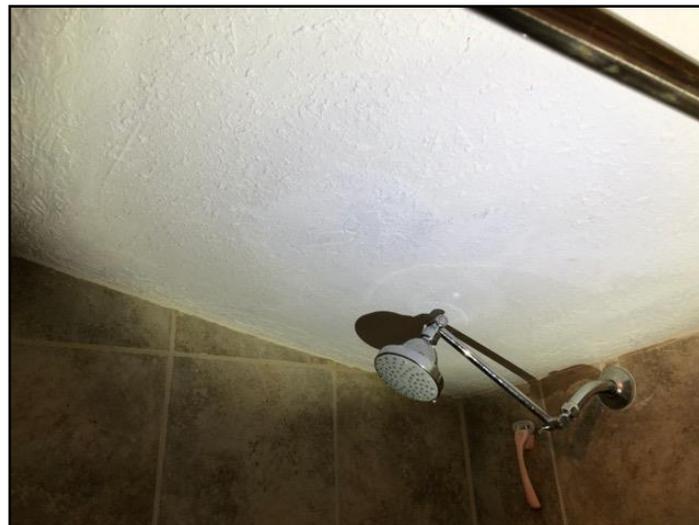
**16. Condition:** • Shower ceiling not sealed to prevent water damage. Paint ceiling with a semigloss paint to properly seal and protect structure.

**Implication(s):** Water damage to drywall and structure.

*Ceiling not sealed from water*

**Task:** Improve

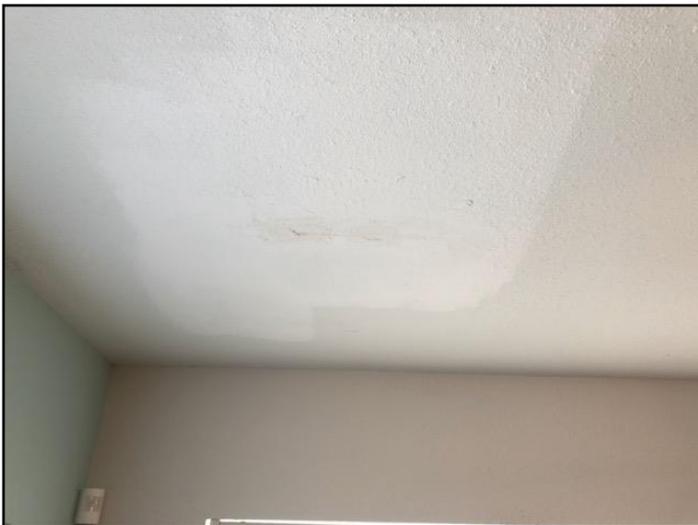
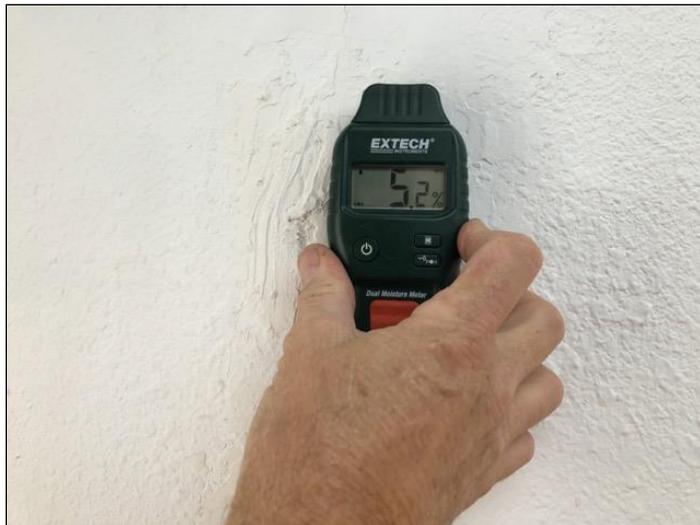
**17. Condition:** • [Patched](#)

Patch over dining room table was tested with a moisture meter and found to be dry during the inspection. To better cover the water stain use a coat of oil based paint to seal the stain properly. Water based paint will only reactivate the stain and allow further bleed-through of the new coat.

**Implication(s):** Chance of damage to contents, finishes and/or structure

Patched

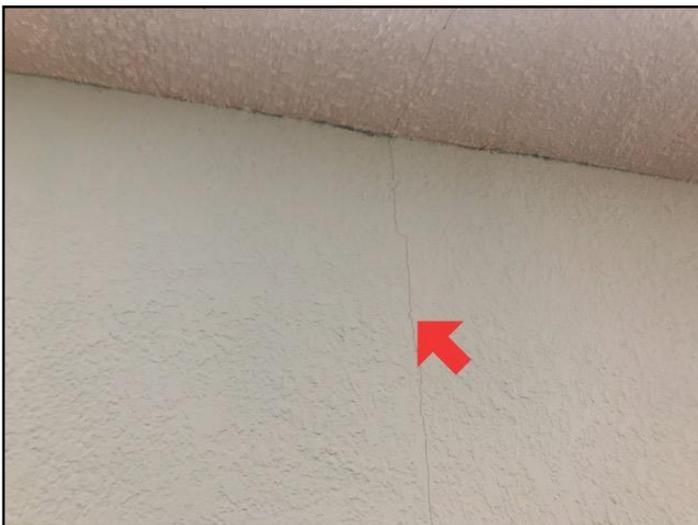
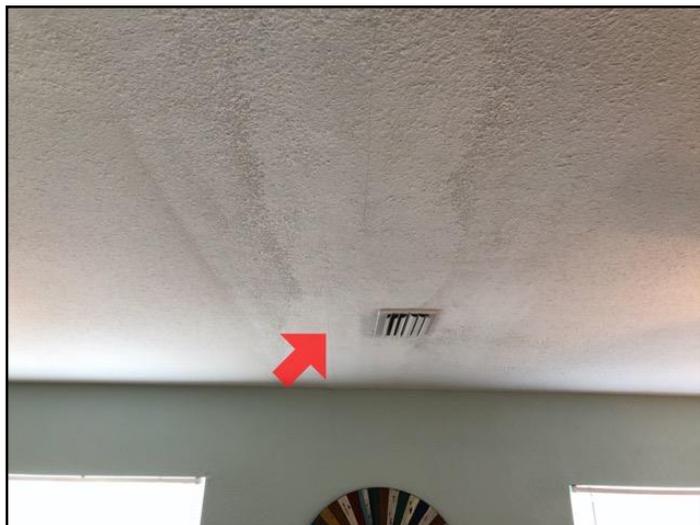
**18. Condition:** • [Cracked](#)

Typical crack observed in living room wall and ceiling. Monitor and contact a licensed professional structural engineer if crack widens. Proper repair of the crack is recommended by a licensed professional drywall contractor.

Cracked

**Task:** Monitor

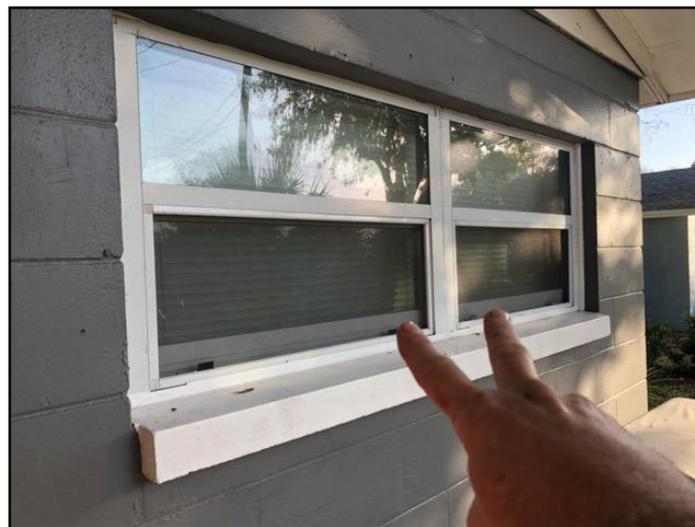
**19. Condition:** • [Won't stay open](#)

*Won't stay open*

**Task:** Repair

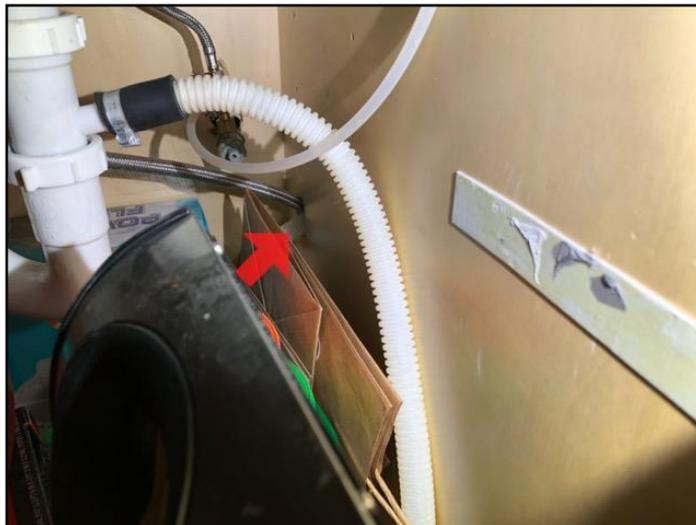
**20. Condition:** • Backflow prevention high loop missing

*Backflow prevention high loop missing*
