IKA Report No. 18-0508-1

Metallographic Examination

Corrosion Protech
Tirat Carmel, Israel

05/03/18

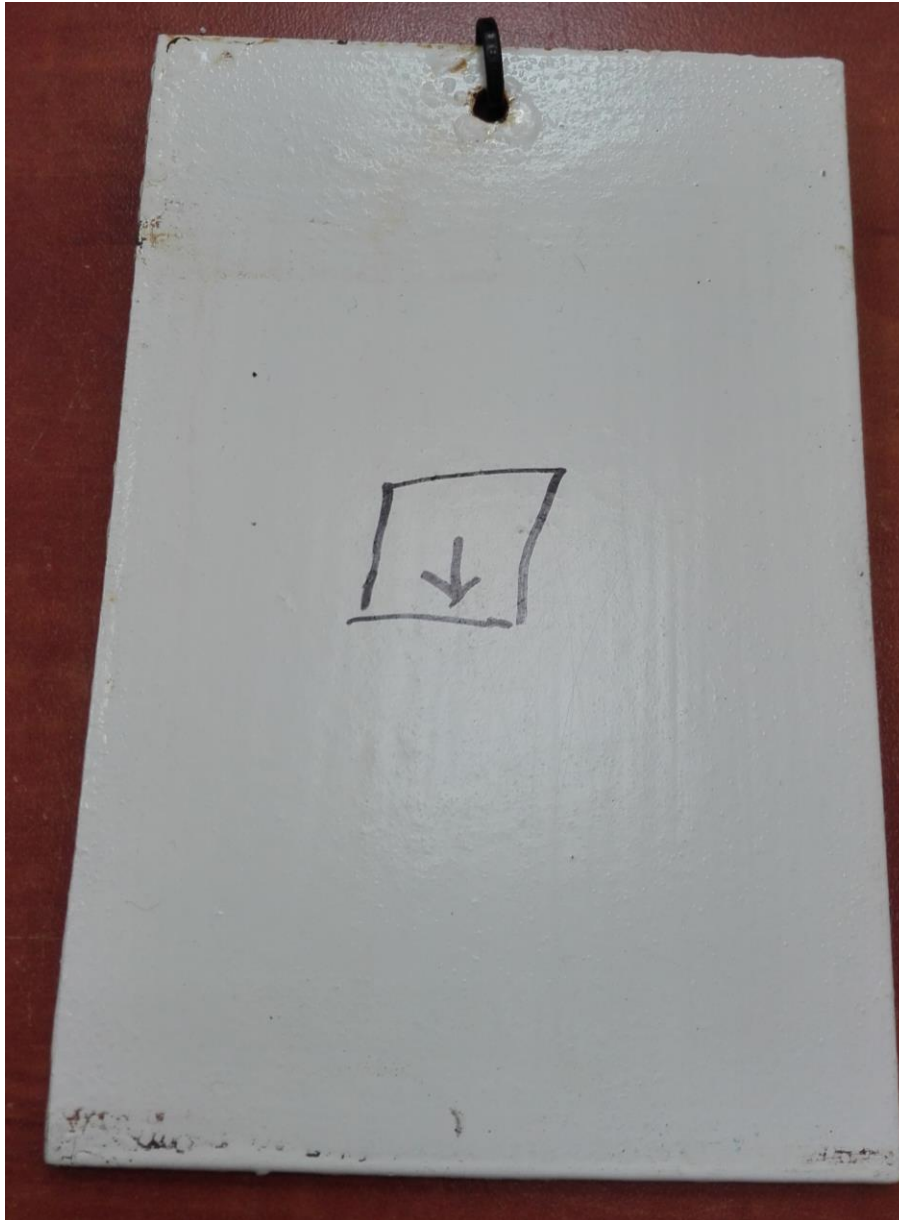
Figure 1

A panel made of ST-37 and coated with a "NFRA BASE" and "Tamaglass PE" was received for examination. (see Figure No. 1). The customer indicated that the part underwent a salt spray test for 3600 hours in accordance with ASTM B117.

Metallographic section was performed through the part in accordance with ASTM E 3-17 standard (see location of the section in Figure No. 1).

The part as received with the section mark

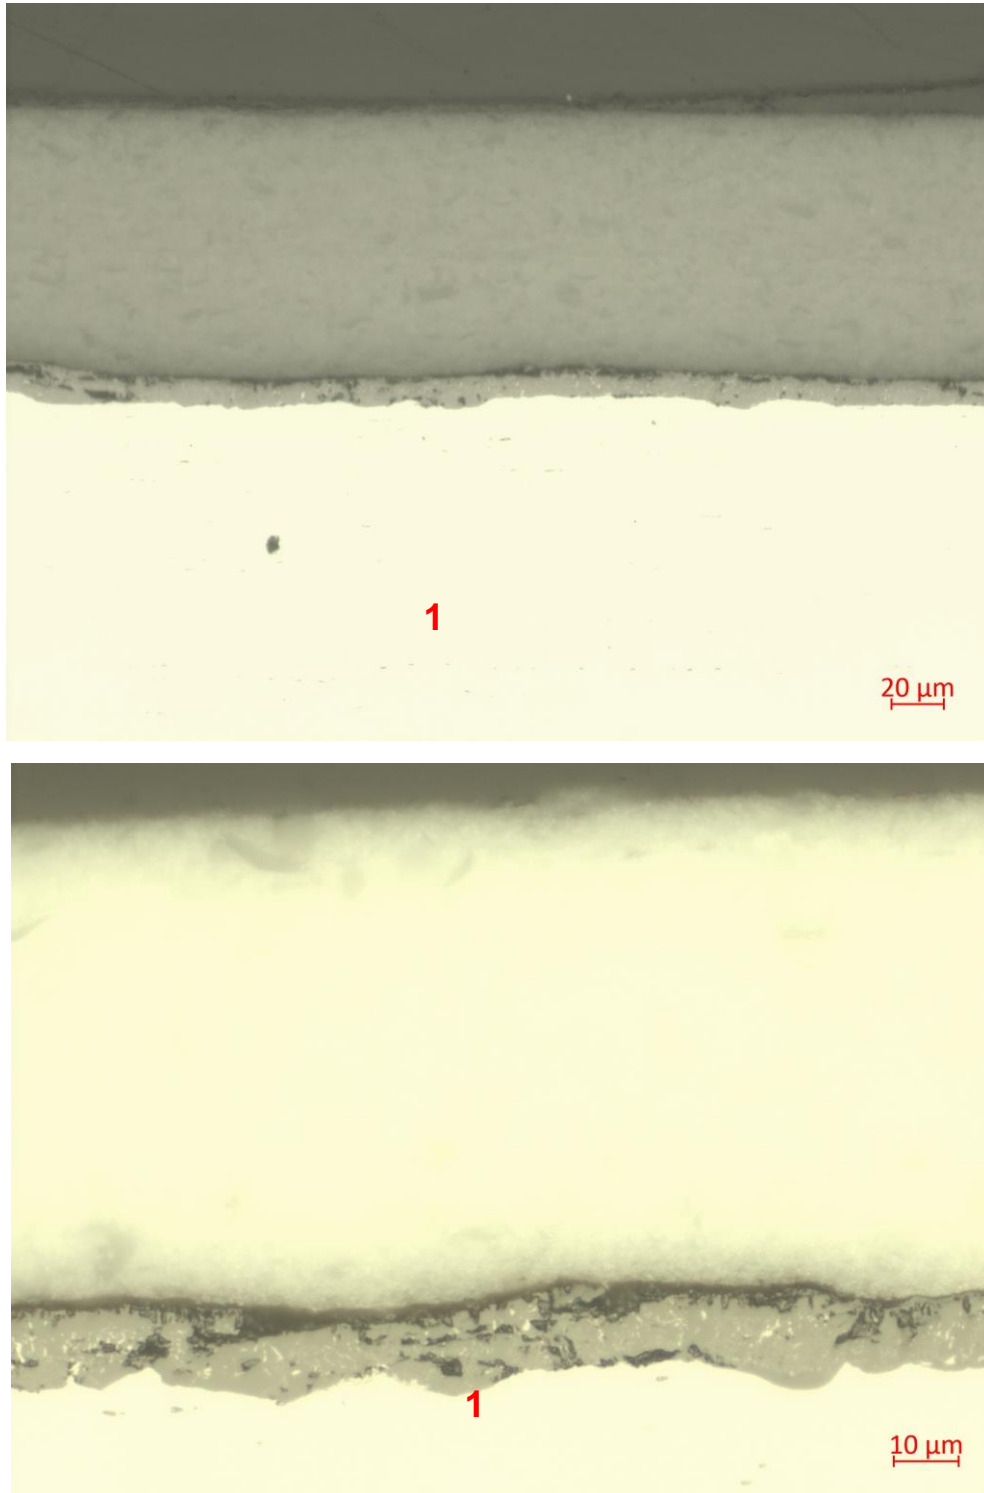
Figure 2

Figure No. 2 shows the section. The examination was performed only at the marked side of the part (see Figure No. 1). No signs of rust were observed at the base metal of the part.

4.1 No signs of rust were observed at the base metal of the part.

The metallographic section through the part, different magnifications

1- Base metal
