## Case Study: Grange Farm - Specialist Parapet Repair and Refurbishment

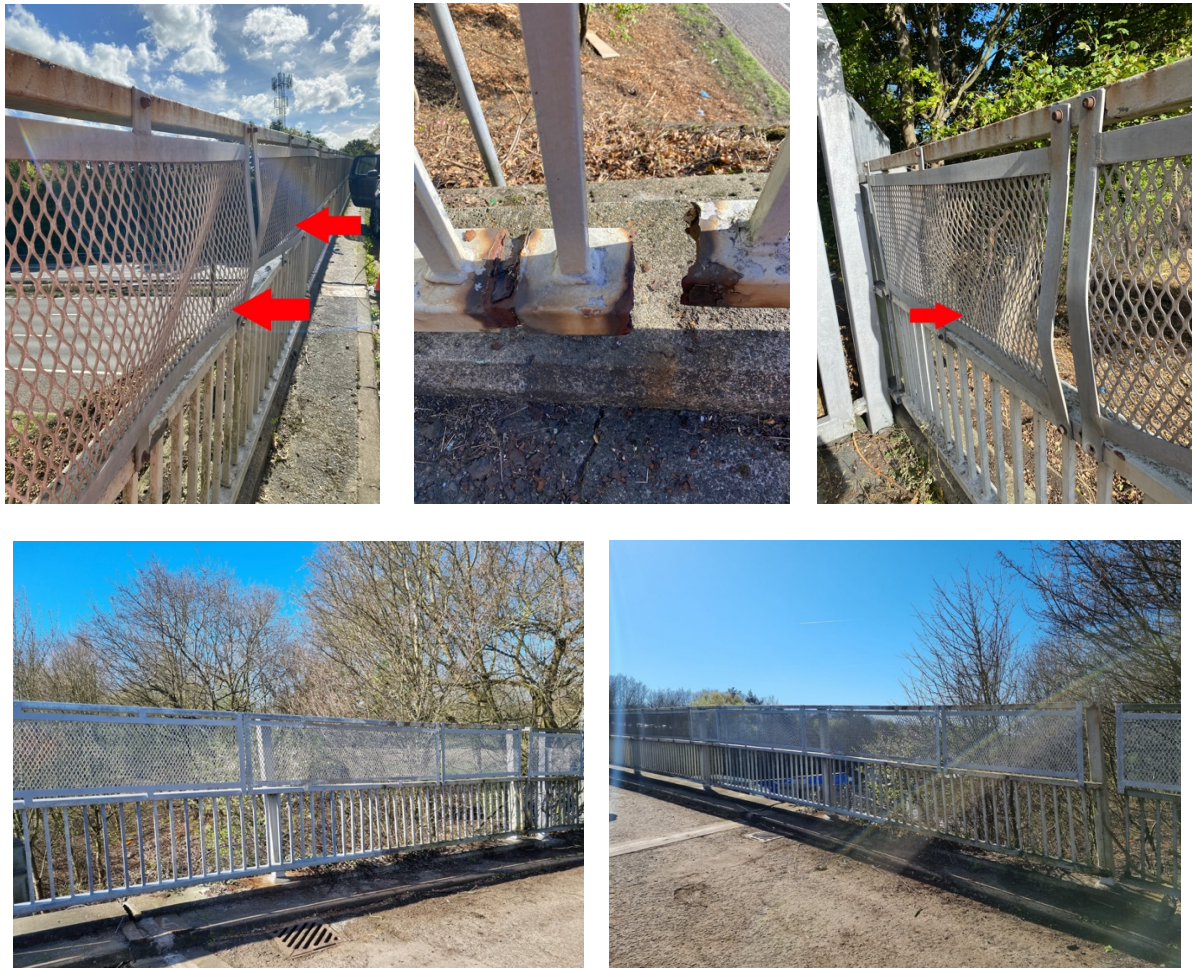
A specialist parapet repair project was undertaken to restore the structural integrity and appearance of an existing parapet system. The works required a tailored approach to ensure compliance with industry standards while maintaining continuity with the existing structure.
