YOUR INSPECTION REPORT

Someplace
Northern, ON P3E Z1Z

Saturday, August 18, 2018

RE: Report No. 1061
Someplace
Northern, ON
P3E Z1Z

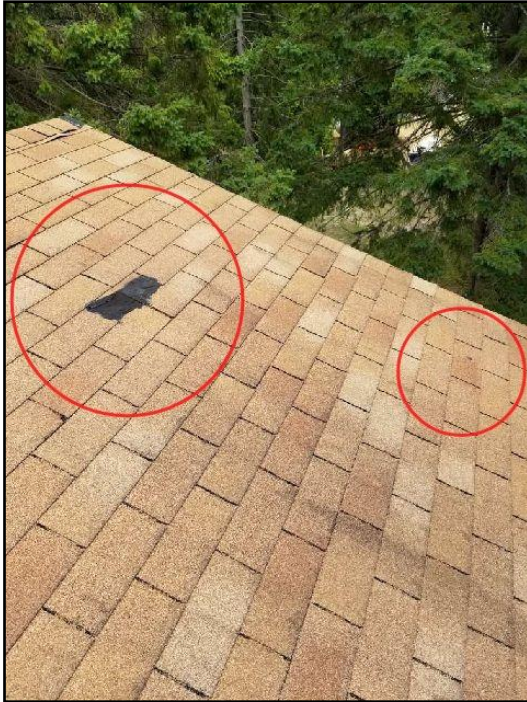
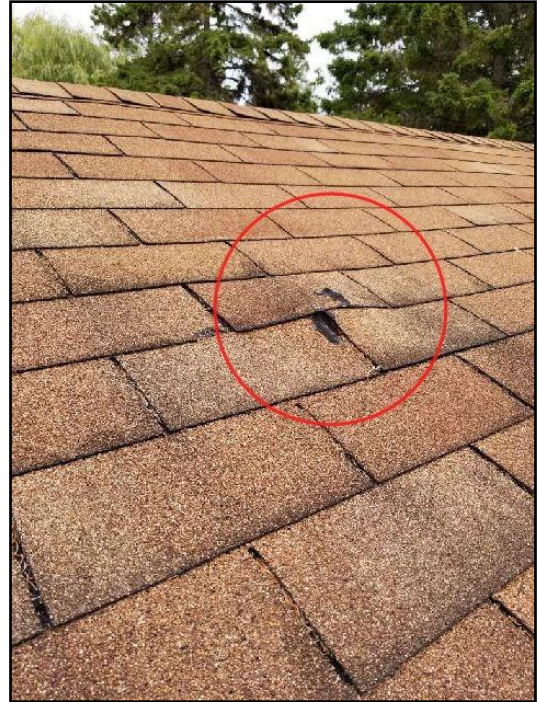
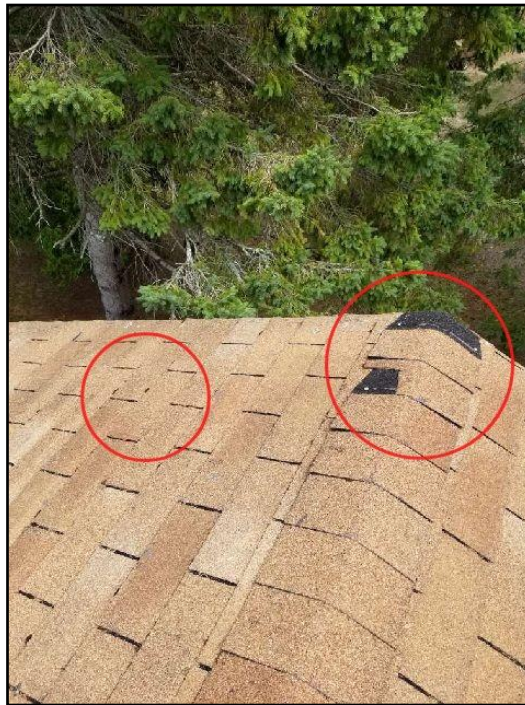
2. Condition: • [Damage](#)

Areas of previous damage. Monitor ongoing and repair/patch as required.

Implication(s): Chance of water damage to contents, finishes and/or structure

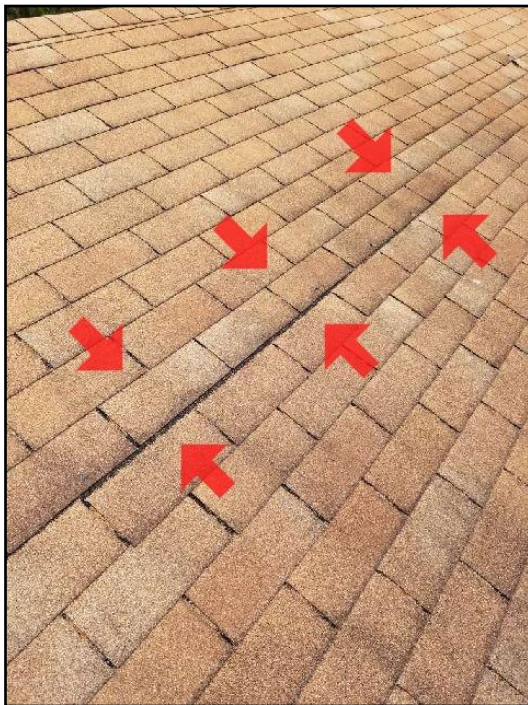
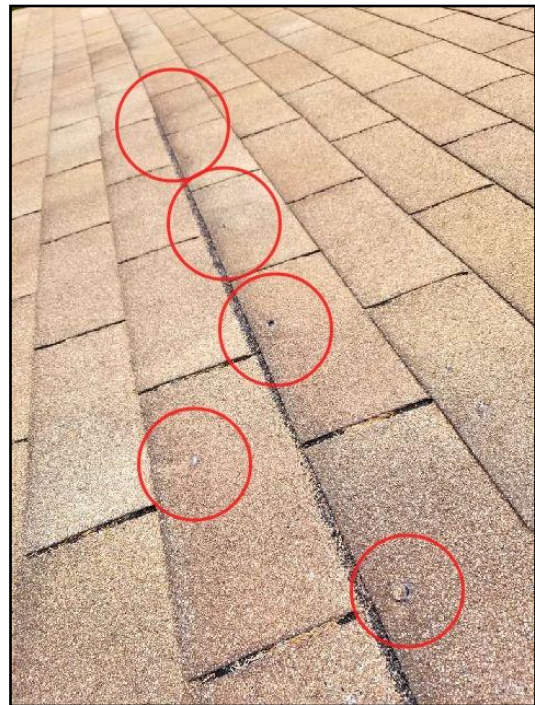
3. Condition: • [Missing, loose or torn](#)

Shingles have slipped out of position and some fasteners have come through upper shingle. Repair and reseal as soon as possible to prevent risk of further damage or leakage.

Implication(s): Chance of water damage to contents, finishes and/or structure

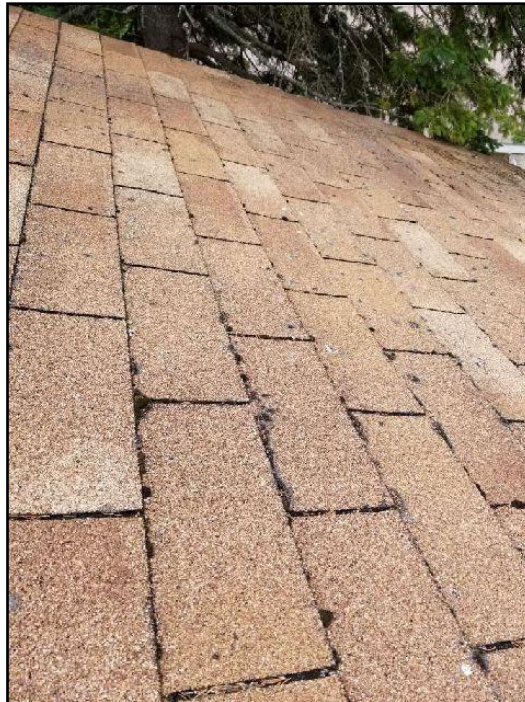
10. Debris/moss

4. Condition: • Debris/moss

Evidence of moss throughout exposed areas of roof. When possible, clean/remove moss to minimize premature deterioration.

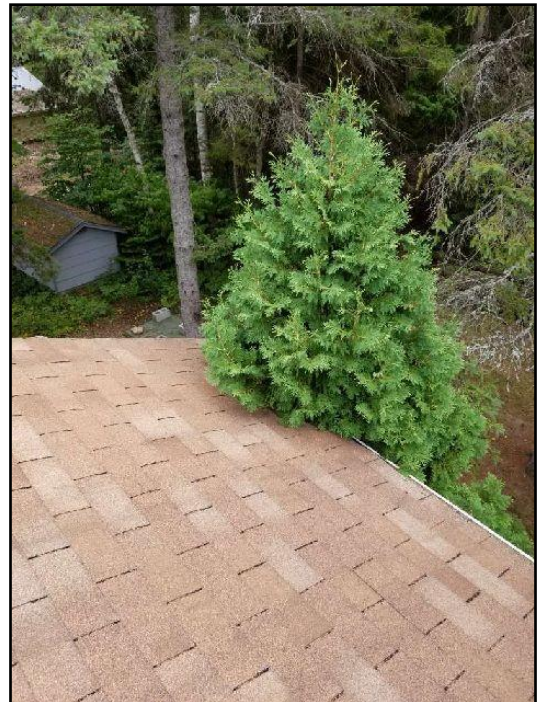
5. Condition: • Tree branches touching roof

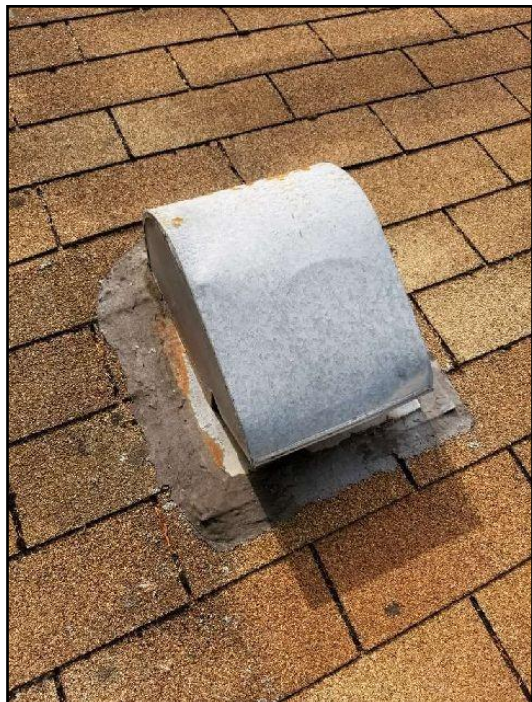
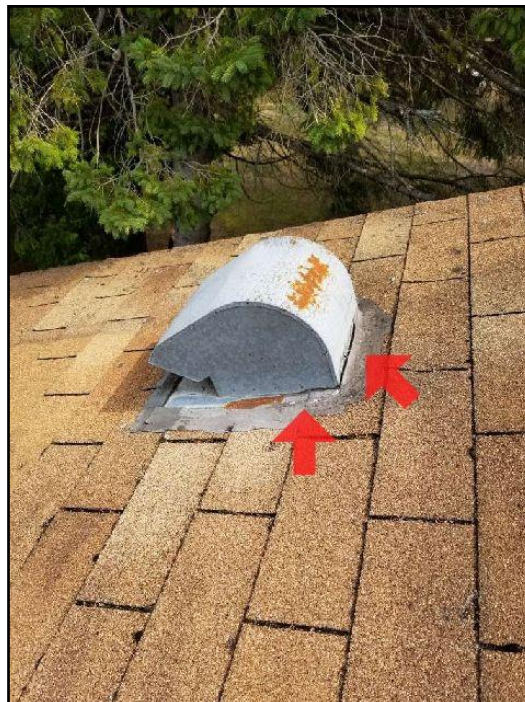
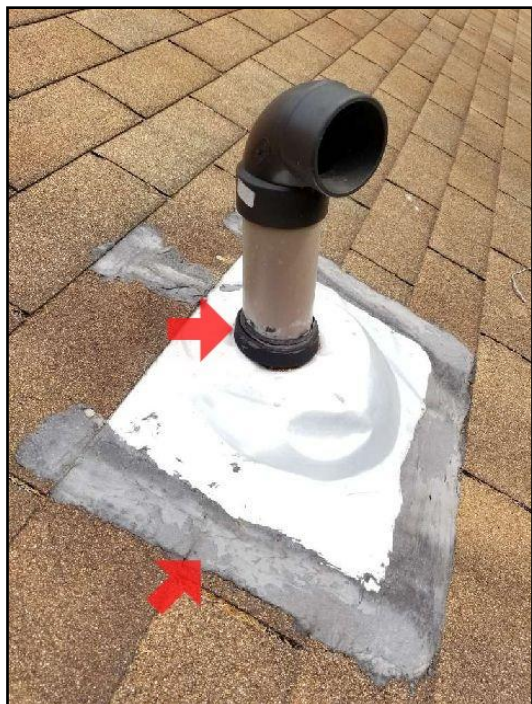
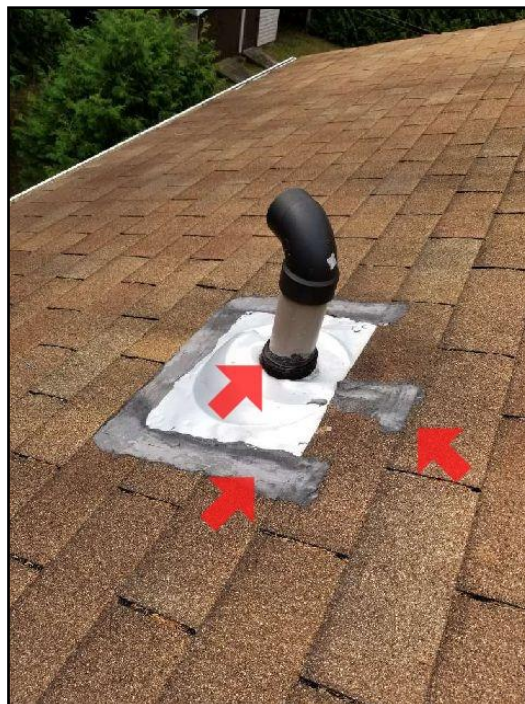
6. Condition: • Inspect & repair, as needed.

Poor/amateur flashing installation and details, excess roof cement/sealant. Monitor for cracking and repair as required. Replace/Improve during next roof replacement.

Implication(s): Chance of water damage to contents, finishes and/or structure

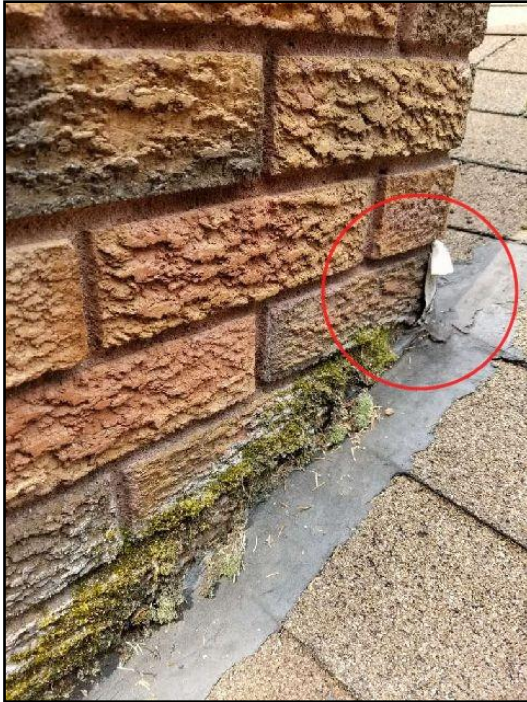
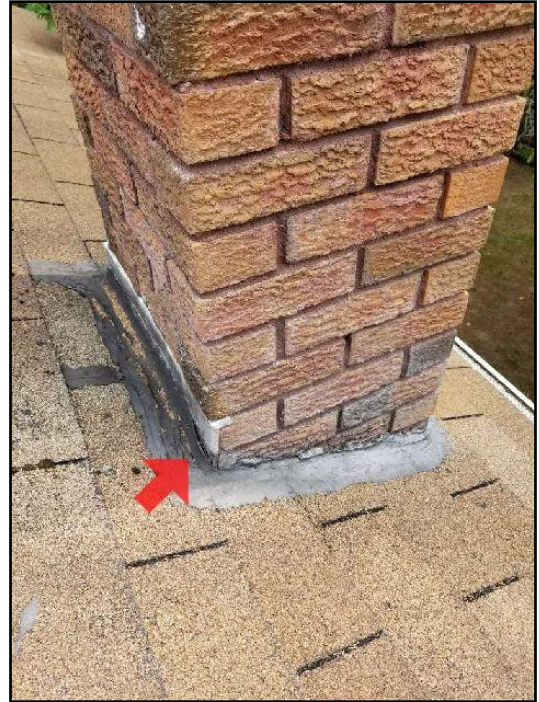
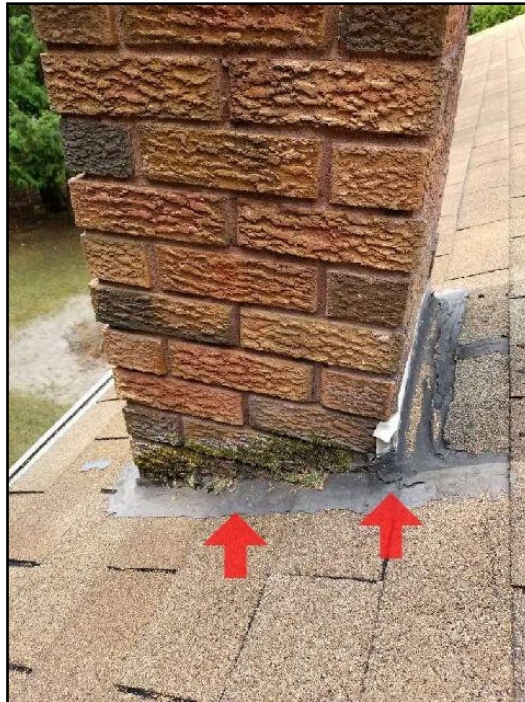
7. Condition: • [Damage, loose, open seams, patched](#)

Poor/amateur flashing installation and details, excess roof cement/sealant. Monitor for cracking and repair as required. Replace/Improve during next roof replacement.

Implication(s): Chance of water damage to contents, finishes and/or structure

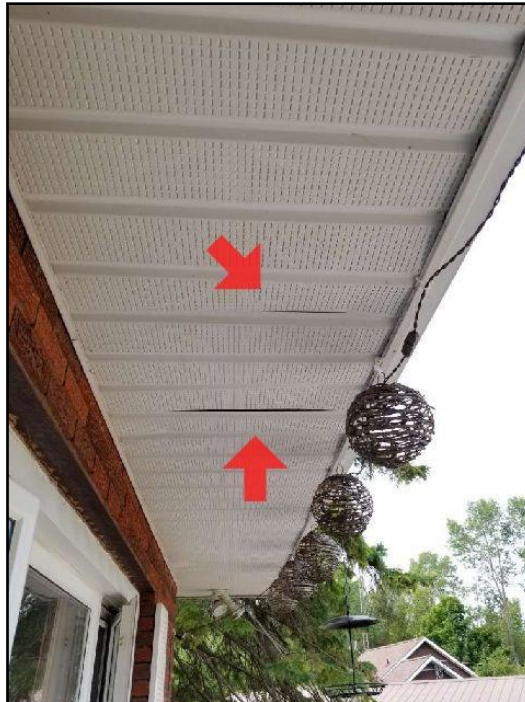
25. Damage

9. Condition: • [Damage](#)

Damage soffit, chance of pest entry.

Implication(s): Chance of water damage to contents, finishes and/or structure

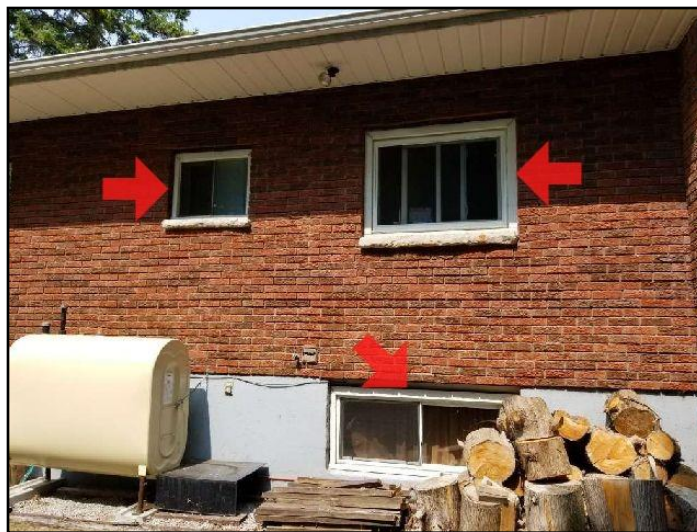
27. Paint and Caulking - deteriorated / missing

11. **Condition:** • Paint and Caulking - deteriorated / missing

Exterior caulking on windows requires ongoing maintenance. Monitor regularly and repair/maintain as required.

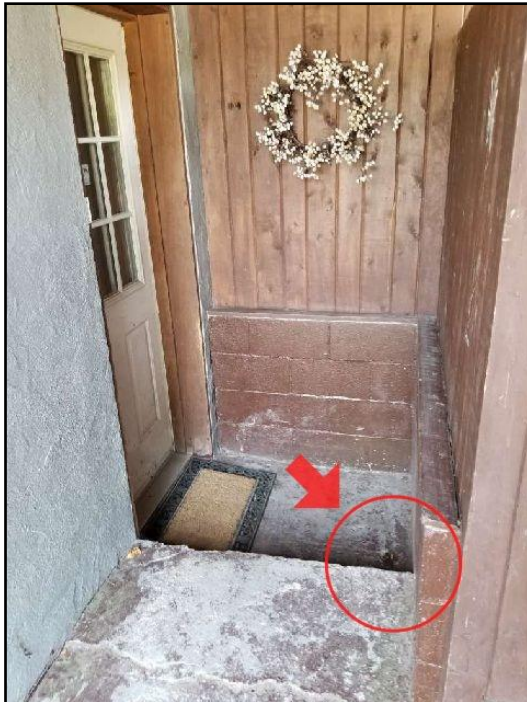
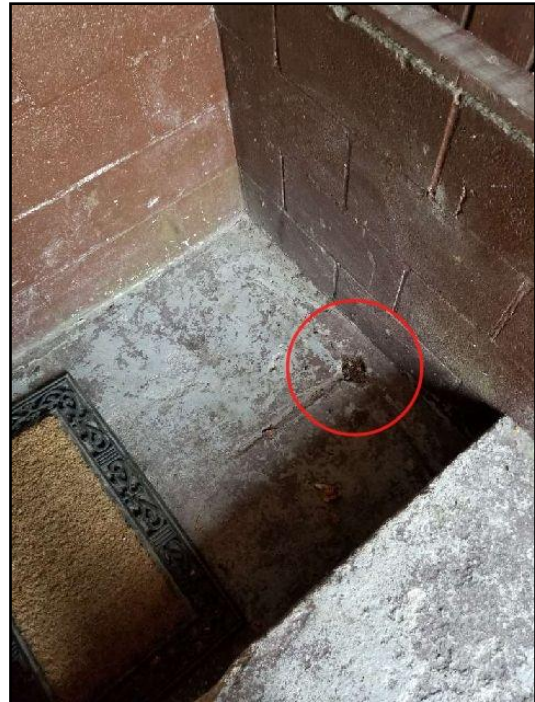
14. Condition: • [Drains missing, clogged or undersized](#)

Implication(s): Chance of water damage to contents, finishes and/or structure

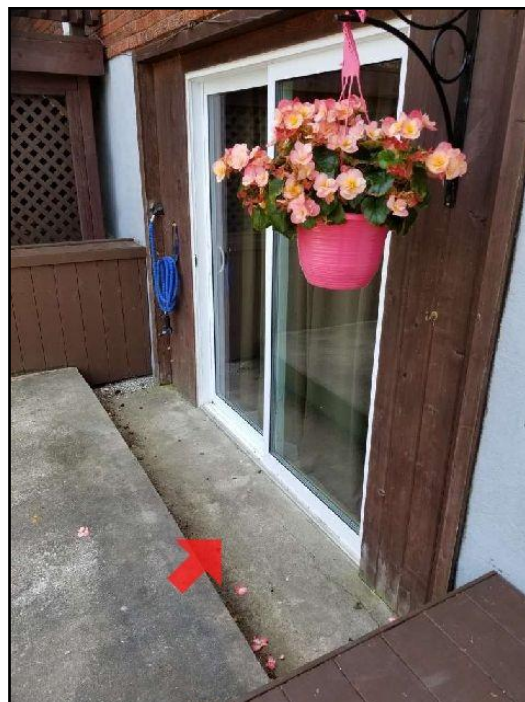
38. Door threshold missing, too low, not...

15. Condition: • [Door threshold missing, too low, not watertight](#)

Implication(s): Chance of water damage to contents, finishes and/or structure

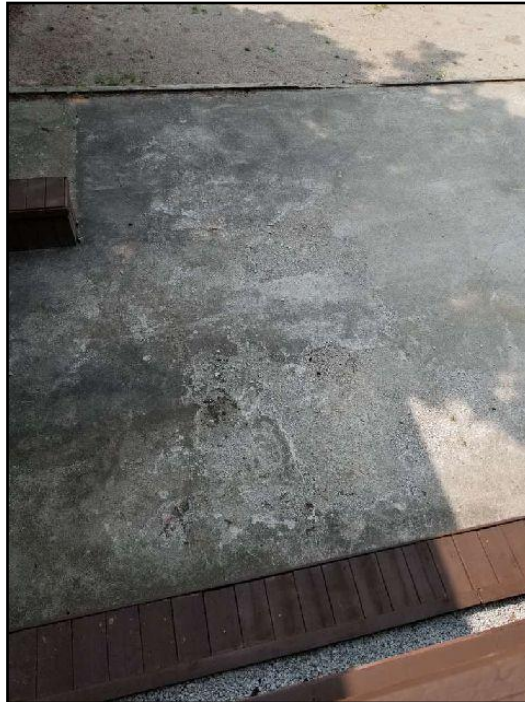
39. Cracked or damaged surfaces

16. Condition: • [Cracked or damaged surfaces](#)

Implication(s): Trip or fall hazard

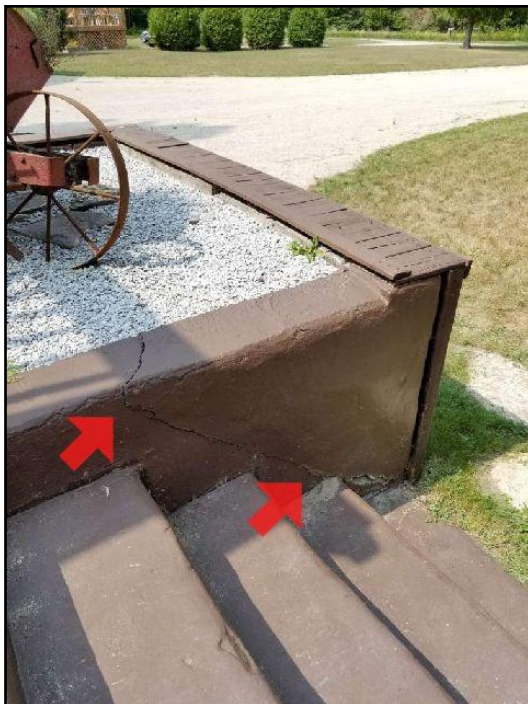
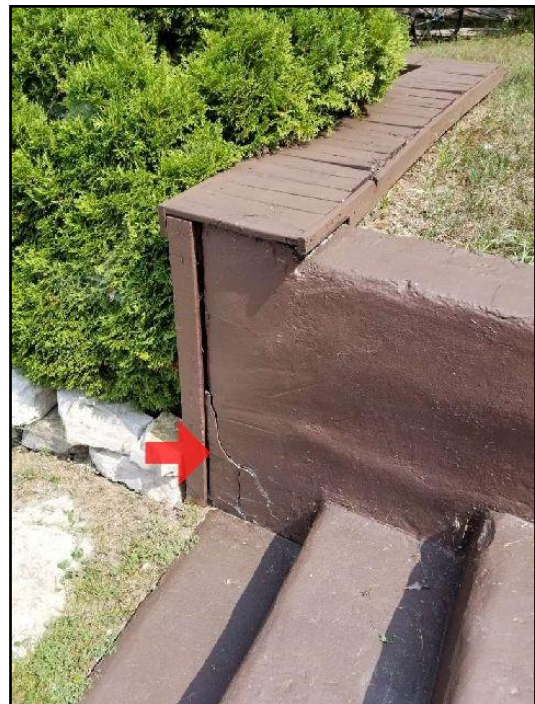
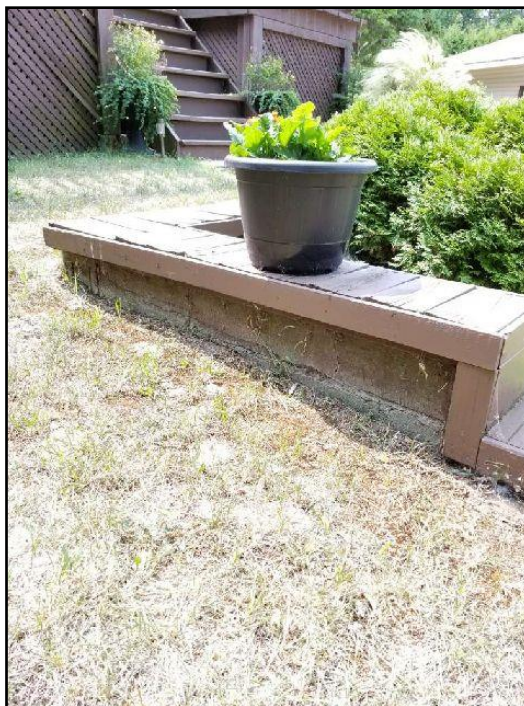
17. **Condition:** • [Cracked](#)

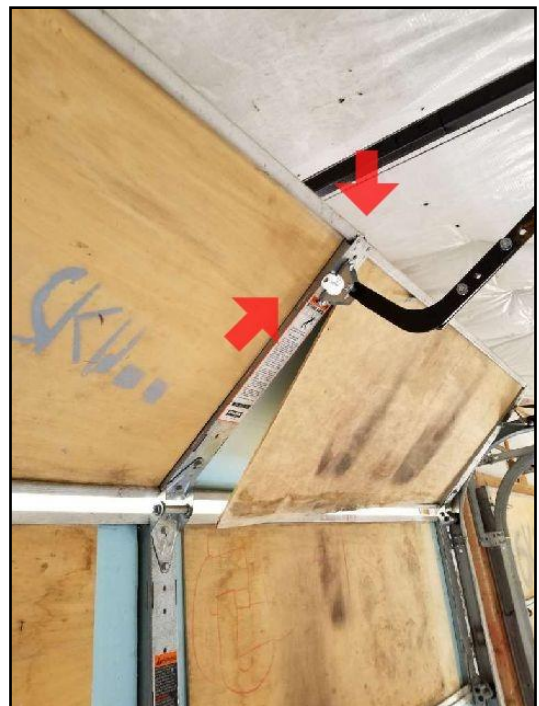
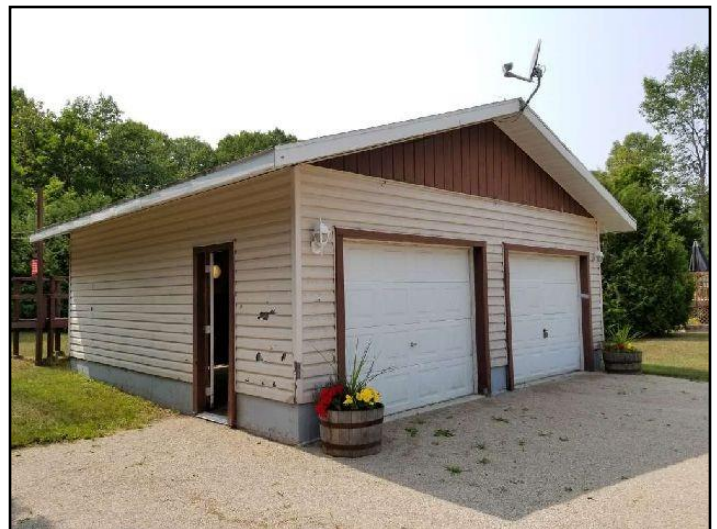
18. Condition: • Disrepair

Garage is generally in poor state of repair and shows lack of maintenance. Siding is damaged, interior insulation is in poor condition, right garage door upper panel is damaged and shows notable flex when actuated by opener, roof has a number of loose fasteners. See pictures for further details.

Implication(s): Chance of water damage to contents, finishes and/or structure | Reduced operability

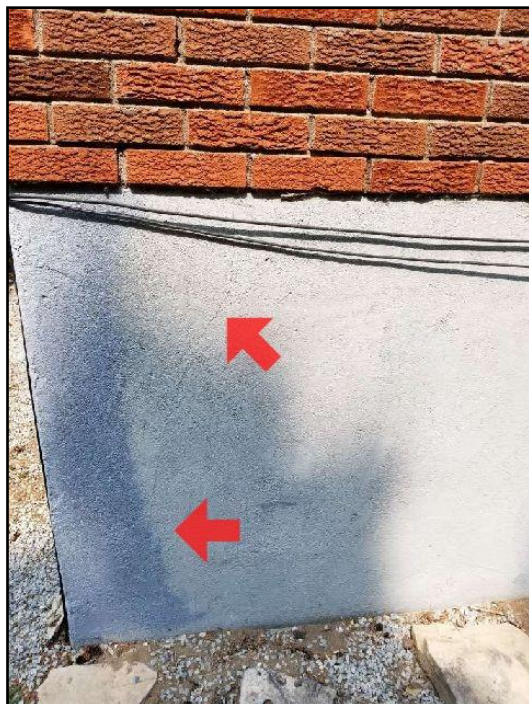
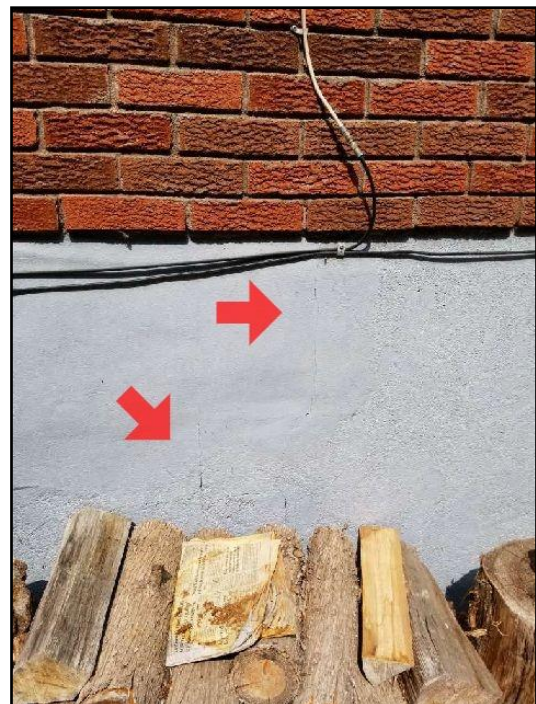
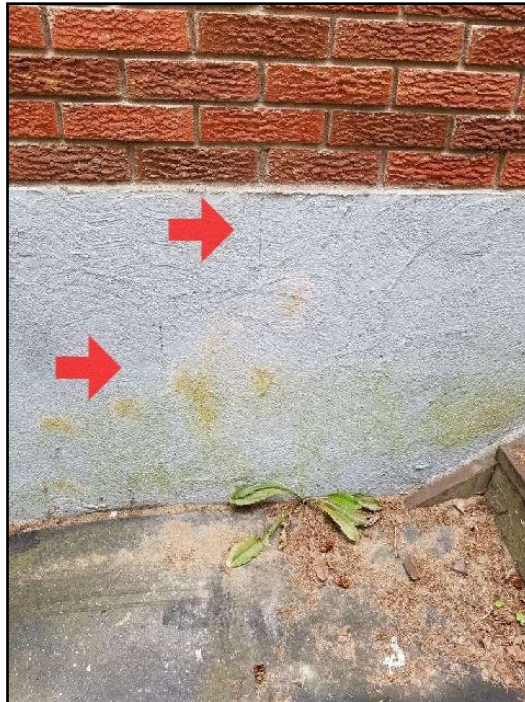
19. Condition: • Typical minor cracks

Typical minor cracking, monitor for change and repair as necessary.

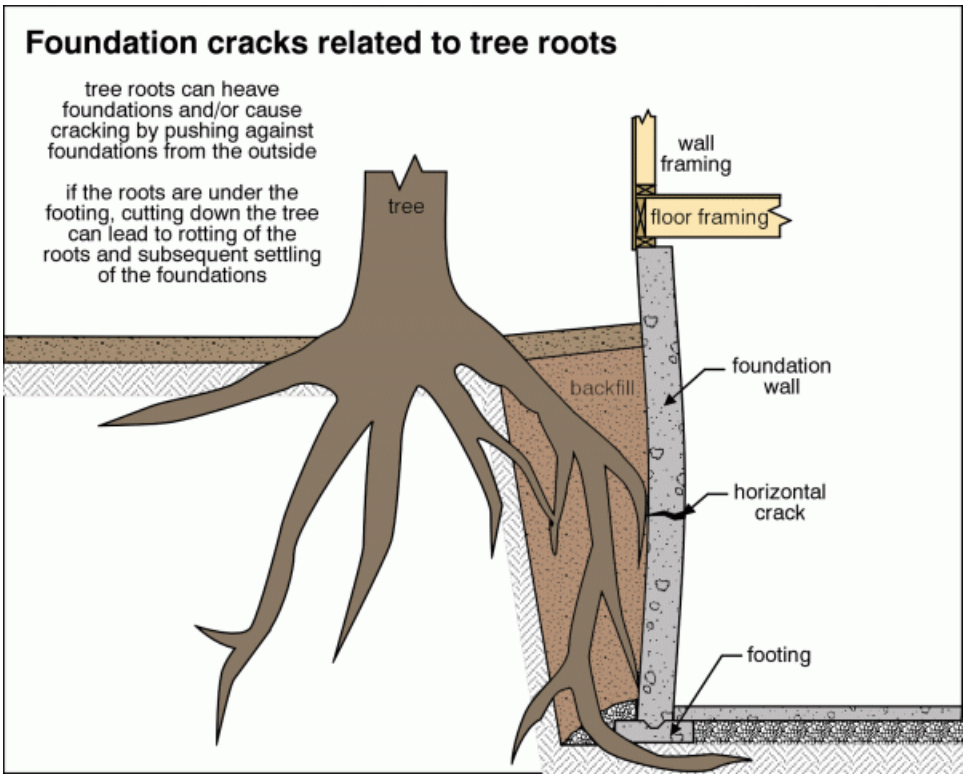
61. Large trees close to building

20. Condition: • [Large trees close to building](#)

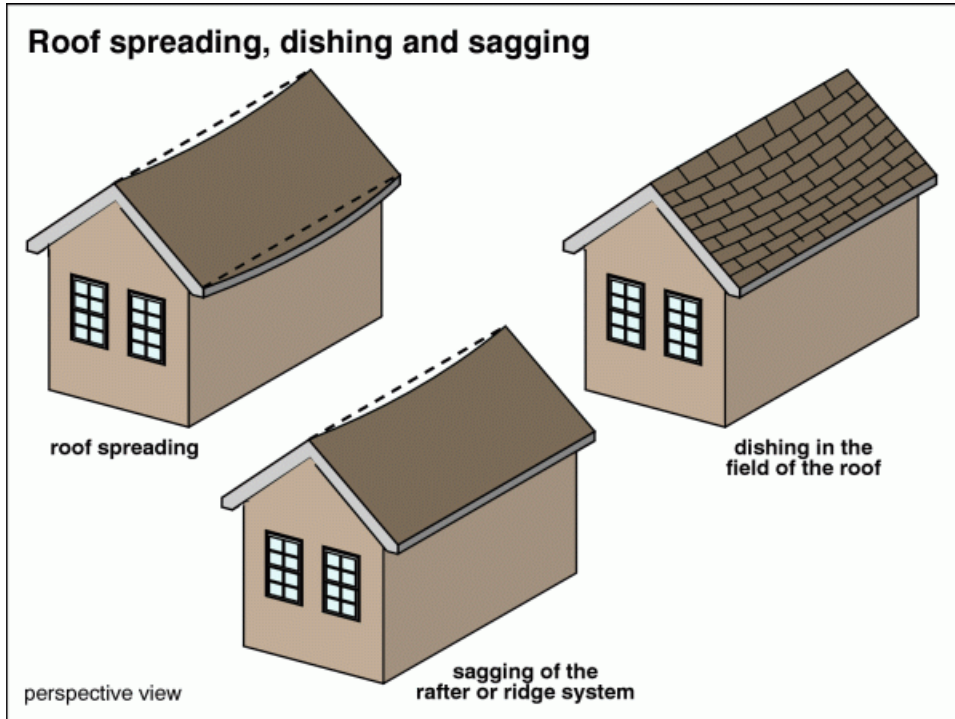
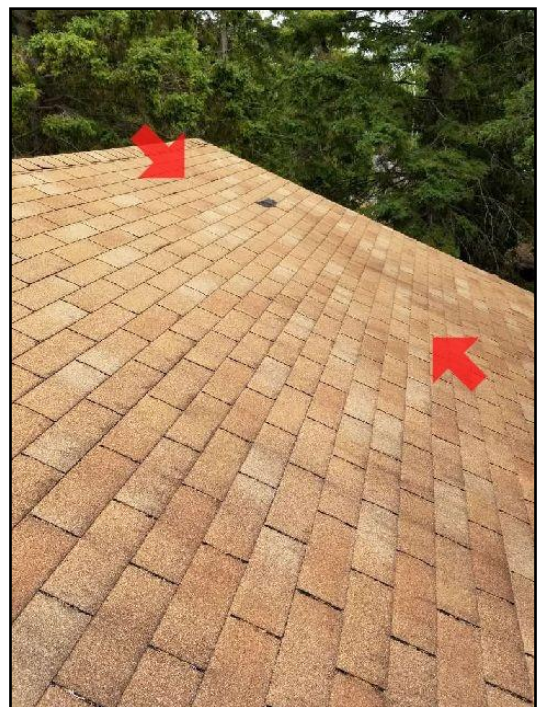
21. Condition: • [Sagging](#)

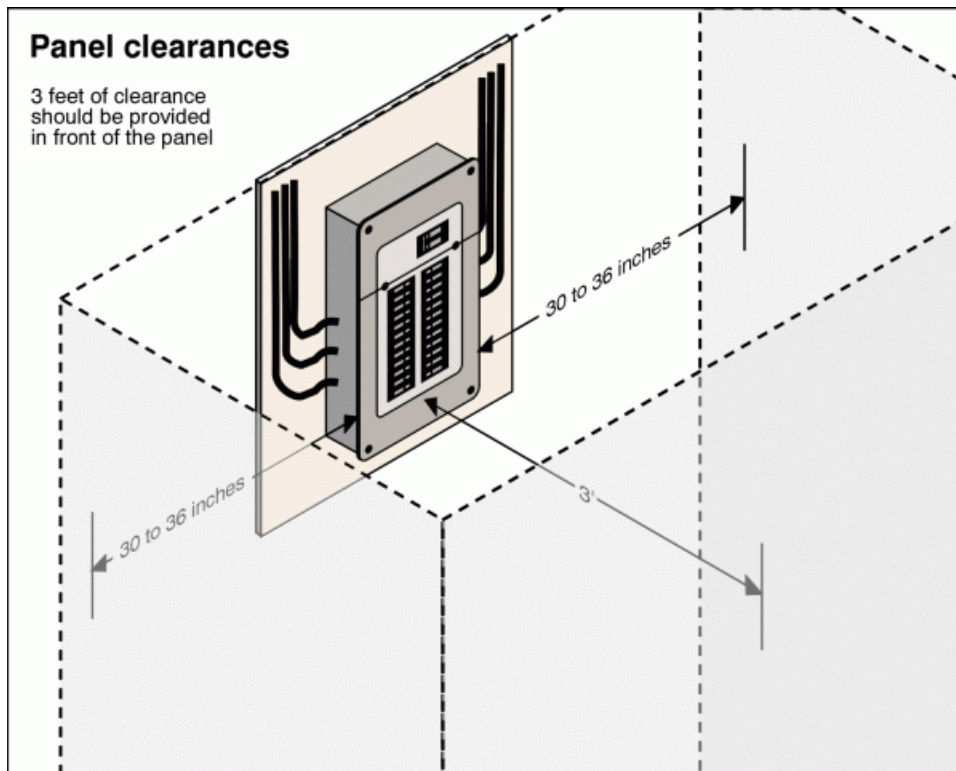
75. Box location poor

23. Condition: • [Box location poor](#)

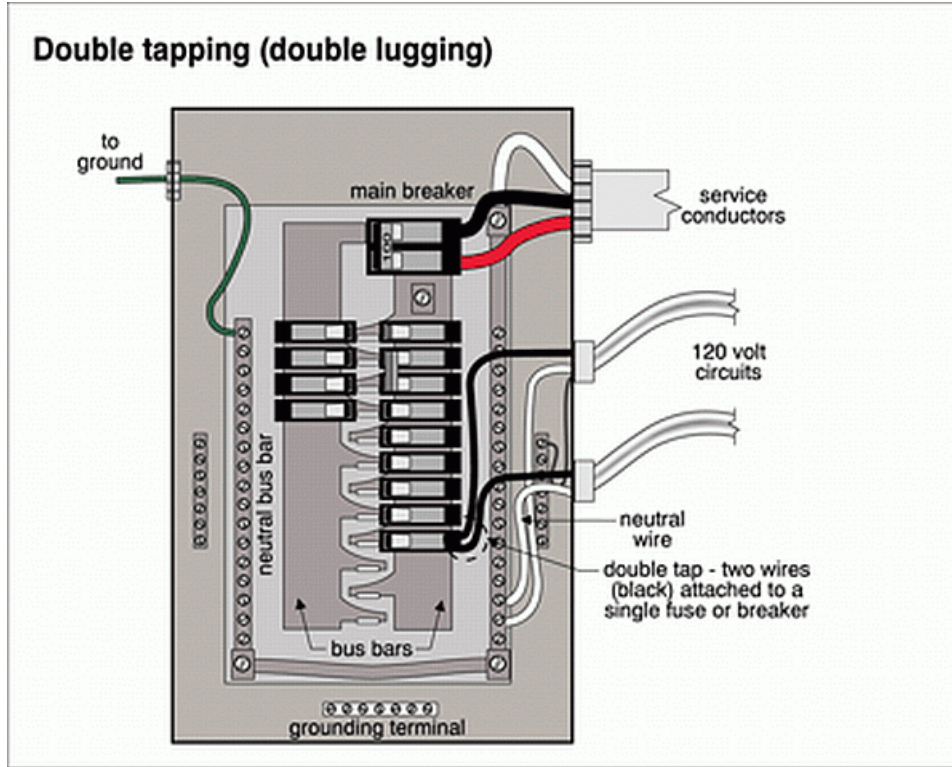
76. Double taps

24. Condition: • [Double taps](#)

Implication(s): Fire hazard

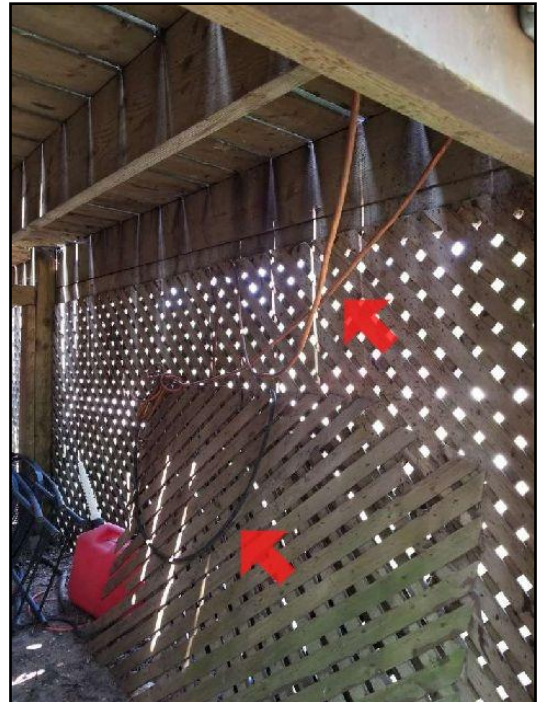
80. Extension cords for exterior outlets...

25. Condition: • [Extension cords for exterior outlets \(receptacles\)](#)

Implication(s): Electric shock | Fire hazard

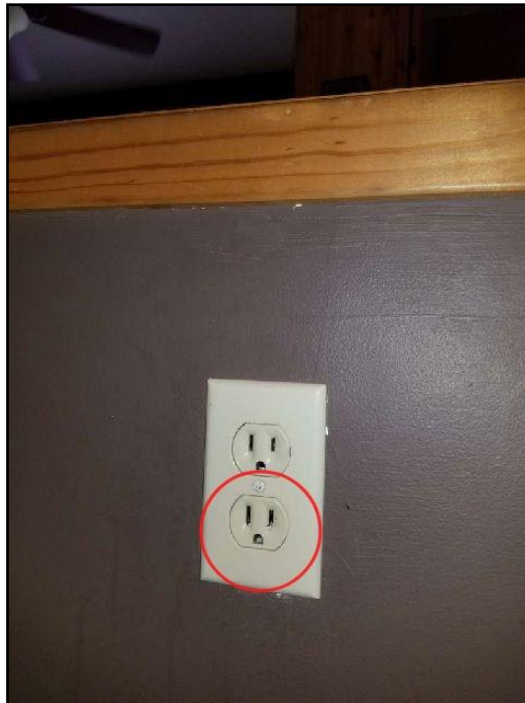
82. *Damage*

26. Condition: • [Damage](#)

Implication(s): Electric shock | Fire hazard

Location: First Floor Staircase

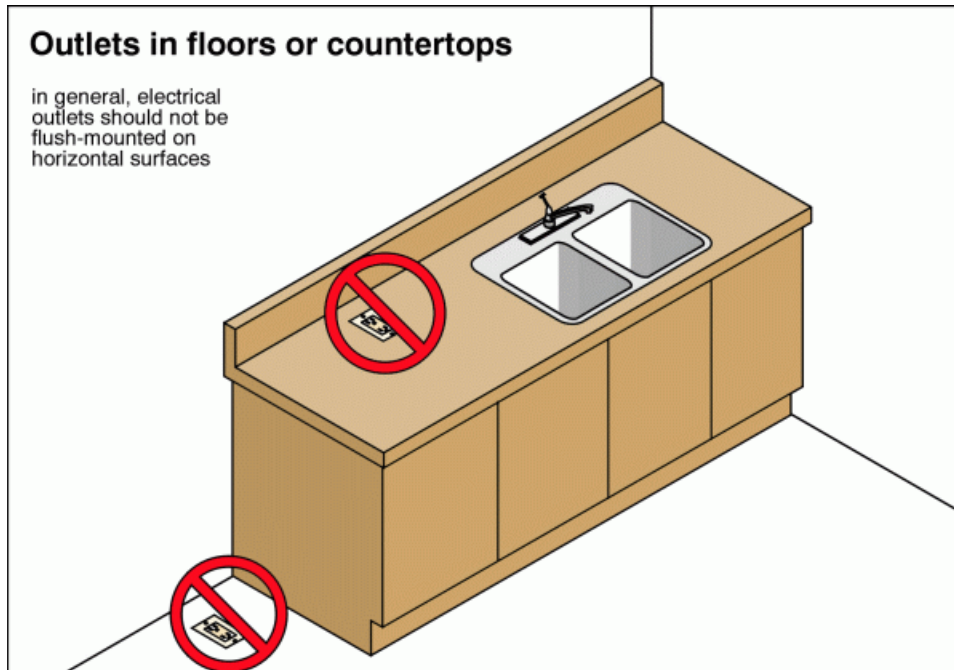
86. In floors or countertops

28. Condition: • [In floors or countertops](#)

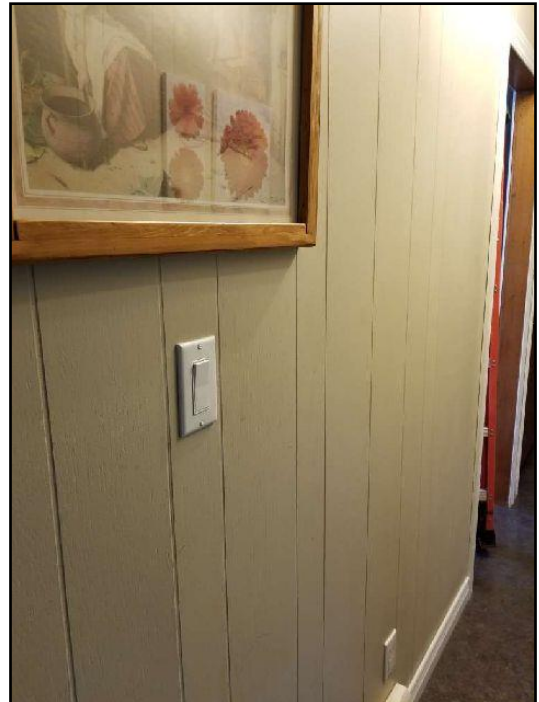
88. Inoperative

29. Condition: • [Inoperative](#)

Implication(s): Inadequate lighting

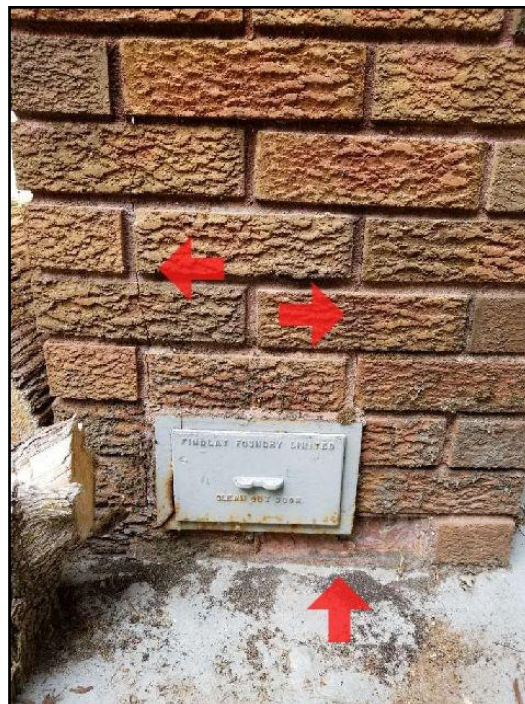
102. Spalling

32. Condition: • [Spalling](#)

Some initial spalling/cracking of brick at base of chimney.

Implication(s): Material deterioration

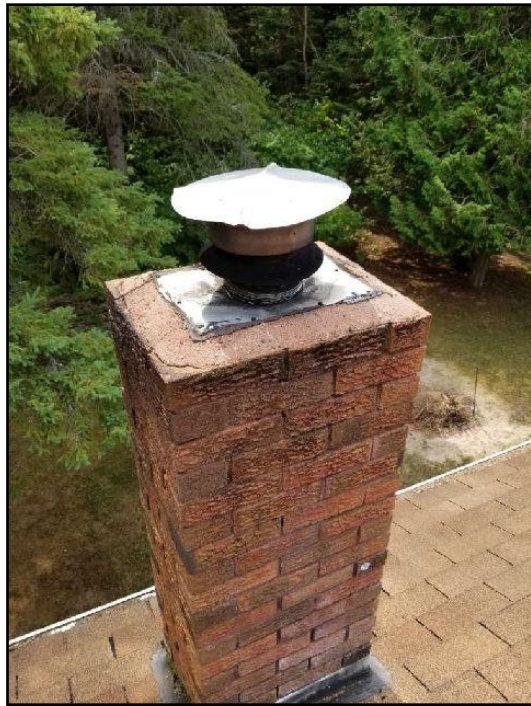
103. Missing

33. Condition: • [Missing](#)

Implication(s): Chance of water damage to contents, finishes and/or structure | Shortened life expectancy of material

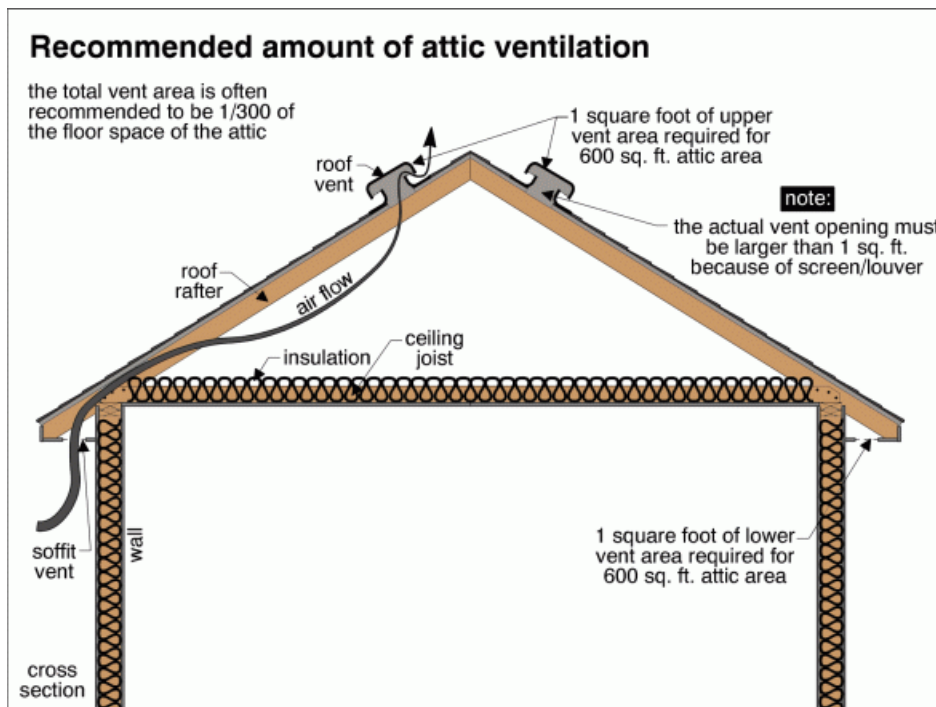
34. Condition: • [Missing](#)

There were no roof vents observed and no airflow detected while in attic. This will cause premature deterioration of roof and may have been contributing factor to observed mold in attic due to condensation. Gable vents could also be added for additional air flow.

Implication(s): Chance of condensation damage to finishes and/or structure

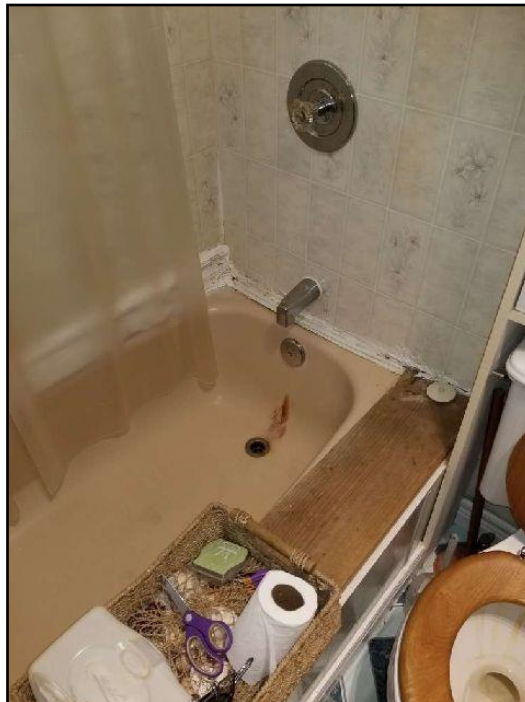
116. Not smooth, impervious or water resistant

37. Condition: • [Not smooth, impervious or water resistant](#)

Severe water damage of lower trim in bathtub area, exposed wood. Likely water damage into wall area.

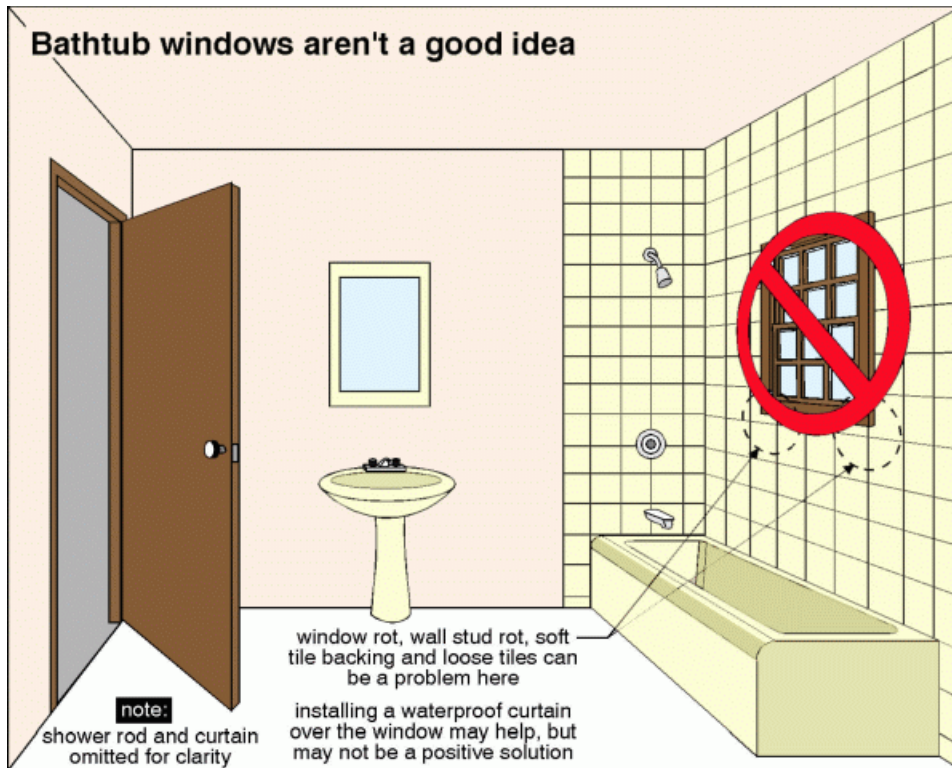
117. Unprotected window

38. Condition: • [Unprotected window](#)

Implication(s): Chance of damage to finishes and structure

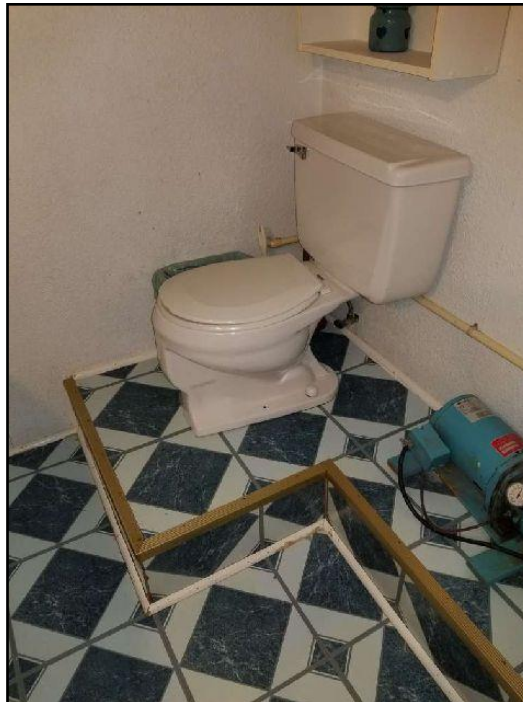
118.

39. Condition: • Poor location of toilet, likely installed on top of waste plumbing clean-out.

Implication(s): Improper plumbing practice.

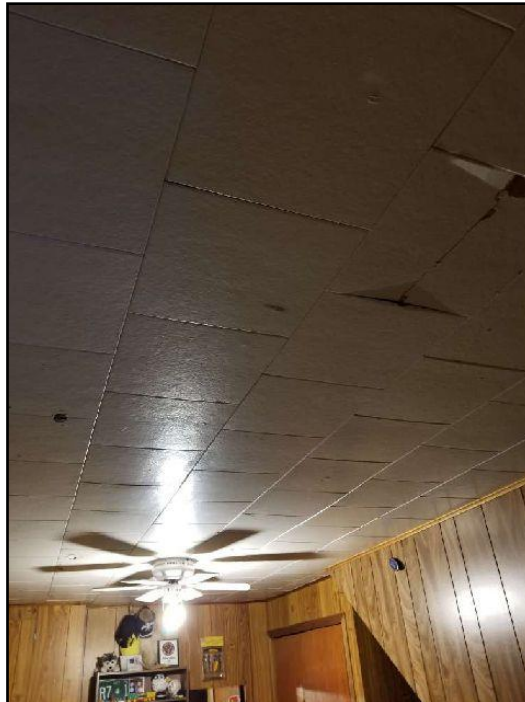
120. Damage

41. Condition: • Damage

Implication(s): Damage or physical injury due to falling materials

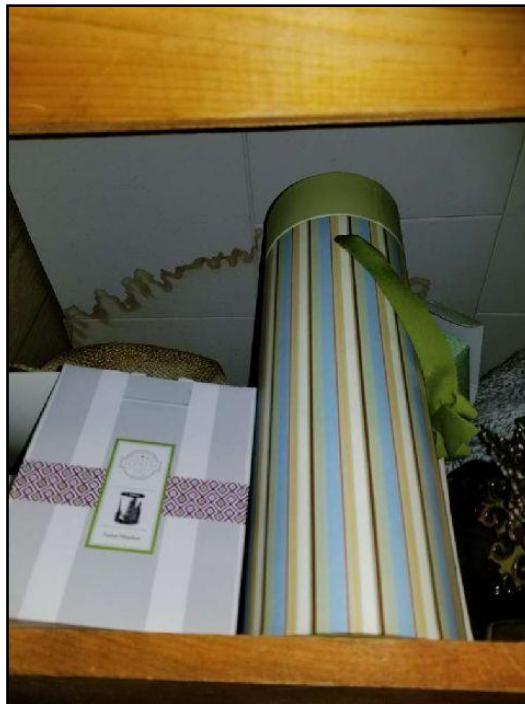
121. Water stains

42. Condition: • Water stains

Bedroom closet, area runs beside plumbing vent stack, likely due to leakage from vent stack/vent stack flashing.

Implication(s): Chance of water damage to contents, finishes and/or structure

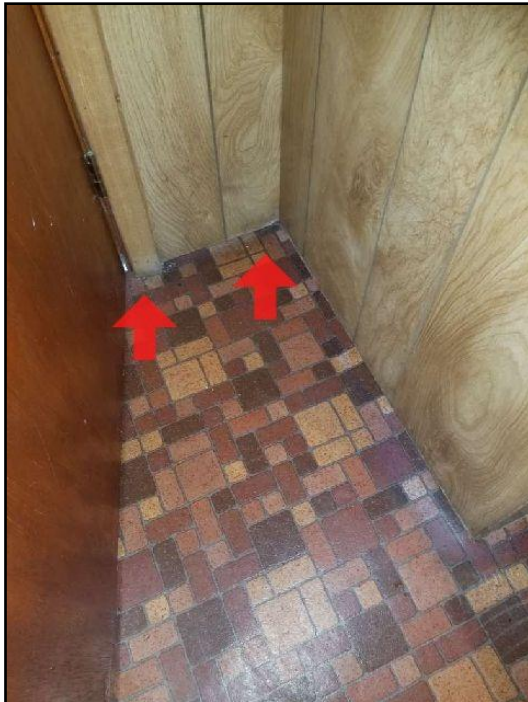
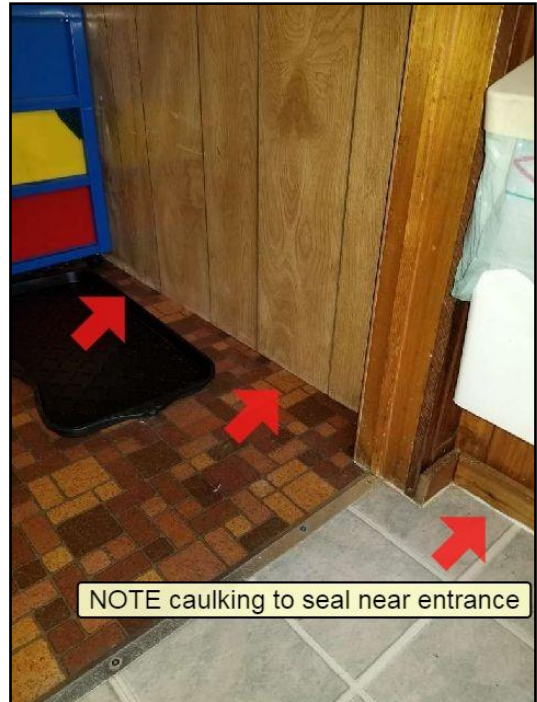
43. Condition: • Water stains

Minor staining of lower paneling and baseboards near rear entrance.

Implication(s): Chance of water damage to contents, finishes and/or structure

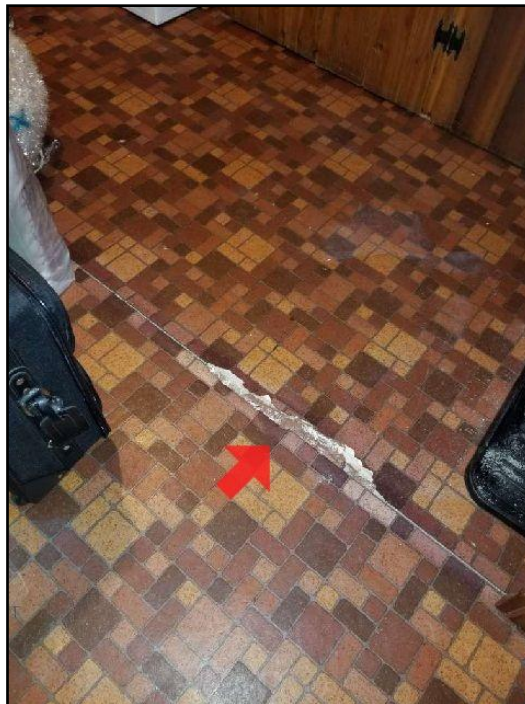
124. Damage

44. Condition: • Damage

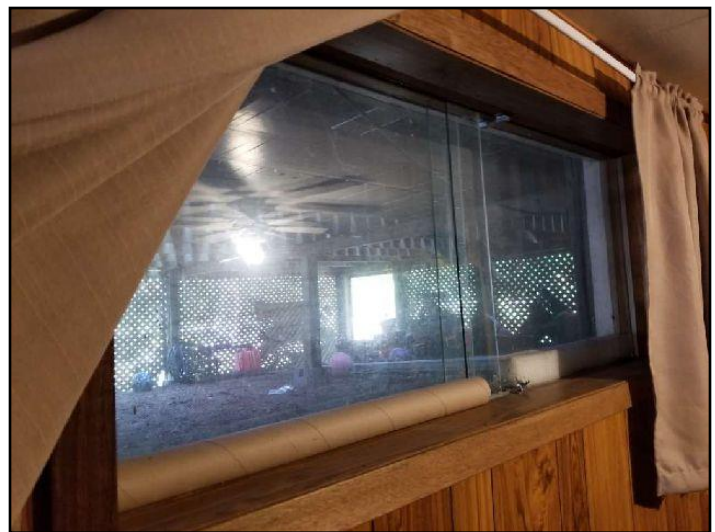
128. Original lower quality units

46. Condition: • [Original lower quality units](#)

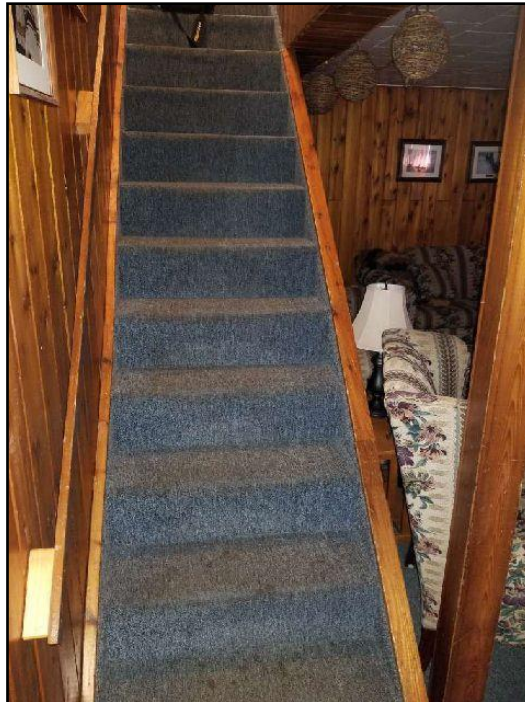
129. Missing

47. Condition: • [Missing](#)

Implication(s): Fall hazard
