Fire Department Apparatus Fleet Review

West Barnstable, Massachusetts

East West Fire Apparatus Consultants Inc.

August 3, 2015

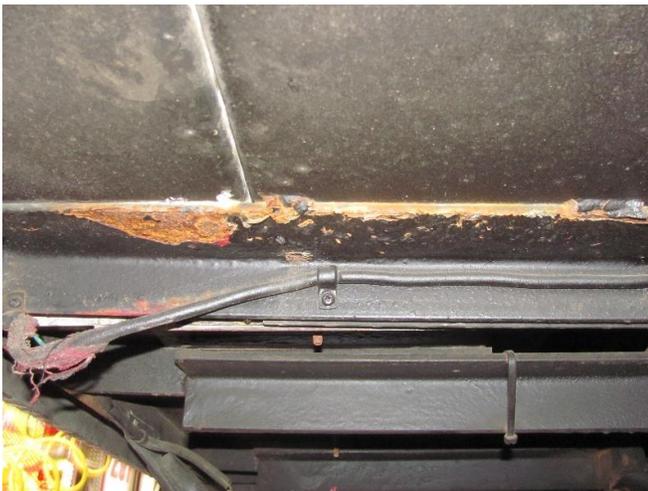
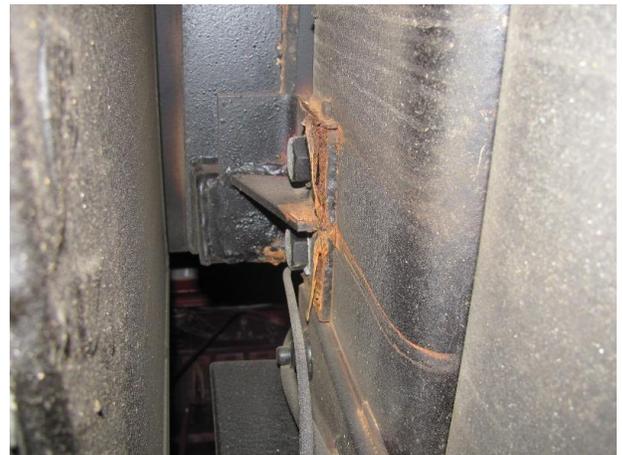
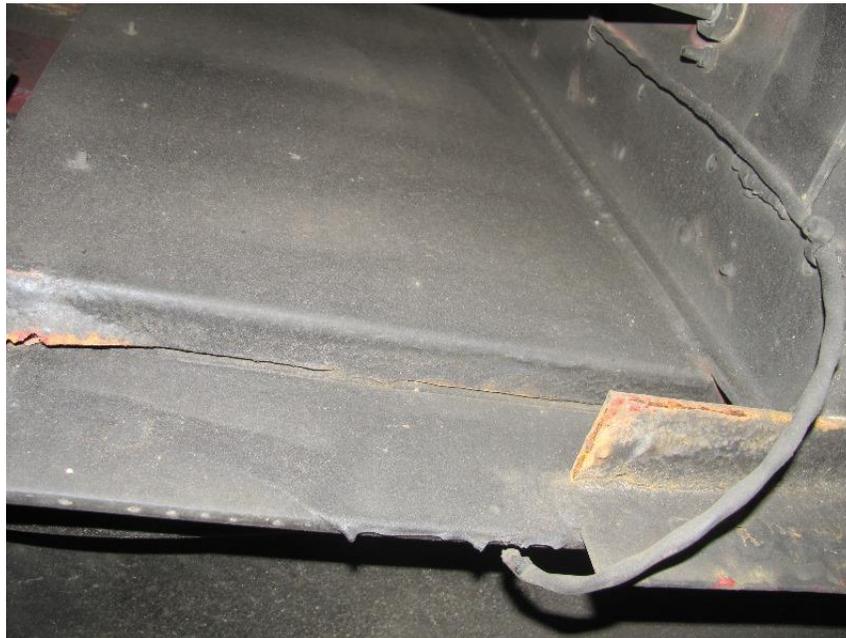
There is some rust beginning to show on various areas of the chassis and/or its components. This can be expected with a vehicle of this age and none of the rust observed appeared to be structural in nature. Removing the rust scales with a wire brush and sealing the rusted spots with good oil base paint like Rustoleum's Damp Proof Red primer will help keep the rust in check. Figures 4, 5 & 6.

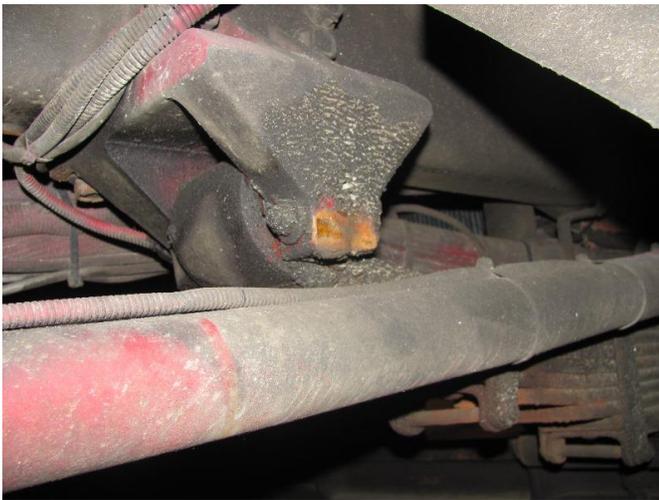
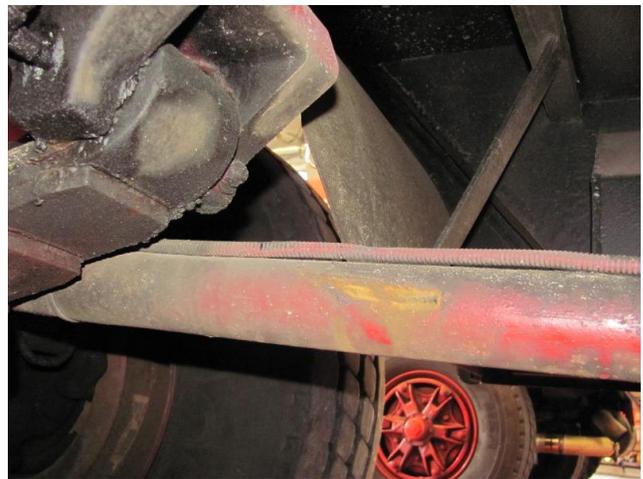
The drag link on the steering system hits one of the left front leaf spring shackles when the steering is exercised. The contact point does not appear to be too old or too severe. Inspection of the leaf spring did not show any cracked leaves. The drag link joints, pitman arm, and steering arm should be checked for wear and alignment. Figures 7 & 8.

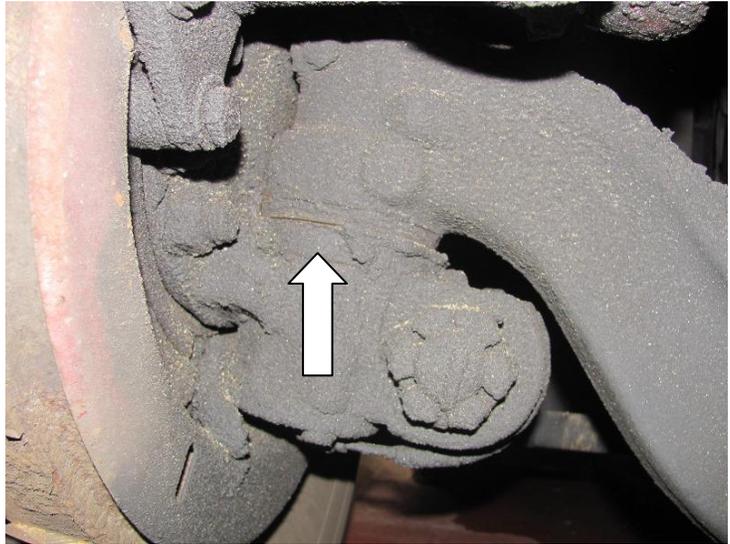
Right front wheel lower king ping.

There is some evidence that the Vogel (now SKF) auto lube system is not working. Many of the grease fittings that are connected to the system show a lack of fresh grease in the joints. Other joints show some more recent grease being present, an improvement but still not what you expect to see. Compounding the situation is that there is an accumulation of road dirt in and around grease areas that make it harder to observe exactly what is happening. The auto lube system should be checked for the proper grease (a critical point) and proper operation. The chassis should be cleaned, especially in areas where there are components that need to be greased and are hooked up to the auto lube system so that the operation can be monitored. Figures 9 & 10.

Notice: The lack of grease and the dry nature of the pivot joint located above the arrow.

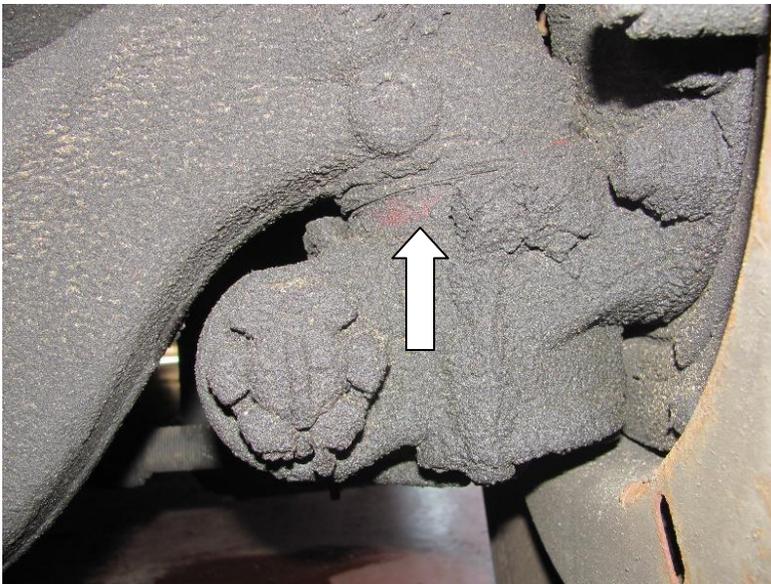
Figure 10

Left front wheel lower king ping.

Notice: The lack of grease and the dry nature of the pivot joint located above the arrow.

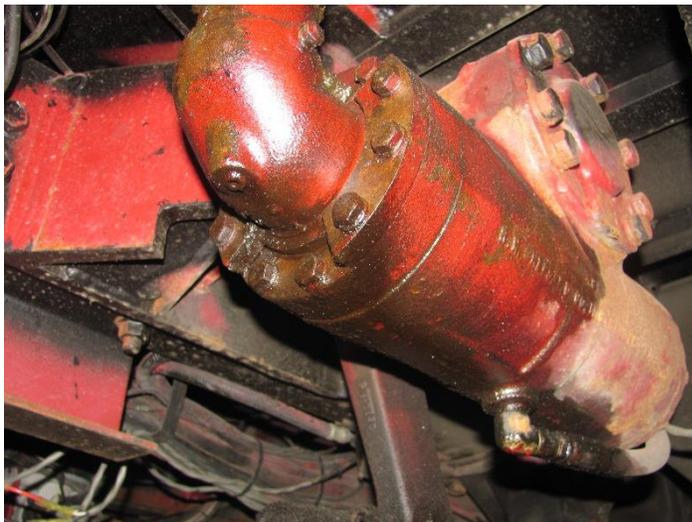
Figure 11

The power steering box is wet from oil, but there was no dripping observed. This should be cleaned of the oil residue and checked periodically to determine where the residue is coming from and whether or not it is an indication of a developing problem. Figure 11.

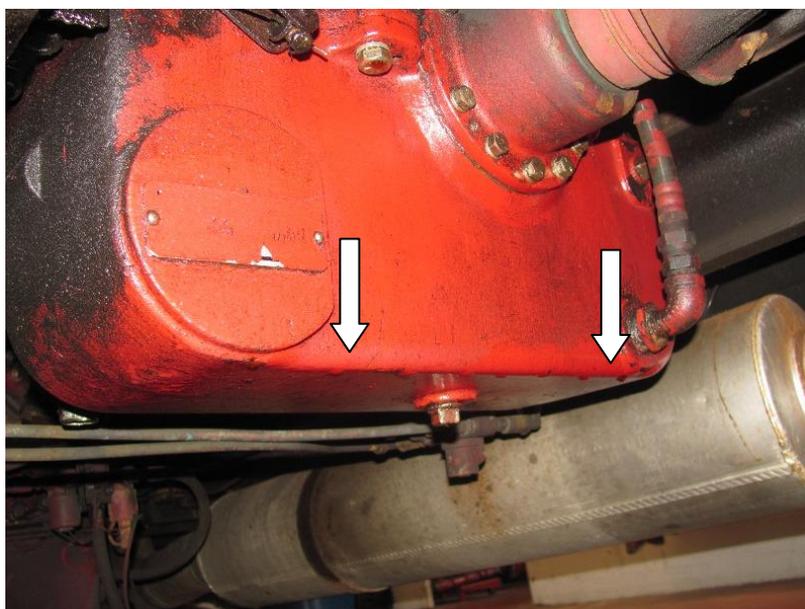
Figure 14

Though difficult to see in the picture because both the fluid and the pump transmission are red in color, there appears to be a hydraulic fluid leak in the pump transmission. Droplets of hydraulic fluid used are forming along the bottom edge of pump transmission. This leak could be as simple as the pump transmission being overfilled when cold and then as the transmission fluid warms up and expands the excess is pushed out of the breather or there may be a leak in pump transmission. The outside of the pump transmission should be cleaned and the situation observed. Figure 14.

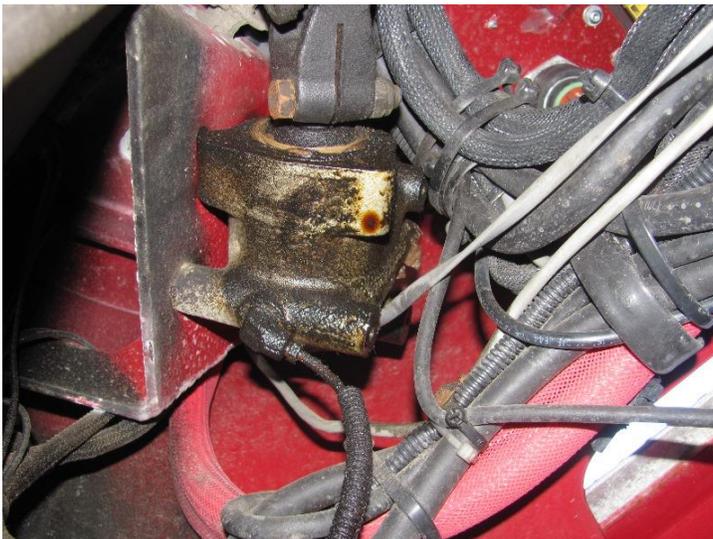
Figure 16

First let's look at the more minor items. There is a leak coming from the steering miter box. Figure 16. The miter box allows the steering column actuation to change direction. Since this leak meets the NFPA criteria for a Class 3 it does create an out of service condition. The steering miter box should be checked and repaired as needed.

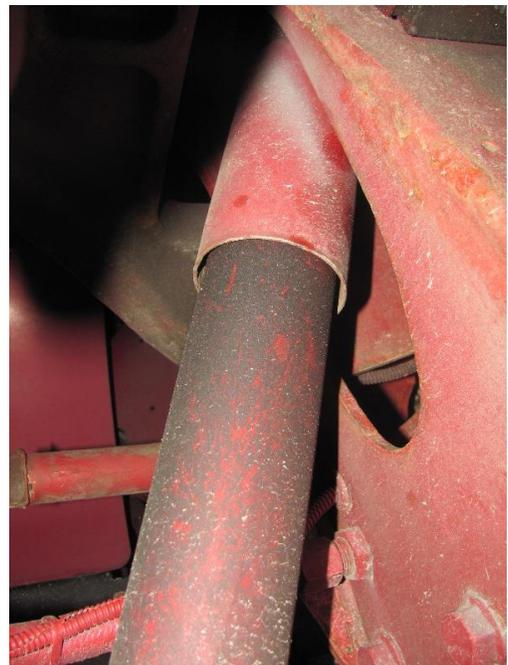
Figure 17 shows a front shock absorber with oil darkening taking place on the lower tube. This was apparent on both front shocks when the apparatus was inspected. This condition usually means that the shock absorbers have developed an oil leak and are in need of replacement.

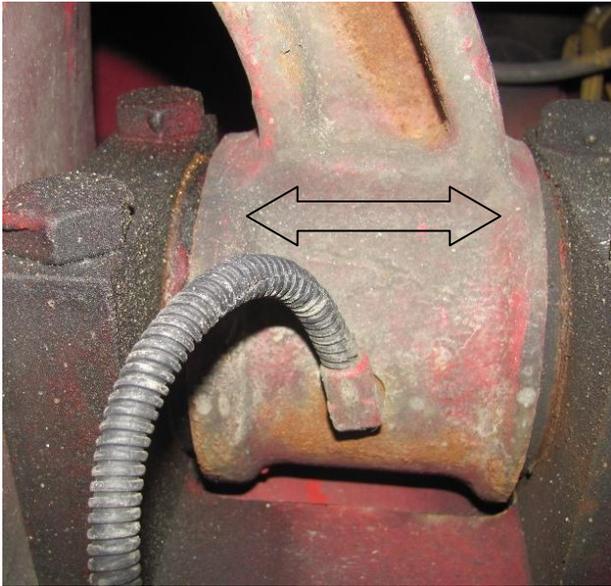
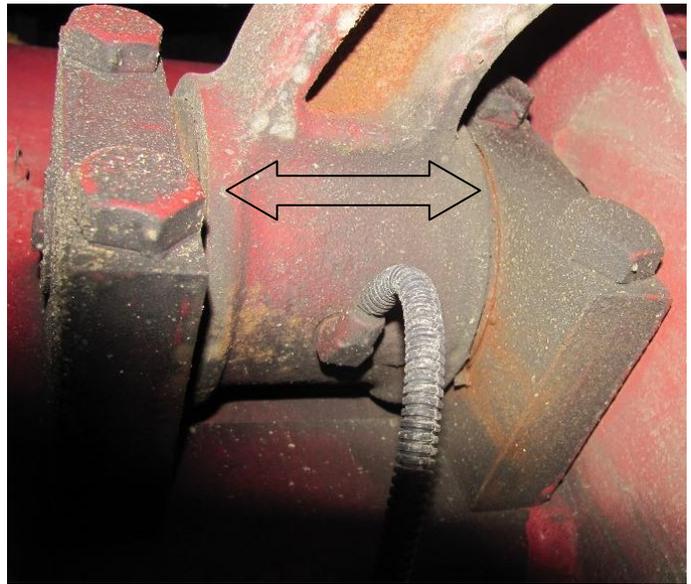
The Vogel (now SKF) auto lube system in this apparatus is also not working. Many of the grease fittings that are connected to the system show a lack of fresh grease in the joints. The

auto lube should be checked for proper grease (a critical point), proper operation, and repaired as needed. Figures 18 & 19.

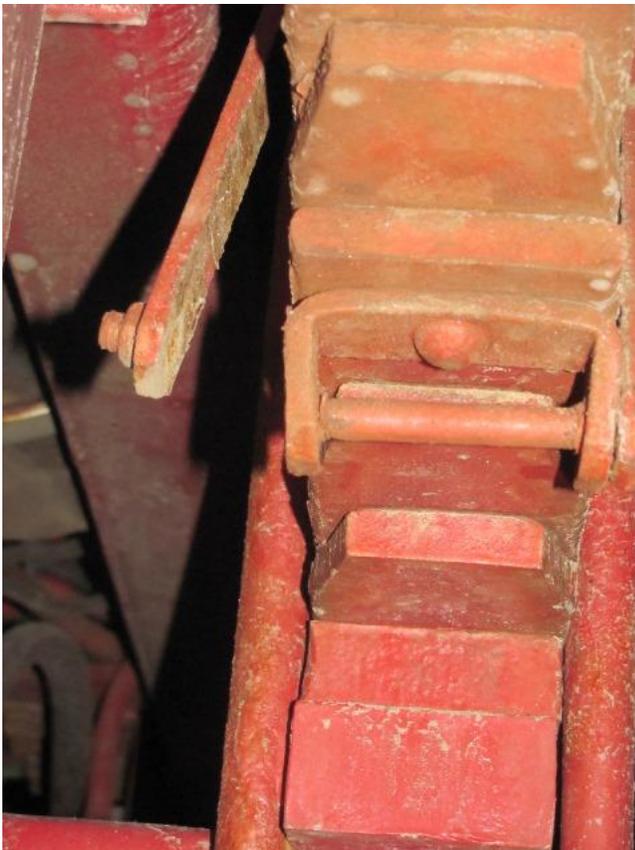
Figure 20

The right rear leaf spring has a broken retention strap (rebound clip). Figure 20.

“The secondary function of the rebound clips is to prevent spreading or "fanning out" of the leaves, which might result in eventual breakage. For these two reasons, it is obviously important that broken rebound clips be replaced by "properly adjusted" rebound clips.” Reprinted from Suspension Specialists, Inc.

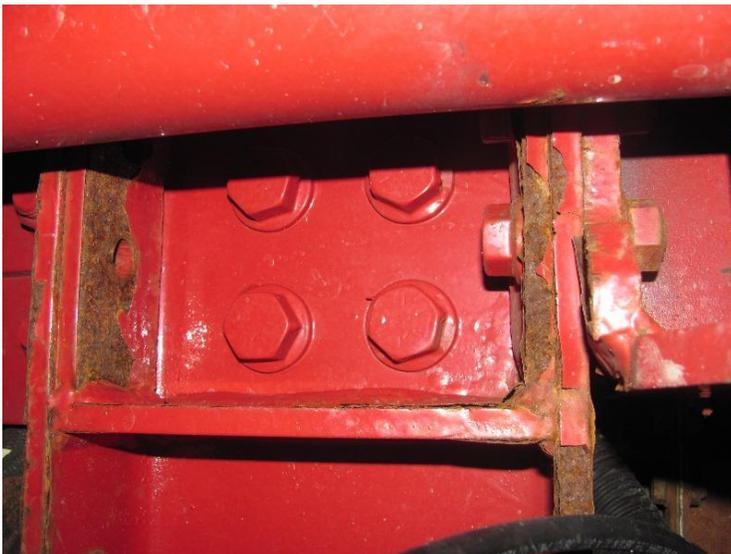
Figure 21 shows a chassis component that has paint blistering off some sections. The paint on the component is clean and free of any road deposits. Since the chassis was not cleaned and there was no special preparation prior to the picture being taken this would reinforce the theory that deicing chemicals are not the cause of all the rust/rot problems.

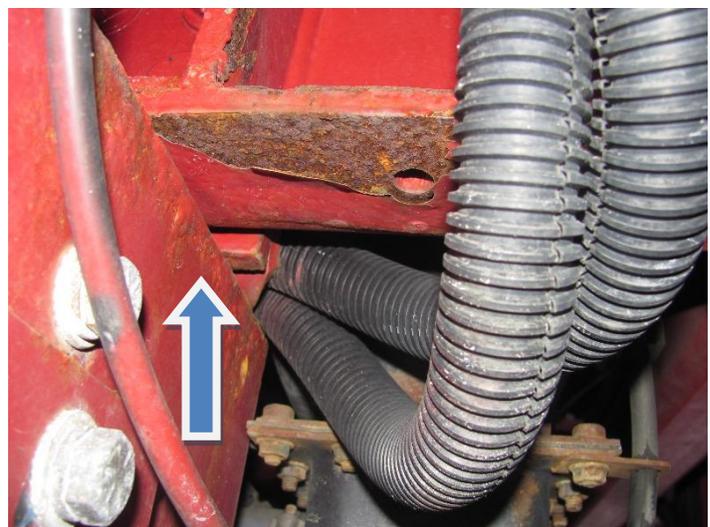
Figure 22 shows other chassis components with rust damage. The arrow is pointing to an area where the paint is blistered and rust is forming under the paint but has not yet broken through.

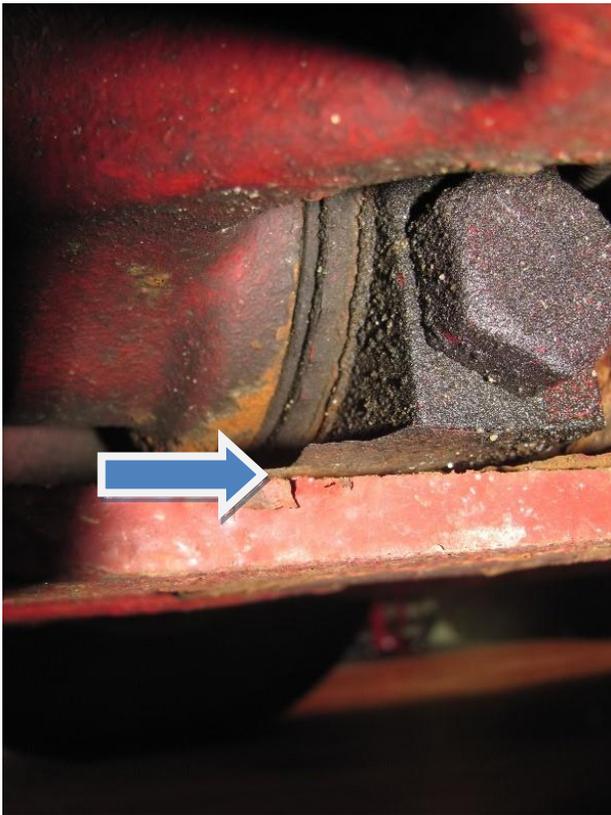
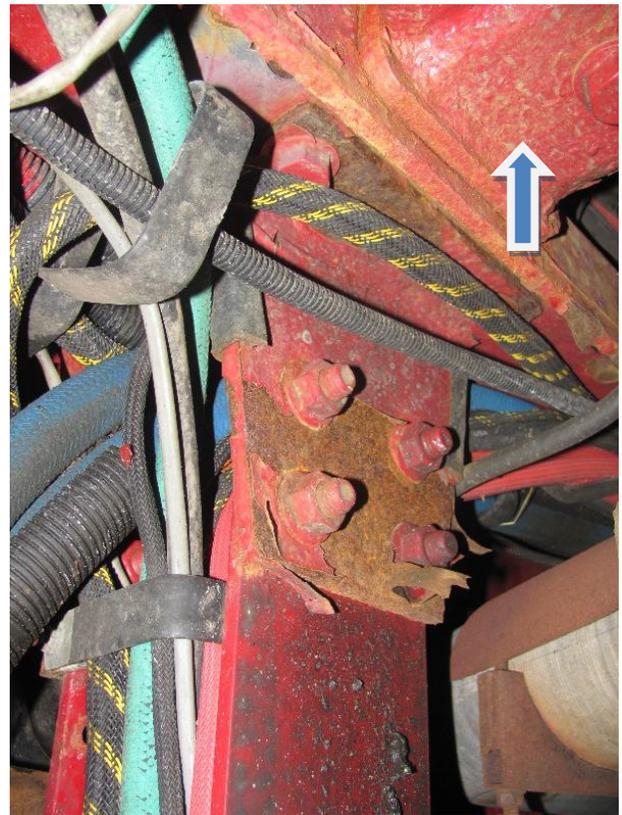
Figures 23 & 24 show more rusting problems. The arrow in figure 23 is pointing to some paint that is delaminating from the surface it is applied to. Delamination (defined by Merriam-Webster as: separation into constituent layers), is a common condition on Engine 294 and in my opinion indicates more problems than can be related to road chemicals. The arrow in figure 24 is pointing to an area previously repaired.

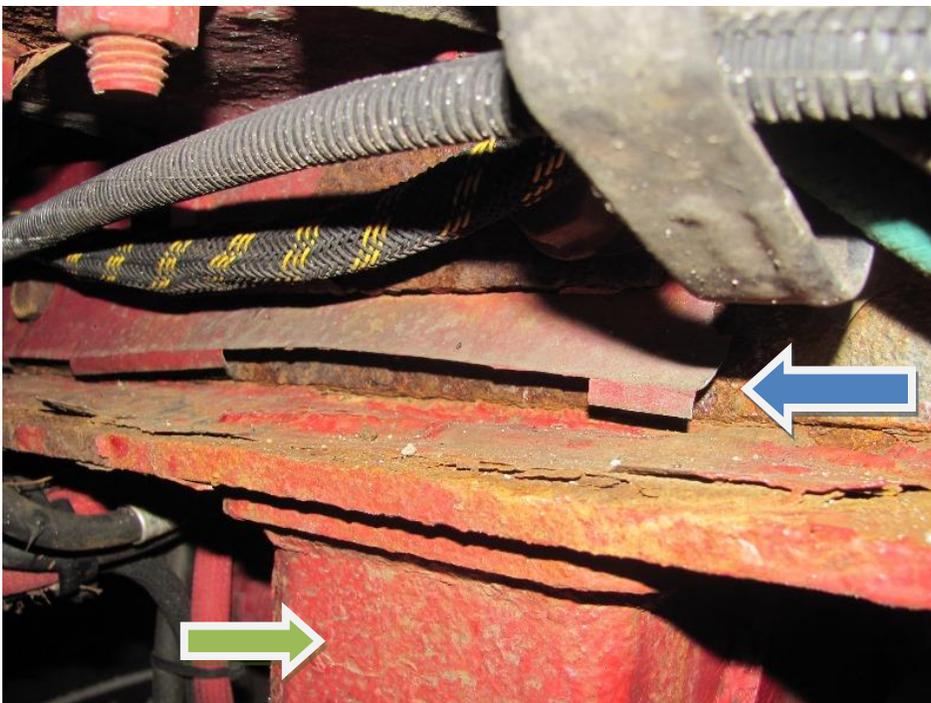
Figure 25

The blue arrow in figure 25 is pointing to the worst area of delamination observed in Engine 294. This actually looks more like a piece of sheet metal peeling away. The green arrow points to another area that had previously been repaired.

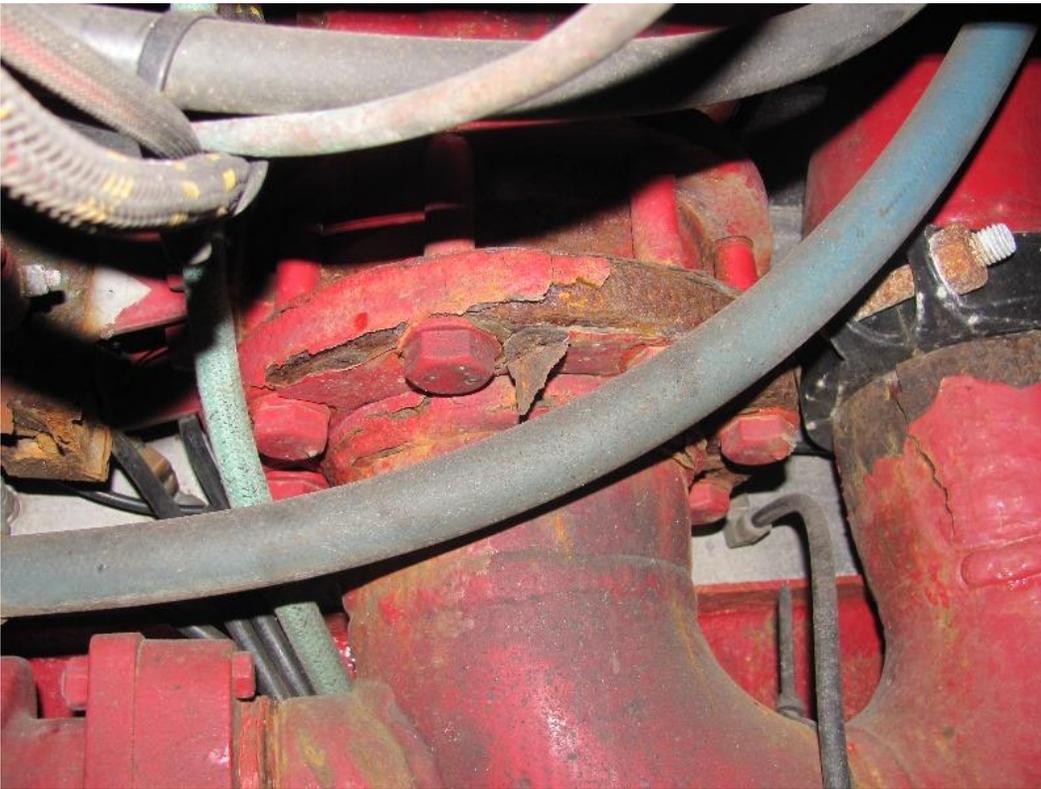
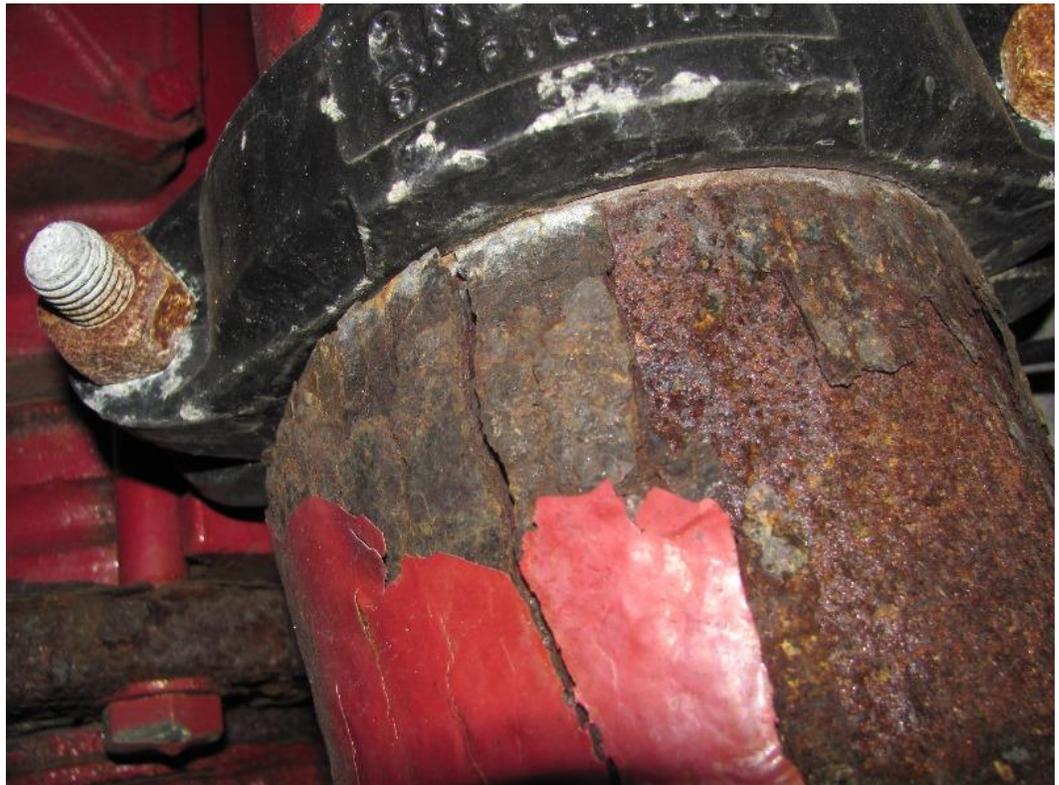
Figures 26 & 27 show the deterioration of the suction piping on the right side of the apparatus. There is rust visible on the shoulders for the butterfly valve and deep material loss to a suction pipe. Failure of the suction pipe is only a matter of time.

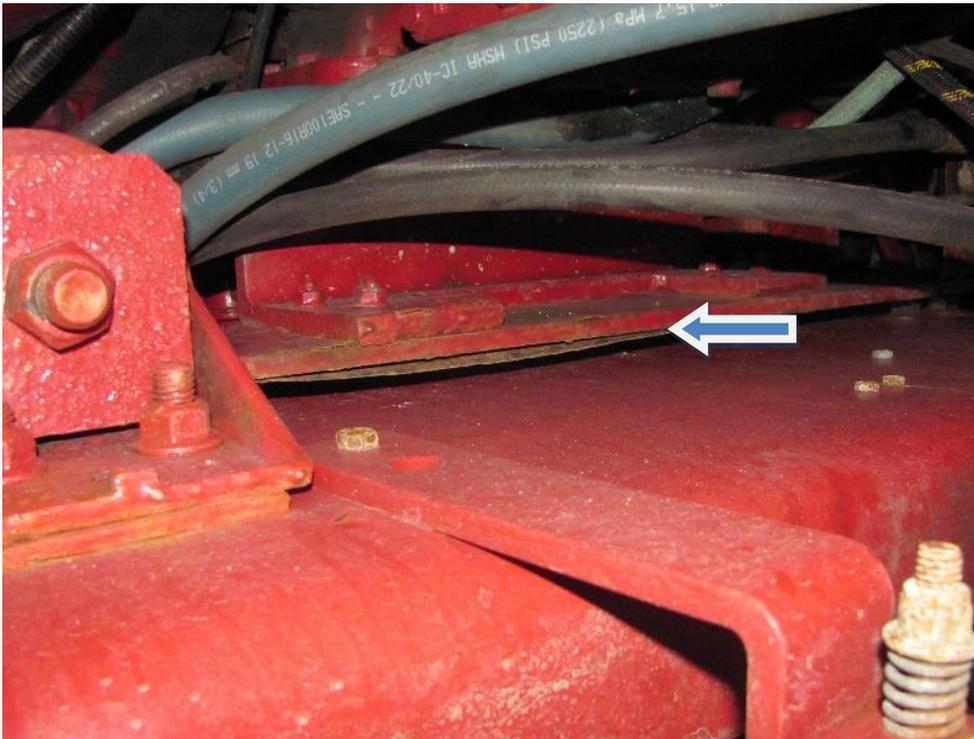
Figure 28

Another example of delamination is highlighted by the blue arrow in figure 28.

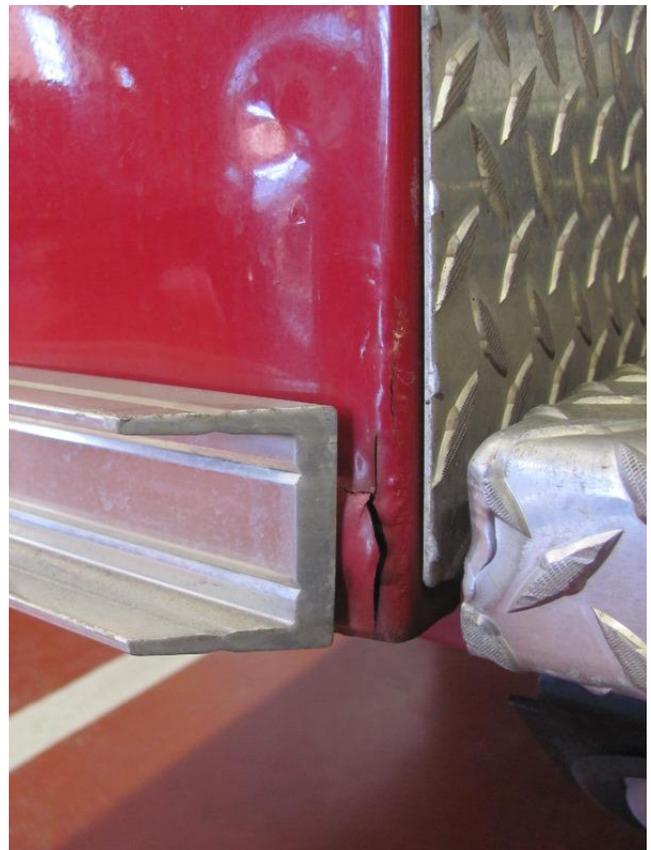
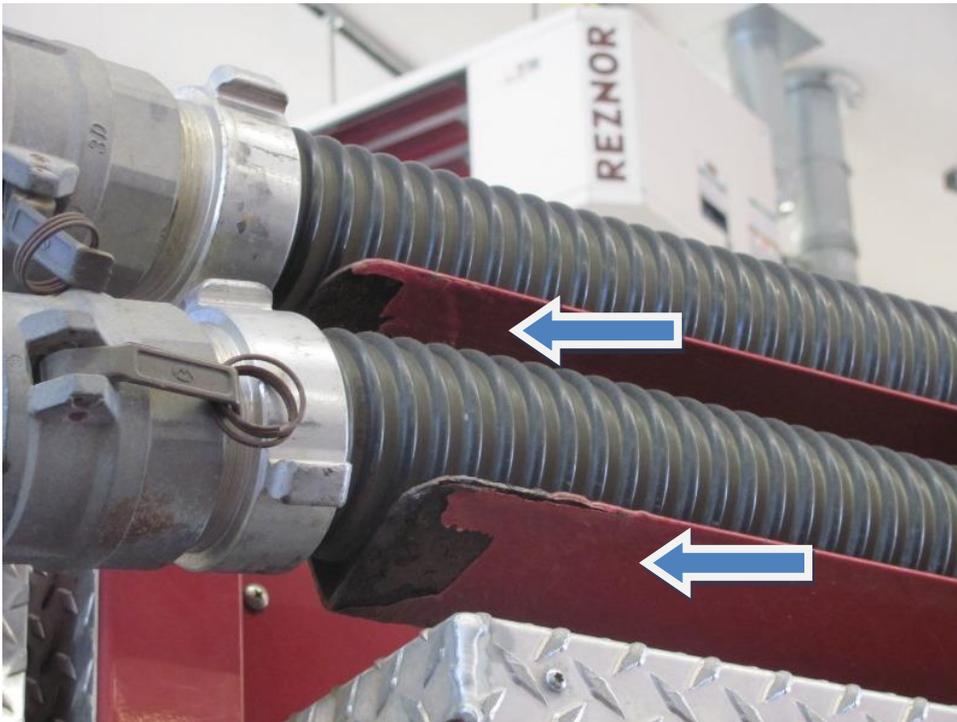
Some of the corrosion that is visible on the exterior of the apparatus body is shown in figures 29 & 30. Difficult to see in the photograph the blue arrows are pointing to areas on the hard suction trays where the paint is blistering from rust but it has not broken through. The rust damage is worse than currently visible.

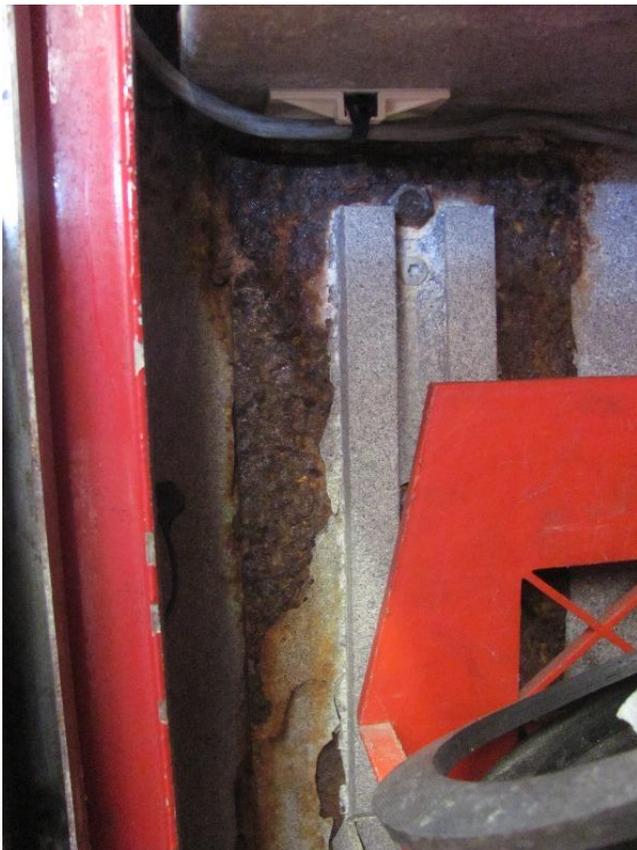
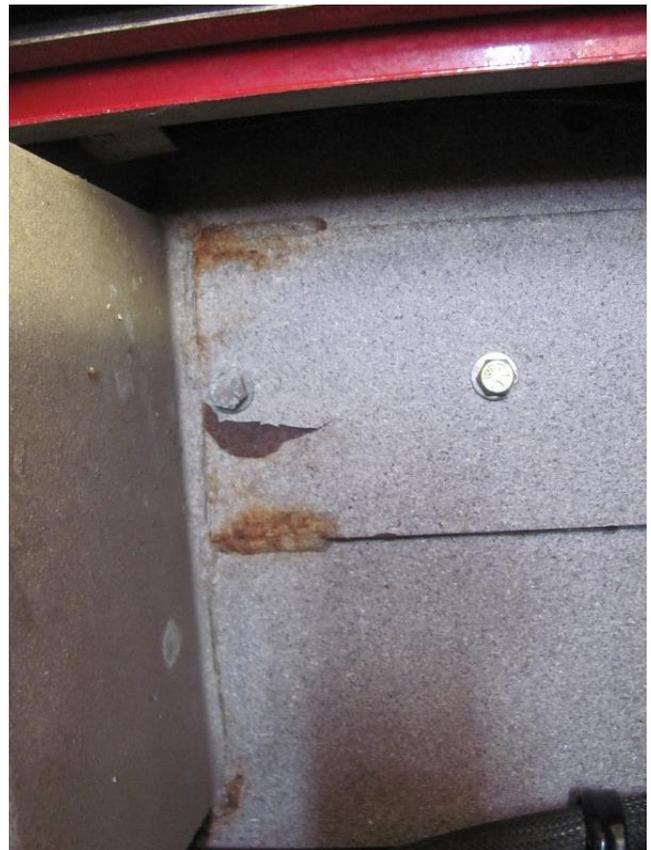
Figure 31 shows rust damage in a compartment interior. The problem is caused by a long standing water leak. This type of leak should be discovered and repaired long before the rust gets to this point. There was no apparent reason for the rust shown in figure 32.

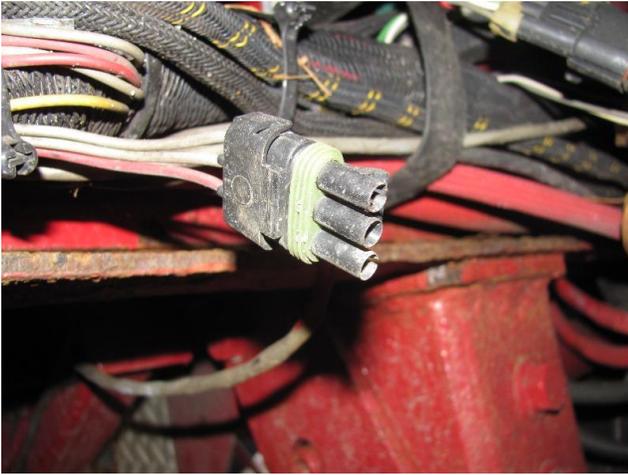
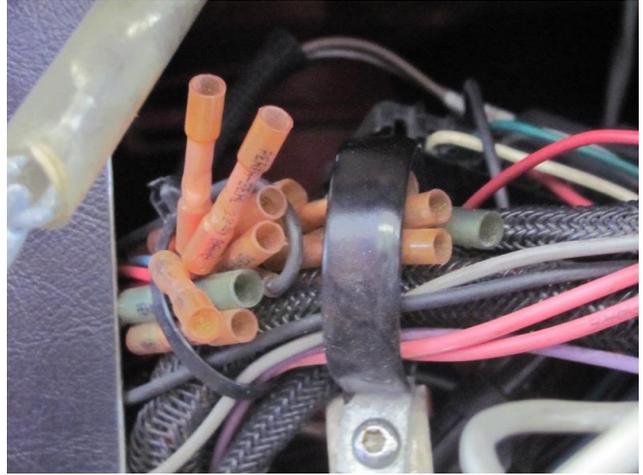
Figures 33 & 34 show two (2) electrical connections points that are not well or properly terminated. This type of connection was not uncommon when Engine 294 was built. It is not something that you would find on apparatus today.

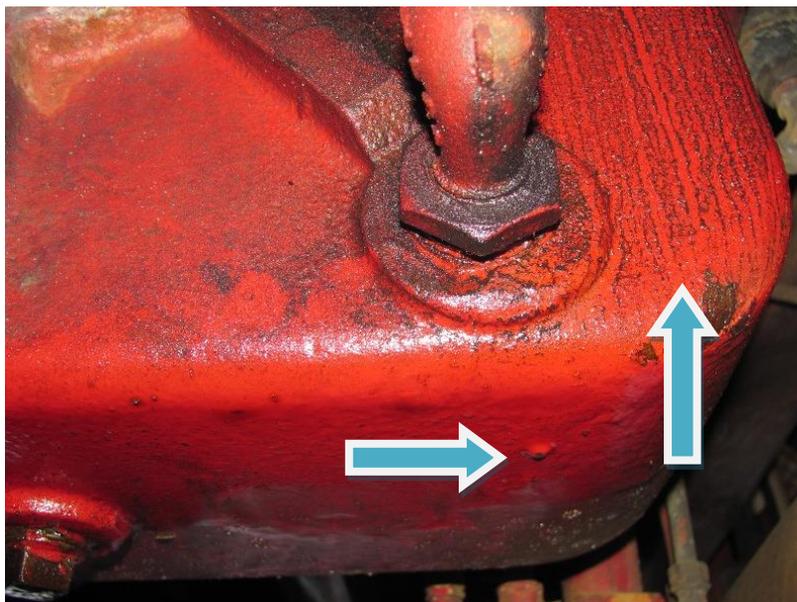
Figure 36

Like ET-296 there is a hydraulic fluid leak in the pump transmission. There is streaking on the rear of the pump transmission case and droplets of hydraulic fluid are forming along the bottom edge of pump transmission. This leak could be as simple as the pump transmission being overfilled when cold and then as the transmission fluid warms up and expands the excess is pushed out of the breather or there may be a leak in pump transmission. The outside of the pump transmission should be cleaned and the situation observed. Figure 36.

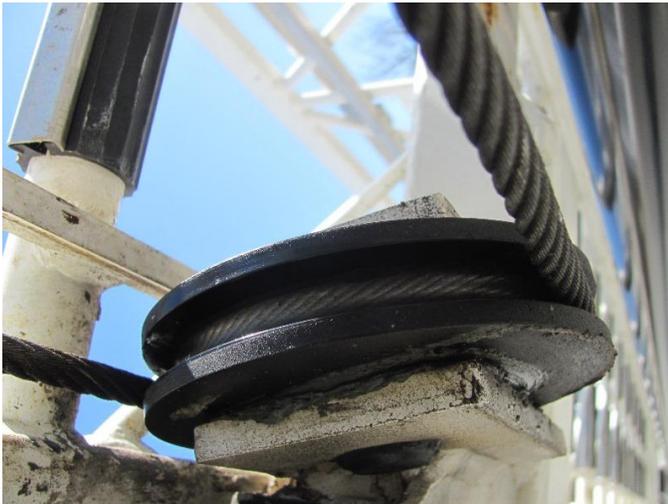
Figure 37

The sheave wheel located on the left side, top, of the aerial bed section is worn and should be replaced. Figure 37.

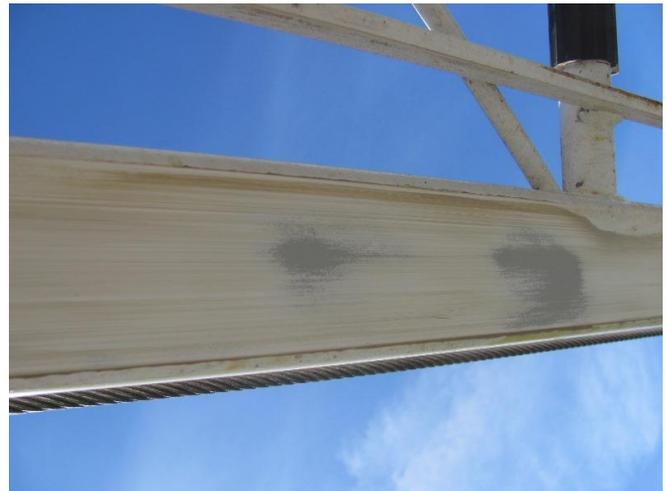
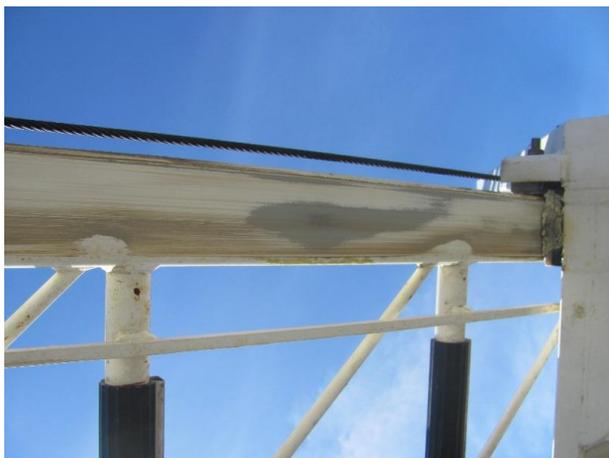
There is some wear on the slide pad contact areas along the aerial device, figures 38 & 39. This is exactly where you expect to find wear. There are some spots that the paint coatings have worn through and some minor surface rust visible.

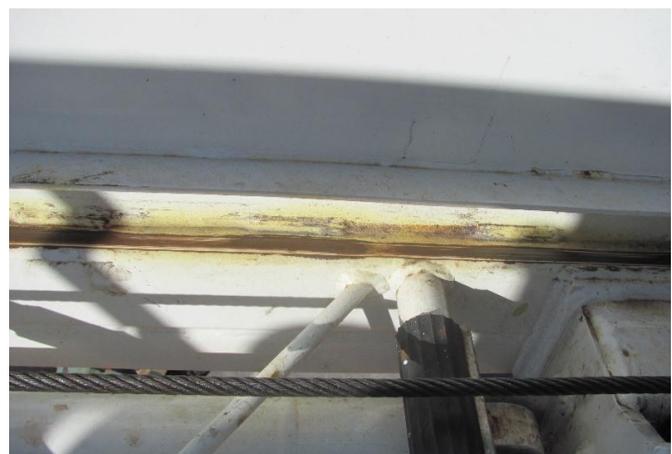
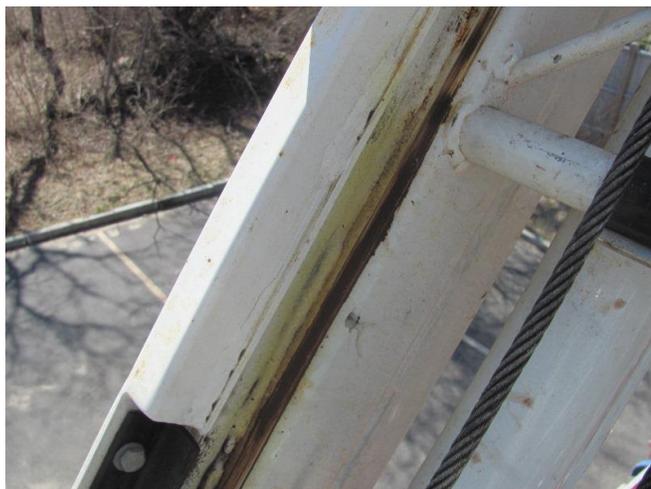
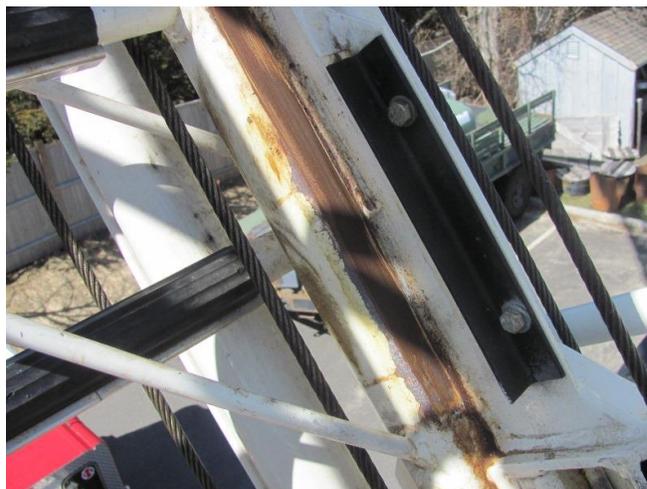
None of the wear observed appears to be extensive but there is some grease that is heavily discolored by rust and these areas will need to be more closely inspected after they are cleaned, figures 40, 41, & 42.

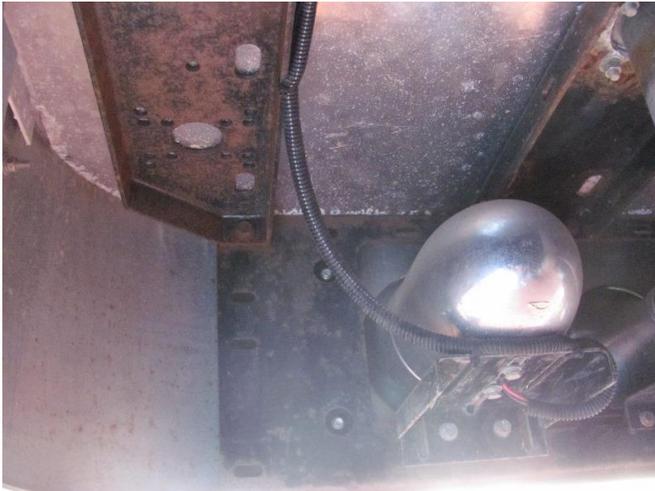
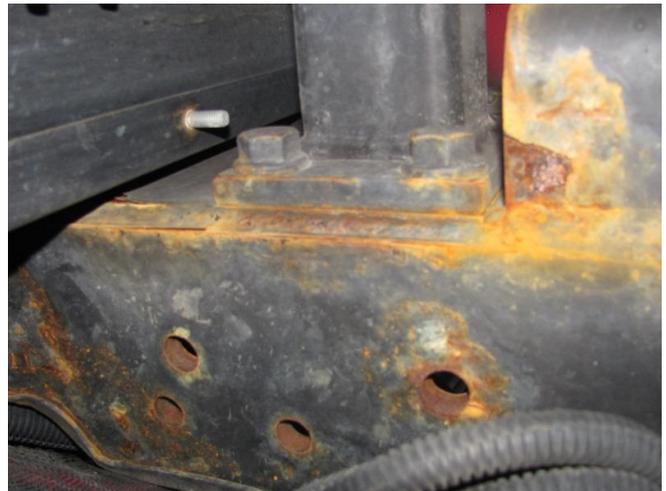
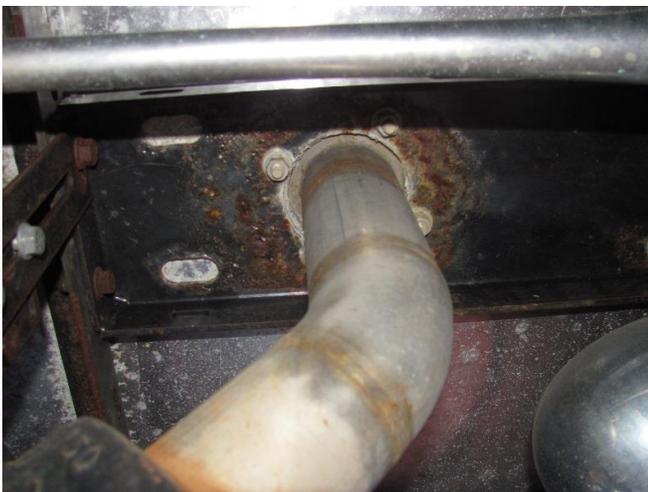
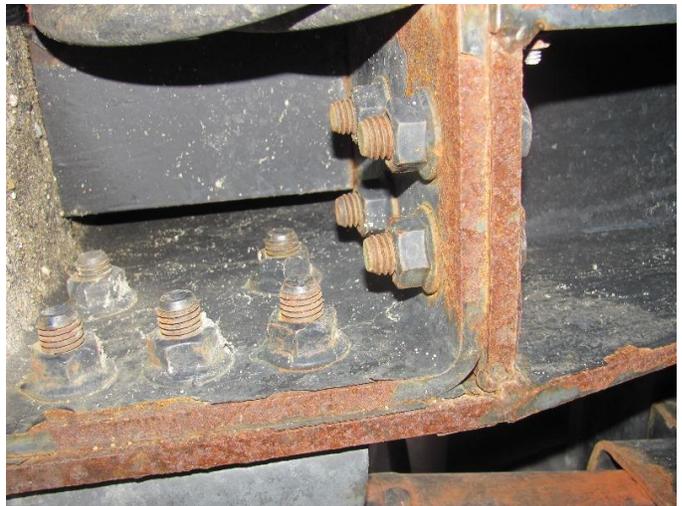
Figures 43, 44, 45, & 46 show various locations and degrees of rust and corrosion on the apparatus chassis.

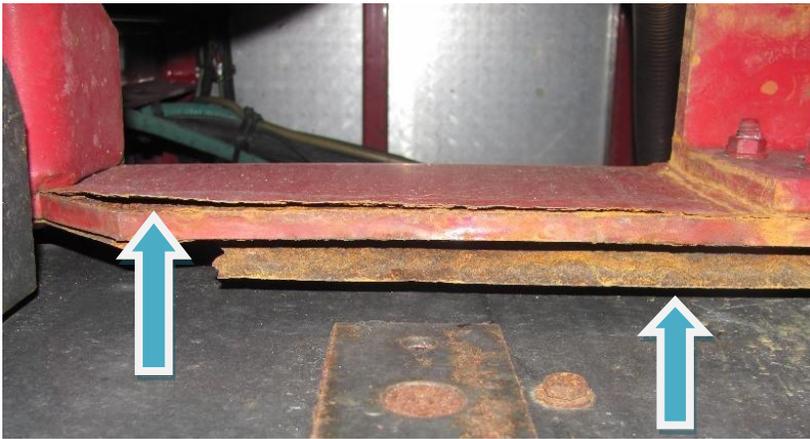
Figure 47 shows some delaminating rust condition on portions of the pump enclosure support framing where it attaches to the apparatus chassis.

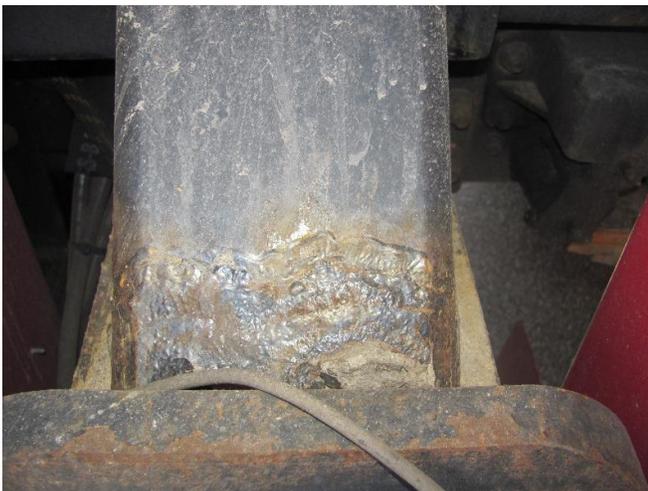
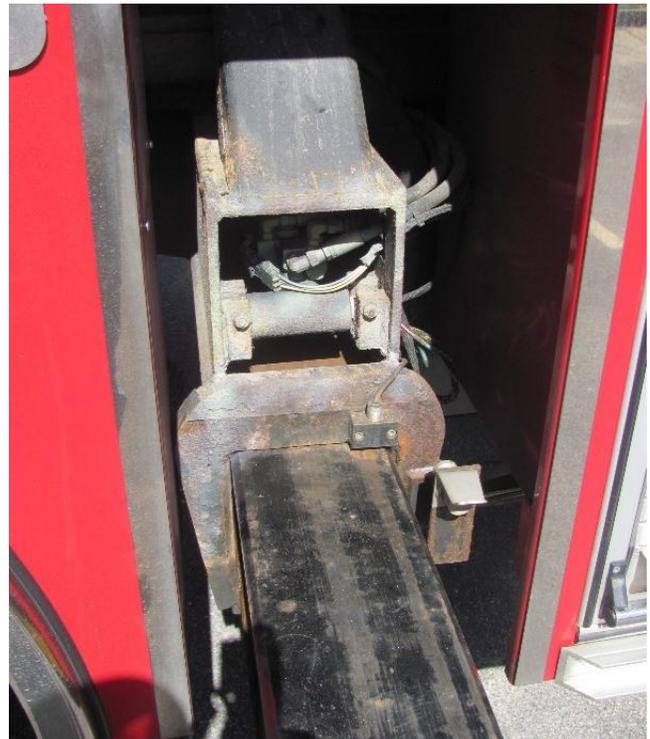
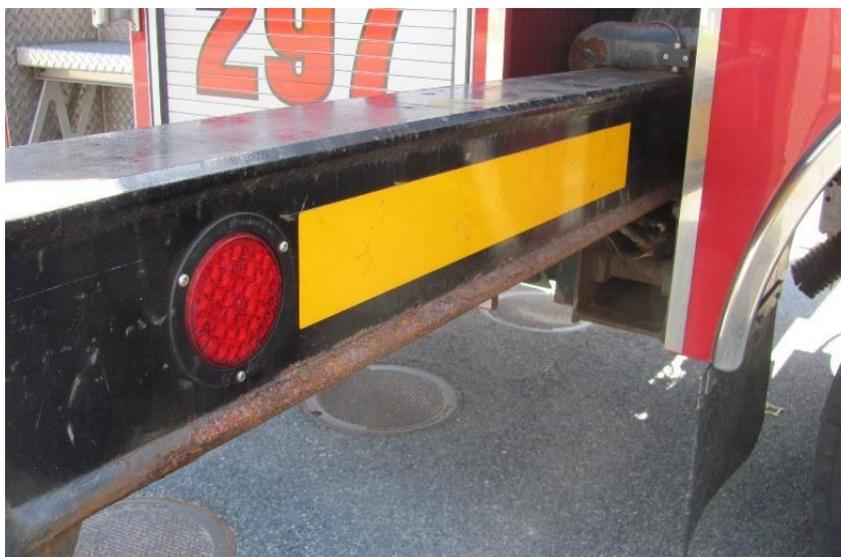
Some of the corrosion visible on the outriggers and their components are detailed in figures 48, 49, & 50.

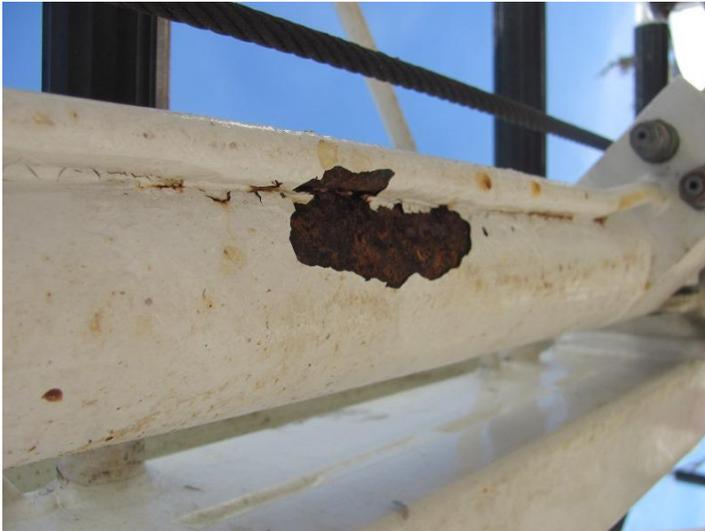
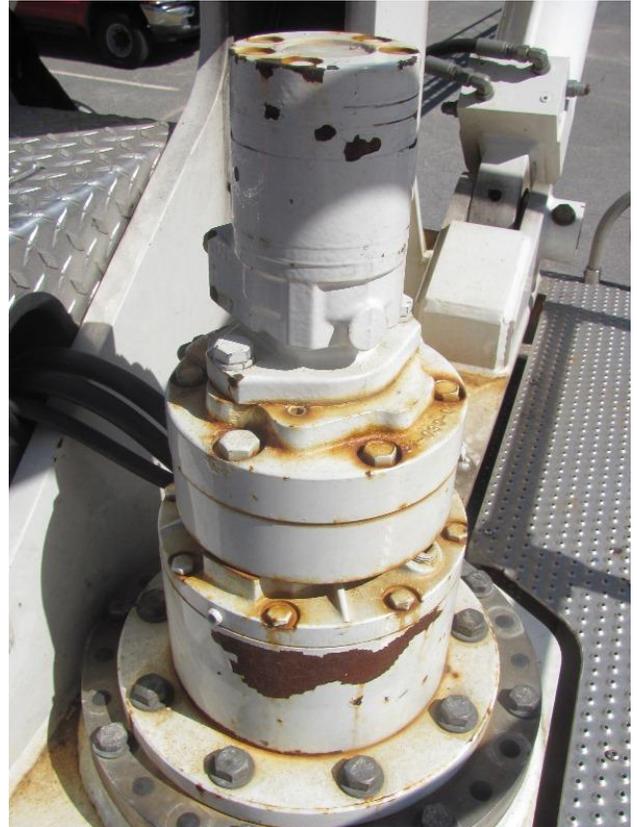
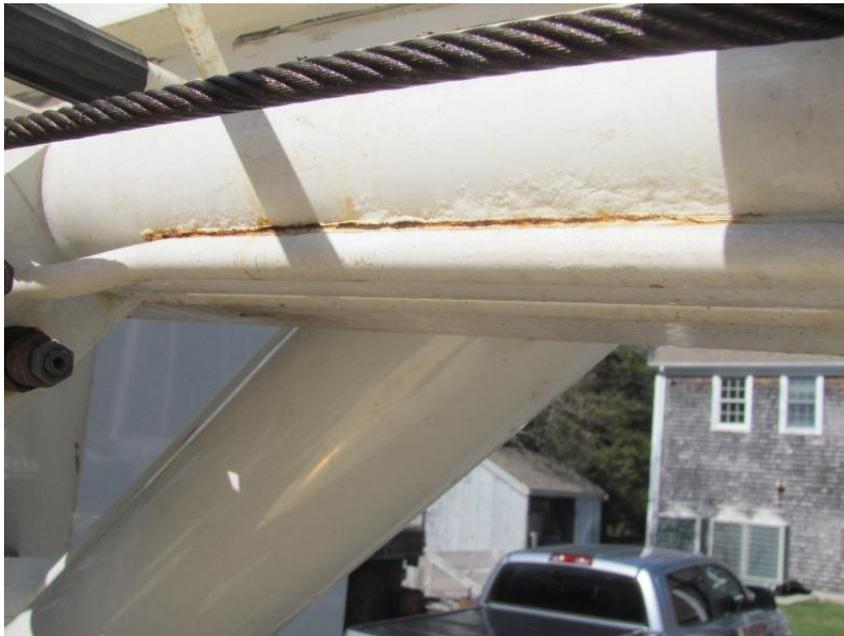
The rust and corrosion is not confined to the chassis. It extends to the upper surfaces of Ladder 297 including the aerial device and its components. Figures 51, 52, & 53
