Fire Department Apparatus Fleet Review

West Barnstable, Massachusetts

East West Fire Apparatus Consultants Inc.

August 3, 2015

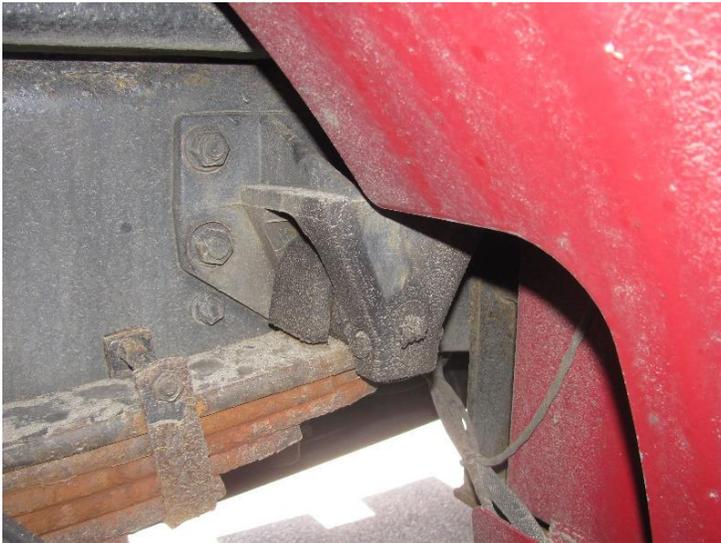
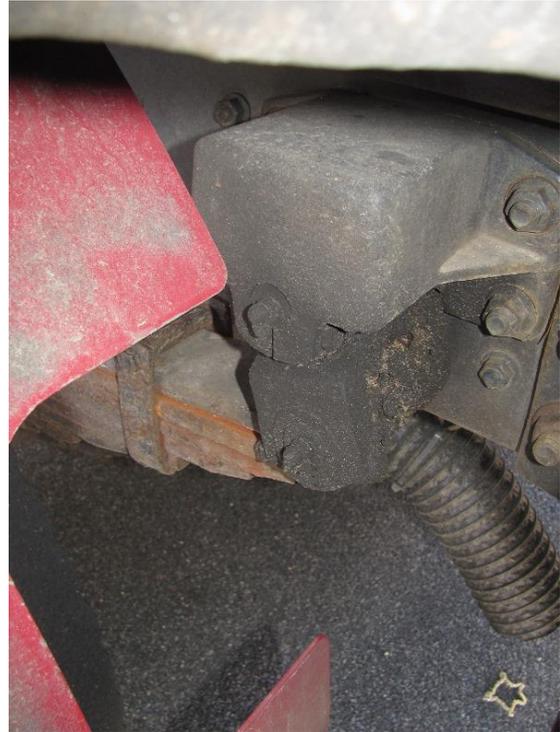
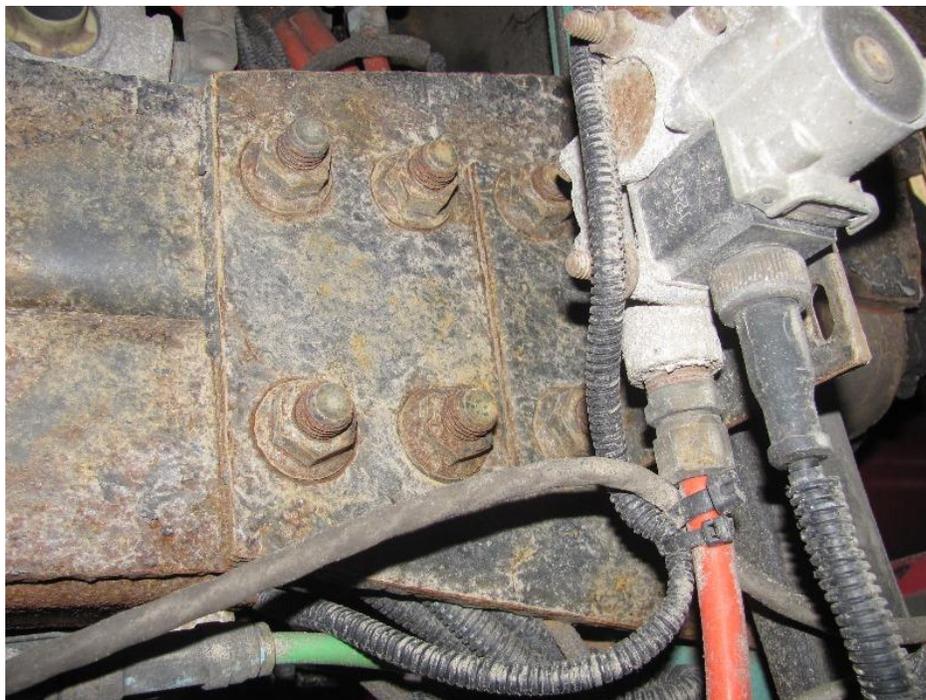
In figures 54, 55, and 56 there are two (2) points being illustrated. The first is dry leaf spring shackles with a fair amount of road dirt collected on the grease fittings. The chassis is not getting the level of preventative maintenance that it should. Broken leaf springs are almost epidemic in the fire service and the main reason is that preventative maintenance is missing, and in this case good and thorough lubrication. Each of these photos shows to some degree road, dirt, sand, and salt deposits on different surfaces of the undercarriage. This is exactly what you want to get rinsed off the apparatus on an ongoing and regular basis. Road dirt holds moisture, contains road salts and other corrosive chemicals that promote rust and rot.

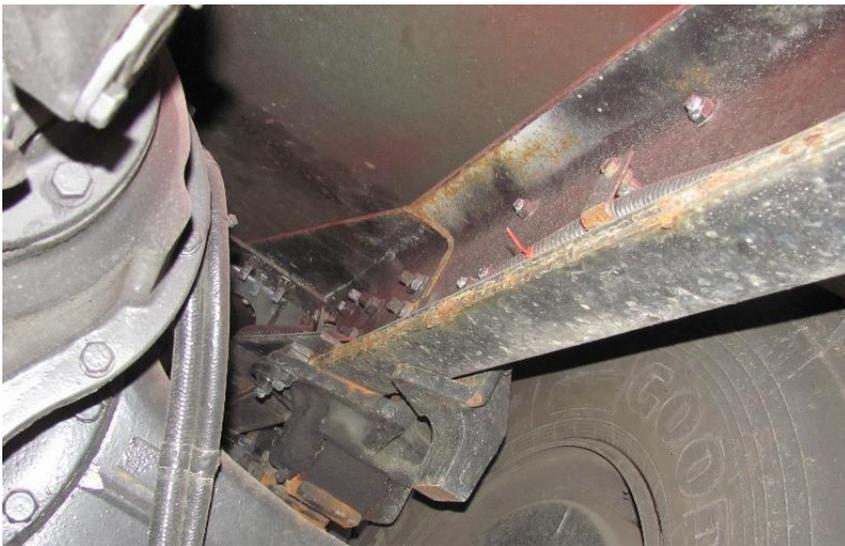
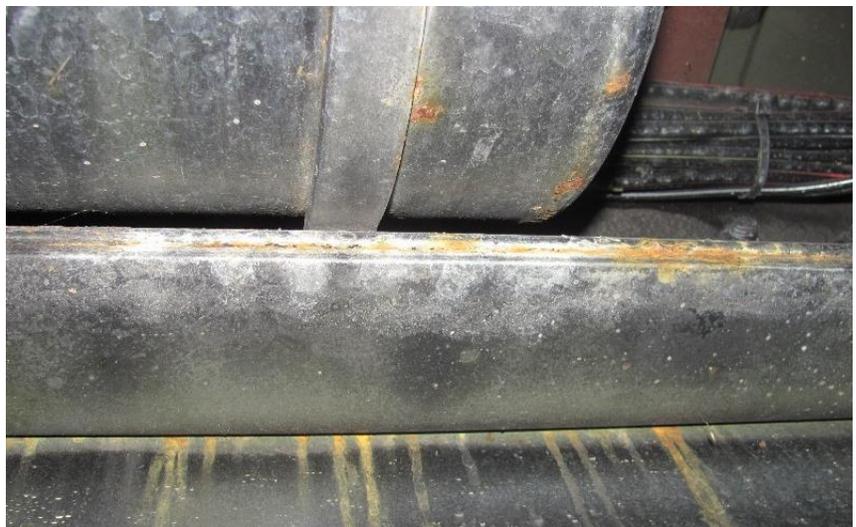
Inspection of Tanker 286 showed it to be in good overall condition with some rust on the chassis that is commensurate with age of the vehicle, figures 58 & 59.

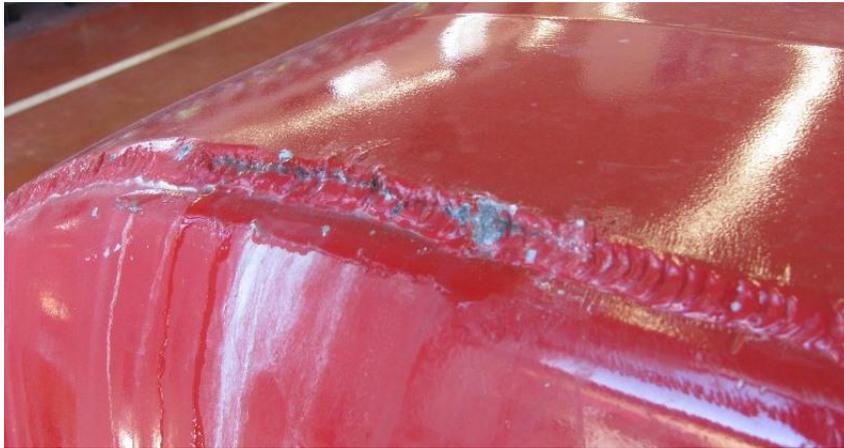
Figure 60

On the rear of the tank on the upper left hand corner there is a water leak through the welded seam. This should be cleaned, ground out and re-welded. The water is causing some corrosion to the aluminum which the longer it goes it will only make performing a successful repair harder. The leak is also staining the paint and will in time cause more extensive paint damage. Figure 60.

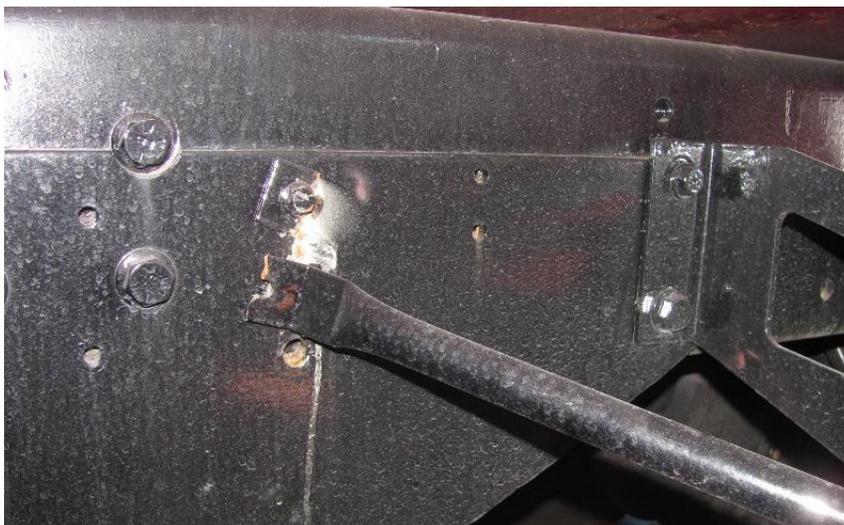
Figure 61

On the left side of the chassis, the forward support arm for the rear axle fender is broken. The fenders over the tandem rear wheel are a fairly thin sheet metal and need the extra support to keep from breaking themselves apart from road vibration. Since the broken side of the support arm is on the chassis side it also is causing more stress on the thin fender which will cause it to crack even faster. The broken support should be removed right away and replaced sooner rather than later. Note: This type of tubular support is pretty easily fabricated from a piece of electrical EMT tubing readily available at most hardware stores or home centers. Figure 61.
