June 16, 2021  
Project No. 21-5808

**SUBJECT: REPORT OF GEOTECHNICAL FILL EVALUATION OF LOTS 28 THROUGH 36  
BELLA RIDGE LOOP SUBDIVISION  
BELLA RIDGE LOOP  
CLATSOP COUNTY, OREGON**

Reference: GeoPacific Engineering, Inc., *Geotechnical Engineering Report*, Bella Ridge Apartment Site, 92257 Lewis and Clark Road, Clatsop County, Oregon, GeoPacific Project Number 16-4212, dated May 23, 2016.

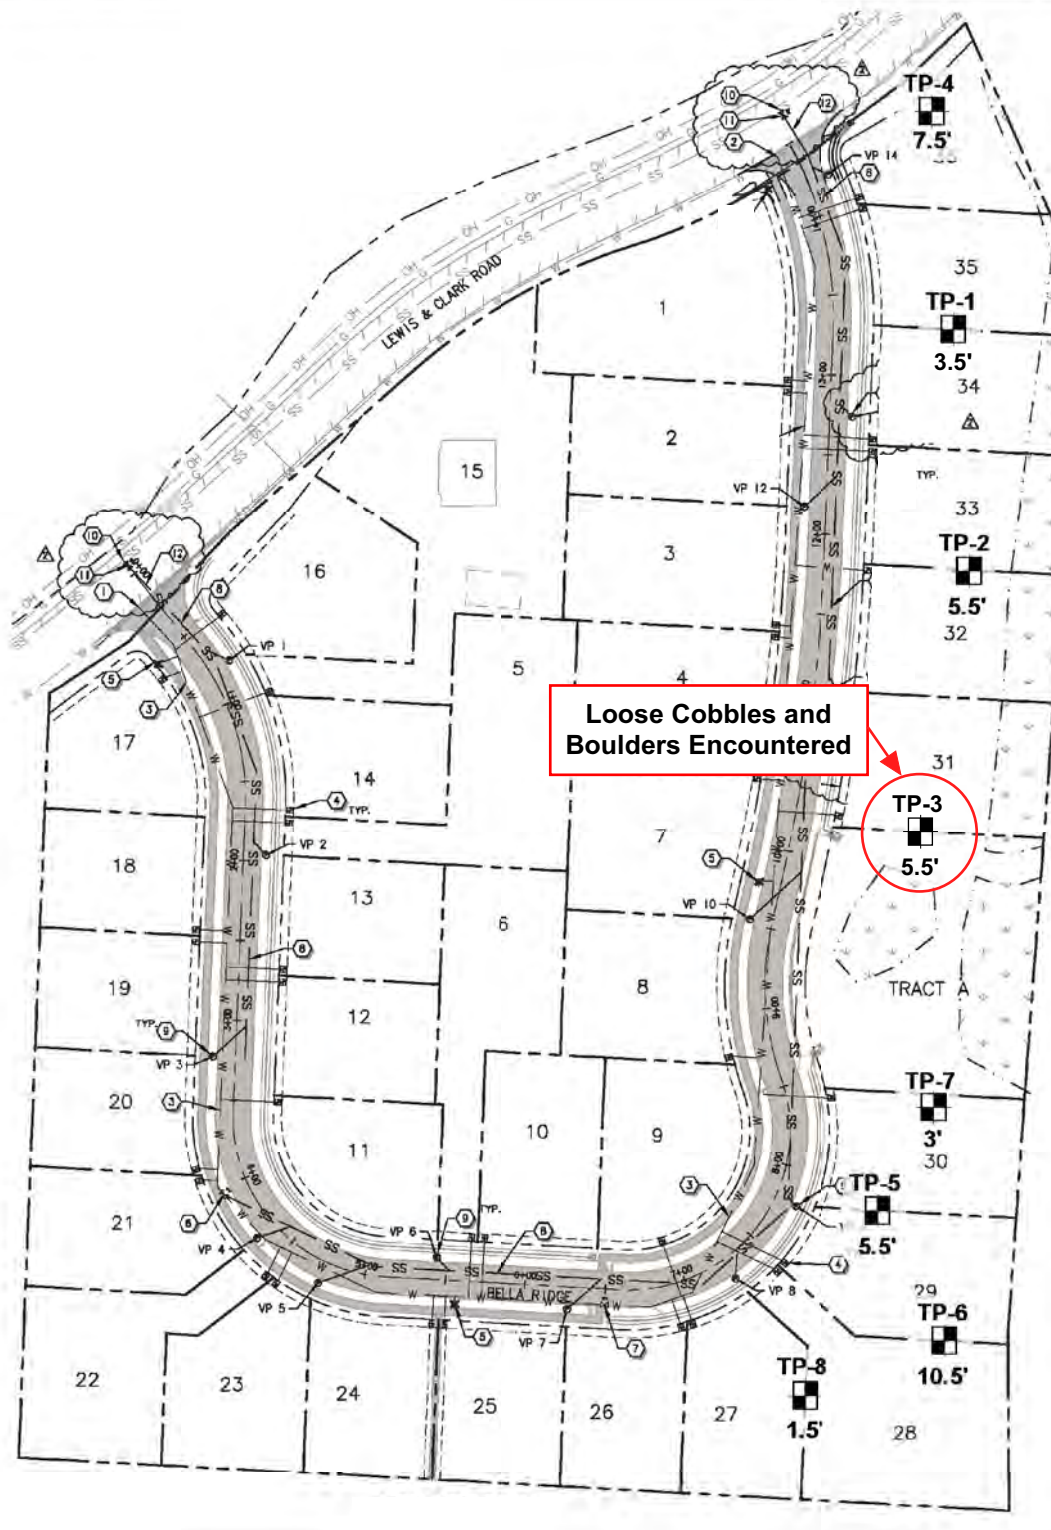
FIGURE 2

Our site-specific exploration for this report was conducted on May 25, 2021. A total of 8 exploratory test pits (designated TP-1 through TP-8) were excavated with a trackhoe to depths ranging from 3.5 to 11 feet at the approximate locations indicated on Figure 2. It should be noted that our explorations were located in the field by pacing or taping distances from apparent property corners and other site features shown on the plans provided. As such, the locations of the explorations should be considered approximate. The test pits were placed on the lot lines where possible to avoid compromising the soil beneath the proposed building footprints.

- 1) The presence of loose cobbles and boulders on the south side of lot 31. In test pit TP-3, located on the south side of lot 31, we encountered loose gravel, cobbles, and boulders to a depth of 4.5 feet. This material was too loose to be considered engineered fill and is not considered suitable to support a structure. This material will either need to be compacted in place, which would require large, heavy compaction equipment such as a diesel plate compactor or a hoe pack, or should be removed and replaced with engineered fill. If the gravel, cobbles, and boulders are to be compacted in place, a geotechnical engineer should provide construction observation services during compaction. Also, at least 12 inches of  $\frac{3}{4}$ "-0 crushed aggregate should be placed and compacted over the top of that remaining material to at least 95 percent of the Standard Proctor (ASTM D698). If the loose gravel, cobbles, and boulders are to be removed, a geotechnical engineer should inspect the exposed subgrade after removal and should observe the placement and compaction of the engineered fill material used as backfill.

- 2) In test pit TP-2, we observed boulders up to 12 inches in diameter. In test pit TP-3, we observed boulders up to 30 inches in diameter. In test pit TP-4, we observed boulders up to 18 inches in diameter. We typically do not recommend particles larger than 6 inches in diameter within 4 feet of finish grade. Large cobbles and boulders can complicate utility trench excavations and the preparation of foundation subgrade for houses. Where encountered in excavations, large cobbles and boulders will likely need to be overexcavated and the resulting voids filled in with granular engineered fill material. Potential developers or home builders should be informed that some large cobbles and boulders may be encountered in utility trenches and/or house digouts.

- 3) While the fill material observed in our test pits was generally stiff to hard, we observed a layer of soft fill material from 3 to 4.5 feet in test pit TP-6. We also observed soft fill material to a depth of about 18 inches in test pit TP-7. If these layers of soft material are at or near the foundation subgrade elevation, then they may need to be overexcavated. Foundation subgrade should be inspected by a geotechnical engineer prior to installing formwork and rebar.

- 4) It appears that some contour grading has occurred on lots 35 and 36 to create a shallow drainage. There may be some soft soils near the ground surface as a result of the contour grading. Excavation depths more than 18 inches may be required to reach suitable foundation subgrade in the area of contour grading on lots 35 and 36 and also on or near existing fill slopes. Adjacent to existing fill slopes, footing-to-slope setback distances of at least 10 feet should be maintained, subject to field verification by a geotechnical engineer during construction.

In general, we expect that the fill material will be suitable for the support of residential foundations and walls with bearing loads of 1,500 psf or less. We recommend each lot excavation be observed by GeoPacific once the potential subgrade material is exposed to confirm its suitability.
