Crabtree, Rohrbaugh & Associates

York Suburban SCHOOL DISTRICT

Construction Projects Update
September 16, 2024

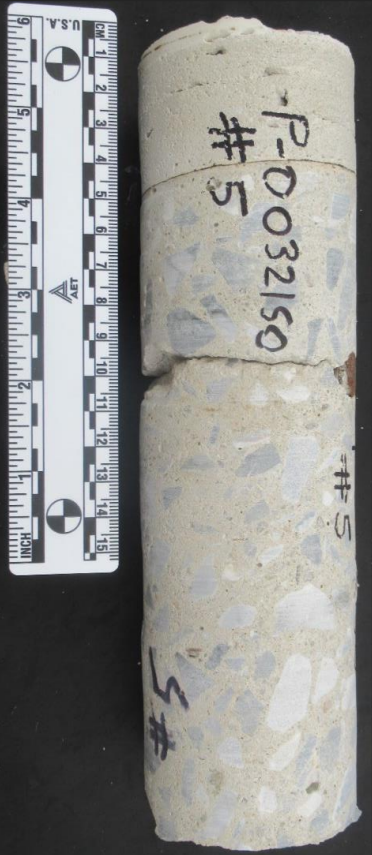
- Pool Structure Condition Assessment September 2024
 - American Engineering Testing performed petrographic testing of 5 concrete cores extracted from the pool:
- Measures chloride **concentration** and carbonation **depth** in concrete
- Chlorides that accumulate in sufficient quantity at the level of reinforcing steel will corrode the steel.
 - Weakens the tensile strength of steel
 - Corrosion on steel will cause concrete to crack
 - Corrosion on steel will affect the bond
- Concentration measured by pulverizing sample into a powder and performing a standard test method for acid-soluble chloride in mortar and concrete

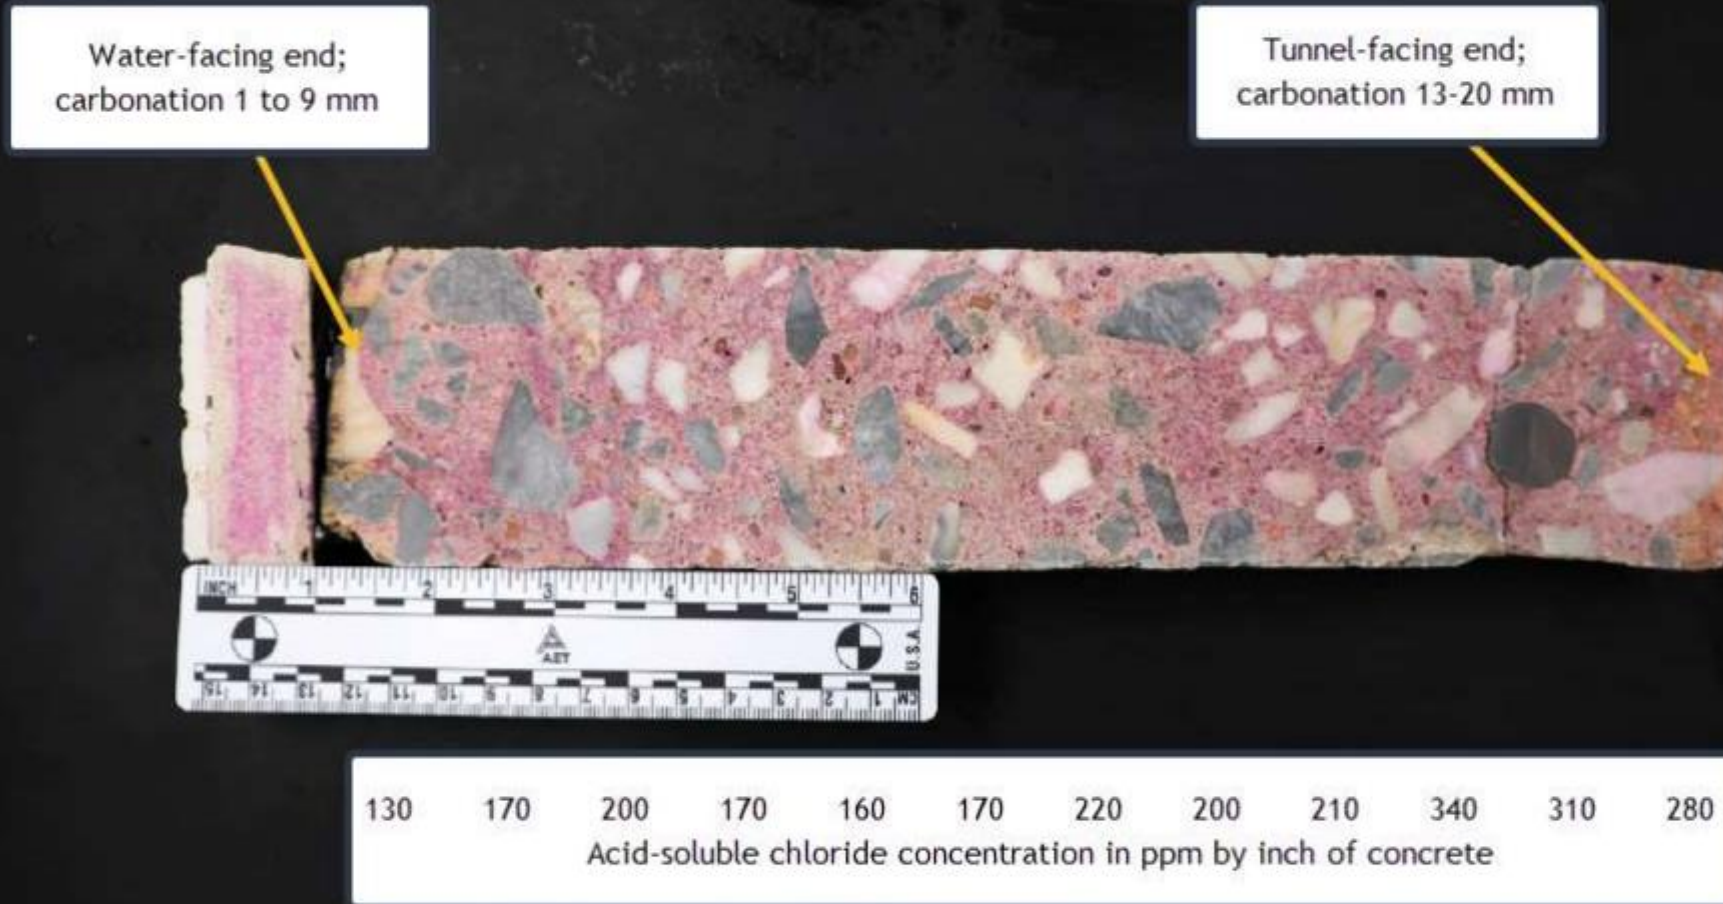
Photograph of cut and lapped sample with the pool-facing side to the left and the tunnel facing side to the right. The pink stain is a phenolphthalein solution. Where the concrete is not pink, it is carbonated.

- Pool Structure Condition Assessment September 2024
 - Chloride Concentration
 - Testing indicated 60-300 ppm
 - 200 – 300 ppm is an elevated chloride concentration from baseline, it is not high enough to cause corrosion of the reinforcing steel.
 - It is likely that 200-300 ppm is an equilibrium chloride concentration meaning that it will not significantly increase over time and represents the chloride concentration in the air.
 - None of the reinforcing steel was corroded beyond the sacrificial corrosion layer.
 - Carbonation Depth
 - Carbonation depth was deeper on the exterior-facing side
 - Depth ranged from 13 – 61 mm (1/2" to 2-3/8")
 - Reinforcing was present in samples with approximately 2.5" of cover on the exterior-facing side.
 - Assuming ingress of 0.5-1 mm/year, chlorides could reach the steel in 15-25 years

- Pool Structure Condition Assessment September 2024
 - The debonding of tile/mortar to the concrete substrate is the most detrimental failure to the service life of the natatorium from a material perspective.
 - AET expects that the concrete carbonation could reach the level of reinforcing steel in 15-25 years when reinforcing steel corrosion could initiate.

- AET recommends that the concrete basin has over 25 years of service life left with the following repairs:
 - Remove the tile and mortar finish on the water facing side of the basin. Remove 1/8" – 1/4" of concrete substrate surface. Install a new tile and grout system that achieves long-lasting, continuous bond between the mortar and concrete substrate.
 - Remove about 1/2" to 1" of concrete from the exterior face of the basin. Leave the surface rough and clean. Surface apply a repair mortar that has a low water-to-cement ratio and includes pozzolans or slag or is a non-Portland cement-based repair product. Repair mortar shall equal the depth of the material removed to maintain concrete cover depth to steel reinforcing.
 - Additionally, CRA recommends a protective coating be applied to the exterior of the pool to prevent future chlorine penetration into the walls.

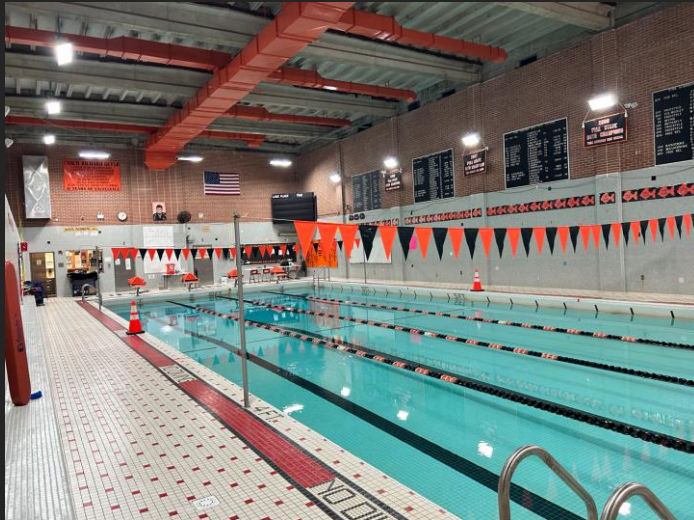
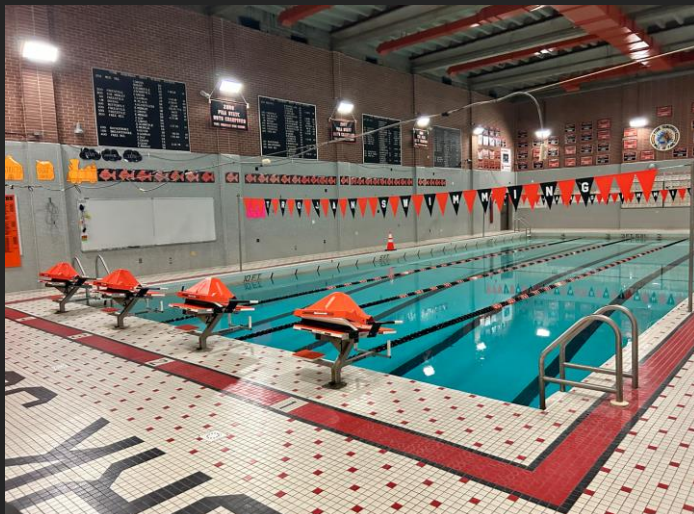
- 4 lane pool.
 - Industry standard recommends a minimum of six (6) 7' wide lanes
 - USA Swimming recommends a minimum of eight (8) 7' wide lanes
- 3'-6" shallow end does not meet the National Federation of State high School Associations recommended minimum depth of 4'-0"
- Perimeter gutter system is antiquated
 - 12" between gutter lip and pool deck makes it difficult to exit pool without ladder
 - Little capacity to capture waves, resulting in a slower competition pool
- Deck space around pool is limited causing difficulties when hosting swim meets, PE classes, swim lessons, or other large groups

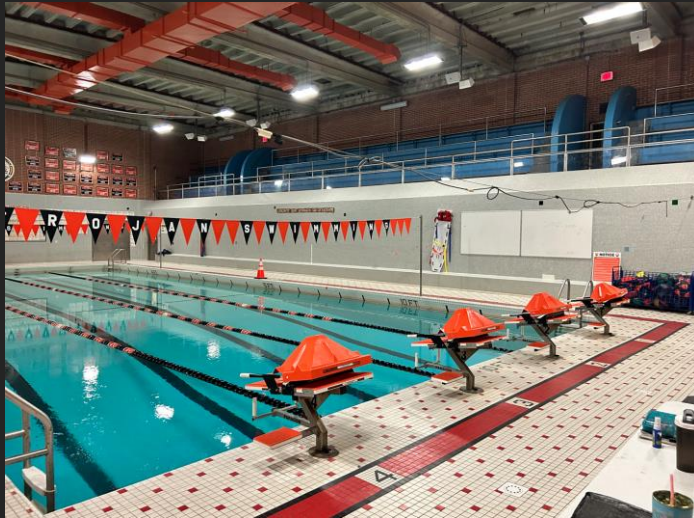
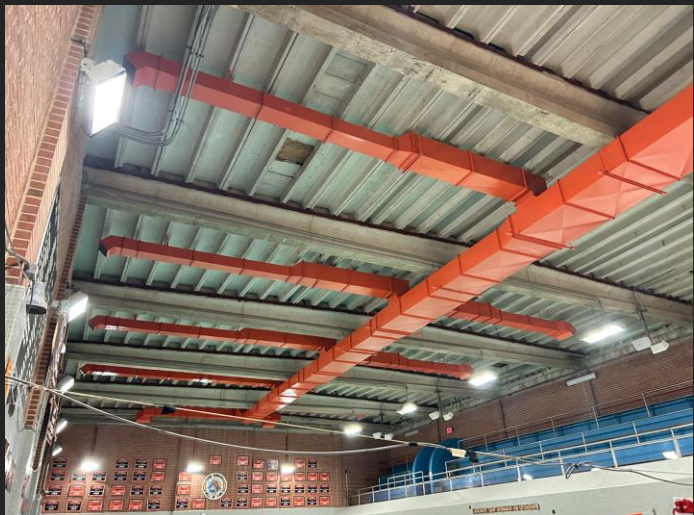
- Space is limited for storage of pool equipment either on deck or adjacent storage rooms.
- Pool does not have the appropriate amount of surge capacity, causing gutters to flood and not function as intended
- ADA access is not provided
- Additional structural repairs are required
 - Active cracking at previously repaired corner following refilling the pool in 2024
 - Window infills show signs of movement and stress following refilling the pool in 2024
- HVAC system is in need of replacement and is in the process of progressive failure
- Pool water boiler requires upgrading to eliminate the last steam boiler

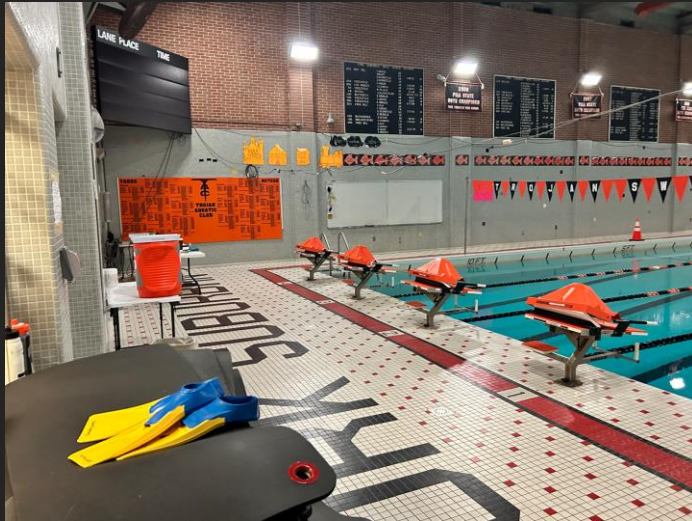
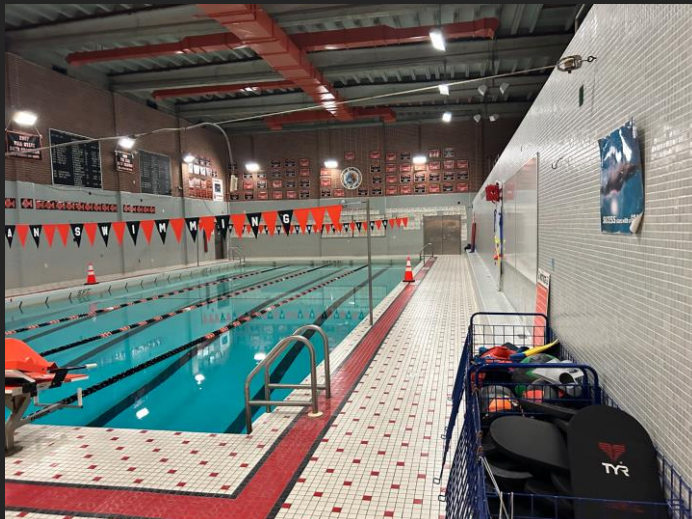
- Pool equipment would be replaced during comprehensive pool renovation to ensure full compliance with current code requirements and industry standards
- Ventilation at the water level should be considered as part of a gutter modernization
- The pool's current location creates security, access, and control issues
- Limited spectator seating & ADA access issues for spectators
