SUSPECT (MARVEL) Restoration Project: Update

Progress on Leak; Frustration with Engine

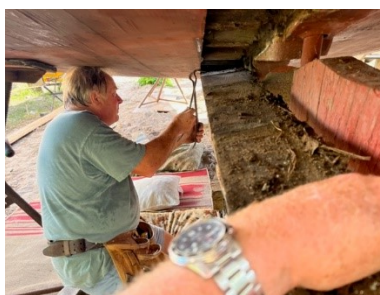
On Day One, Bob removed the port garboard plank. Unlike the starboard plank, the port plank did not run the full length of the boat and would be easiest to remove. The screws holding the plank to the ribs were extracted (a labor intensive process) and the plank was removed.

Photo 1: Bob Luckraft removing the port garboard plank

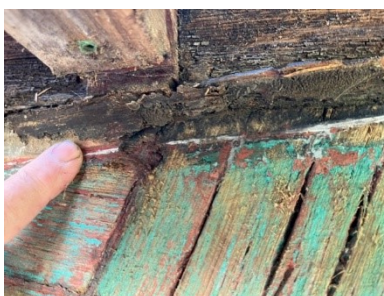
As Bob had predicted there were no stopwaters (wooden dowels) located in the joints under the edge of the garboard where they should have been inserted. Bob speculates that an earlier repair had incorrectly inserted stopwaters in the seams below the garboard. Further, the existing stopwaters were made from ¼ inch **hardwood** dowels. These would not have swollen sufficiently to stop any leaks. Bob fashioned new ¾ inch stopwaters from Alaskan cedar, a **softwood** that swells significantly when wet.

Photo 2: No stopwaters where they should have been.

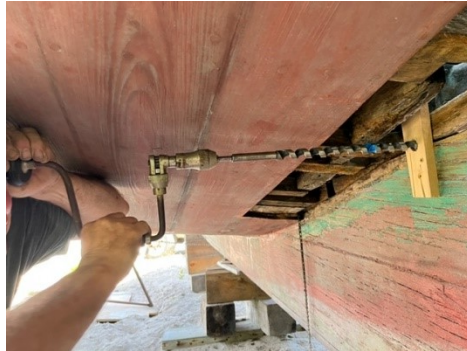
Photo 3: Bob drilling new stopwater holes with a bit brace and auger

To insert the new stopwaters into the proper position, new holes needed to be drilled horizontally through the white oak keel. The curve of the bilge prevented the use of an electric drill so Bob drilled the holes using a classic bit brace and auger... yet another labor-intensive task.

Once the holes had been drilled, Bob pounded the new stopwaters into place and secured them with a dab of marine epoxy. Thus ended Day One

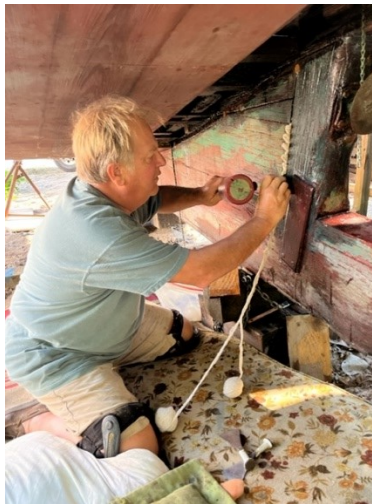
Photo 4: Bob caulking the deadwood seams.

Day Two began with Bob routing out all of the old caulking around the garboard rabbet (the inner seam against which the plank and caulking rest) and the deadwood. He then hammered new caulking cotton into the cleaned out seams.

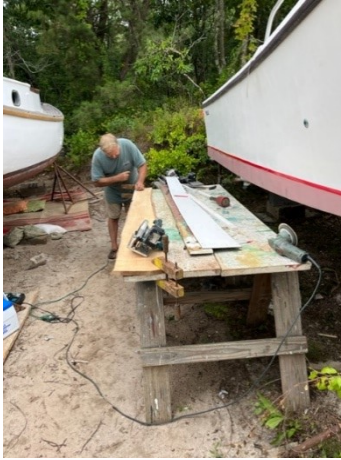
Photo 5: Bob used a template of the old garboard plank to fashion a new one

Rather than replace the old garboard plank, Bob decided to fabricate a new one from a piece of Atlantic white cedar that had been sitting in his shop in Falmouth for over 10 years. This project involved creating a template from the original plank. Once fabricated the template was placed atop the rough cedar board and traced. Bob then used a combination of saws and a belt sander to follow the trace lines and cut and tweak the new plank into shape.

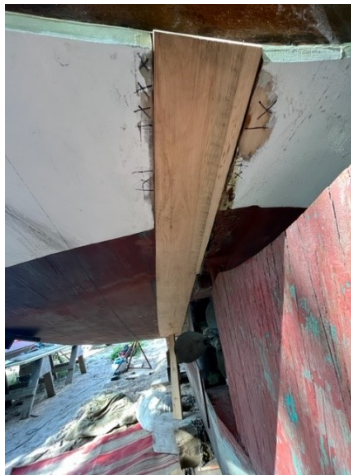
Photo 6: The new garboard looked “like it had grown there.”

With a bit of fussing the new garboard popped into place under the boat and against her ribs “looking like it had grown there.” Thus ended Day Two.

When Bob returns this week or next for Day Three he will secure the plank to the ribs with new, countersunk and bunged bronze screws and then caulk it into place with caulking cotton and Interlux seam/bedding compound. A coat of anti-fouling paint will complete the process.
