MEMORANDUM

TO: Green Trails Estates Trustees
FROM: Greg Staley, PE
DATE: 6/17/2020
SUBJECT: Site Visit for Dam

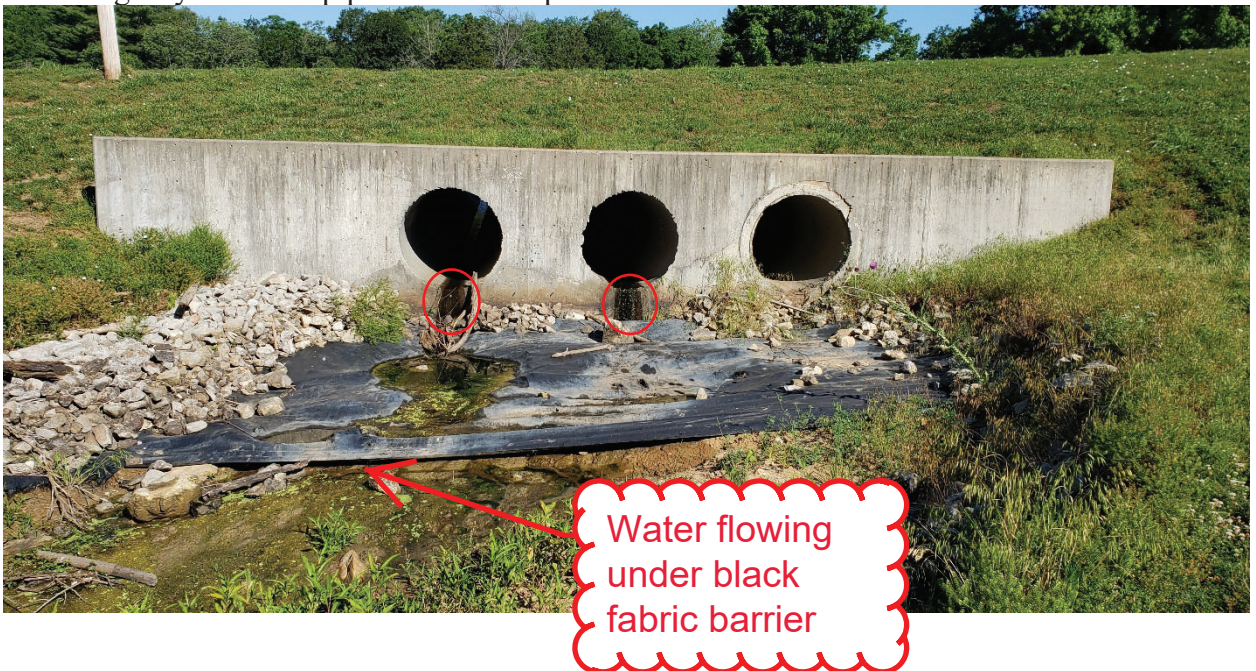
1. Water is draining out of the two southern pipes, which is dropping down under the black fabric barrier causing erosion of the earth surface. The concrete headwalls on either end of the pipes seem to be in good condition. Below is the view of the downstream ends of the emergency overflow pipes with markups.

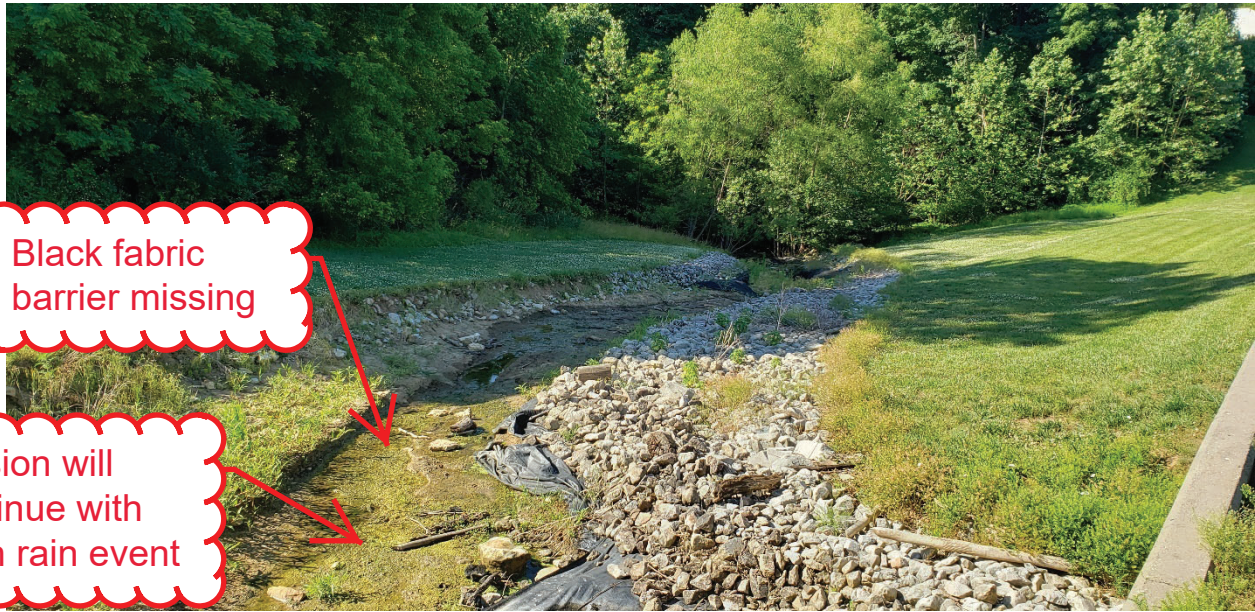
2. Due to major storms, the downstream channel's rock revetment (similar to the rock on the banks) has been washed away with portions of the black fabric barrier. The earth is exposed and susceptible to erosion, deep cutting, and meandering of the channel.

Black fabric barrier missing

Erosion will continue with each rain event

We will investigate ways to better control the major storms with the following potential options: larger diameter rock; stilling basin(s); stream drops; other energy dissipation devices; etc.

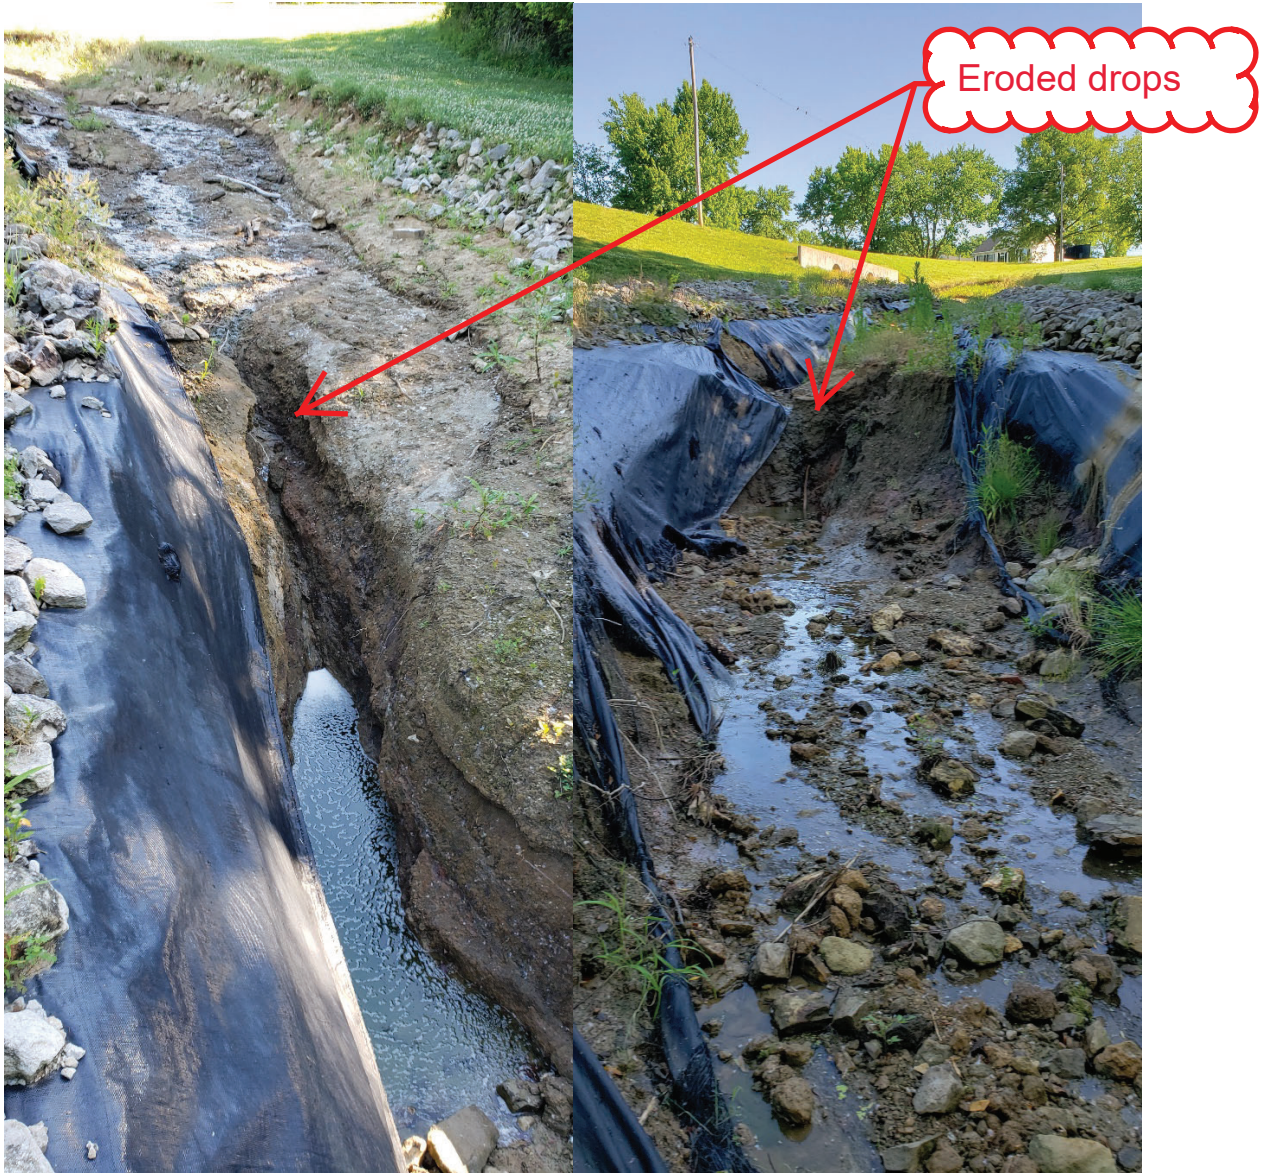
- The next two pictures below (looking upstream) is hard to see in a 2D picture, but there are two significant drops in the channel that are susceptible to continued erosion upstream.

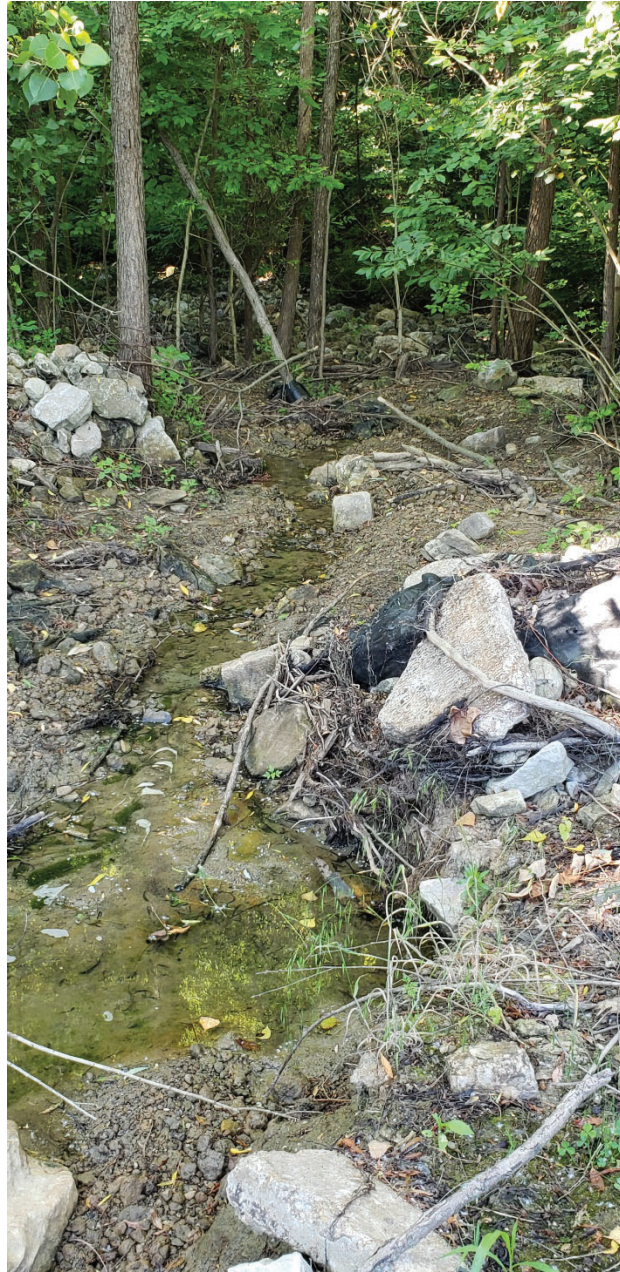
4. All-in-all, the downstream area where the stream flattens out is not eroding as much in comparison to the steeper portion upstream, however, there is still erosion occurring.

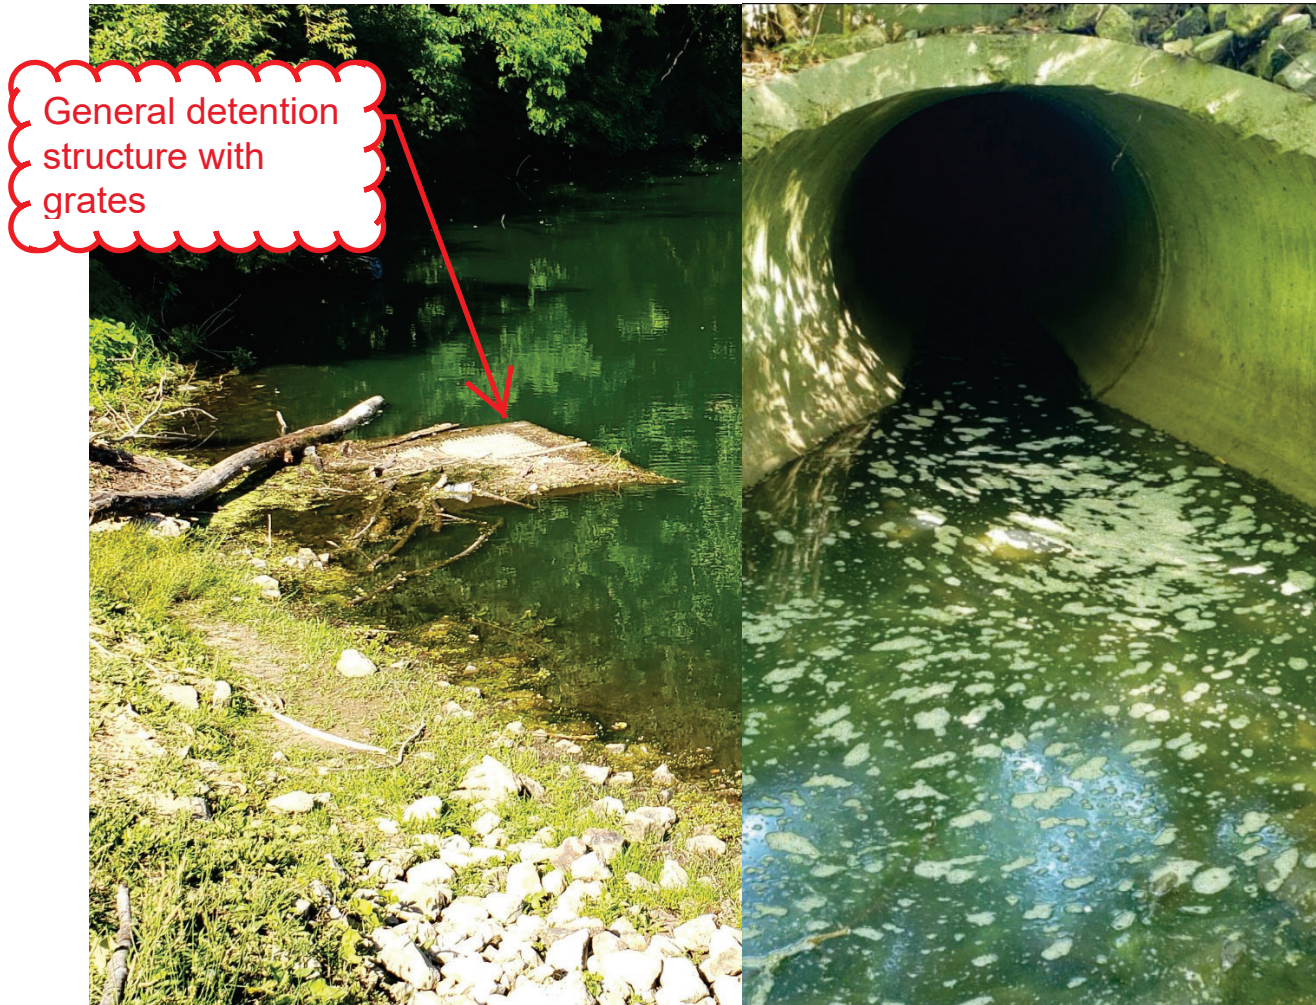
5. At the downstream end of the general detention structure's outflow pipe I could hear water dropping into the pipe, but there did not seem to be any outflow that I could see. This should be investigated via a roving camera to see the condition of the pipe.
