Everglades Society for Historic Preservation

ESHP BUSINESS PLAN FOR THE BANK OF EVERGLADES BUILDING

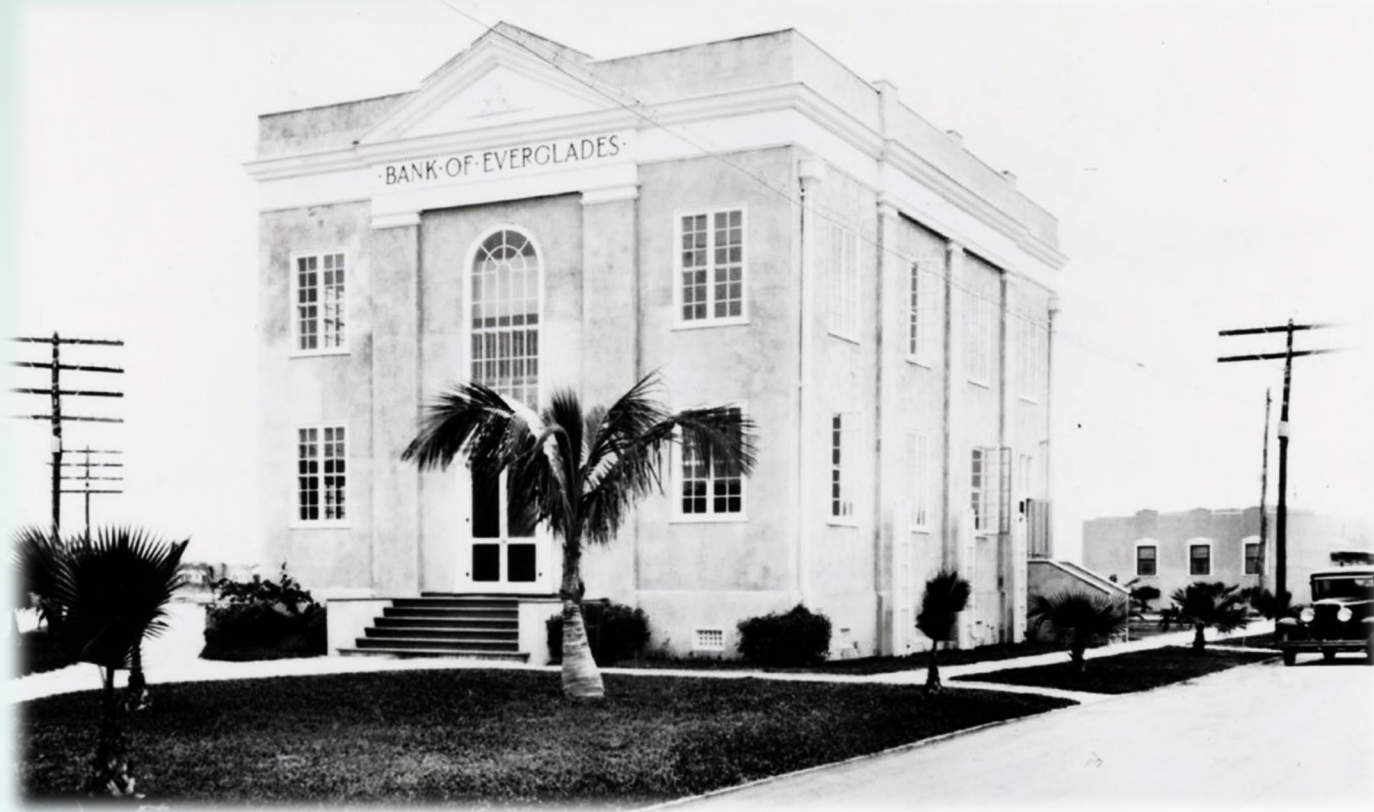
This presentation and complete details about our organization can be found on our websites:

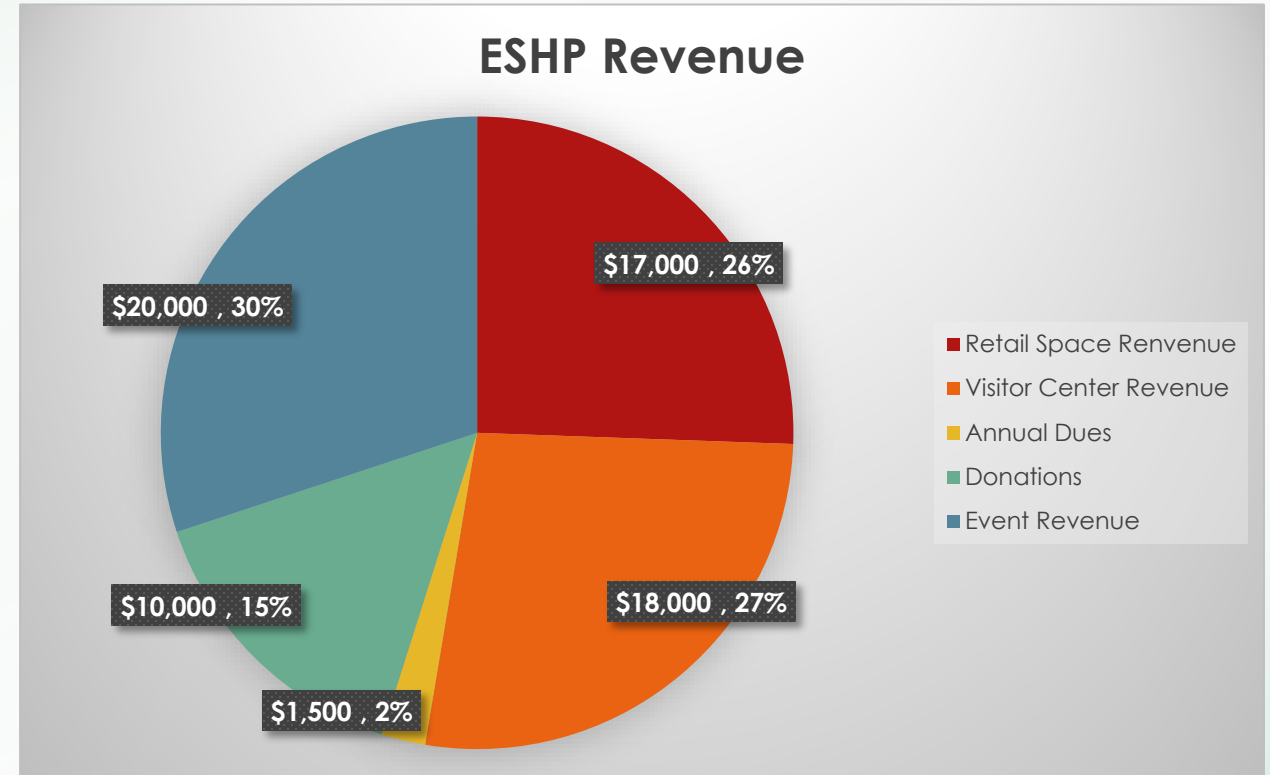
- ▶ Proj. retail space revenue.....\$17,000
- ▶ Visitor Center shop revenue.....\$18,000
- ▶ Annual Dues.....\$1,500
- ▶ Donations.....\$10,000
- ▶ Revenue from Events.....\$20,000
- ▶ **Estimated Annual Revenue.....\$66,500**

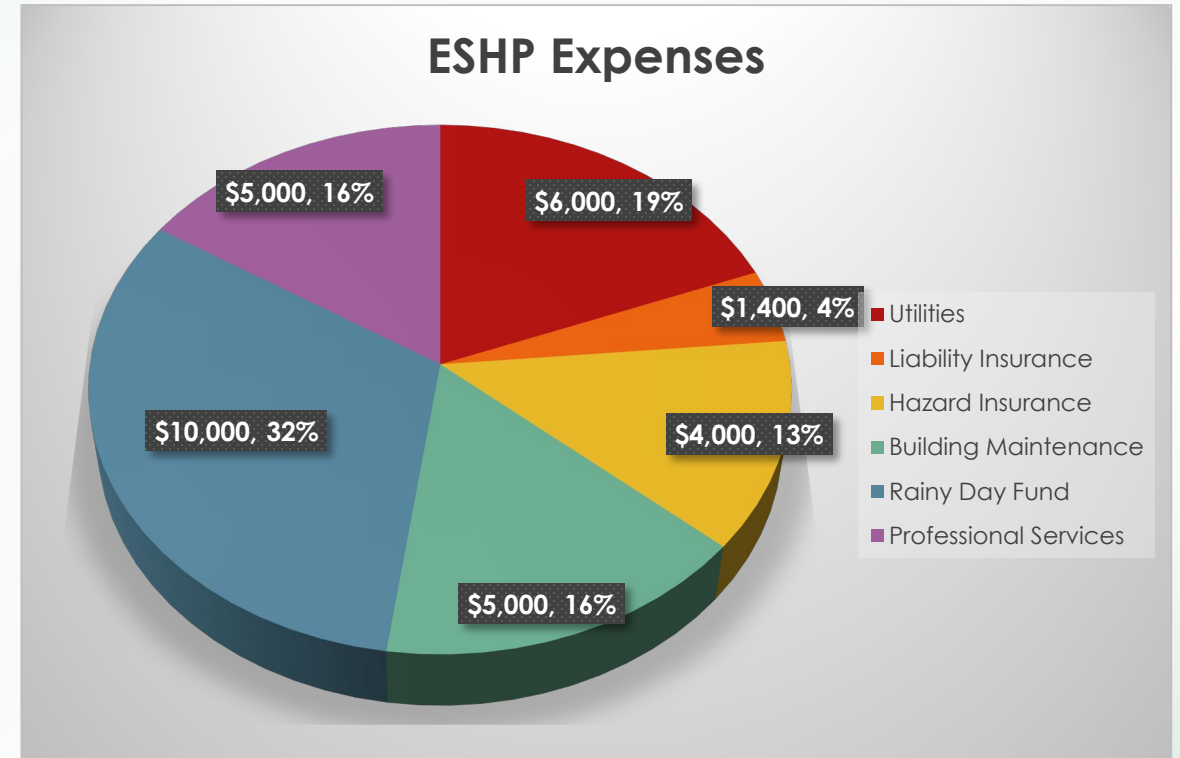
Economic Impact to the Community

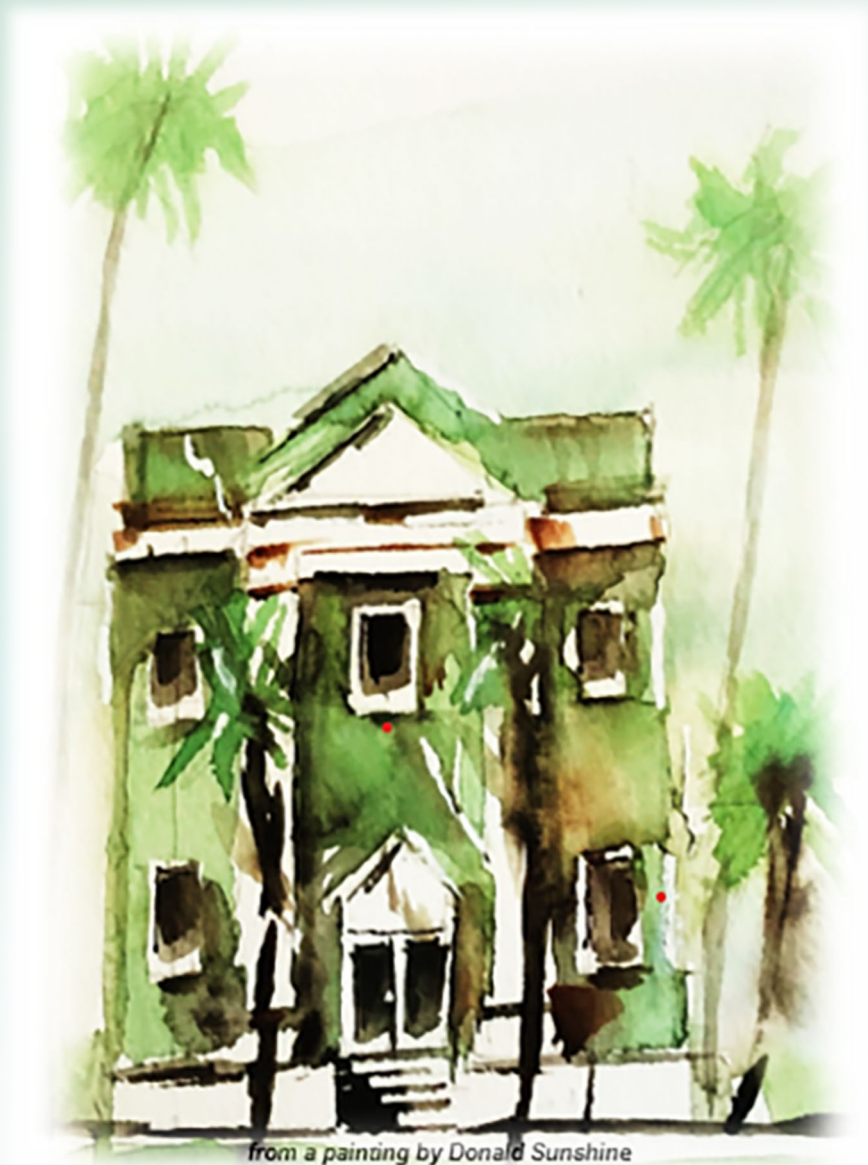
from a painting by Donald Sunshine

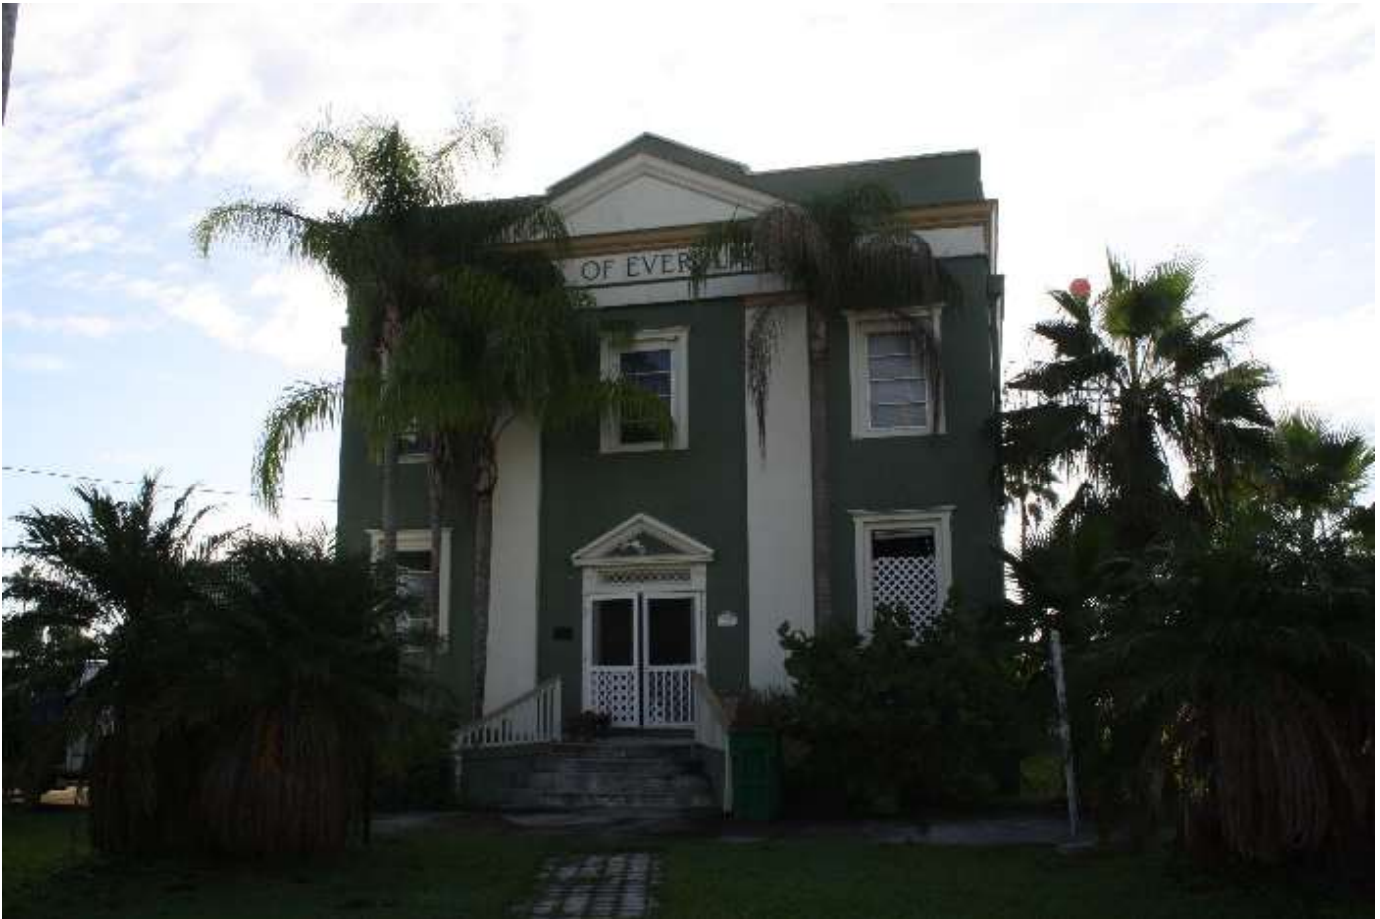
There are 30 aluminum windows on this building that replaced original wood units, 21 in the historic building and 9 on the 1950s addition. It is assumed that all were installed in 1950 when the addition was built. All will need restoration to the original wood or aluminum windows at a future date.

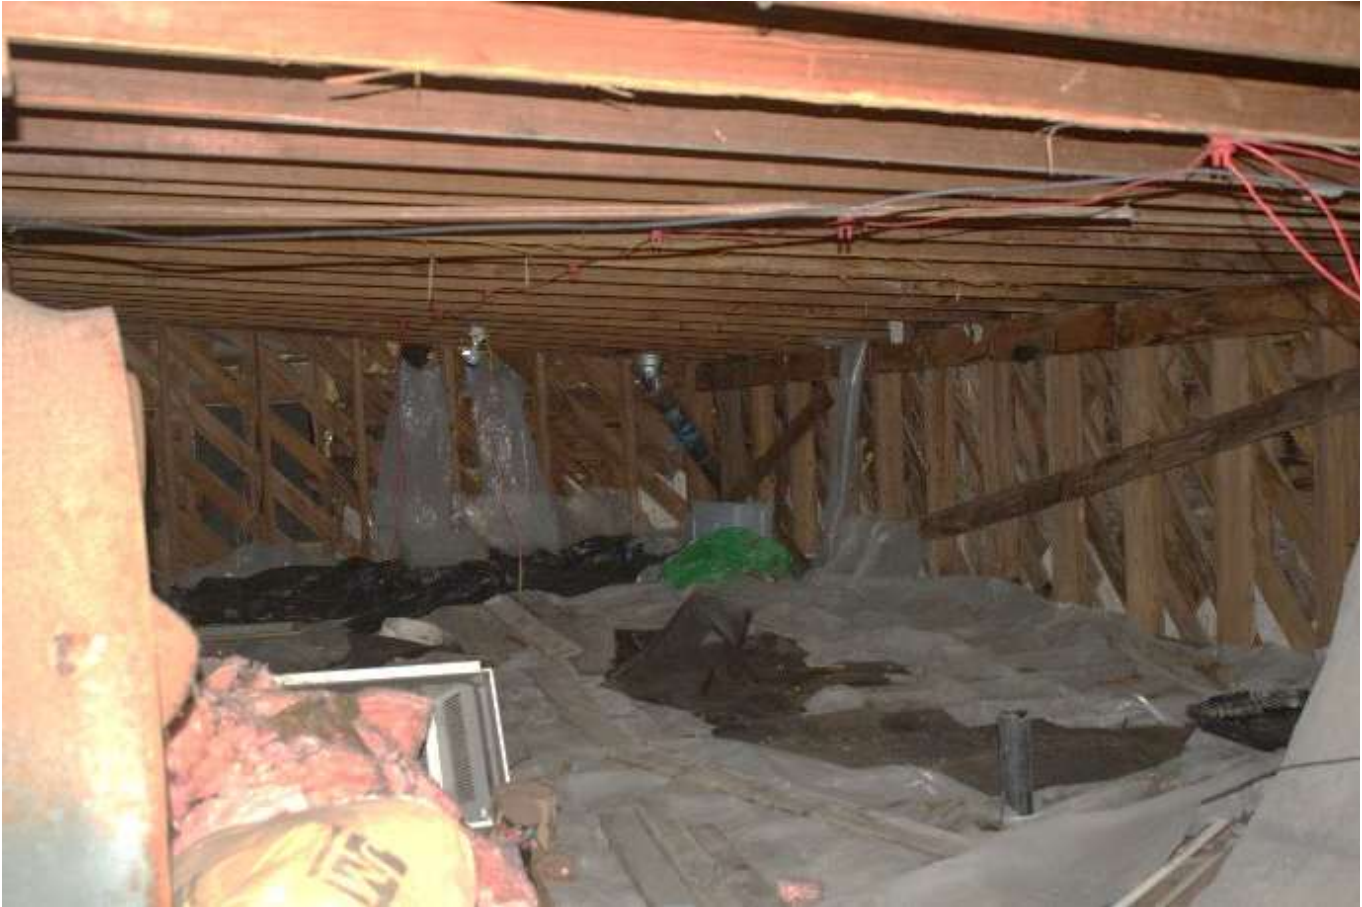
Exterior walls of the historic building are constructed of nominal 2 x 6 wood studs, 3/4" inch wood siding, 1.5 inches of concrete stucco outside, and a plaster interior finish for a 9 inch finish wall system. The vault is constructed with 8-inch thick concrete walls and roof. The 1950 addition is constructed of masonry with a stucco exterior finish. There are some cracks in the walls, but overall, they are in good condition.

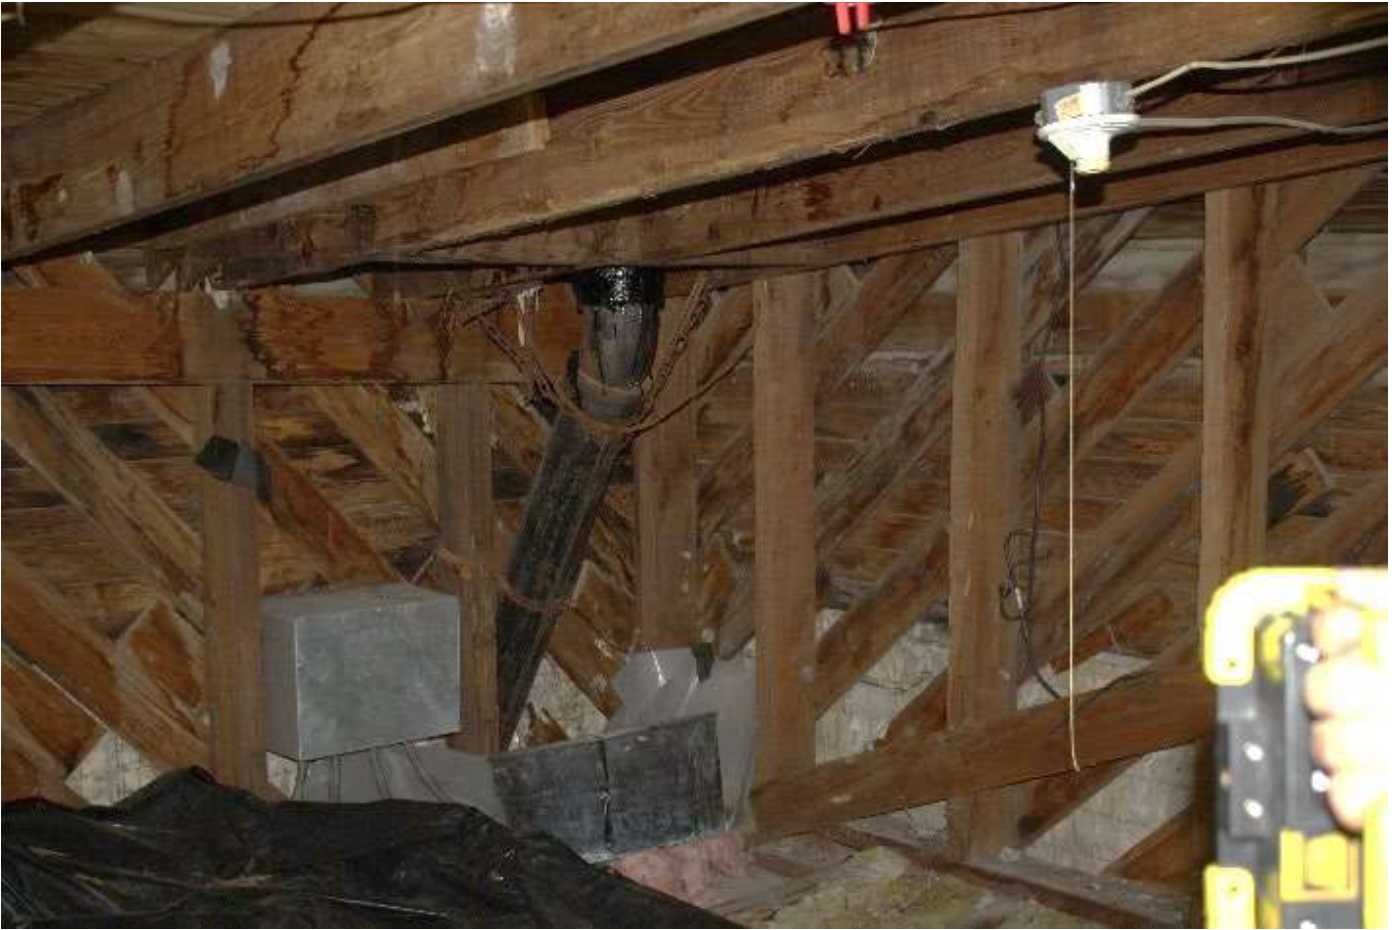
Attic area showing roof drain and plastic

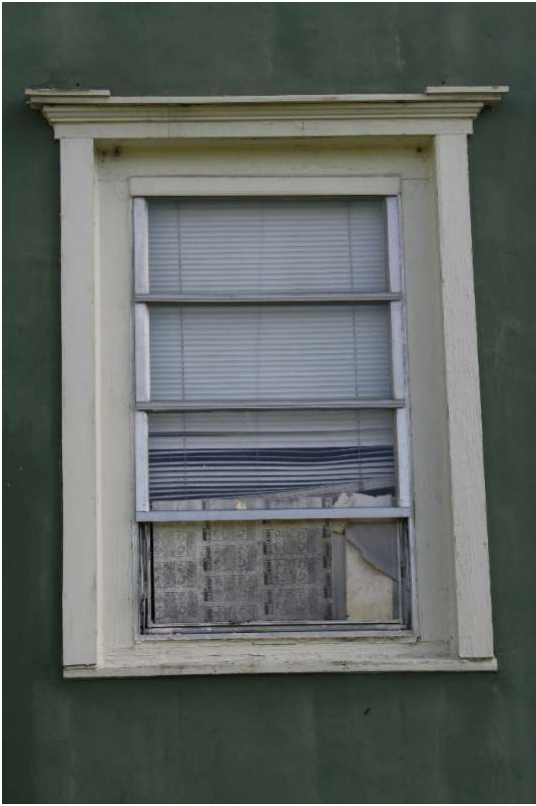
New air conditioning systems should be installed in this building to replace the through window units. Two systems will allow more control. The first-floor unit can be in the rear closet area. This system can be altered to A/C the first-floor as needed. The second-floor unit will address the second-floor rooms. The design should be adjustable to allow second floor offices or housing units to be comfortable. The final design will be based on what the final use is. This might require using separate units for each apartment or allowing units to adjust their temperature.

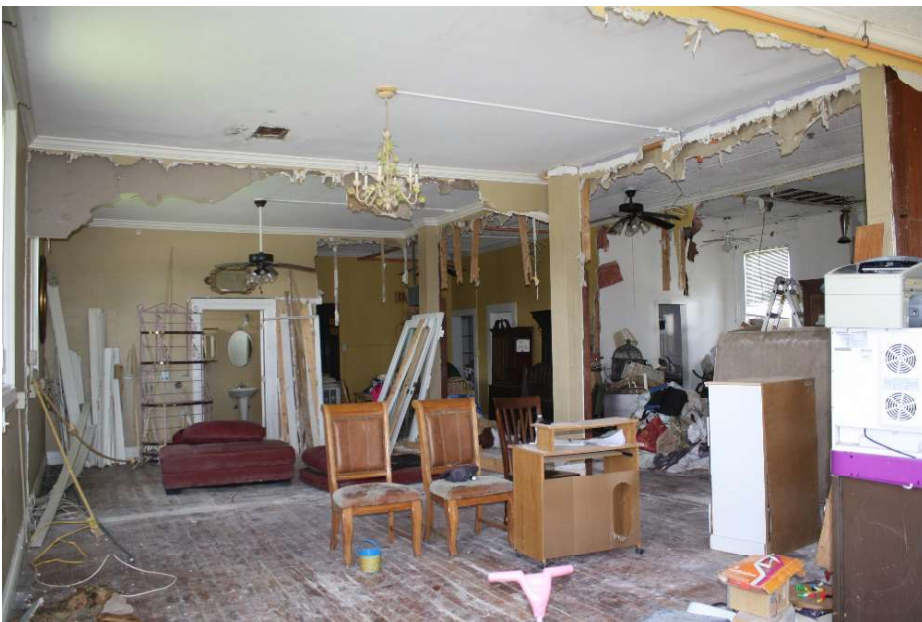
This photo shows the first floor with partitions partially demolished.

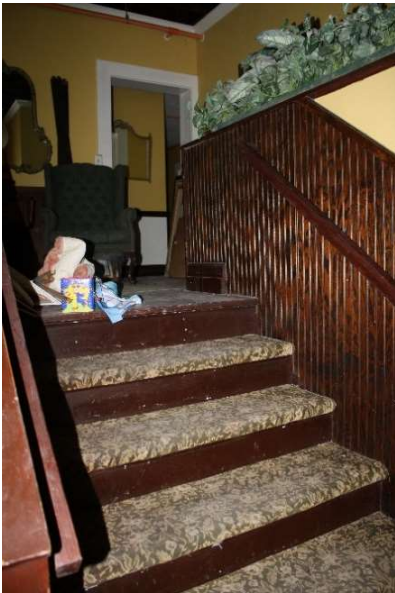
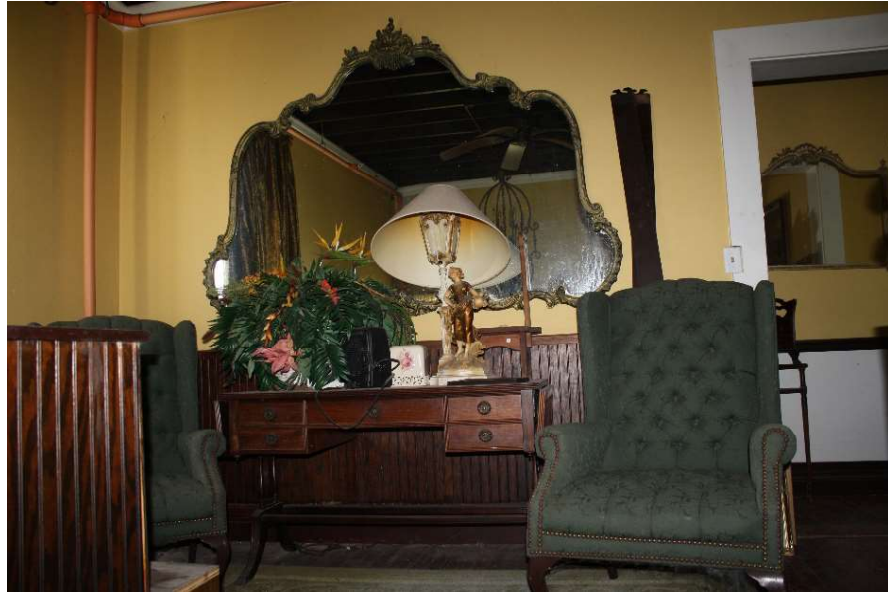
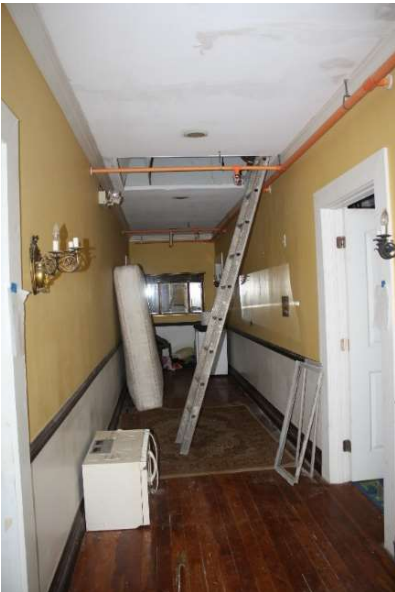
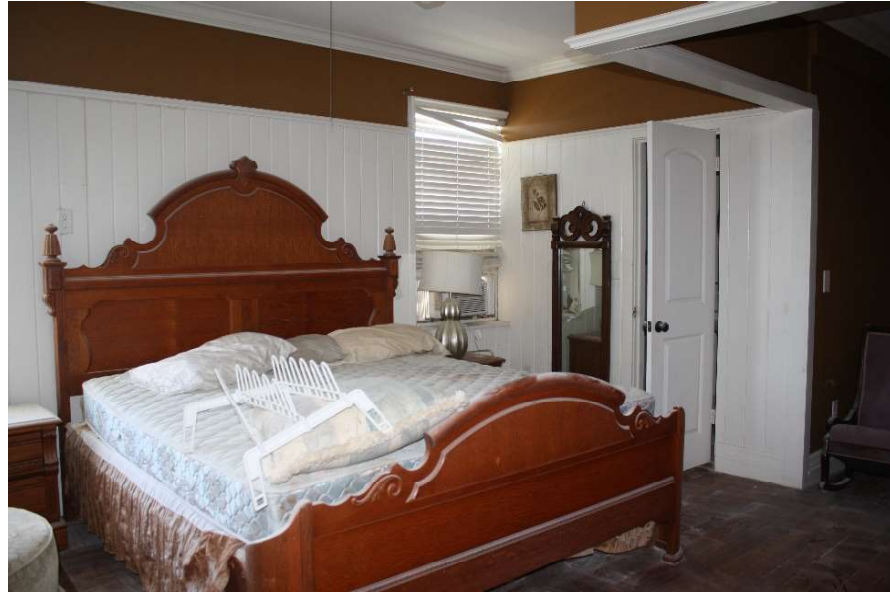
These photos show second floor areas. Top left is the stair. Top right is the upper landing. Lower left is the hall. Lower right is the bedroom.

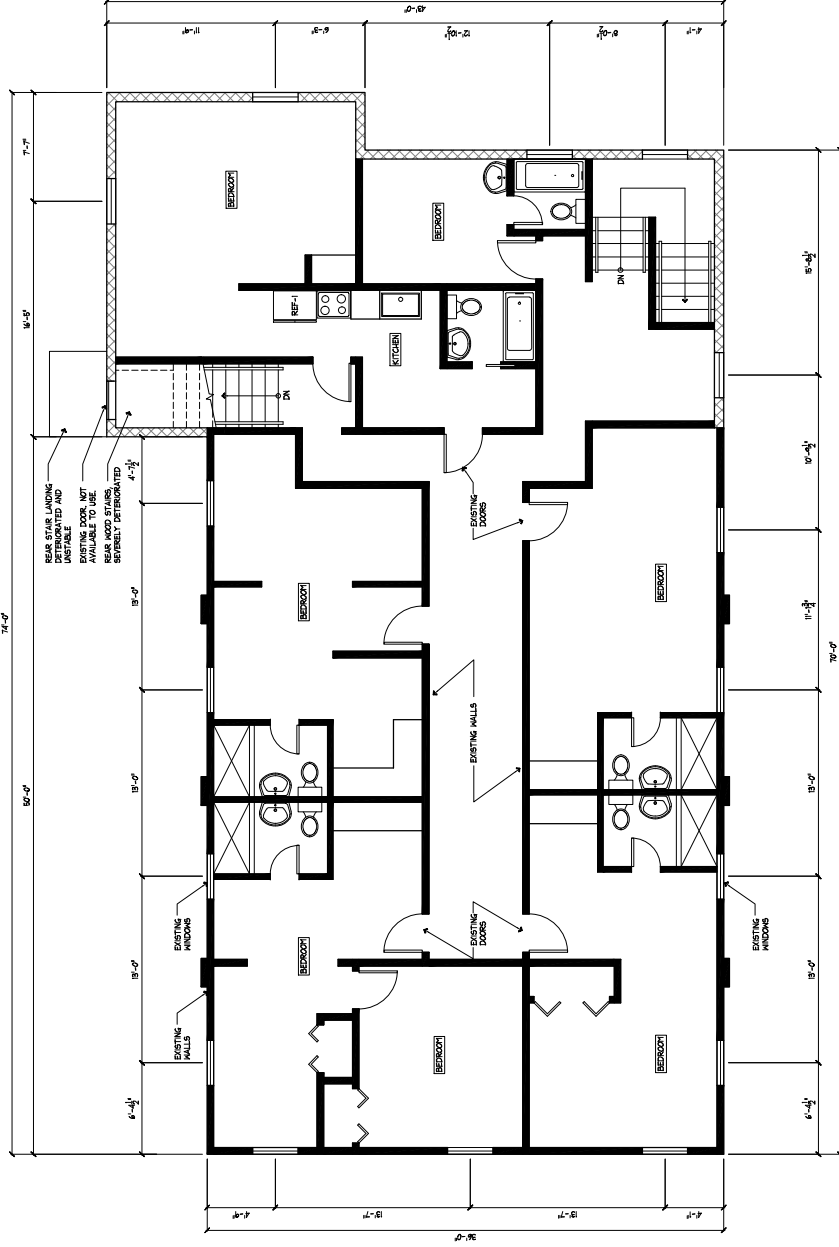
SCALE SHOWN IS FOR 24"x36" SHEET OF PAPER

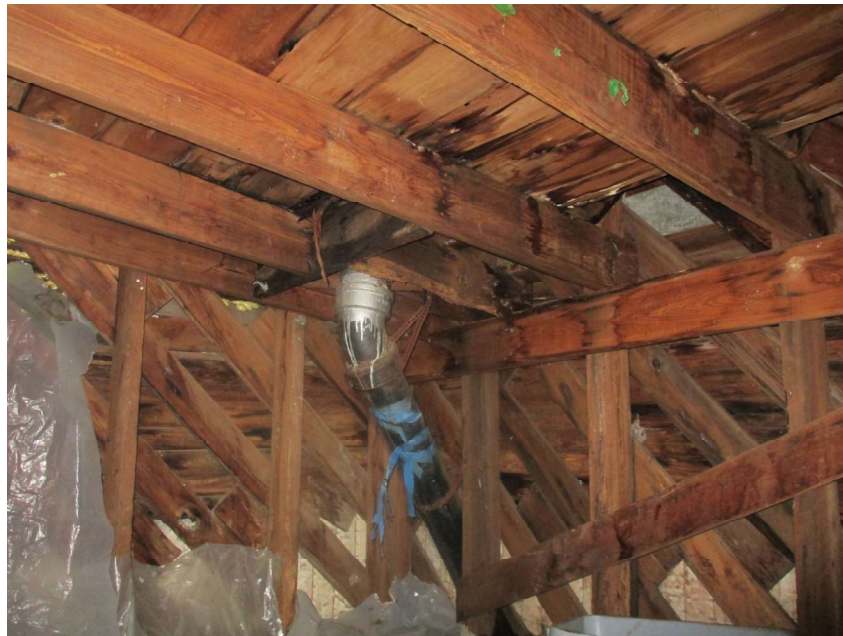
Photograph 4
Deteriorated Roof Framing at Drain

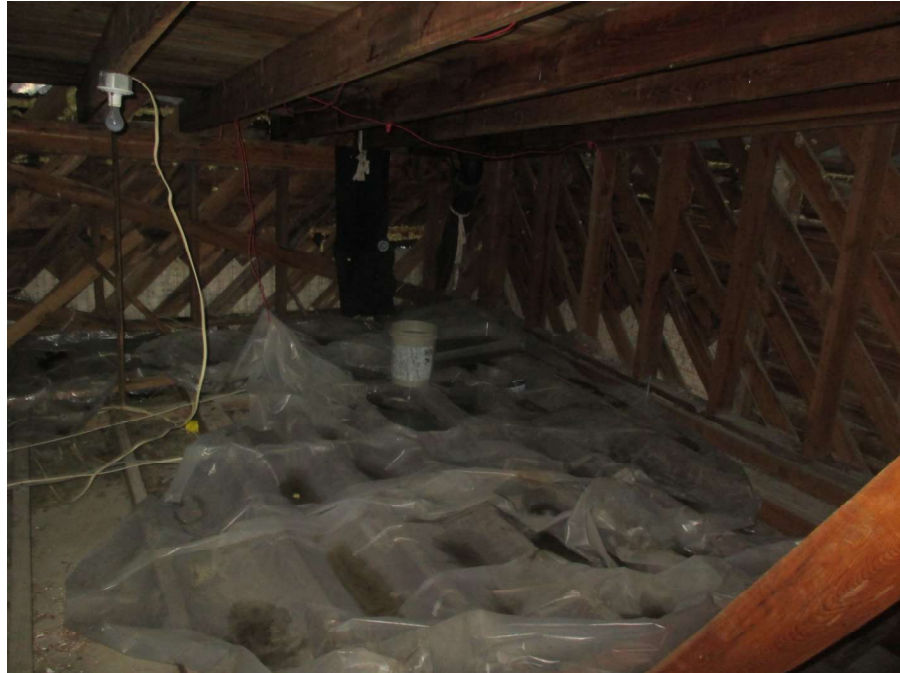
Photograph 5
Plastic Membrane in Attic Over Ceiling

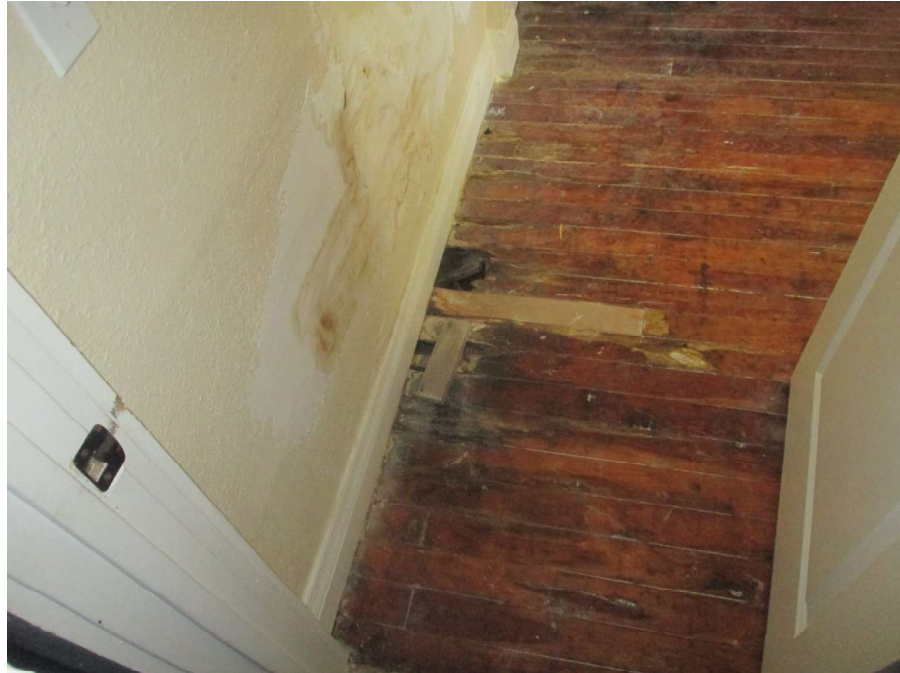
Photograph 7
Water Damage Due to Plumbing Leak

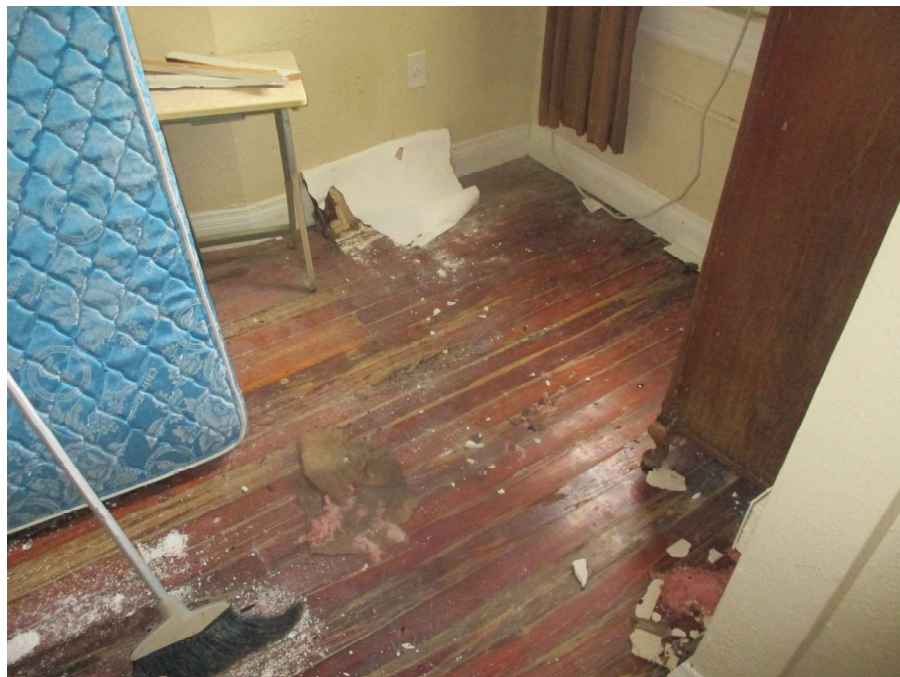
Photograph 8
Water Damage Due to Roof Leak

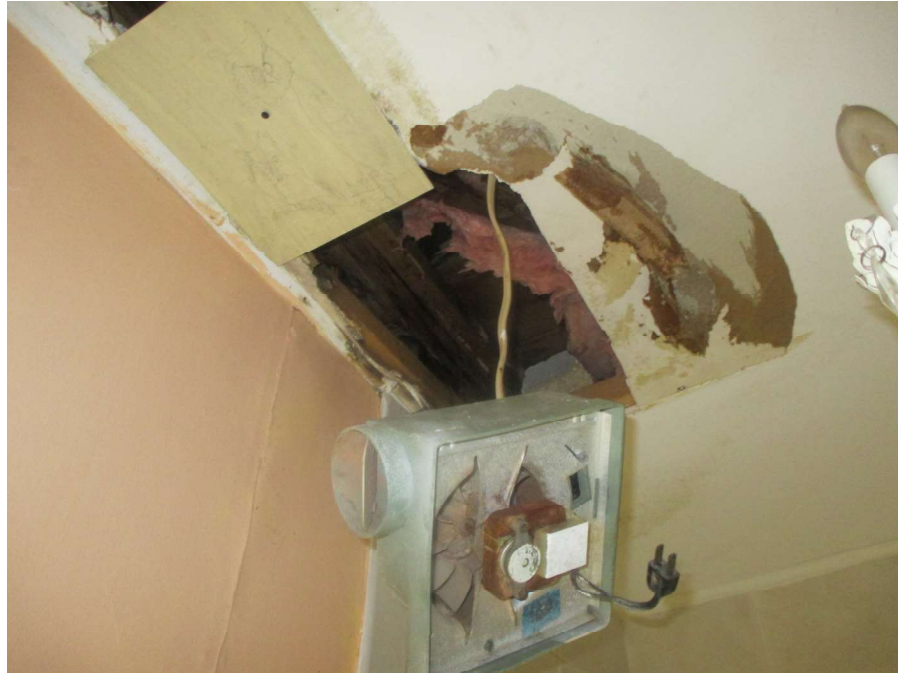
Photograph 9
Water Damaged Framing at Exhaust Fan

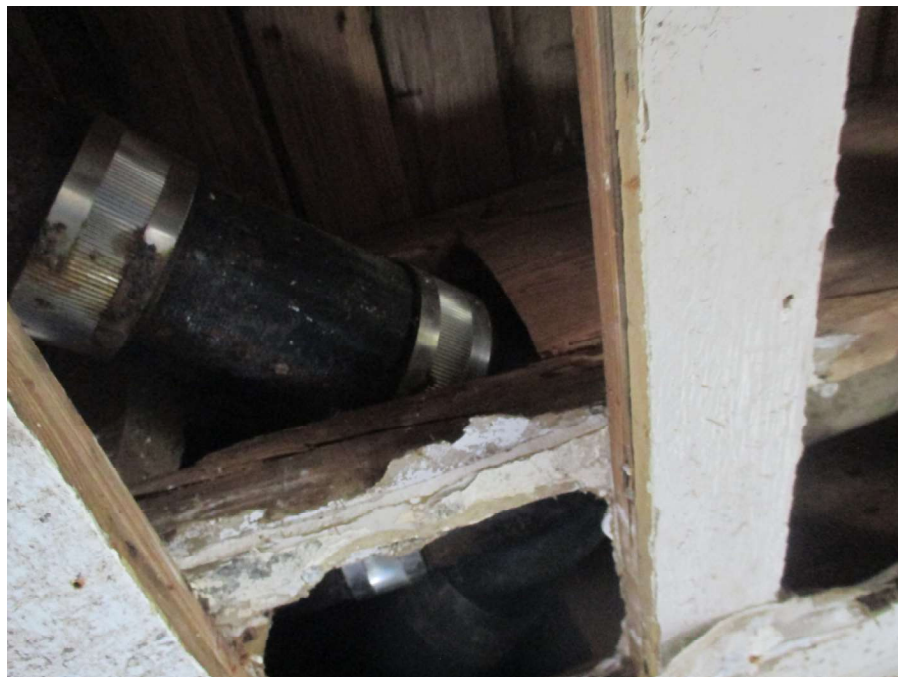
Photograph 10
Compromised Joist Due to Coping and Leaking Drainpipe

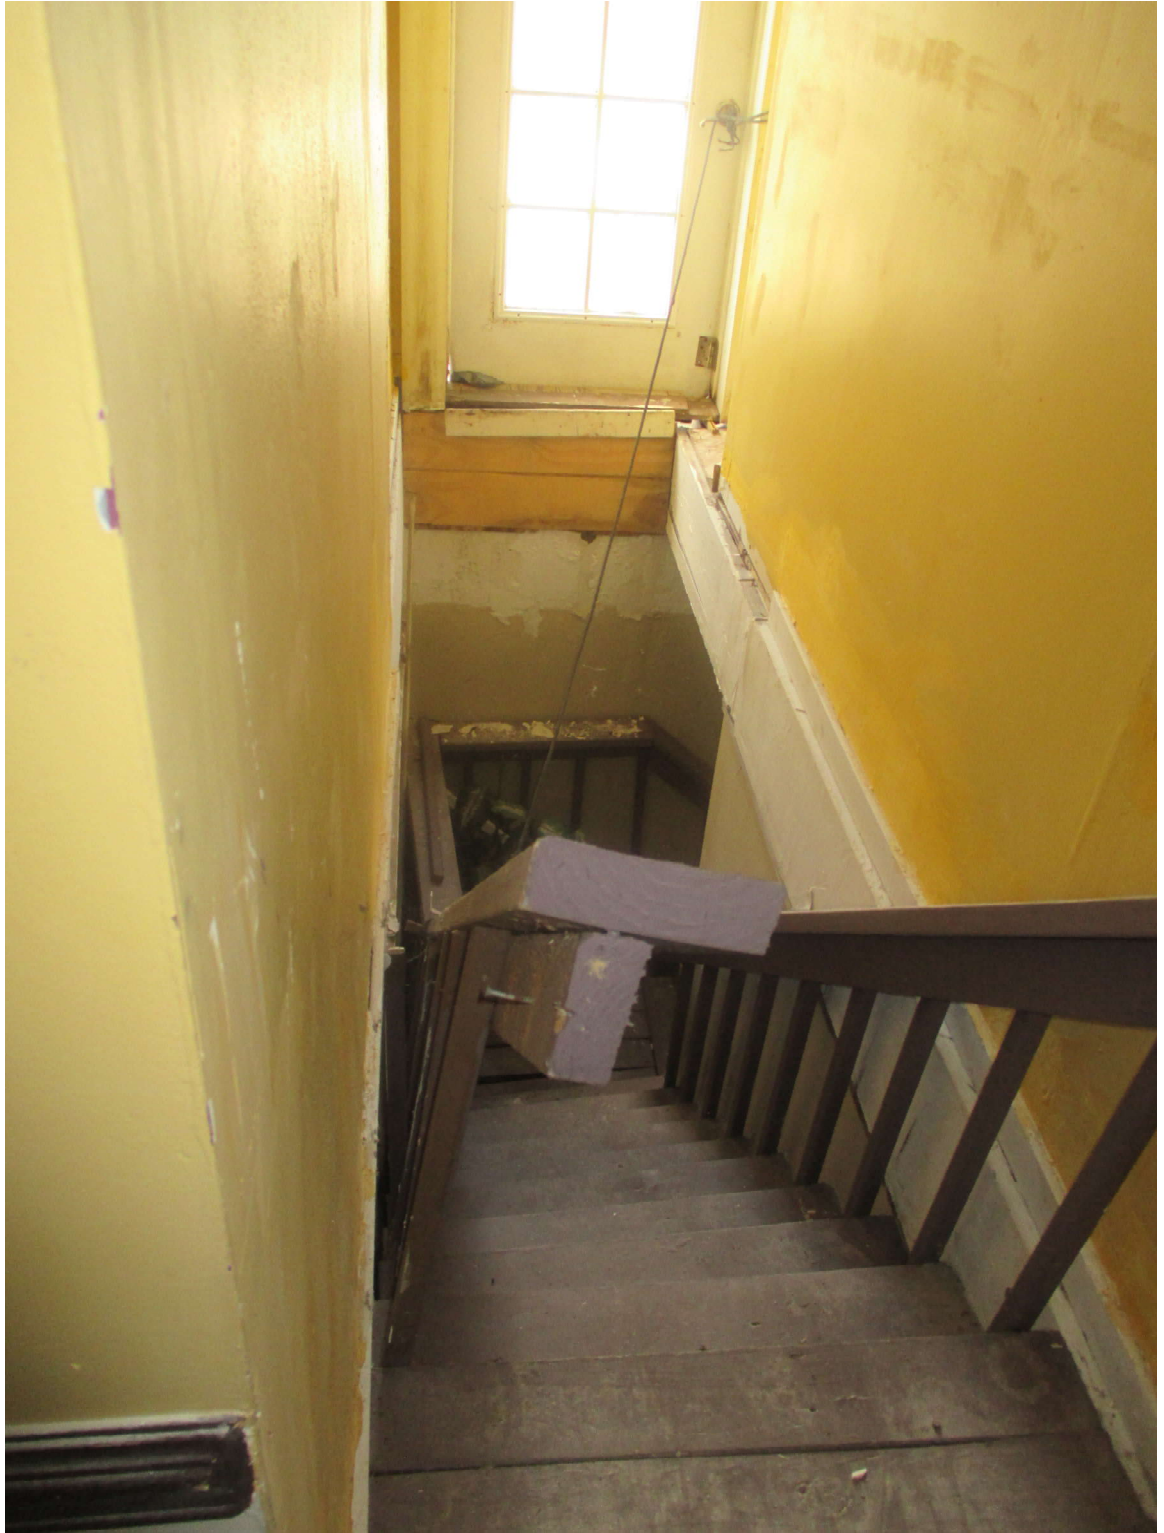
Photograph 11
Failed Stairs and Handrail at Northeast Corner

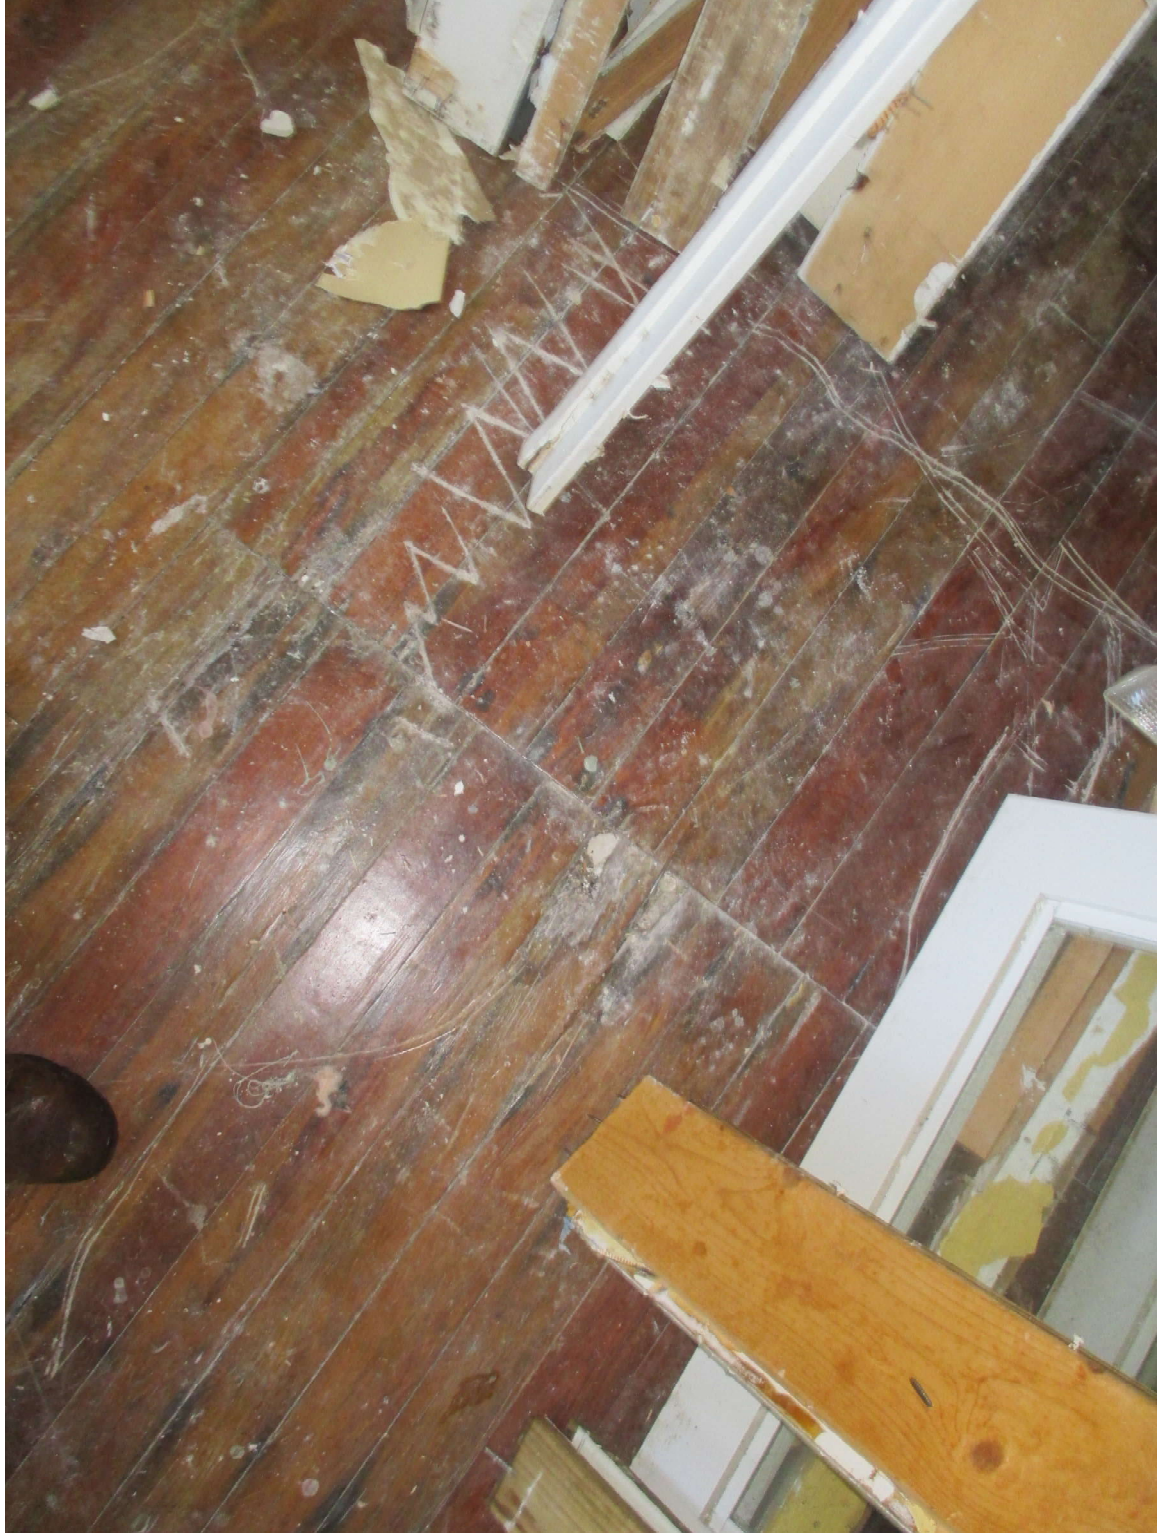
Photograph 12
Deteriorated First-Floor Decking

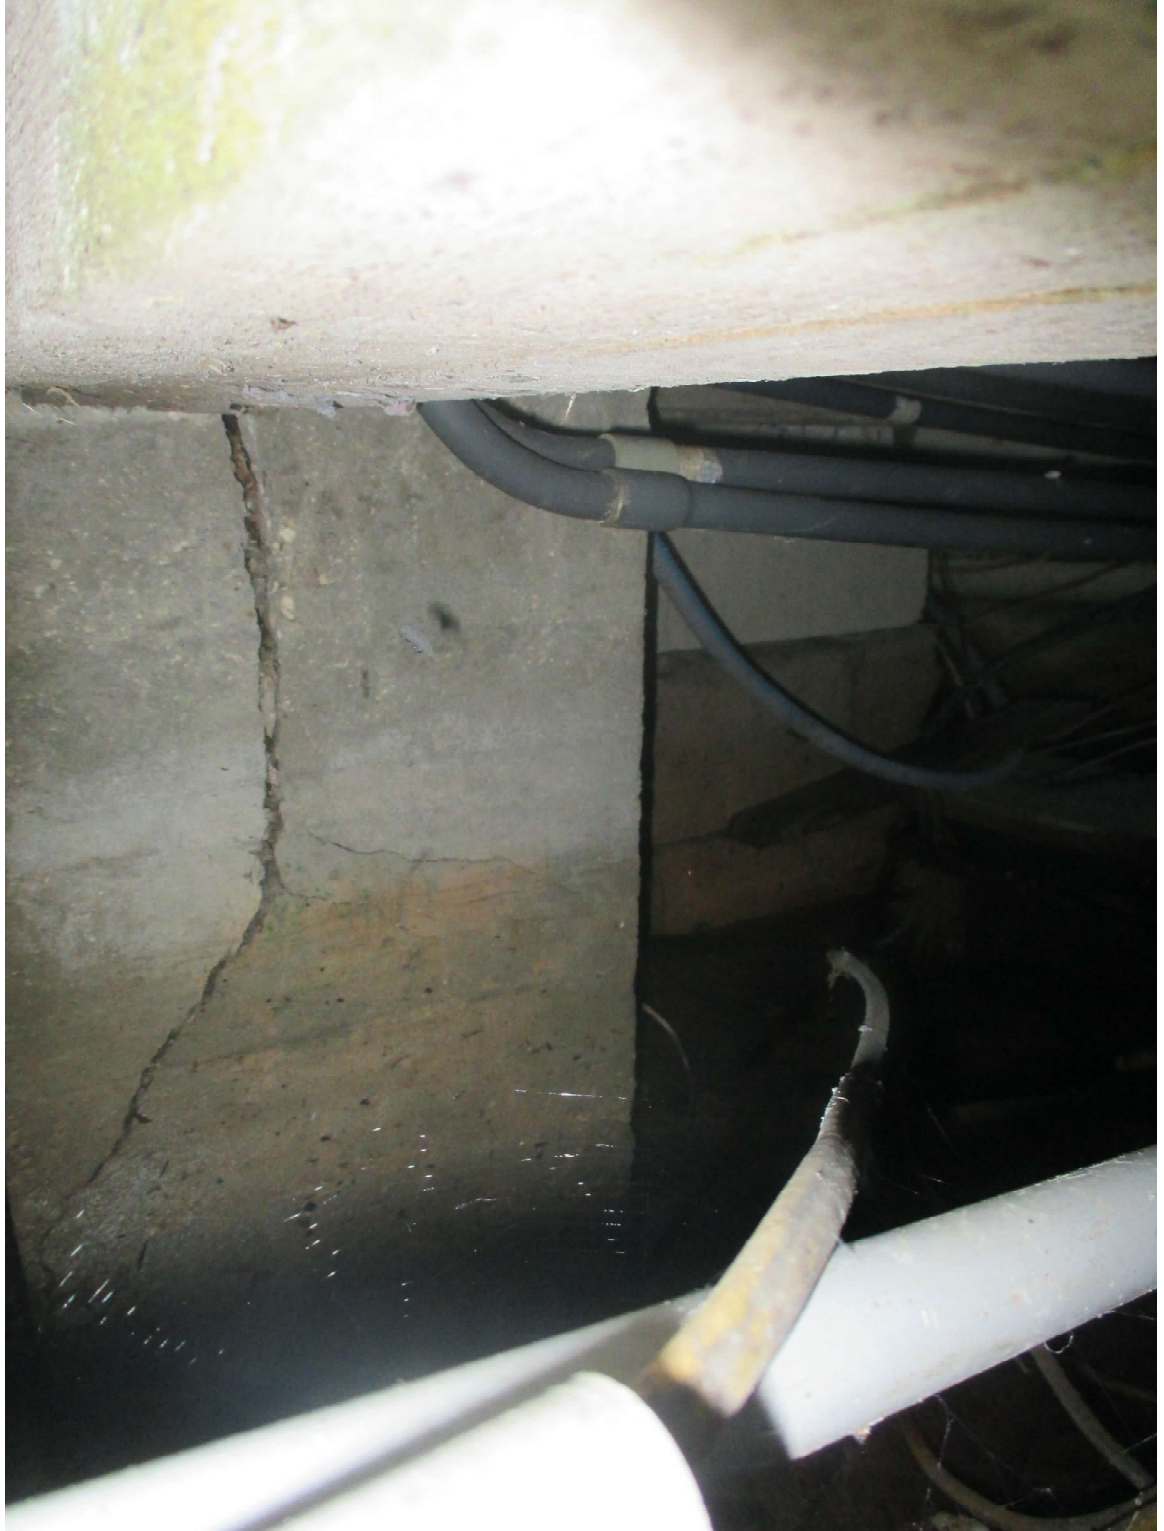
Photograph 13
Northeast Foundation Pier Cracked

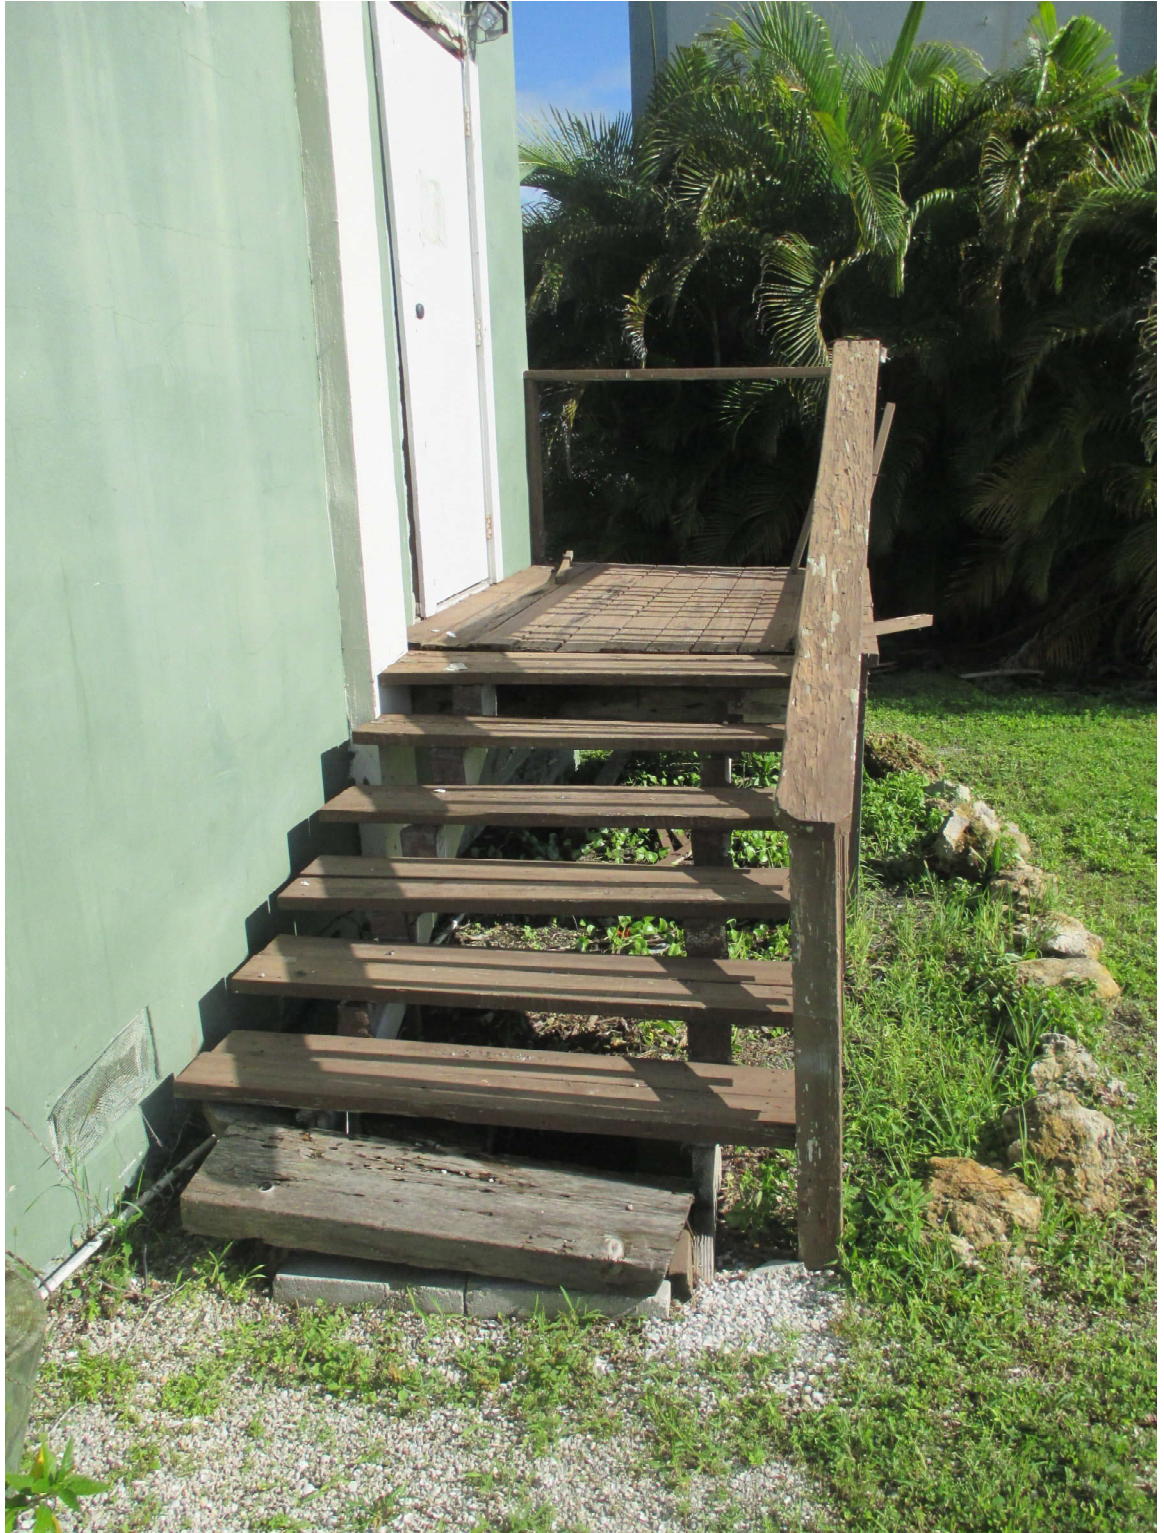
Photograph 14
East Facade Deteriorated Wood Stair Requiring Replacement on New Footings
