Everglades Society for Historic Preservation

ESHP BUSINESS PLAN FOR THE BANK OF EVERGLADES BUILDING

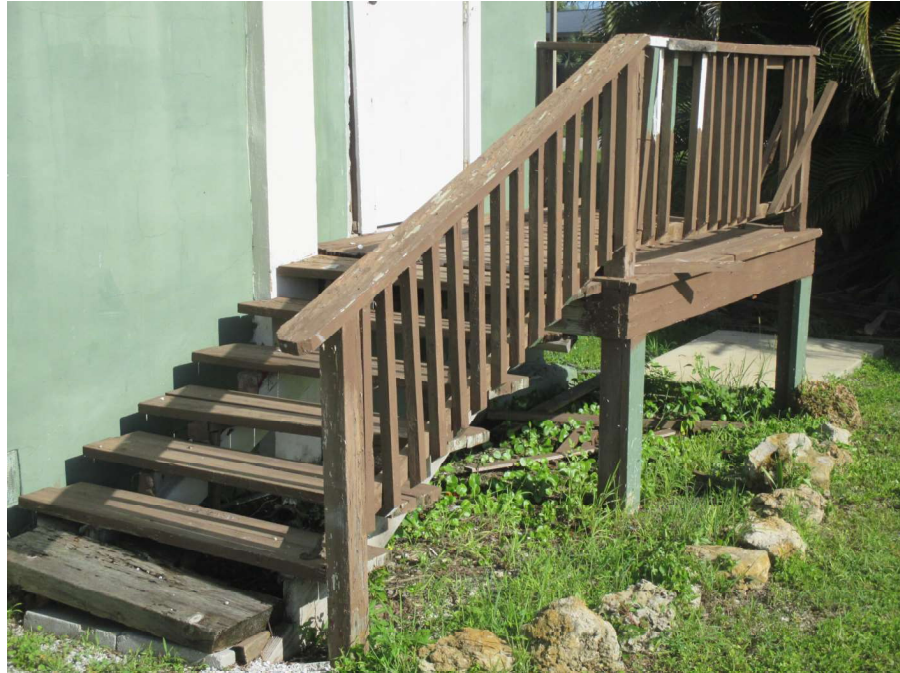
Photograph 15
Failed Handrail and Bearing On Grade

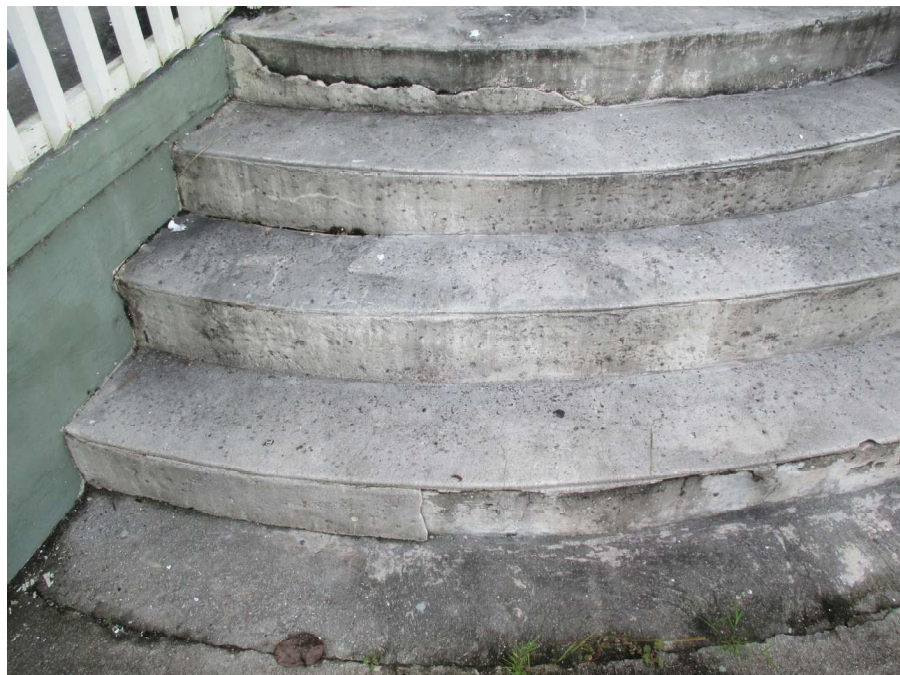
Photograph 16
West Façade Entry Steps - Topping Deterioration

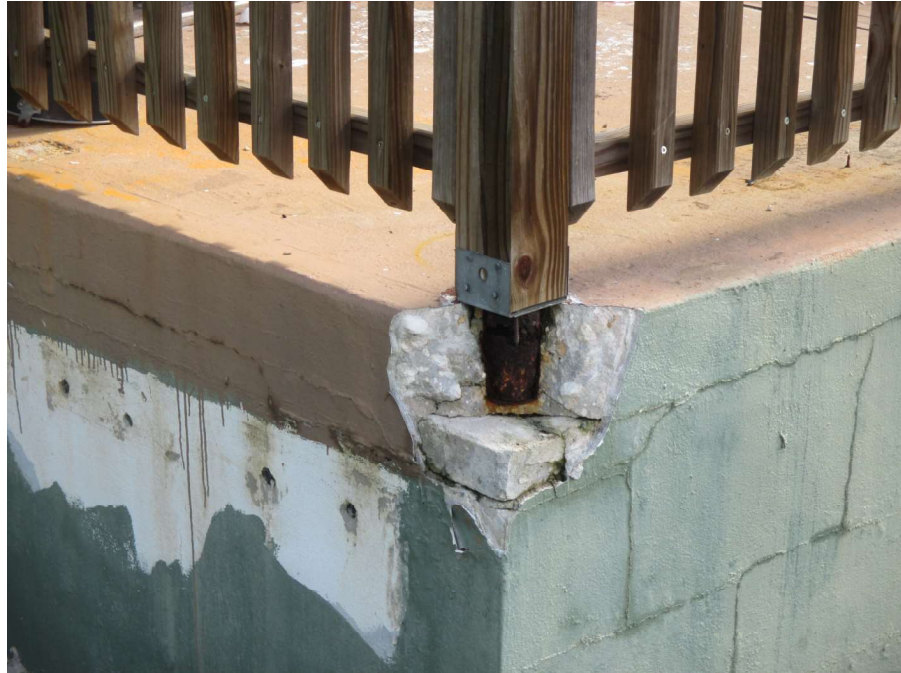
Photograph 17
South Façade Entry Handrail - Base Deterioration

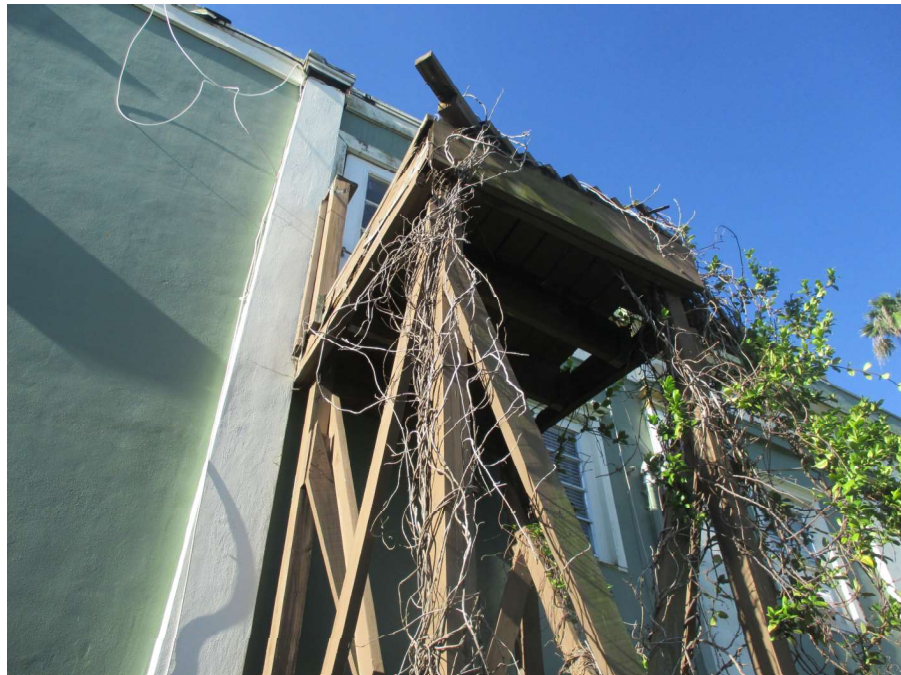
Photograph 18
North Façade Entry Deterioration

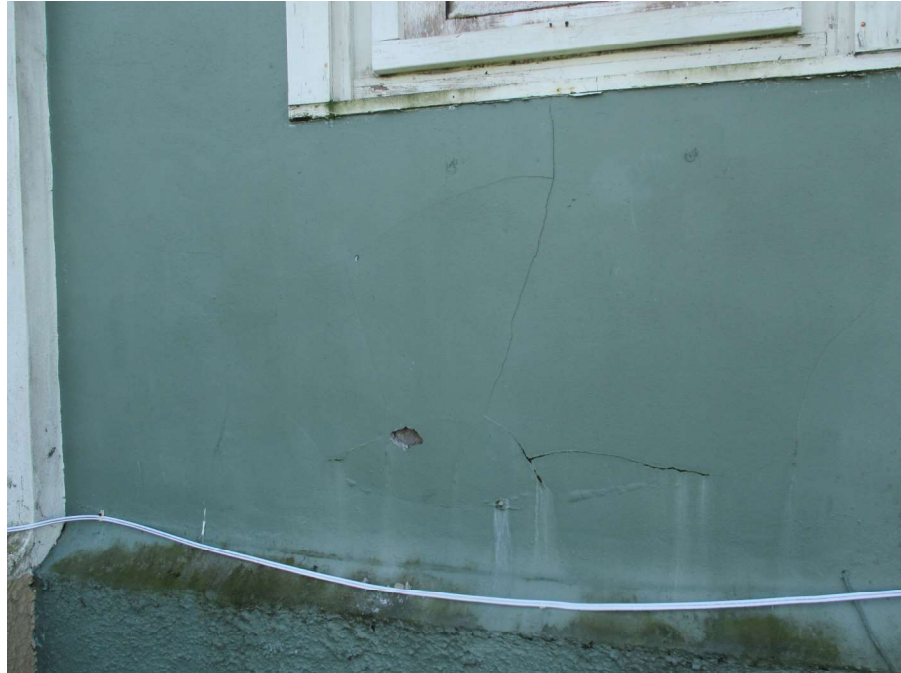
Photograph 19
Northwest Corner Cladding Spall

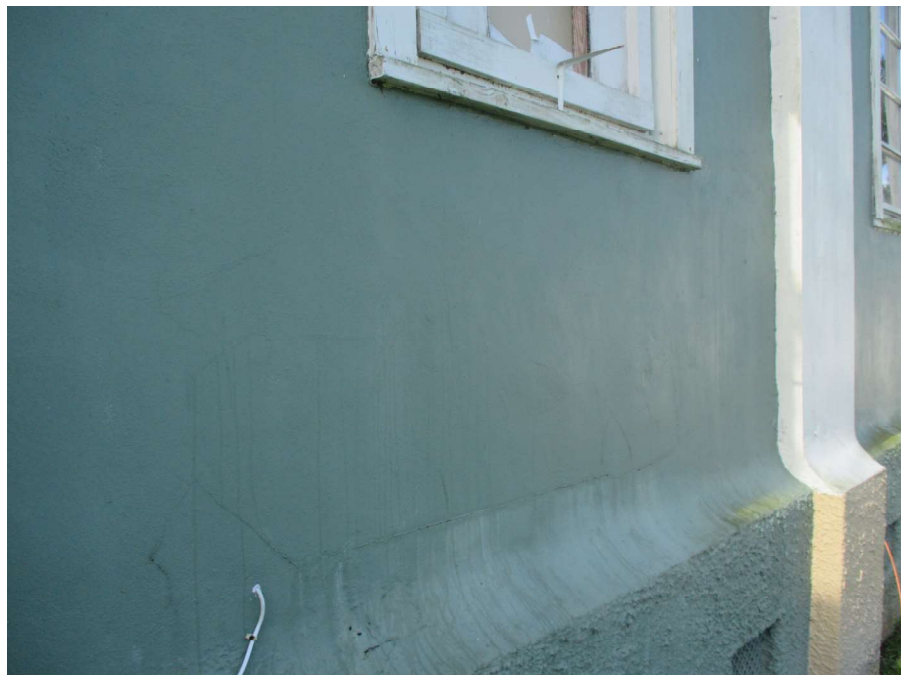
Photograph 20
Cladding Crack at First Floor Joint

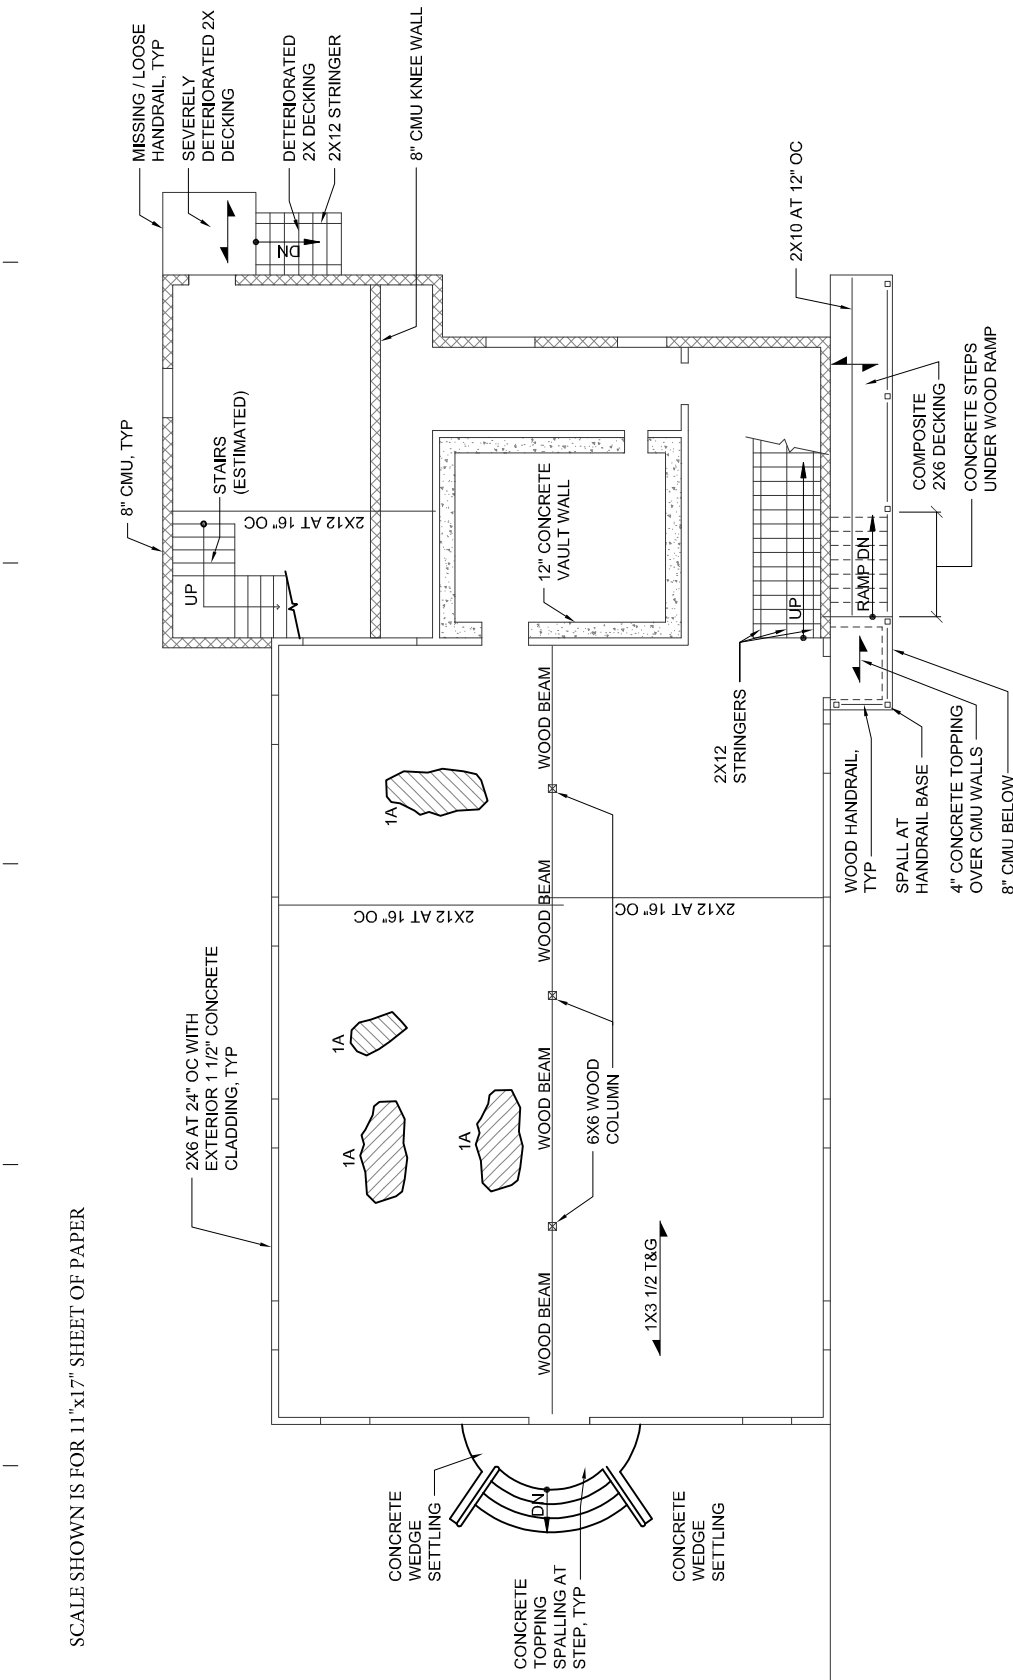
SCALE SHOWN IS FOR 11"x17" SHEET OF PAPER

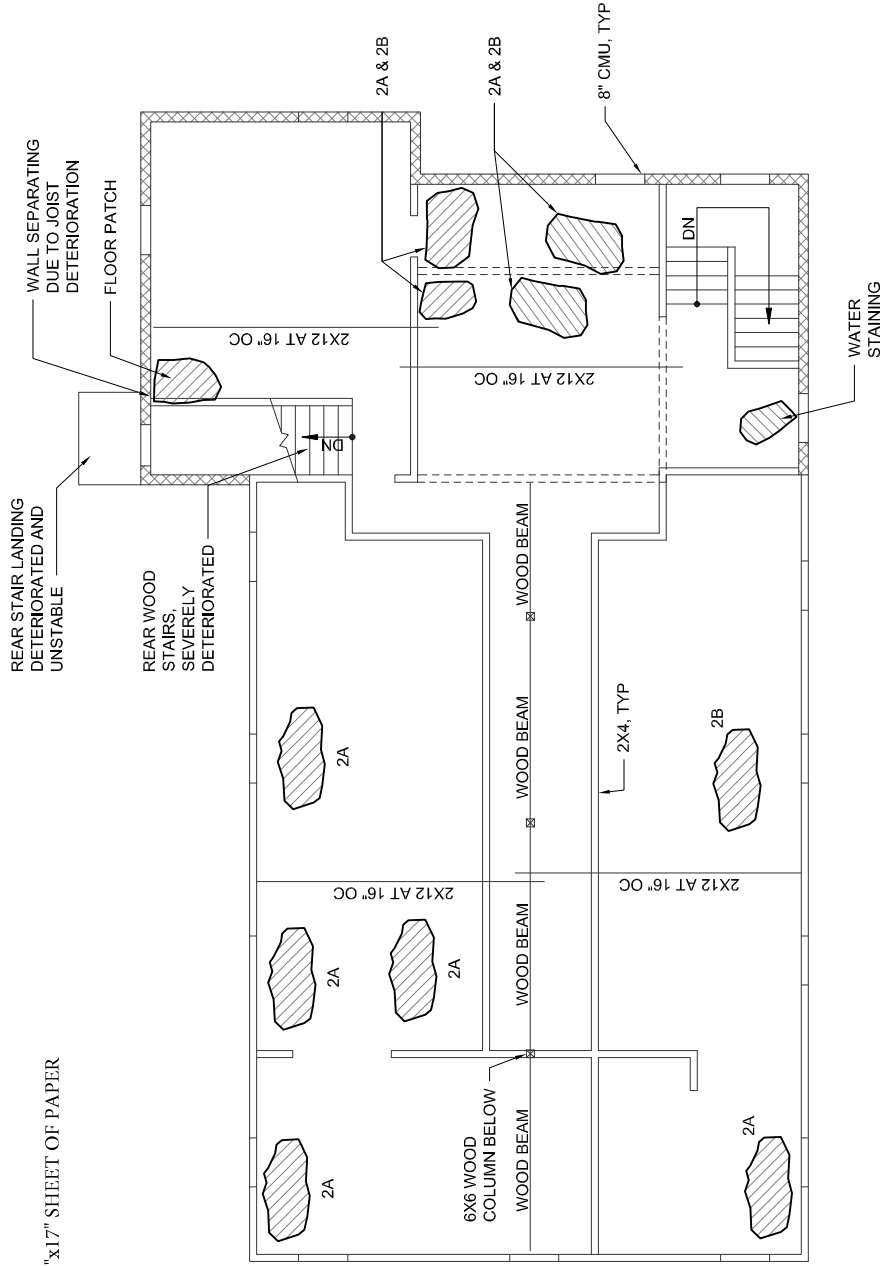
SCALE SHOWN IS FOR 11"x17" SHEET OF PAPER

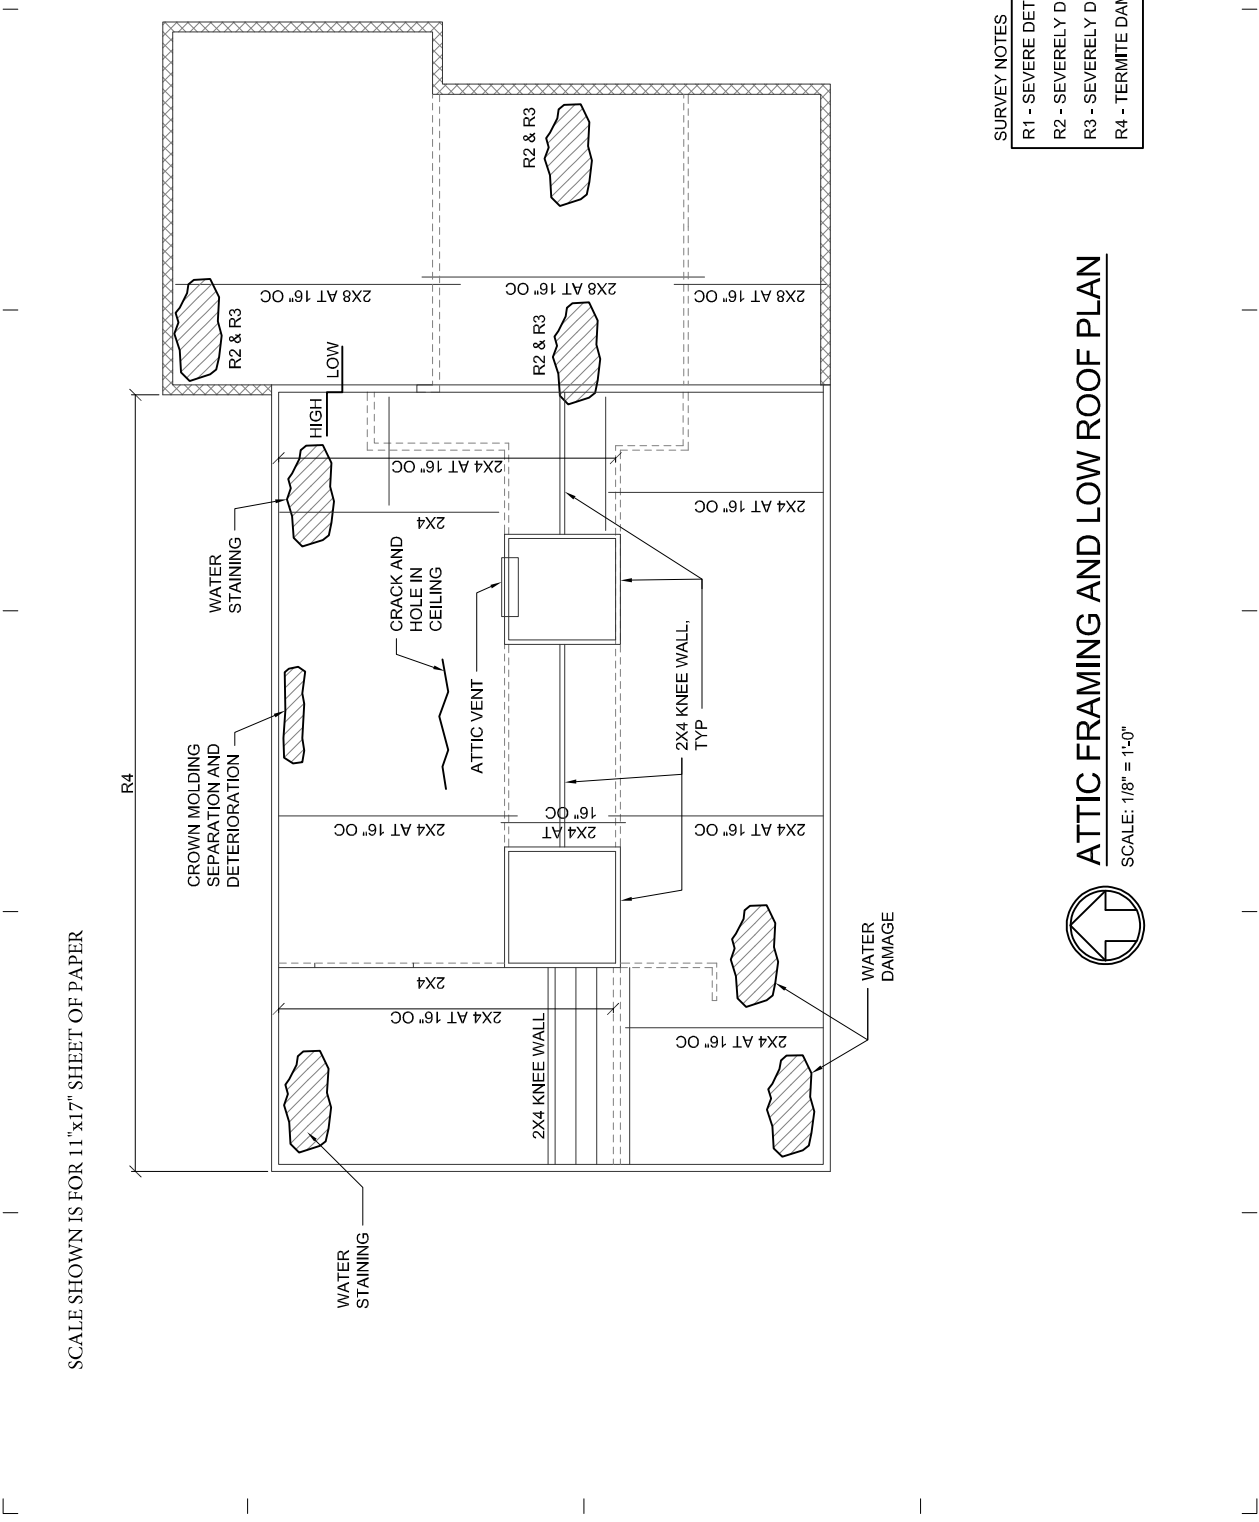
SCALE SHOWN IS FOR 11"x17" SHEET OF PAPER
