**Garden Grove Condominium
Owners Association
*Everett, WA***

Report #: 13381-0
Beginning: January 1, 2023
Expires: December 31, 2023

RESERVE STUDY
"Full"

December 20, 2022

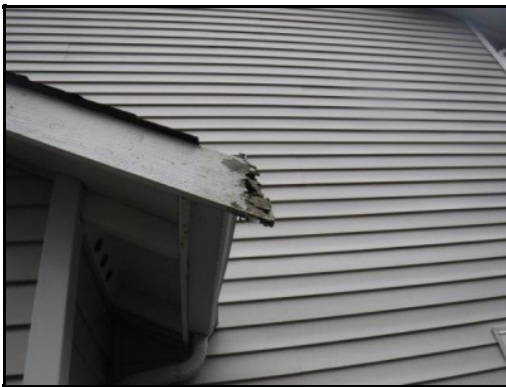
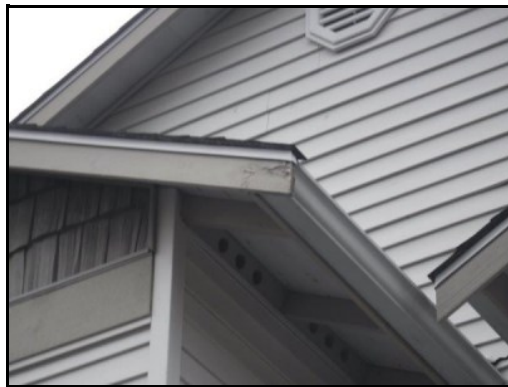
Several ends of trim pieces were noted to have rot and deterioration. We strongly recommend the association have the pieces repaired and complete an exterior painting project. Paint is not only aesthetically pleasing, it also waterproofs the wood.

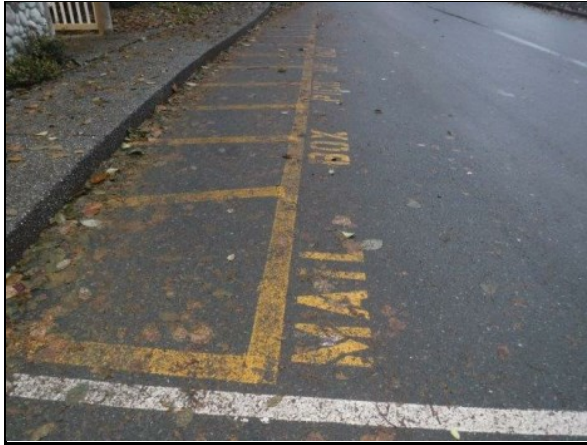
Comp #: 125 Asphalt - Repair & Seal

Useful Life:
5 years

Remaining Life:
0 years

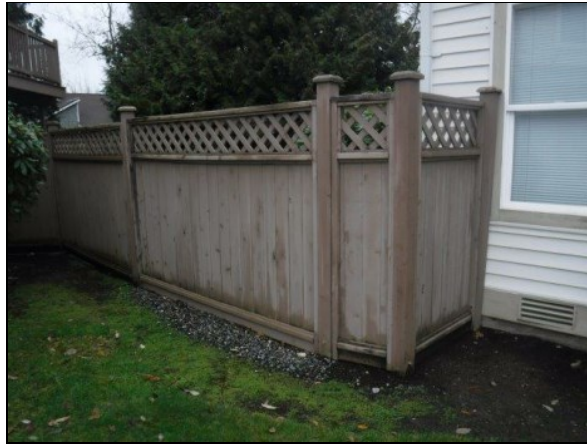
Comments: This component represents the wood fencing along the perimeters of individual lots/yards. We have provided a cyclical allowance below for localized replacement of this fencing as it is unlikely simultaneous replacement will be required. Track the actual history and costs, and adjust future reserve studies accordingly.

Useful Life:
5 yearsRemaining Life:
4 years

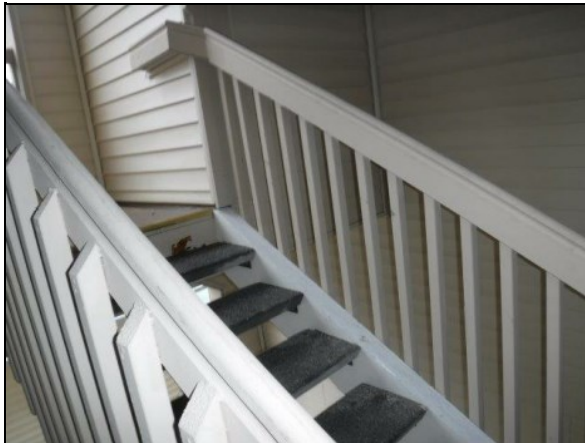
As routine maintenance, all railings and connections should be inspected at least annually for structural and/or waterproofing issues. Repair promptly, as needed, using operating funds. A general allowance is provided below for larger repair projects.

Useful Life:
10 yearsRemaining Life:
6 years
