Garden Grove Condominium Owners Association *Everett, WA*

Report #: 13381-3
Beginning: January 1, 2026
Expires: December 31, 2026

RESERVE STUDY

Update "With-Site-Visit"

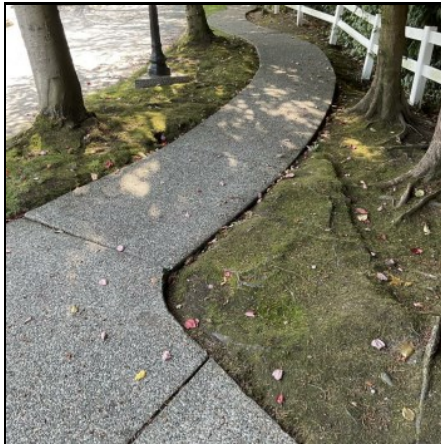
As routine maintenance utilizing operating funds, inspect regularly, and pressure wash for appearance. Repair promptly as needed to prevent water penetrating into the base, which can cause further damage. Factors affecting the quality of the concrete include the preparation of the underlying soil and drainage, thickness and strength of the concrete used, steel reinforcement (none likely), and the amount and weight of vehicle traffic.

Due to the general age and eventual wear, we suggest a periodic funding allowance to supplement the operating budget for periodic large-scale repair/replacements as reflected below.

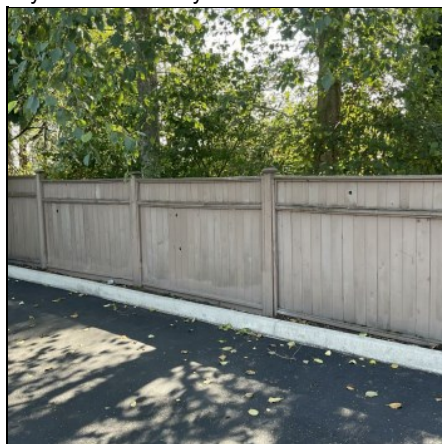
Comp #: 140 Perimeter Fences - Replace**Approx Quantity: 965 LF, Wood****Location:** The west and south community perimeters.**Funded?:** Yes.**History:** Repairs complete in 2025 by Northwest Infrastructure - \$7,573**Comments:** The wood fence did not show evidence of significant damage, instability, or failure. Wood board fence is approximately 6-foot tall and painted, so we were unable to confirm if the posts and rails are a pressure treated material.

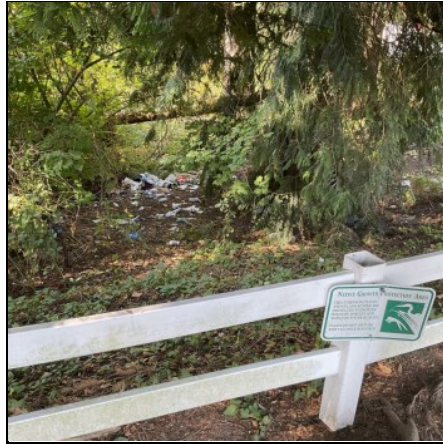
Comments: There were no specific problems with the trees observed or reported at this time.

This component may be utilized for larger tree removal/trimming projects which do not occur on an annual basis. If the community has not already done so, consult with a qualified arborist to assess the current plantings and to prepare a long term plan for the care and management of the community's trees, balancing aesthetics with the protection of the association's assets. Tree roots can be damaging to walkways, irrigation, underground utilities, and building structures. Track actual expenses, and adjust accordingly in reserve study updates.

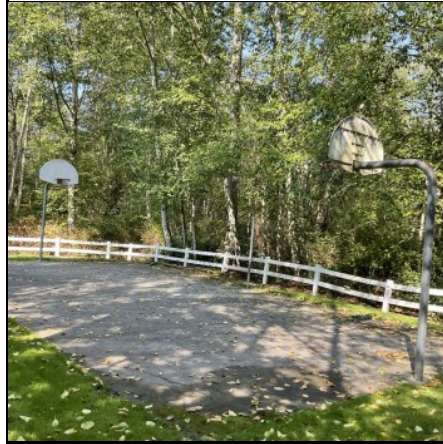
Comp #: 220 Sport Court - Resurface**Approx Quantity: 1,125 GSF / Concrete****Location:** Behind building CC (#11501).**Funded?:** Yes.**History:** Installed 1999.**Comments:** The sport court surface was observed with some local cracks noted, but not significant or widespread at this time.

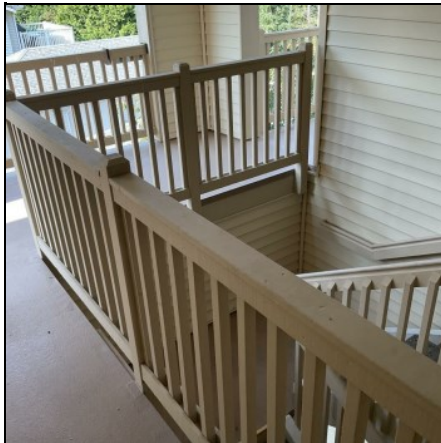
Comp #: 555 Building Wood Rails - Replace**Approx Quantity: 2,000 LF****Location:** The decks, walkway, and stairs.**Funded?:** Yes.**History:** Installed 1999.**Comments:** The wood rails did not show evidence of significant damage, instability, or failure. Some localized decay was observed. The rails were not attached through the waterproof surface of the deck.
