PROPERTY INSPECTION  
**REPORT**

**12345 123rd St E, Puyallup, WA 98374**

DATE OF INSPECTION: 10/9/2026

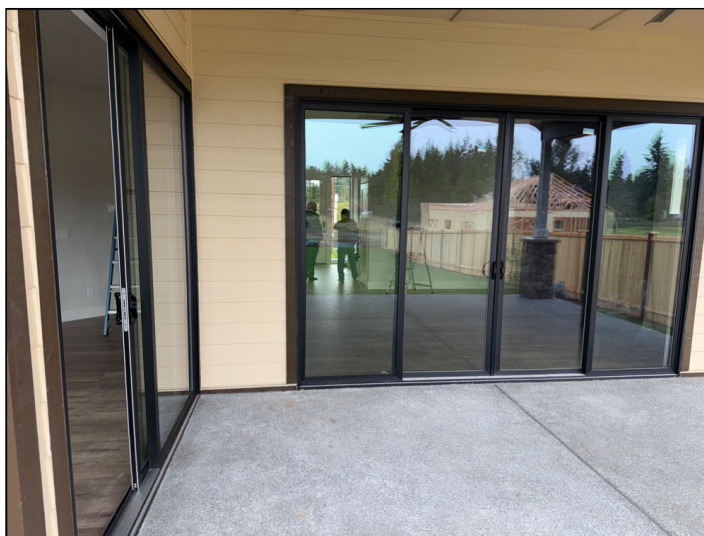
Screen doors have not been installed at the back patio.

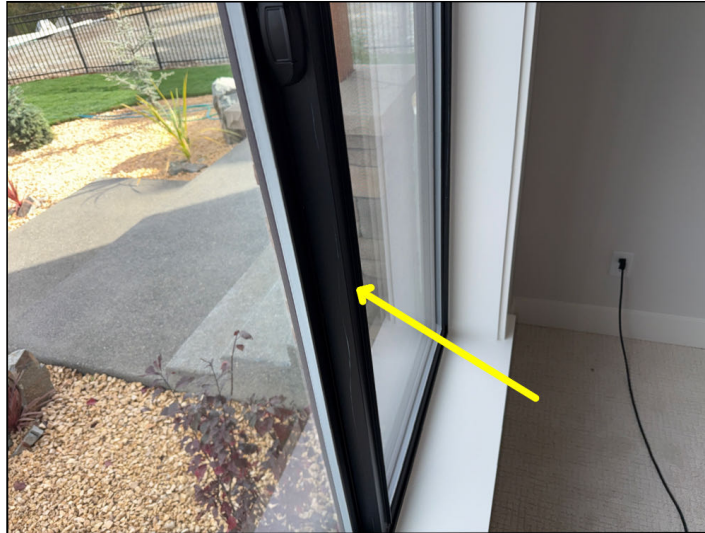
A cosmetic scratch was noted on the office window frame. Recommend having the builder repair the scratch using a method approved by the window manufacturer to restore the finish.

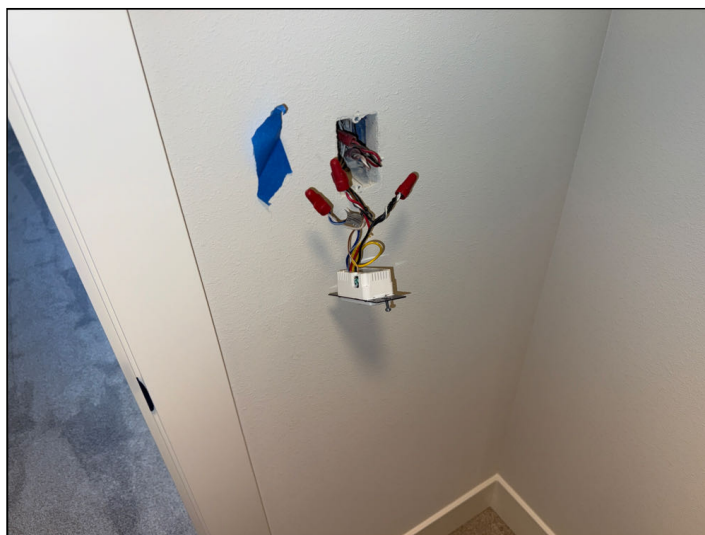
| Bedrooms | | |
|---|---|---|
| Page 9 Item: 5 | Electrical | <ul style="list-style-type: none"> <li>• West Bedroom Closet – Electrical: Exposed electrical components were noted at the light switch in the west bedroom closet. Recommend installing the appropriate cover/trim or completing the installation as needed to prevent access to electrical components.</li> </ul> |

West Bedroom Closet – Electrical: Exposed electrical components were noted at the light switch in the west bedroom closet. Recommend installing the appropriate cover/trim or completing the installation as needed to prevent access to electrical components.

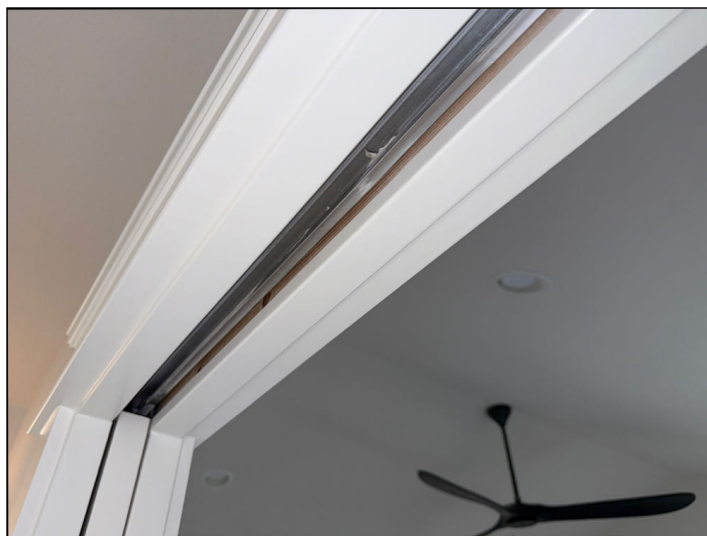
Tape noted inside the track of the pocket door for the primary bathroom. Recommend removing to prevent gumming up the track.

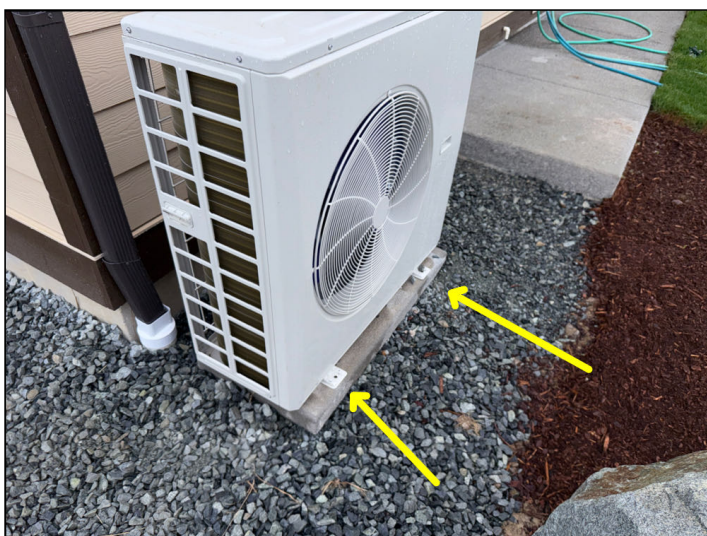
| Bedrooms | | |
|---|---|---|
| Page 20 Item: 7 | AC Compress Condition | <ul style="list-style-type: none"> <li>• The exterior heat pump is secured to the pad with four small fasteners that appear undersized compared with the manufacturer's specified M10 mounting bolts. Recommend having the HVAC installer verify the fastener size and suitability for the pad material and correct the anchorage according to the manufacturer's installation instructions.</li> </ul> |

The exterior heat pump is secured to the pad with four small fasteners that appear undersized compared with the manufacturer's specified M10 mounting bolts. Recommend having the HVAC installer verify the fastener size and suitability for the pad material and correct the anchorage according to the manufacturer's installation instructions.

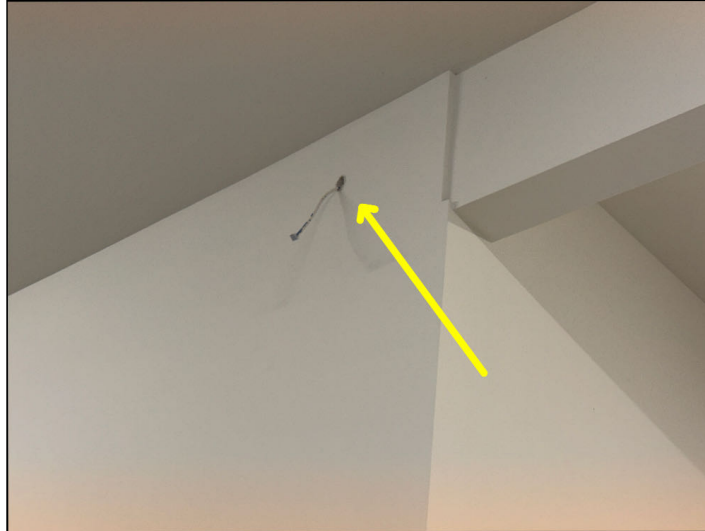
Recommend fire sealing the hole in the main home garage wall where roughed in for the security cameras.

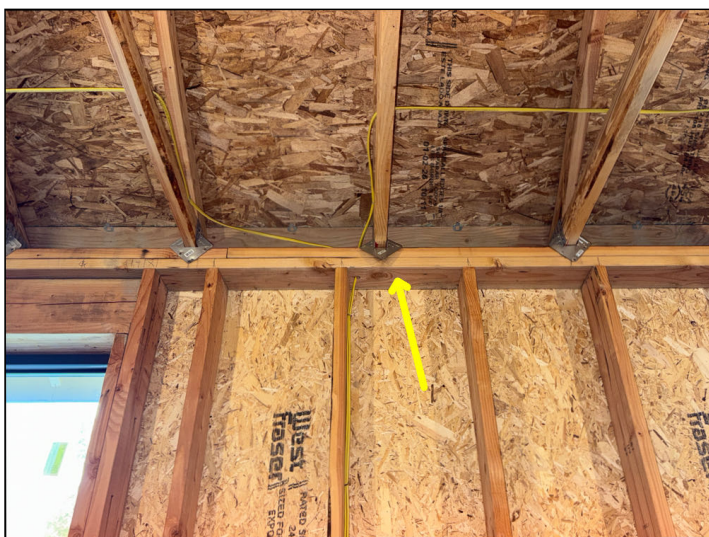
| Bedrooms | | |
|---|---|---|
| Page 26 Item: 5 | Rafters & Ceiling | <ul style="list-style-type: none"> <li>• Multiple Simpson truss tie-down clips in the detached garage have improperly placed nails that missed the manufacturer's designated fastener holes. One clip on the east side of the garage was not fastened and appeared to be pinched in place. These conditions may reduce the strength of the roof-to-wall connections. Recommend having the builder inspect all clips and correct the installations using the manufacturer-specified fasteners and fastening pattern before the framing is concealed. Improper fastening may reduce the connectors' rated capacity and affect manufacturer warranty coverage. Recommend correction according to Simpson's installation instructions.</li> </ul> |

Multiple Simpson truss tie-down clips in the detached garage have improperly placed nails that missed the manufacturer's designated fastener holes. One clip on the east side of the garage was not fastened and appeared to be pinched in place. These conditions may reduce the strength of the roof-to-wall connections. Recommend having the builder inspect all clips and correct the installations using the manufacturer-specified fasteners and fastening pattern before the framing is concealed. Improper fastening may reduce the connectors' rated capacity and affect manufacturer warranty coverage. Recommend correction according to Simpson's installation instructions.

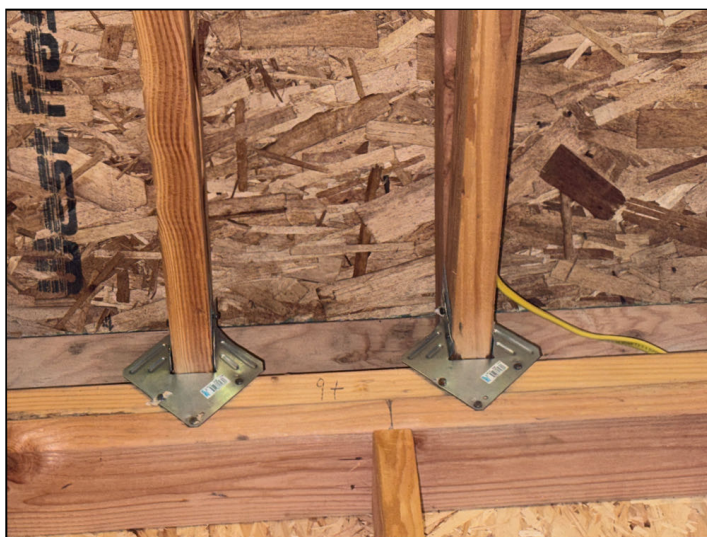
Multiple Simpson truss tie-down clips in the detached garage have improperly placed nails that missed the manufacturer's designated fastener holes. One clip on the east side of the garage was not fastened and appeared to be pinched in place. These conditions may reduce the strength of the roof-to-wall connections. Recommend having the builder inspect all clips and correct the installations using the manufacturer-specified fasteners and fastening pattern before the framing is concealed. Improper fastening may reduce the connectors' rated capacity and affect manufacturer warranty coverage. Recommend correction according to Simpson's installation instructions.

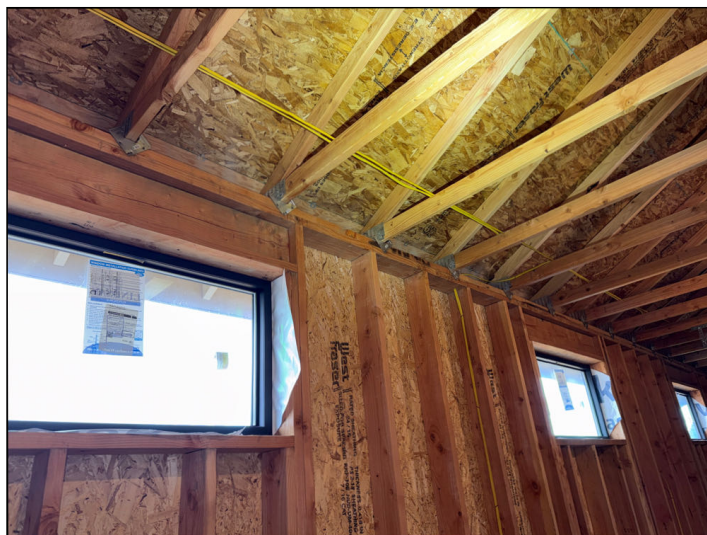
Multiple Simpson truss tie-down clips in the detached garage have improperly placed nails that missed the manufacturer's designated fastener holes. One clip on the east side of the garage was not fastened and appeared to be pinched in place. These conditions may reduce the strength of the roof-to-wall connections. Recommend having the builder inspect all clips and correct the installations using the manufacturer-specified fasteners and fastening pattern before the framing is concealed. Improper fastening may reduce the connectors' rated capacity and affect manufacturer warranty coverage. Recommend correction according to Simpson's installation instructions.

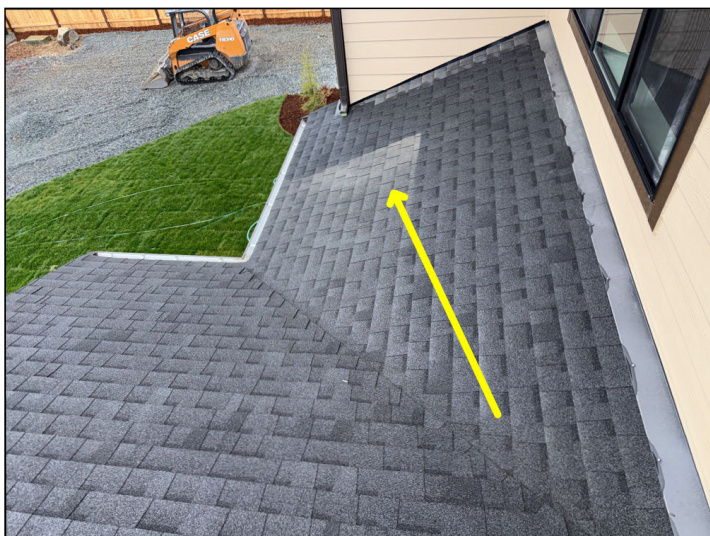
Paint overspray was noted on the first-floor roof above the living/dining room area, causing visible discoloration. Recommend having the builder correct the affected areas using a method approved by the roofing manufacturer to avoid damaging the shingles.

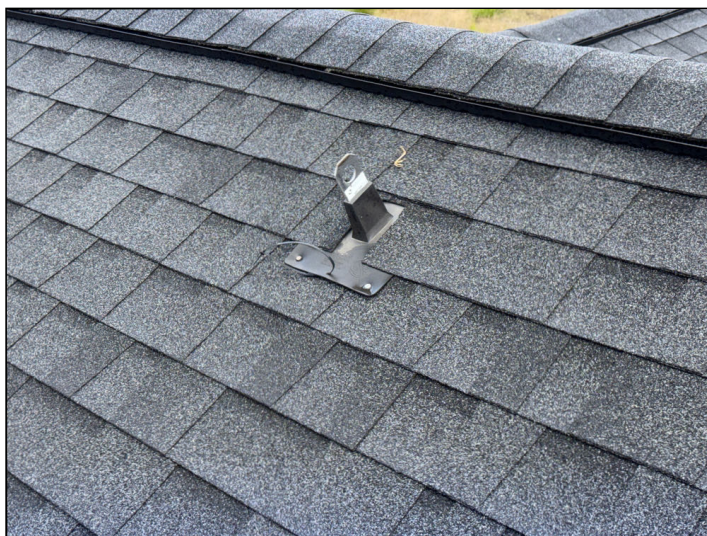
| Bedrooms | | |
|---|---|---|
| Page 31 Item: 1 | Roof Condition | <ul style="list-style-type: none"> <li>• The protective cover/cap is missing from the roof safety tie-off anchor. Recommend having a qualified roofing contractor install the appropriate cover and verify that the anchor's flashing and exposed fasteners are properly sealed to prevent leaks.</li> <li>• Paint overspray was noted on the first-floor roof above the living/dining room area, causing visible discoloration. Recommend having the builder correct the affected areas using a method approved by the roofing manufacturer to avoid damaging the shingles.</li> </ul> |

The protective cover/cap is missing from the roof safety tie-off anchor. Recommend having a qualified roofing contractor install the appropriate cover and verify that the anchor's flashing and exposed fasteners are properly sealed to prevent leaks.

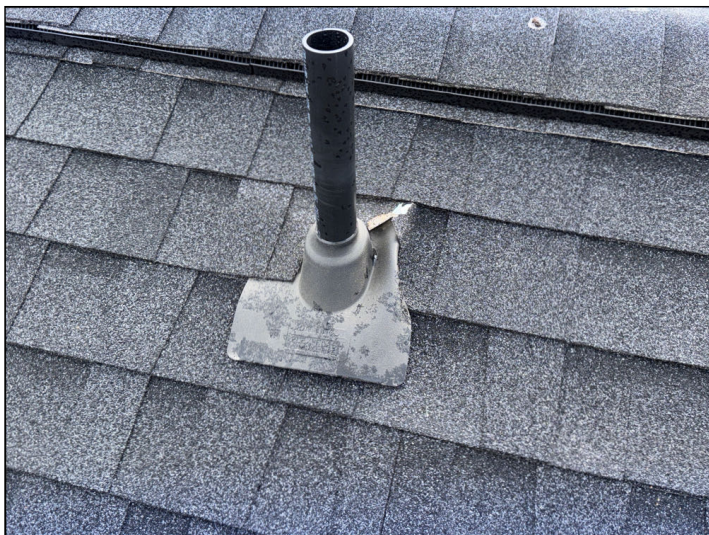
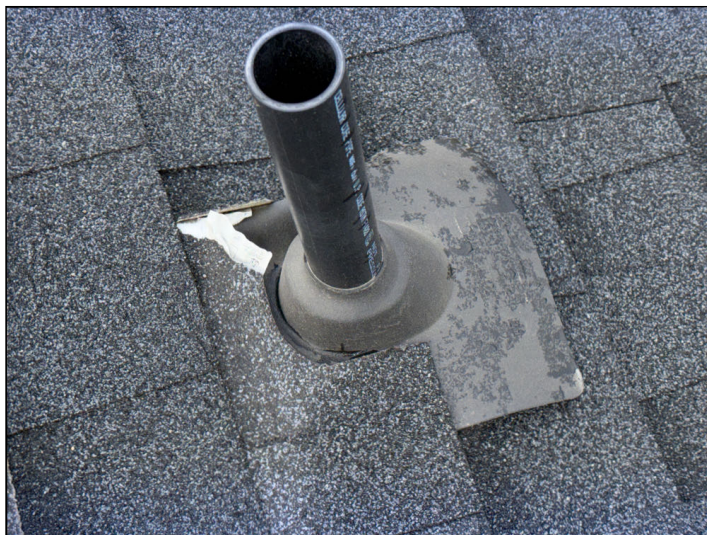
| Page 34 Item: 6 | Vent Caps | <ul style="list-style-type: none"> <li>• Damaged and poorly fitted shingles were noted around the plumbing vent boot above the primary bathroom, leaving the underlayment exposed and increasing the risk of leaks. Recommend having a qualified roofing contractor verify and correct the boot installation and replace the damaged shingles as needed.</li> </ul> |

Damaged and poorly fitted shingles were noted around the plumbing vent boot above the primary bathroom, leaving the underlayment exposed and increasing the risk of leaks. Recommend having a qualified roofing contractor verify and correct the boot installation and replace the damaged shingles as needed.

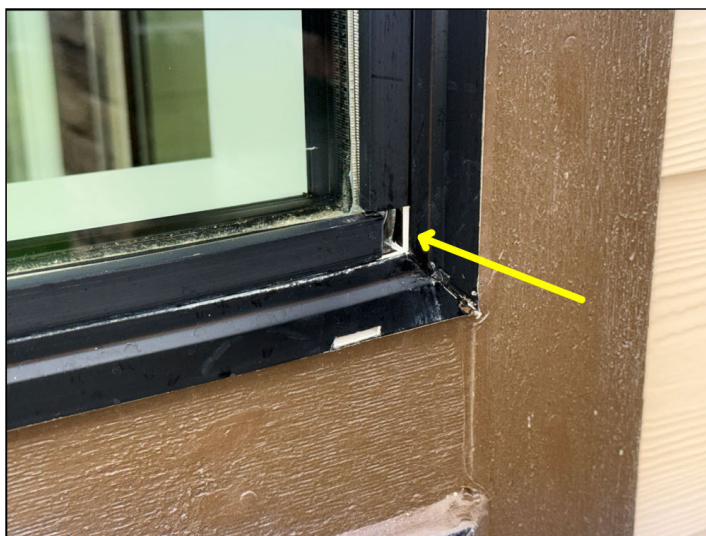
| Page 38 Item: 2 | Window Condition | <ul style="list-style-type: none"> <li>• South 1st Floor Window: The window glazing bead is cut short or missing a section at the lower corner, leaving a visible gap and exposing internal components. Recommend having the window installer replace or properly fit the glazing bead in accordance with the manufacturer's installation requirements.</li> </ul> |

South 1st Floor Window: The window glazing bead is cut short or missing a section at the lower corner, leaving a visible gap and exposing internal components. Recommend having the window installer replace or properly fit the glazing bead in accordance with the manufacturer's installation requirements.

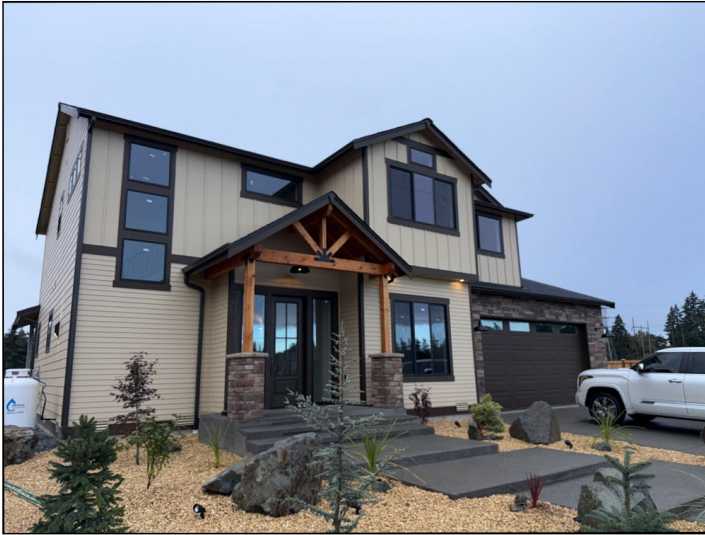
Missing address numbers on the home which is required for final county inspection. (Fire Safety Concern)

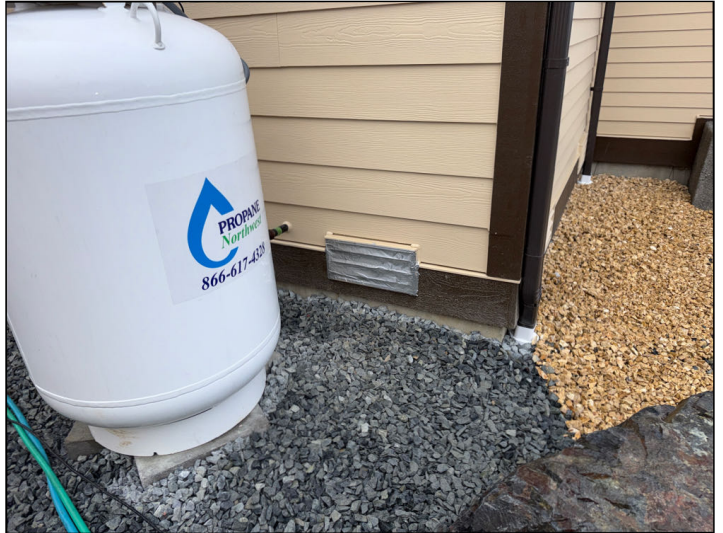
The crawlspace vent at the NE corner of the home has been covered over with foil faced ducting tape. This is not typical and should be removed or repaired as needed.

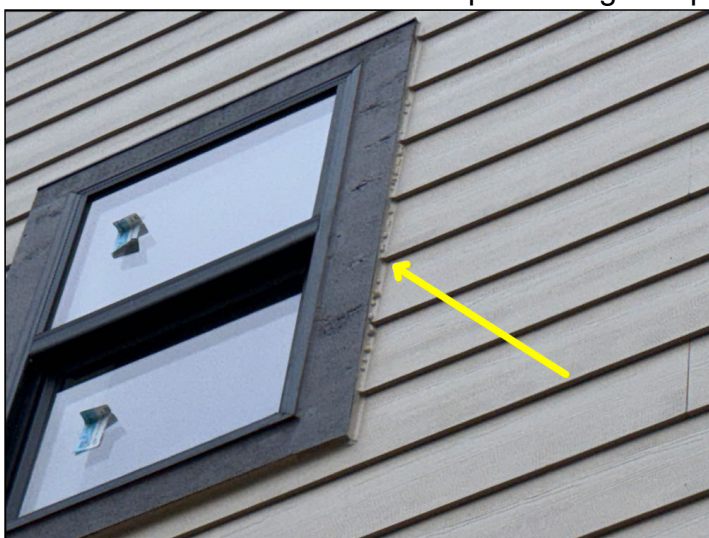
Caulking Blistering

Caulking blistering or bubbling was observed at exterior surfaces. Recommend repair and repainting as needed.

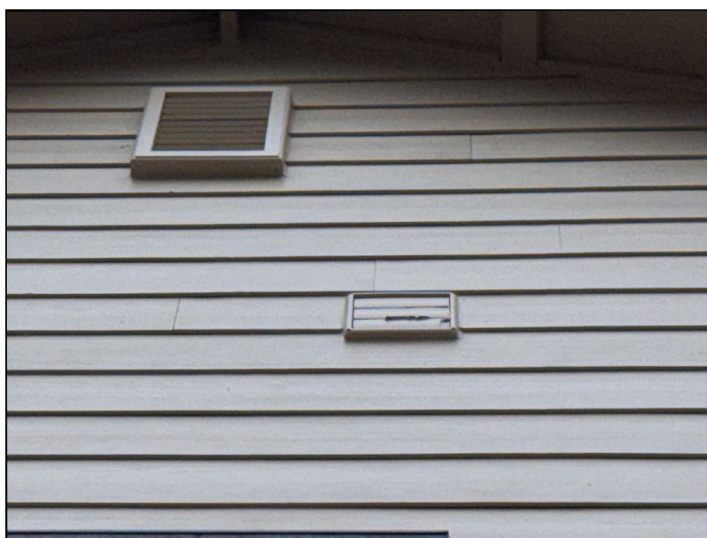
Peeling paint noted on the upper exhaust fan vent hood on the east side of the home.

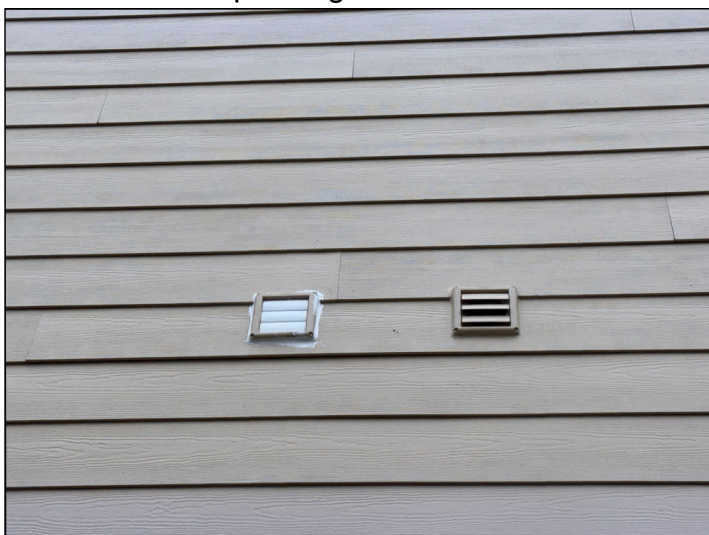
The dryer vent hood appears to have been installed after the fact and needs paint touch up.

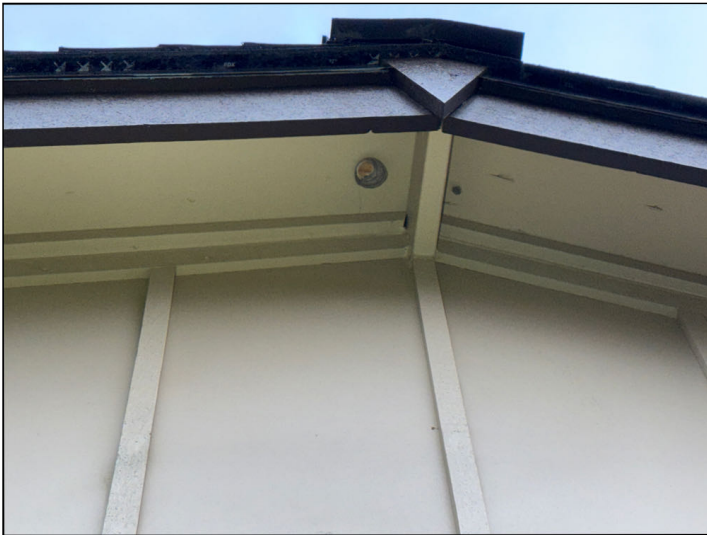
Paint touch up at the back patio gable / eave where a bees nest block full coverage and exposed plywood is present.

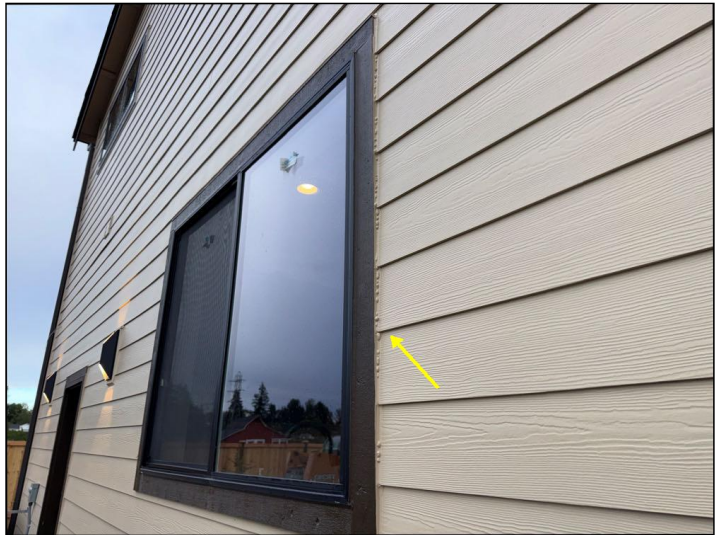
Caulking Blistering

Caulking blistering or bubbling was observed at exterior surfaces. Recommend repair and repainting as needed.

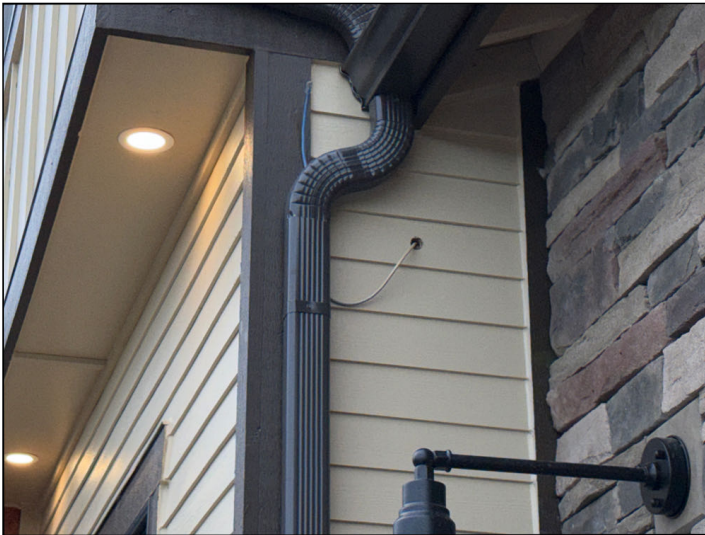
**Caulking Blistering**

Caulking blistering or bubbling was observed at exterior surfaces. Recommend repair and repainting as needed.

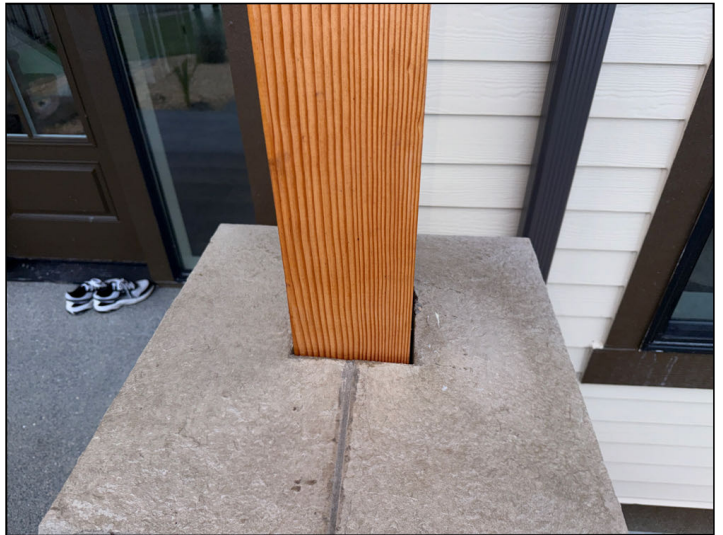
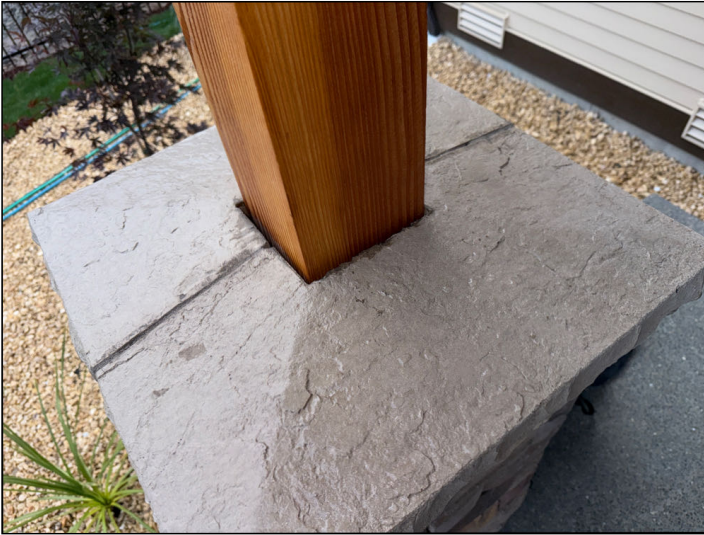
Caulking missing around the front porch post. Currently, water will travel down the post and get trapped inside the brick column.

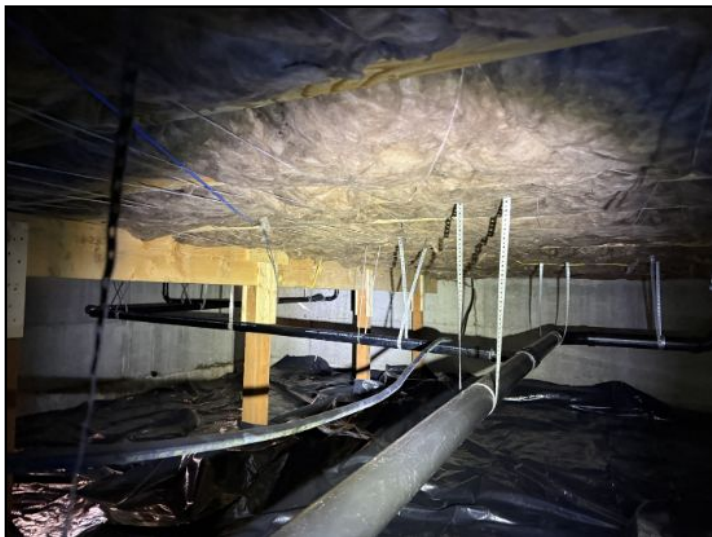
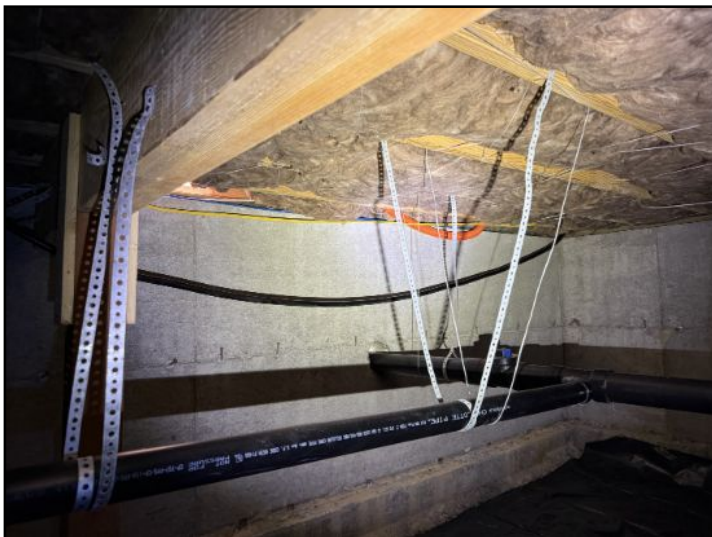
| Page 52 Item: 8 | Plumbing Materials | <ul style="list-style-type: none"> <li>• Crawlspace – Flexible Gas Line: The flexible gas line in the crawlspace is not properly secured to the structure and is resting on the plumbing drain lines. Recommend having the gas piping properly supported and secured in accordance with the manufacturer's installation requirements to prevent movement or damage.</li> </ul> |

Crawlspace – Flexible Gas Line: The flexible gas line in the crawlspace is not properly secured to the structure and is resting on the plumbing drain lines. Recommend having the gas piping properly supported and secured in accordance with the manufacturer's installation requirements to prevent movement or damage.
