PROPERTY INSPECTION  
**REPORT**

**12345 125th St E, Puyallup, WA 98374**

DATE OF INSPECTION: 9/8/2026

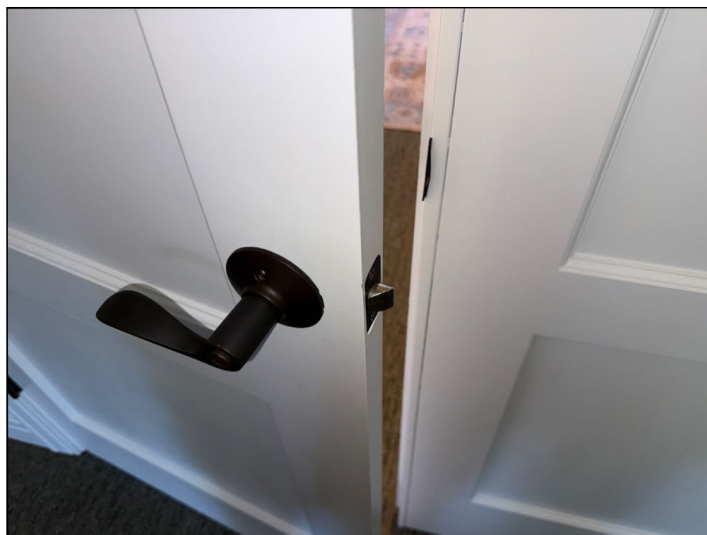
The latch for the second-floor French doors off the media room appears to be installed backward. The knob must be turned to close the doors, but they can be pushed open without turning the knob. Recommend correcting the latch installation so the doors close and secure properly.

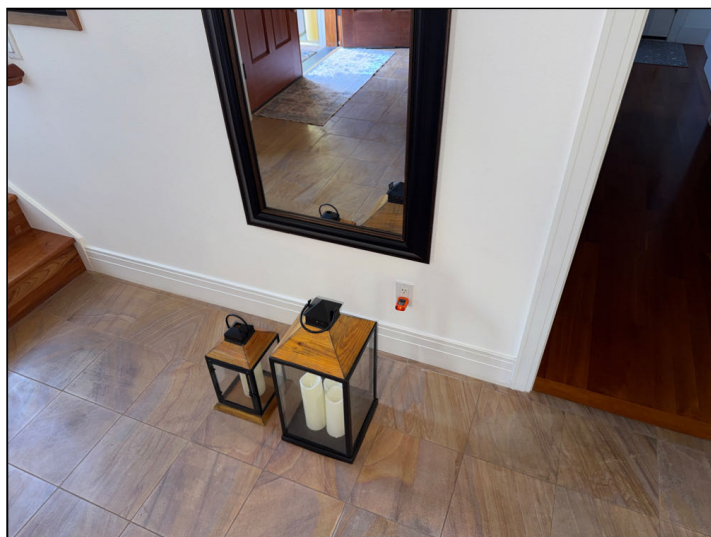
| Interior Areas | | |
|---|---|---|
| Page 7 Item: 7 | Electrical | <ul style="list-style-type: none"> <li>• The receptacle on the south wall of the front entry, between the stairs and the hallway leading to the garage, tested as ungrounded. Recommend evaluation and repair as needed by a licensed electrician.</li> <li>• The right side of the duplex receptacle in the north family room did not have power, and no switch controlling it was found. Recommend confirming proper operation with the seller or having the receptacle evaluated and repaired as needed by a licensed electrician.</li> </ul> |

The receptacle on the south wall of the front entry, between the stairs and the hallway leading to the garage, tested as ungrounded. Recommend evaluation and repair as needed by a licensed electrician.

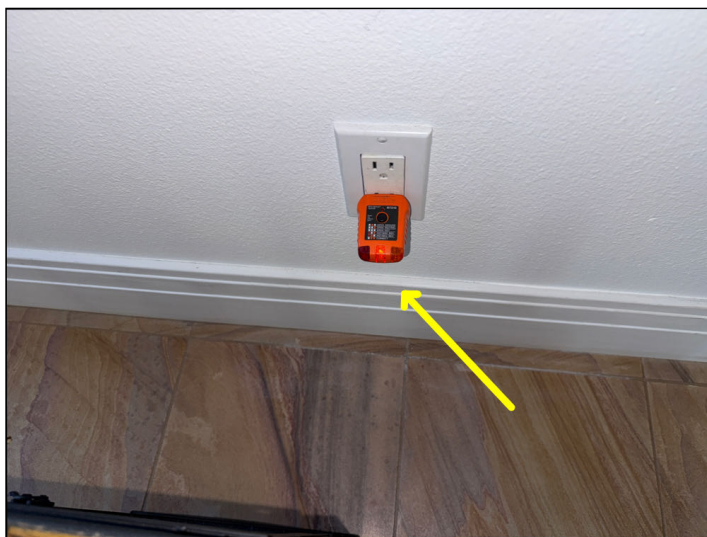
The receptacle on the south wall of the front entry, between the stairs and the hallway leading to the garage, tested as ungrounded. Recommend evaluation and repair as needed by a licensed electrician.

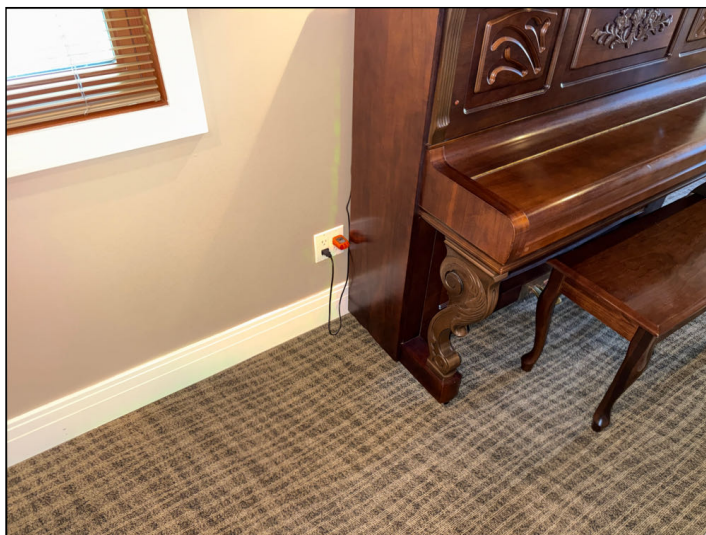
The right side of the duplex receptacle in the north family room did not have power, and no switch controlling it was found. Recommend confirming proper operation with the seller or having the receptacle evaluated and repaired as needed by a licensed electrician.

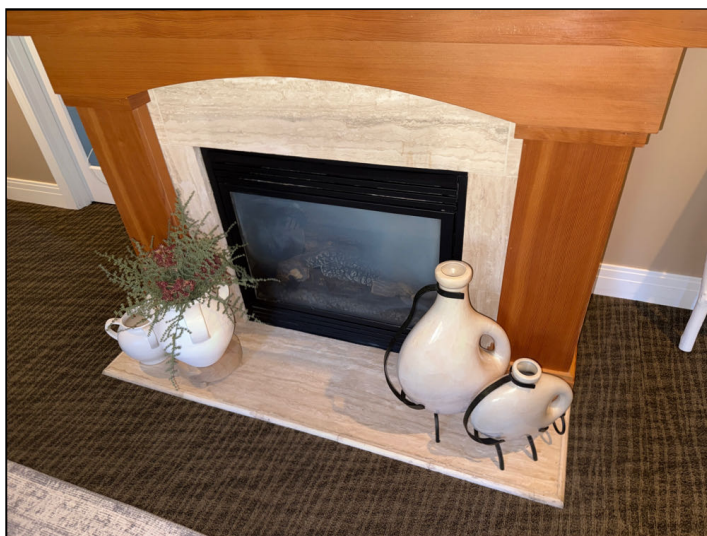
| Interior Areas | | |
|---|---|---|
| Page 10 Item: 15 | Fireplace | <ul style="list-style-type: none"> <li>• The north family room fireplace did not operate using the available switches, and the pilot light was not on even though the unit control was set to the "on" position. The gas supply may have been shut off at the keyed gas valve. Recommend confirming operation with the seller and servicing or repairing the fireplace as needed by a qualified fireplace technician.</li> </ul> |

The north family room fireplace did not operate using the available switches, and the pilot light was not on even though the unit control was set to the "on" position. The gas supply may have been shut off at the keyed gas valve. Recommend confirming operation with the seller and servicing or repairing the fireplace as needed by a qualified fireplace technician.

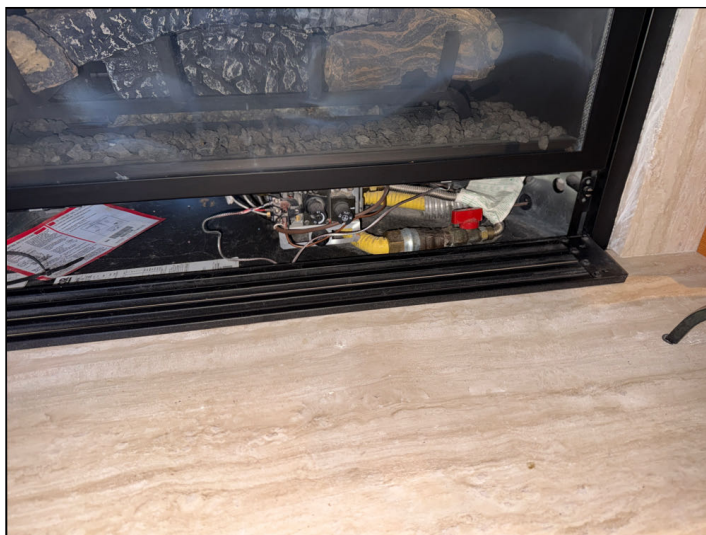
The north family room fireplace did not operate using the available switches, and the pilot light was not on even though the unit control was set to the "on" position. The gas supply may have been shut off at the keyed gas valve. Recommend confirming operation with the seller and servicing or repairing the fireplace as needed by a qualified fireplace technician.

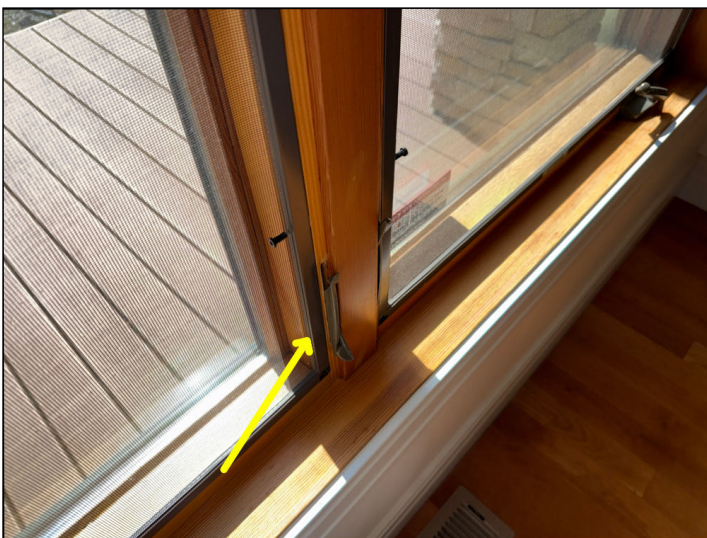
A few of the plastic housing components for the casement-window latches were loose and fell out when the windows were unlocked. Recommend repairing or replacing the affected latch hardware to ensure the windows operate and lock properly.

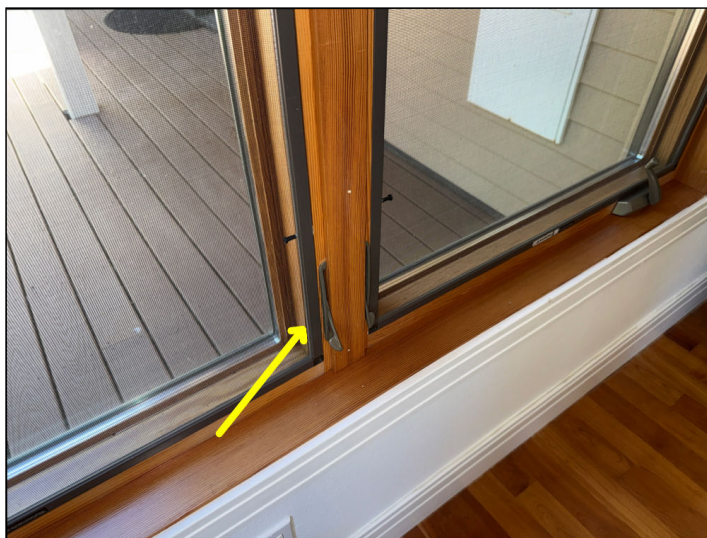
A few of the plastic housing components for the casement-window latches were loose and fell out when the windows were unlocked. Recommend repairing or replacing the affected latch hardware to ensure the windows operate and lock properly.

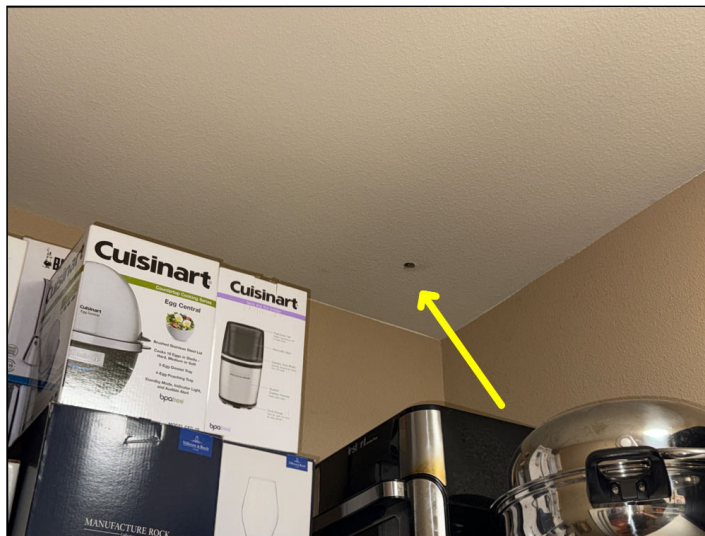
Small hole noted in the pantry ceiling.

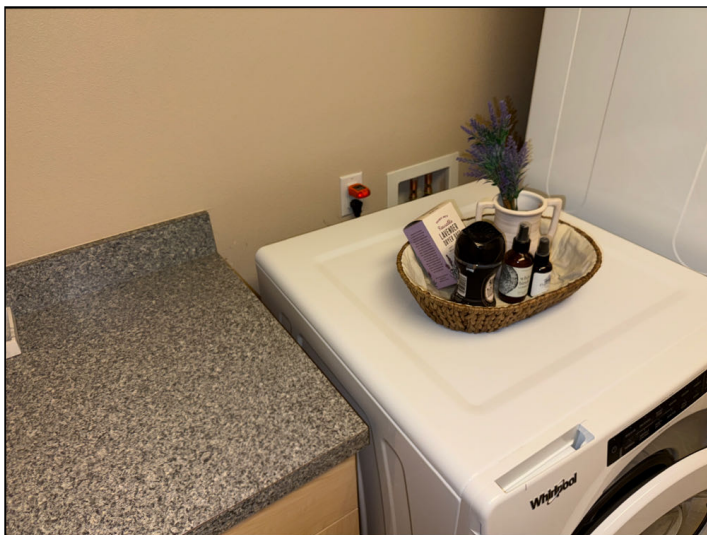
| Interior Areas | | |
|---|---|---|
| Page 23 Item: 5 | Electrical | <ul style="list-style-type: none"> <li>• The washing-machine receptacle in the laundry room tested with reversed polarity. This is a potential electrical safety concern. Recommend evaluation and repair by a licensed electrician.</li> </ul> |

The washing-machine receptacle in the laundry room tested with reversed polarity. This is a potential electrical safety concern. Recommend evaluation and repair by a licensed electrician.

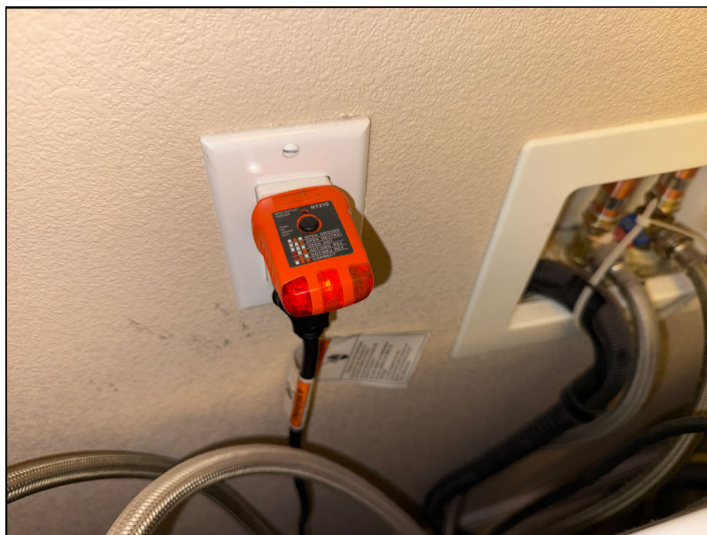
The washing-machine receptacle in the laundry room tested with reversed polarity. This is a potential electrical safety concern. Recommend evaluation and repair by a licensed electrician.

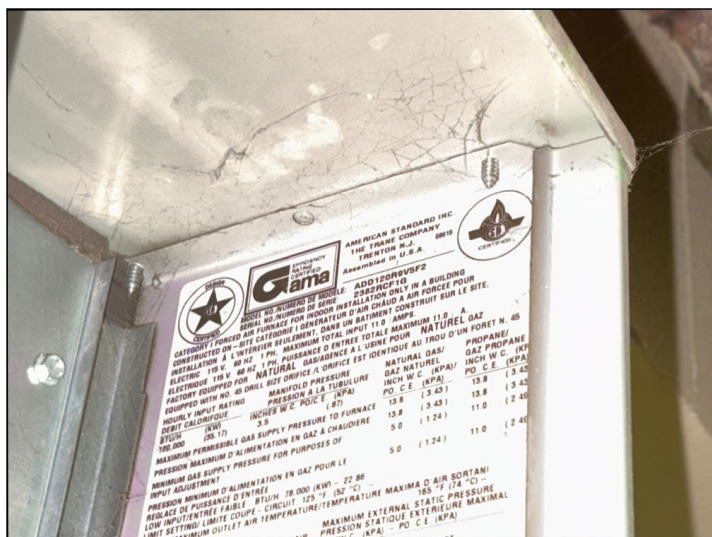
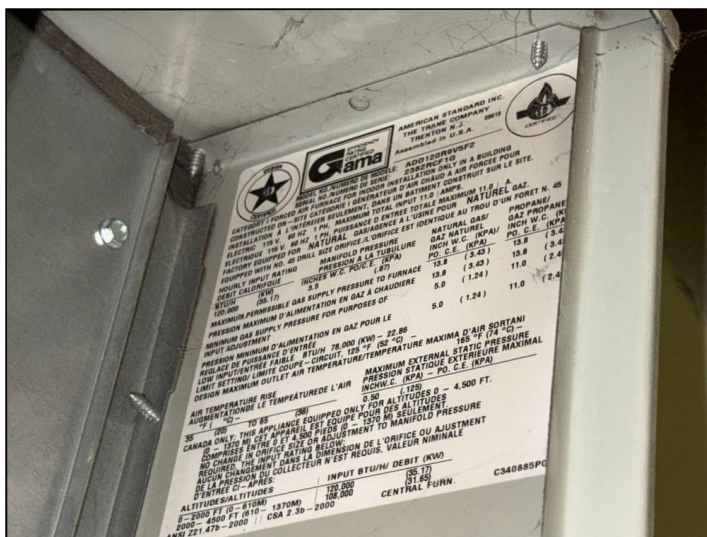
| Page 25 Item: 1 | Heater Condition | <ul style="list-style-type: none"> <li>• The furnace's last service date was more than one year ago or could not be determined. Although the unit responded properly to normal controls, internal components cannot be fully evaluated without specialized equipment and training. Recommend servicing by a licensed HVAC contractor and repairing as needed.</li> <li>• The furnace appears to be original to the home and is approximately 21 years old. Although it operated properly from normal controls, it is nearing the end of its typical service life. Recommend servicing by a licensed HVAC contractor and budgeting for replacement.</li> </ul> |

The furnace's last service date was more than one year ago or could not be determined. Although the unit responded properly to normal controls, internal components cannot be fully evaluated without specialized equipment and training. Recommend servicing by a licensed HVAC contractor and repairing as needed.

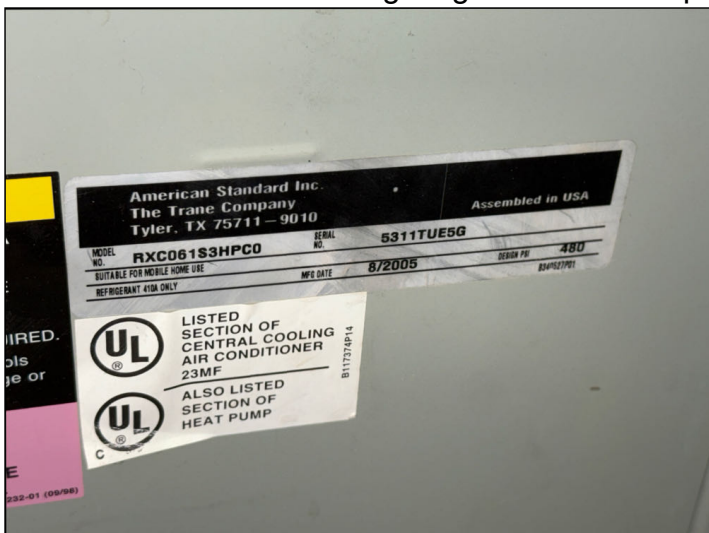
The air-conditioning system was manufactured in 2005 and is approximately 21 years old. It operated during the inspection, with approximately 71°F at the return-air vent and 58°F at the front-door floor register—a temperature difference of about 13°F. Due to its age, recommend budgeting for eventual replacement.

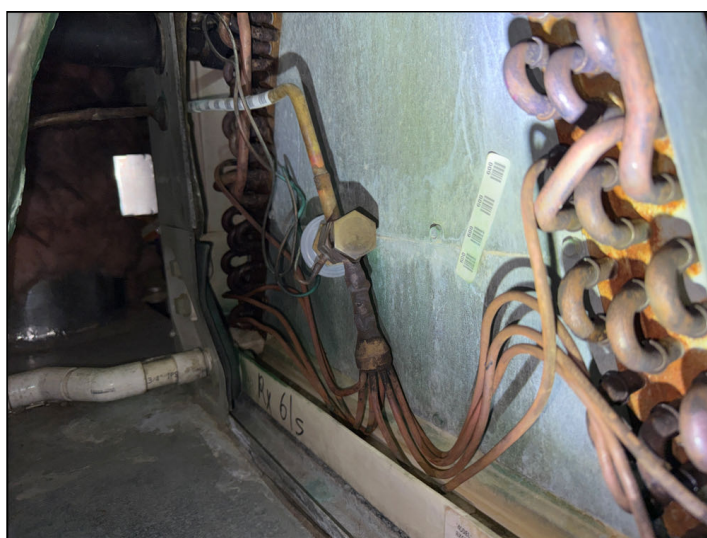
The refrigerant lines were showing signs of age. Functional at the time of the inspection. Recommend budgeting for replacement in the next 5 years.

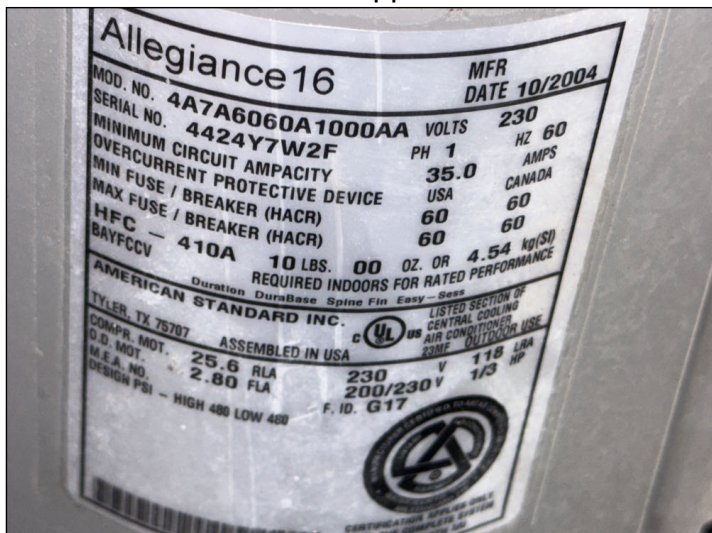
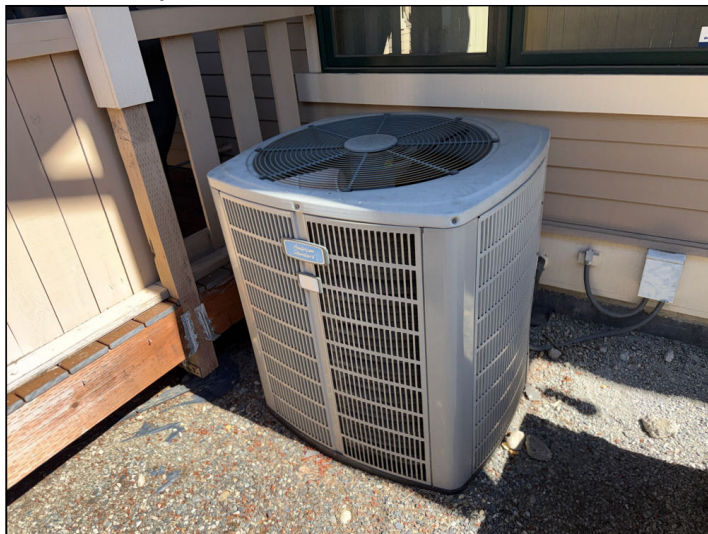
The air-conditioning condenser was operational at the time of inspection but is approximately 22 years old and beyond its typical service life.

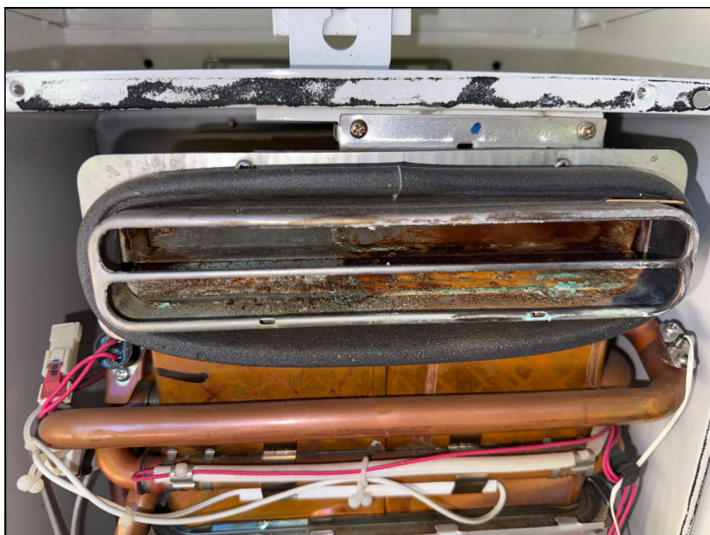
Some corrosion noted at both water heaters vent pipe which is an indication of age.

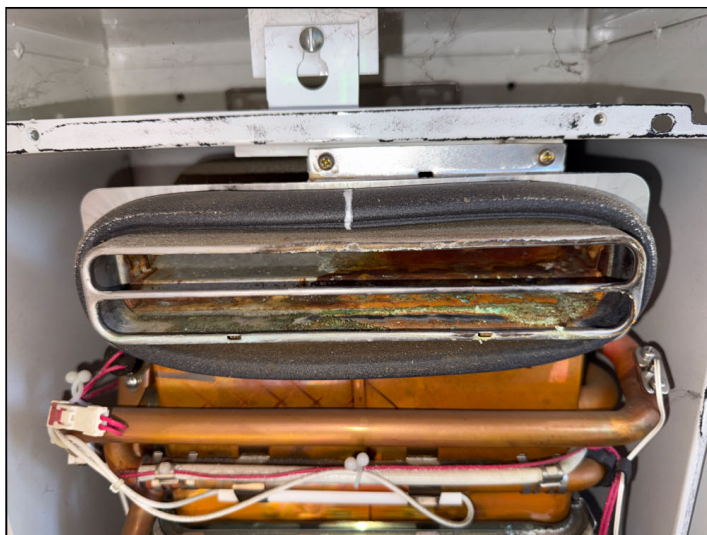
Some corrosion noted at both water heaters vent pipe which is an indication of age.

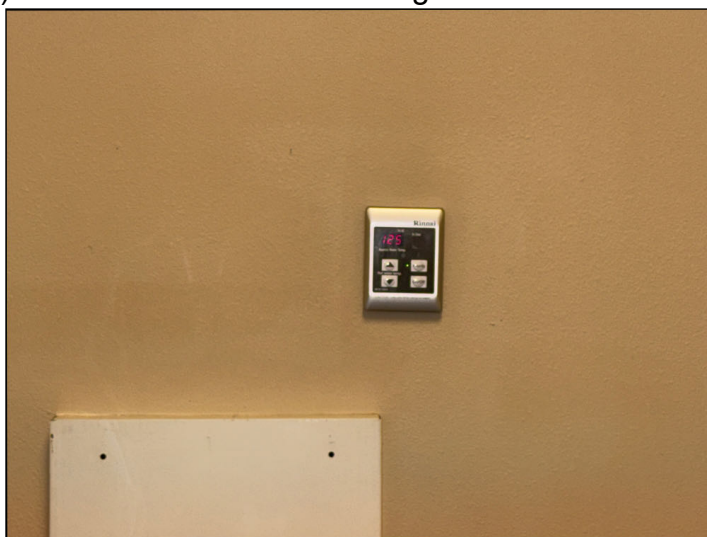
The north water heater temperature is set at 125 which is slightly above the recommended 120.

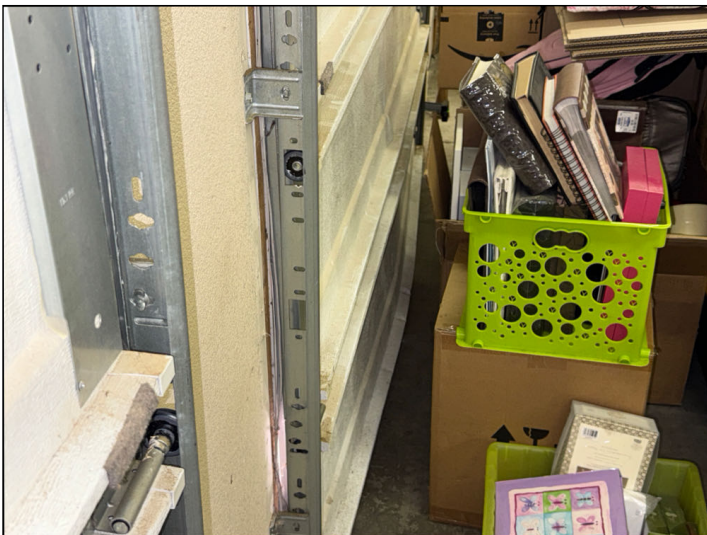
The west garage vehicle door has damaged panels. Recommend repair or replacement as needed by a qualified garage door contractor.

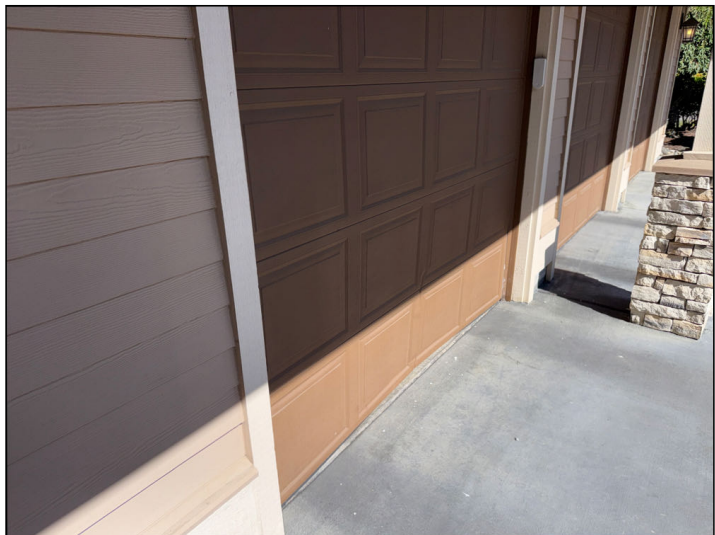
The west garage vehicle door has damaged panels. Recommend repair or replacement as needed by a qualified garage door contractor.

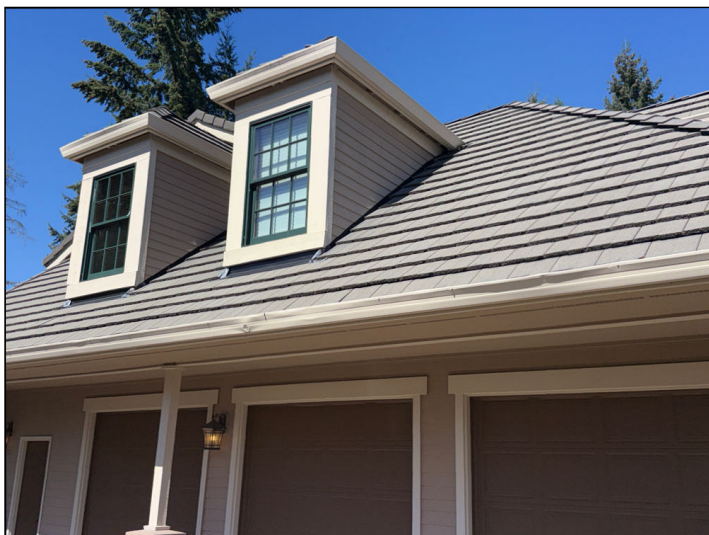
The gutter is dented along the south elevation, which may restrict proper drainage. Recommend repairing or replacing the damaged section as needed.

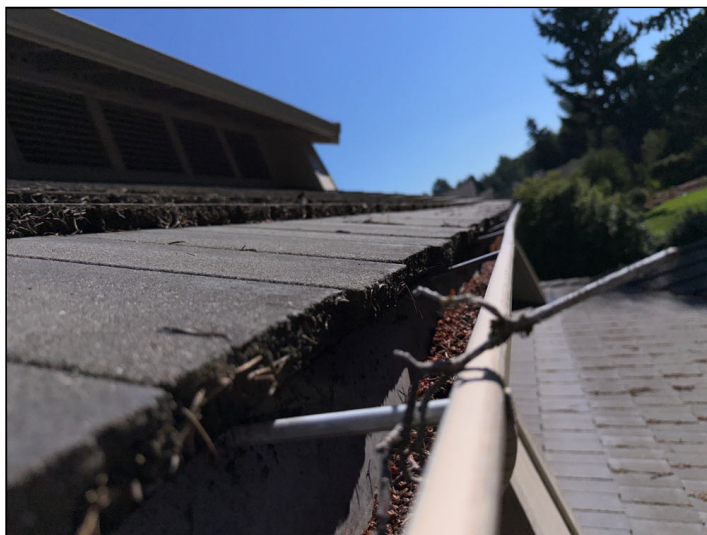
Clean gutters: Significant amounts of debris evident at the gutters throughout.

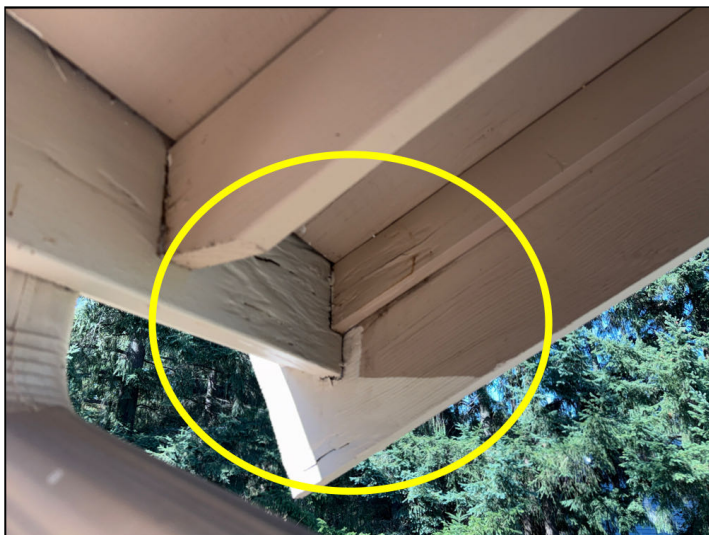
| Page 54 Item: 4 | Eaves & Facia | <ul style="list-style-type: none"> <li>• Moisture damage and wood rot were observed at the northwest corners of both the second-floor dormer and the upper attic dormer. Recommend evaluation and repair by a qualified contractor, including correction of the moisture source and replacement of damaged materials as necessary.</li> </ul> |

Moisture damage and wood rot were observed at the northwest corners of both the second-floor dormer and the upper attic dormer. Recommend evaluation and repair by a qualified contractor, including correction of the moisture source and replacement of damaged materials as necessary.

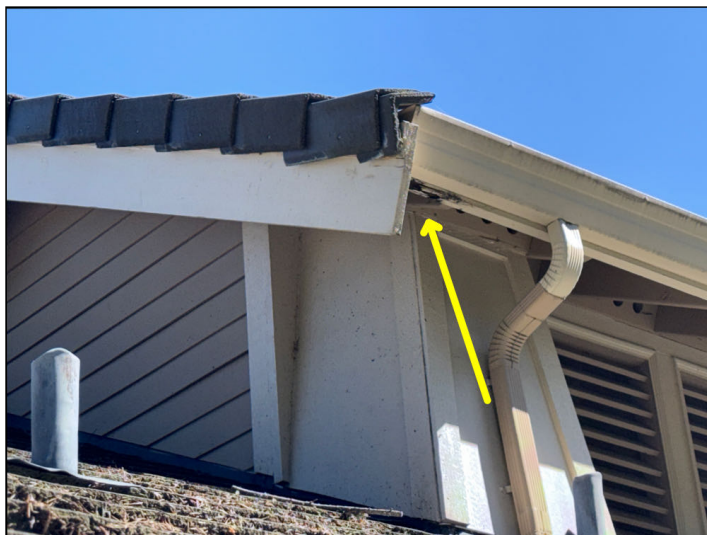
Moisture damage and wood rot were observed at the northwest corners of both the second-floor dormer and the upper attic dormer. Recommend evaluation and repair by a qualified contractor, including correction of the moisture source and replacement of damaged materials as necessary.

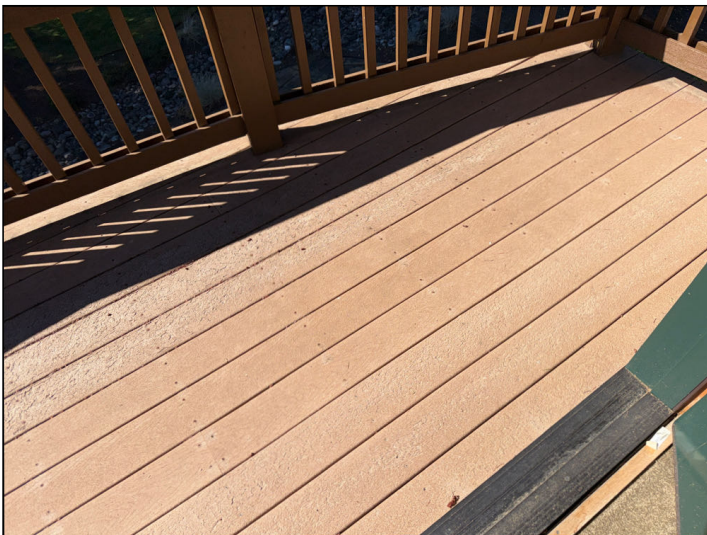
The second-floor deck accessed from the primary bedroom has visible surface deterioration and delamination of the composite decking. Recommend monitoring for continued deterioration and repairing or replacing affected boards as needed.

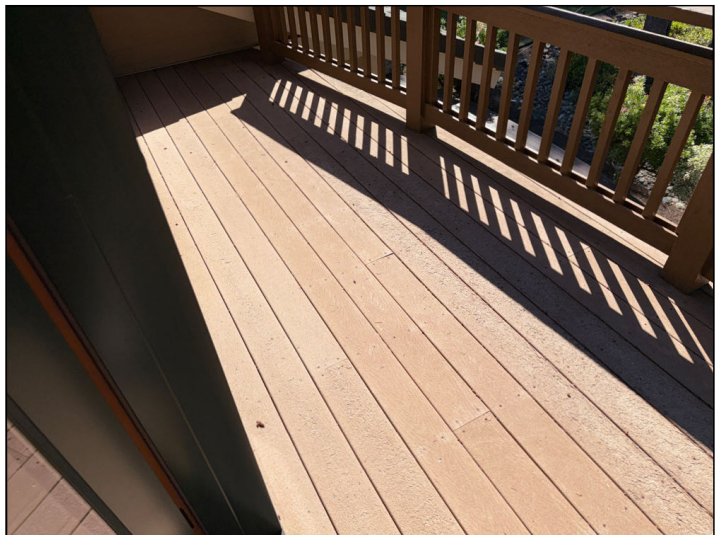
The second-floor deck accessed from the primary bedroom has visible surface deterioration and delamination of the composite decking. Recommend monitoring for continued deterioration and repairing or replacing affected boards as needed.

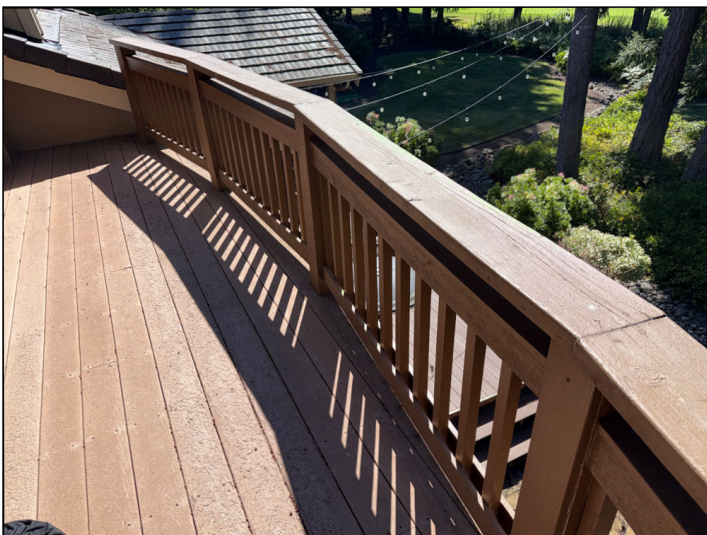
| Page 56 Item: 6 | Stairs & Handrail | <ul style="list-style-type: none"> <li>• The back 2nd floor deck railings were observed to be loose or unstable. Guardrails should be securely fastened to provide adequate safety for occupants and visitors. Recommend further evaluation and repair as needed to improve stability.</li> </ul> |

The back 2nd floor deck railings were observed to be loose or unstable. Guardrails should be securely fastened to provide adequate safety for occupants and visitors. Recommend further evaluation and repair as needed to improve stability.

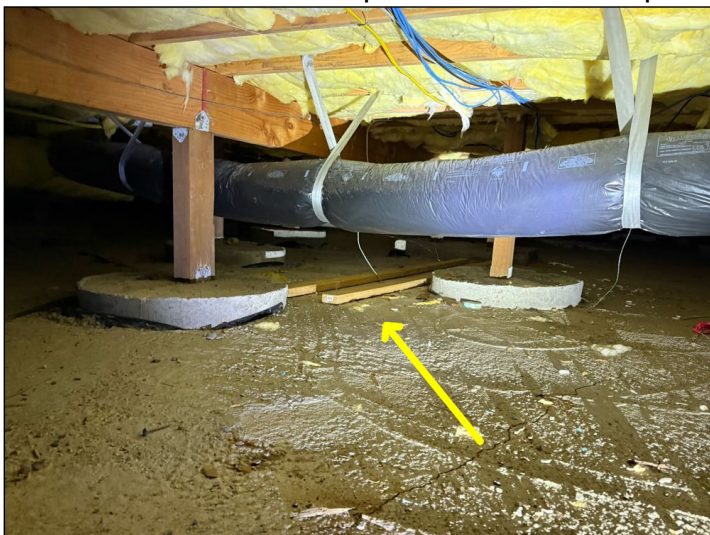
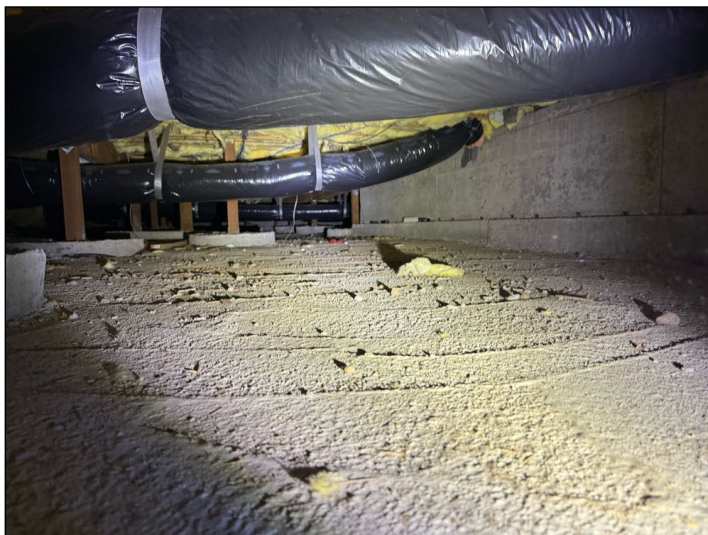
Recommend cleaning the crawlspace of all debris as it can be used as nesting material and is considered a conducive location for wood destroying organism.

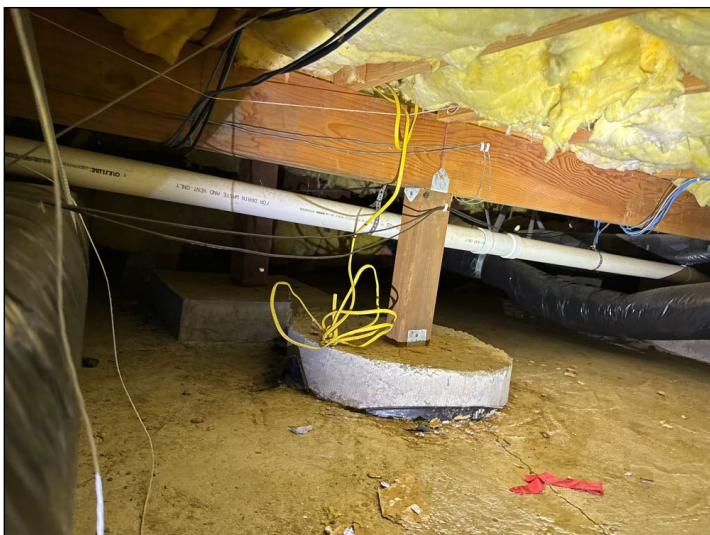
| Page 62 Item: 9 | Crawlspace Electric | <ul style="list-style-type: none"> <li>• Loose and unterminated wiring was noted in the crawlspace below the kitchen. This presents a potential electrical safety and damage concern. Recommend having a licensed electrician secure the wiring to the structure and properly terminate all wiring within covered junction boxes.</li> </ul> |

Loose and unterminated wiring was noted in the crawlspace below the kitchen. This presents a potential electrical safety and damage concern. Recommend having a licensed electrician secure the wiring to the structure and properly terminate all wiring within covered junction boxes.

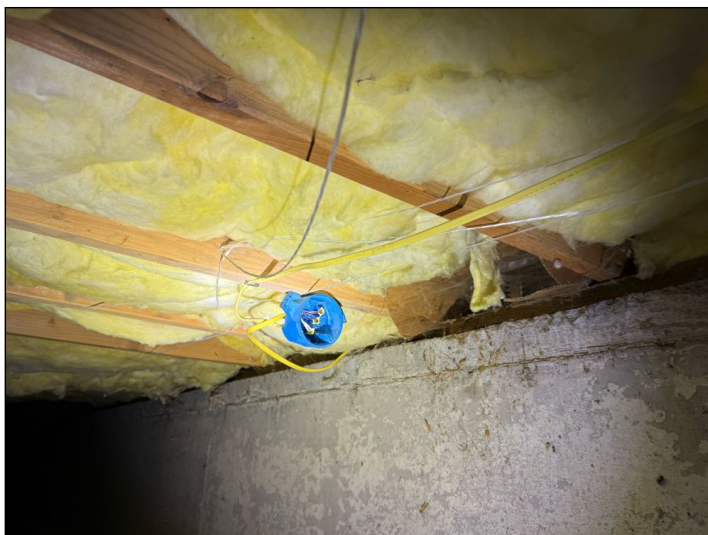
Open junction boxes or outlets were observed in the crawlspace, which is a safety concern. Recommend installing proper covers, as needed, for safety.

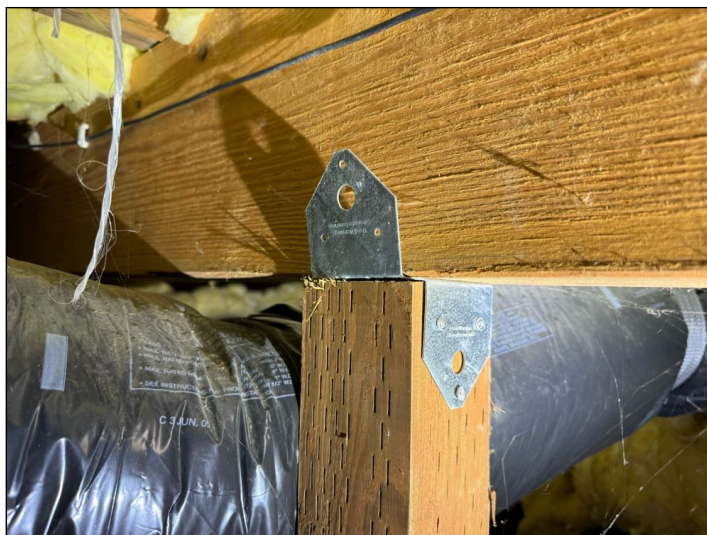
| Page 63 Item: 13 | Columns | <ul style="list-style-type: none"> <li>• A crawlspace support column southwest of the access opening was not properly secured to the beam. The installed connector was missing fasteners. Recommend securing the column-to-beam connection with approved hardware and fasteners to help prevent movement.</li> </ul> |

A crawlspace support column southwest of the access opening was not properly secured to the beam. The installed connector was missing fasteners. Recommend securing the column-to-beam connection with approved hardware and fasteners to help prevent movement.
