## PROPERTY INSPECTION **REPORT**

**12345 125th St E, Puyallup, WA 98375**

DATE OF INSPECTION: 9/10/2026

Year Built: 1986

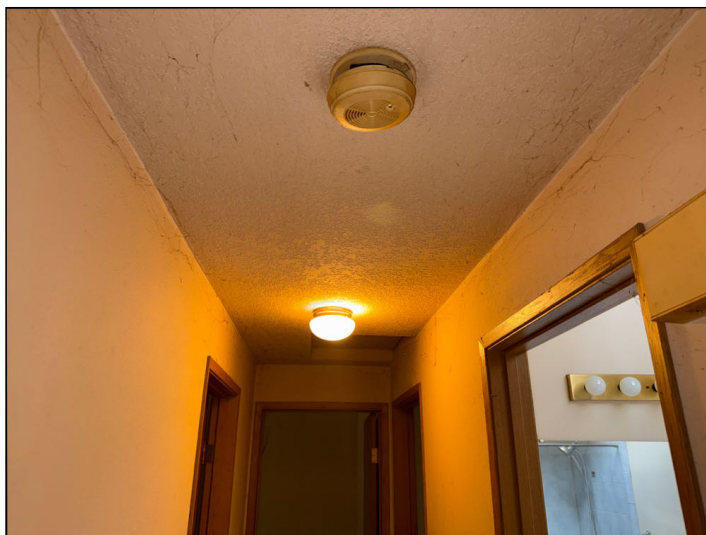
**IMPROVE:** There were no visible CO (Carbon Monoxide) detector(s) in the home. Since 2015 Washington State law requires all sellers to provide and install CO detectors at each level of the home and within 15' of each bedroom door.

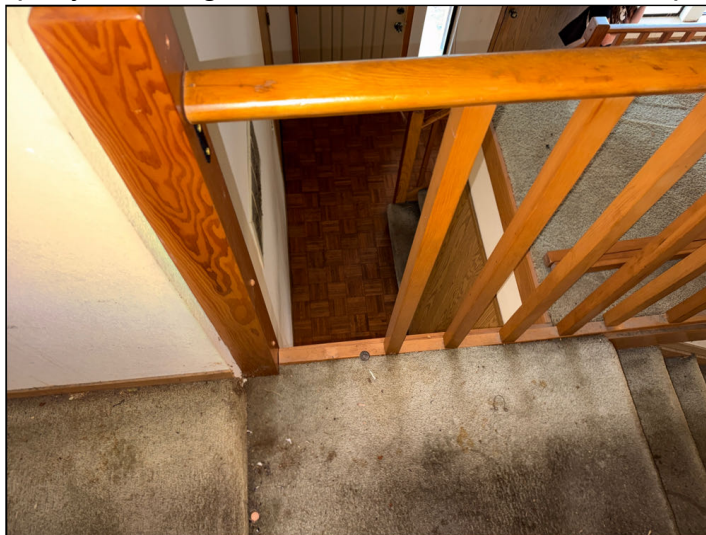
Missing spindles were noted at the stair railing near the top landing. The spindles appear to be present but have not been installed. Recommend properly installing them to reduce the risk of falls, particularly for children.

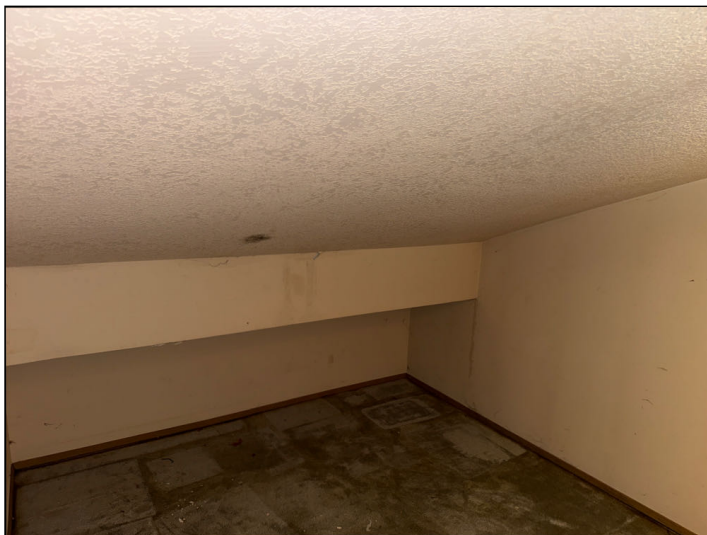
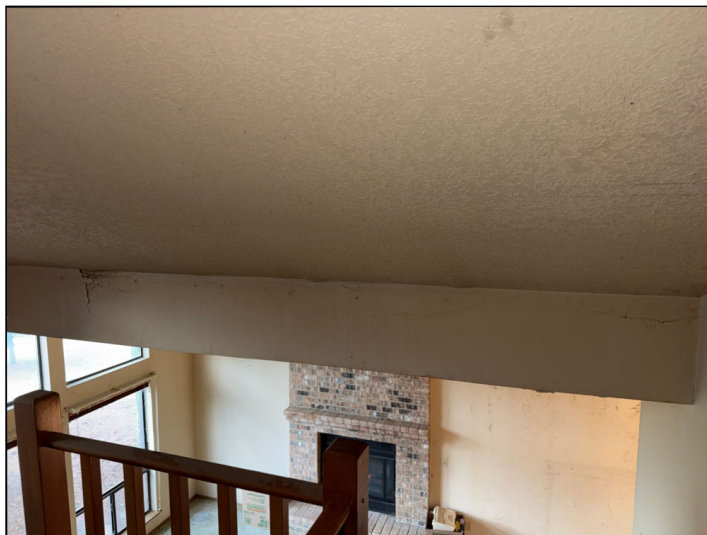
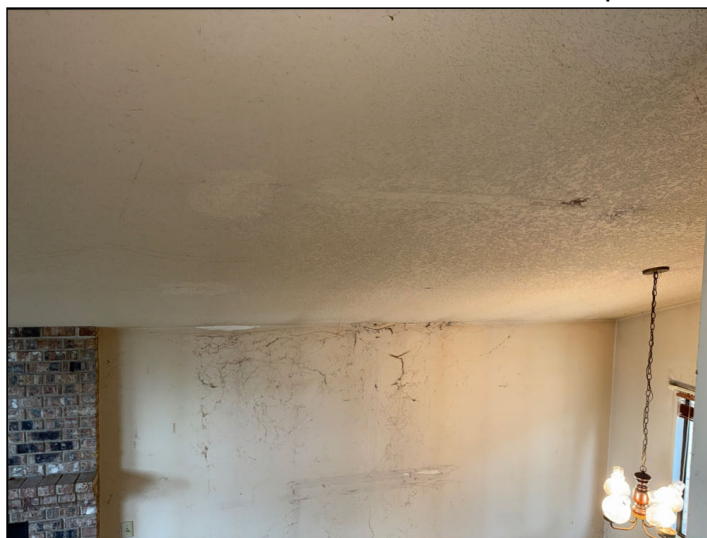
| Interior Areas | | |
|---|---|---|
| Page 9 Item: 11 | Ceiling Condition | • Moisture damage and mold-like staining were noted at the ceilings in the living room and front entry. The affected areas appeared dry at the time of the inspection and may be related to a previous roof leak. Recommend confirming the source has been repaired and having the stained and damaged materials evaluated and repaired or replaced as needed. |

Moisture damage and mold-like staining were noted at the ceilings in the living room and front entry. The affected areas appeared dry at the time of the inspection and may be related to a previous roof leak. Recommend confirming the source has been repaired and having the stained and damaged materials evaluated and repaired or replaced as needed.

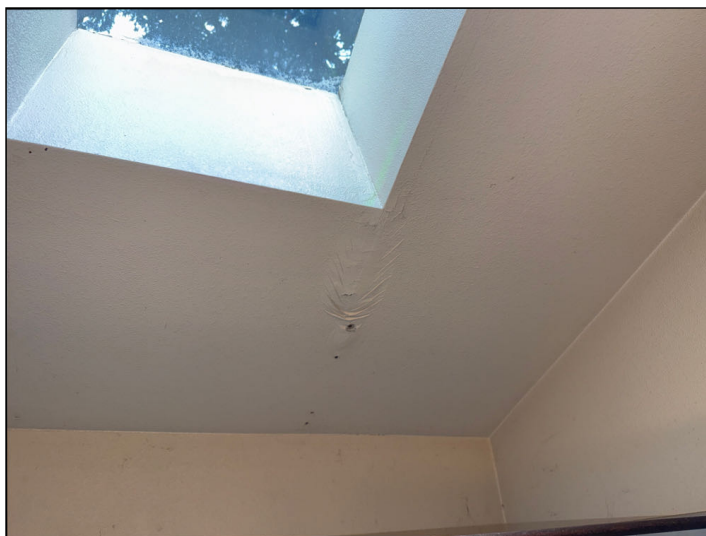
| Interior Areas | | |
|---|---|---|
| Page 13 Item: 4 | Ceiling Condition | • Moisture staining and damage were noted at the bathroom ceiling, likely from past leakage around the skylight. The damage may be from the previous skylight installation, and no elevated moisture was detected with a moisture meter at the time of the inspection. Recommend confirming that the leak has been repaired and monitoring the area for any signs of recurring moisture. |

Moisture staining and damage were noted at the bathroom ceiling, likely from past leakage around the skylight. The damage may be from the previous skylight installation, and no elevated moisture was detected with a moisture meter at the time of the inspection. Recommend confirming that the leak has been repaired and monitoring the area for any signs of recurring moisture.

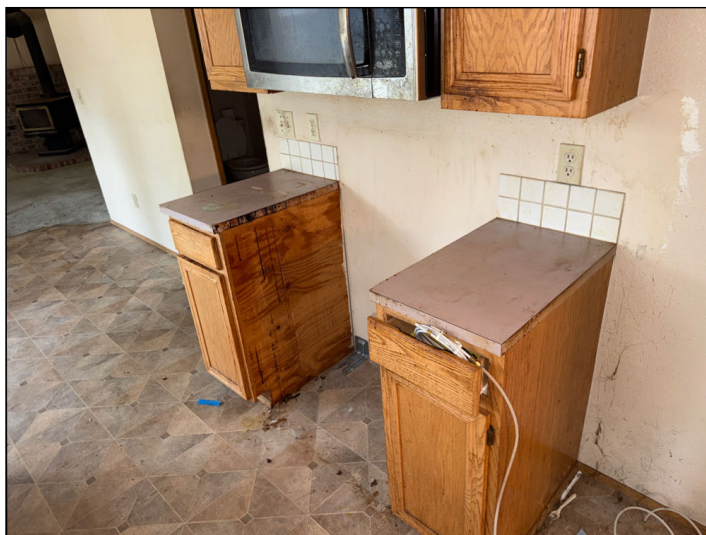
| Interior Areas | | |
|---|---|---|
| Page 16 Item: 7 | Cook top condition | • No oven or range was present at the time of the inspection. Many loan programs require the home to have a functional cooking appliance. Recommend confirming the specific lender's requirements and installing a range before the appraisal if required. |

No oven or range was present at the time of the inspection. Many loan programs require the home to have a functional cooking appliance. Recommend confirming the specific lender's requirements and installing a range before the appraisal if required.

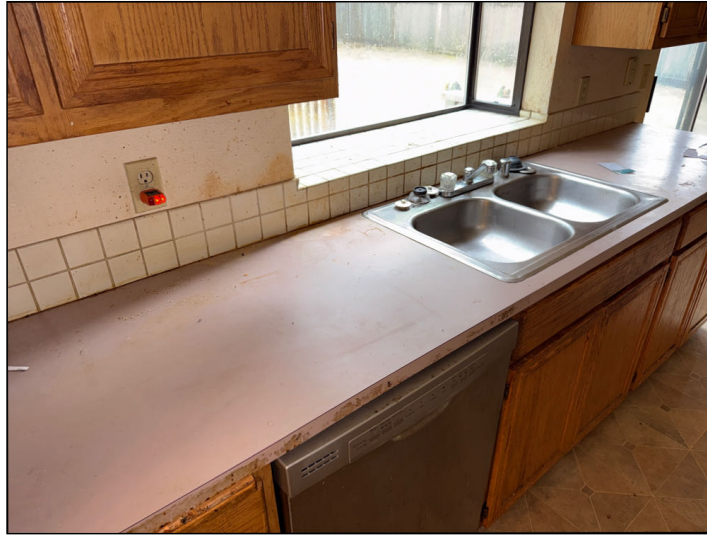
No GFCI protection present, suggest installing GFCI protected receptacles for safety.

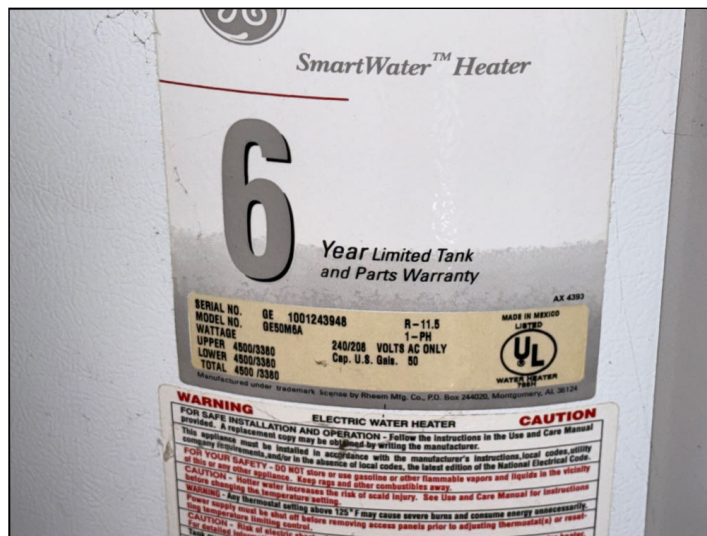
| Interior Areas | | |
|---|---|---|
| Page 26 Item: 7 | Manufacture | • The water heater is over 10 years old and should be budgeted for replacement as it is at the end of its expected lifespan. Appears to have been manufactured in 2001. On average a water heater is expected to get 10-12 years of service. |

The water heater is over 10 years old and should be budgeted for replacement as it is at the end of its expected lifespan. Appears to have been manufactured in 2001. On average a water heater is expected to get 10-12 years of service.

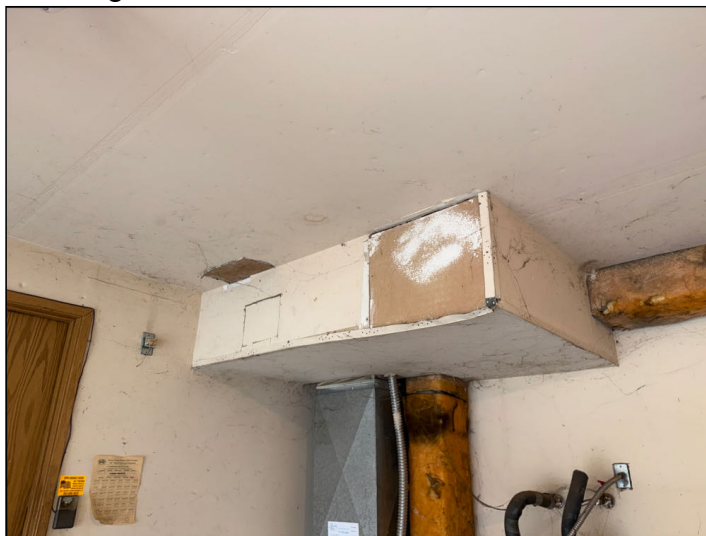
Recommend repairing drywall damage as needed on the upper garage wall above the furnace/water heater area.

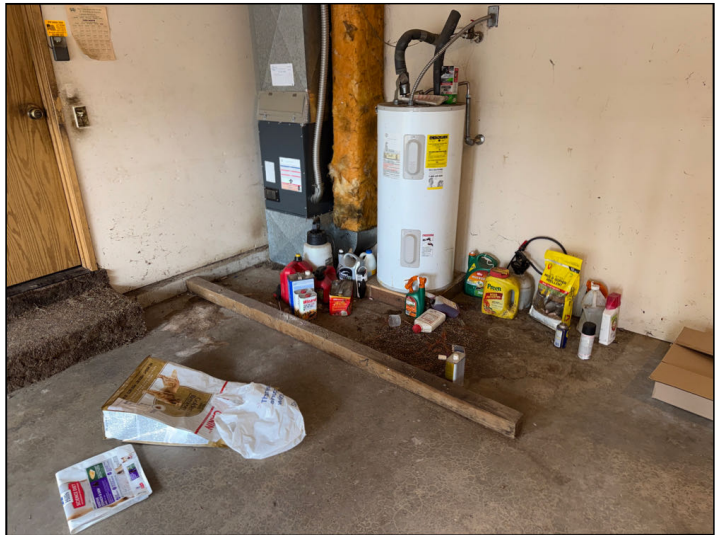
Rodent droppings noted on the concrete floor around the furnace in the garage.

Recommend repairing the wood curb to ensure a vehicle does not hit the furnace or water heater.

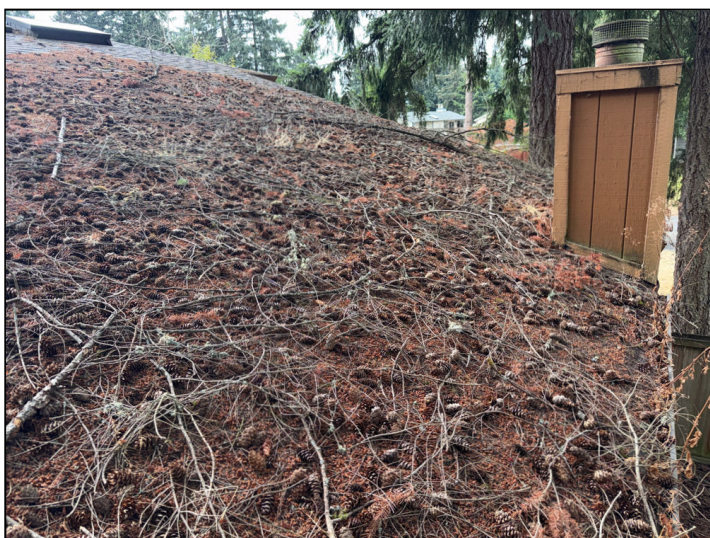
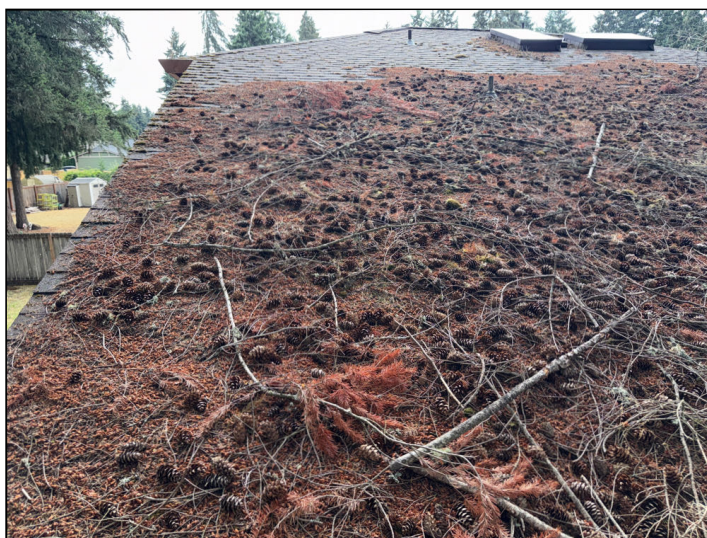
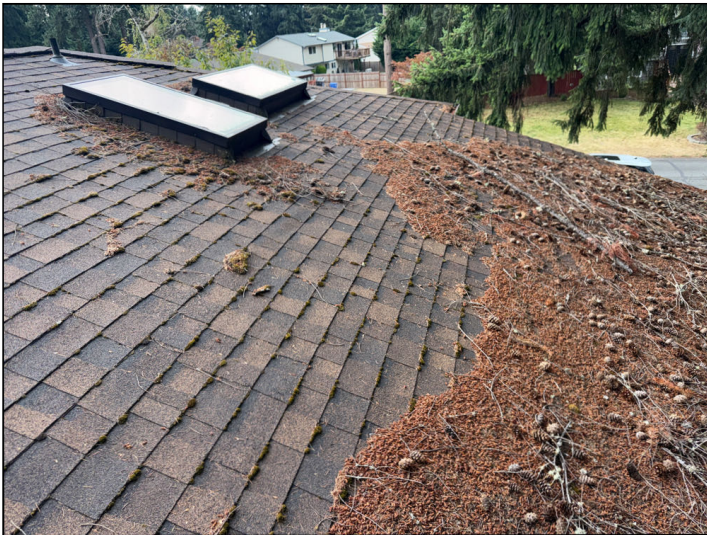
Debris on Roof

Organic debris was observed on the roof surface. Debris can trap moisture and accelerate deterioration of roofing materials. Recommend cleaning the roof as part of routine maintenance.

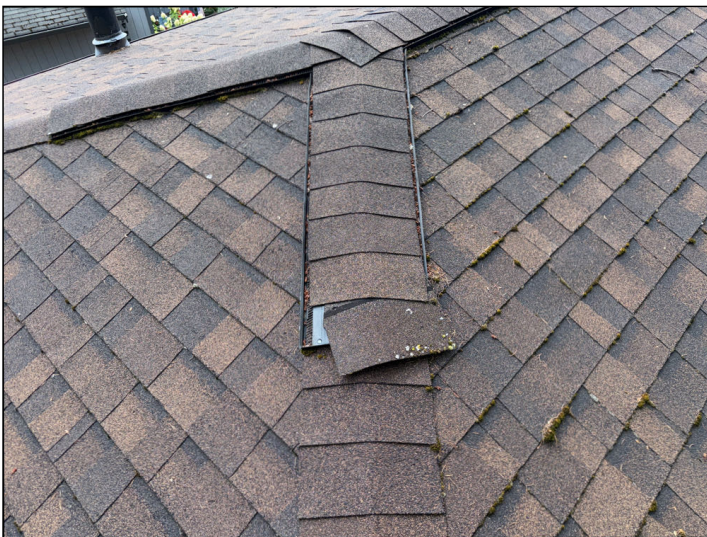
Recommend securing the loose ridge shingle. Due to the ridge vent longer roof nails will be needed.

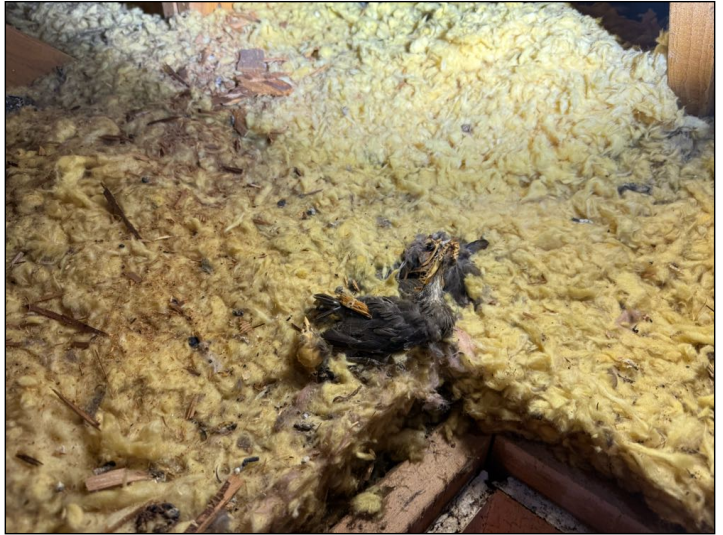
| Page 39 Item: 4 | Vent Screens | <ul style="list-style-type: none"> <li>• Multiple bird nests and entry points were noted on the south side of the attic. Bird nesting materials, droppings, and dead birds were observed throughout the attic insulation. Recommend professional removal and cleaning, replacement of contaminated insulation as needed, and sealing all entry points to prevent future access.</li> </ul> |

Multiple bird nests and entry points were noted on the south side of the attic. Bird nesting materials, droppings, and dead birds were observed throughout the attic insulation. Recommend professional removal and cleaning, replacement of contaminated insulation as needed, and sealing all entry points to prevent future access.

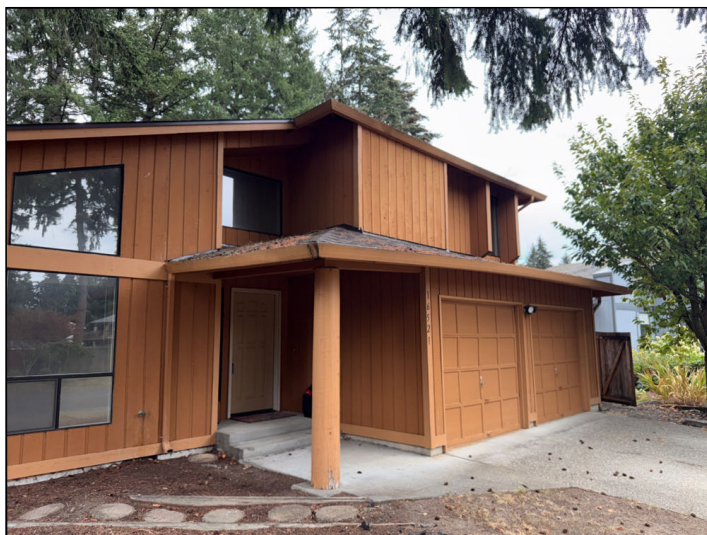
| Page 43 Item: 3 | Siding Condition | <ul style="list-style-type: none"> <li>• Some of the channel siding at the front (west) elevation is cupping and pulling away from the home. Recommend securing and painting the affected siding as needed. Replace any boards that cannot be properly repaired.</li> <li>• Moisture damage and wood rot were noted at the siding on the east elevation near the leaking hose bib. Recommend repairing the leak and replacing all damaged siding and underlying materials as needed.</li> </ul> |

Some of the channel siding at the front (west) elevation is cupping and pulling away from the home. Recommend securing and painting the affected siding as needed. Replace any boards that cannot be properly repaired.

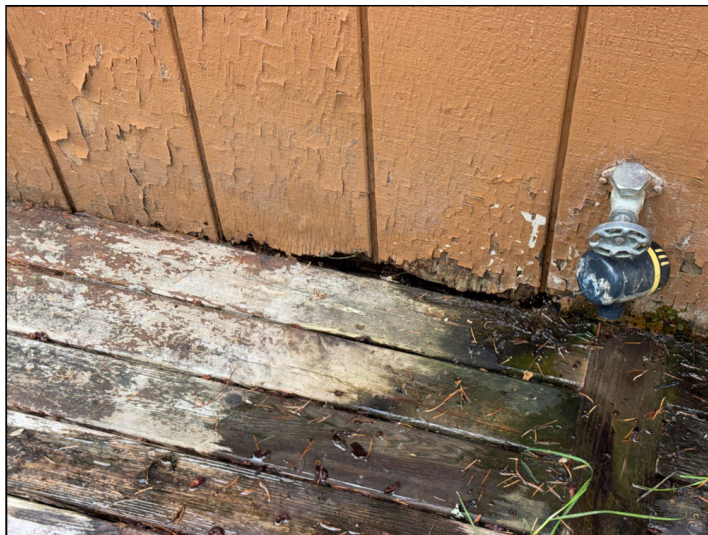
Moisture damage and wood rot were noted at the siding on the east elevation near the leaking hose bib. Recommend repairing the leak and replacing all damaged siding and underlying materials as needed.

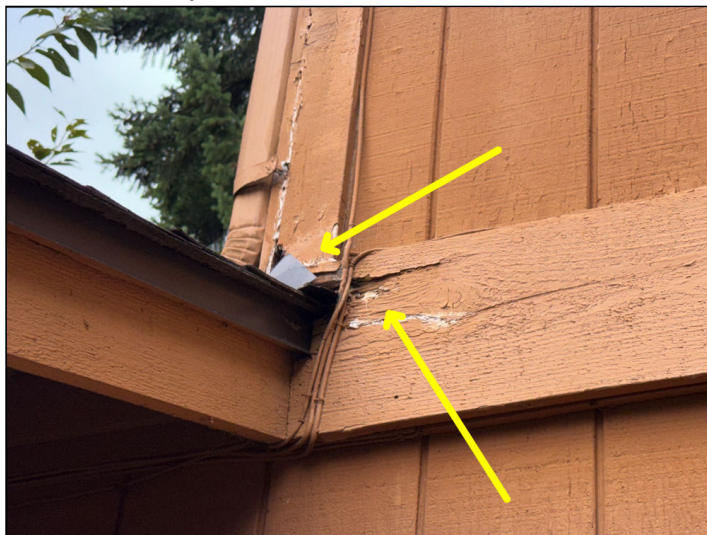
Damaged belly trim noted at the SW corner of the house. Recommend having the trim repaired/replaced as needed.

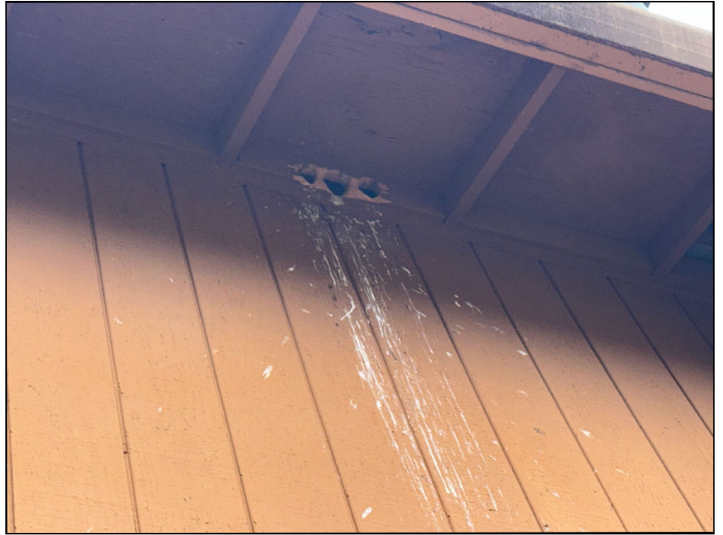
Missing vent screen noted on the south side of the home.

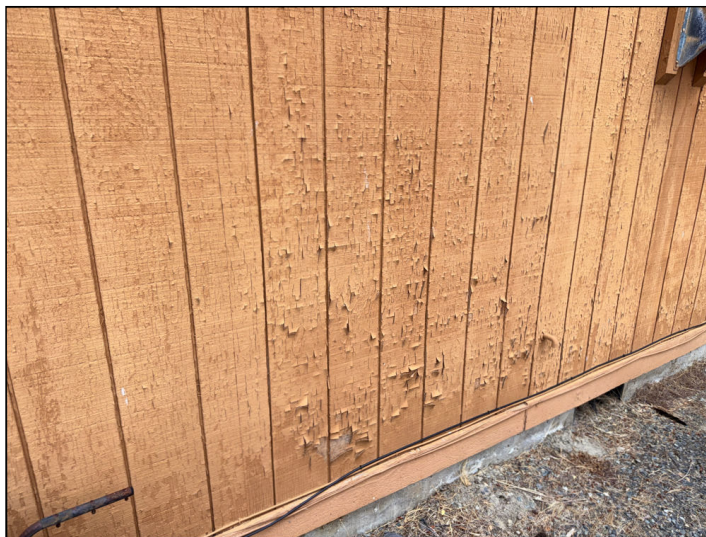
Paint Deterioration

| Page 48 Item: 5 | Exterior Paint | <ul style="list-style-type: none"> <li>• Paint Deterioration</li> </ul> <p>Areas of deteriorated or peeling paint were observed at the exterior surfaces. Paint helps protect exterior materials from moisture intrusion and weather exposure. Recommend scraping, priming, and repainting the affected areas.</p> |

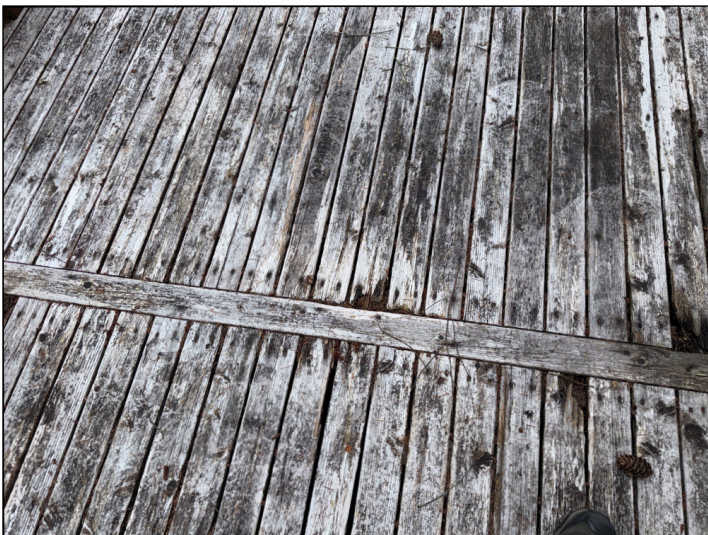
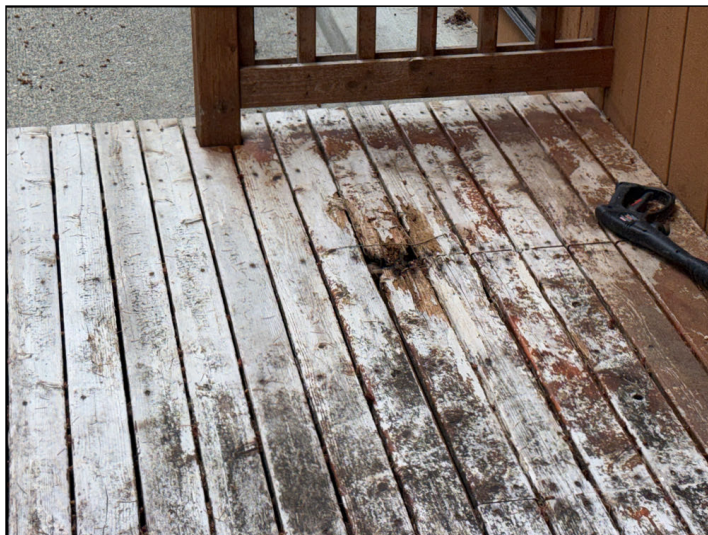
| Grounds | | |
|---|---|---|
| Page 50 Item: 5 | Patio and Porch Deck | <ul style="list-style-type: none"> <li>• Some boards at the deck were rotting/deteriorating. Recommend replacing damaged boards as needed.</li> </ul> |

Some boards at the deck were rotting/deteriorating. Recommend replacing damaged boards as needed.

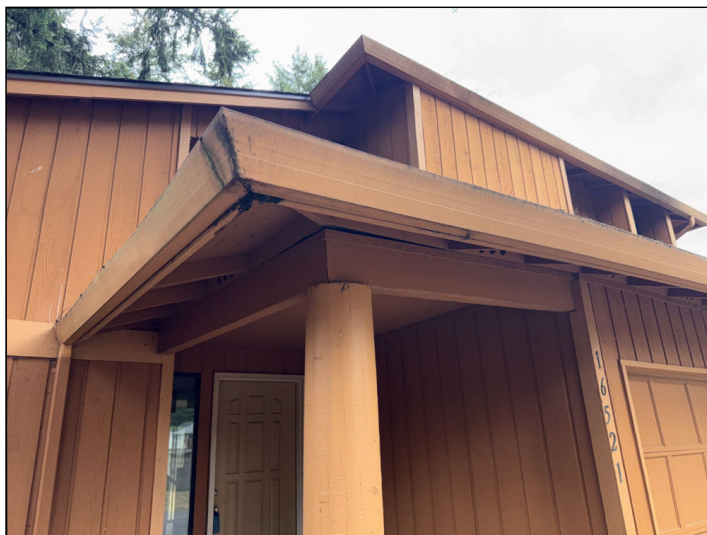
| Grounds | | |
|---|---|---|
| Page 52 Item: 16 | Patio and Porch Condition | <ul style="list-style-type: none"> <li>• The front porch support post has visible wood rot and has settled to the point that it is no longer in contact with the roof structure. Recommend replacement of the damaged post and releveled and properly securing the roof structure as needed by a qualified contractor.</li> </ul> |

The front porch support post has visible wood rot and has settled to the point that it is no longer in contact with the roof structure. Recommend replacement of the damaged post and releveling and properly securing the roof structure as needed by a qualified contractor.

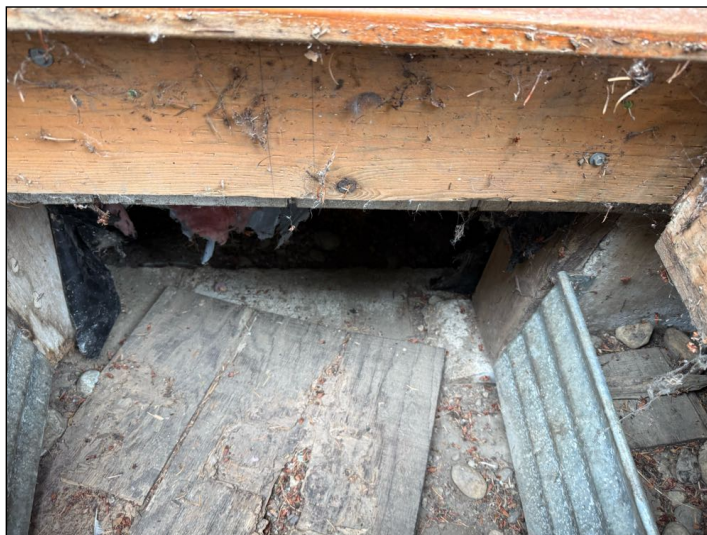
| Grounds | | |
|---|---|---|
| Page 54 Item: 1 | Access | <ul style="list-style-type: none"> <li>• The crawlspace access door is missing, creating a large entry point for animals and rodents. Recommend installing a properly fitted and secured access door to prevent pest entry.</li> </ul> |

The crawlspace access door is missing, creating a large entry point for animals and rodents. Recommend installing a properly fitted and secured access door to prevent pest entry.

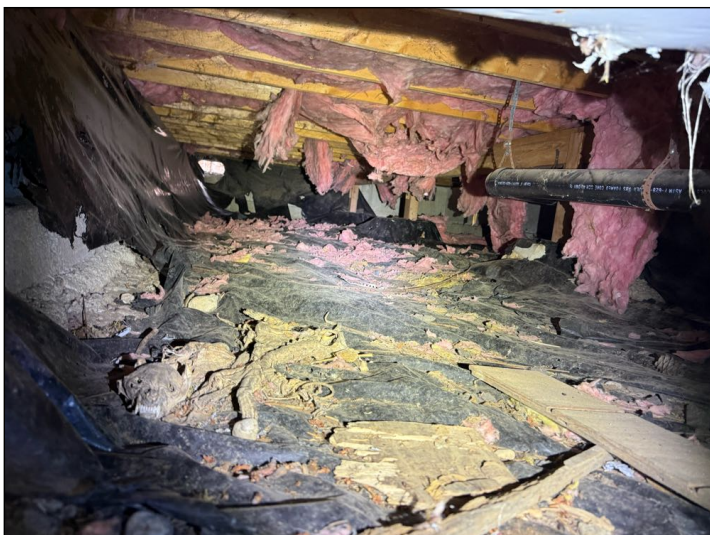
Rodent droppings present in the crawlspace. Recommend monitoring for activity and repair as needed.

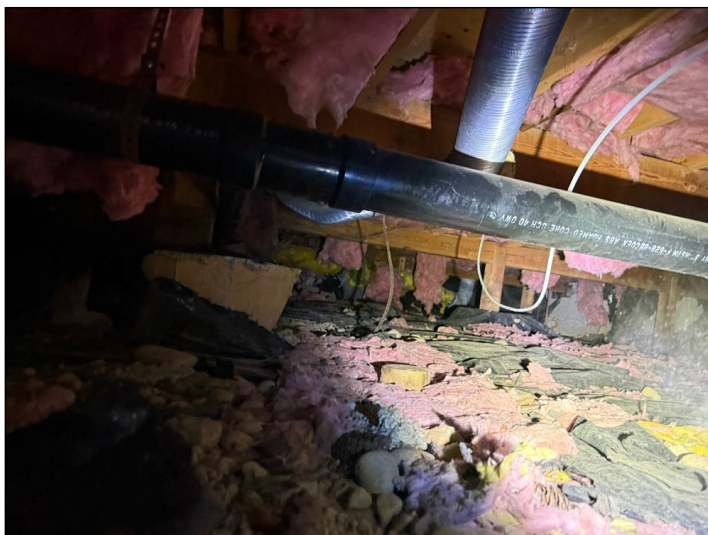
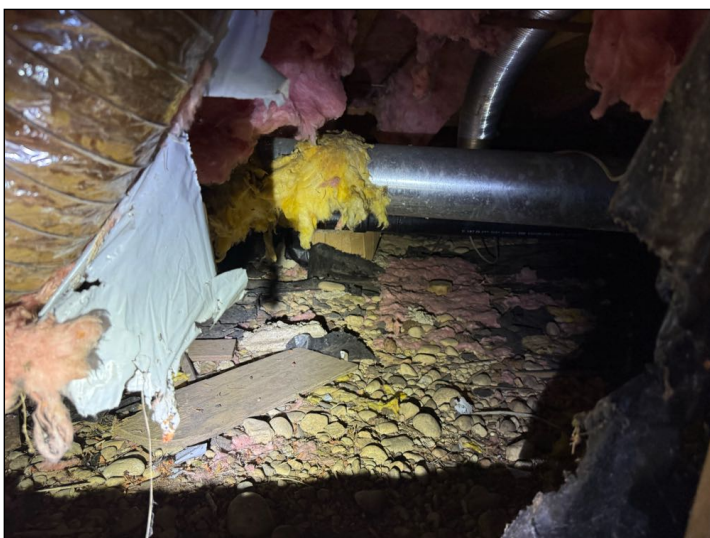
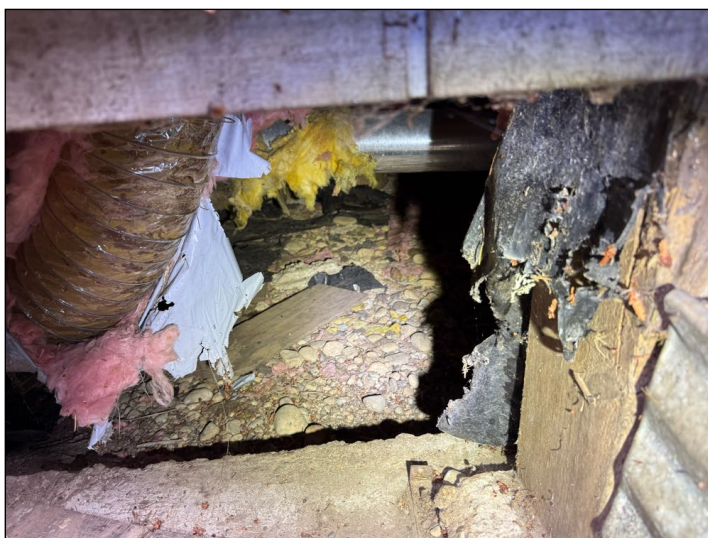
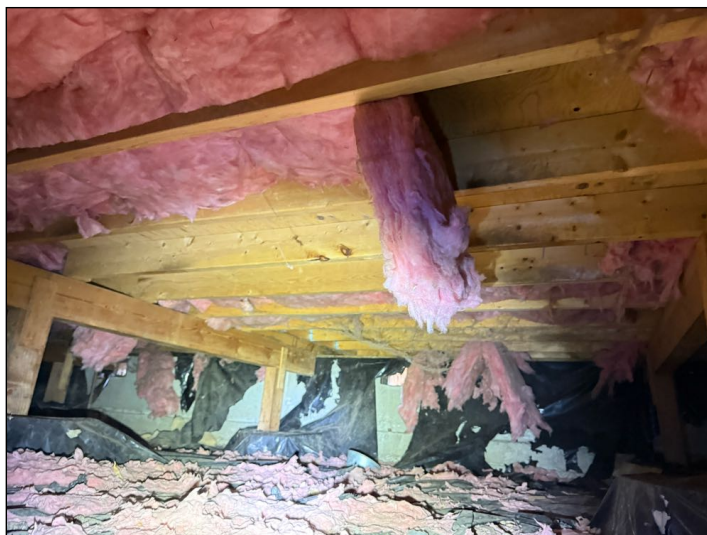
Debris and fallen insulation were noted throughout the crawlspace. These materials can provide nesting areas for rodents and create conditions conducive to wood-destroying organisms. Recommend removing all debris and damaged insulation. Install new vapor barrier as needed.

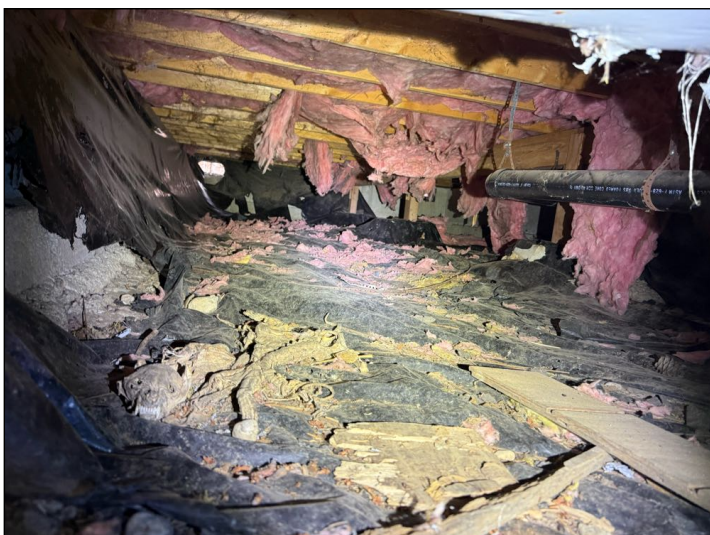
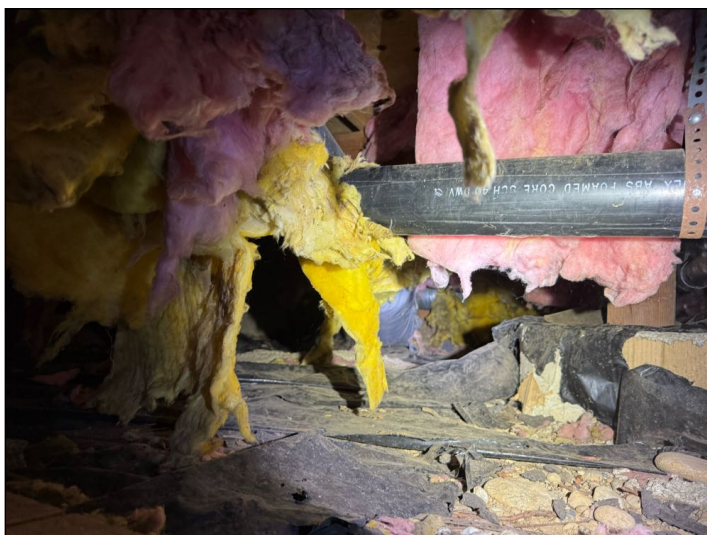
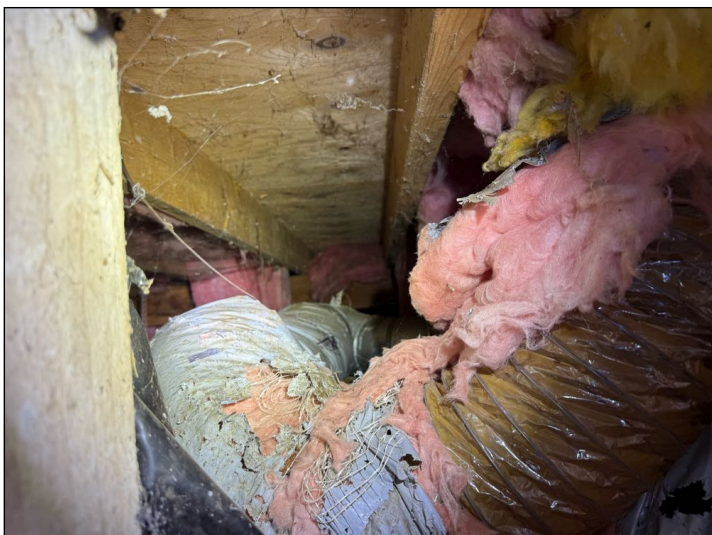
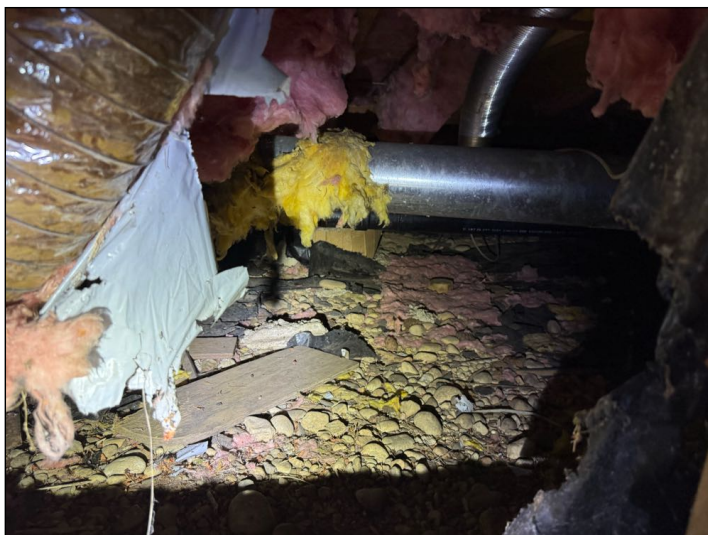
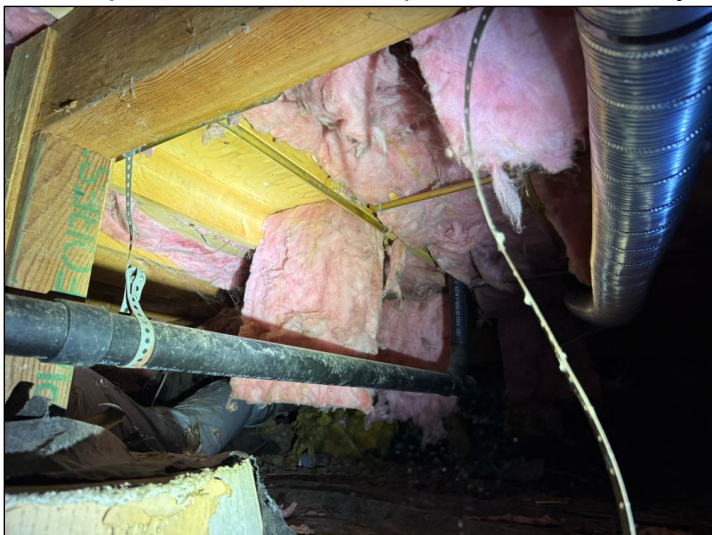
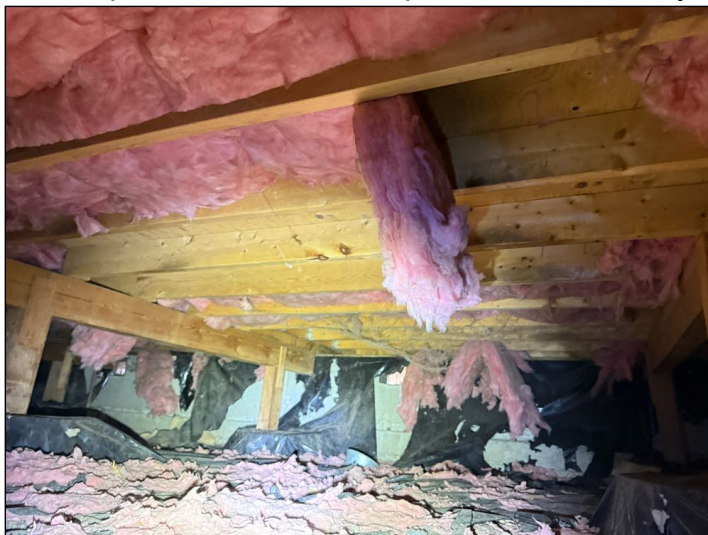
| Grounds | | |
|---|---|---|
| Page 56 Item: 7 | Insulation | <ul style="list-style-type: none"> <li>• The crawlspace insulation has been extensively damaged and pulled down, likely due to animals entering through the open access door. Recommend removing and replacing the damaged insulation and properly securing the crawlspace access door to prevent further entry.</li> </ul> |

The crawlspace insulation has been extensively damaged and pulled down, likely due to animals entering through the open access door.

The crawlspace insulation has been extensively damaged and pulled down, likely due to animals entering through the open access door. Recommend removing and replacing the damaged insulation and properly securing the crawlspace access door to prevent further entry.

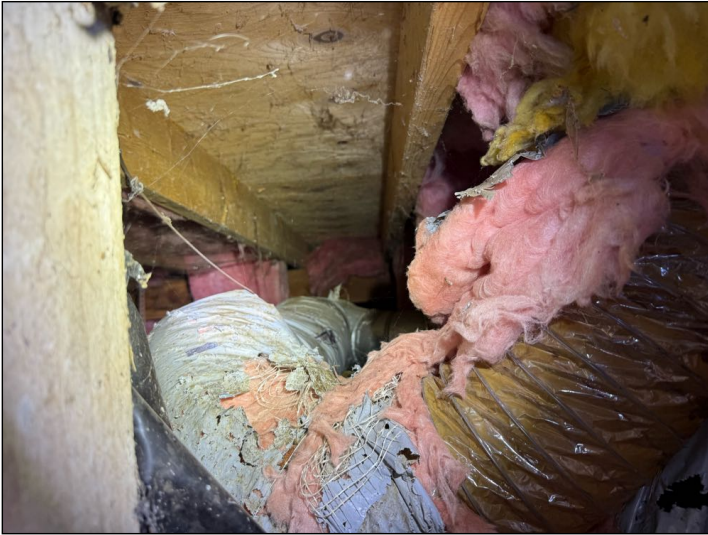
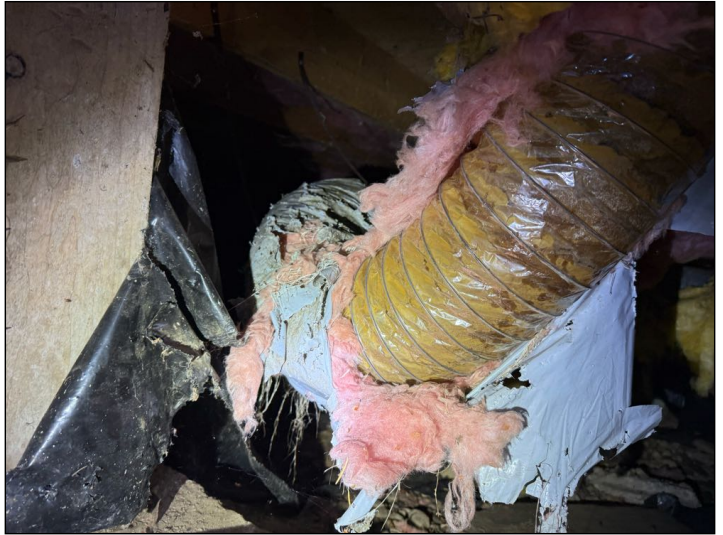
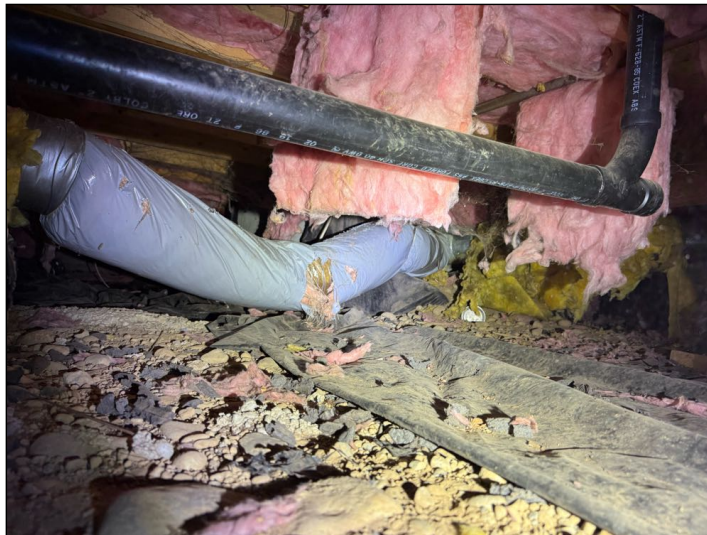
| Grounds | | |
|---|---|---|
| Page 58 Item: 15 | Basement/Crawlspace Ductwork | <ul style="list-style-type: none"> <li>• Damage was noted to the flexible ducting in the crawlspace. Recommend replacing all damaged flexible ducting as needed and having the remaining rigid ductwork professionally cleaned before use.</li> </ul> |

Damage was noted to the flexible ducting in the crawlspace. Recommend replacing all damaged flexible ducting as needed and having the remaining rigid ductwork professionally cleaned before use.
