Update

Project Update: Status and Next steps

## Project Overview

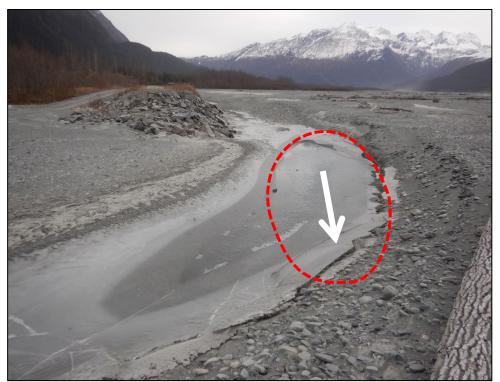
• Example: Tip of Groin 2

#### Scour Hole

• Dimensions of scour hole:

• Depth: 8+ feet

• Width: 40 feet

• Length: 93 feet
