To: Crystal River Country Estates Property Owners

Re: Information packet – Bridge inspection/maintenance results.

Subject: Observation of Existing Bridge Abutments, Crystal River Country Estates, Pitkin County, Colorado

**TO:** Ray Pojman, Crystal River Country Estates HOA  
**FROM:** Marijean Frymoyer, PE  
**DATE:** December 6, 2021  
**SUBJECT:** Crystal River Country Estates HOA (Bridge #8)

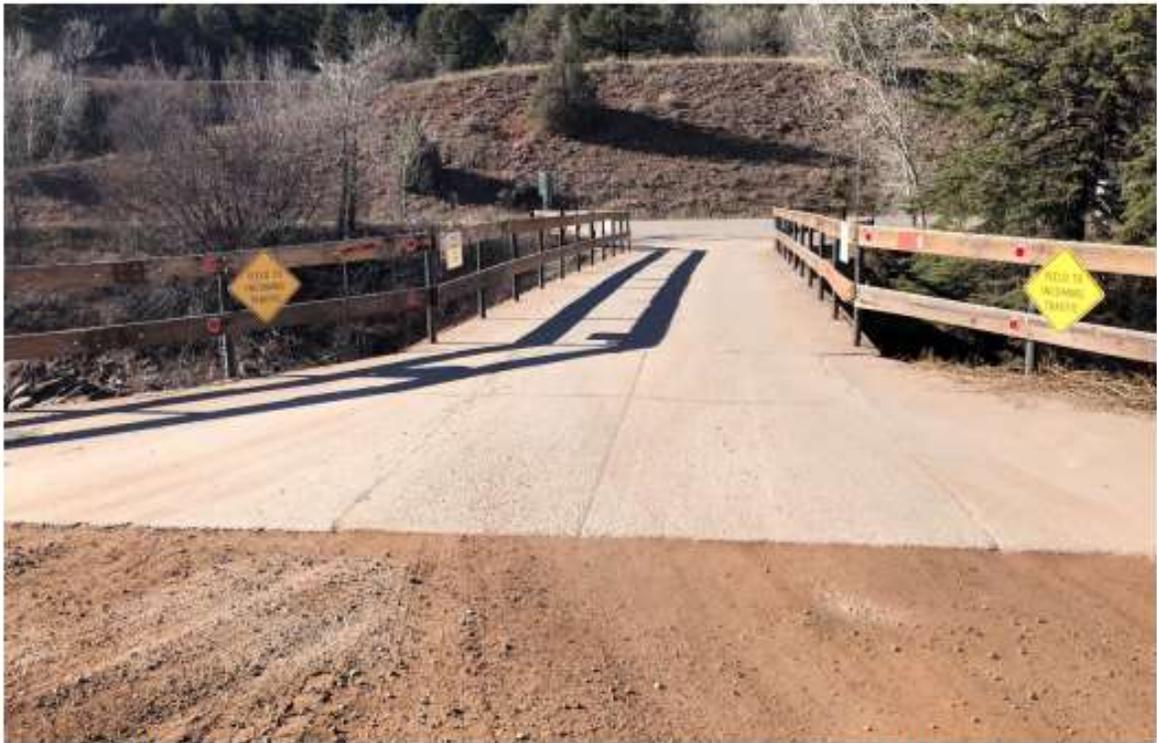
The deck consists of 6” deep reinforced concrete that is fully supported by the top flange of the prestressed girders. **The deck is in good condition.** The railing consists of horizontal timber rails and steel pipe posts. While this is not a crash tested design, **the railing is in fair condition.**

*Photo 1: Bridge Deck, Looking West (Towards State HWY 133)*

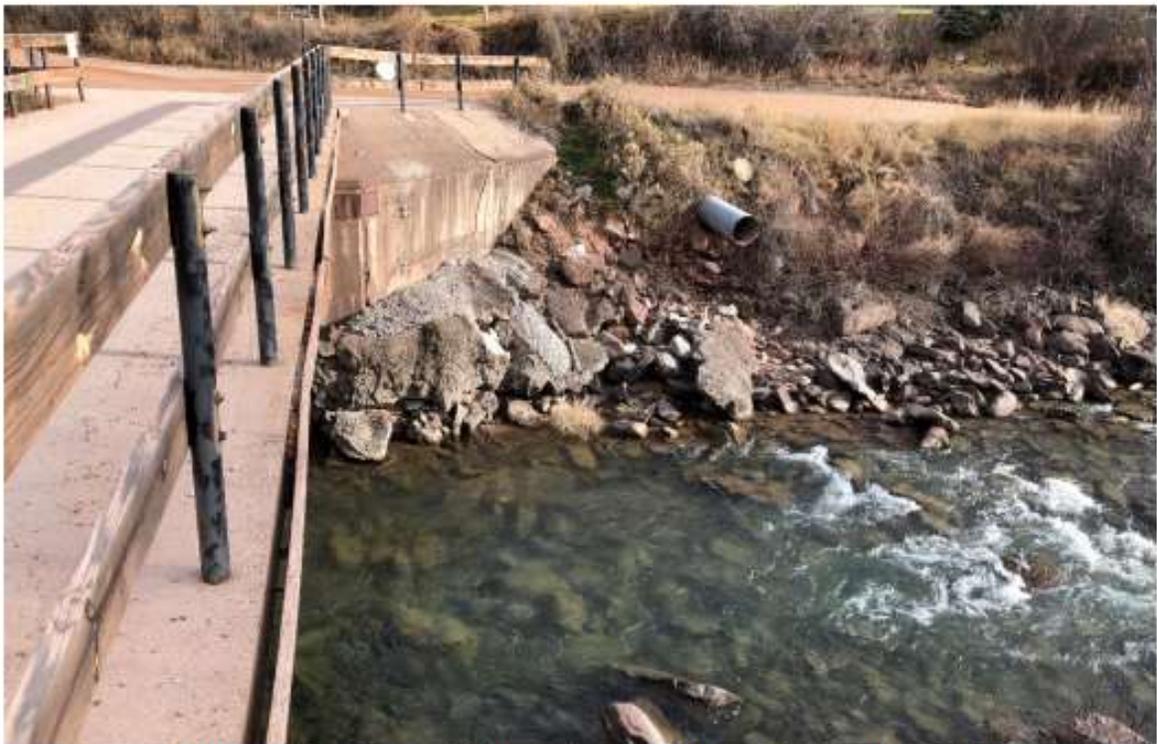
*Photo 2: Southeast Wingwall and Riprap (Upstream Side)*

- Extend grout at the SE corner riprap to the bottom of the rip rap, filling in all voids.
- Review bridge records to determine appropriate load posting sign weight limit.

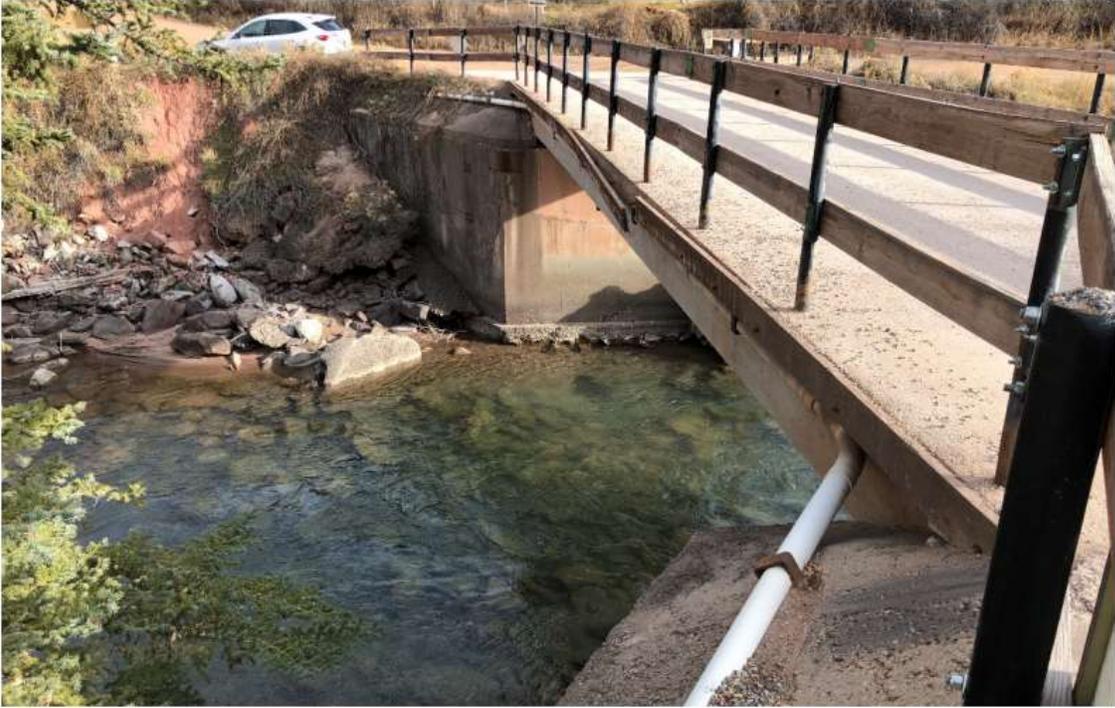
*Photo 3: Northeast Wingwall and Riprap (Downstream Side)*

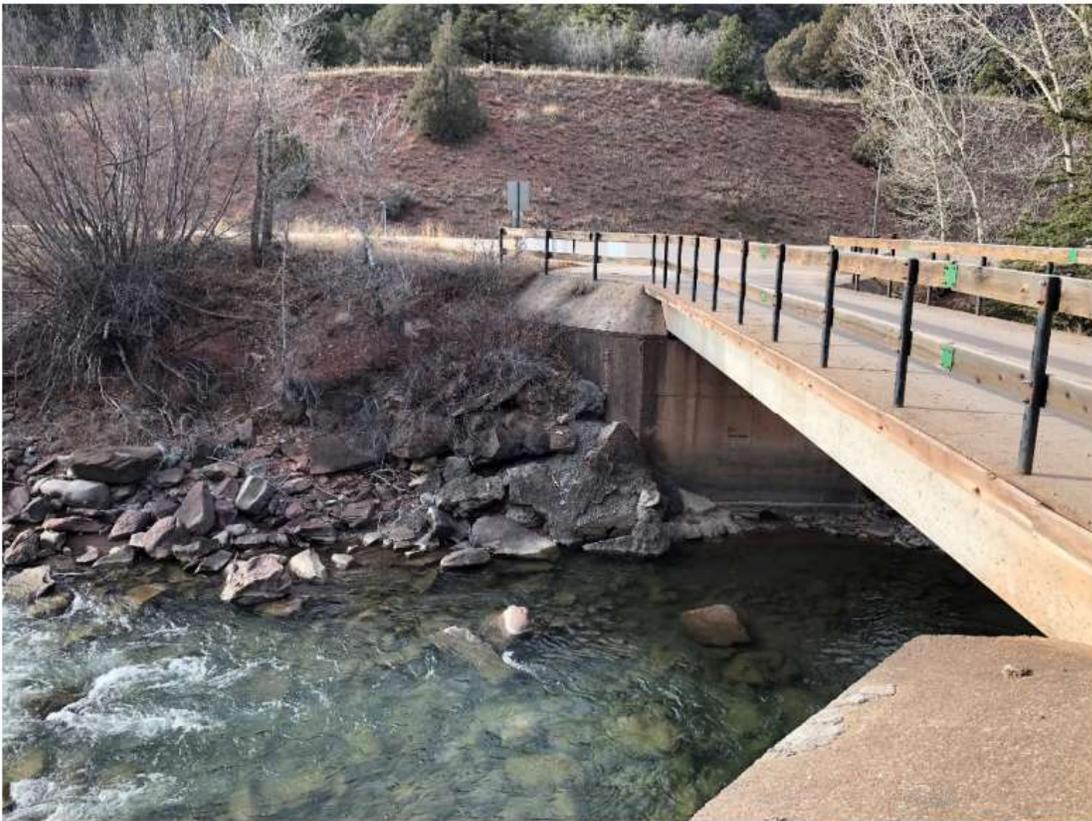
*Photo 4: Southwest Wingwall and Riprap (Upstream Side)*

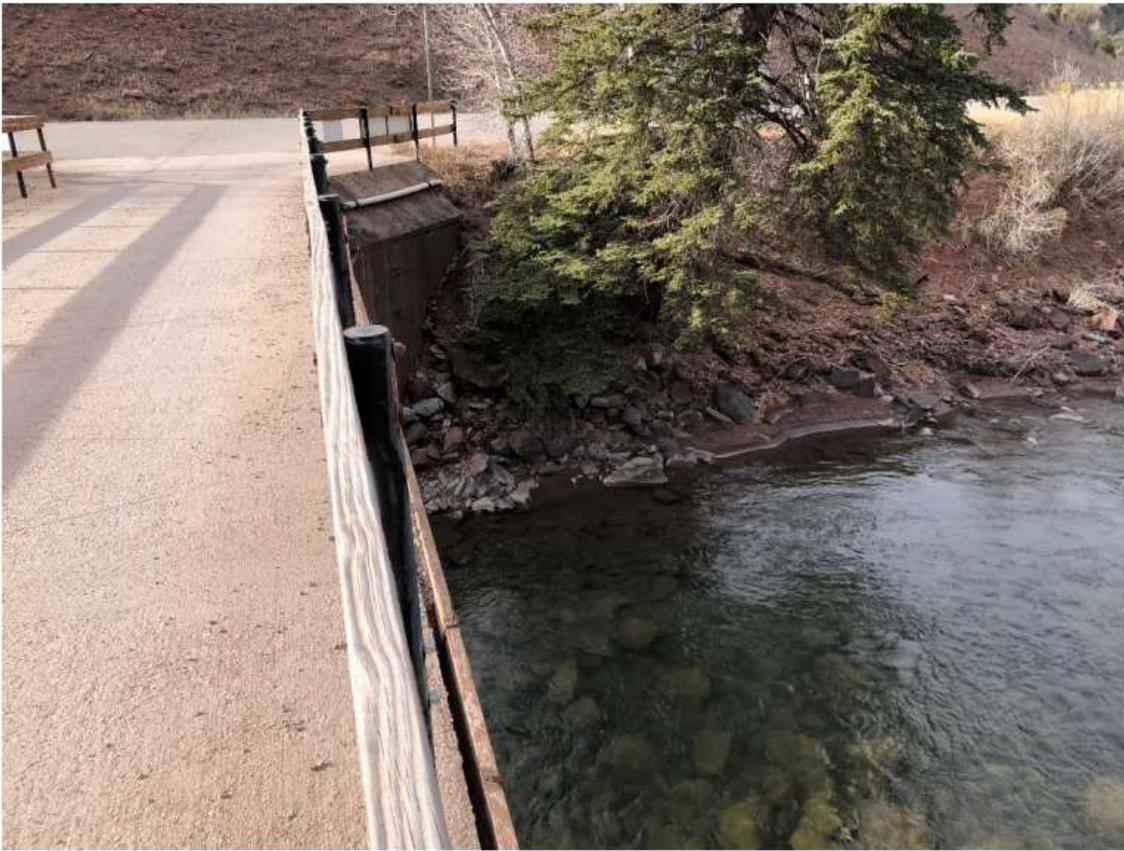
*Photo 5: Northwest Wingwall and Riprap (Downstream Side)*

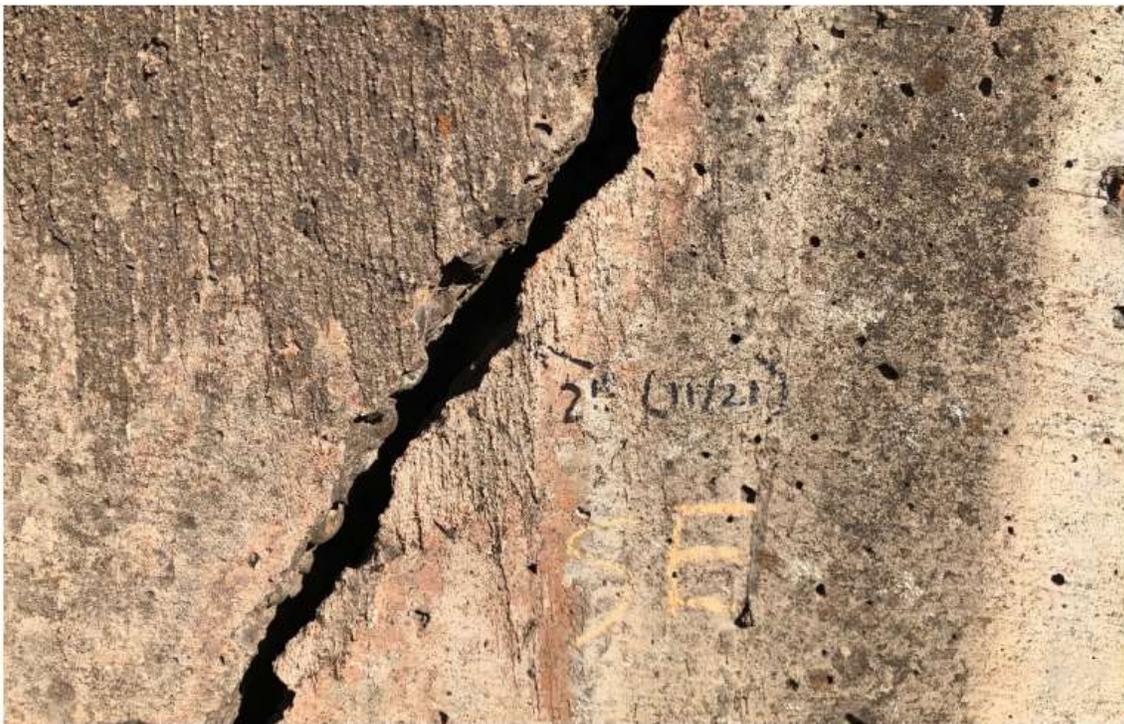
The old abutments and wingwalls consist of unreinforced concrete. The old wingwalls have a metal plate with 4 rebars sticking out, presumably to restrain the walls from rotating out. **The old concrete abutment and wingwalls are in poor condition.** The following defects were noted in the old concrete abutment and wingwalls:

*Photo 6: 2" Open Diagonal Crack in Southeast Wingwall*

- Monitor width of cracks in the old abutments and wingwalls to determine if there is continued movement. If crack growth continues, repairs should be developed to stabilize, strengthen and/or replace the walls.

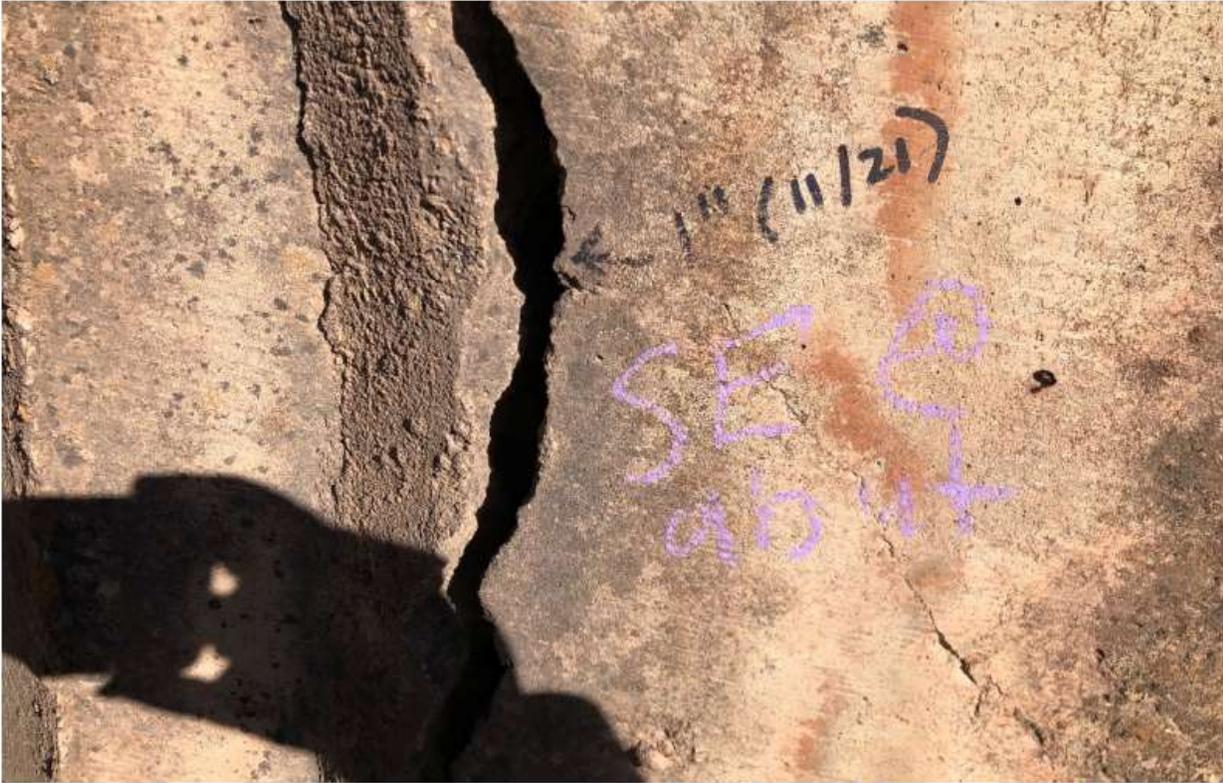
*Photo 7: 1" Open Vertical Crack at corner of Southeast Wingwall and Abutment*

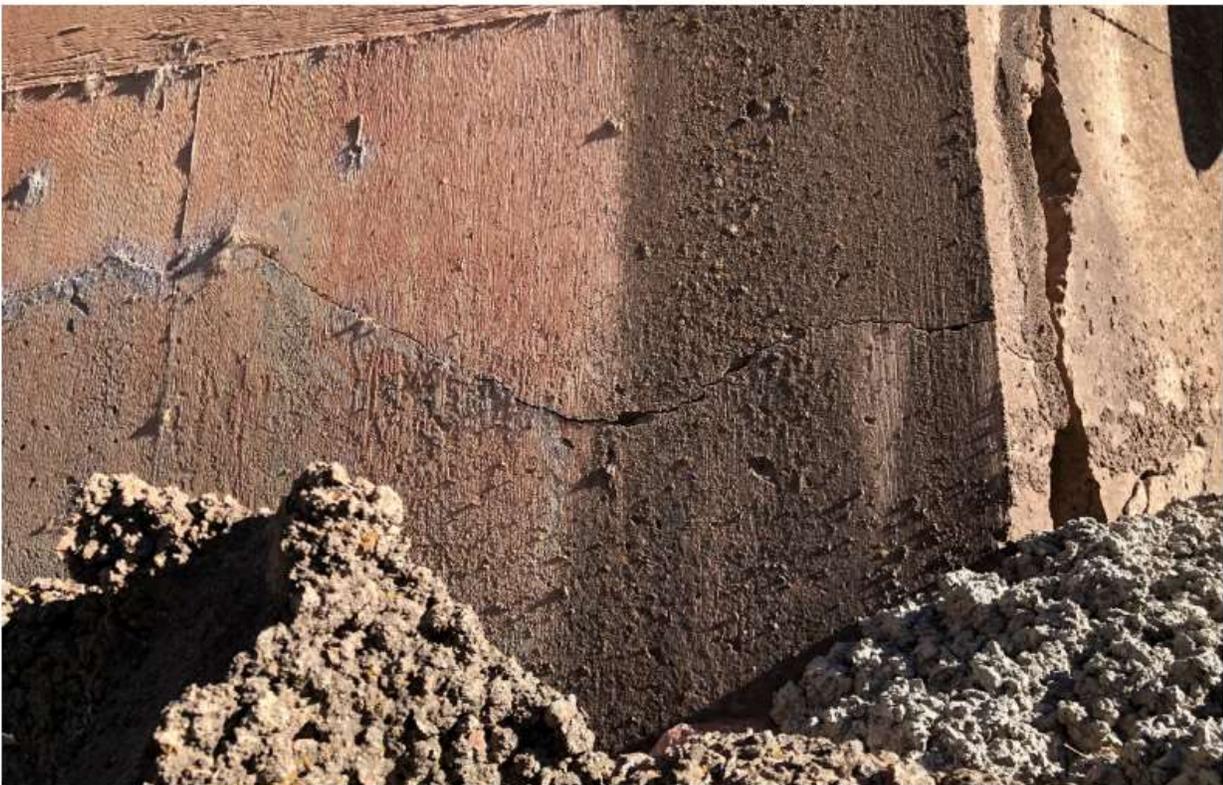
- East Abutment:
  - Footing is exposed and undermined near center of the bridge. The most significant scour location measured 30" from the top of the footing to the creek groundline
  - Abutment wall has 1/4" wide horizontal crack at ~mid height
  - Corner between abutment wall and SE wingwall has 1" wide vertical crack, full height, note it appears that this was previously filled with grout
  - Southeast Wingwall has 2" wide crack, full height, the portion of wingwall on the south side of the crack is offset ~1/4" towards the river
  - Southwest Wingwall has 1/4" wide diagonal cracks, full height
- West Abutment:
  - Footing is exposed up to 11"
  - Abutment wall has hairline vertical and diagonal cracks throughout
  - Abutment wall has 6" diameter rock pocket
  - Southwest Wingwall has 1/4" wide diagonal crack

*Photo 8: 1/4" Horizontal Crack in East Abutment*

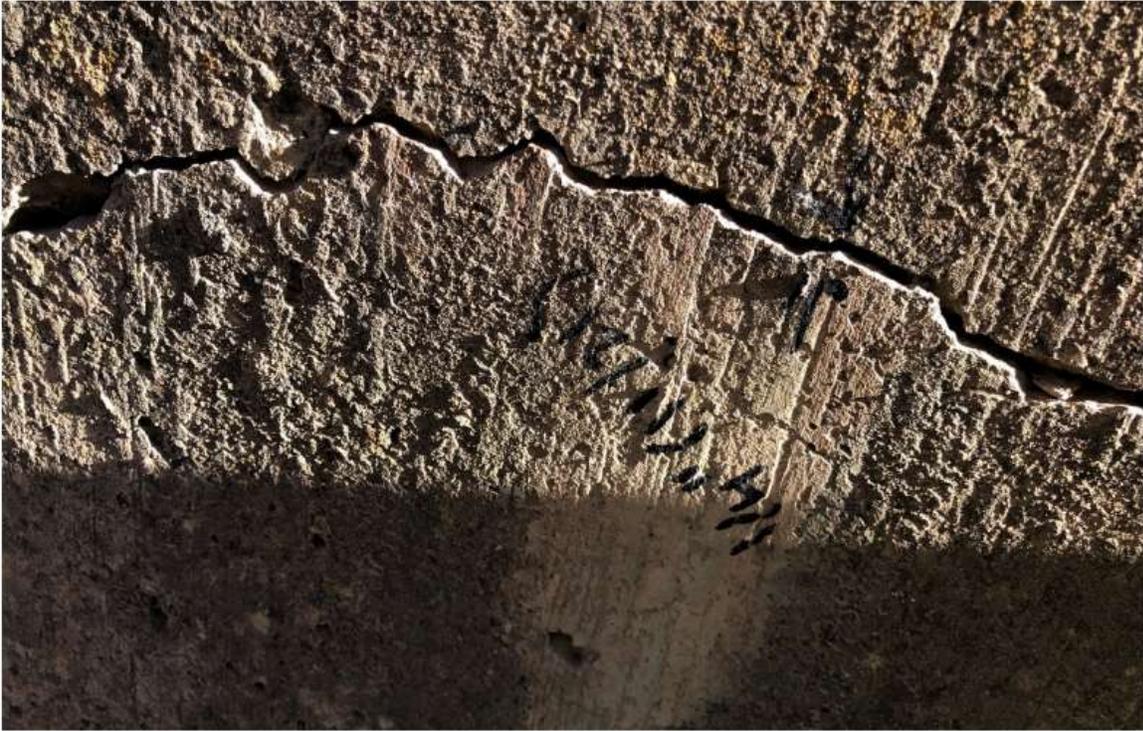
*Photo 9: ¼" Horizontal Crack in East Abutment*

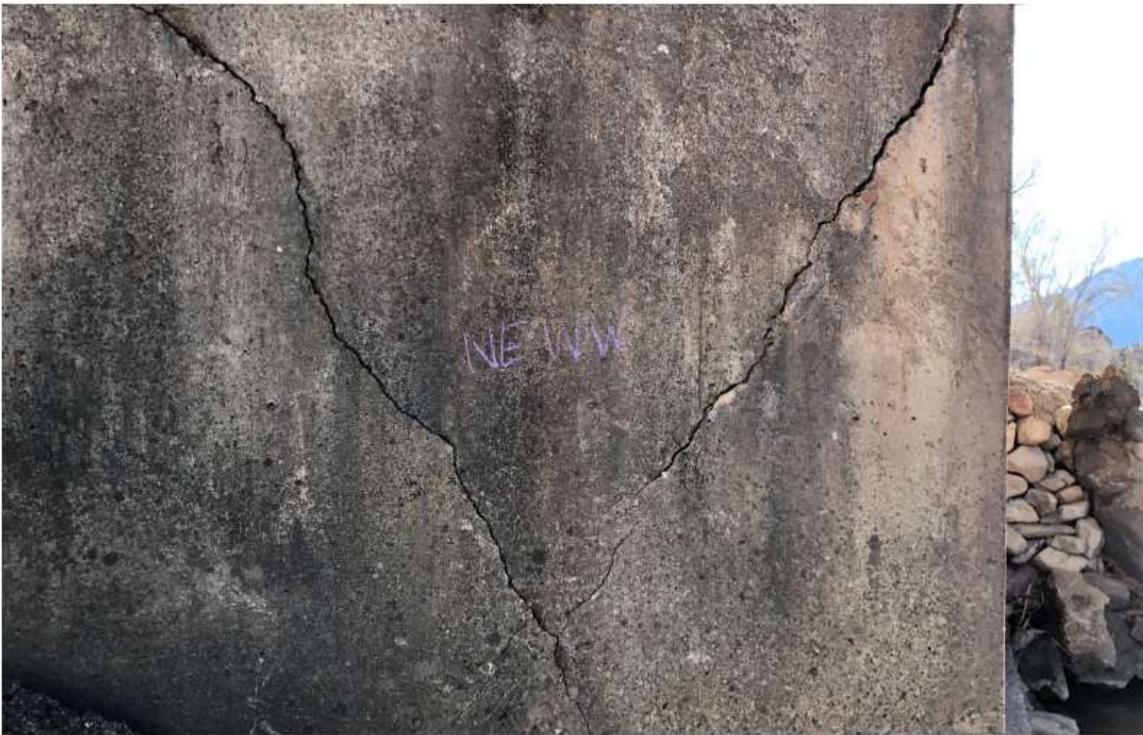
*Photo 10: ¼" Diagonal Cracks in Northeast Wingwall*

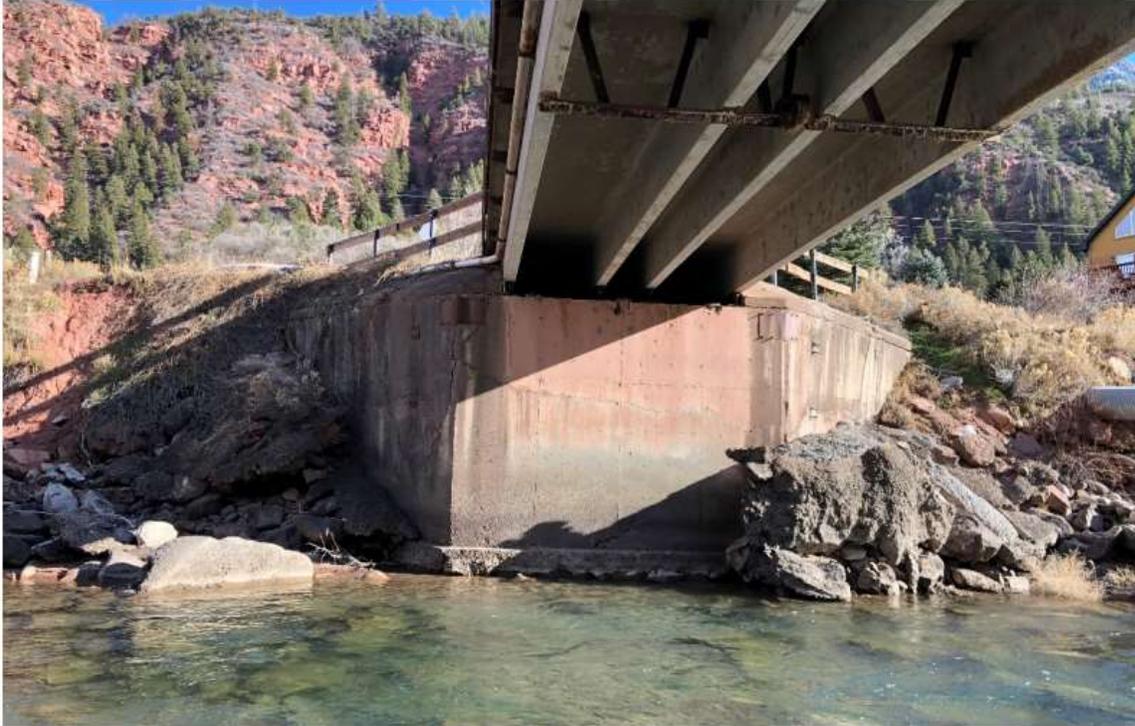
- The old abutments are connected to the new superstructure to provide lateral resistance.
- **Failure of the old abutment would result in inadequate scour protection for the new abutment and could result in an unstable condition for the new abutment.**

*Photo 11: East Abutment Original Bridge Footing Exposed and Undermined*

- Monitor scour at old abutment footing and condition of rip rap in front of old wingwalls (especially after high flow events).
- Extend the bottom of the old abutment footings and/or provide rip rap in front of the old abutment footings and across the channel below the bridge. Prior to repairs, a hydraulic analysis of the stream channel should be performed to determine proper sizing and extents of rip rap.

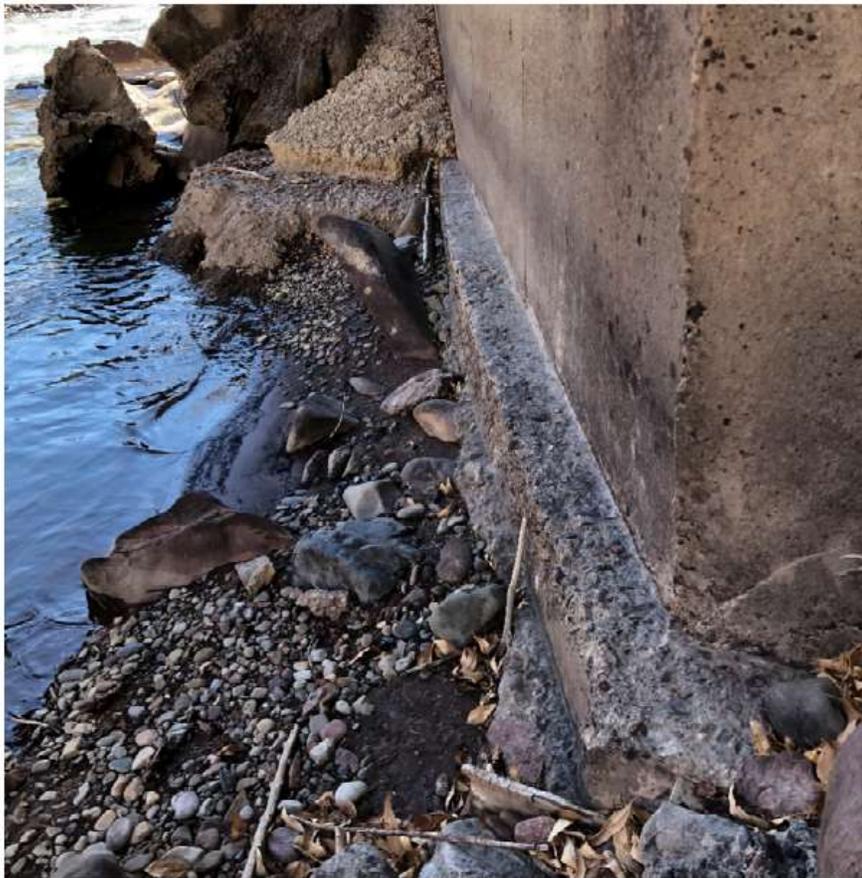
*Photo 12: West Abutment Original Bridge Footing Exposed*

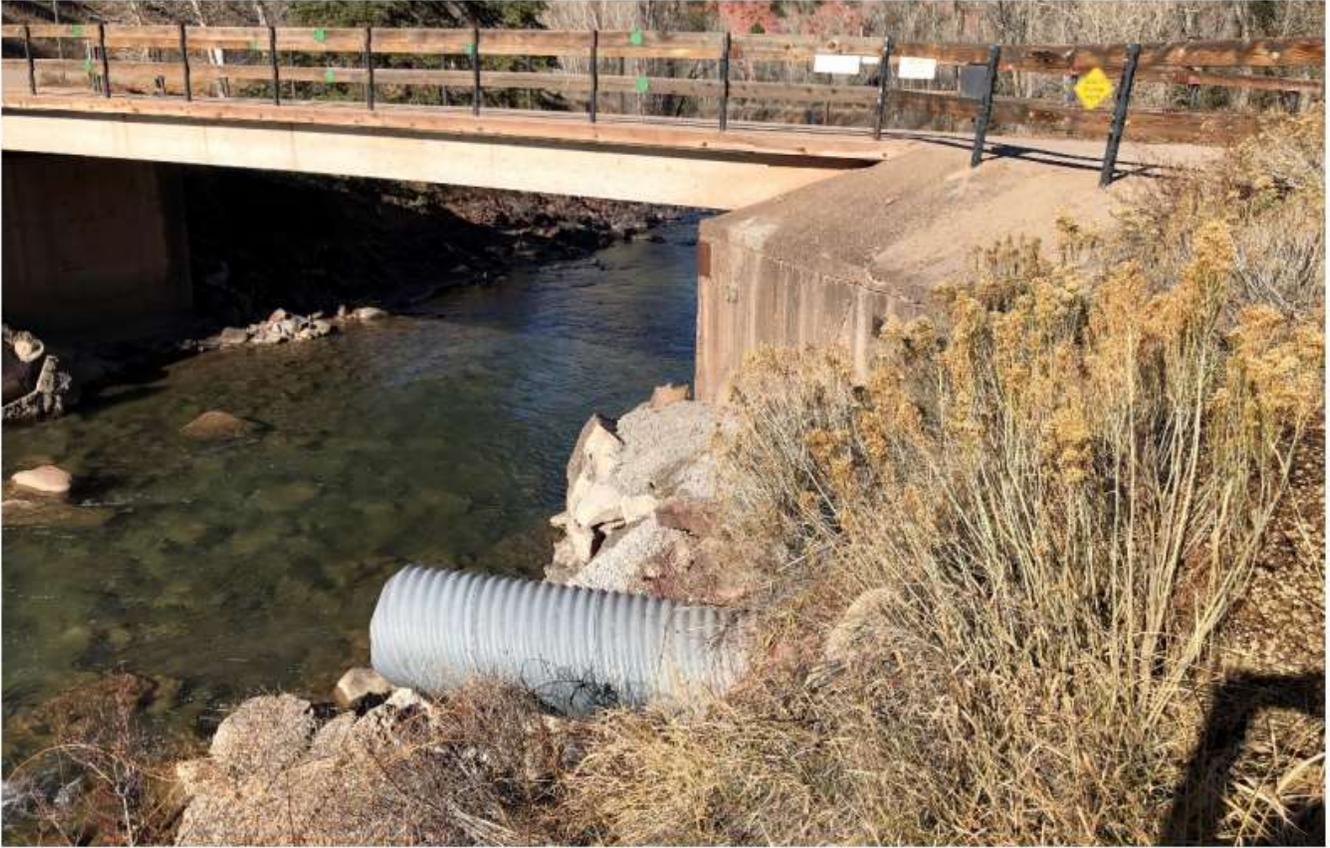
The Crystal River is generally straight upstream of the bridge and the channel consists of medium to large cobbles. The old bridge abutments create a constriction in the channel which increases the flow velocity and the scour potential. Currently the channel is deeper near the east abutment. There is rip rap located along the four wingwalls and on the banks upstream and downstream of the bridge. The rip rap at the SE wingwall was filled with concrete in the spring of 2021. The rip rap at the SW and NE wingwalls were previously grouted. There is no rip rap in front of the old abutments. **Additional protection is required in front of the abutments to prevent further undermining.**

*Photo 13: Grouted Riprap at Southeast Wingwall*
