## Crystal River Country Estates

### Annual Bridge Monitoring

November 8, 2025

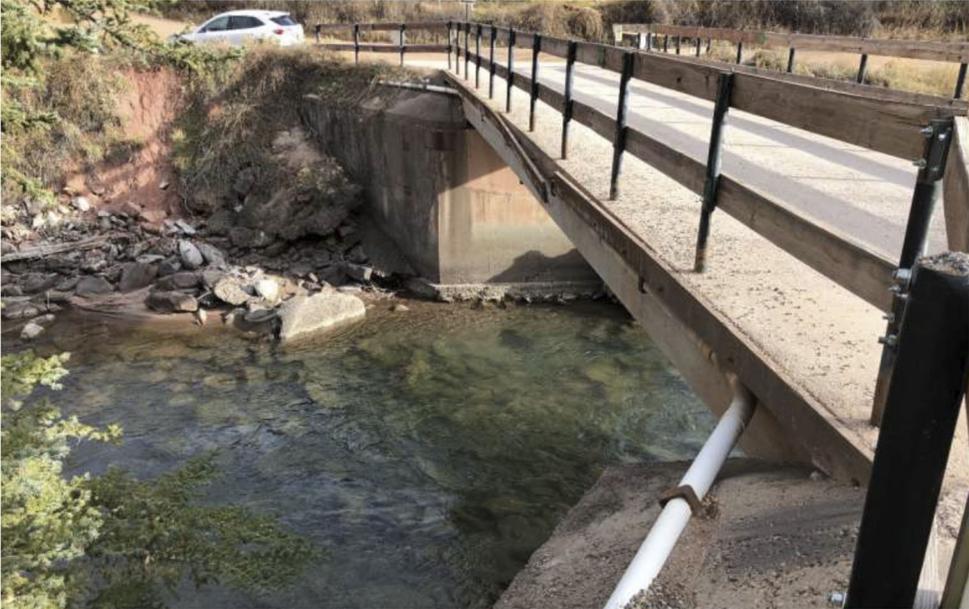
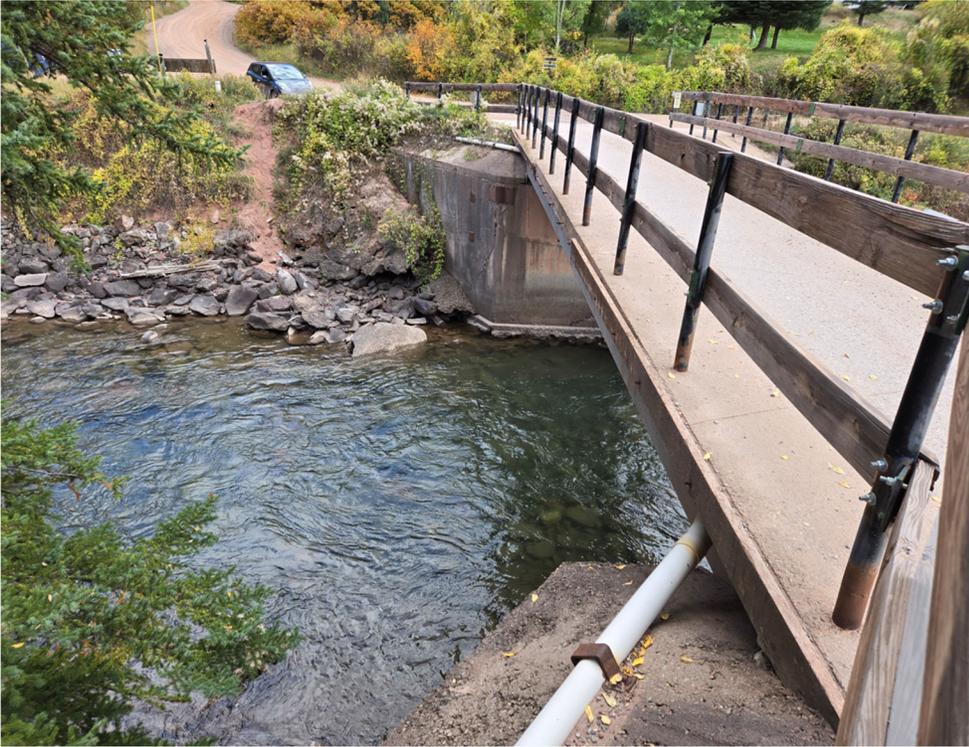
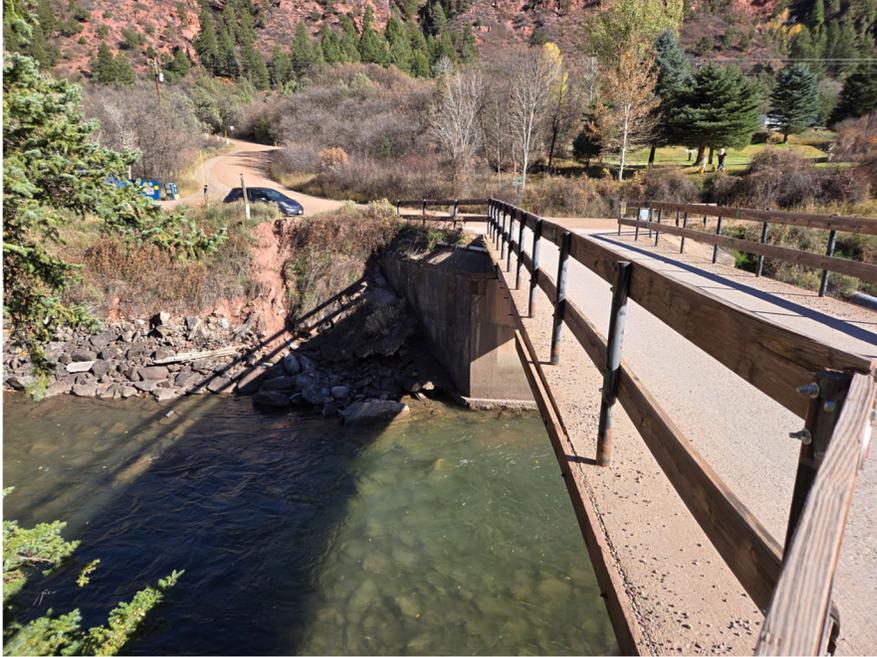
**Photo 3: Northeast Wingwall and Riprap (Downstream Side)**

- NE wingwall has a ¼" wide diagonal crack full height. **The 2023 report measured a ½" wide diagonal crack but not full height. The 2024 and this report find slight opening of these diagonal cracks to ½" and more. Where the diagonal crack approaches the corner of the abutment that faces the river, there is a wider opening that was not noted in reports prior to 2024.**

The opening of cracks on the NE wingwall is the only change in the east abutment condition and loss of chunk of upstream (NE abutment riprap) are the only changes noted on east abutment.

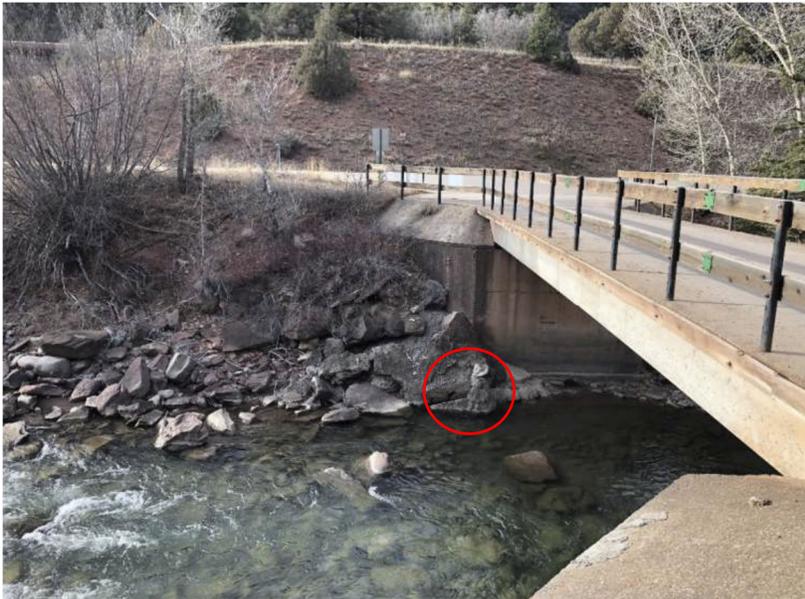
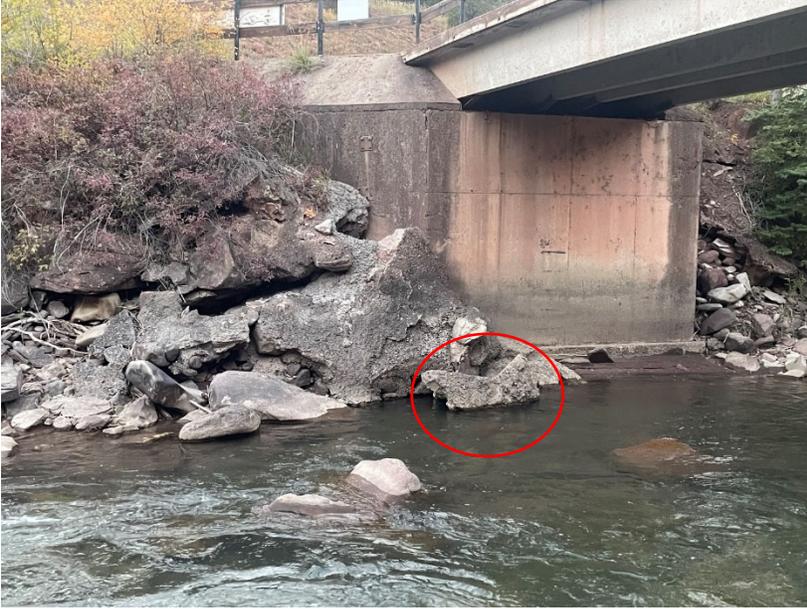
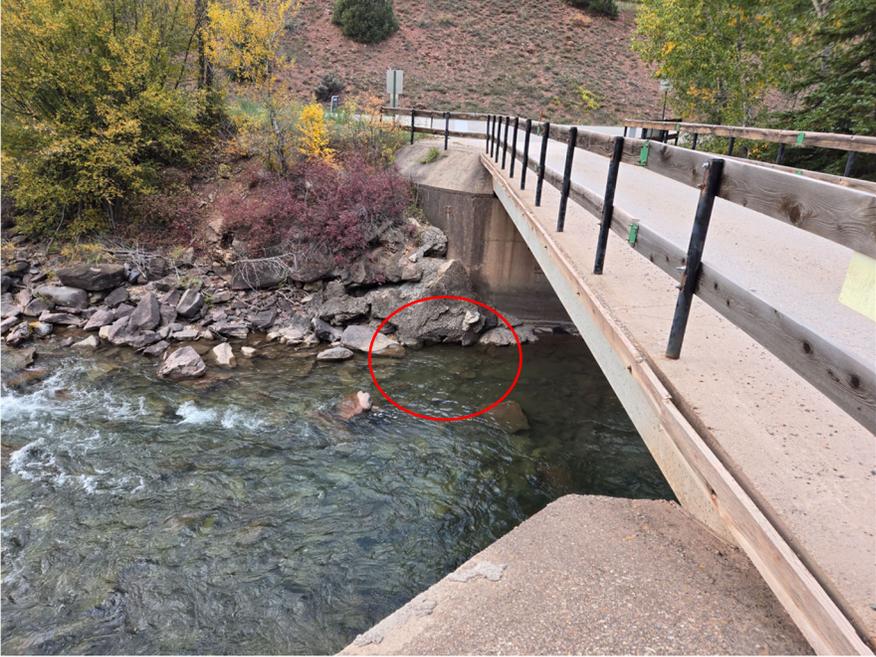
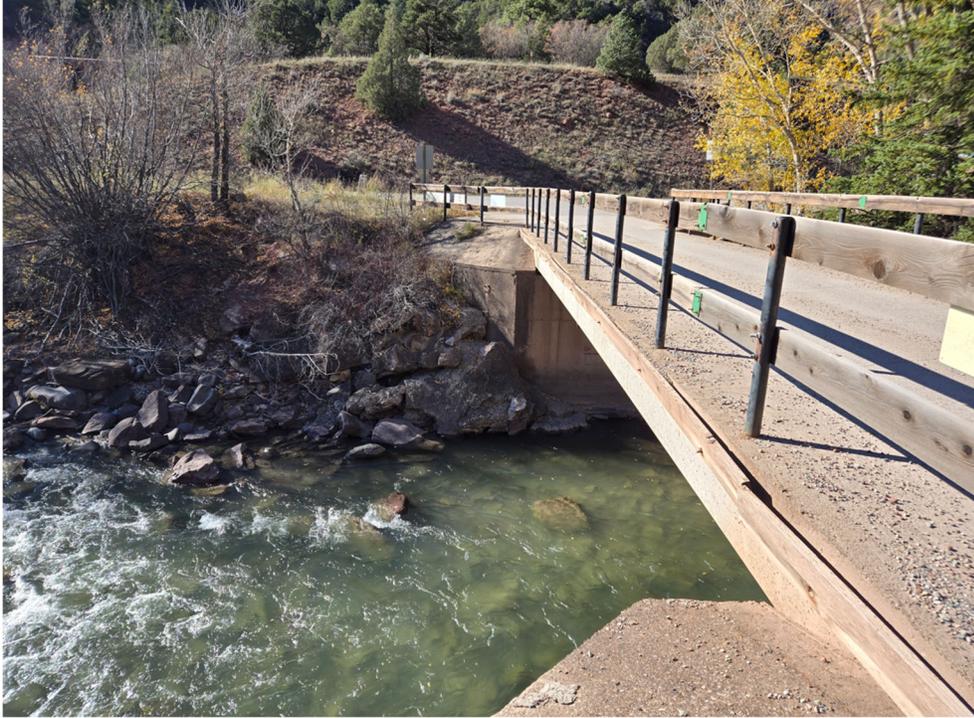
Picture 4: Southwest Wingwall and Riprap upstream side

- SGM reported the footer exposed up to 11". The 2023, 2024 and this report measured no change.
- SGM reported abutment wall has hairline vertical and diagonal cracks throughout. The 2023, 2024 and this report measured no change.
- SGM reported abutment wall has a 6" diameter rock pocket. The 2023, 2024 and this report measured no change.
- SGM reported SW wingwall has a ¼" wide diagonal crack. The 2023, 2024 and this report measured no change.
- A small chunk of concrete covered rock appears to have been washed away from the south west abutment in the 2024 inspection. **In 2025 all riprap appeared similar to 2024.**

2021 – note circled area missing in 2024

2023- note circled area missing in 2024

2024- note circled area

2025 same as 2024

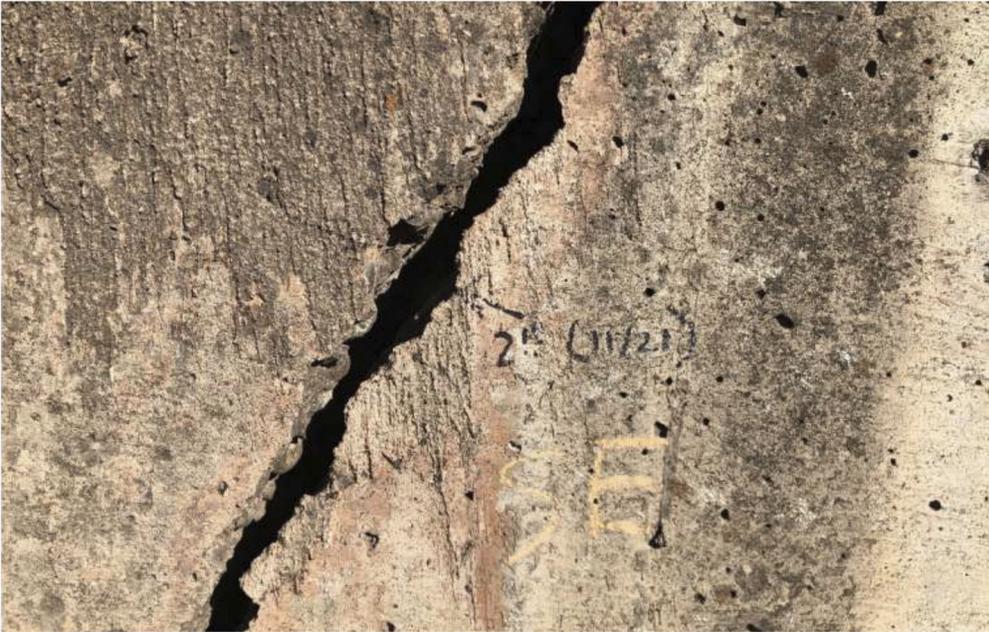
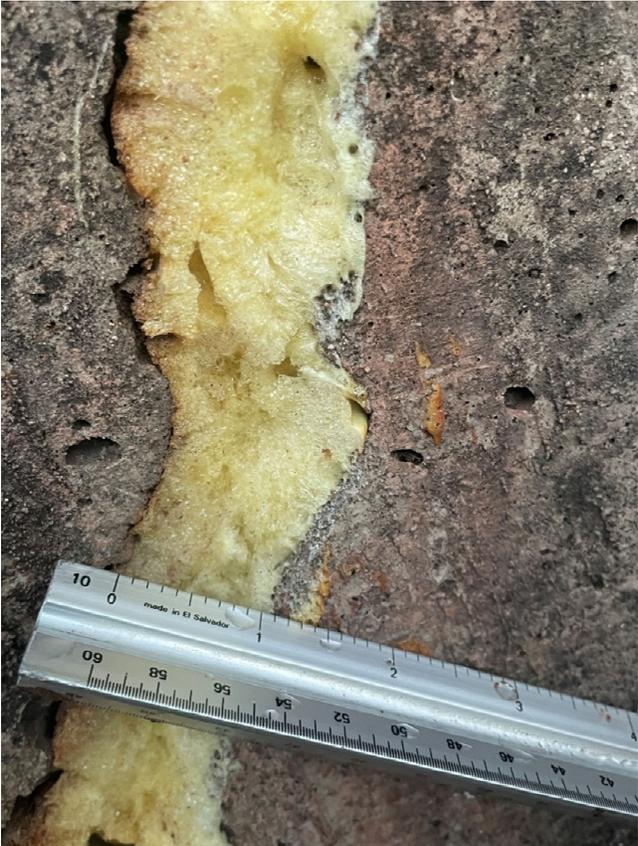
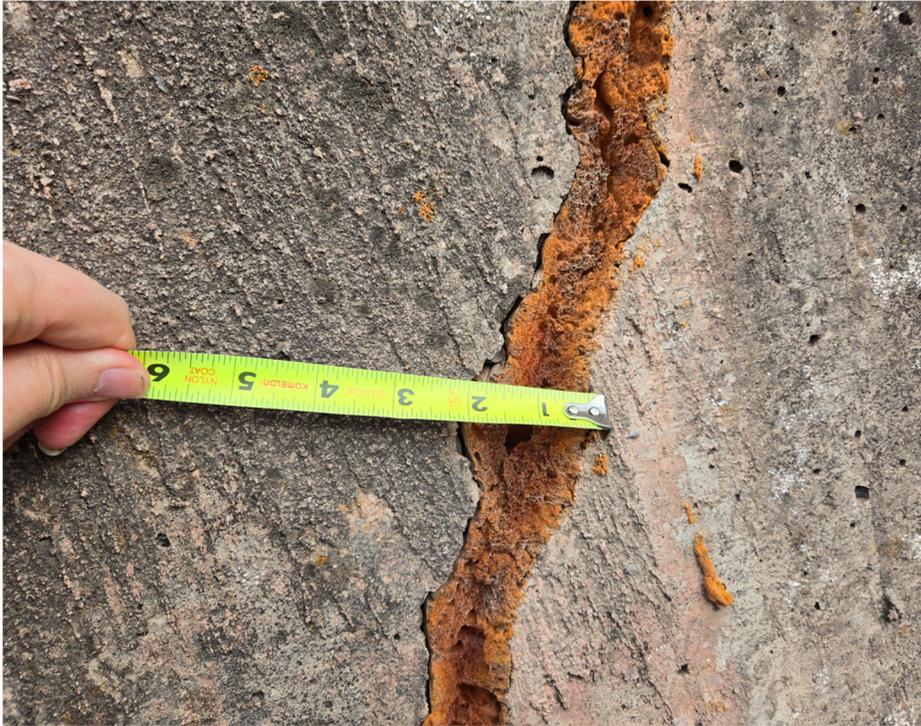
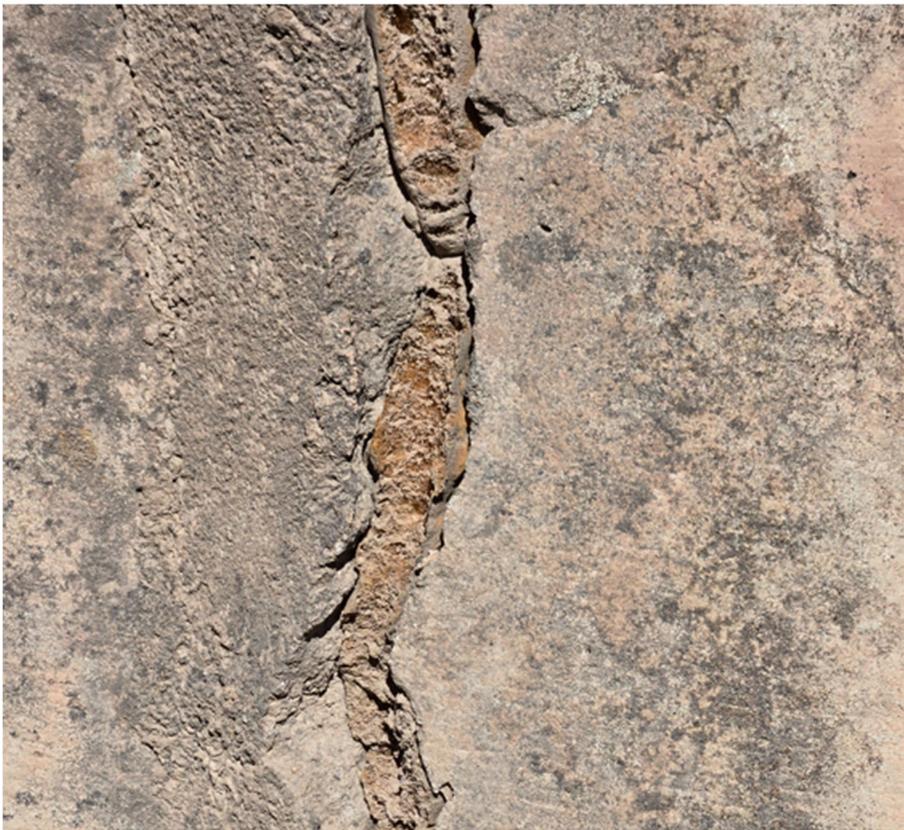
- SGM reports the SE wingwall has a 2" wide crack, full height, the portion of the wingwall on the south side of the crack is offset ¼" towards the river. The 2023, 2024 and this report measured an average of a 1" crack but up to 2" in isolated locations along with a ¼" offset.

Photo 6: 2" Open Diagonal Crack in Southeast Wingwall

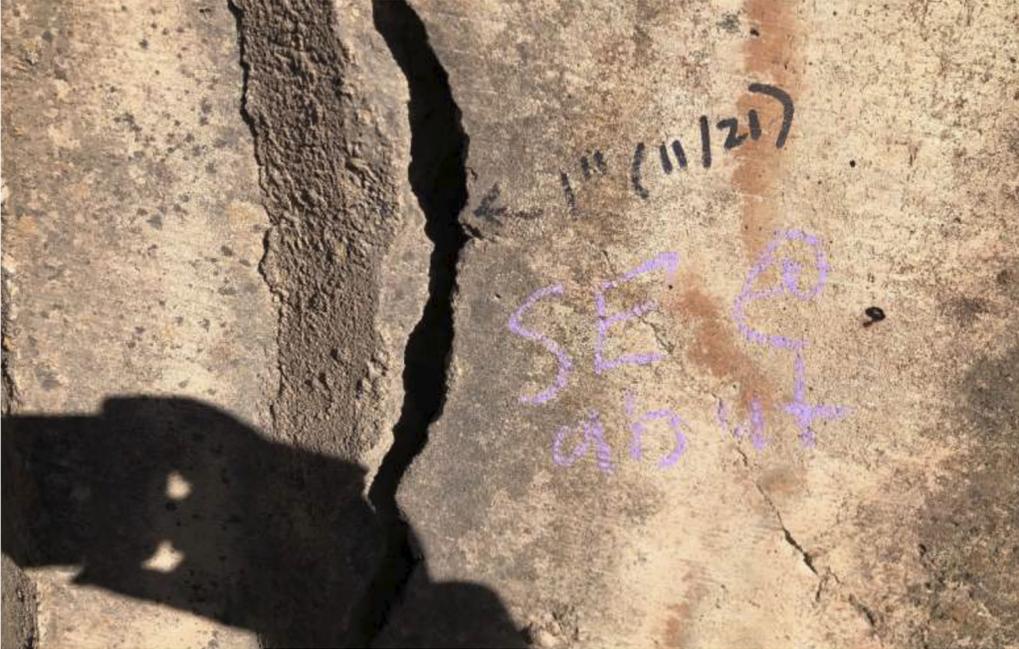
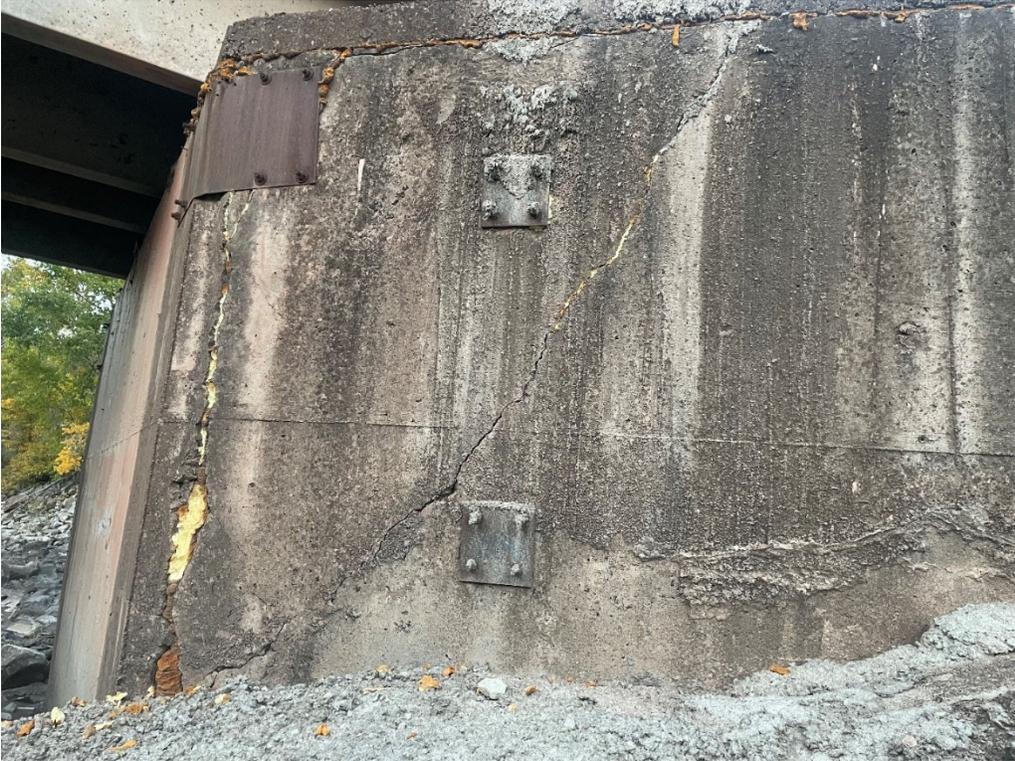
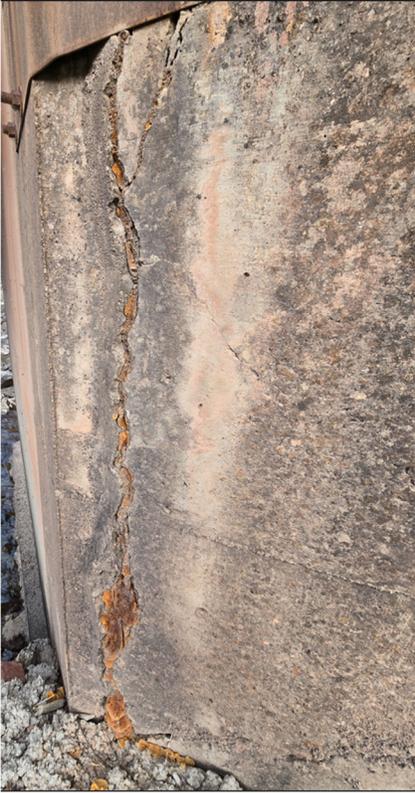
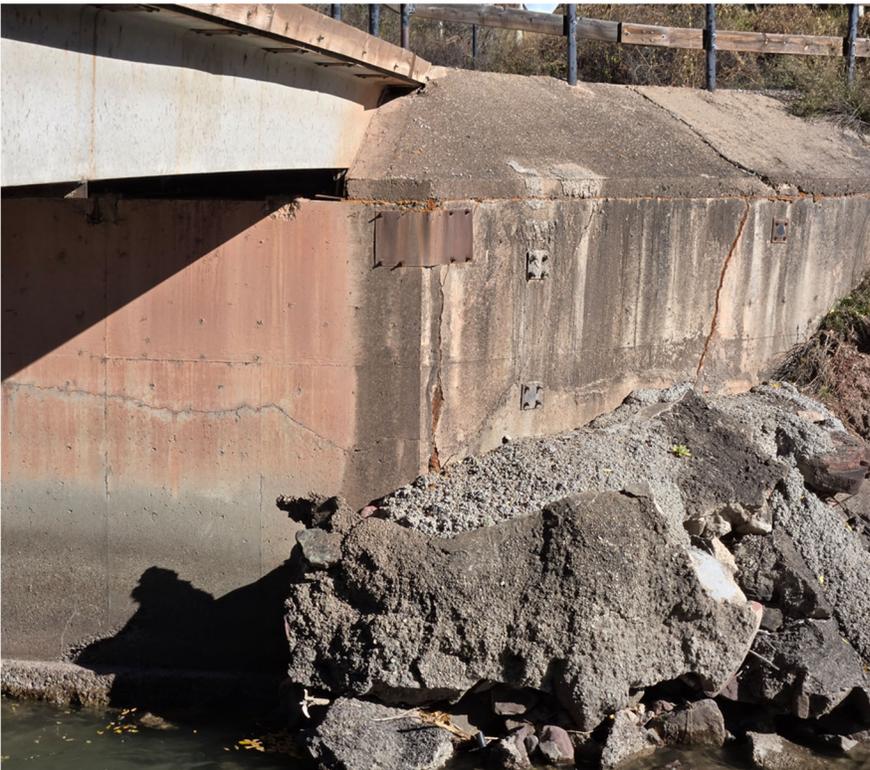
- SGM reports the corner between the abutment and the SE wingwall has a 1" wide vertical crack full height. The 2023, 2024 and this report measured the same.

Photo 7: 1" Open Vertical Crack at corner of Southeast Wingwall and abutment

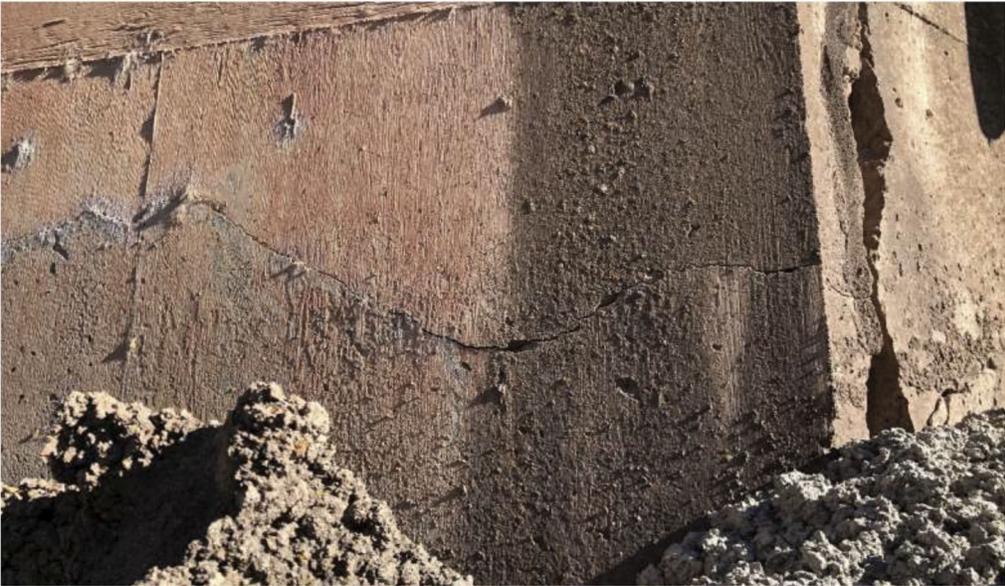
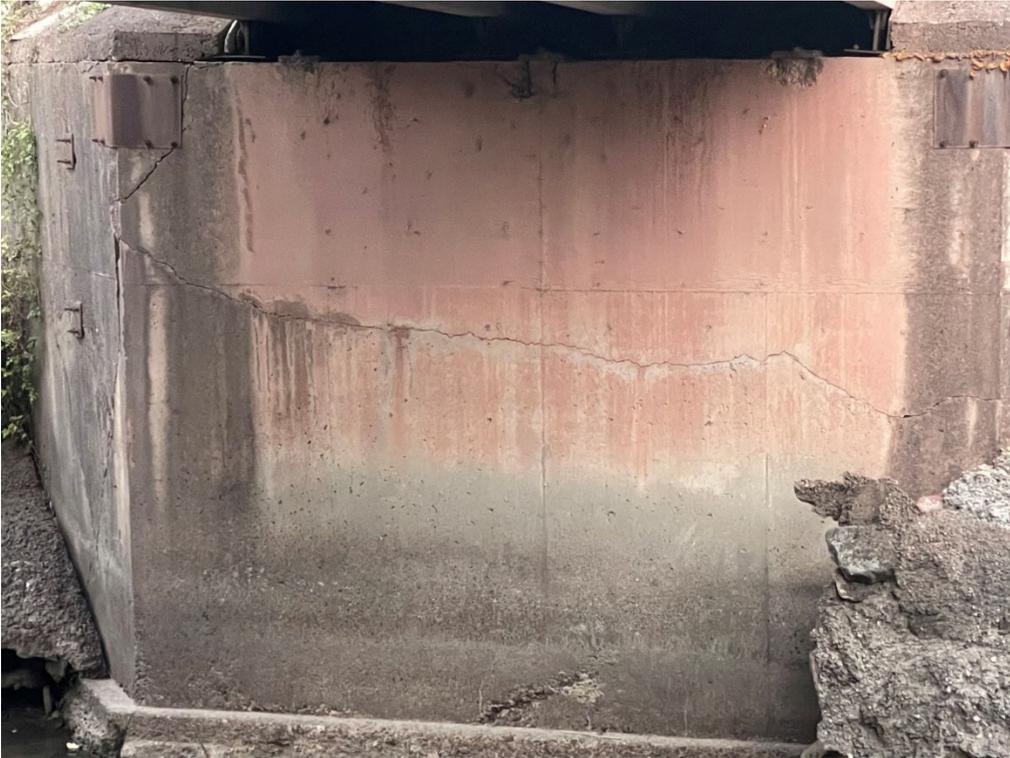
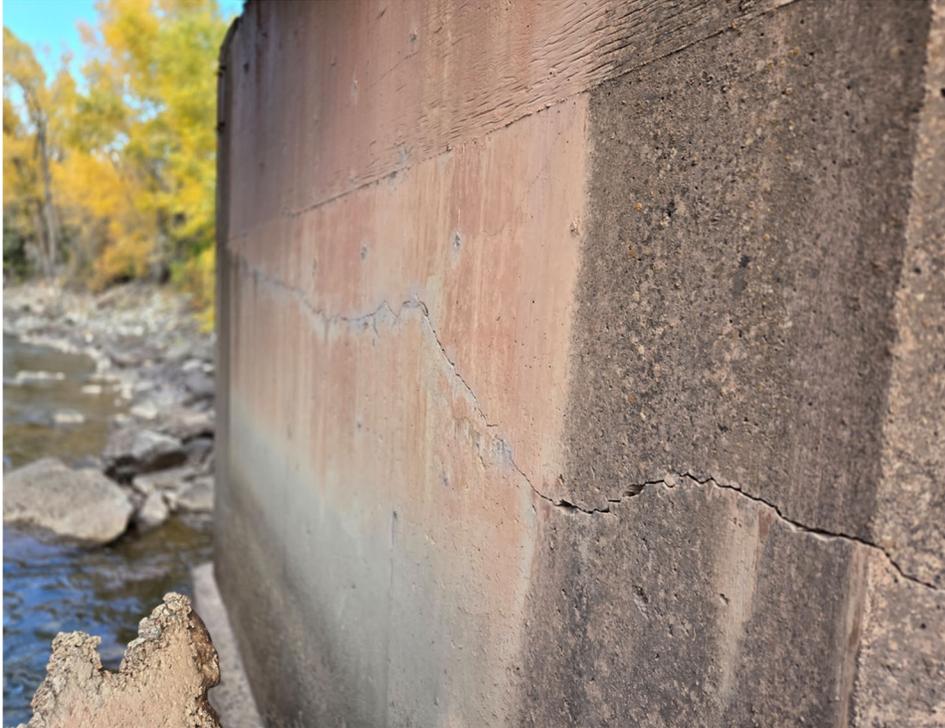
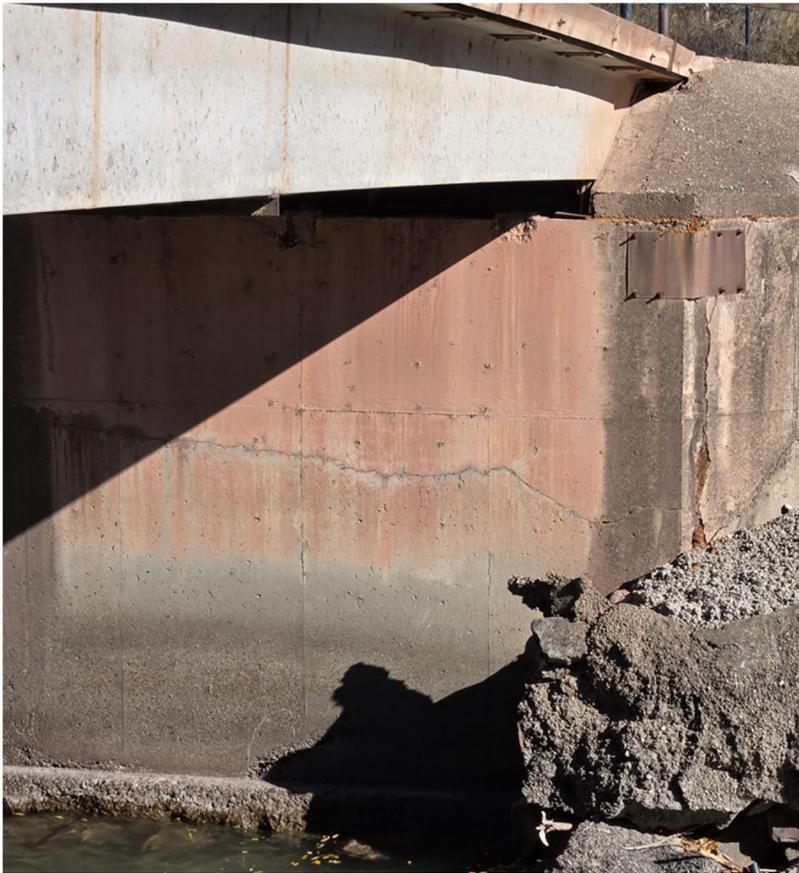
- SGM reported 30" of exposed footing. The 2023, 2024 and this report measured the same.
- SGM reported abutment wall under the bridge had a ¼" wide horizontal crack at approximately mid height. The 2023, 2024 and this report measured the same.

Photo 8: ¼" horizontal Crack in East Abutment

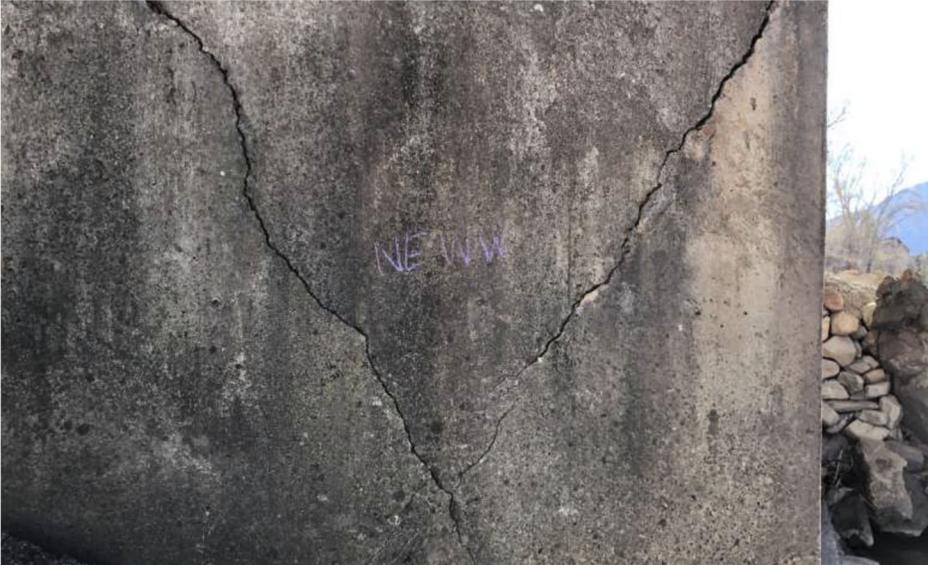
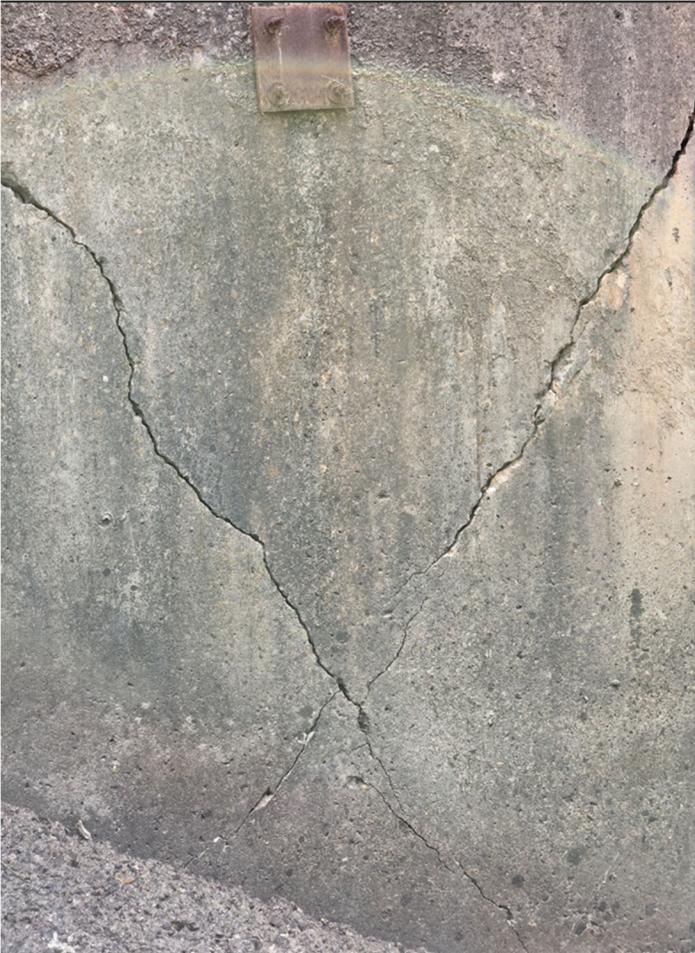
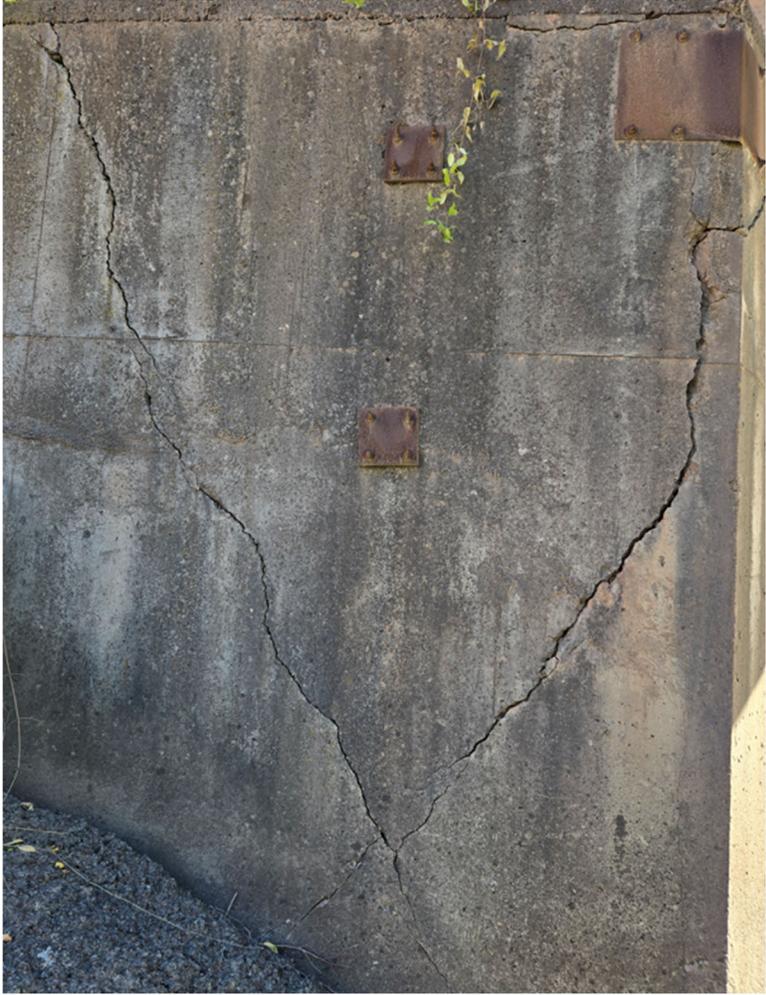
Photo 10: ¼" diagonal Cracks in Northeast Wingwall

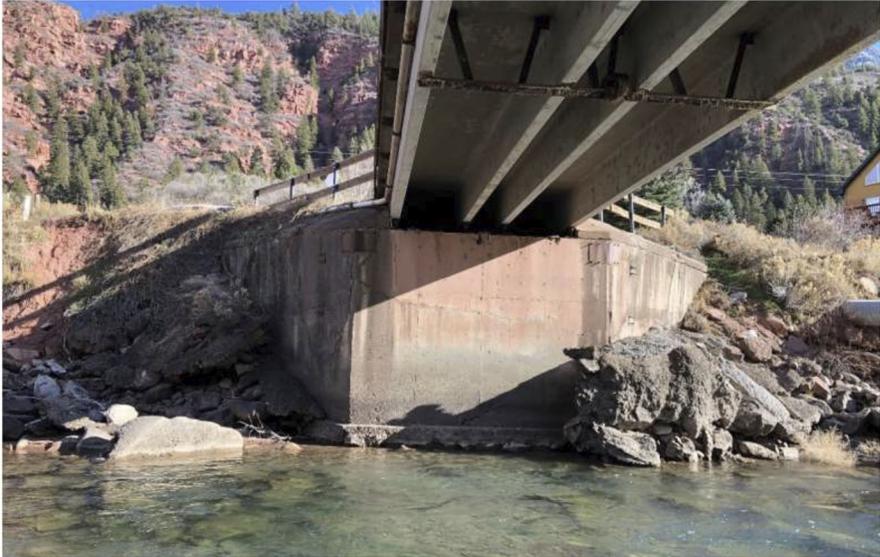
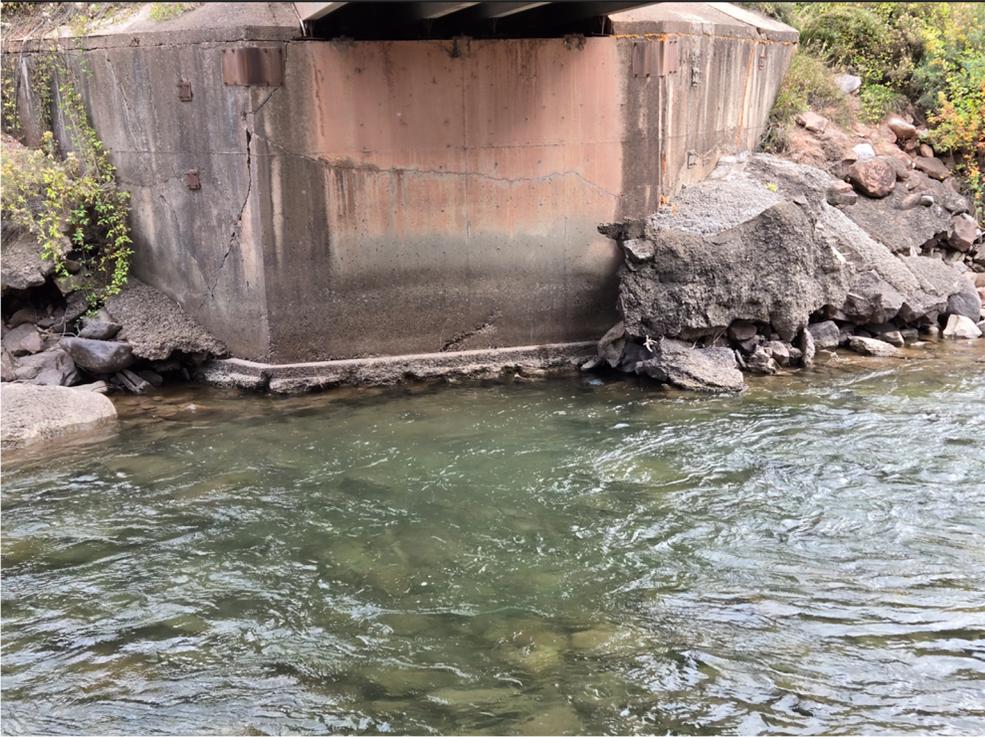
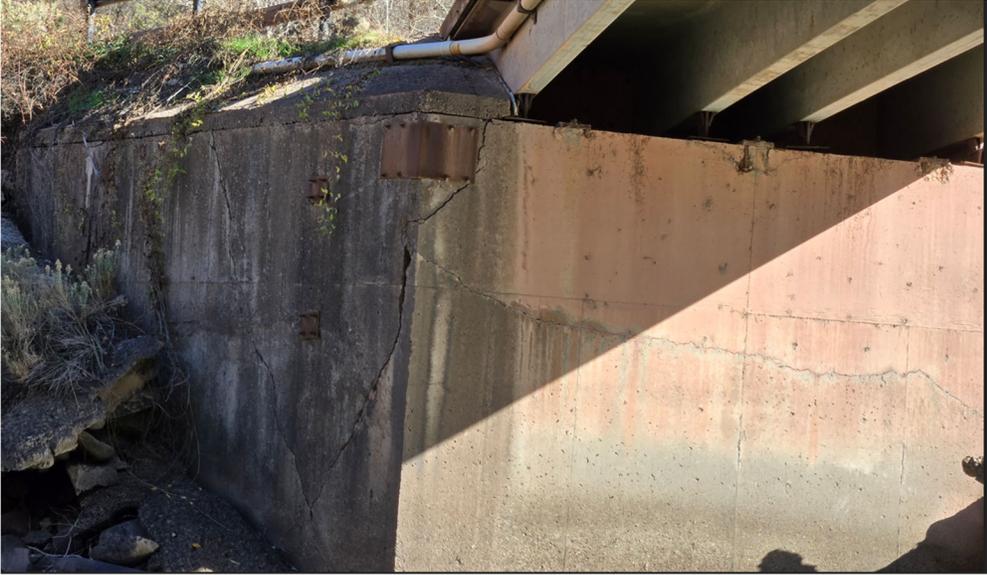
**Photo 11: East Abutment Original Bridge Footing Exposed and Undermined**

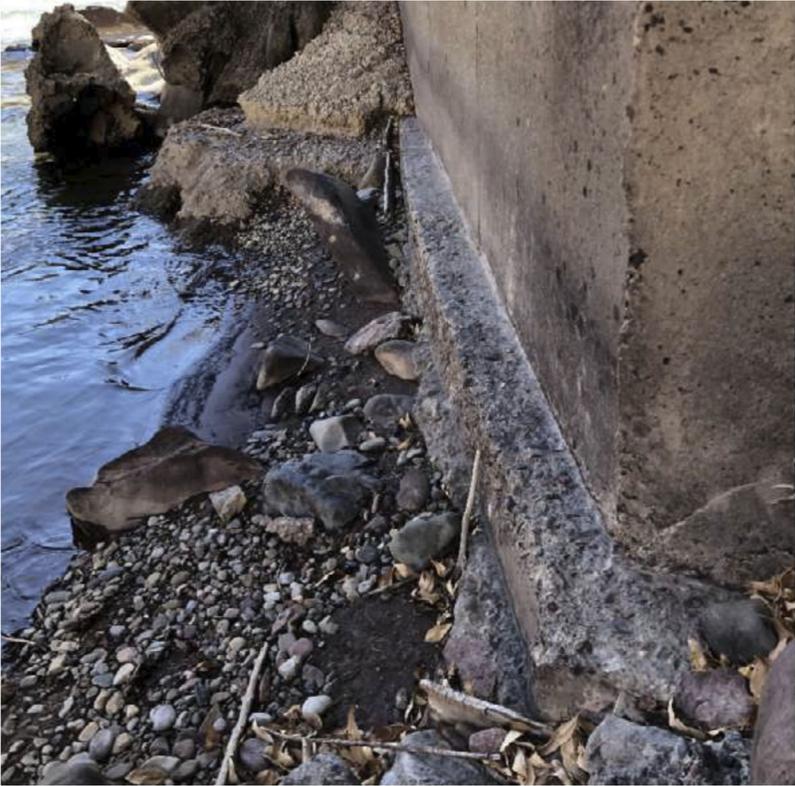
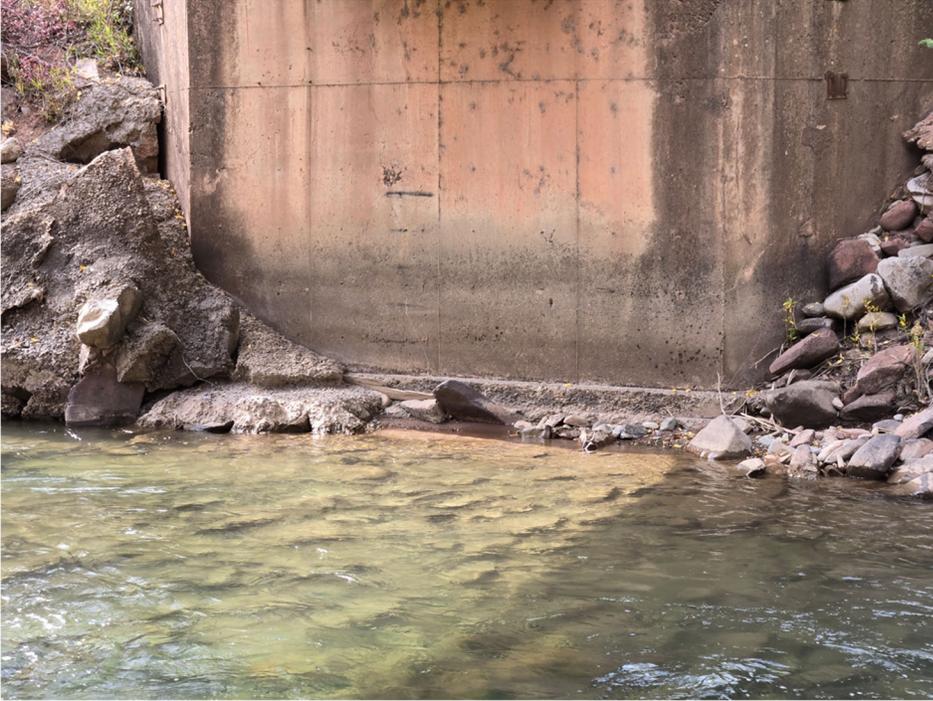
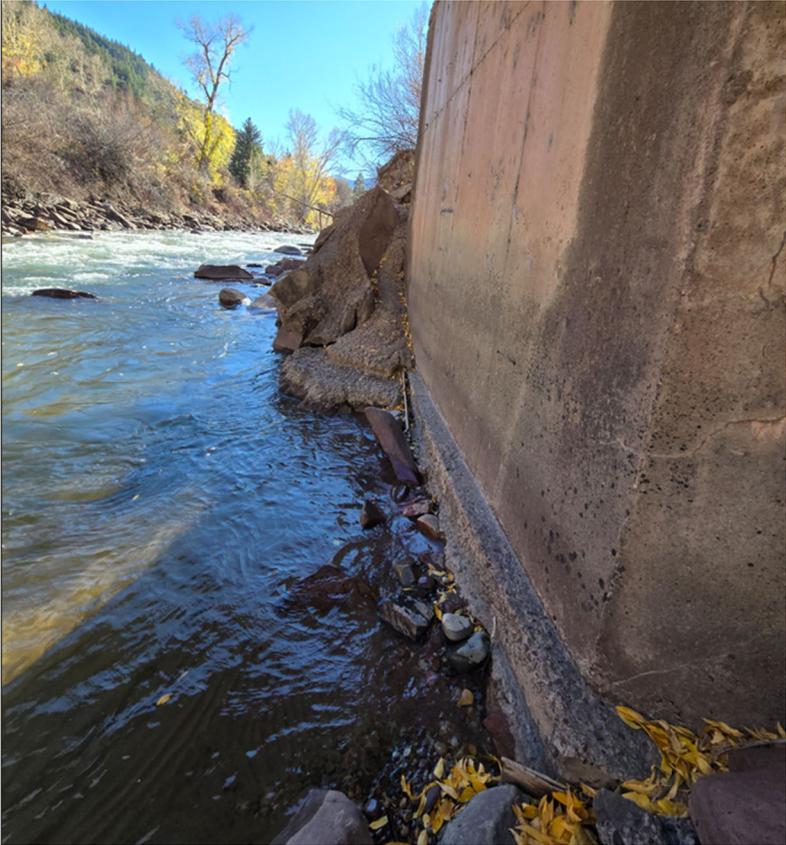
**Photo 12: West Abutment Original Bridge Footing Exposed**
