# SIGNET HOME INSPECTIONS, LLC

## COMPREHENSIVE PROPERTY INSPECTION REPORT

13668 Auburn Rd., Grass Valley , CA 95949

Date of Inspection: 11/27/2024 Time: 1:00 PM

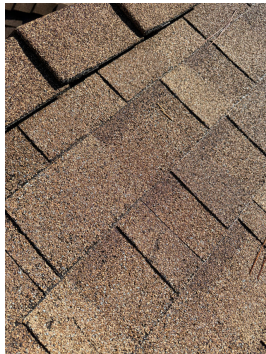
1.1. Light granule loss noted on roof shingles. Since leaking is always a possibility with a less than perfect roof, we suggest a roof check-up to take care of any problems as well as an annual roof & gutter cleaning with inspection for any condition which may necessitate repairs should they be found at risk of leaking.

Light roof wearing

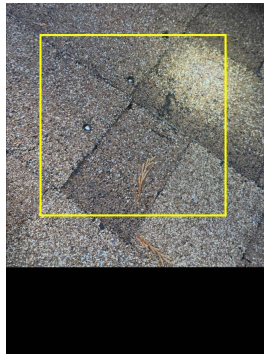
1.2. Damaged shingle(s) noted on roof which appear to be inadequately sealed repaired. Recommend a qualified roofing contractor repair or replace as needed.

Damaged shingles

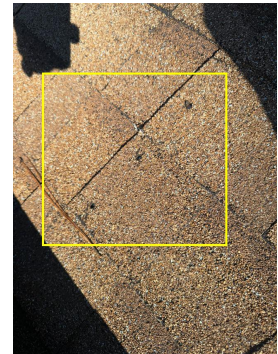
Damaged shingles

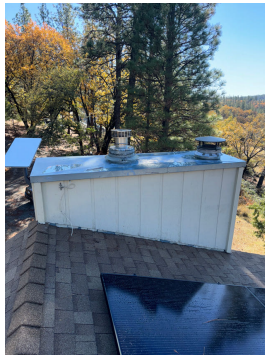
4.1. Chimney enclosure siding and/or trim noted as sitting on roof deck. It is recommended that siding be held up at least 1 inch from roof decking to avoid water saturation during rain and subsequent deterioration over time.

Chimney detail

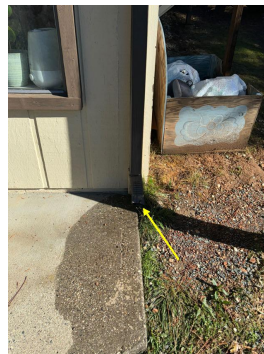
7.1. **Deficient downspout termination** noted at or near the structure foundation. Recommend drain pipe(s) to divert roof water away from the foundation.

Downspout terminates at foundation

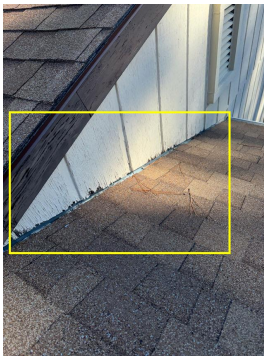
3.1. Area(s) of siding wood decay noted. Refer to pest report for more detail and consider consulting a qualified contractor for remediation options.

Siding wood decay at roof level

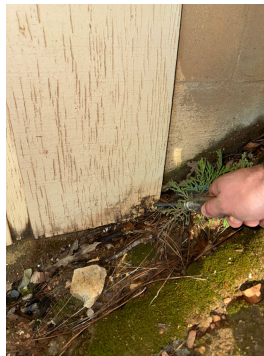
3.2. Siding to ground contact noted which will eventually cause moisture damage and degradation. Recommend flashing, correcting so siding is a minimum of 6 to 8 inches above ground or consulting with a qualified contractor for other options.

Left side siding to ground contact and decay

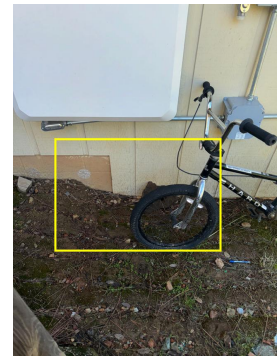
Right side siding to ground contact

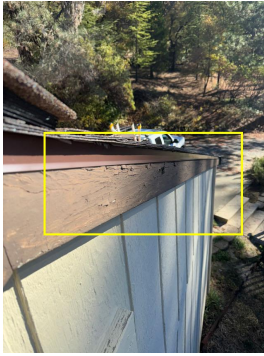
5.1. Deficient paint and poorly sealed exterior cladding junctions noted in places. Recommend painting and caulking as needed to avoid moisture intrusion and its related negative effects.

Deficient paint

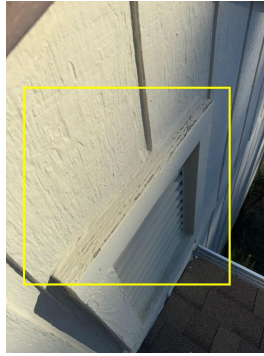
Deficient paint

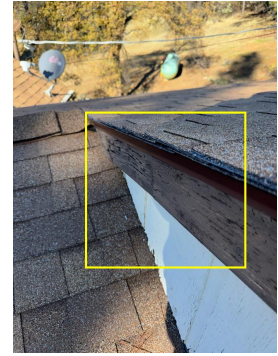
Deficient paint

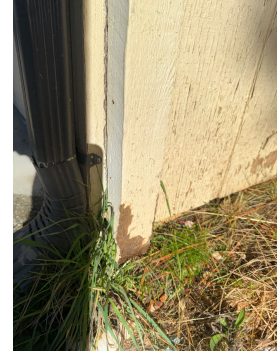
Deficient paint on siding

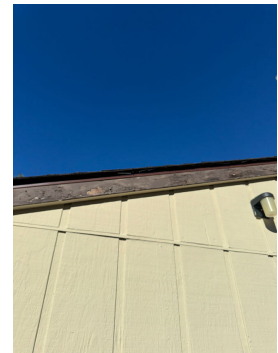
Deficient paint on siding/barge rafter

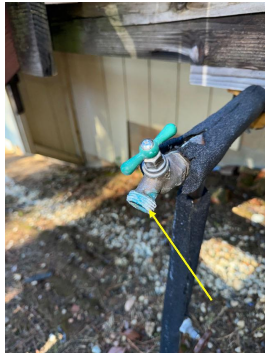
9.1. **Anti-siphon hose bibb** vacuum breakers not present on outdoor faucets. Most likely not required when home was built, they would now be required for new construction. Although you would be under no obligation to do so, consider adding for safety.

Missing anti siphon vacuum breaker

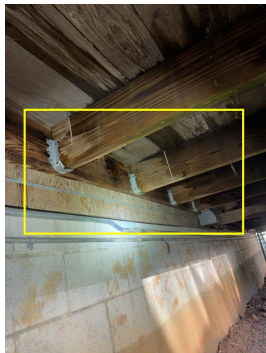
10.1. Deck **ledger board** flashing appears to be lacking. Recommend consulting with a qualified contractor for remediation options.

10.2. Less than ideal attachment of ledger board noted with nails used instead of lag or through bolts. Although the ledger board appeared sound, this form of ledger attachment will loosen over time and could present a safety issue down the road. Recommend monitoring and if conditions change, consulting with a qualified contractor for remediation options.

Ledger installed with nails and lacking flashing

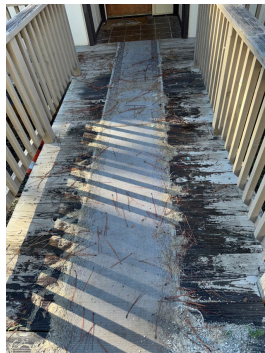
10.3. Areas of the wood decking material noted to be worn. Consider repainting to avoid moisture intrusion and prolong useful life.

Worn decking

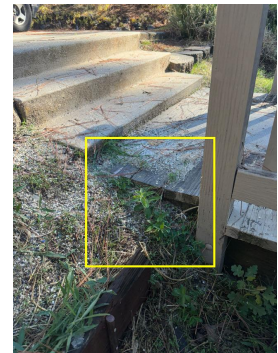
Deck structure to earth contact

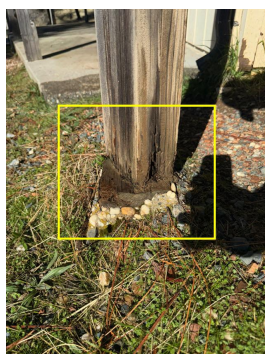
10.4. Wood decay of structural component(s) noted on this deck. Refer to pest report for more detail and consider

Decayed deck post

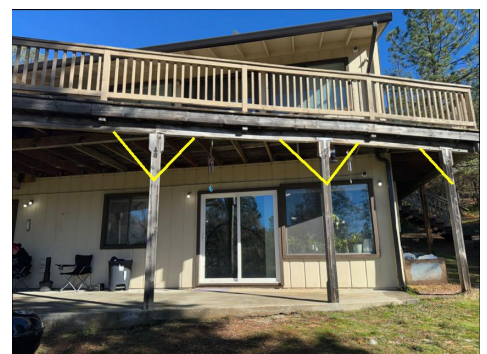
10.8. Deck support posts do not have lateral bracing. Although this may not have been a requirement when this deck was built, deck bracing will serve to increase the strength and safety of this deck. We therefore recommend consulting with a qualified contractor for remediation options.

No deck lateral bracing

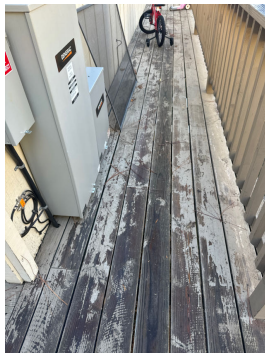
Worn decking

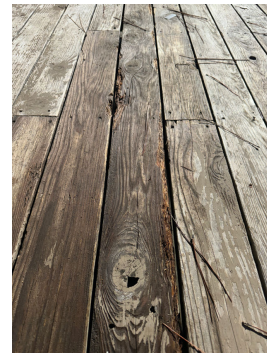
Worn/decayed decking

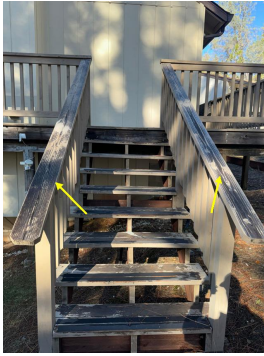
11.2. Handrail(s) noted as not graspable on deck stairs. By today's standards, rails should be configured that a small hand may grasp around a rail for safety and 2 x 6 boards do not satisfy this requirement. Recommend adding a proper handrail as needed.

Handrails not graspable

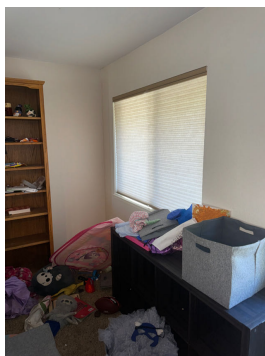
7.1. NOTE: Window(s) noted to be inaccessible and therefore not inspected. Recommend removing obstacle(s) and inspecting as needed.

Blocked window

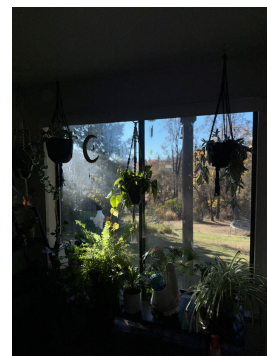
7.2. Fog and/or condensation or the resulting stains were noted in double-pane window(s) which is an indication of a failed seal. Recommend review for repair or replacement as necessary.

Failed downstairs window seal

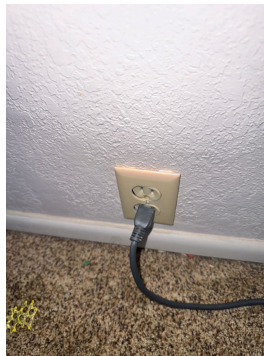
11.2. Outlet plug(s) & cover(s) not aligned properly. Recommend a qualified contractor repair as is needed.

Misaligned outlet and cover

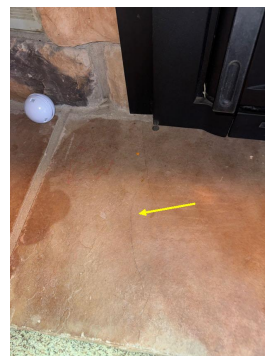
12.2. Fireplace hearth, wall or mantel deficiency noted. Recommend repairs as needed.

Cracked hearth

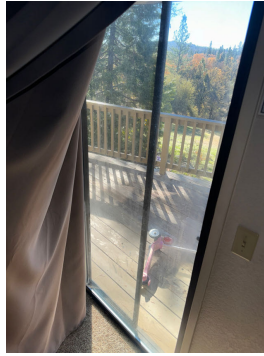
13.1. Fog and/or condensation was noted in door glass which is an indication of a failed seal. Recommend review for repair or replacement as necessary.

Failed door glass seal

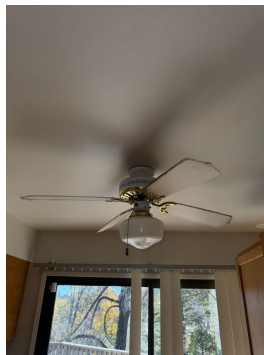
2.1. The ceiling fan wobbles when tested indicating inadequate anchoring or an out-of-balance fan. Recommend further investigation and remediation as needed.

Wobbling ceiling fan

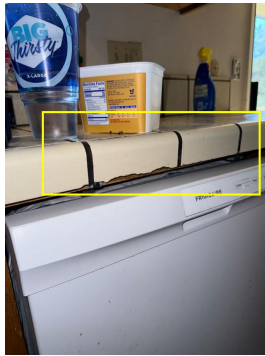
4.2. Cracked or broken tile observed. Recommend sealing or replacing as needed.

Broken tiles

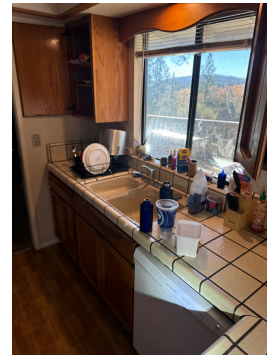
4.1. NOTE: Counter surfaces were partially blocked with personal items and therefore not fully inspected. Recommend clearing and inspecting as needed.

Blocked counters

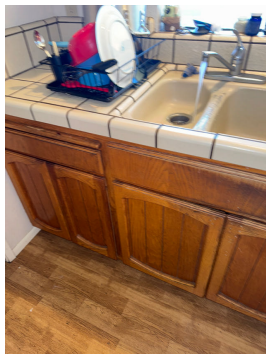
8.2. Worn finish noted on some cabinet areas. Consider refinishing as needed.

Worn cabinets

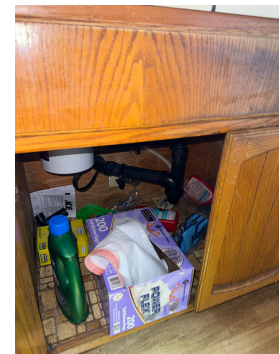
8.1. NOTE: Cabinet(s) noted with personal items blocking access and therefore inside cabinet, plumbing and other under-cabinet appliances may not be completely inspected.

Blocked cabinet

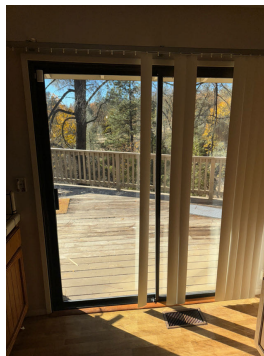
17.1. Screen door was noted to be missing. Recommend replacement as needed.

Missing sliding screen door

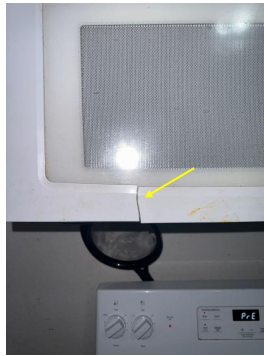
8.1. Damaged microwave door was observed. Recommend repairs as needed.

Damaged microwave

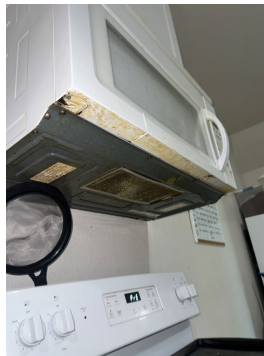
9.1. Fan light fixture or bulb noted as inoperable. Change bulb(s) and re-check and if necessary, consult a qualified contractor for further options.

Light inoperable

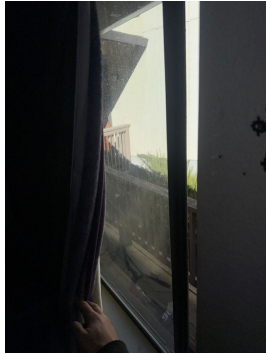
6.2. Fog and/or condensation or the resulting stains were noted in double-pane window(s) which is an indication of a failed seal. Recommend review for repair or replacement as necessary.

Failed window seal

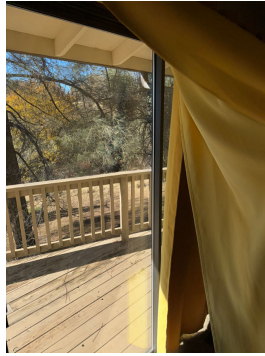
10.1. Screen door was noted to be missing. Recommend replacement as needed.

Bedroom 12 missing sliding screen door

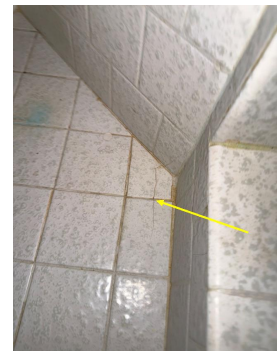
Cracked tiles

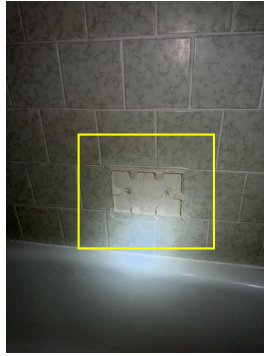
Broken tiles

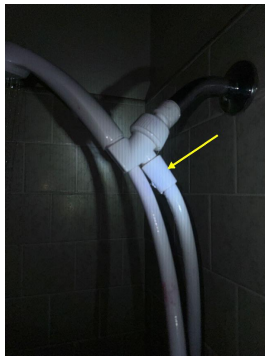
6.1. Shower head and/or hose noted to be leaking. Recommend repair as needed.

Leaking shower head

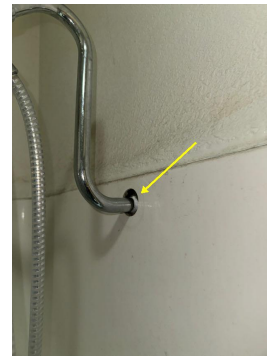
6.2. Missing **escutcheon** noted which should seal the shower wall plumbing penetration. Recommend adding as needed.

Missing escutcheon

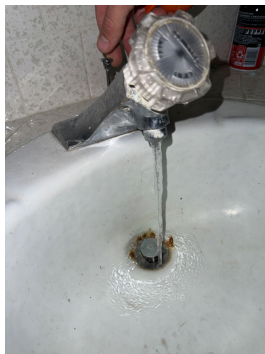
8.1. Defective or missing sink stopper(s) noted. Recommend repair or replacement as needed.

8.2. Sink surface crack(s) and/or chips with corrosion noted. Recommend repairs as needed.

Deficient sink stopper, rust in sink

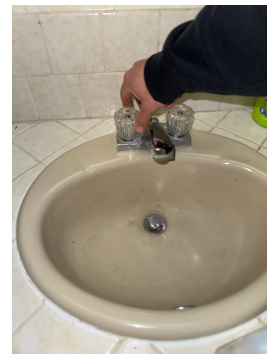
Deficient sink stopper

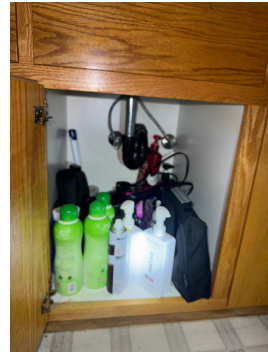
Blocked cabinet

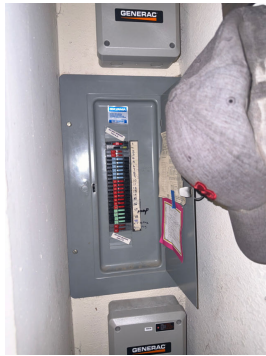
3.1. **NOTE:** Main service panel access was limited and due to the safety issues of this GTE Sylvania/Zinsco panel, the panel was not opened. Recommend further review and panel replacement as deemed necessary by a qualified electrician.

3.2. Noted was a GTE Sylvania Zinsco, Sylvania Zinsco or **Sylvania electrical panel**. Due to the problems associated with some of these service panels, we recommend contacting a qualified electrical contractor for a full safety assessment of the home's electrical system and component repairs or replacement as needed.

Main panel detail

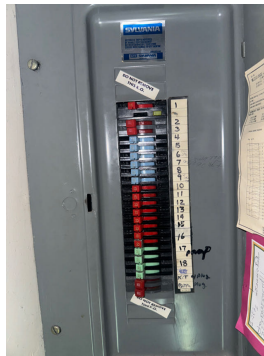
4.1. **Zinsco breakers** noted which have a higher than normal failure rate. Recommend a qualified electrician replace as needed for safety.

Zinsco brand circuit breakers

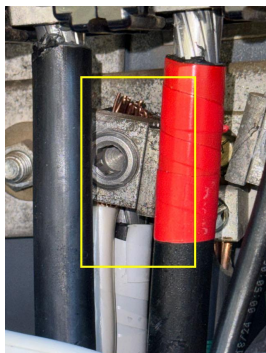
5.1. Wiring feed in the main breaker box was double tapped under lugs which may cause a poor connection, wires to loosen and possible arcing. Recommend a qualified electrician for review and repairs as needed.

Double tapped wire feed

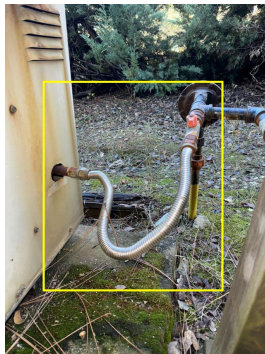
8.1. **Sediment trap** is missing and most likely not required when this house was built, sediment traps are now required by the Uniform Plumbing Code and are therefore incorporated into most, if not all, city building and safety codes. Although you would be under no obligation to do so, consider adding to increase appliance longevity.

Sediment trap missing from gas line

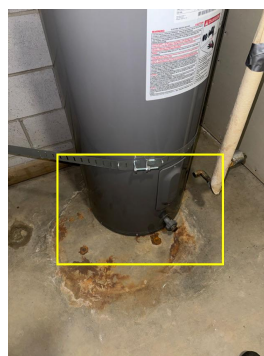
3.1. **Water heater pan** and drain noted to be missing. Even though local code may not require one, consider installing an approved pan with drain to protect the closet and/or surrounding area should a leak occur.

Missing pan and drain line

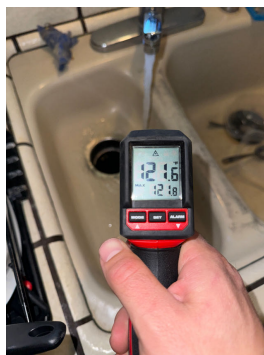
8.1. **Water temperature** is 121.6° as measured at the kitchen sink. Recommend resetting temperature to 120° or lower to avoid scald injuries.

Water temperature noted at 121.6° F

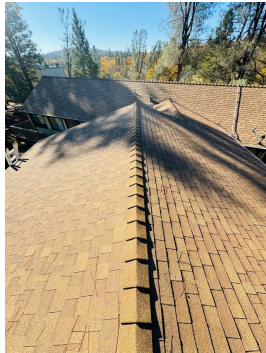
1.1. Light granule loss noted on roof shingles. Since leaking is always a possibility with a less than perfect roof, we suggest a roof check-up to take care of any problems as well as an annual roof & gutter cleaning with inspection for any condition which may necessitate repairs should they be found at risk of leaking.

Roof detail

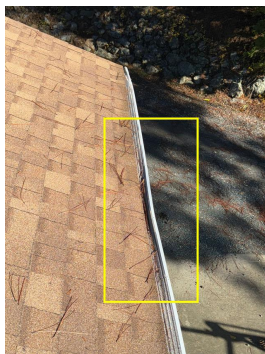
3.2. One or more gutter sections noted to be damaged for reasons undetermined. Recommend repair or replacement as needed.

Damaged front gutter

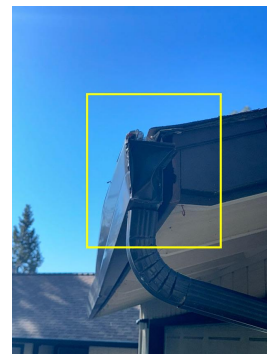
Damaged gutter

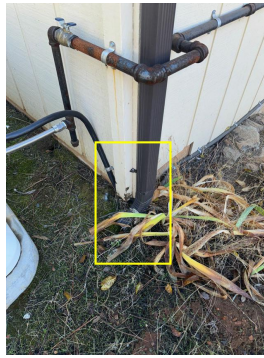
4.1. Deficient downspout termination noted at or near the structure foundation. Recommend drain pipe(s) to divert roof water away from the foundation.

Downspout terminates at foundation

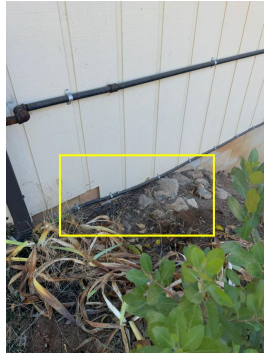
8.1. Siding to ground contact noted which will eventually cause wood decay. Recommend correcting so siding is a minimum of 6 to 8 inches above ground.

Siding to ground contact

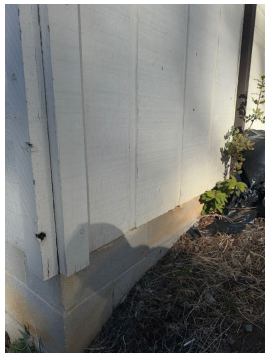
10.1. Deficient paint and poorly sealed exterior cladding junctions noted in places. Recommend painting and caulking as needed to avoid moisture intrusion and its related negative effects.

Deficient paint on siding

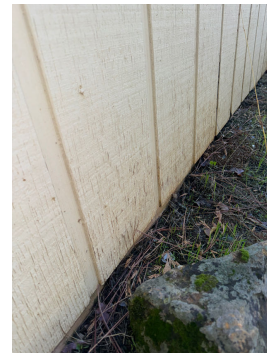
Deficient paint on siding

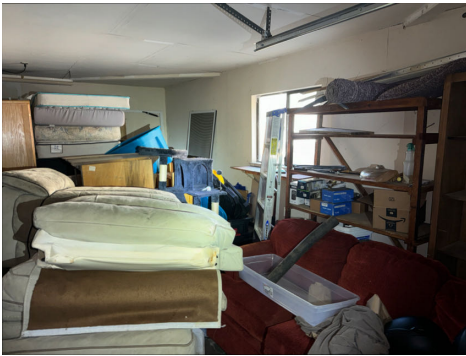
12.1. NOTE: Most areas of the walls were not accessible for inspection due to personal items. Recommend inspecting these areas when clear.

Blocked walls

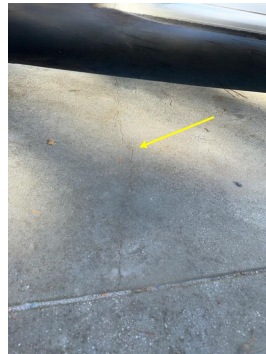
1.1. NOTE: Minor settlement or "hairline" cracks noted in driveway and/or walkway(s) and are normal to properties of any age. Recommend sealing the cracks, continued monitoring and consulting a qualified contractor for remediation options should condition worsen.

Minor driveway crack

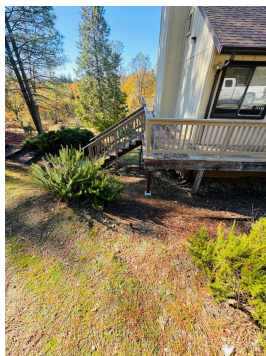
2.2. There are areas of negative grading towards the house and it is not known if a **drainage system** exists to take rain water away from the foundation. Recommend checking with seller on the presence of a drainage system and if necessary, consider adding additional backfill and/or drain lines to create the proper slope or drainage to take rain water away from house.

Negative grade toward house

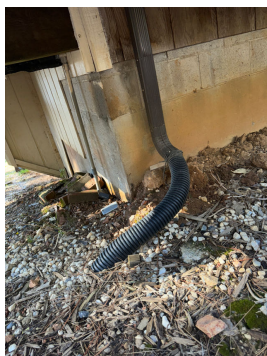
3.2. NOTE: A lot drainage system was noted but not inspected. Recommend checking with seller on serviceability.

Drainage system not inspected

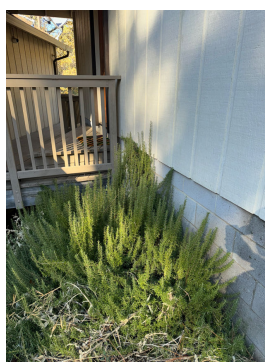
- 4.1. **Vegetation against house** was noted in areas. Recommend trimming so no plant to exterior cladding exists.

Vegetation against house
