# SIGNET HOME INSPECTIONS, LLC

## COMPREHENSIVE PROPERTY INSPECTION REPORT

12875 Rattlesnake Rd., Grass Valley, CA 95945

Date of Inspection: 11/27/2024 Time: 9:00 AM

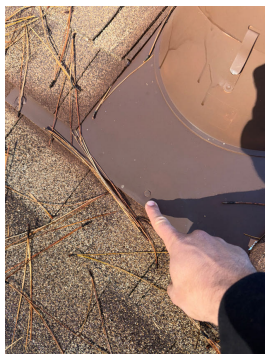
2.1. Exposed and unsealed flashing nails noted. Recommend checking all exposed flashing nails and sealing as needed.

Unsealed flashing nail

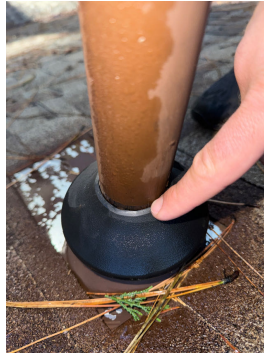
3.1. Vent pipe flashing rubber boot seal(s) noted to be worn and/or loose, not properly sealing the vent pipe flashing penetration. Recommend replacement as needed to avoid moisture intrusion into attic space.

Worn/loose vent pipe rubber boot

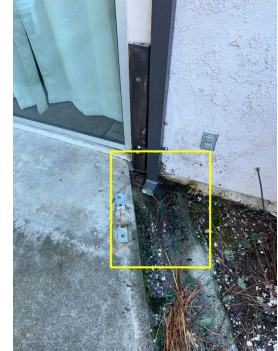
7.1. **Deficient downspout termination** noted at or near the structure foundation. Recommend drain pipe(s) to divert roof water away from the foundation.

Downspout terminates at foundation

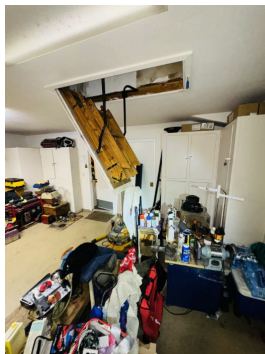
2.2. NOTE: Pull down ladder attic access in the garage was blocked by personal items and the attic area was therefore not entered and inspected. Recommend further inspection when the attic is accessible.

Blocked attic access hatch

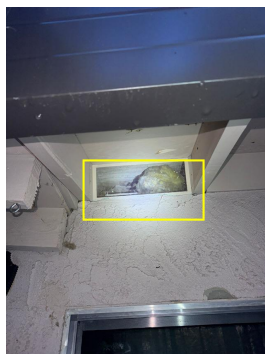
5.1. Soffit vent screen(s) noted to be blocked with insulation. Recommend clearing as needed and consider installing attic baffle vents to correct problem without losing ceiling R-value.

Soffit vent blocked with insulation

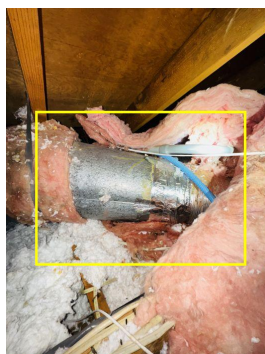
6.1. Some insulation noted as loose or missing from duct work. Recommend insulating as needed.

Deficient insulation on ductwork

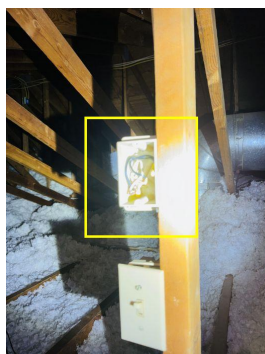
7.2. Missing junction box(s) and/or cover(s) observed for live wires which represent a possible electrocution hazard. Whenever a live electric wire is cut and left loose or is reconnected, the wire or wire splice should be encased in a covered junction box to isolate the wire(s) and prevent electric shock. Recommend adding junction box(s) and/or cover(s) for safety.

Open junction box

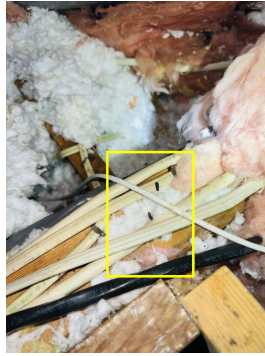
11.1. Evidence of rodent infestation was noted in attic. Consider the services of a pest control specialist for eradication.

Rodent droppings in attic

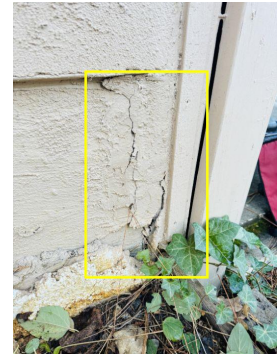
2.1. NOTE: Minor shrinkage/settlement cracking and **cold joints** from multiple concrete pours or additions, noted at exterior perimeter. These are relatively common conditions and are normally no reason for concern. Recommend sealing and contacting a qualified contractor should condition worsen or if water intrusion occurs.

Back right foundation wall crack

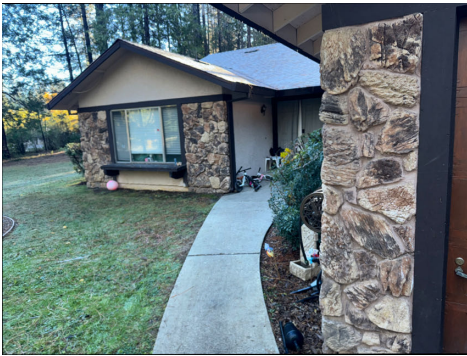
4.4. Masonry veneer noted attached to exterior wood framed wall without any visible weep holes for drainage as recommended by the **IRC** which would prevent moisture the ability to exit should a leak occur. Since adding this feature is not a cost-effective option after the fact, at minimum we recommend an annual check-up to ensure no moisture intrusion is possible.

Masonry veneer lacking drain plane

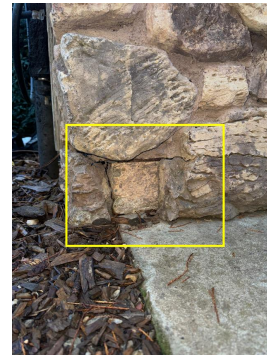
4.3. Separated and/or missing stone(s) noted on masonry wall cladding. Recommend repairs by a qualified contractor as needed.

Missing masonry stone

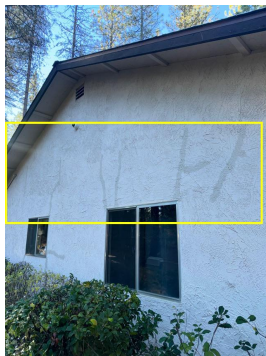
5.3. Stucco patching noted for reasons undetermined. Recommend checking with seller for further details.

Patched **stucco cracks**, left side

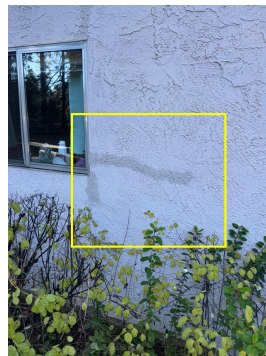
Patched stucco cracks, left side

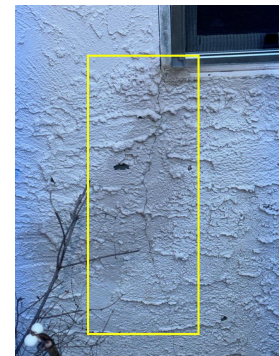
Stucco crack, left side

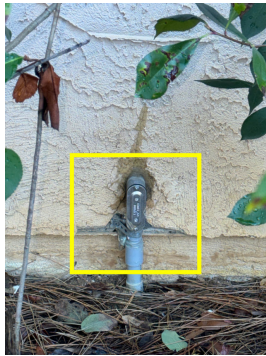
5.4. Area(s) of stucco wall damage noted for reasons undetermined. Recommend checking with seller for further details and repairs as needed to avoid moisture intrusion.

Left side damaged stucco

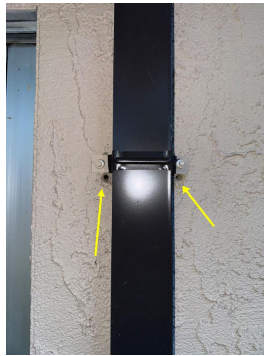
5.2. Open stucco penetration(s) noted. Recommend sealing to avoid moisture intrusion.

Back left stucco holes

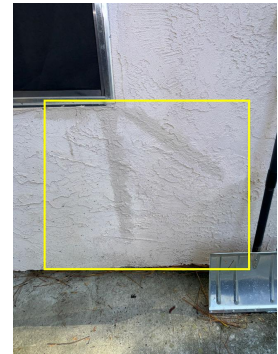
Patched stucco cracks, right side

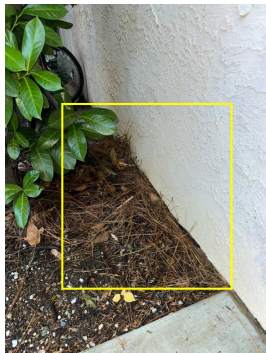
5.5. Soil to stucco contact observed which could limit the ability of moisture to exit should a leak occur and cause wall moisture damage in the process. Recommend removing soil to at minimum of 1 inch below weep screed and checking stucco wall structure for moisture intrusion and damage.

Right side stucco to soil contact

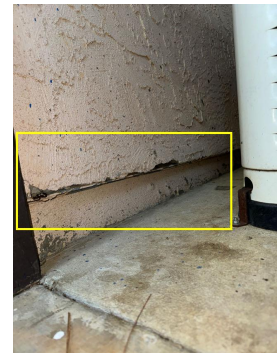
Front right corner damaged stucco

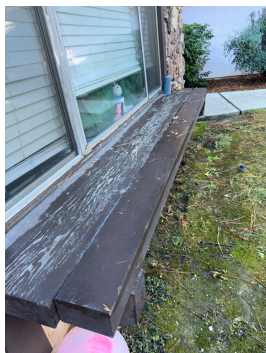
6.1. Deficient paint and poorly sealed **exterior cladding** junctions noted in places. Recommend painting and caulking as needed to avoid moisture intrusion and its related negative effects.

Deficient paint and/or caulk

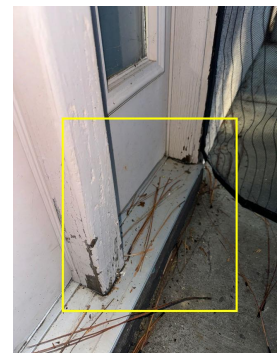
Deficient paint and/or caulk

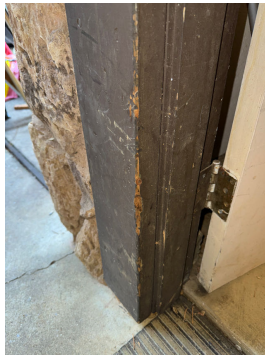
Deficient paint

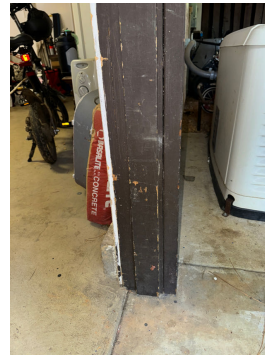
Deficient paint

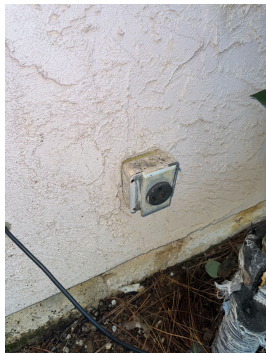
7.5. Back left corner electrical panel noted to be outside of a waterproof cover. Recommend a qualified electrician install waterproof box to prevent moisture intrusion.

Back left corner missing waterproof cover

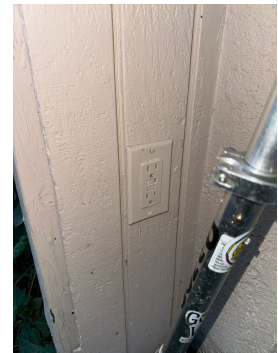
Missing waterproof cover

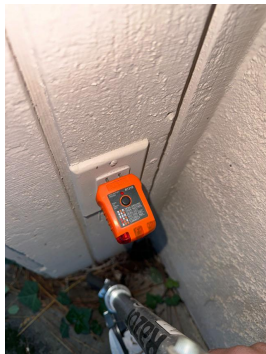
7.6. No power to outlet(s) noted. Recommend checking with seller for further details and if necessary, contacting a qualified electrician for repairs as needed.

No power to outlet

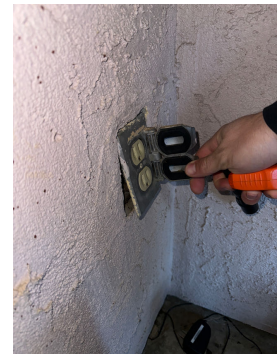
Loose back patio outlet

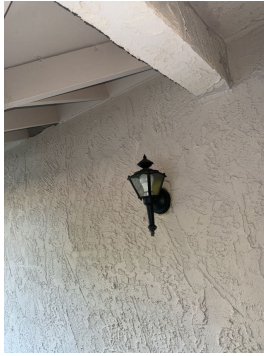
7.1. Light switch, fixture or bulb noted as inoperable. Change bulb(s) and re-check and if necessary, consult a qualified contractor for further options.

Light fixture inoperable

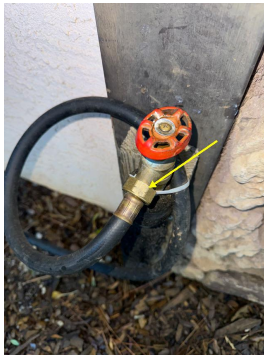
9.1. **Anti-siphon hose bibb** vacuum breakers not present on outdoor faucets. Most likely not required when home was built, they would now be required for new construction. Although you would be under no obligation to do so, consider adding for safety.

Missing anti siphon vacuum breaker

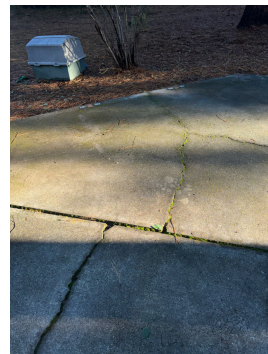
Patio cracking

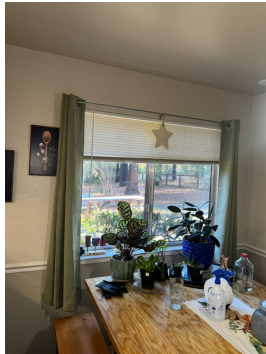
5.1. NOTE: Window(s) noted to be inaccessible and therefore not inspected. Recommend removing obstacle(s) and inspecting as needed.

Blocked window

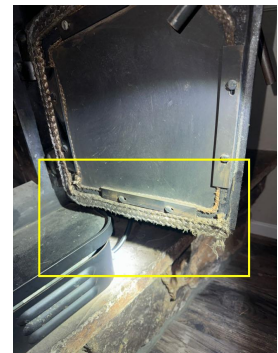
8.2. Wood stove door gasket was noted as deficient or missing which can allow CO gases into the living space. Recommend replacement as needed.

Damaged door rope gasket

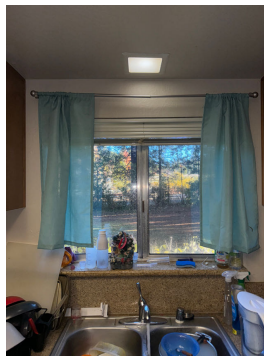
2.1. NOTE: Window(s) noted to be inaccessible and therefore not inspected. Recommend removing obstacle(s) and inspecting as needed.

Blocked window

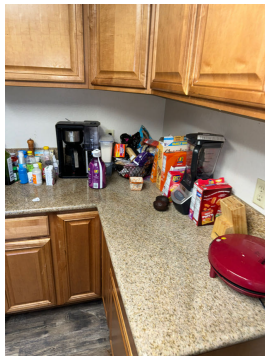
3.1. NOTE: Counter surfaces were partially blocked with personal items and therefore not fully inspected. Recommend clearing and inspecting as needed.

Blocked counters

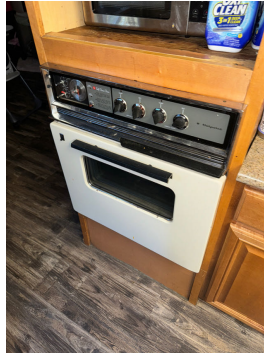
11.2. Older electric oven noted to be in questionable condition. Recommend further review by a qualified appliance technician.

Older electric oven in questionable condition

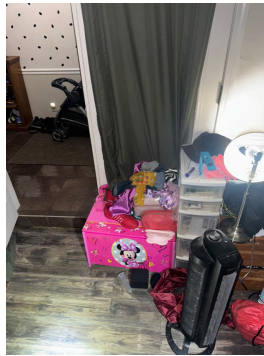
4.1. **NOTE:** Bedroom 6 door was blocked and could not be tested/inspected. Recommend inspection when accessible.

Blocked room 6 door

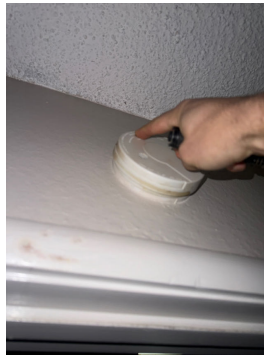
6.1. **Smoke alarm(s)** not operational at time of inspection which represents a safety hazard. Recommend repair or replacement as needed.

Bedroom 7 smoke alarm inoperable

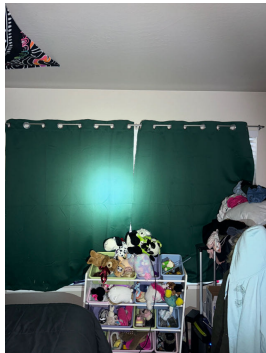
7.1. NOTE: Window(s) noted to be inaccessible and therefore not inspected. Recommend removing obstacle(s) and inspecting as needed.

Room 6 blocked window

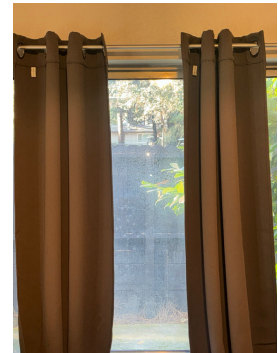
7.2. Fog and/or condensation or the resulting stains were noted in double-pane window(s) which is an indication of a failed seal. Recommend review for repair or replacement as necessary.

Bedroom 10 failed window seal

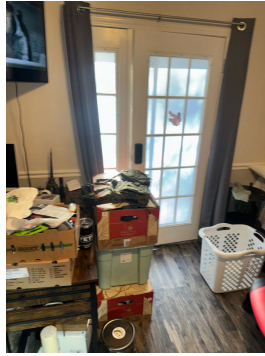
11.1. Exterior door noted to be blocked and therefore not inspected. Recommend clearing and inspecting as needed.

Bedroom 10 blocked exterior door

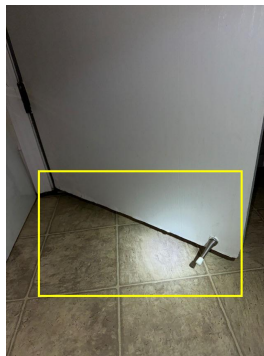
2.1. Damage to door skin or surface noted. Recommend repairs as needed.

Damaged bathroom 1 door skin

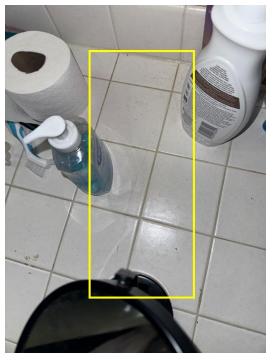
10.2. Cracked or broken tile observed. Recommend sealing or replacing as needed.

Bathroom 1 counter tile cracks

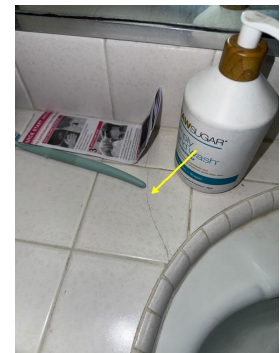
Bathroom 2 cracked tile

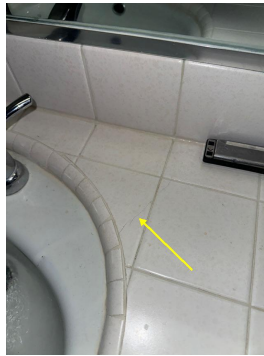
Bathroom 2 cracked tile

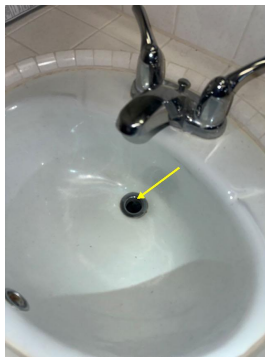
11.1. Defective or missing sink stopper(s) noted. Recommend repair or replacement as needed.

Missing bathroom 2 sink stopper

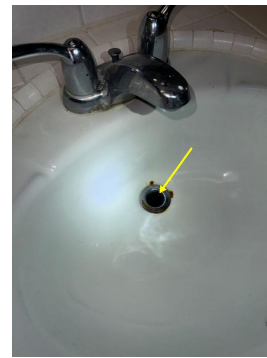
Missing bathroom 2 sink stopper

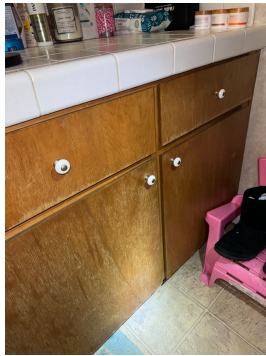
13.2. Worn finish noted on some cabinet areas. Consider refinishing as needed.

Worn bathroom 1 cabinets

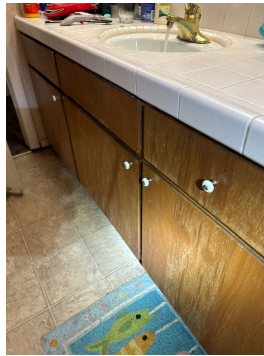
Worn bathroom 1 cabinets

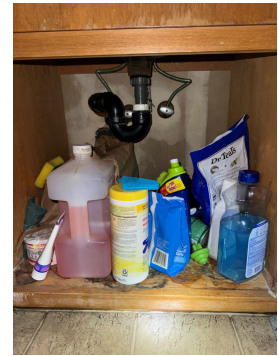
13.1. NOTE: Cabinet(s) noted with personal items blocking access and therefore inside cabinet, plumbing and other under-cabinet appliances may not be completely inspected.

Blocked bathroom 1 cabinet

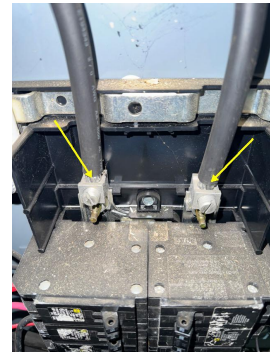
Missing anti oxidant paste

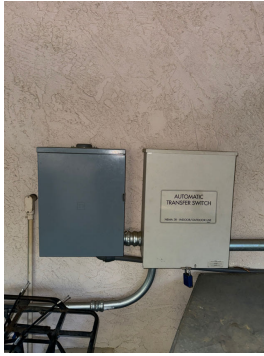
9.1. NOTE: Auxiliary generator and/or switch box noted but not inspected. Recommend confirming serviceability and if necessary a full evaluation by a qualified electrician.

Auxiliary generator system not inspected

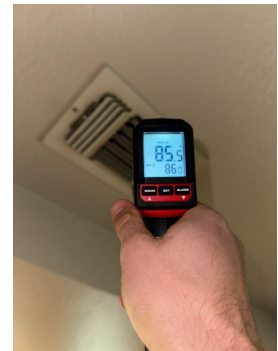
Inadequate heating temperature at 85.5° F

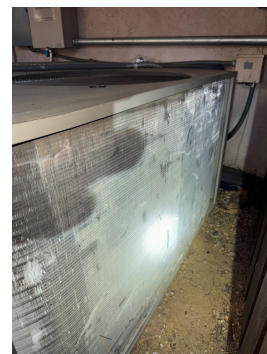
Damaged/bent cooling fins

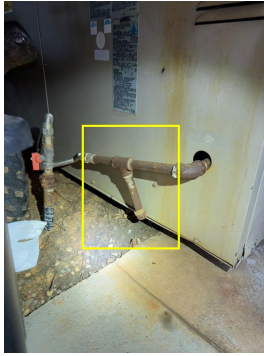
9.1. **Sediment trap** is not to code that requires a change of direction of gas flow. Recommend repairs by a qualified plumbing contractor as needed.

No change of direction in sediment trap

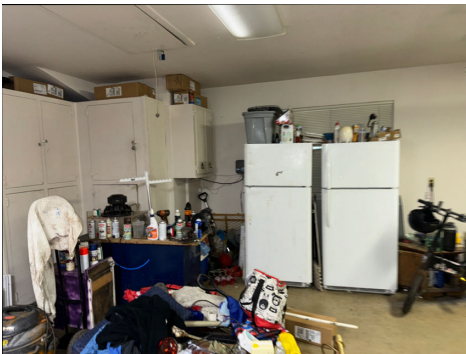
2.1. NOTE: Most areas of the walls were not accessible for inspection due to personal items. Recommend inspecting these areas when clear.

Blocked walls

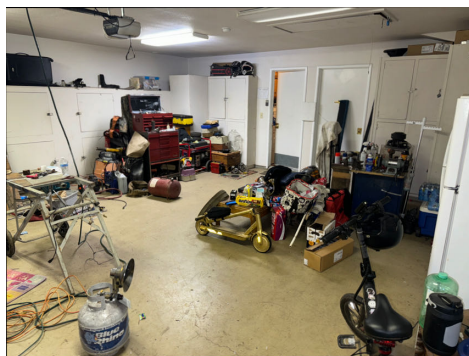
4.1. NOTE: Areas of the floor were not accessible for inspection due to personal items. Recommend inspecting these areas when clear.

Blocked floors

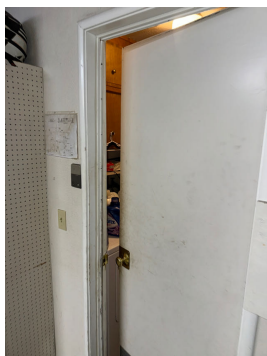
6.2. The automatic closure device does not close the garage to house fire separation door properly. This could allow a fire to enter the home. Recommend adjusting or replacing the hinges to allow for proper closure of the door.

Deficient self closing device on fire door

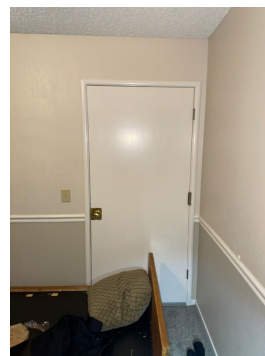
6.1. NOTE: Fire door from garage to bedroom was blocked and could not be tested. Recommend testing when clear.

Blocked fire door

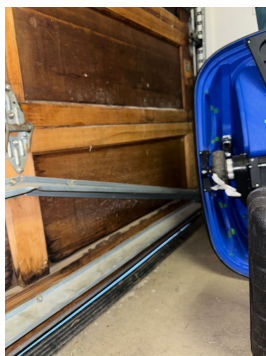
7.2. Vehicle door damage noted. Recommend repair or replacement as needed.

Damaged vehicle door

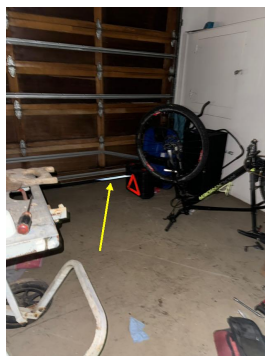
7.1. Vehicle door weatherstripping is damaged. Recommend repair or replacement.

Deficient door weatherstripping

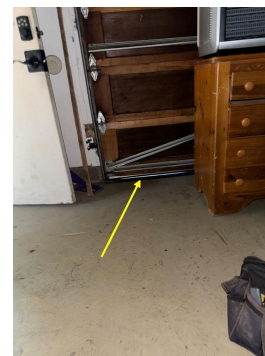
Deficient door weatherstripping

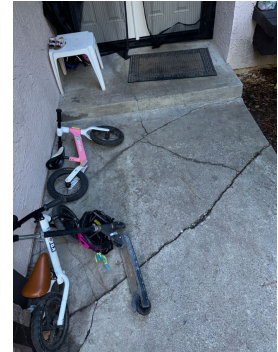
Heavy front walkway cracking

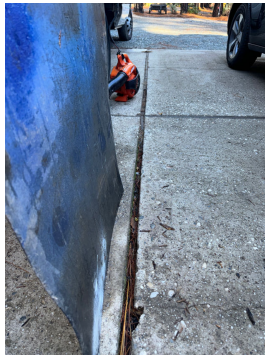
Decayed expansion joint wood

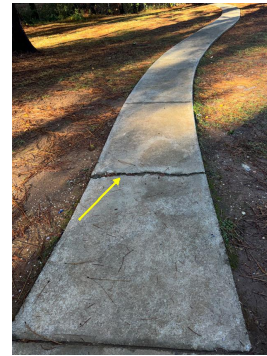
Walkway crack

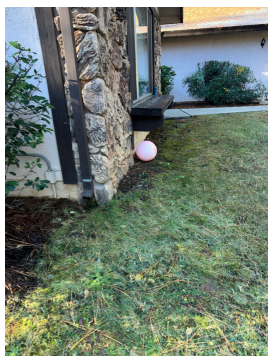
2.2. There are areas of negative grading towards the house and it is not known if a **drainage system** exists to take rain water away from the foundation. Recommend checking with seller on the presence of a drainage system and if necessary, consider adding additional backfill and/or drain lines to create the proper slope or drainage to take rain water away from house.

Negative grade toward house

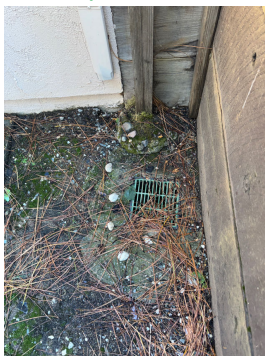
3.2. NOTE: A lot drainage system was noted but not inspected. Recommend checking with seller on serviceability.

Drainage system not inspected

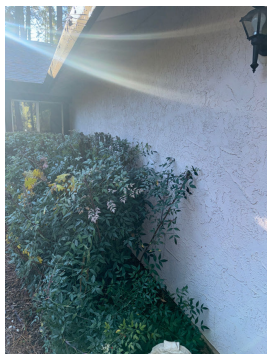
4.1. **vegetation against house** was noted in areas. Recommend trimming so no plant to exterior cladding exists.

Vegetation against house

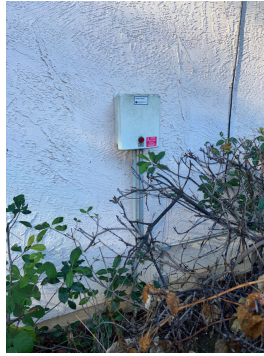
5.1. NOTE: A septic system was observed. Since testing this system is beyond the scope of this inspection, we recommended a qualified professional empty the tank and check the system for serviceability.

Septic system not inspected
