# SIGNET HOME INSPECTIONS, LLC

## COMPREHENSIVE PROPERTY INSPECTION REPORT

11855 Slow Poke Ln., Grass Valley, CA 95945

Date of Inspection: 12/2/2024 Time: 1:00 PM

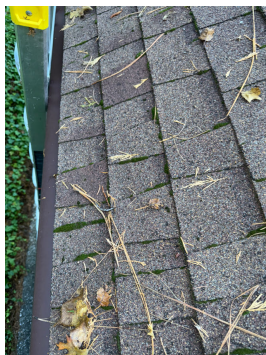
1.3. **Moss on composition** roof noted which can lead to the premature failure of the roof and subsequent leaks. Recommend treating moss during its growing season (wet months) with a moss killer.

Moss on roof

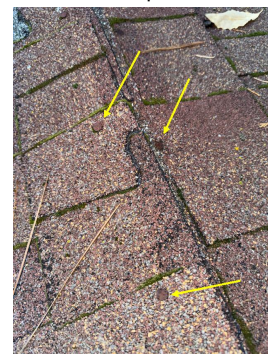
1.4. Exposed and/or protruding nails noted on roofing material. Ideally there should rarely if ever be exposed face nails on any roofing materials and if there are, they should be sealed to avoid moisture intrusion. Recommend a qualified roofing contractor re-nail if needed and seal all exposed fastener heads.

Exposed roof nails

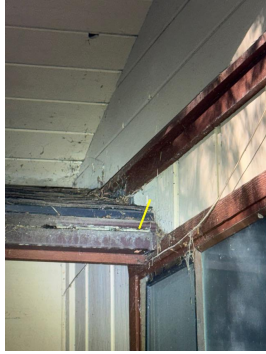
2.3. Missing kickout **diverter flashing** noted which is meant to redirect water away from the structure and into a gutter. Recommend a qualified roofing contractor add as needed and further investigation for moisture intrusion.

Missing back side **kickout flashing**

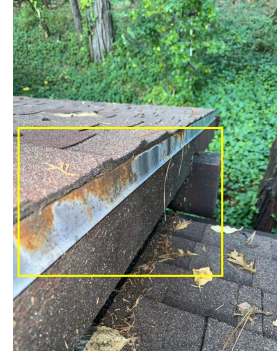
2.2. Rusted flashing noted. Recommend either replacing or prepping and painting with a rust-resistant paint as needed.

Rusted edge flashing

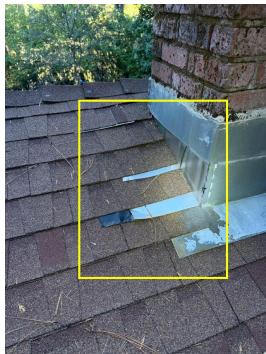
2.4. Questionable chimney flashing noted. Recommend further review by a qualified roofing contractor and repairs if needed.

Questionable chimney flashing

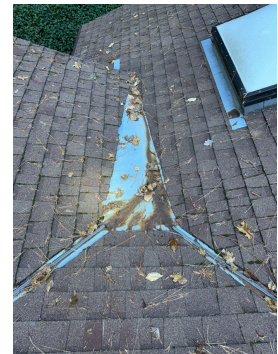
Rusted flashing

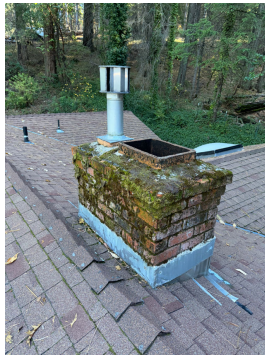
4.2. Excessive moss was noted to be growing on the brick chimney. Recommend removal as needed.

Excessive moss on chimney

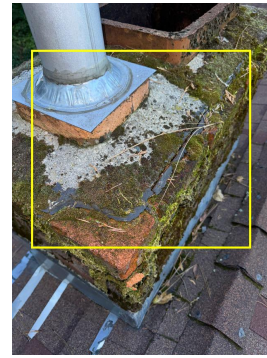
4.1. Chimney cement crown noted to be cracking which will allow moisture intrusion and subsequent deterioration during freeze and thaw cycles. Recommend sealing as needed.

Cracked chimney crown

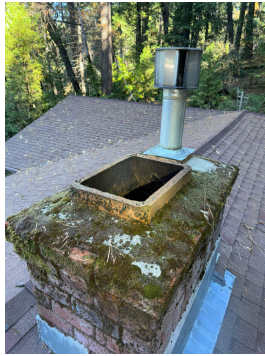
5.1. No chimney rain cap and spark arrestor was noted. Recommend installing to prevent water intrusion, preserve chimney life and to prevent sparks from escaping and small animals from entering.

Missing rain cap and spark arrestor

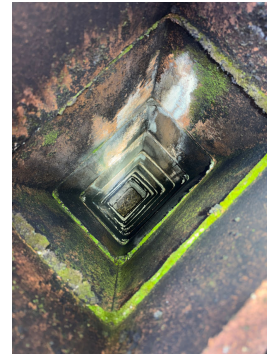
Missing rain cap/spark arrestor

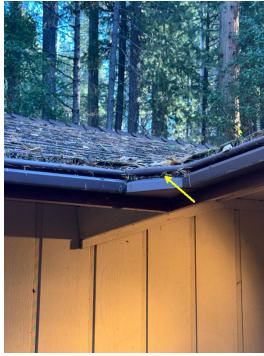
7.3. Leafless gutters clogged with organic materials were noted. Recommend cleaning to avoid overflow and foundation edge saturation.

Clogged leafless style gutter guard

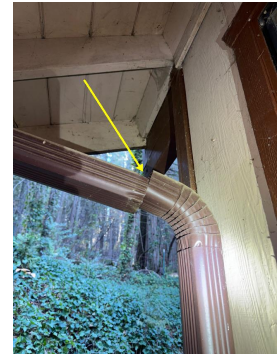
8.2. Disconnected downspout pipe section noted. Recommend reconnecting as needed.

Disconnected back left downspout section

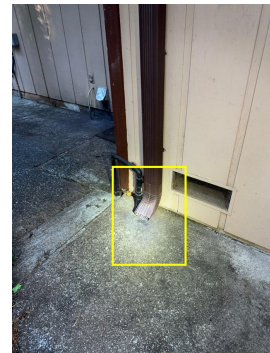
8.1. **Deficient downspout termination** noted at or near the structure foundation. Recommend drain pipe(s) to divert roof water away from the foundation.

Downspout terminates at foundation

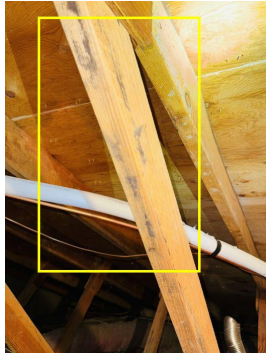
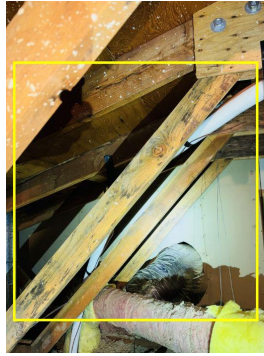
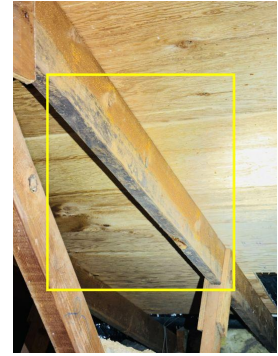
3.2. NOTE: Black staining (possible fungal/organic growth) was observed on areas of the attic structure. This staining is very common and is likely the result of the lumber being exposed to outdoor elements and moisture prior to construction. Although common, if buyer has high sensitivities to mold we recommend further review and testing.

Black staining on attic structure

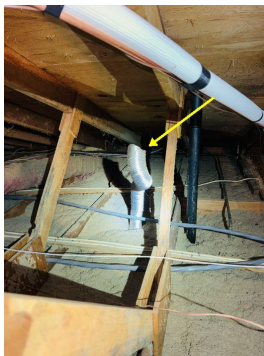
9.1. **interior moisture exhaust fan** (bathroom, laundry, kitchen, etc.) ducting appears to terminate inside attic space. It is always recommended that ducting be routed to exterior or at minimum to the gable-end or ridge vent to minimize excessive moisture and possible mold development.

Exhaust duct terminates inside attic

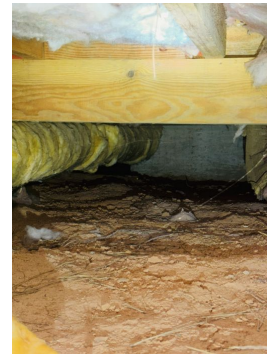
2.1. NOTE: Due to the low height of construction of this home and the installation of rigid ductwork in the crawl space area, most areas could not be accessed or inspected. If necessary, recommend a qualified specialist for further review and inspection.

No access due to ducting

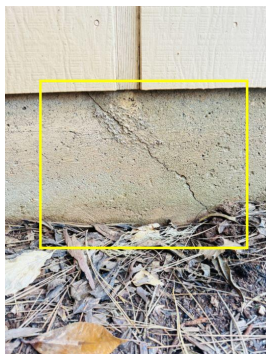
3.1. Various foundation wall cracks 3/8" or less noted on foundation wall. Inspector does not believe these represent a structural problem but since this is only a visual observation and DOES NOT constitute a certification of structural integrity, if in doubt consider having a structural engineer evaluate the integrity of the structure. At a minimum, recommend sealing exterior cracks to prevent water infiltration and damage during freeze/thaw cycles.

Foundation wall crack

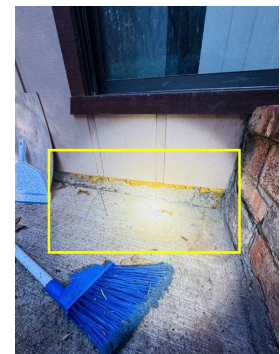
3.2. NOTE: Foundation wall **spalling**/outer layer deterioration noted at the outside back right corner, but did not appear to affect foundation wall integrity. Recommend sealing to avoid any further deterioration from freeze/thaw cycles.

Back left foundation wall spalling/deterioration

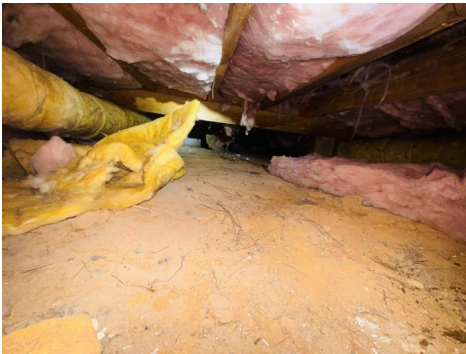
6.1. Some insulation noted as missing or out-of-place. Recommend replacing or repositioning as needed.

Disturbed insulation

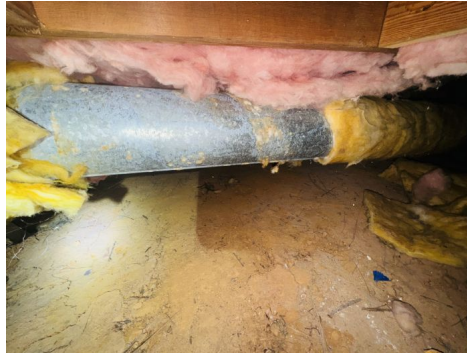
11.1. Some insulation noted as loose or missing from duct work. Recommend insulating as needed.

Deficient insulation on ductwork

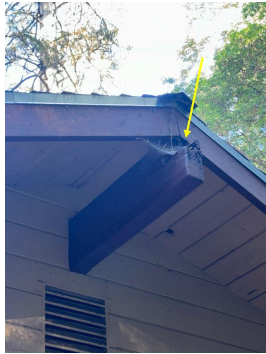
2.3. Exterior beam end wood decay was noted. Refer to pest report for more detail and consider consulting a qualified contractor for remediation options.

Decayed back side beam end

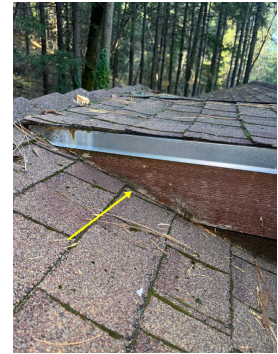
2.2. Barge rafter **roof contact** noted. It is recommended that all wood building materials be held up at least 1 inch from roof decking to avoid water saturation during rain and subsequent deterioration over time.

Barge rafter to roof deck contact

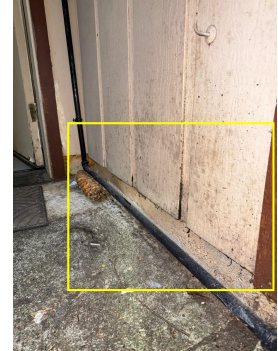
3.2. Area(s) of siding wood decay noted. Refer to pest report for more detail and consider consulting a qualified contractor for remediation options.

Back side siding decay

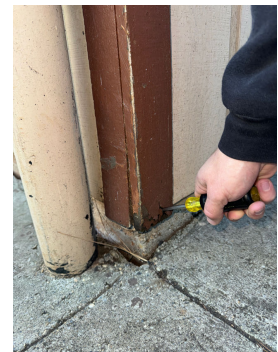
Back right side trim wood decay

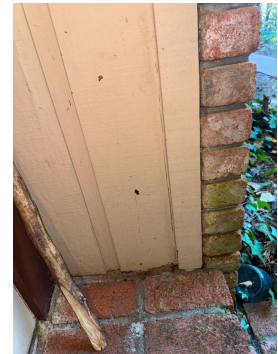
Deficient paint

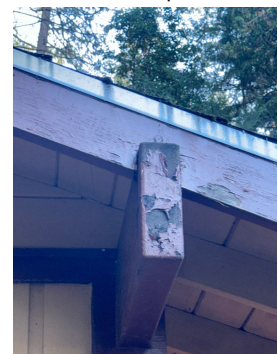
Deficient paint

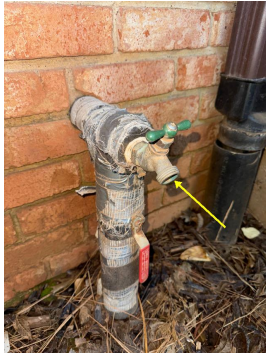
10.1. **Anti-siphon hose bibb** vacuum breakers not present on outdoor faucets. Most likely not required when home was built, they would now be required for new construction. Although you would be under no obligation to do so, consider adding for safety.

Missing anti siphon vacuum breaker

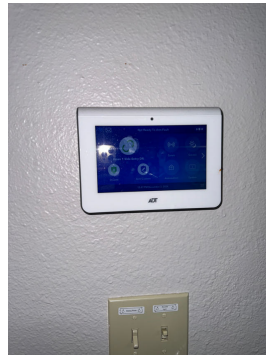
6.1. **NOTE:** A security system was noted with wall sensors, ceiling alarms and a control panel. Since testing this system is beyond the scope of this inspection, it is recommended the buyer seek operation guidance from the seller and if necessary, that a qualified professional check the system for serviceability.

Security system not inspected

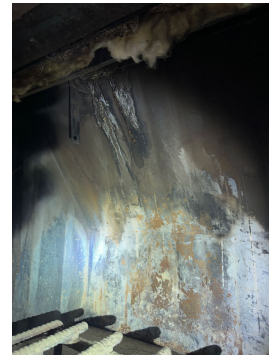
Rust/corrosion inside fireplace

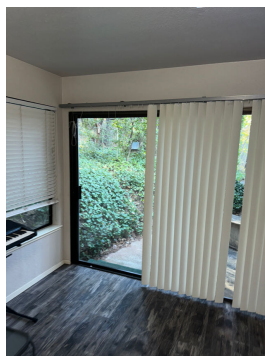
14.1. Door is difficult to operate for reasons unknown. Recommend further investigation to determine cause and repairs as needed.

Sliding glass door difficult to operate

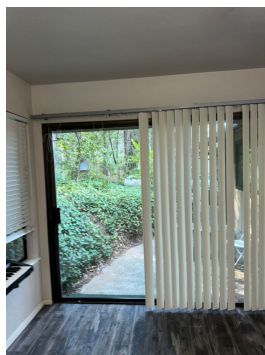
15.1. Screen door was noted to be missing. Recommend replacement as needed.

Missing sliding screen door

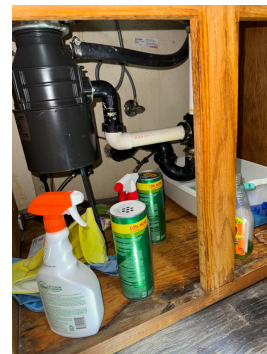
Blocked sink cabinet

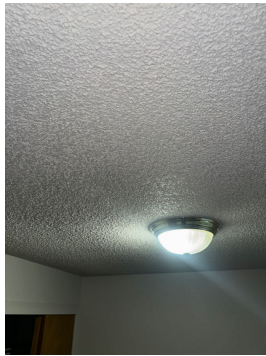
3.1. Popcorn texturing noted on ceiling which presents a possible asbestos hazard. Recommend leaving undisturbed until having done additional research and preparation for removal if desired.

Room 2 popcorn ceiling texturing

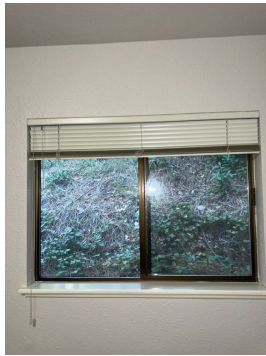
5.2. Fog and/or condensation or the resulting stains were noted in double-pane window(s) which is an indication of a failed seal. Recommend review for repair or replacement as necessary.

Room 5 possible failed seal

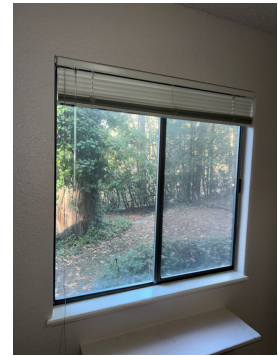
Room 2 possible failed window seal

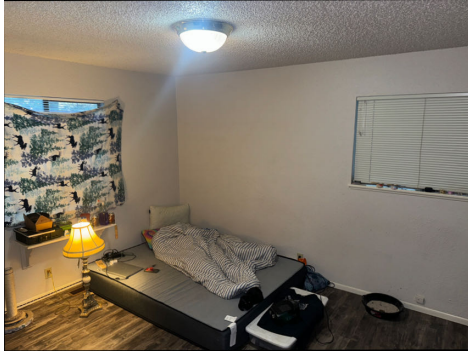
Room 3 blocked windows

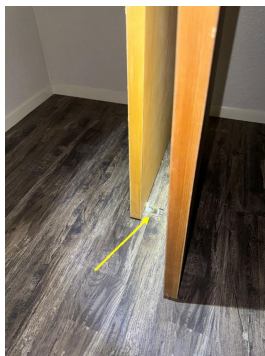
7.2. Missing or damaged bottom track noted on closet doors allowing them to swing in or out with the possibility of dislodging from upper track. Recommend installing bottom track for stability and safety.

Room 2 damaged closet door bottom track

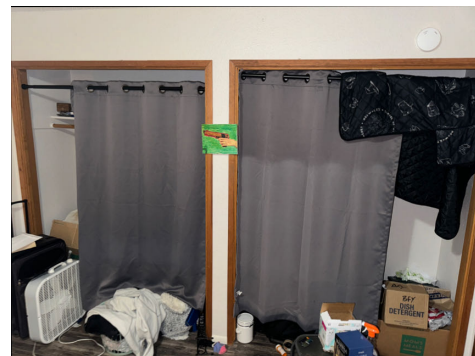
7.1. NOTE: Closet noted with a large amount of personal items blocking access and therefore inside not fully inspected.

Room 3 items blocking closet

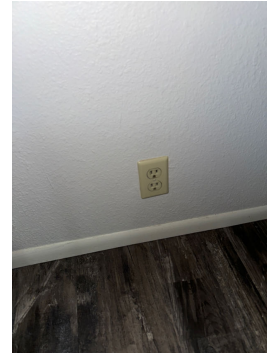
Room 1 loose outlet

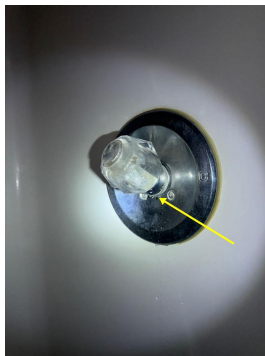
10.2. Faucet handle noted to be leaking. Recommend repair or replacement as needed.

Bathroom 1 leaking faucet handle

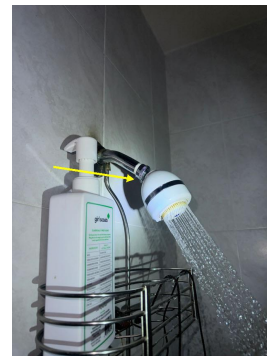
10.1. Shower head and/or hose noted to be leaking. Recommend repair as needed.

Bathroom 2 leaking shower head

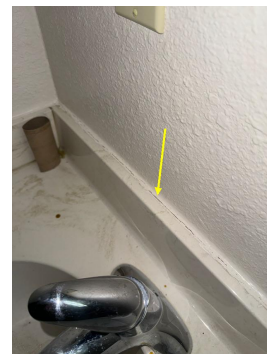
Bathroom 2 deficient counter caulk

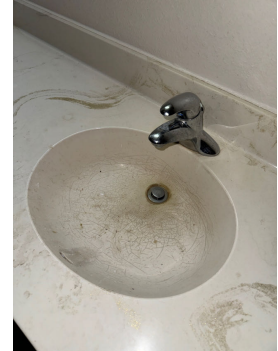
Bathroom 2 cracked sink surface

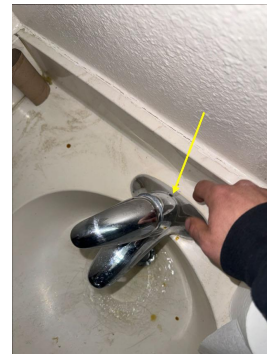
Bathroom 2 missing sink stopper handle

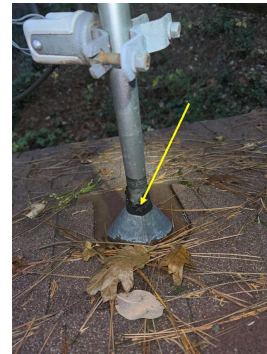
Worn cable feed masthead tape seal

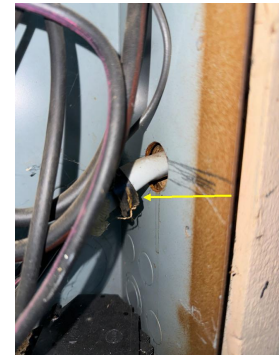
3.2. Cable clamp has come loose/out of place inside main service panel, leaving wiring penetrating through sharp panel box opening. Recommend a qualified electrician re-position cable clamp to protect wiring from sharp edges.

Loose cable clamp

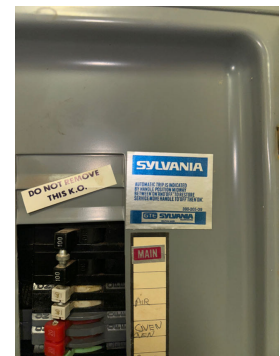
GTE Sylvania brand sub panel

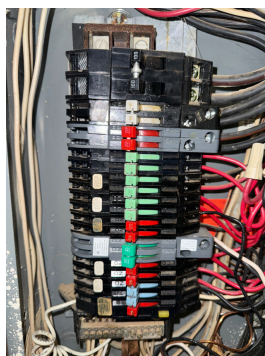
5.1. **Zinsco breakers** noted which have a higher than normal failure rate. Recommend a qualified electrician replace as needed for safety.

Zinsco brand circuit breakers

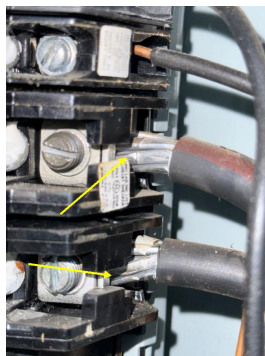
6.1. Stranded aluminum wiring ends connected to breaker are noted without proper **anti-oxidant paste**. Recommend adding to avoid oxidation.

Missing anti oxidant paste

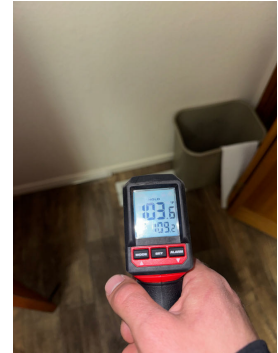
Heating noted at 103.6° F

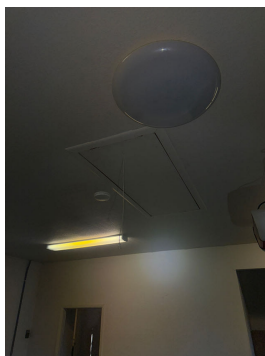
2.2. **Fire barrier** access hatch on ceiling is not properly fire-rated and/or without a self closing device. Recommend repairs as needed to ensure dwelling occupant(s) safety.

Attic pull down ladder not fire rated

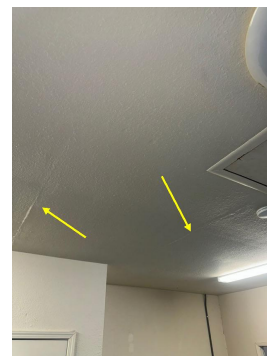
2.1. **Sheetrock crack(s)** noted which normally does not represent a structural problem. Consider patching with a flexible caulking to reduce or eliminate eyesore.

Sheetrock cracks

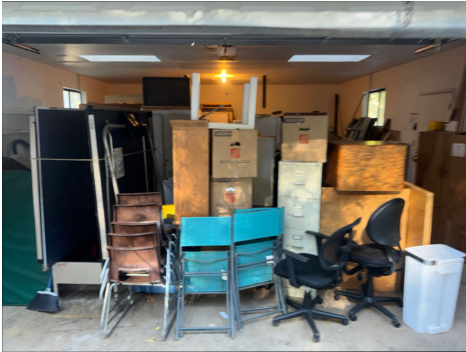
1.1. NOTE: The garage was completely filled with personal items and most interior areas of the garage could not be accessed and inspected. The crawlspace access door for under the garage was locked with a padlock and no key was available to open this lock/door. Recommend further inspection when the areas are accessible.

Blocked garage access

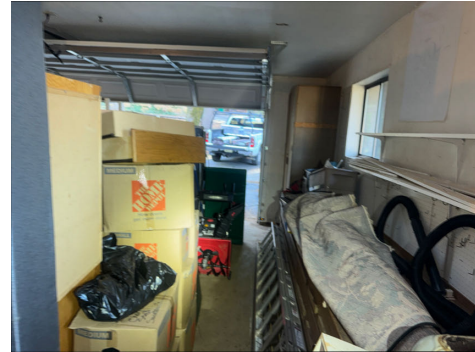
Blocked garage access

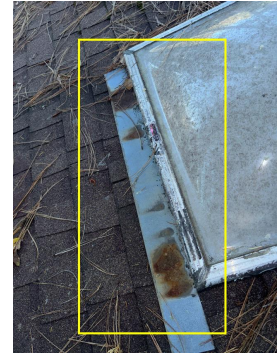
Rusted skylight flashing

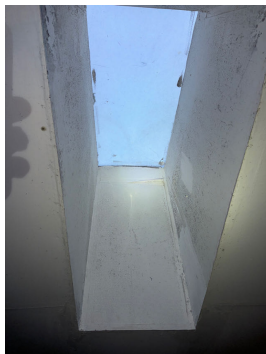
4.1. Staining noted inside the skylight sheetrock. Recommend checking with seller for further details and if necessary repairs as needed by a qualified contractor.

Staining inside skylight

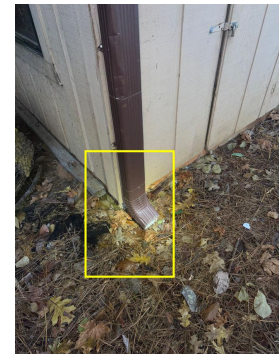
Downspout terminates at foundation

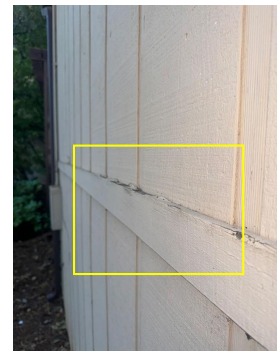
Deficient paint

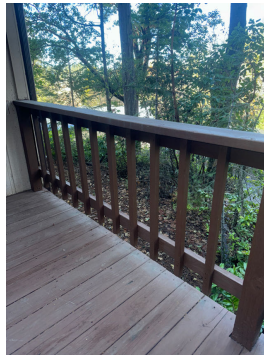
16.2. Stair/guard railing opening and/or stair riser openings noted to be over 4 inches with a plus 30 inch drop at points which could be a fall hazard for small children or animals. Recommend consulting with a qualified contractor to explore remediation options.

16.3. Stair and/or guard railing height noted to be under 42". Although most likely not required when this house was built, consider alterations or replacement for safety.

Baluster spacing over 4", height under 42"

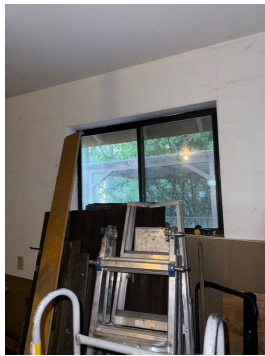
18.1. NOTE: Window(s) noted to be inaccessible and therefore not inspected. Recommend removing obstacle(s) and inspecting as needed.

Blocked window

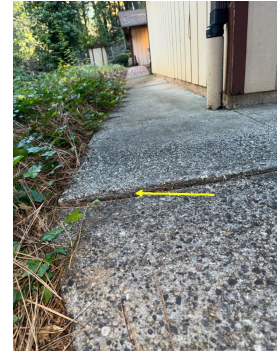
Walkway displacement and trip hazard

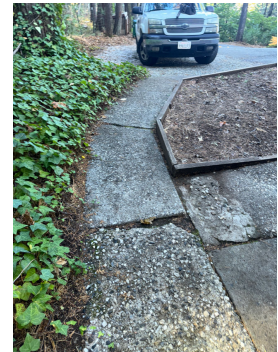
Heavy walkway cracking and displacement

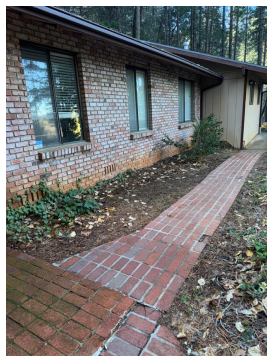
necessary, consider adding additional backfill and/or drain lines to create the proper slope or drainage to take rain water away from house.

Negative grade toward house

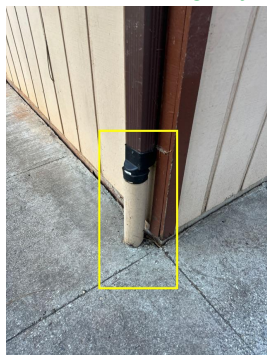
3.2. NOTE: A lot drainage system was noted but not inspected. Recommend checking with seller on serviceability.

Drainage system not inspected

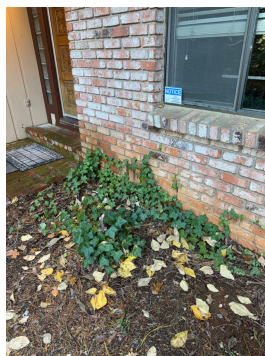
4.1. **Vegetation against house** was noted in areas. Recommend trimming so no plant to exterior cladding exists.

Vegetation against house
