American Marine Surveyors
Quality. respect. professionalism

Marine Survey Report For

2018 Grady White Canyon 271 FS

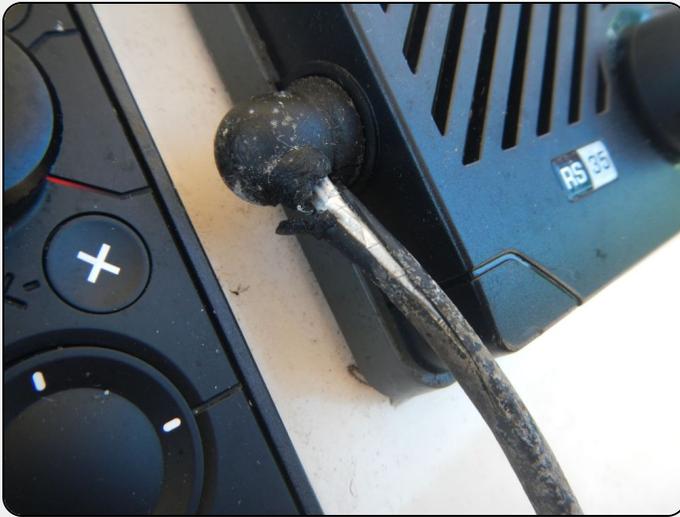
FINDING B-2 HELM

Microphone wiring has some damage to the insulation.

RECOMMENDATION

Replace mic cord or mic if desired.

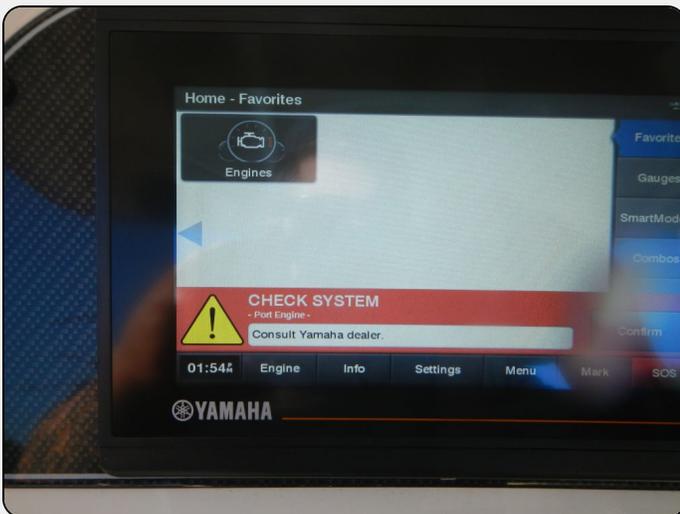
**FINDING B-3 OTHER ELECTRONICS & CONTROLS**

Setpoint technology not operational during the trial run.

RECOMMENDATION

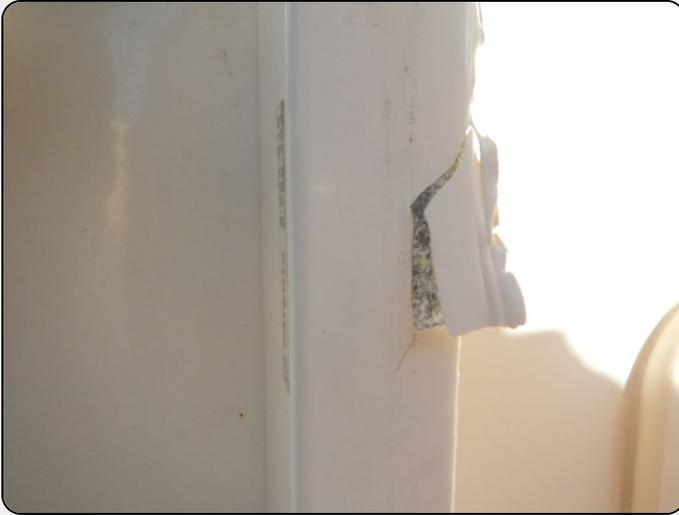
**FINDING C-2 HULL, DECK & SUPERSTRUCTURE**

Small cosmetic blemishes and a small crack in the gelcoat above the waterline.

RECOMMENDATION

To be noted only: Refinish areas if desired.
