American Marine Surveyors

Marine Survey Report For

2022 Freeman 47'

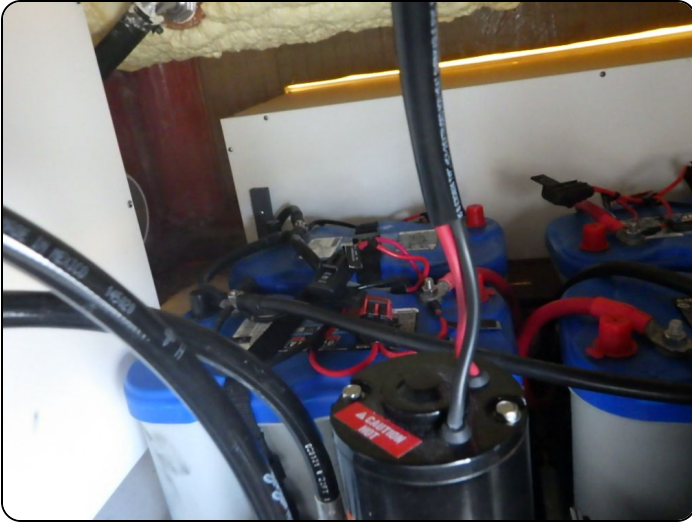
FINDING A-2

Unprotected terminals & posts exposed on batteries.

ABYC E-10 7.7 states: "To prevent accidental contact of the ungrounded battery connection to ground, each battery shall be protected so that metallic objects cannot come into contact with the ungrounded battery terminal and uninsulated cell straps. This may be accomplished by means such as: covering the ungrounded battery terminal with a boot or non-conductive shield". Recommend Compliance.

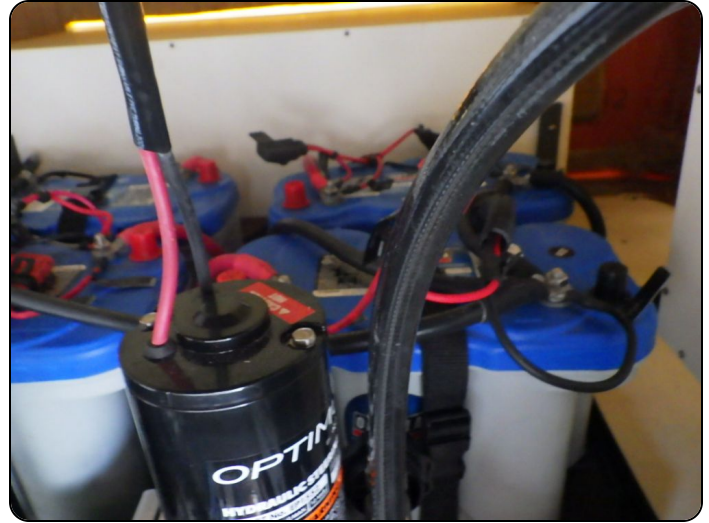
FINDING B-2

During the survey, the vessel was unplugged for a short amount of time and a low voltage alarm was present on the main chartplotter screen.

Investigate and load test batteries, replace batteries if needed.
