KUHN FAMILY
HOME INSPECTIONS

INSPECTION REPORT
123 Main St
NoWhereVille NJ 00000

INSPECTED BY
Ryan Kuhn
Kuhn Family
Home
Inspections LLC
#24GI00152800

1/1/2023

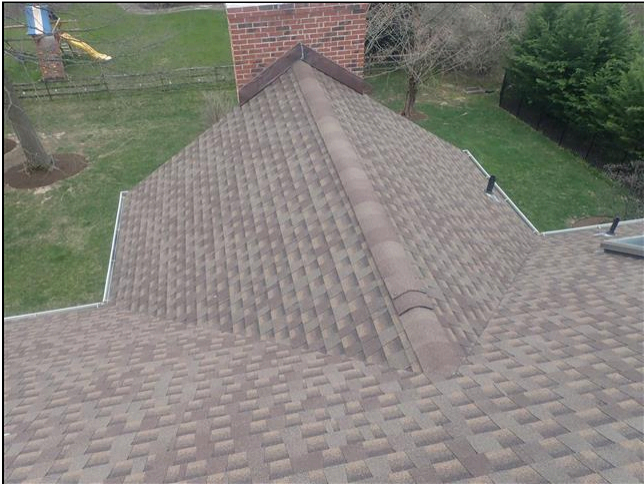
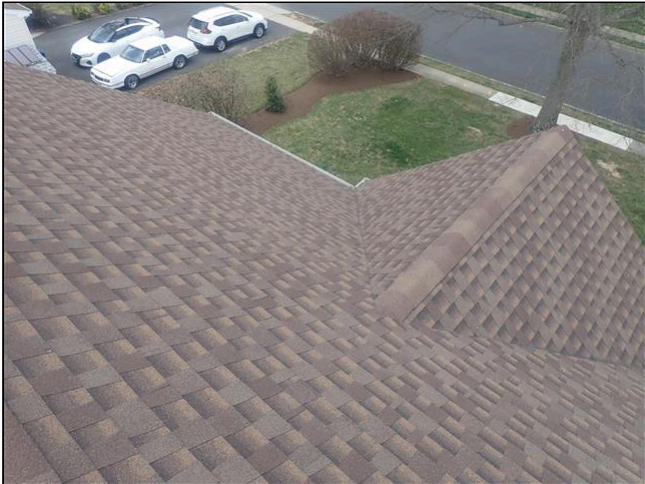
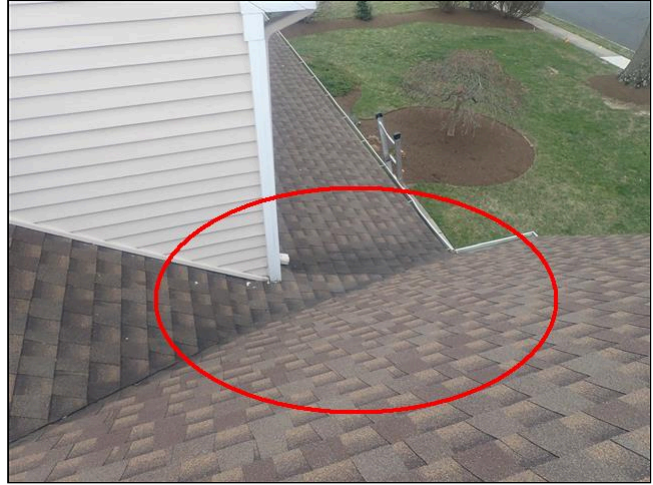
1.0 Roof covering is estimated to be 5-10 with a typical 20-25 year design life. Shingle condition appears consistent with age of the material, normal wear and tear observed throughout. Area around valley on front-left section near garage/house area will wear quickly over time and should be monitored.

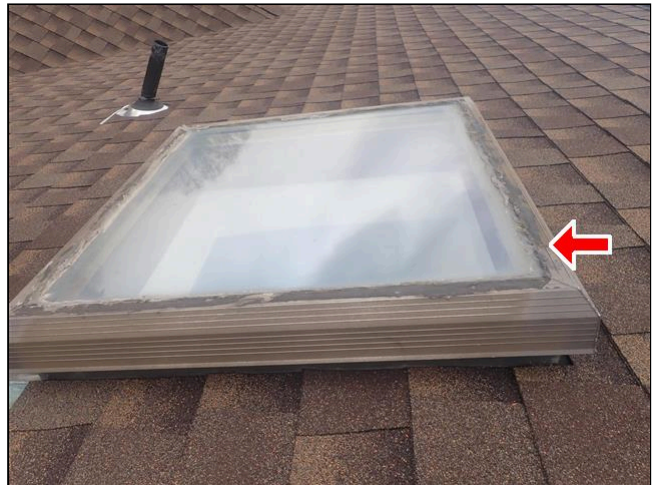
1.2 Skylight appear older and have been heavily caulked around glass pane. While no immediate defects were noted replacements should be anticipated based on age & deteriorated condition.

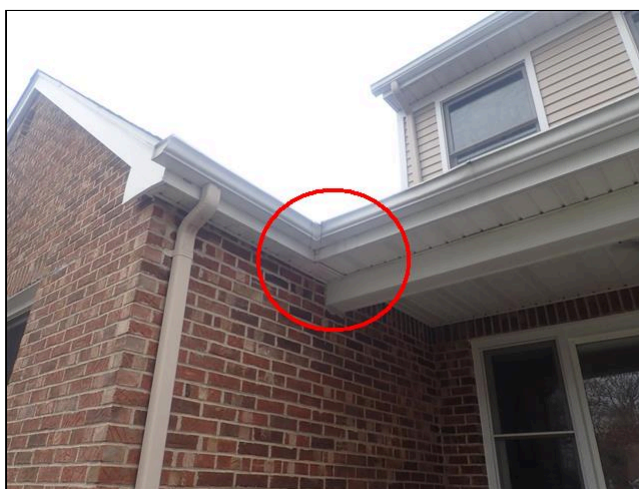
1.4 Item 1 (Picture)

1.4 (1) Slight rot and deterioration noted around front-left corner of gutter at lower roof. Repair as preventative maintenance to avoid larger damages over time.

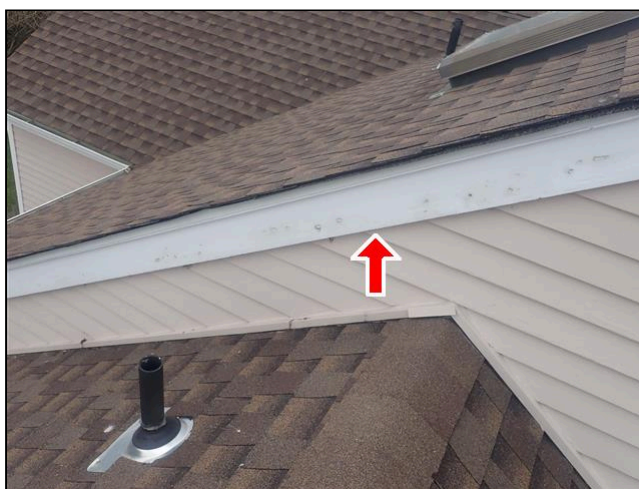
1.4 Item 2 (Picture)

1.4 (2) Evidence of past carpenter bee damage/activity observed at upper roof on left side of building appears treated and repaired. This is for your information.

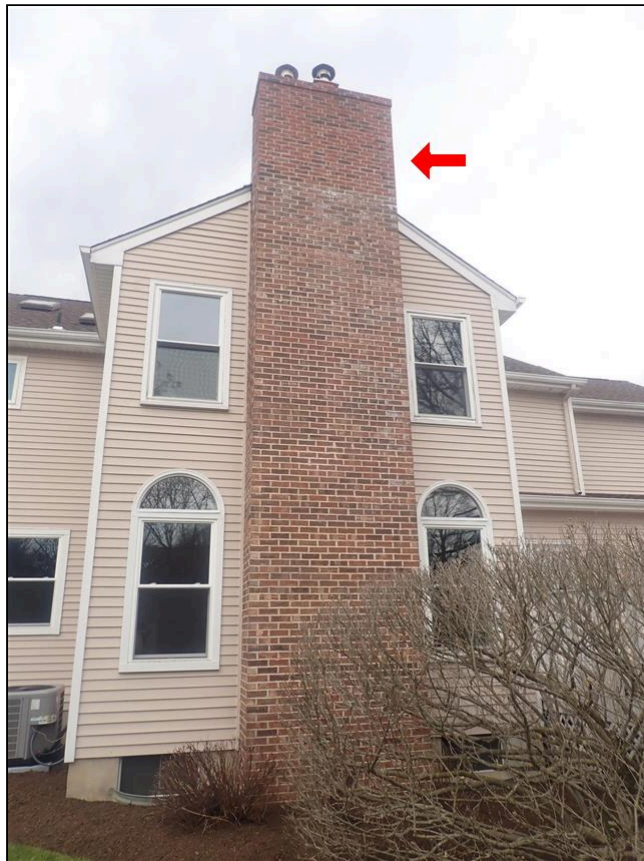
2.0 Item 1 (Picture)

2.0 Chimney shows evidence of past repairs, appears to have been rebuilt above roof line. Efflorescence noted throughout base of chimney is indicative of water penetration into masonry block. While common, ongoing water infiltration can lead to larger damages if not properly maintained over time. Obtain documentation from seller regarding past repairs and maintain exterior masonry over time.

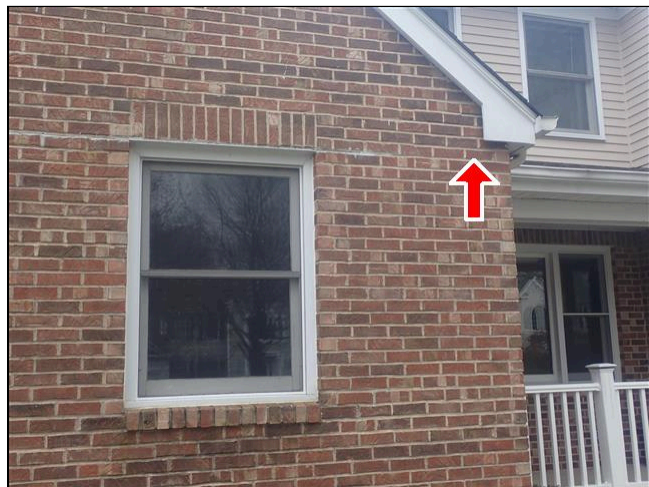
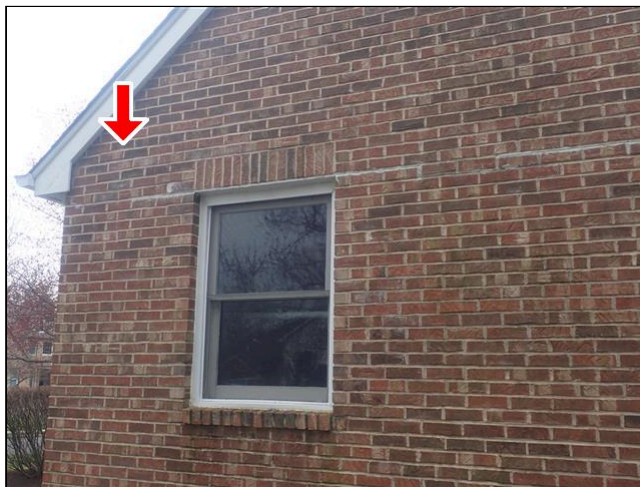
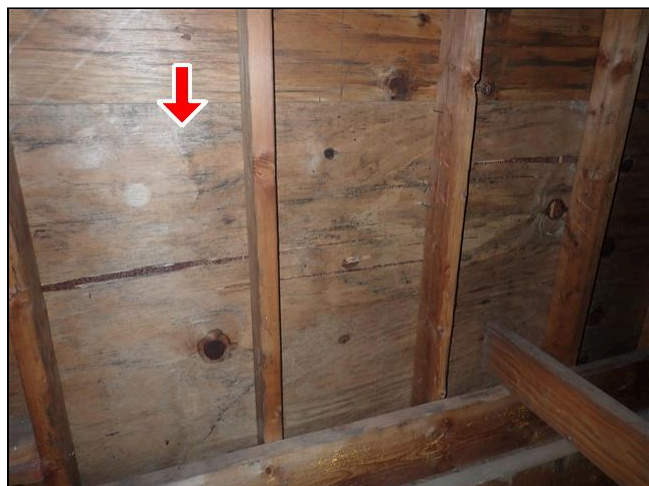
1. Brick veneer siding at garage area is poorly installed and damaged. Lack of proper weep holes

or drainage system prevents proper drainage behind siding material and lead to moisture concerns.

- Large cracks observed around window lintels indication of settlement and damages.
- Suspect mold was observed on plywood sheathing behind wall in garage attic location.
- Efflorescence noted throughout masonry (white/chalky depositing on bricks) is indication of water penetration.

4.7 See Siding section for comments on suspect mold at wood sheathing behind damaged siding.

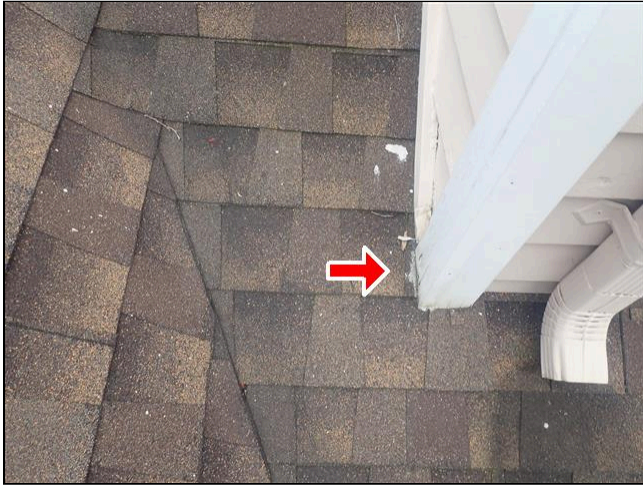
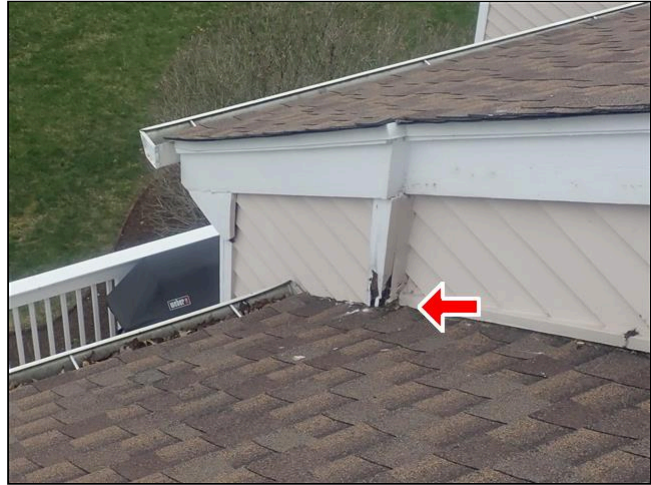
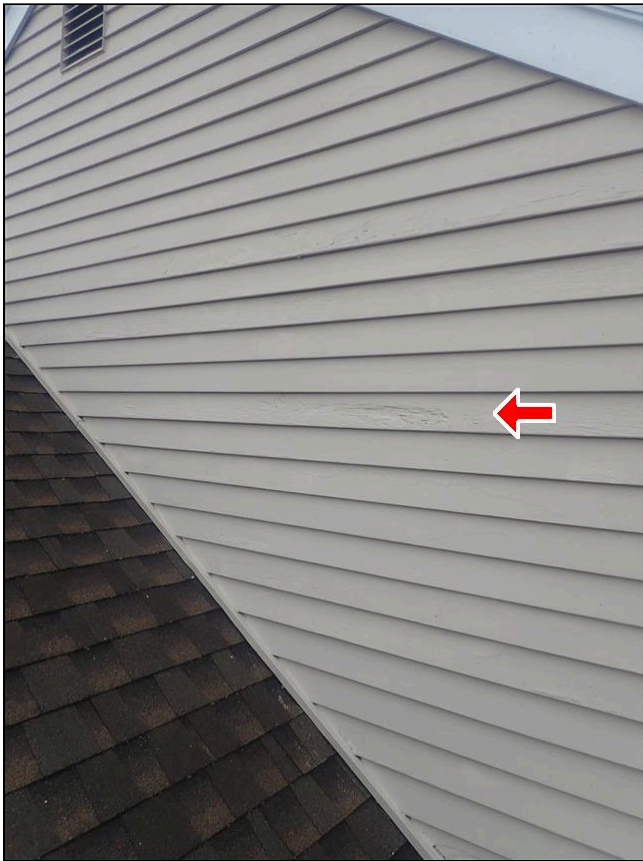
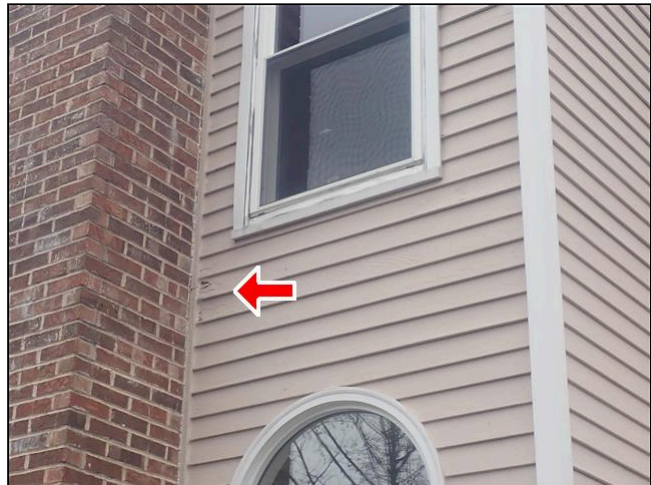
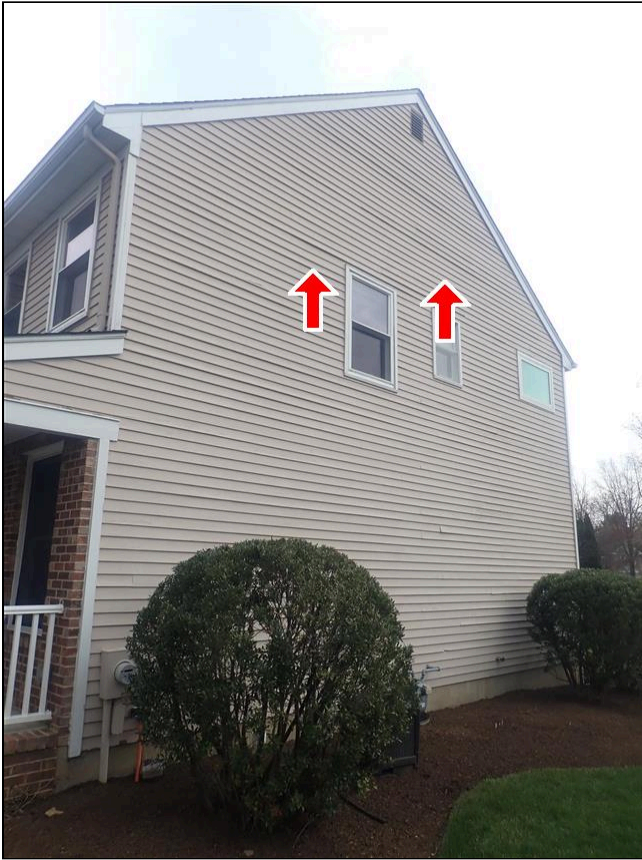
2.1 (2) Rotting wood siding was at various locations:

1. Loose and curling wood boards observed throughout right side of building
2. Rotting boards around chimney area on backside of home
3. Rotting trim at upper sections of roof at backside of home
4. Soft areas of siding noted at upper section of building at left side

Based on conditions observed, recommend having qualified contractor assess to determine repairs necessary and costs associated.

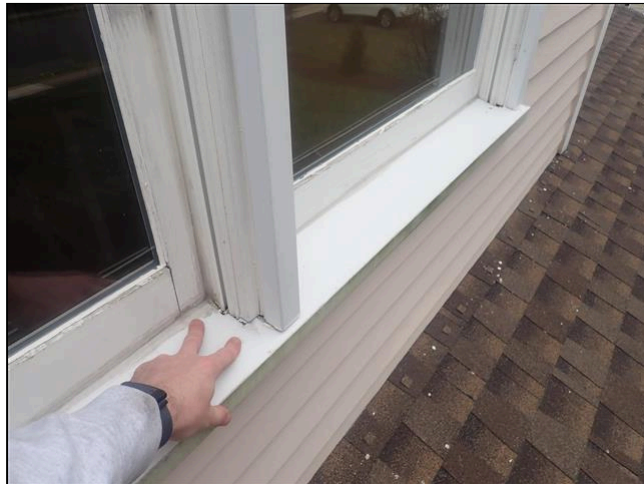
2.3 Item 1 (Picture)

1. The evaluation of windows is based on a limited inspection of representative, readily accessible units. Varying conditions may be found at other units. Review the Interior Section for additional information on window conditions.
2. Vinyl window trim at front-middle of home (second floor) has large gaps around sides and is leading to water damage around framing. Recommend repairing to prevent ongoing damaged and future concerns.

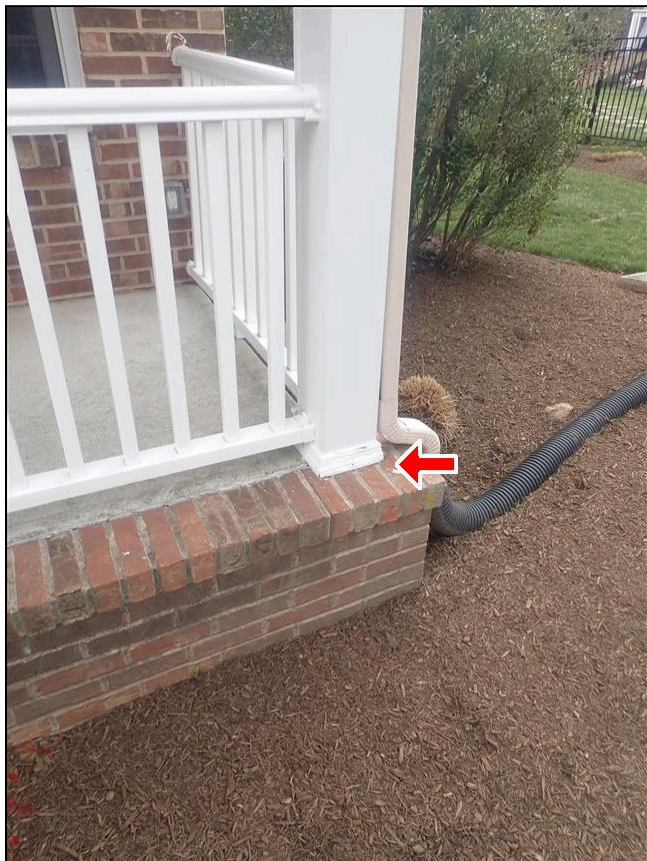
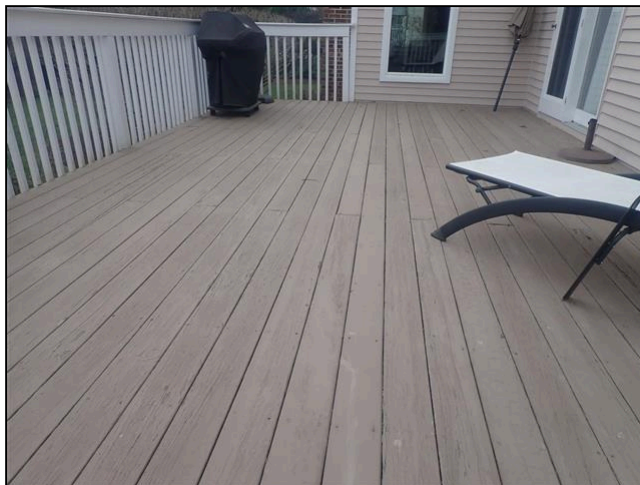
1. Repair rotting base at far-right column of front porch.
2. Older decking materials noted throughout with normal wear and tear observed. While no significant/immediate concerns were observed, eventual replacement of decking materials should be anticipated as normal upgrades.

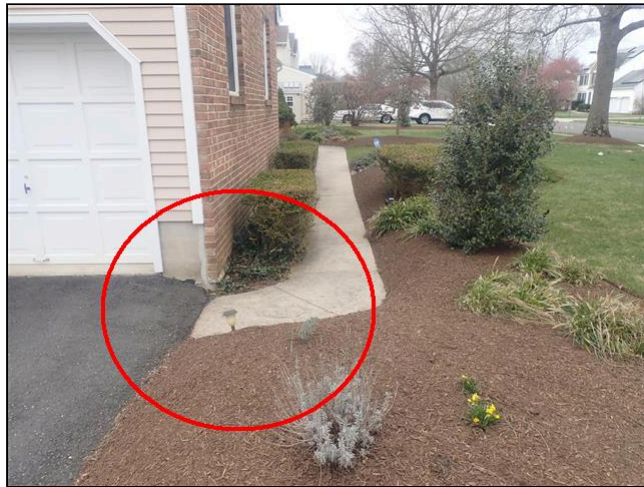
3.6 Item 1 (Picture)

3.6 Walkways slope towards garage foundation area and may not drain well. Monitor drainage provisions and improve to prevent ponding around foundation and water penetration/settlement concerns.

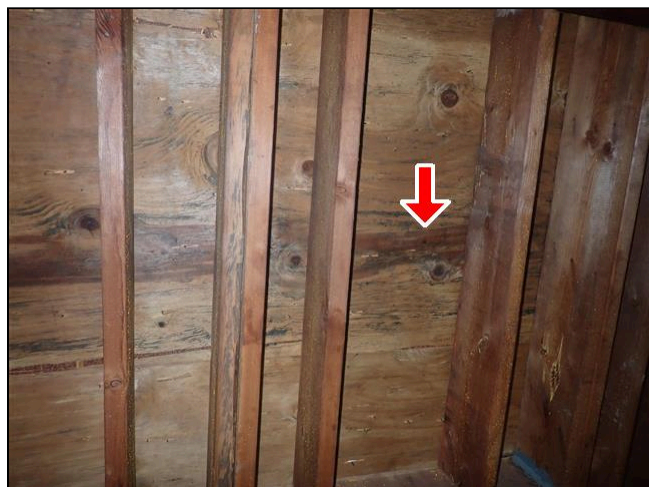
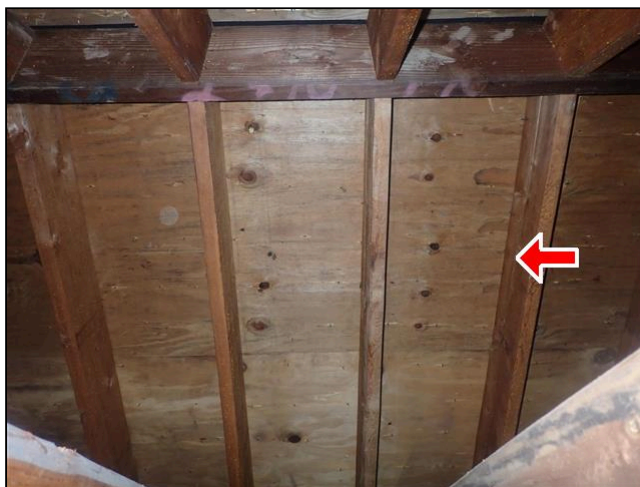
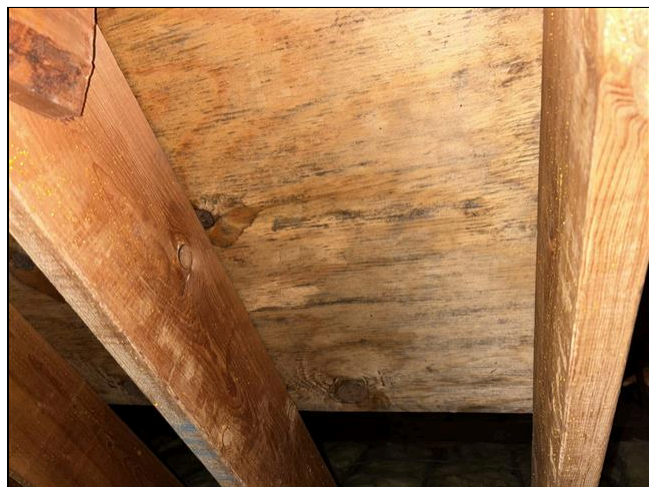
5.3 (1) Venting an attic space is not a one-way-fits-all type of situation. Many factors and variables can affect performance such as insulation levels, air-sealing, attic fans, humidity levels throughout home and lower levels, roof leaks, etc. While no apparent defects were observed, recommend monitoring regularly for changes throughout attic. This is for your information.

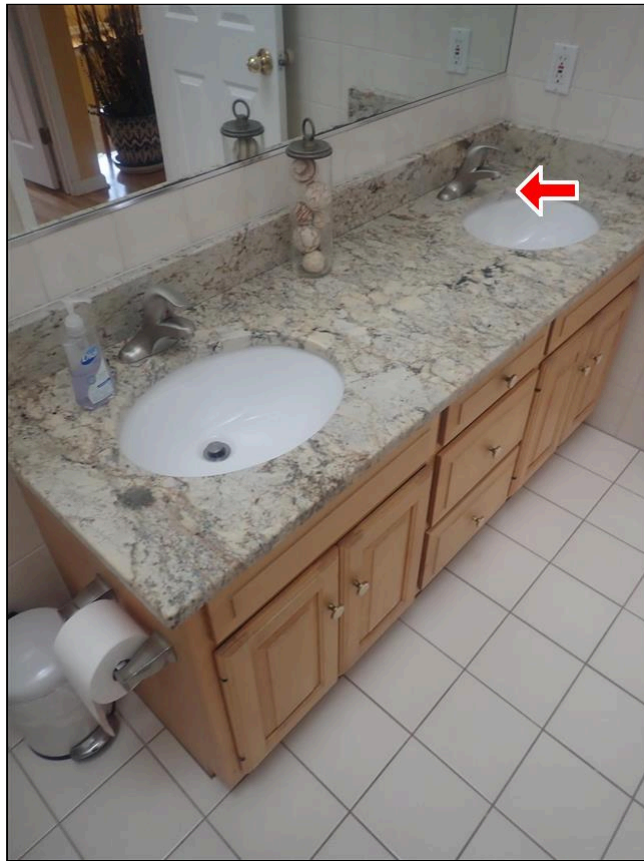
6.0.A Item 1 (Picture)

1. See main plumbing section for comments regarding corrosion.
2. Right side sink did not have hot water during inspection, mixing valve is defective. Recommend repairing.

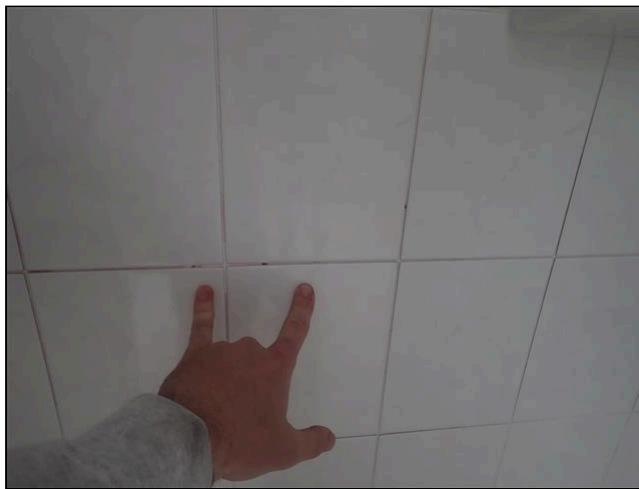
6.4.B Item 1 (Picture)

6.4.B Repair gaps in wall tile at shower area to prevent leaks and possible damages behind wall tile.

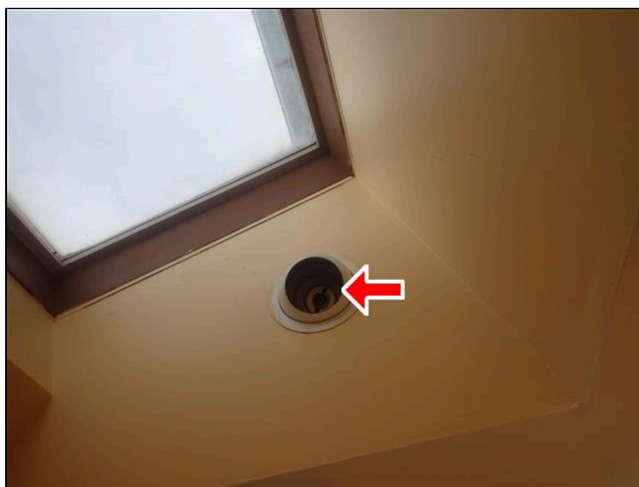
7.0 Item 1 (Picture)

1. Recommend adding GFCI outlets to ALL kitchen locations to meet current electrical and safety standards. GFCI's were noted at some, not all, locations.
2. Replace ceiling light over kitchen sink location.

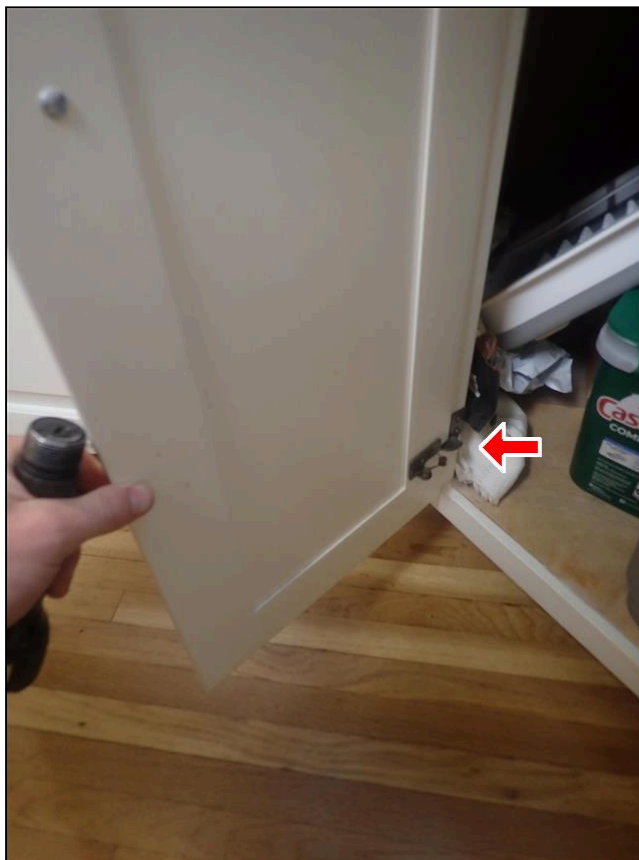
7.2 Item 1 (Picture)

7.2 Secure loose hinge at bottom left of sink area.

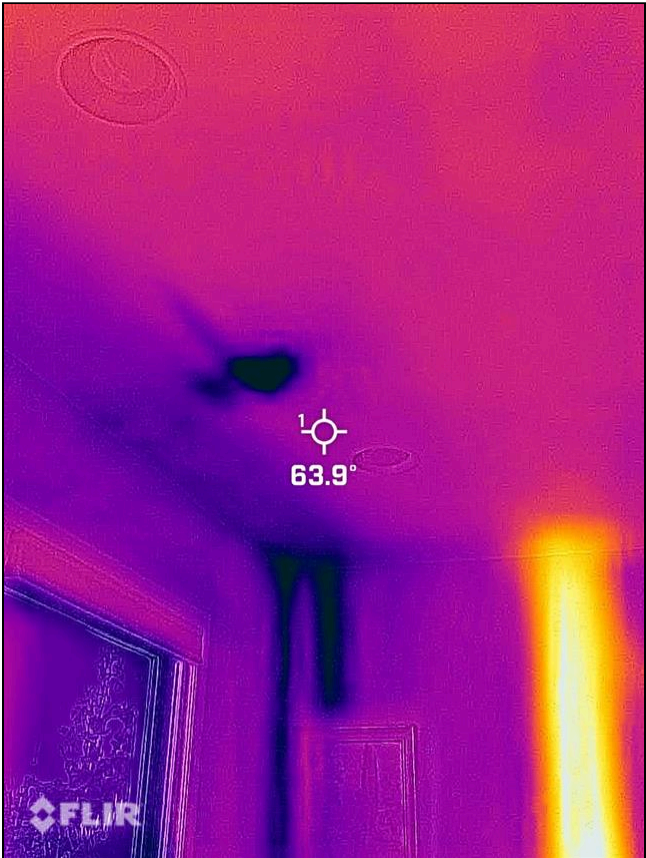
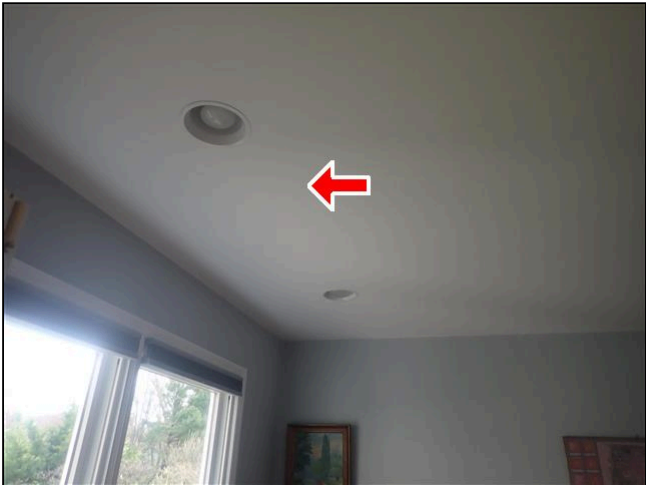
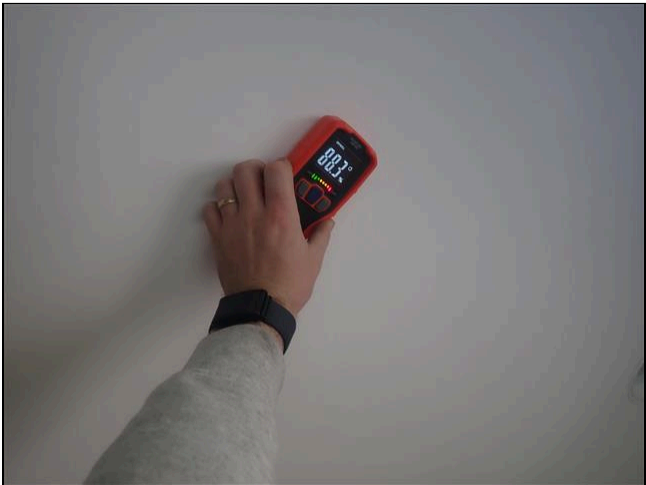
8.0 (2) Active water leak was observed under the master bathroom tub down into the ceiling below. Moisture meter and thermal camera were used with active concerns observed. Recommend further evaluation by a qualified professional to assess conditions and repair.

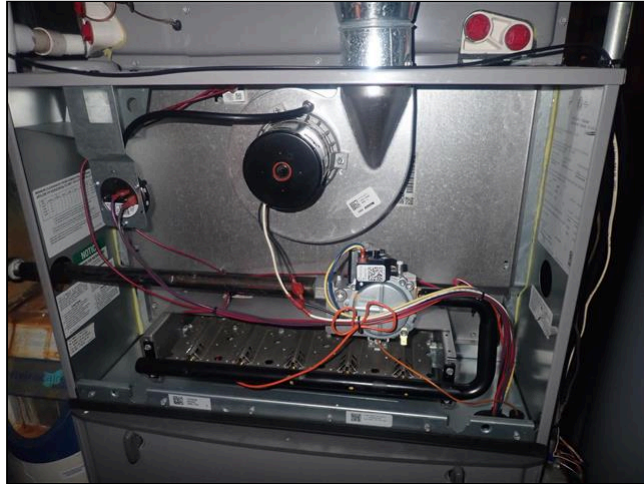
10.0 Item 1 (Picture)

10.0 Heating system is estimated to be 2-4 years old with a typical 15-20 year design life. System was operational during the inspection with no immediate concerns or defects noted. Recommend annual servicing by a qualified professional as normal maintenance.

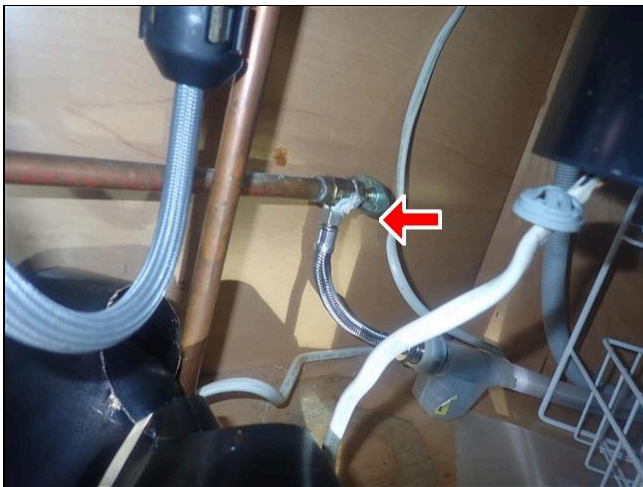
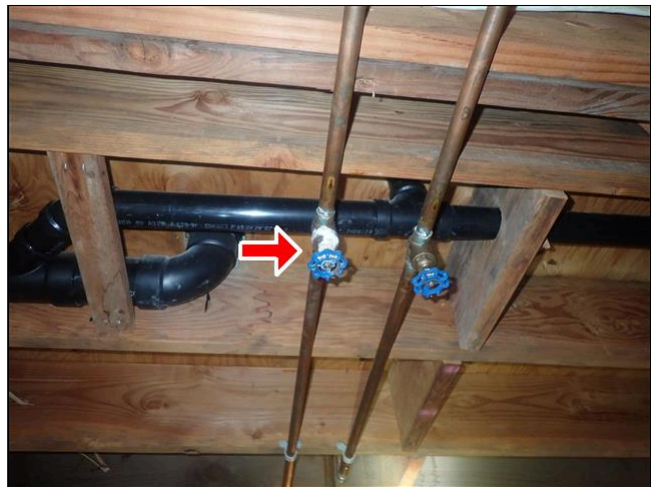
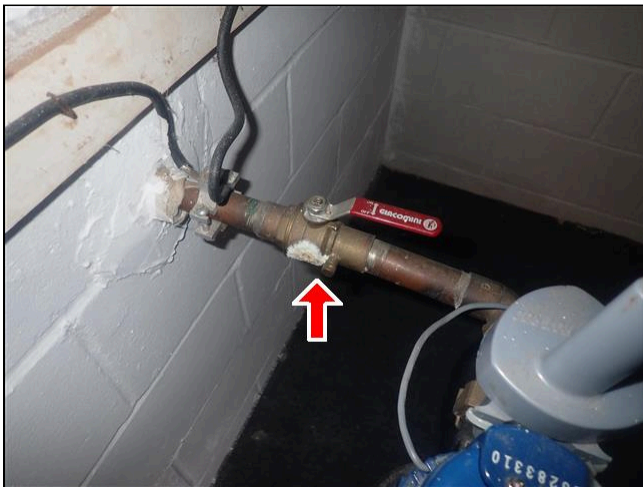
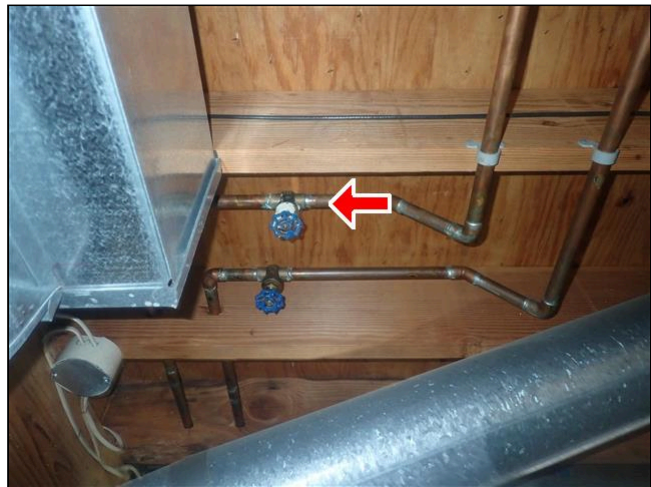
13.0 Excessively corroded valves and fixtures were observed throughout the home, specific locations include:

Recommend a full evaluation by a qualified plumber to assess and repair damaged areas to prevent possible failure and damages.

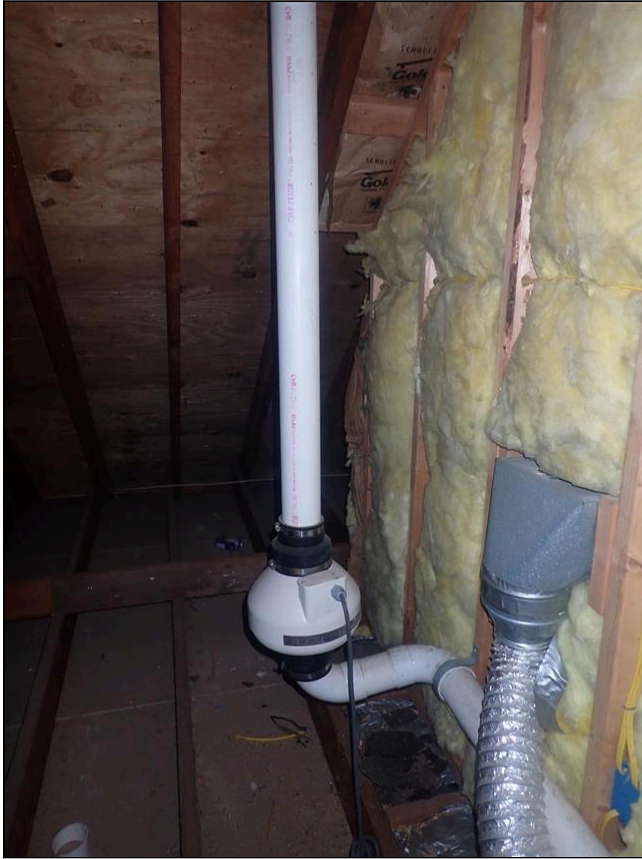
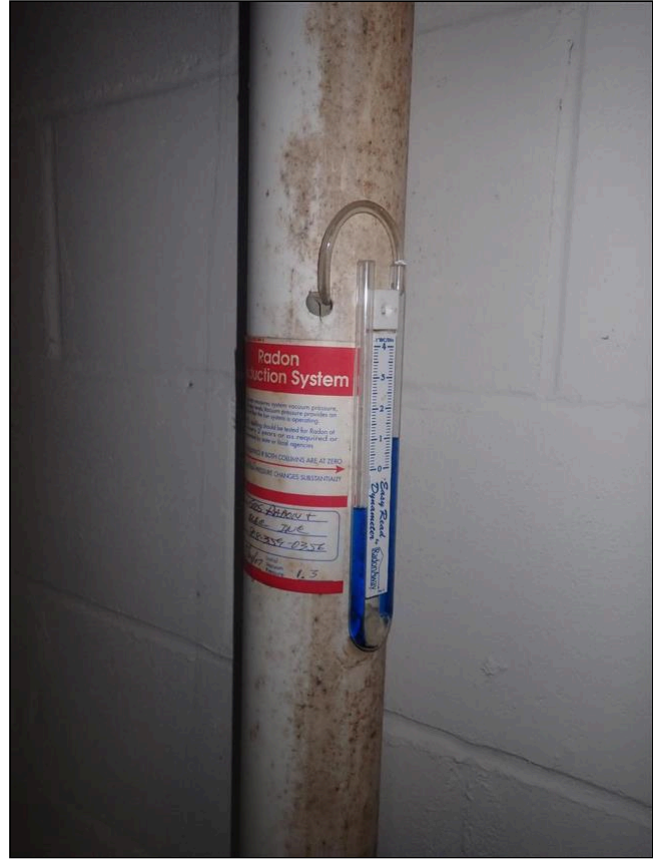
15.12 There is an active radon mitigations system installed, fan located in garage attic space, site-gauge located in basement. System was operational, test is ongoing to determine results.

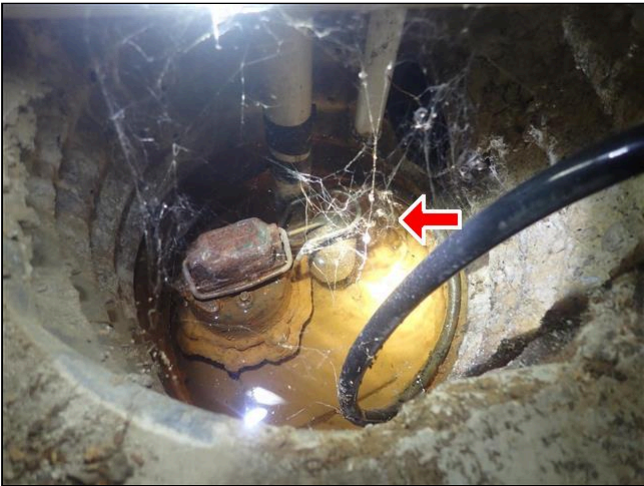
16.2 Item 1 (Picture)

16.2 Sump pump is excessively rusted and in poor condition. Float valve turned on but did not adequately turn off during the inspection, had to be manually turned off. Recommend replacing based on deteriorated condition.
