Corrosion Troubleshooting – Case Study

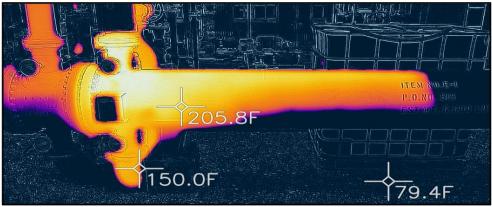
corrosion. It was found that the primary amine, MEA was no longer the optimal amine as gas composition changes over the years resulted in rapid corrosion rates. The thermal images taken indicated that the high chromium level was due to the new lean/rich exchanger internals nearly completely corroded.

The thermal image above indicates how the lean amine (hottest temperature, bright color) does not flow through the entire vessel. This indicted that the stainless-steel seal strips were compromised by corrosion. It

was also found that when recently installed the rich outlet temperature was 195F and rapidly decreased to 160F. The lack of heat provided to the regenerated caused the reboiler to work much harder and in return stripped high levels of CO₂. When CO₂ stripping occurs in the reboiler high corrosion rates may appear in the reboiler and bottom of the regenerator.

corrosion due to the high CO₂ stripping. MDEA was the optimized amine to use to reduce corrosion. With only a pump to replace the facility could strip the gas at higher rates and a reduction of 30% heat duty to the reboiler with substantial decrease of corrosion

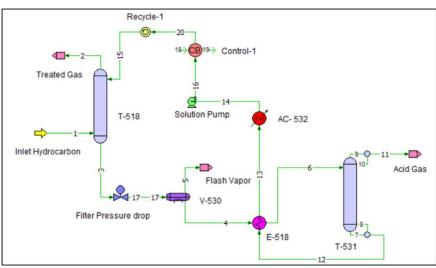
The simulation performed results indicated that the lean rich exchanger and reboiler were at high risk of
